WYDDIAL BURY FARM
Wyddial, Herts.

(HN337)

*Historic Building Record &
Archaeological Monitoring Report*

Report no.198

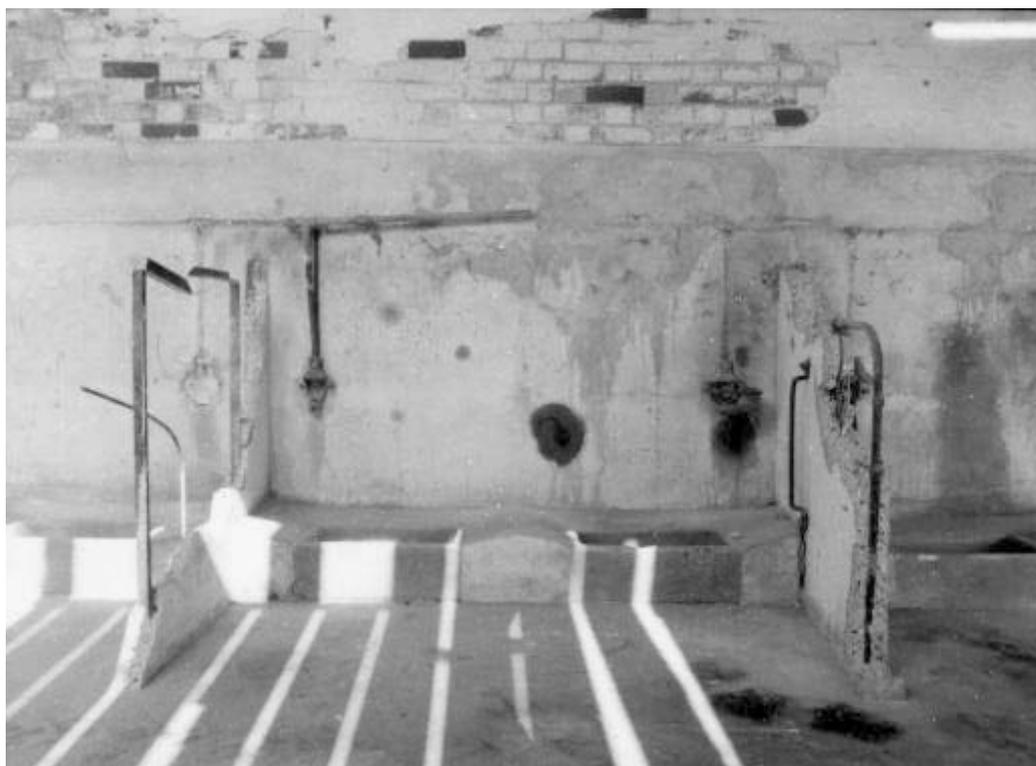
Plate 6a

Cow stalls

2.11 Barn 2 measures approximately 9.30m in length. Five cow stalls are set into the north wall (Fig. 5 & Plate 6a). Each stall has two feeding troughs on the floor, water bowls on the walls and vertical tying bars. A drainage channel runs down the centre of the barn. The walls have been concreted to half height. Some of the plaster has fallen from the wall above the concrete, revealing that the interior wall was constructed from various, possibly cheaper, types of bricks. The remaining original window is in the south wall of this barn, and to the east of it is a sliding barn door approximately 3.42m wide. A single door in the southern end of the east wall connects Barn 2 with Barn 3.

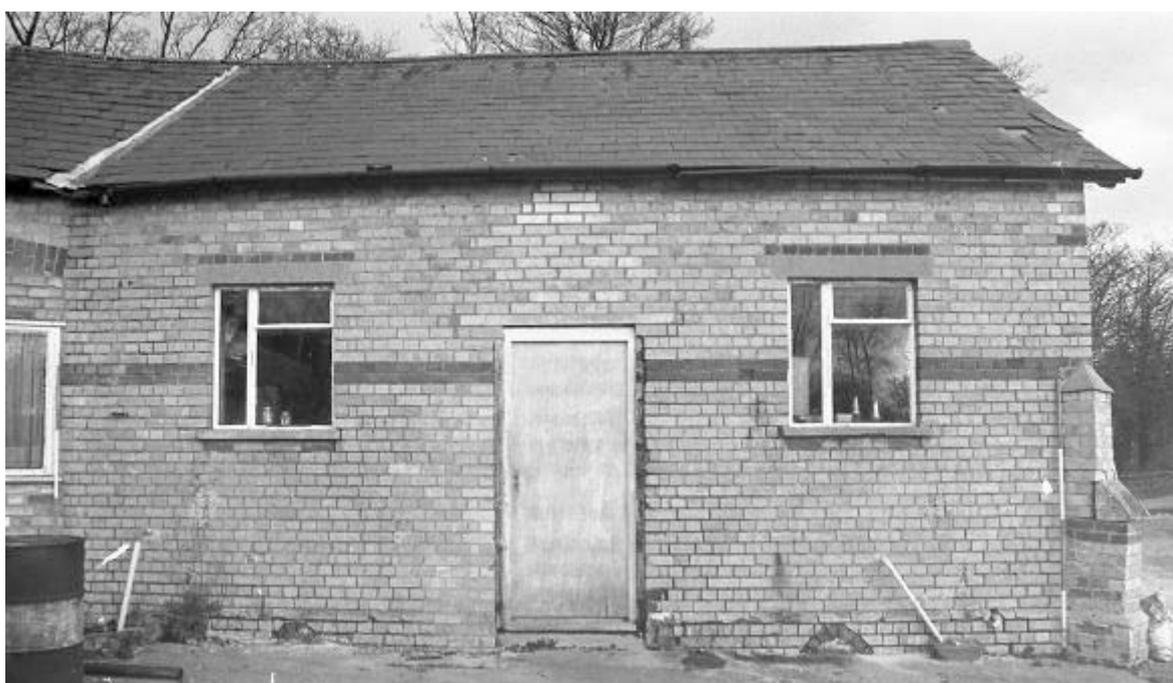
Plate 6b

Barn 6

2.15 Barn 6, which is in total approximately 7.0m in length, has been subdivided to provide living accommodation (Fig. 5 & Plate 6b). The door in the south wall leads into a kitchen cum living area, which measures no more than 4.34m in length. The window to the north of the door in the south wall has a sink below it. To the south of the kitchen is a bathroom, which measures approximately 2.12m by 2.34m. It is lit by the southernmost window in the barns. In the south-east corner of the barn is a bedroom which measures approximately 3.27m by 3.04m. The window in the south gable provides the light for this room.
