WELLBURY HOUSE SCHOOL School Lane, Offley, Herts.

(HN412)

Archaeological Evaluation Report

Report No. 193

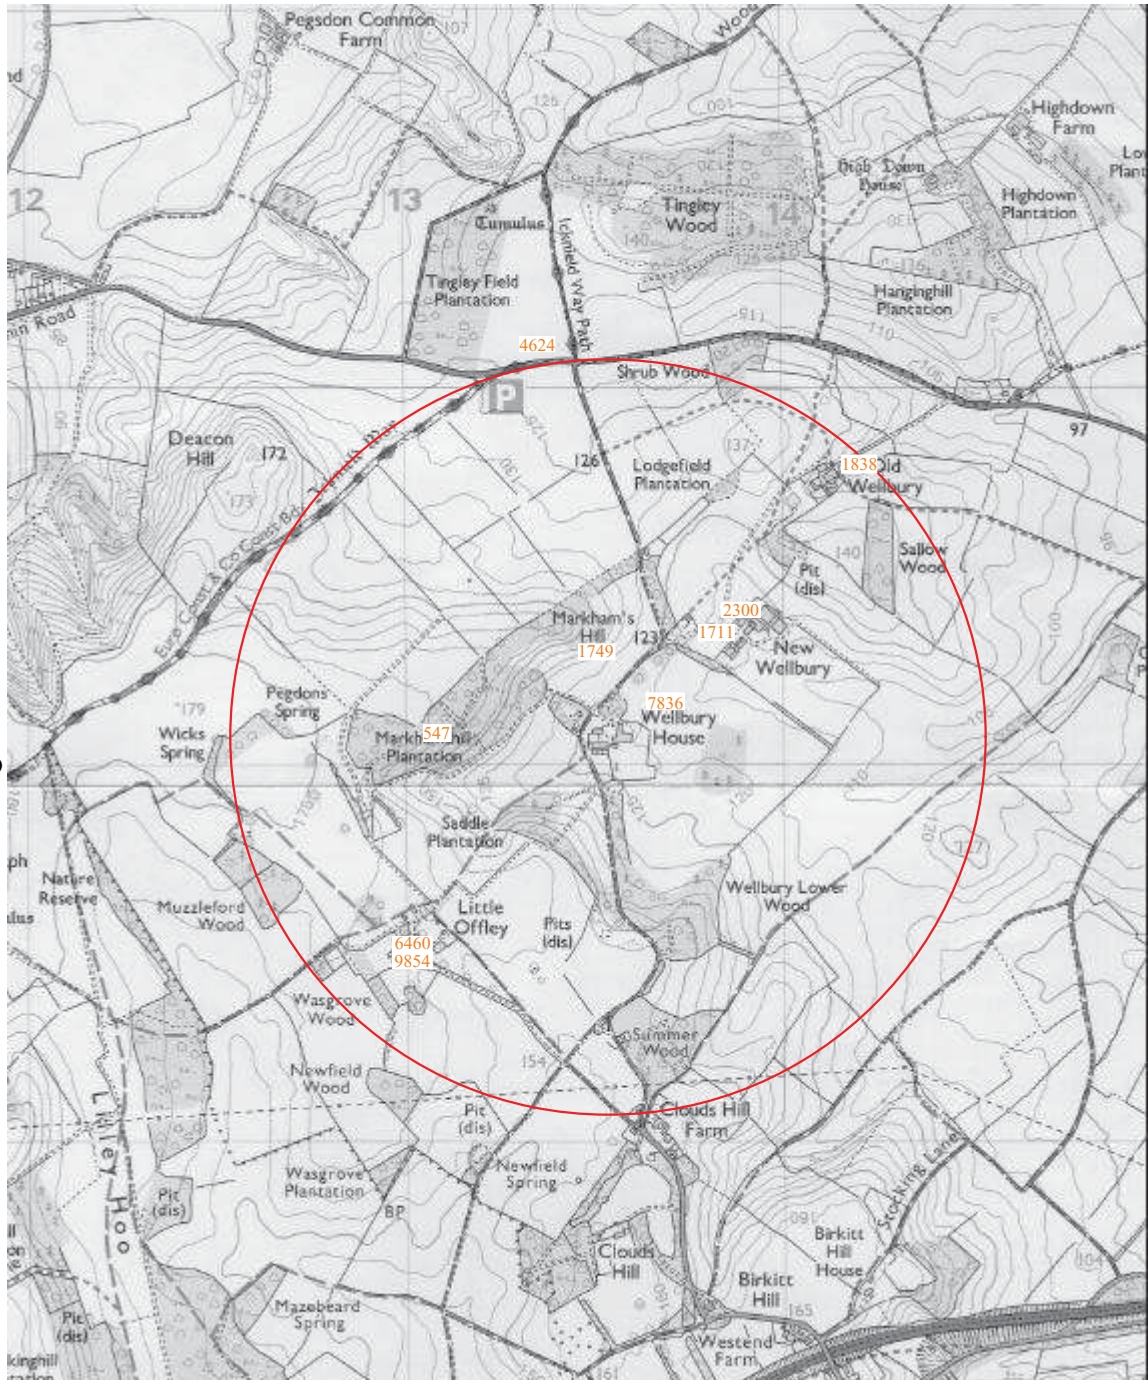
Figure 2

SMR plot for 1km radius from study area

2.3 The County Sites and Monuments Record (SMR) and the field section of the North Hertfordshire District Council hold data on archaeological sites within 1km of the study area (Figure 2).
