Two Timber-Framed Houses at El

STEPHEN CASTLE

Creasey's Fruiterers (figs. 1-3)

Leonardo Antiques (figs. 4-7)

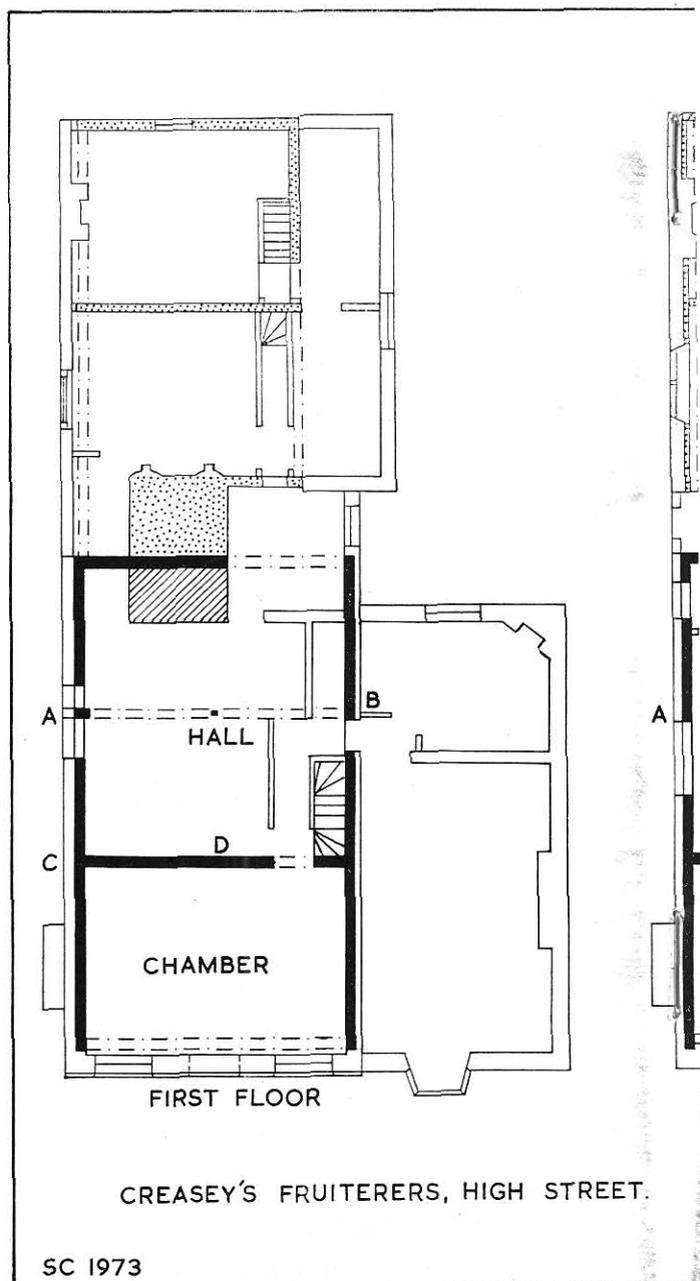
Fig 2. Creasey's: ground and first floor plan.

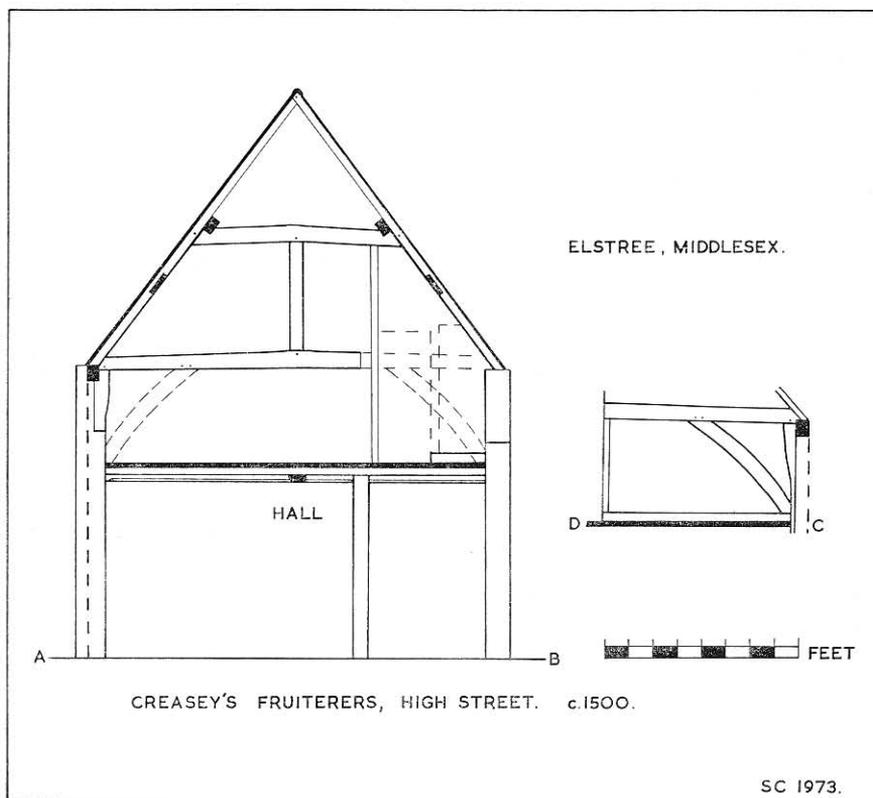
Fig. 3. Creasey's: section through the open hall showing the lower ring-strut roof truss A-B and the inserted first floor; also a section of the hall partition D-C.

Immediately behind the frontage is the three-bay hall house, comprising a two-bay open hall 17½ft. x 15½ft. internally, which is spanned by a plain cambered tie-beam⁴ above which is a plain square-sectioned lower king-strut (fig. 3)⁵. Springing from the jowled wall-posts to the soffit of the tie-beam were plain arch braces. Above the king-strut is a cambered collar which clasps the side-purlins. Springing from the principal rafters to the purlins are arch wind-braces. The soot encrusted rafters of the open hall are halved and pegged at the apex. Heating would have been provided by an open fire, probably in the centre of the hall, the smoke from which presumably escaped through a louvre at the east gable end. Between the hall and third bay is a lower king-strut truss with upright studs, comprising an original partition with tie-beam supported by arch braces, one of which survives. Presumably the first floor of

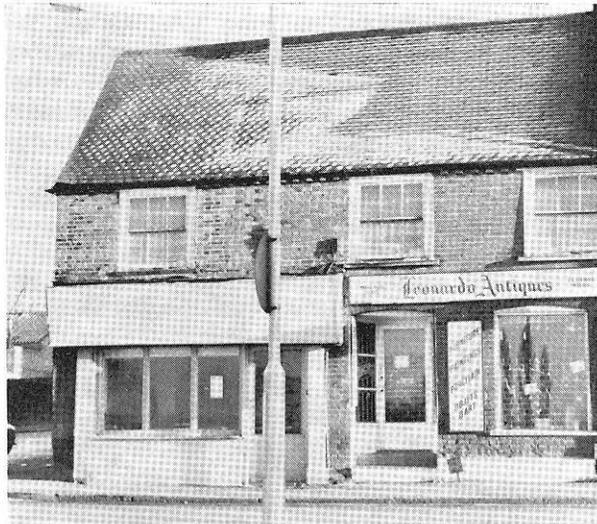
Fig. 4. Leonardo's Antiques from the west showing late-brick facade to hall house.

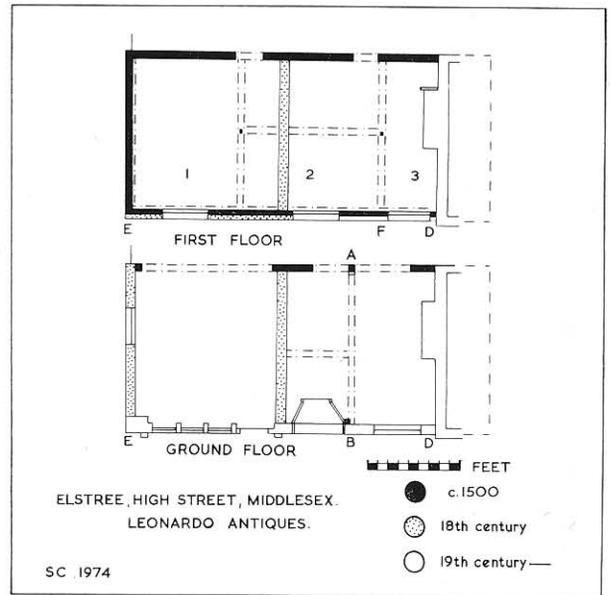
Fig. 5. Leonardo's: ground and first floor plans of the three bay hall.

This building comprises merely an open hall of three bays, the southernmost of which, bay 3, is incomplete. What remains of the hall is 16ft. wide by at least 30ft. 6ins. long, externally, though to judge from the position of a 19th century extension at the rear, bay 3 like bay 1 was probably 11ft. long, suggesting a total length of 36ft. The hall is spanned by slightly cambered tie-beams, above which are plain rectangular-sectioned lower king-struts which support the cambered collars (fig. 6)⁹. These collars clasp the side-purlins which are supported by arch wind braces. A notable feature of the principal rafters is that they narrow in width above the purlins¹⁰. Also noteworthy is the absence of wind-braces, and

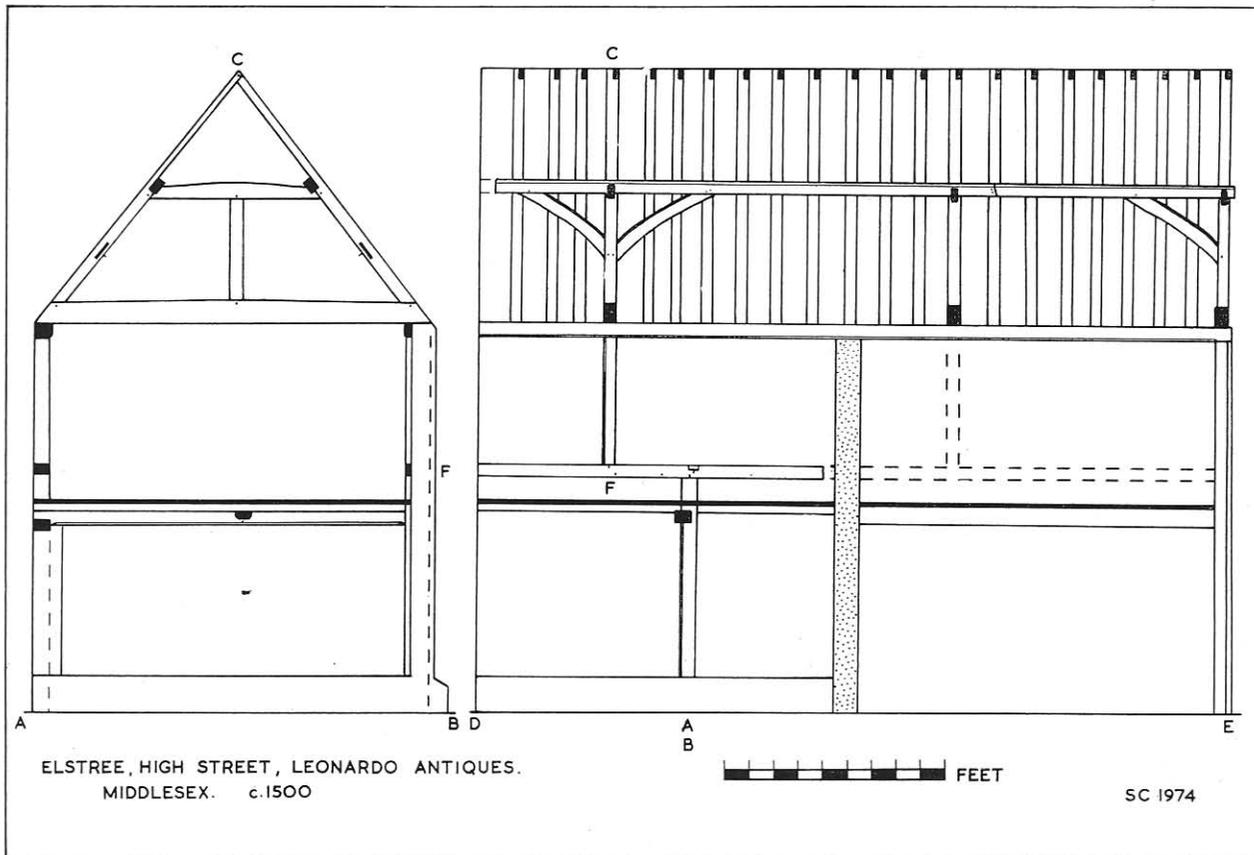
Fig. 6. Leonardo's cross and longitudinal sections of hall showing inserted first floor, lower ring-strut roof truss (left) and arch wind-braces (right).

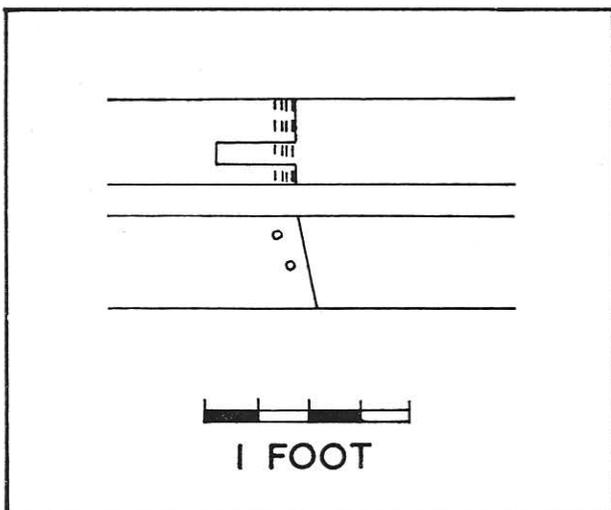
Fig. 7. Leonardo's: bridled scarfjoint of the side-purlin (see fig. 6 for position).

The bridled scarf joints of the purlins are slightly splayed (fig. 7) and medieval carpenters' numerals (Roman numeral's) are inscribed on the rafters. The principal wall-posts which are not jowled, merely extend from the middle to upper wall-plates and the absence of mortise sockets confirms that the tie-beams were not braced. Both the principal and common rafters, the collars and wind-braces are soot-encrusted thus indicating that this building was originally an open hall, possibly part of a much larger building.
