Medieval Buildings at Trig Lane

GUSTAV MILNE
CHRISIE MILNE

A DETAILED ANALYSIS of the medieval riverfront reclamation investigated on the Trig Lane site from 1974-6 (TQ 326 808) will be published later this year¹. However, the buildings recorded during that excavation are not assessed in that particular report, and the purpose of this short paper is to summarise the evidence for these structures and to establish their context.

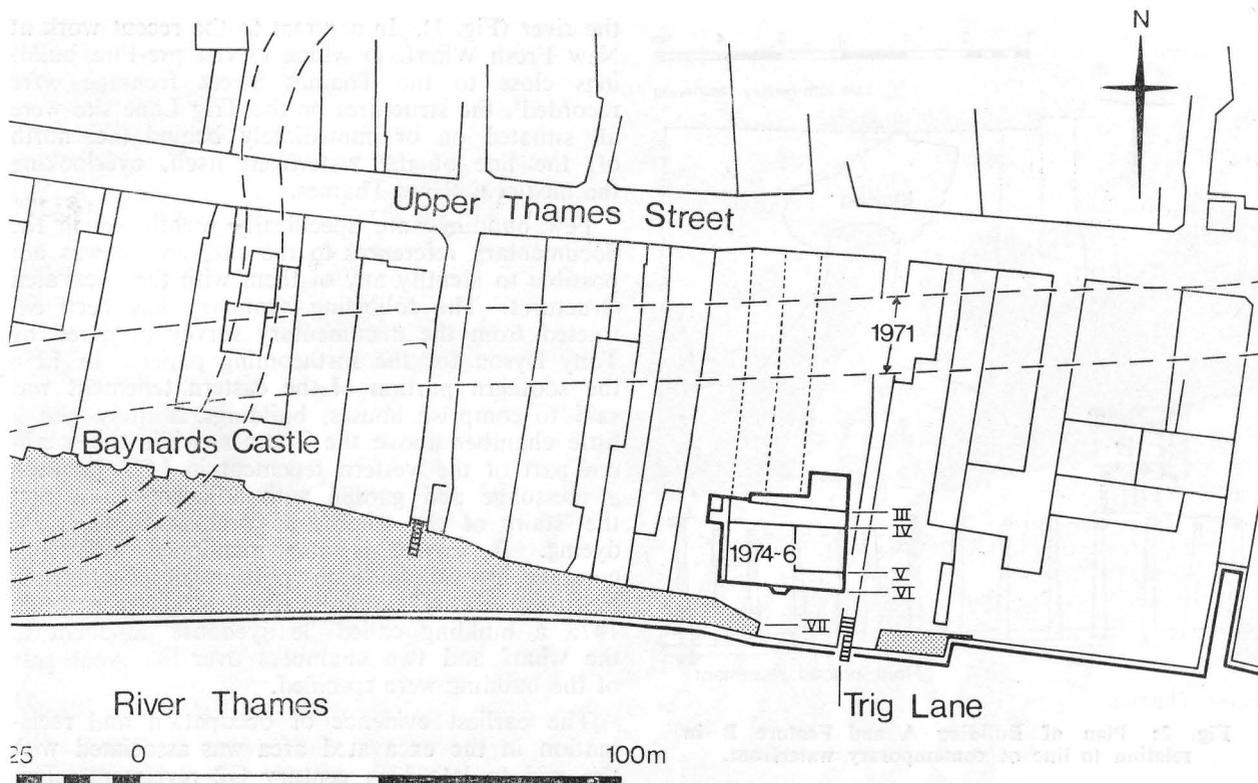
Fig. 1: Site of 1971 and 1974-6 excavations in relation to pre-Fire waterfront and former line of Thames Street. Dashed line shows present day street alignment, dotted line assumed medieval property boundaries. Chronology of waterfront reclamation: Period III — mid 13th century; Period IV — mid 14th century; Period V — late 14th century; Period VI — mid 15th century; Period VII — post 17th century (shown toned).

From 1974-6 the Museum of London's Department of Urban Archaeology excavated a 450m² site to the west of Trig Lane, just south of the line of Upper Thames Street (Fig. 1). The detailed examination of this area showed that it had been gradually reclaimed from the river, from the 13th to the 15th century. This process was effected by erecting a timber or stone revetment upon the foreshore to the south of the contemporary frontage, and infilling the intervening area with dumps of refuse sealed by a stone or gravel surface³.

the river (Fig. 1). In contrast to the recent work at New Fresh Wharf, in which eleven pre-Fire buildings close to the Thames Street frontage were recorded⁵, the structures on the Trig Lane site were all situated on or immediately behind (i.e. north of) the line of the waterfront itself, overlooking the medieval River Thames.

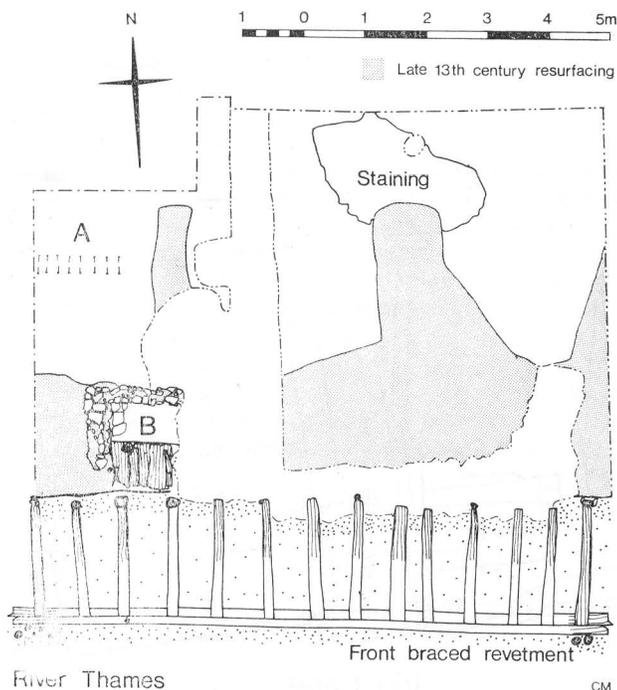
Fig. 2: Plan of Building A and Feature B in relation to line of contemporary waterfront.

In the later 13th century, the G2 revetment was replaced by the G3 structure which involved the cutting of a number of north-south trenches through the earlier deposits to accommodate the back-braces⁷. One of the back-braces was itself cut by Feature B. The northern and western walls of this feature were built of random chalk rubble; the southern wall was formed by part of the horizontal planking of the G3 revetment, but the eastern wall had been destroyed by the mid 14th century Building C (Figs. 2 & 3). In its earliest phase, the

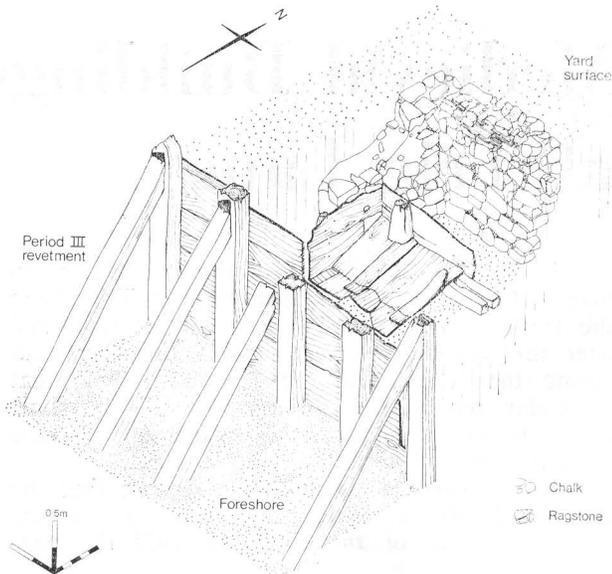
Fig. 3: Projection of sub-surface Feature B showing timber compartment probably used for storage.

feature had a gravel and earth floor set 1m below the level of the contemporary ground surface. Four ragstone blocks had been carefully laid in the north west corner of the floor, perhaps to support a timber floor which was subsequently removed. In its latest phase, Feature B was divided into two with the construction of a timber compartment in its southern half with a planked floor (Fig. 3). The southward slope of the floor was probably the result of later dumping of debris onto it and subsidence below it rather than a deliberate structural attribute.

Feature B cannot have been larger than c. 1.4m (4ft 6in) square, although it may well have been part of a larger complex, the evidence for which was not recorded. Its compartmental layout and lack of direct access to the river preclude the possibility of it functioning as a garderobe pit. The timber lining did not seem so well fitted as to render the compartment watertight, so it is unlikely to have been constructed to store liquids. The storage of a perishable commodity in a cool moist state is therefore considered to be the most likely function of Feature B.

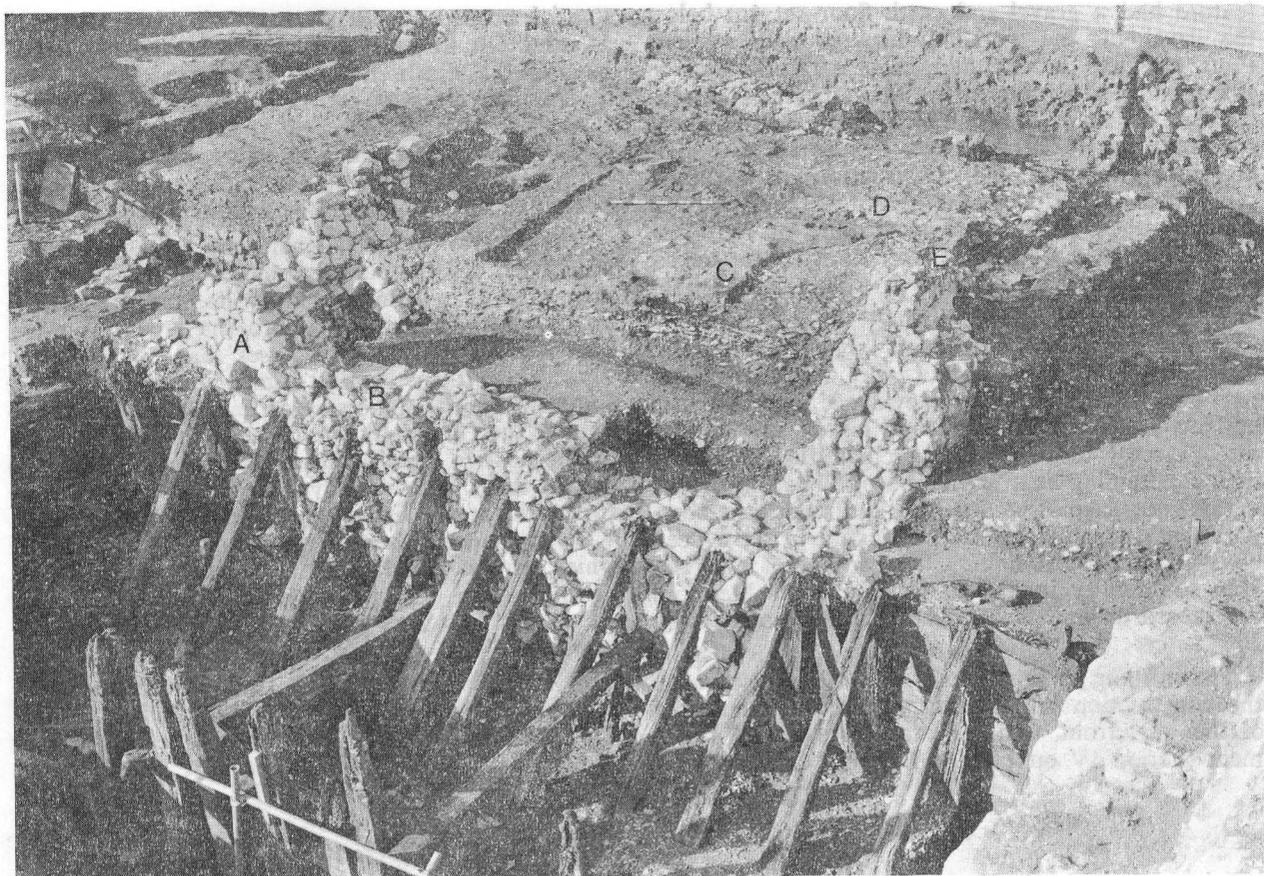
Fig. 4: Building C looking NW. (a) drain (b) chalk rubble foundations (c) floor sealing earlier levels of fire-damaged building seen in section (d) partition wall (e) dwarf stone wall.

On the western side, where the building overlay the Period III compacted stone surface (see above), the wall was c. 0.5m (1ft 8in) wide, and founded on flint nodules laid directly onto the ground surface. The wall was only two courses high, and was flat topped as if to support timber-framing. To the south, where the stone surface had been cut away to remove the G2 revetment and erect the G3 structure, more massive chalk rubble foundations over 2m (6½ ft) deep were employed to compensate for the softer less stable backfill material in this area. Fig. 4 shows the undressed, roughly coursed chalk rubble which cannot have served as a river wall, but was a sub-surface foundation sealed within the infill associated with the Period IV advance of the waterfront. The size of these foundations suggests that they may have supported a two-storied building.

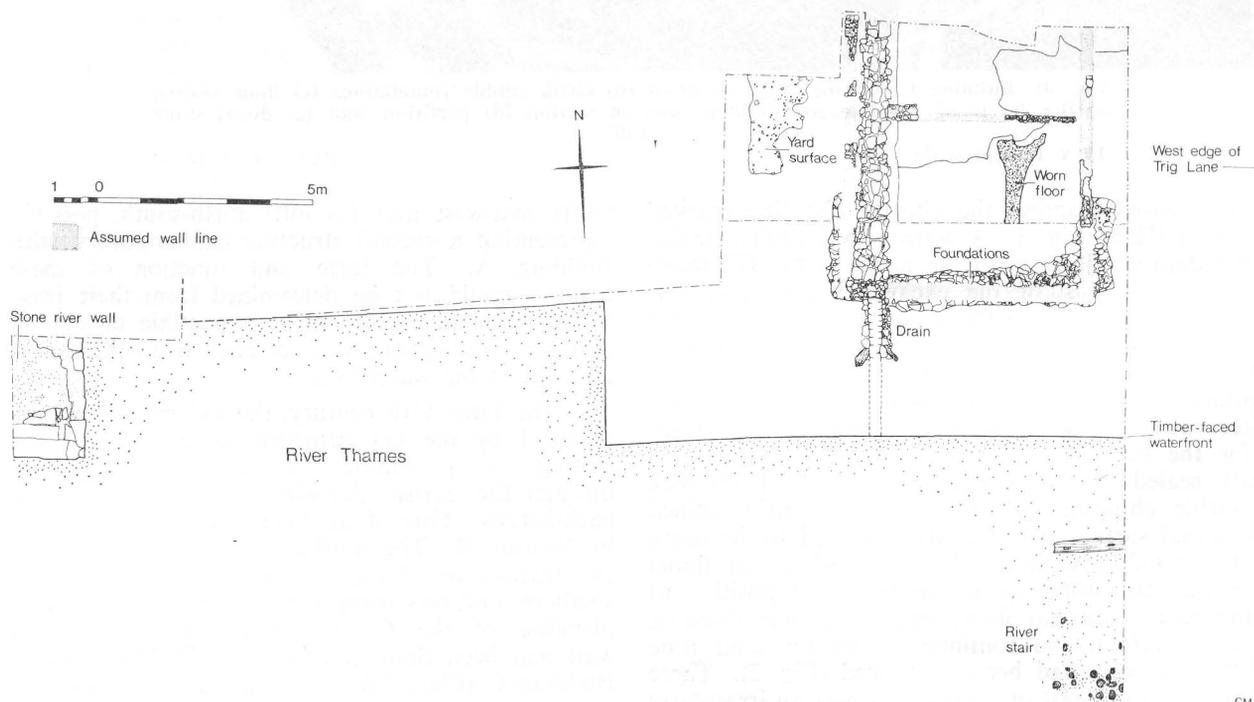
Fig. 5: Plan of Trig Lane waterfront in c. 1350 showing position of Building C, cf. Fig. 6.

The tile base of a ?partition wall and a rammed chalk floor were also shown to be contemporary with the earliest phase of Building C (Fig. 5). The

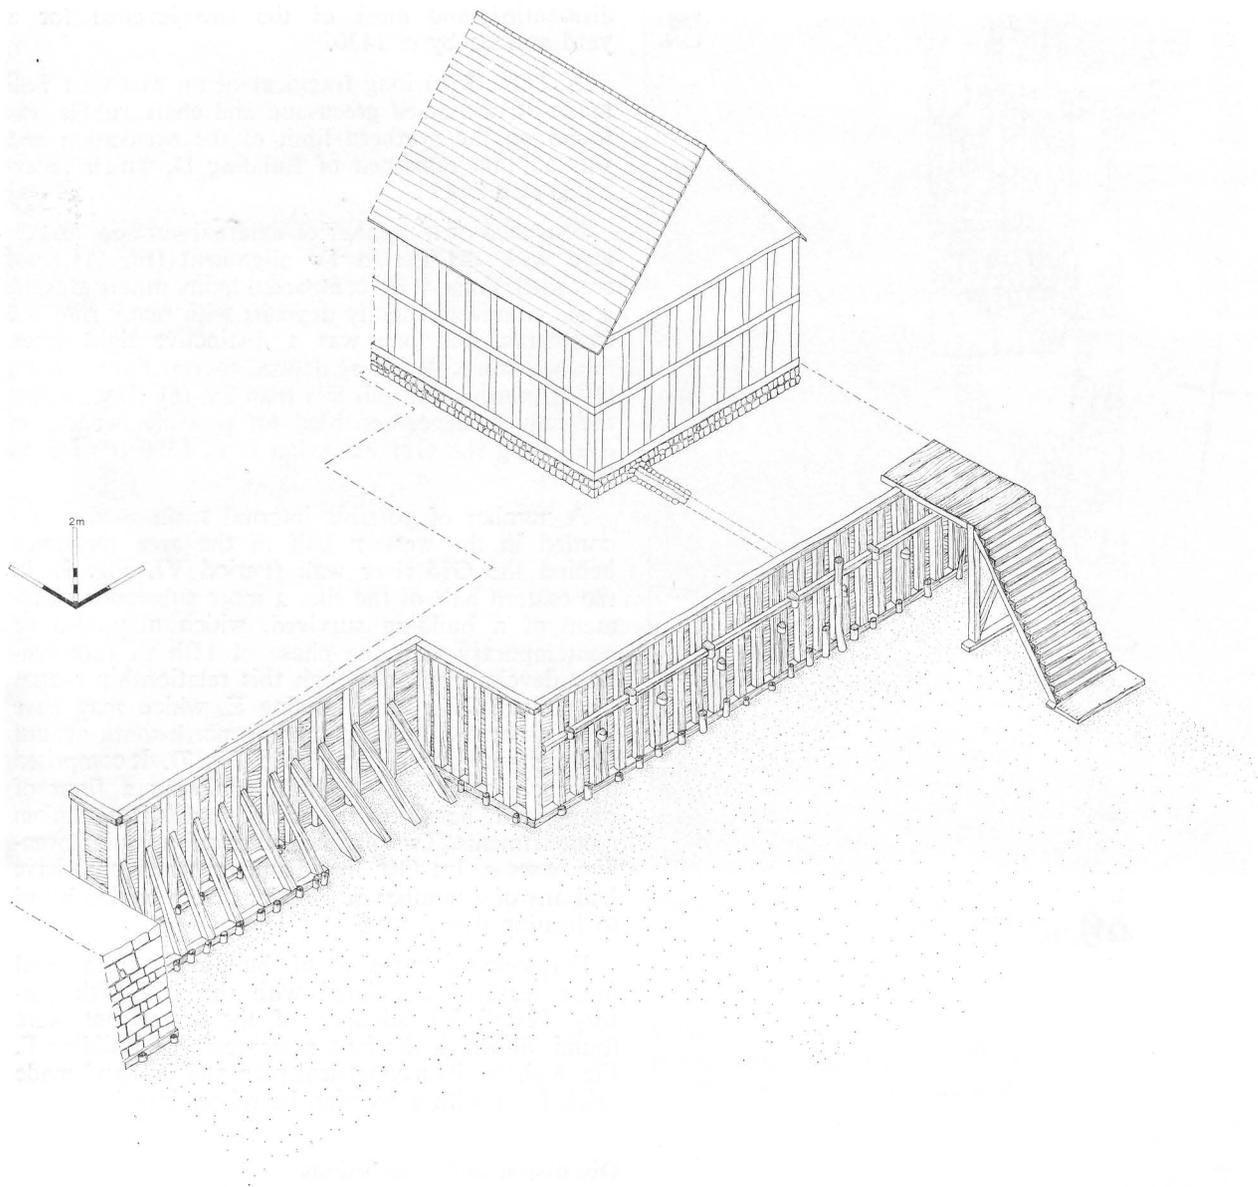
Fig. 6: Partial reconstruction of Building C, showing relationship to other features on Trig Lane waterfront in c. 1350. Looking NE, cf. Fig. 5.

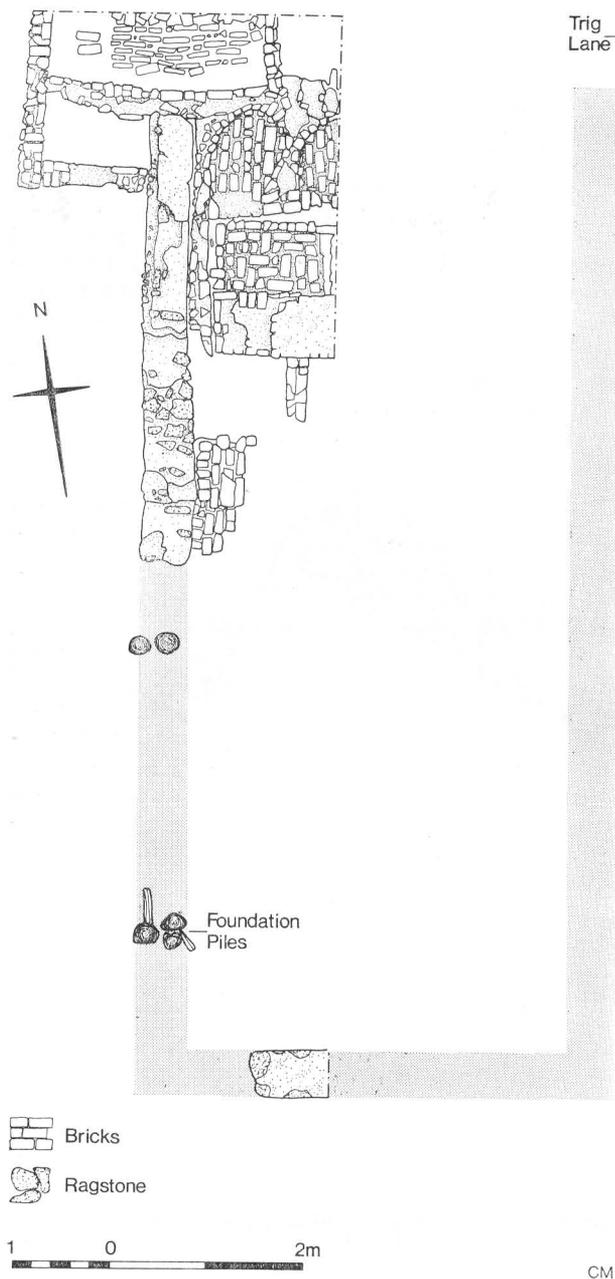
Fig. 7: Plan of Building E situated c 10m north of Period VI river wall (see Fig. 1).

A number of possible internal surfaces were recorded in the western half of the area reclaimed behind the G15 river wall (Period VI, Fig. 1). In the eastern half of the site, a more substantial fragment of a building survived, which may also be contemporary with the phase of 15th to 16th century development, although this relationship cannot be proved. This was Building E, which may have been a narrow building running north-south against the western edge of Trig Lane (Fig. 7). It comprised a trench built ragstone wall enclosing a floor of orange-red hand made bricks and three sunken compartments. Two of these were sub circular oven-like bases c. 1m (3ft 3in) diameter, which may have had any of a number of functions from baking bread to heating dyers' vats.

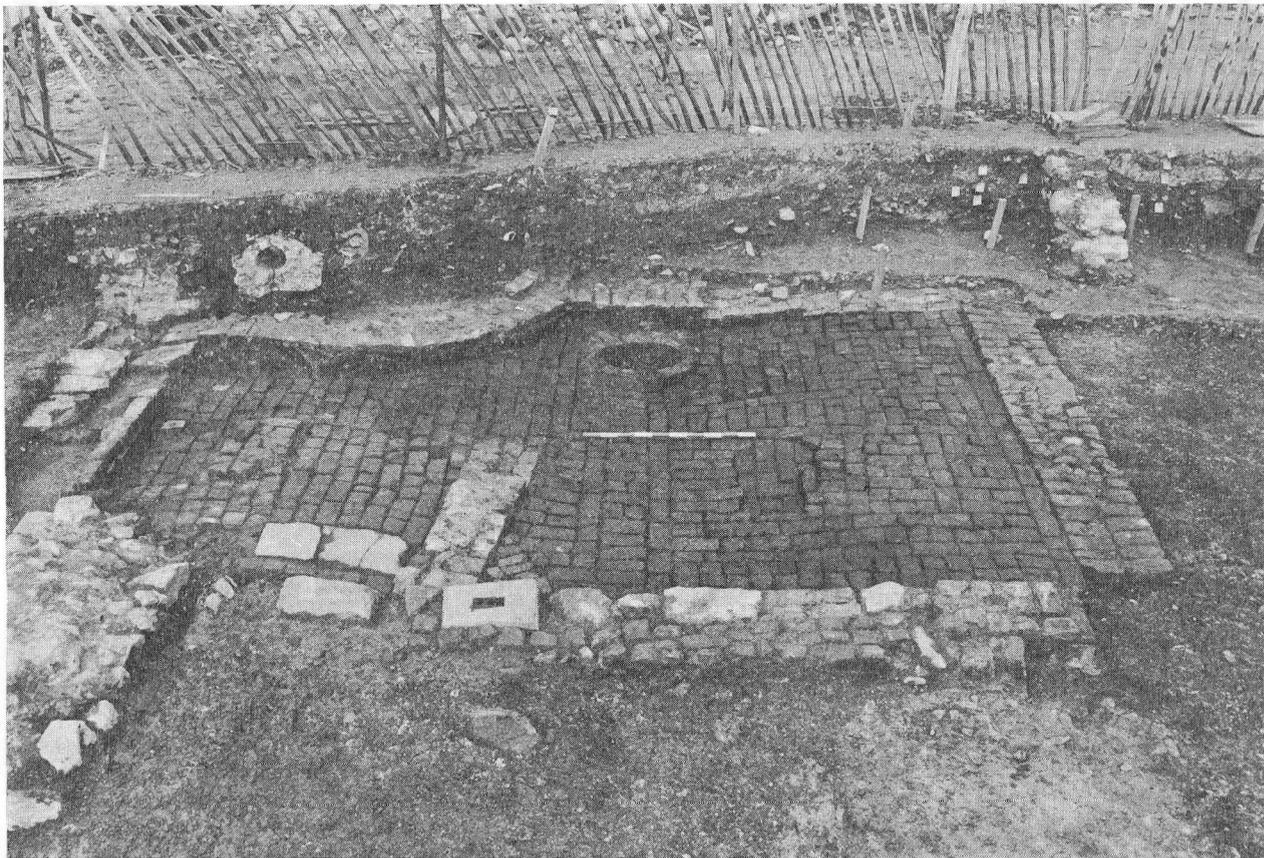
Fig. 8: Building F, situated in northwest corner of site, looking N.

Fragmentary remains of buildings, drains and other features associated with the 16th-17th century Period VI advance of the waterfront were found, of which the best preserved was Building F. Fig. 8 shows its asymmetrical plan and its hand made brick floor with a wooden barrel set into it.
