Chiswick Municipal Stables

GEOFFREY BOWLES

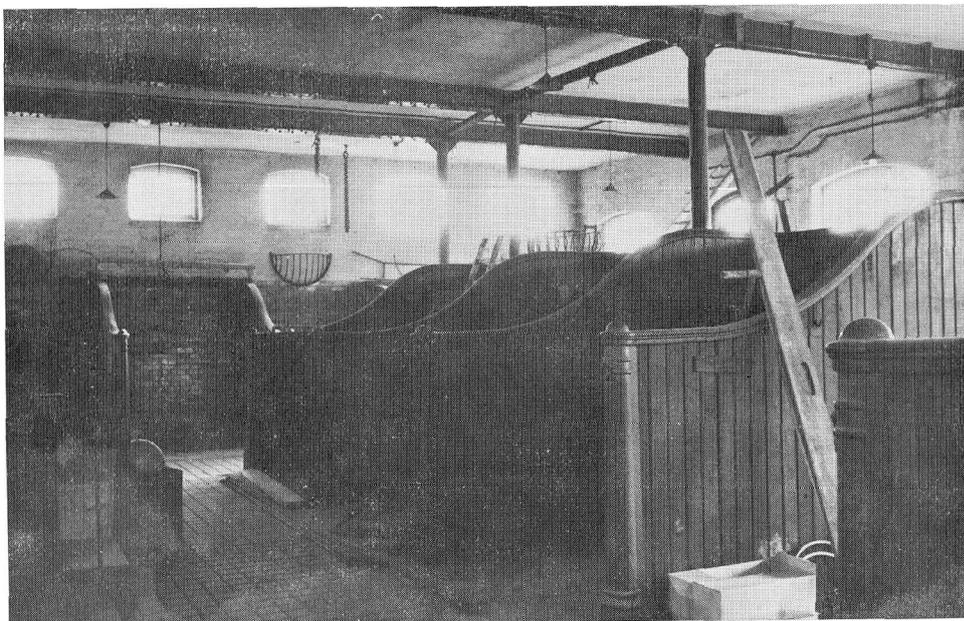
Fig. 1: Ground floor interior

According to Council records, the stall divisions (Fig. 1) were bought at auction in 1909, and the stables were apparently planned around them. They are constructed of teak tongued and grooved boards set in a curved cast iron frame and are provided with wide elm kick boards. The free end of each division is supported by a cast iron post

bearing the initials 'L.G.O.Co'. This identifies the stalls as surplus stock of the London General Omnibus Company, which was at this time gradually replacing its horse buses. Each stall contains a large iron hay rack, and in a few stalls mangers for oats and chaff remain, consisting of deep galvanized bowls fitting into a triangular framework fixed across one corner of the stall. The stalls have no permanent water supply. The construction of the loose boxes is broadly similar to that of the stalls. Here the cast iron posts, which bear no initials, take the form of double doorposts at the entrance to each box. The doors, which have been taken off their hinges, are massively built, with iron frames, teak panelling and closely spaced iron bars.

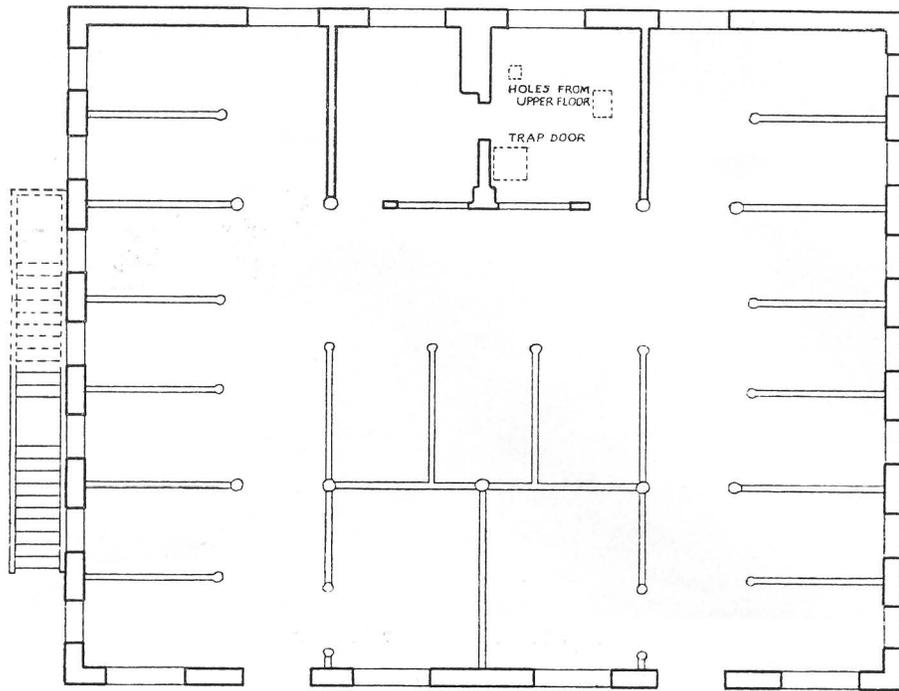
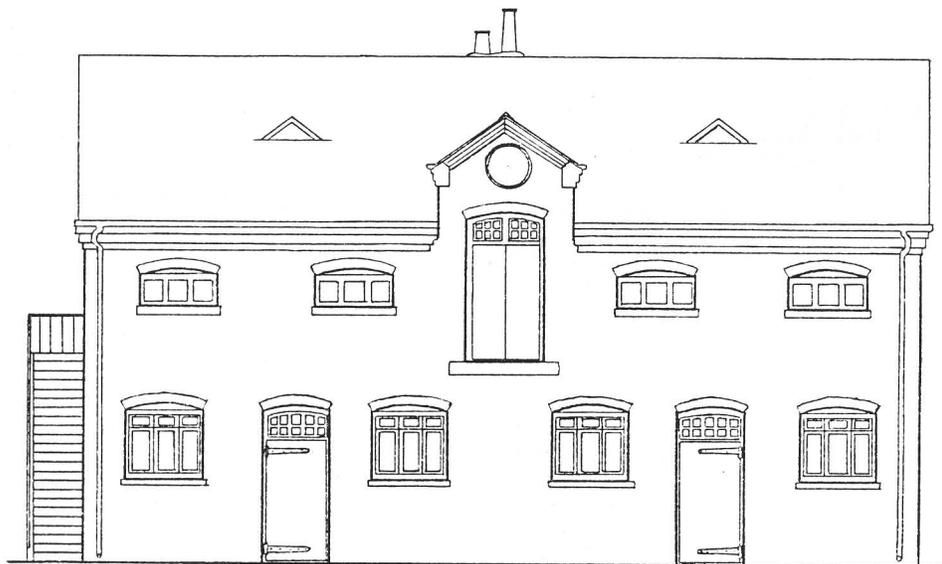
Fig. 2

GROUND FLOOR PLAN

FRONT ELEVATION

The stable block was built in 1910 to accommodate horses used by Chiswick U.D.C. for carting refuse. It is a substantial two-storey brick building under a slate roof; floors are concrete and the upper storey rests on cast iron pillars. The horses were kept tethered in stalls on the ground floor, while fodder was stored and processed above. Lighting was by electricity from the Chiswick Electrical Supply Corporation; the original fittings have been removed. The layout of the ground floor is shown in Fig.2. There are seventeen stalls, roughly nine feet by six, and two loose boxes of twice that size, probably used for veterinary pro-

cedures and, until 1913 when a small additional stable was built for the purpose, for isolating sick horses. The ground floor also contains two inter-connecting rooms. One of these, distinguished by a timber floor and a fireplace, was provided for the stable attendant; the other was a store room into which fodder and bedding straw was dropped from the upper storey. On the partition wall which divides the store room from the stall area are a number of large tack hooks. The walls of the stables are faced with salt glazed brick on the inside up to a height of about seven feet, and whitewashed above this level. The floor is in concrete granolithic paving, giving the effect of bevel-edge tiles, while within the stalls the surface is crossed by oblique channels which empty into drainage gullies.

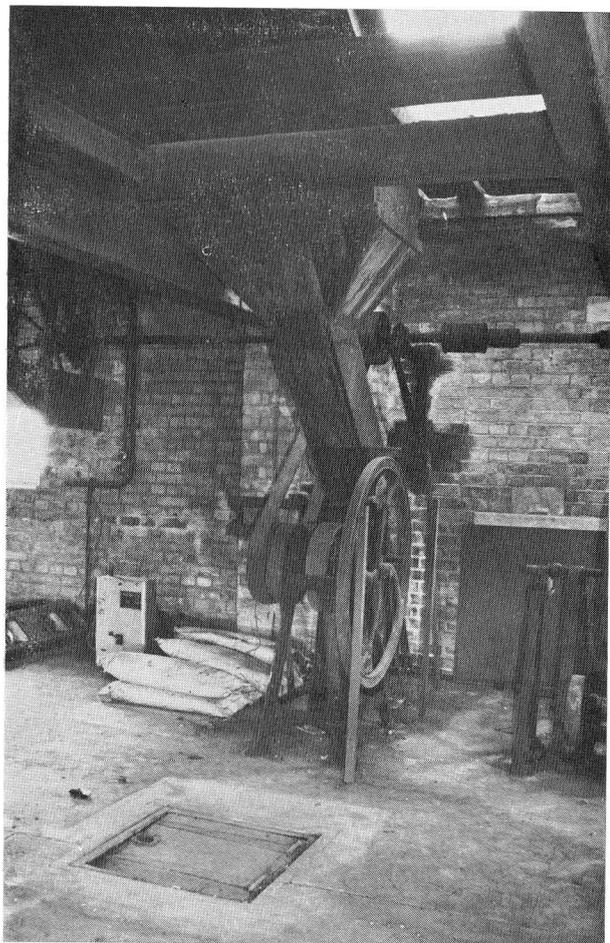
Fig. 3: Bentalls oat grinder

Both chaff cutters could be hand or belt driven, and fed hay or straw on a continuous slatted conveyor through revolving blades geared to the conveyor's drive. The larger of the two, a 'Samuel Edwards Patent Duplex' (Fig. 4) fitted with a Bentalls dust extractor, stands beside the oat grinder over a hole in the floor so that the cut chaff fell directly into the store room, while dust removed by the belt-driven extractor fan passed out through a pipe in the wall. The Edwards machine is clearly a replacement for the other chaff cutter, a Bentalls machine bought in 1906, which has been moved to one side. The machinery was driven by belt from a shaft mounted on the back wall, turned, according to Council records, by an electric motor. A 20 volt DC motor now standing beside the retired Bentalls chaff cutter has obviously been used for this purpose.

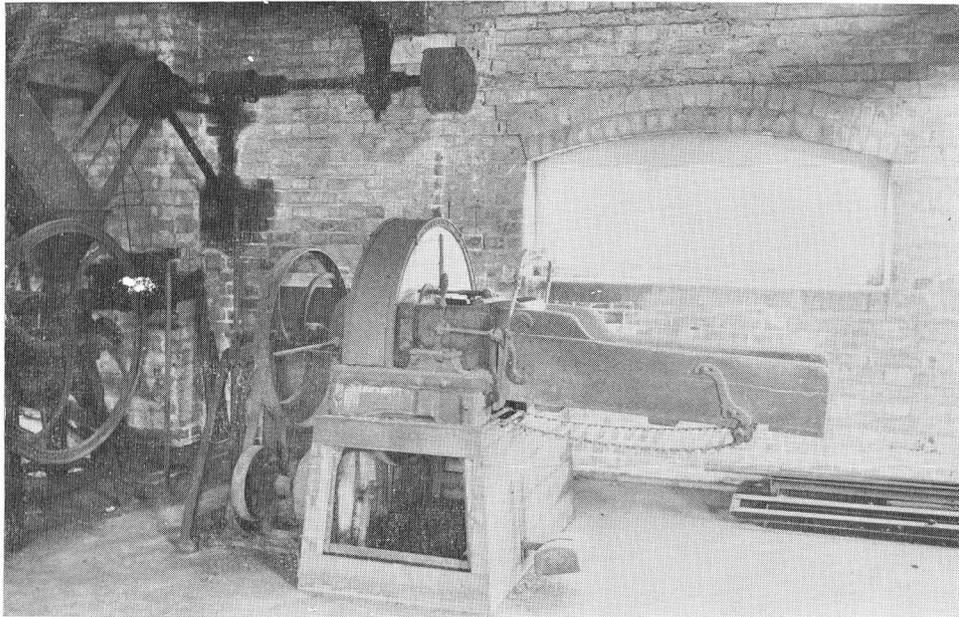
Fig. 4: Edwards chaff cutter

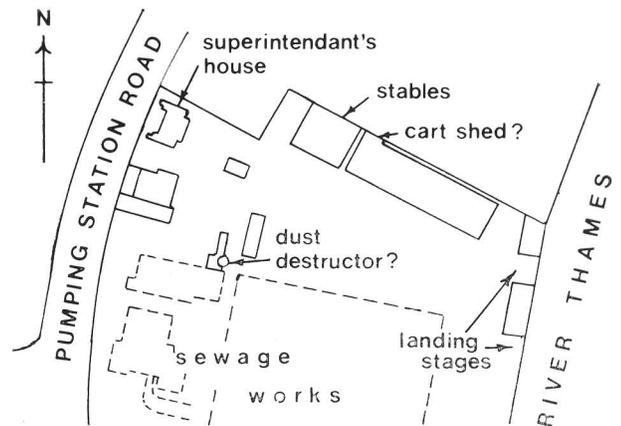
Fig. 5: Sketch plan of the depot in 1915 (from Ordnance Survey)

posal, built on an existing sewage pumping and treatment site. The only remaining building associated with the sewage works, which employed four steam engines and one diesel engines, is the superintendent's house (see Fig. 5). In 1908 a cart shed, housing dust vans, road sweeping and watering machines and the municipal steam roller, was added to the depot, probably at the site now adjoining the East wall of the stable block. The stables were, as we noted, built two years later. In 1911 a farrier's shop was added to an existing smithy and in 1913 an isolation stable was erected; the sites of these buildings cannot now be identified. Cartage functions became concentrated at the depot largely because of its easy access to the river, where a wharf had been built for unloading coal and building materials. When, in 1899, the Council lacked a convenient rubbish tip they employed contractors to barge refuse away. Three years later the practice was discontinued, partly for health reasons, and a dust destructor was built at Corney Road, which combined refuse and sewage functions by incinerating the refuse along with chemically treated sewage sludge. During the 1900s, therefore, refuse disposal was increasingly being concentrated at the depot and the advantages of stabling the horses on the site were obvious. The depot was the final destination of the refuse, the carts were already being kept there and fodder could be unloaded direct from the wharf. Moreover the old stables on the High Road were inadequate and had been supplemented by renting
