## Be a match for the arsonists

LESLEY ADKINS  
ROY A. ADKINS

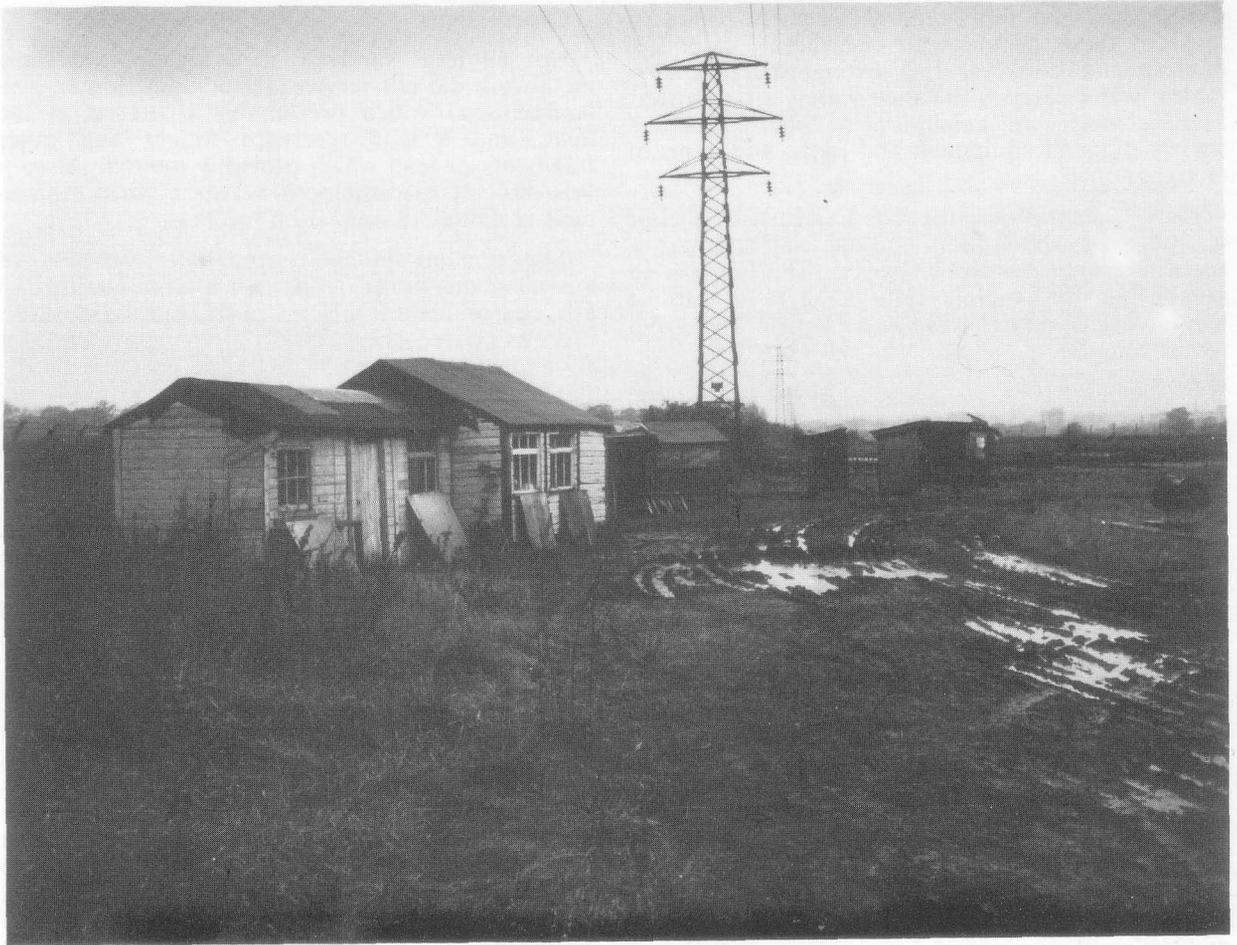
Fig. 1: the site huts before the fire.

IN MAY 1985 an arson attack on the site huts of the Beddington excavation resulted in the loss of most of the wooden site huts and their contents. Four huts were damaged or destroyed. Hut 1 (the mess hut) had a floor area of 15ft × 15ft and a pitched roof 11ft high at the ridge. Hut 2 (the finds hut) had a floor area of 10ft × 15ft and a pitched roof 9ft high at the ridge. Hut 2 was built onto hut 1, and both had roofs covered with bitumen felt and walls partly covered with felt. Hut 3 (the directors' hut) had a floor area of 6ft × 10ft, with a pitched roof 7ft high at the ridge, and hut 4 (the supervisors' hut) had a floor

area of 6ft × 8ft with a pitched roof 7ft high at the ridge. The roofs of these huts were also covered with bitumen felt. Huts 3 and 4 stood 8ft apart, but were joined by a wooden frame supporting a shelter of heavy duty plastic sheet. These were the huts affected by the fire: in addition there were three huts containing elsan toilets and an ex-customs steel storage container.

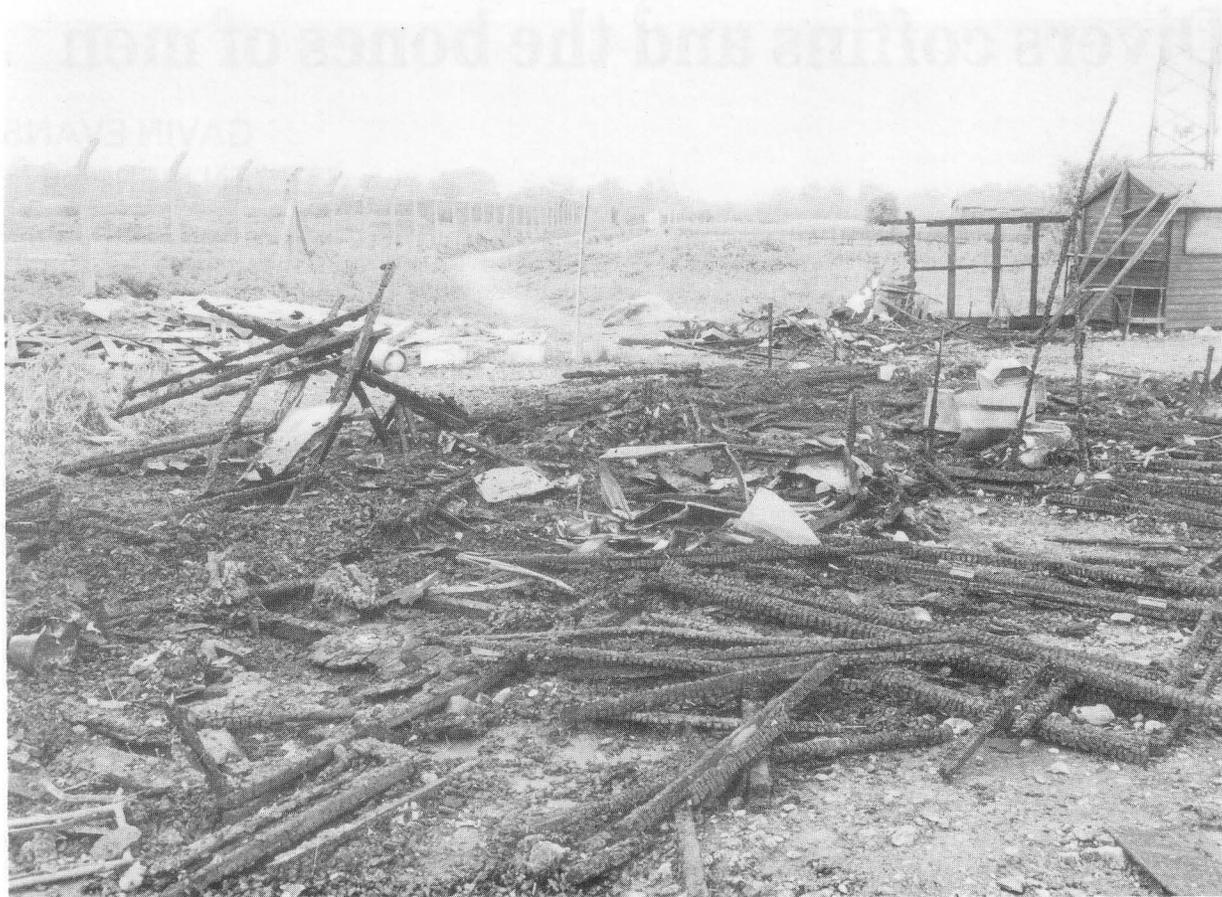
Huts 1, 2 and 3 and the wood and plastic shelter were burnt to the ground, and one wall and part of the roof of hut 4 were destroyed. The fire was so severe that, for example, only the steel toe caps of leather boots survived, and the kettles and typewriter completely melted.

The remains of the burnt huts consisted of miscellaneous burnt debris and a large quantity of ash, charcoal and fragments of charred wood. After this was cleared, there was no surviving evidence for a building apart from a blackened area with the charred stumps of two posts set in the ground, and a short section of drainage gully. Some stones beneath the huts had been reddened by heat, but no stones appeared to have been shattered by it. The blackened area of ground became so bleached by weathering that it was almost undetectable. It seems likely that if the burnt debris had been left for future excavators, the presence of the huts would be easily detectable, but clearance of the site has removed nearly all trace of them.

Fig. 2: the burnt remains of the huts.

1. All field drawings should be done on plastic drafting film in order to minimise damage by water.
2. All records should be photocopied – completed records within a few days of completion and on-going records at regular intervals. Photocopies should be taken of *everything*, including photographic records, accounts and staff employment details, as well as site records and drawings. The security copies should be stored far enough away to be unaffected by fire – preferably several miles away.

7. If space permits, huts should be placed well apart from each other, with separate huts for different functions (the Beddington elsan toilets were saved because they were placed well away from huts 1-4).

8. If possible a steel container (such as an ex-customs storage container) should be used for storage of equipment, finds and records. Most of the equipment at Beddington was stored in such a container and so was not affected by the fire.
