The discovery of Londinium's amphitheatre: excavations at the Old Art Gallery site 1987-88 and 1990

Nick Bateman

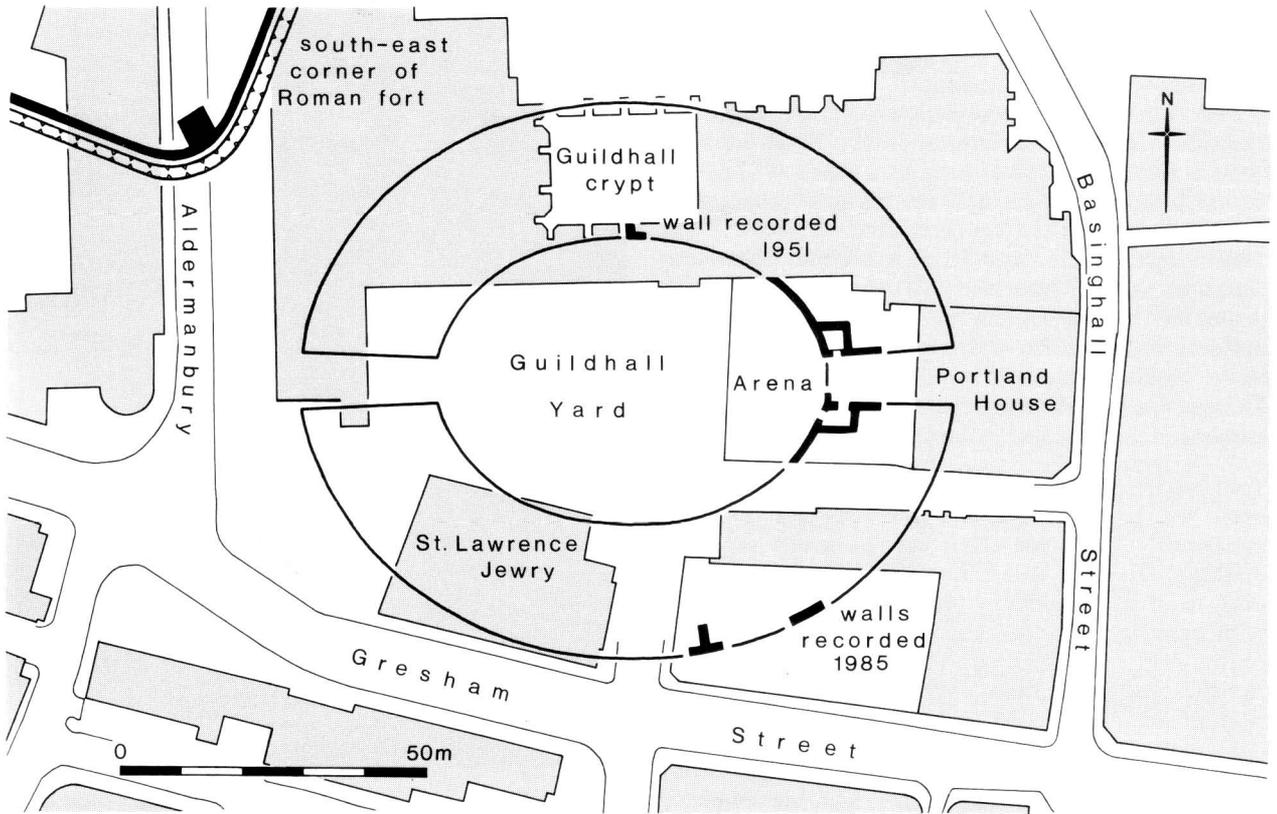
Fig. 1: site location.

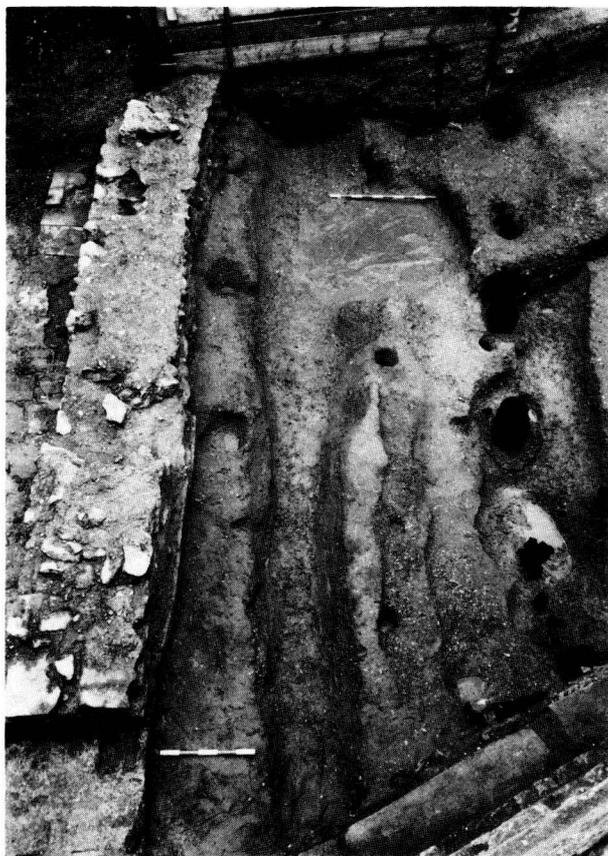
Fig. 2: 1st-century amphitheatre, showing the timber piles of the early amphitheatre. On the left is the arena wall.

The main element of this structure was the feature recorded in Areas A, E and H, comprising a row of substantial squared timbers set in a curving foundation trench, which may represent the remains of a timber wall or palisade⁵. To the west of this was a large open space in which were compacted gravel surfaces.

An entrance across a threshold defined by the large sill beam (Figs. 2 and 8) connected the open space with a subsurface room to the east. Part of this seems to have been provided with a planking floor, most of

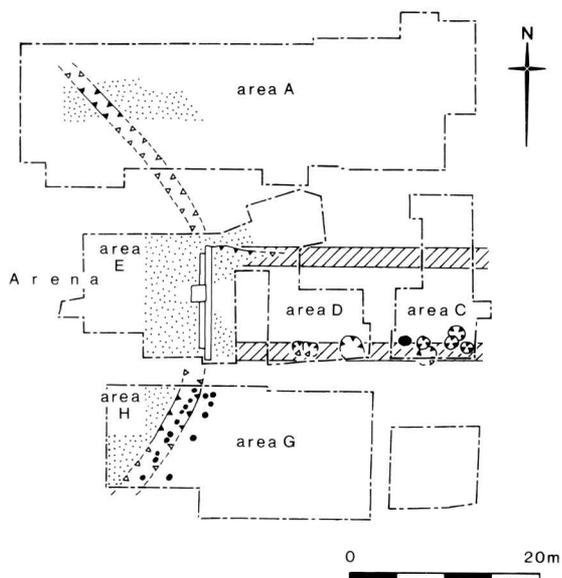
Fig. 3: 1st-century amphitheatre.

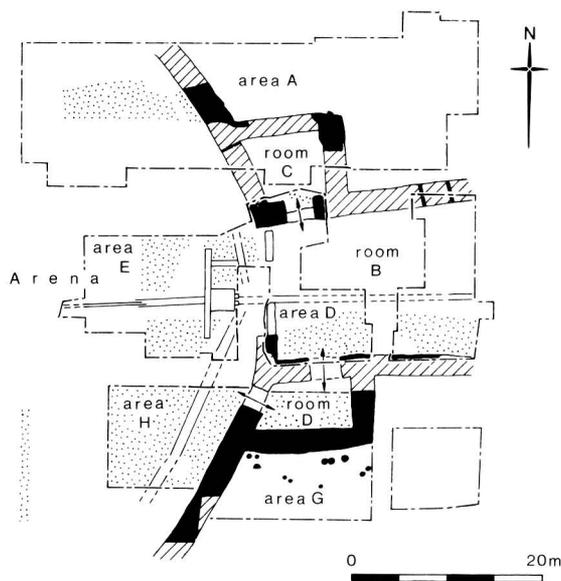
Fig. 4: 2nd-century amphitheatre as originally built.

Within the arena (Fig. 4), the first surface laid was a patchy *op sig* which was continued up the face of the arena wall as rendering. If the walls which defined the arena continued at the same curvature they would define an elliptical shape which would be unlikely to be less than c 100m (330ft) wide at its maximum⁹.

The 'entrance way' (Fig. 4) is so defined by the large gap separating the northern stretch of curving wall from its southern counterpart. The extent of the surfaces within indicates that the 'entrance way' must have continued beyond the eastern limit of excavation although the eastward extent of the walls was more ambiguous. The lowest and earliest surface comprised a thick deposit of large ragstones and tiles, the top of which was firm and compact. In spite of being perhaps more distinctive than any later surface, in Areas F and B it was not traced where the succeeding surfaces were recorded.

Two small antechambers (Fig. 4) were built on the north and south sides of the wide 'entrance way'. They were quite different in size and neither was rectangular, but both had doorways with timber thresholds giving access to the 'entrance way'. In addition the south chamber had a stone-flagged threshold leading onto the surfaces of the arena (Fig. 6), and the north chamber may have had a similar arrangement.

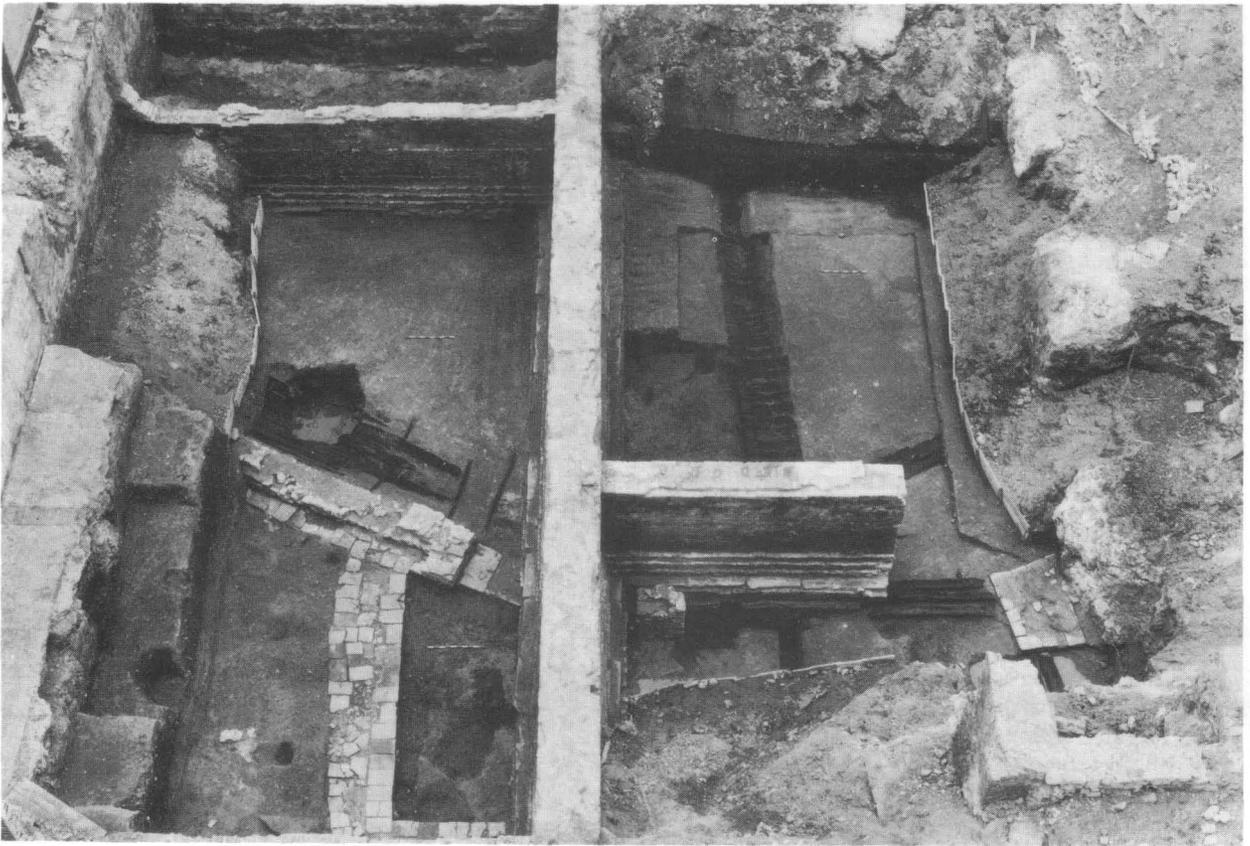
Fig. 5: looking west over the amphitheatre. The main entrance way (between arrows) is slightly obscured by the Victorian foundation. The central timber drain can be seen extending west through the arena.

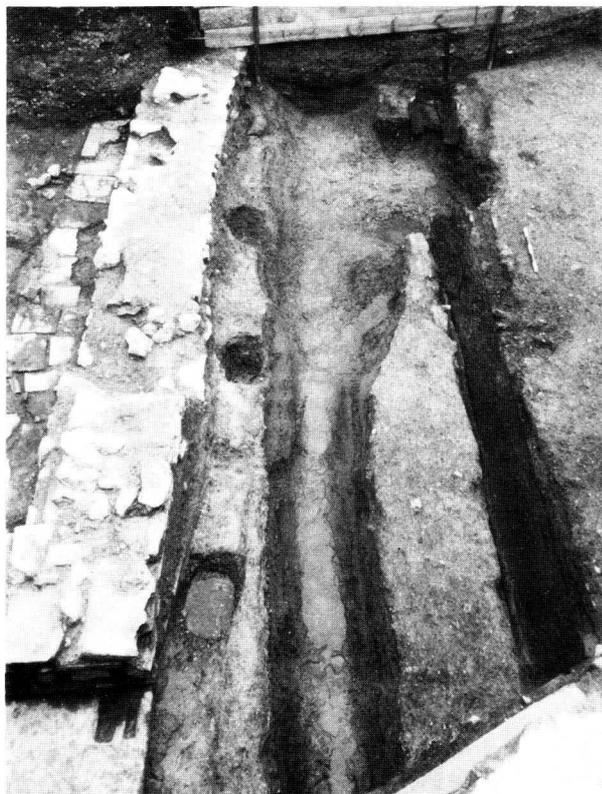
Fig. 6: on the left is the tile-built arena wall and the later ragstone rebuild directly over it. In the bottom corner is the stone threshold leading into the arena. The timber lid of the first peripheral drain is on the right and the gully of the second peripheral drain lies between them.

The peripheral drain was also replaced but in this case not only was the new drain in a slightly different position (Fig. 6) but there was conclusive evidence for its existence in Area A as well. The timber lid of this drain did not survive in the north of the site.

The curving arena wall was rebuilt at least once. In Areas G (Fig. 6) and less certainly in Area D, there were surviving masonry courses which did not appear to be part of the initial build of the amphitheatre, and

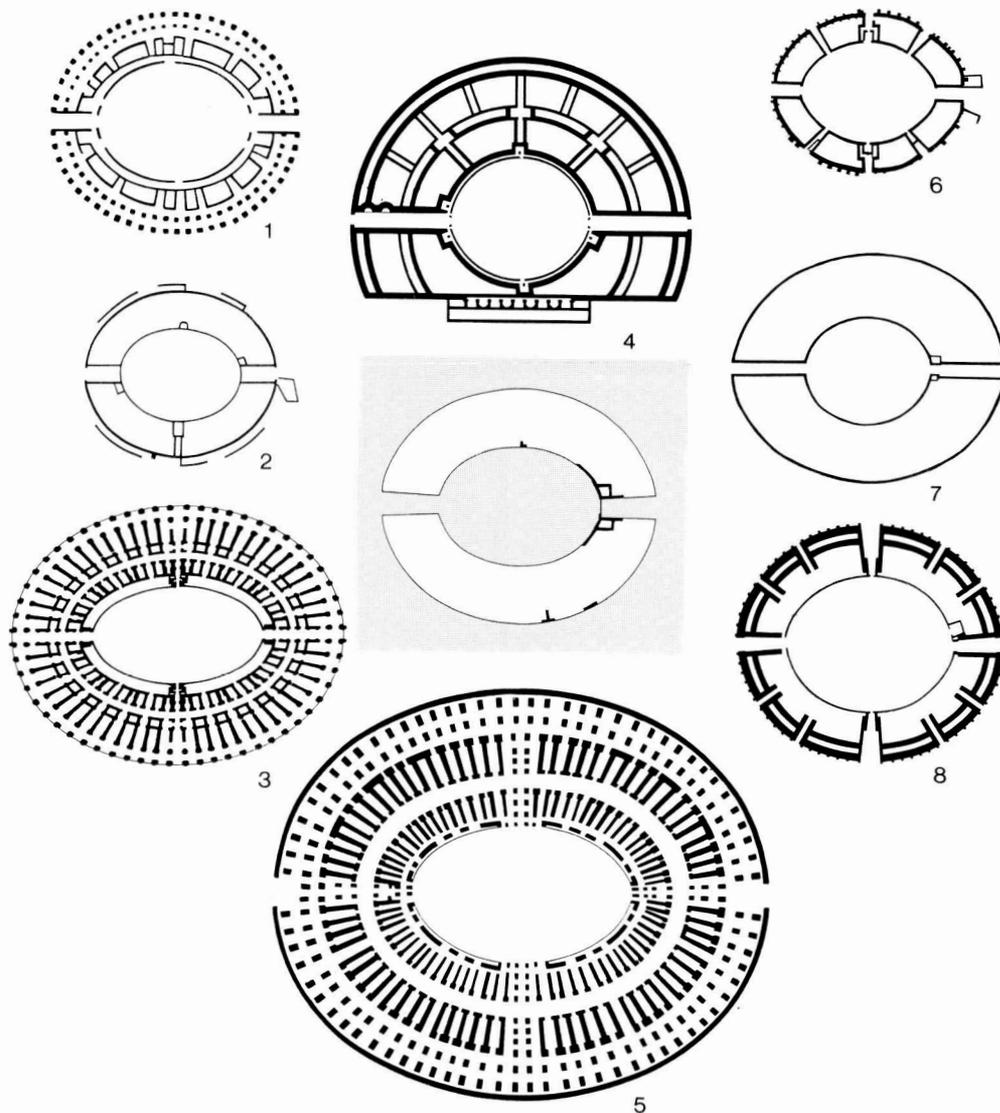
Fig. 7: the London amphitheatre with comparative forms from Xanten, Germany (1); Martigny, Switzerland (2); Arles, France (3); Lutèce, France (4); Rome (5); Caerleon (6); Cirencester (7); and Chester (8).

the building was an amphitheatre, the large open space being the arena; Room B being the ceremonial 'entrance way' into the arena; Rooms C and D being changing rooms or shrines giving access to both⁸ (Fig. 7).

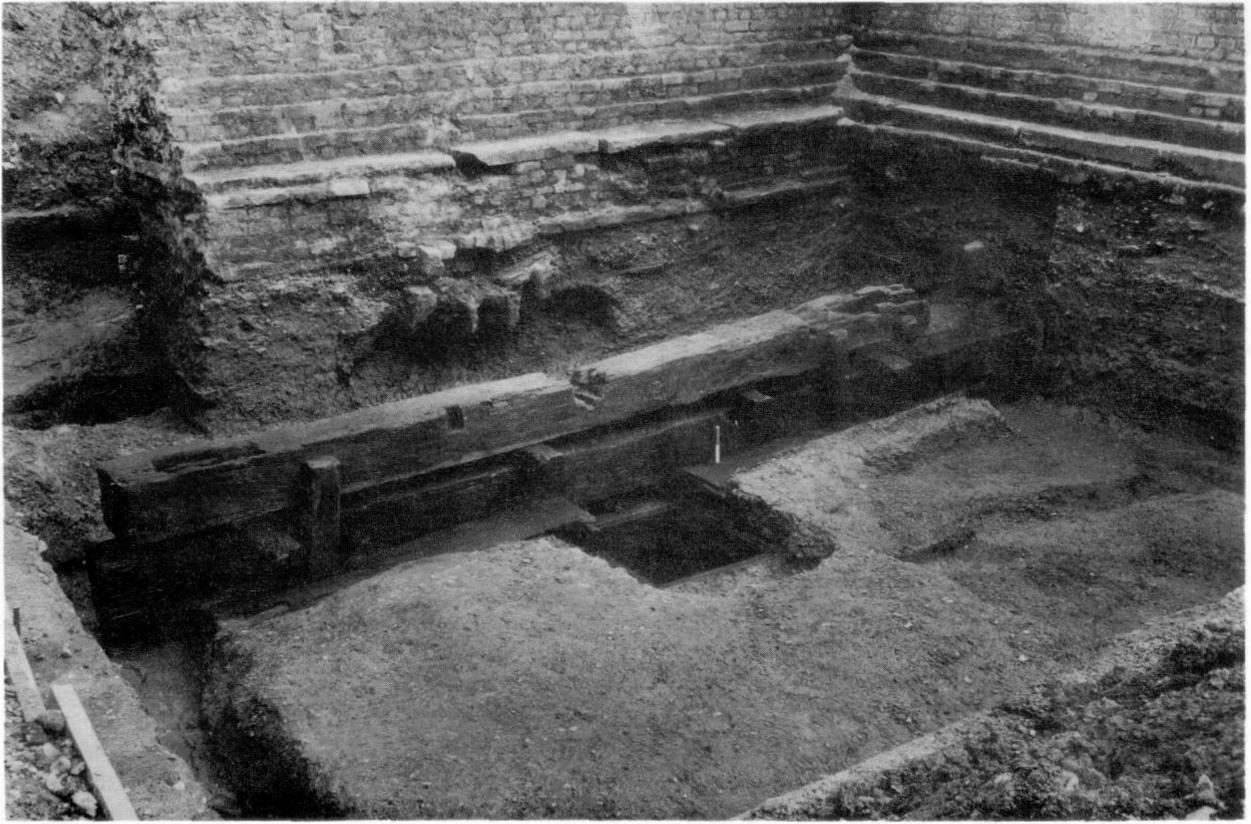
Fig. 8: the timber sill of the 2nd-century amphitheatre entrance way supported on small wedges over the sill of the earlier timber amphitheatre. In front of the latter is its related timber drain and collecting tank.

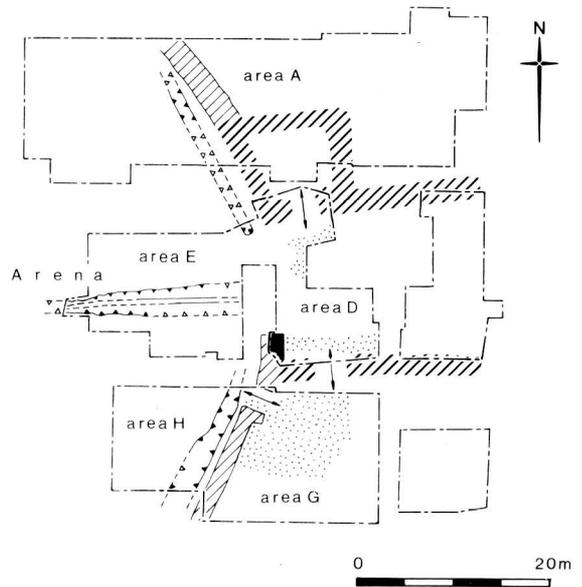
Fig. 10: 2nd-century amphitheatre modifications and rebuilds.

Rebuilds (Fig. 10)

in Areas G and A there were later robber cuts marking the presence of this rebuild. The rebuild was reduced in width to *c* 0.80m (2ft 7in) and was directly associated with one of the higher surfaces in the 'entrance way' and the arena.

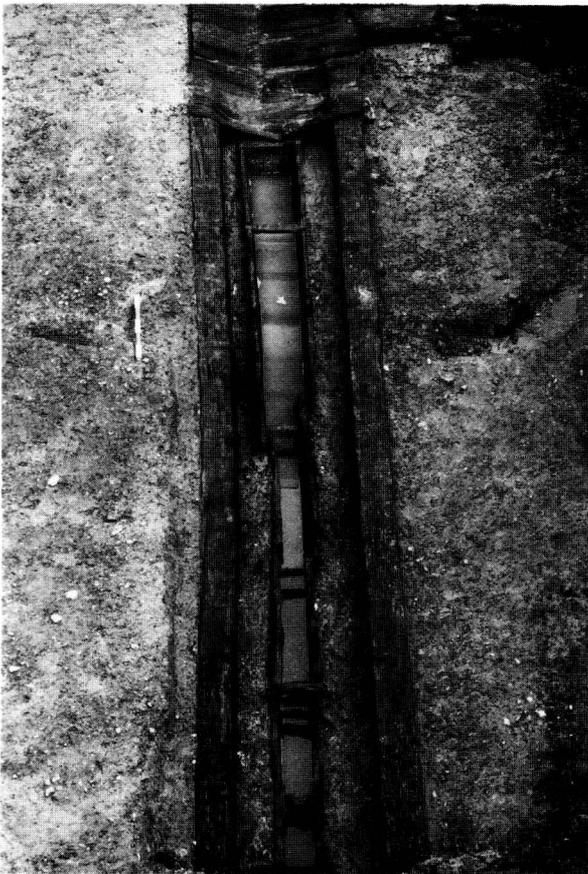
Fig. 9: view down the central timber drain. The drain sides are held apart by small cross braces. Part of the planking lid can be seen at the top.

On the west side of the beam was a subsurface timber-lined drain of very unusual construction which fed into a solidly-built timber water collecting tank. Since the drain was co-extensive with the timber sill, it may have served to channel off ground water (Fig. 9).

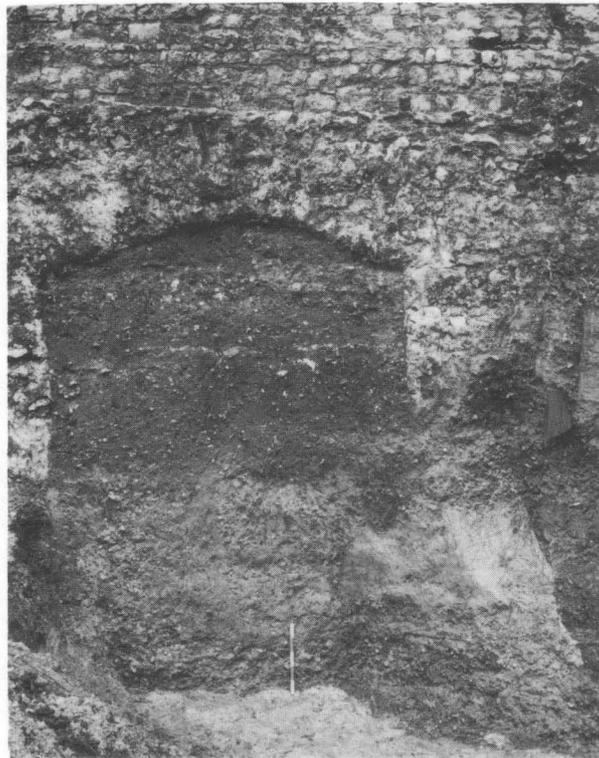
Fig. 11: the scale rests on the remains of the arena wall (1). Directly above the wall are the robber trench infills (2) which are themselves sealed by ‘dark earth’ (3) and later medieval surfaces (4).

Evidence for the final robbing of the reduced width circular wall of the arena was found in Areas A and G. It appeared to be later than the latest activity in the arena but before the whole of what had previously been the amphitheatre was sealed by thick ‘dark earth’

The whole site was sealed with a thick deposit of largely sterile dark grey silts with little or no destruction debris in them (Fig. 11). The mechanics of the deposition of this layer remain uncertain whether accumulating naturally or as a single dump. The deposit has been provisionally identified with the so-called ‘dark earth’ deposit which seals much of late Roman London. There was no evidence for structures or buildings laid out immediately on the top of this deposit. There was however a number of pits which appeared to have been cut from this level. The whole site seems to have been used as a large open external

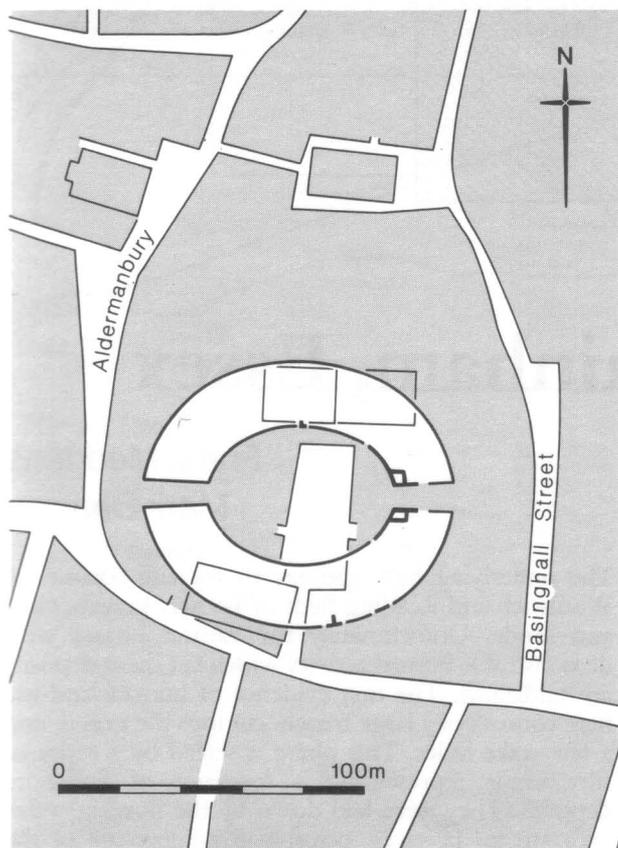
Fig. 12: the position of the amphitheatre as located by the excavations in 1951¹⁵, 1985 and 1987, in relation to the Guildhall (13th century and possibly earlier) and the late medieval street pattern. These features seem to respond to the shape of the amphitheatre and may indicate that elements of the Roman structure were still surviving in the early medieval period.

It is interesting to note that the GAG 87 site has a long history as an open area: from the time when there was an amphitheatre arena through to the early medieval period (not discussed here)¹³. This appears to suggest some kind of continuity from the arena. Furthermore it has been noted that early street plans of this area of London, and in particular Leake's map of 1666, show a distinct curvature of the adjacent streets, Aldermanbury and Bassishaw, around some large space of which the Guildhall lay at the centre¹⁴. The fact that the earlier of the crypts of Guildhall, which has itself been suggested as the remains of the 13th century Guildhall, lies directly over the projected lines of the amphitheatre walls, seems to add further weight to the suggestion that the ruins of the
