Roof recording in St Thomas's Church

Gustav Milne
Sue Hurman

Archaeology above ground

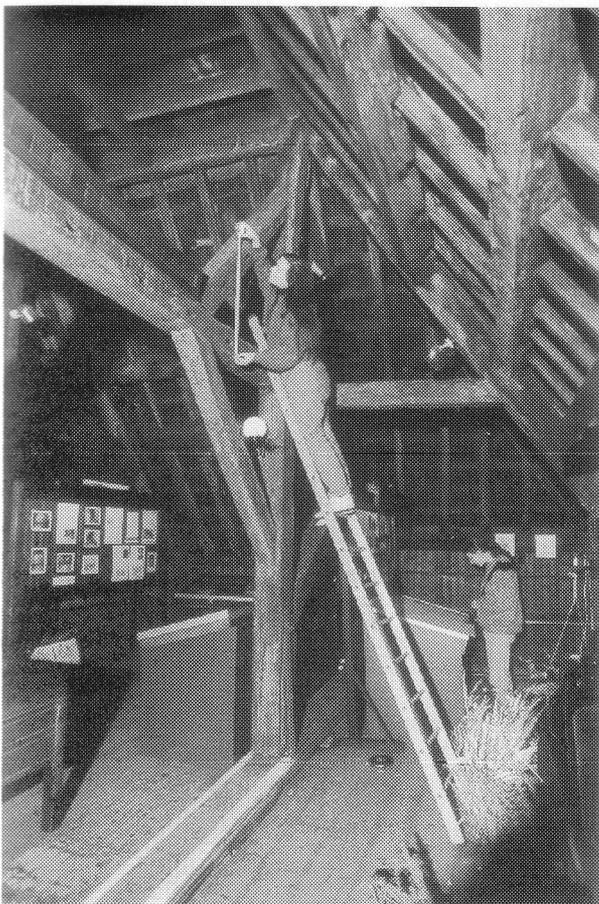
Fig. 1: measuring the main truss at the east end of the roof. (R. Bartkowiak, London Archaeological Research Facility)

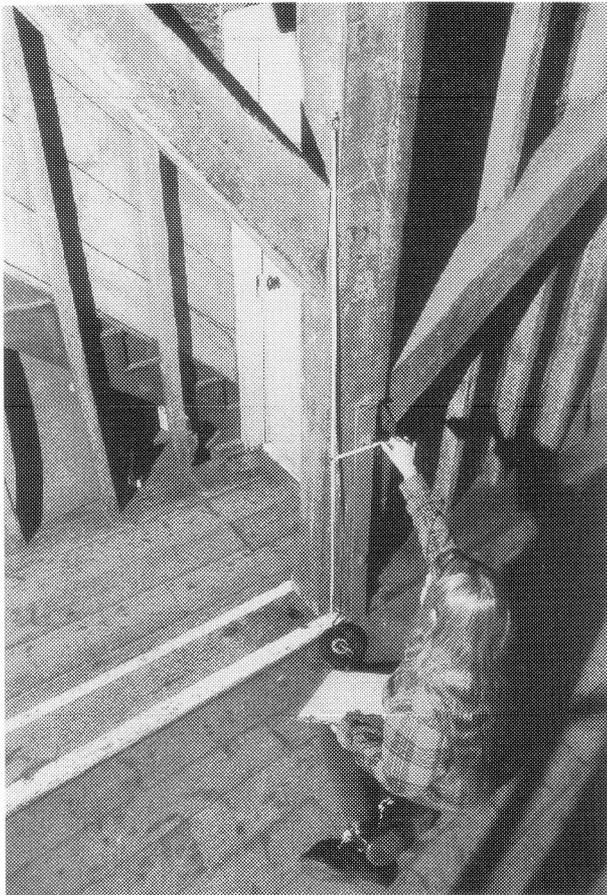
Fig. 3: recording details of the roof structure.
(R. Bartkowiak, London Archaeological Research Facility)

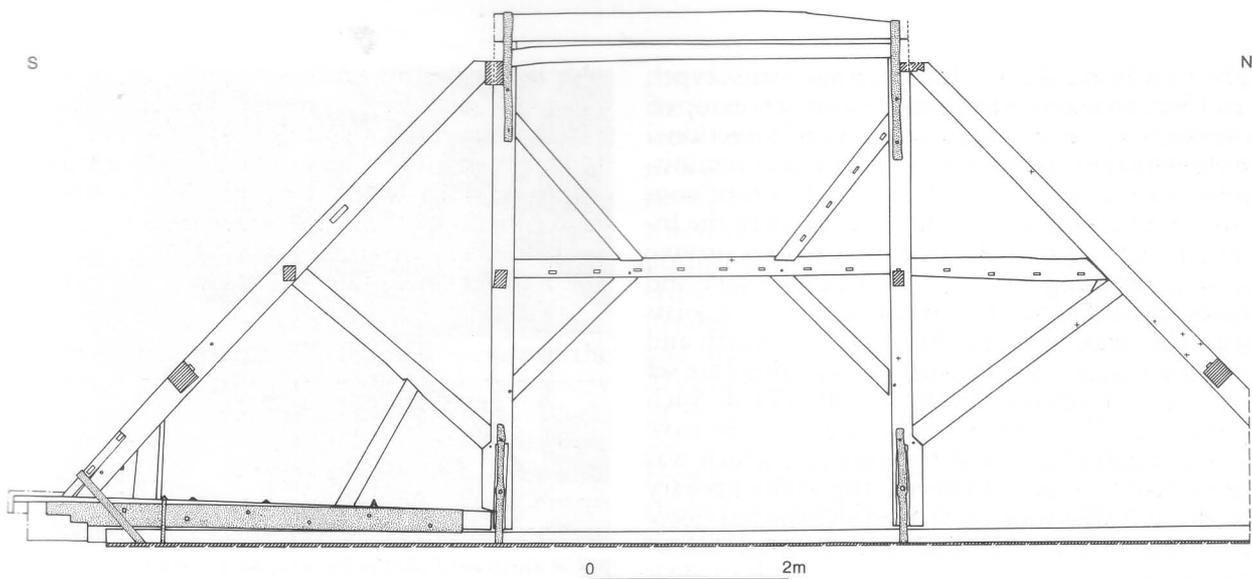
Fig. 4: east-facing elevation of main truss at east end of roof. (S. Hurman)

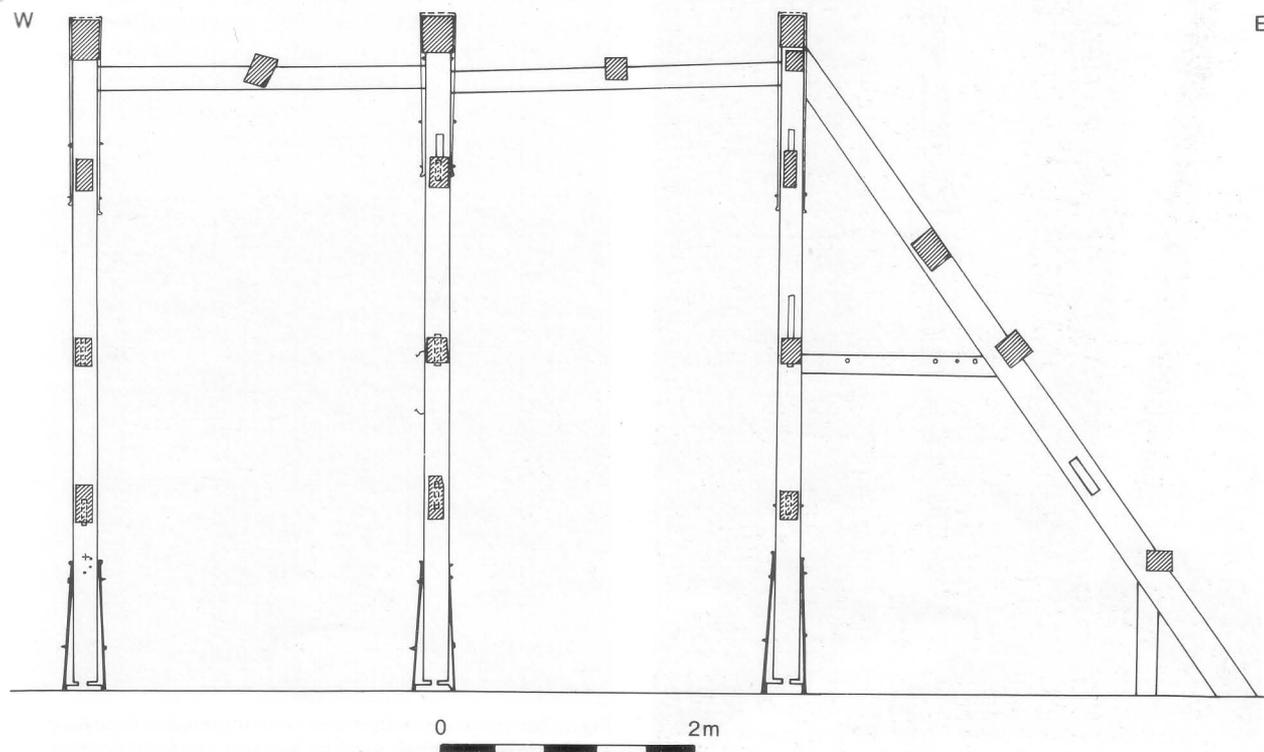
Fig. 5: south-facing elevation of arcade or aisle posts on north side of roof (S. Hurman).

The roof is broadly of the raised aisle-truss type⁴, in effect, an aisled barn-like structure set on top of the church. It was built in a robust and functional style which although had few features reminiscent of the great medieval traditions of roof construction, nevertheless seemed earlier than the Industrial Revolution. At least three trusses survive (Fig. 4), defining a garret with a central nave and aisles to north (Fig. 5) and south. Bridging joists span the space between the top of the north and south walls, into which paired arcade posts are set with iron straps and forelock bolts (Fig. 6). Such fixtures are known from the east end of the nave at Winchester Cathedral for example, which was re-roofed in 1699⁵. However, the contemporary works at in the roof of St Paul's Cathedral (1696-1706) seem to have used the more advanced screw-threaded bolts⁶.

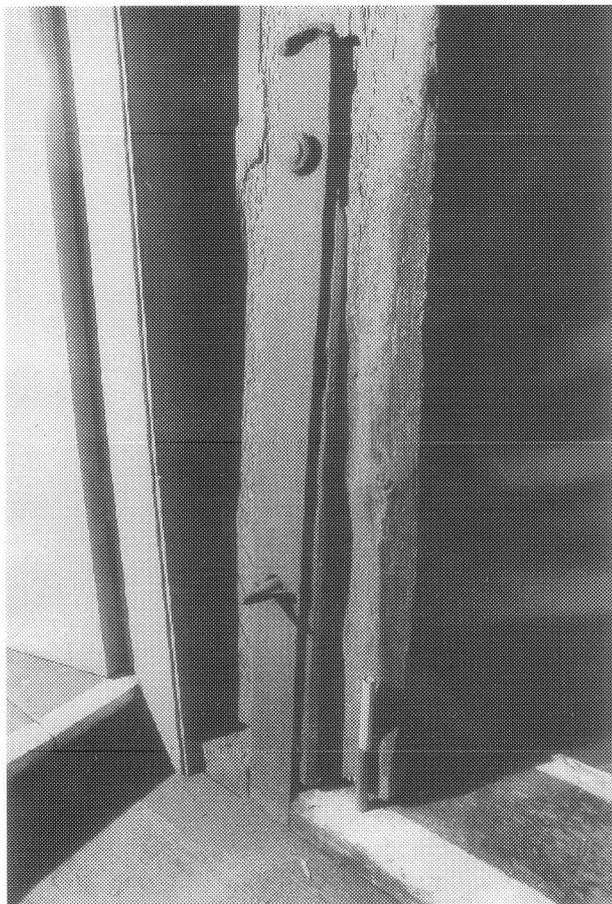
Fig. 6: detail of base of arcade post showing forelock bolts and iron straps.
(R. Bartkowiak, London Archaeological Research Facility)

The arcade posts at St Thomas' church are braced with a horizontal strainer beam, while the heads of the arcade posts articulate with a tiebeam (N-S) and an arcade plate (E-W). The principal rafters run from the head of the post to the eaves, while purlins run horizontally between the principal rafters (Fig. 7).

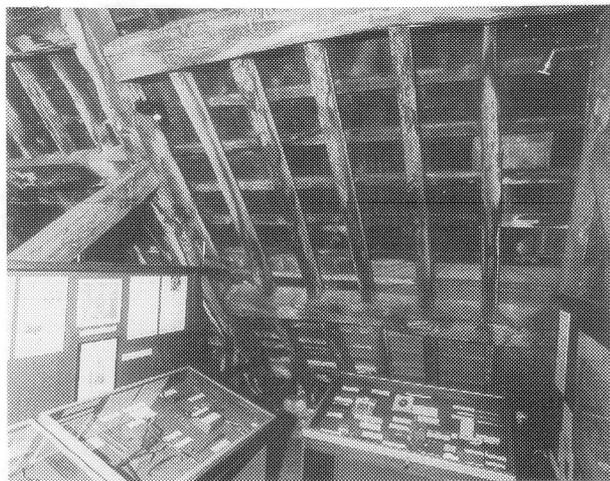
Fig. 7: horizontal purlins in primary position in roof.
(R. Bartkowiak, London Archaeological Research Facility)

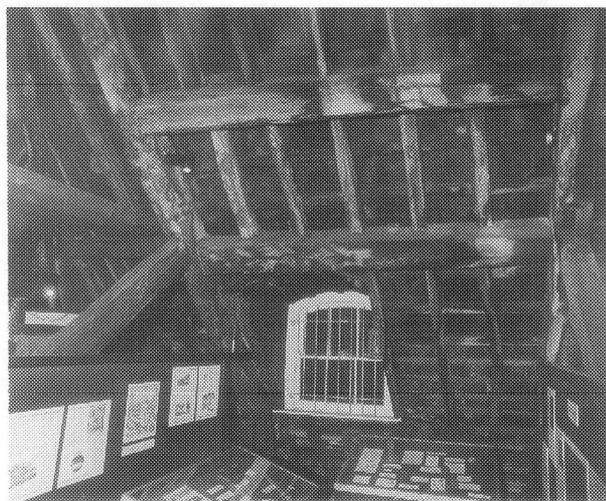
Study of the structure showed that some purlins had been cut and others moved to allow for the insertion of the windows (Figs. 8 & 9). This shows that the windows were not an original feature of the garret, but were an addition, probably inserted in 1821 during the conversion to an operating theatre. There was also clear evidence that the trusses had all been strengthened on the southern side of

Fig. 8: horizontal purlin reset over inserted window: the 2 x 10mm scale stands next to mortise marking former position of purlin: see Fig. 9.
(R. Bartkowiak, London Archaeological Research Facility)

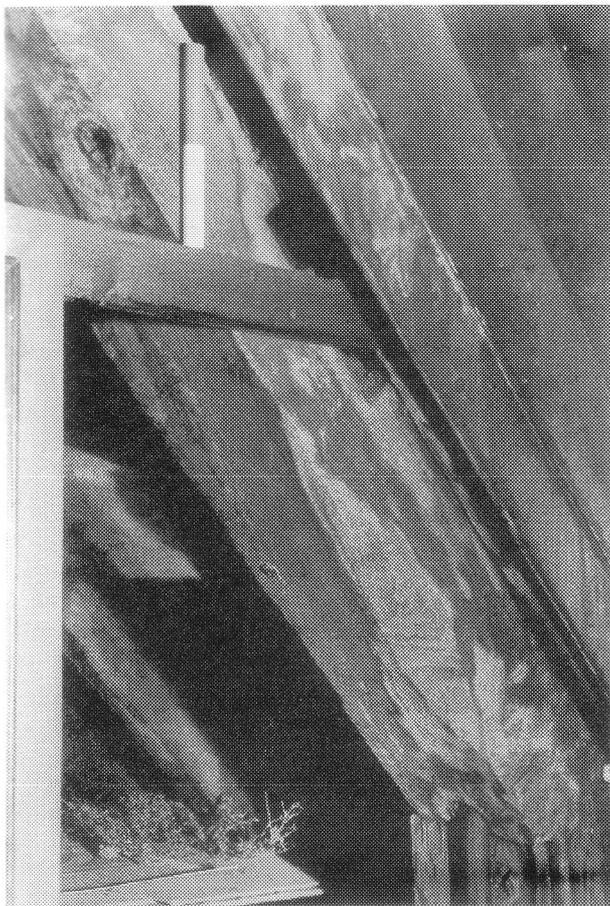
Fig. 9: the 2 x 10mm scale rests on modern batten which partially obscures the empty mortise marking original position of the purlin (cf Fig 7).

the roof as a whole), the insertion of windows in the east end, after and above which the purlins were replaced. It seems therefore that the conversion of the garret into an operating theatre saw a substantial rebuilding of the roof, ultimately with a new skylight over the theatre itself and smaller dormer windows set into the northern and southern sides. The eastern end was now opened up, the drying racks had been removed, a new roof laid and windows set between the trusses. All this development would seem to be to allow greater use of the space, which no longer seems to have been solely for bulk storage. The area may even have been used as a recovery ward with beds laid out in the bays defined by the trusses. The parapet on the southern side may also have been rebuilt at this stage to shield the windows.
