# Excavations at Sutton House in Hackney 1990-92

Chris Phillpotts

## The excavations

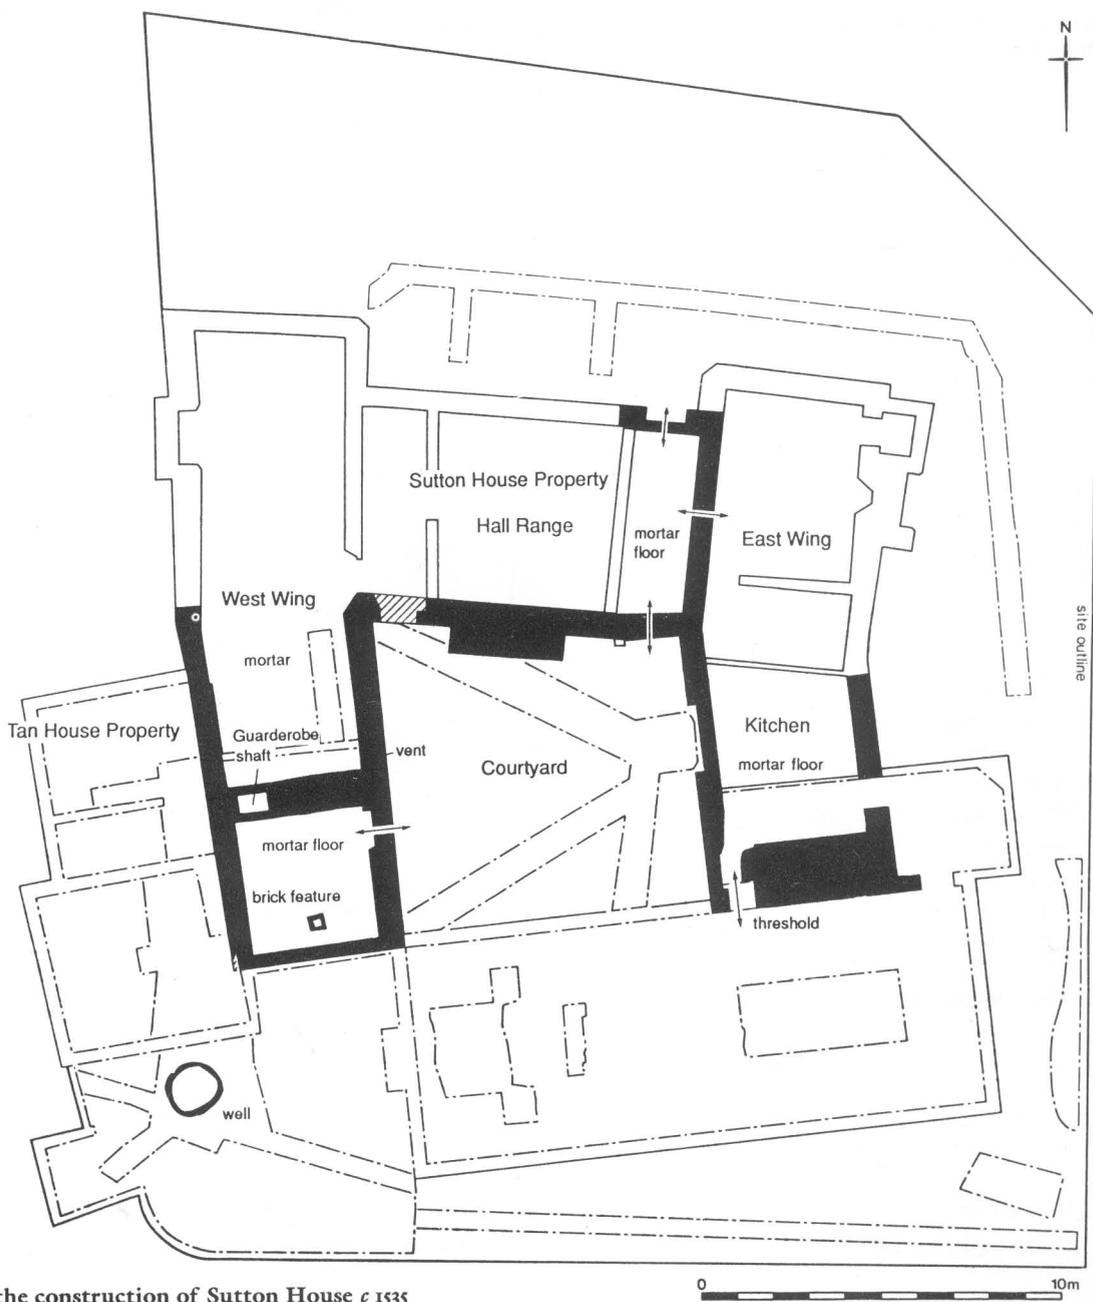
Fig. 2: the construction of Sutton House c 1535

The House was a classic Tudor brick-built H-shaped house, but with its wings twisted slightly to conform to the shape of its building plot. The plot was formed of the north ends of two selions of the common field. The distorted shape can clearly be seen in the plan of the original House (Fig. 2). The walls which have been investigated in the excavations are shown in black. All the walls were laid out at once, and their brickwork bonded together at the corners. It was therefore all of one build, including the cellars in the fronts of the two wings. Some of the post-holes and slots which supported the builders' scaffolding were traced around the rear of the wings. The Hall was not divided, except perhaps by a Screens partition near the east end. The ground to the north and the east was levelled up over the selions to form gardens, although the land to the east may not have belonged to the Sutton House property at this time.

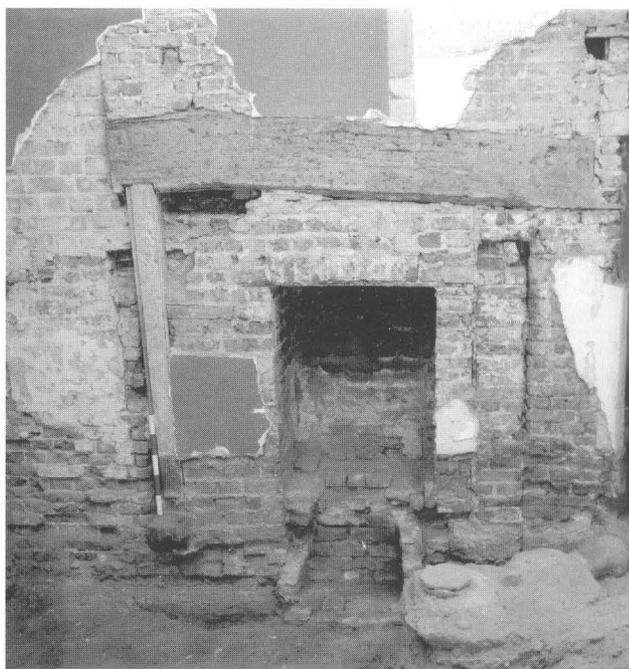
**Fig. 3: 16th-century kitchen fireplace, narrowed in the 18th century**

All three building ranges originally had mortar floors. The Kitchen was in the rear of the East Wing. Its fireplace was originally 1.9m wide, under a timber *bressumer*. On the west side of the fireplace was a doorway leading out to the garden behind the house (Fig. 3).

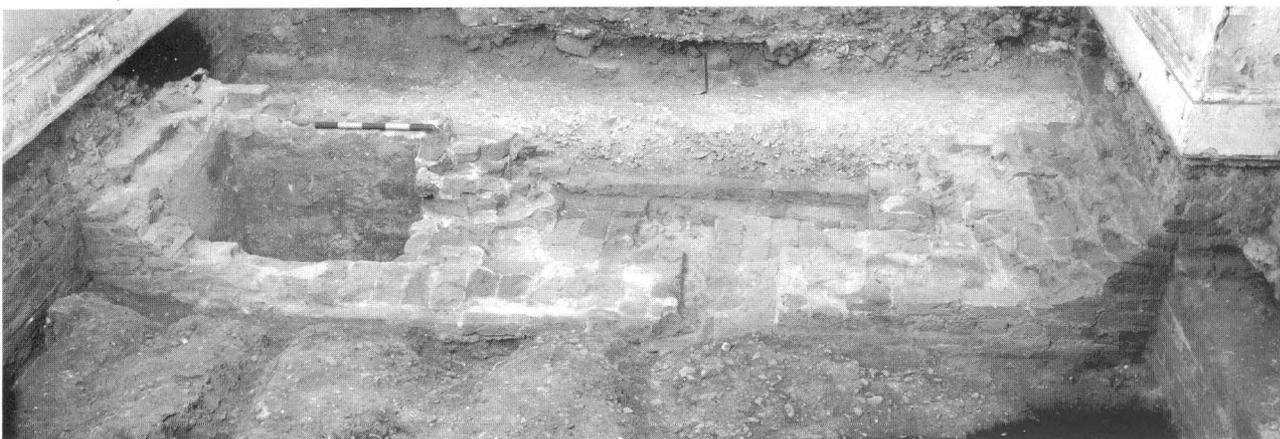
**Fig. 4: 16th-century cross-wall in West Wing showing garderobe shaft, demolished in the 18th century**

The ground floor of the West Wing was originally divided by a substantial cross-wall one metre thick, later demolished. This tied the two sides of the wing together and created a square ground-floor room to the south which could only be entered from the courtyard. It incorporated in its thickness a base for a fireplace, which served the room to the north, and a garderobe shaft, which must have served the upper floors, though with a cleaning entrance on the ground floor (Fig. 4). Some fine glassware was found in the fill of the shaft. The square room at the rear of the wing may have had

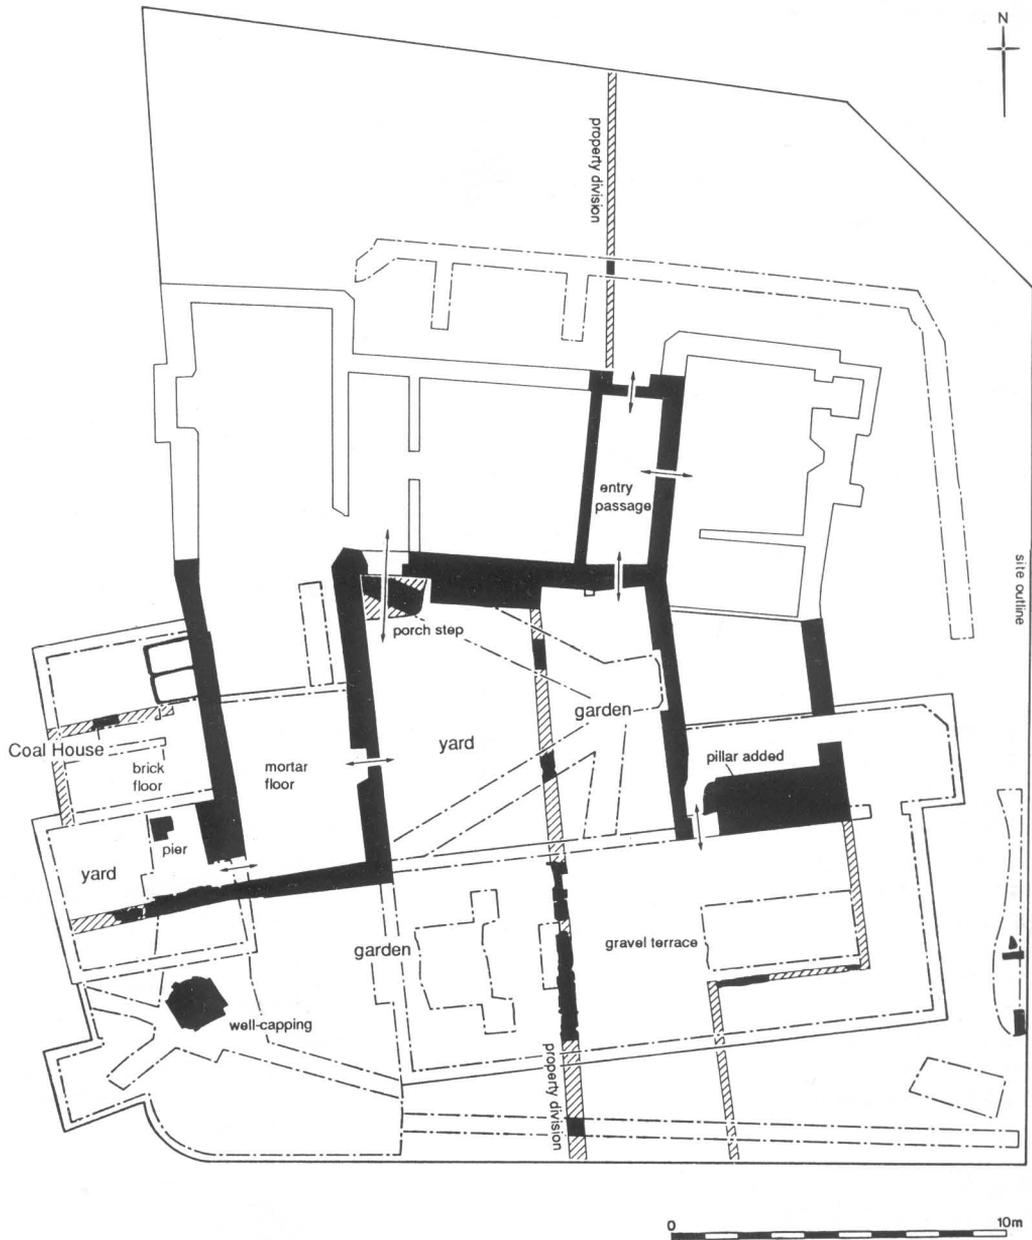
Fig. 5: West Wing rebuilt and House divided, c 1740-1760

The cross-wall in the West Wing was removed in about 1700 and partially robbed out, creating one long room from the rear of the Wing to the end of the room with the linenfold panelling at the front. A new doorway was made at its south end, leading out onto the terrace. This fundamental remodelling led to a structural weakness in the Wing, by removing its main cross-bracing element, which meant that its rear had to be taken down and rebuilt in the middle decades of the 18th century. A new yard was then laid out to its west, bounded by a retaining wall on its south side and an open-sided coal-house on its north side.

At this time the House was divided into two properties by walls built to run across the front yard, through the Hall Range creating an entrance passage, across the Courtyard, and on through the Garden. The West Wing and the Hall Range became the Western house, and the East Wing and the entrance passage became the Eastern house (Fig. 5). These changes were reflected in the Land Tax assessments of the middle of the 18th century. The property division across the courtyard and

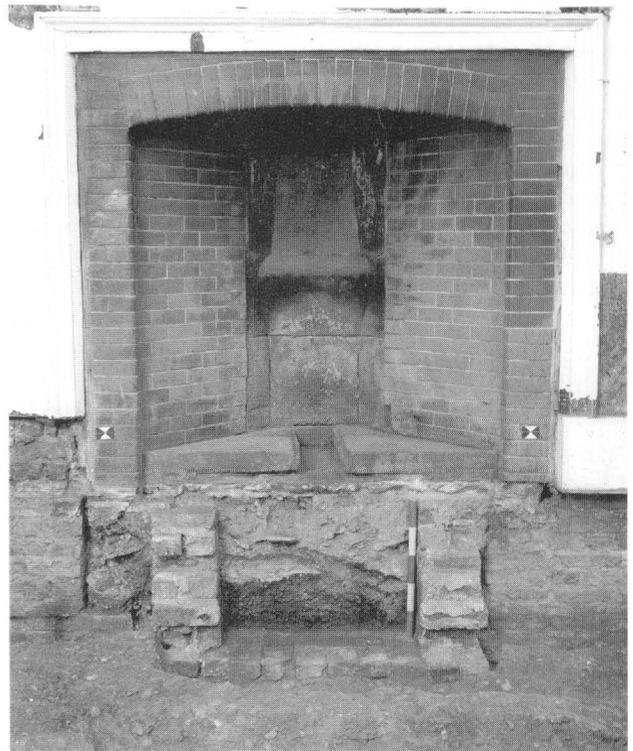
Fig. 6: 18th-century firebox and Edwardian firebox

In the last part of the 18th century, suspended wooden floors were laid in both wings and in the entrance passages. The joist of the new floors were supported on small brick piers in the West Wing, and the door-sills were raised by the height of four brick courses. The East Wing probably had the same arrangement. Here the former Kitchen fireplace was narrowed to a width of 0.75m by brick blocking (Fig. 3). Fireboxes were installed in front of the fireplaces in both wings, corresponding in height to the new floor levels. The fire-box in the

West Wing was found still full of ashes, buried underneath the Edwardian fireplace (Fig. 6). At this time the coal-house to the west of the House burned down and the remains were demolished.
