Post-medieval glass manufacture at Hopton Street in Southwark

Victoria Ridgeway
with a contribution by J. Butler

Introduction

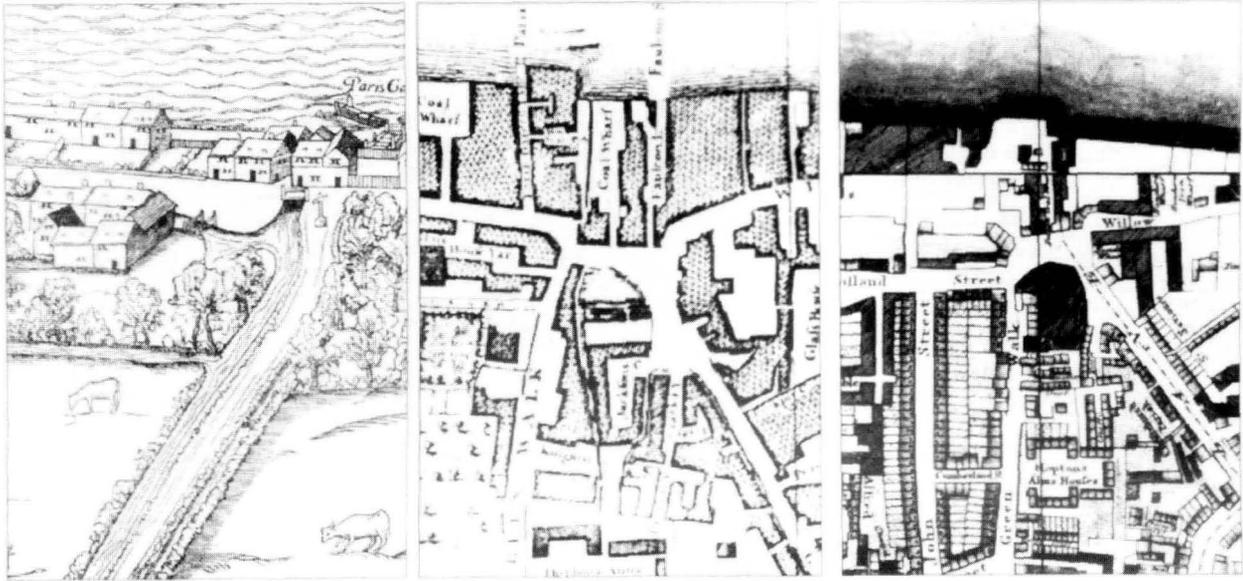
Fig. 2: the 'Agas' map, 1561-1570 The 'Rocque' map, 1746 The 'Horwood' map, 1799

mid 16th century (see Fig. 2). The southern edge of the pond was located; it appeared to have been re-cut several times, probably by natural agencies, and laminations within the deposit may indicate frequent attempts at dredging followed by silting up. A group of timber posts observed close to the southern edge of the pond possibly represent the remains of revetments.

The millpond and a substantial watercourse, apparently to the west of that seen during excavations, survived until at least 1746 (according to Roque's map of that date) but had been infilled by the time of the production of Horwood's map, in 1799 (Fig. 2).

Glasshouses were recorded in the area from as early as 1688 when a petition was sent to James II requesting that His Majesty "would put a stop to the erection of such glasshouses till they be heard". Glasshouses were known to be located on the west side of Hopton Street and to the north-east in the vicinity of the present Bankside Power Station, Rocque's map of 1746 shows a "Glasshouse Yard" in both these locations. In 1803 Pellatt & Green took over the business of A T & J Cox of the Falcon glasshouse on the site, and this is probably the Falcon Glasshouse owned by Francis Jackson and his partner John Straw established before 1693⁸. Rocque indicates "Jackson's Court" in this location by 1746 (Fig. 2).

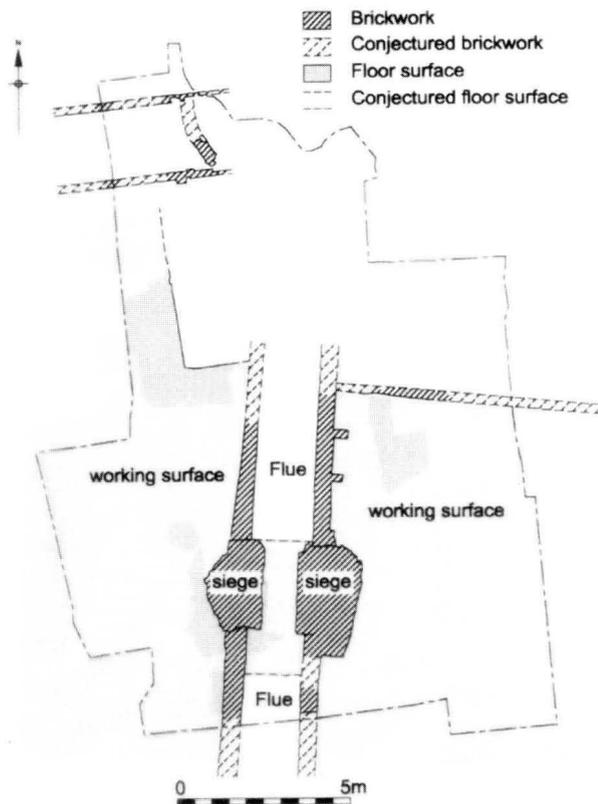
Fig. 3: the early glasshouse, area 1

Cutting through the land reclamation dumps and built over them were the remains of a glasshouse. It comprised a brick built glassworking kiln with a central furnace area 0.70m wide and c. 3m long, between two opposing "sieges", semi-circular brick platforms to either side of the furnace upon which stood pots for the melting of glass. Extending to the north and south were large subterranean flues,

1.70m wide internally, into which the sieges had been set (Figs. 3 and 4). Air would have been drawn into the furnace from the outside by means of the subterranean flues, and the fire would have been built above the flues on a metal grate set between the sieges (see Fig. 5 for a contemporary representation of a similar type of furnace). The structure, sieges and flues appeared to have undergone several rebuilds, some major, some representing only minor repair work and patching up. The sieges, in particular, showed evidence of having been completely replaced as they were the elements of the structure closest to the fire itself, thus the most prone to burning and damage, and therefore likely to need replacing before the flue walls. The sieges themselves would have extended further into the flue, but had been truncated, initially only slightly at the base for the replacement of floors, but subsequently and more drastically for the building of a later wall. Brick dating suggests that the largely rebuilt structure dated from the mid 18th century with modifications and repairs taking place towards the end of the century⁶.

of raking-out hot coals from the base of the flue, and suggest that the original structure had a simple clay floor, and that the raking-out took place from the north. The flue base was later strengthened by the insertion of a brick and limestone floor. The intense heat and continual raking-out process finally destroyed this floor, which was repaired by a circular and two rectangular iron plates, surrounded by flagstones (visible in the base of the flue on Fig. 4). The plates did not appear purpose made for the flue base and may well have been re-used "marvers", polished iron plates originally set on wooden tables and used in the glass making process for rolling of glass to smooth and shape it prior to blowing.

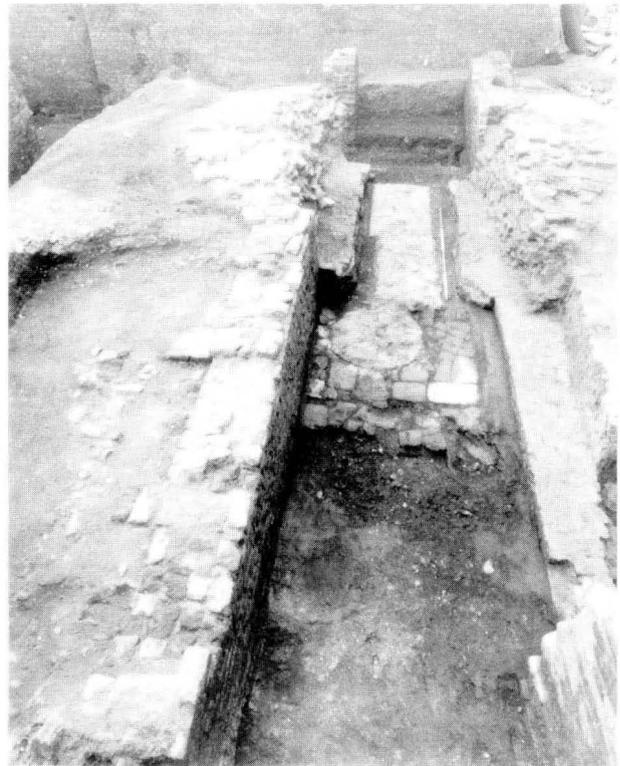
Fig. 4: the early glasshouse, under excavation, looking south
amorphous nature, containing industrial waste such as glass, slag, coke and charcoal. These appeared to have resulted from a continuous process

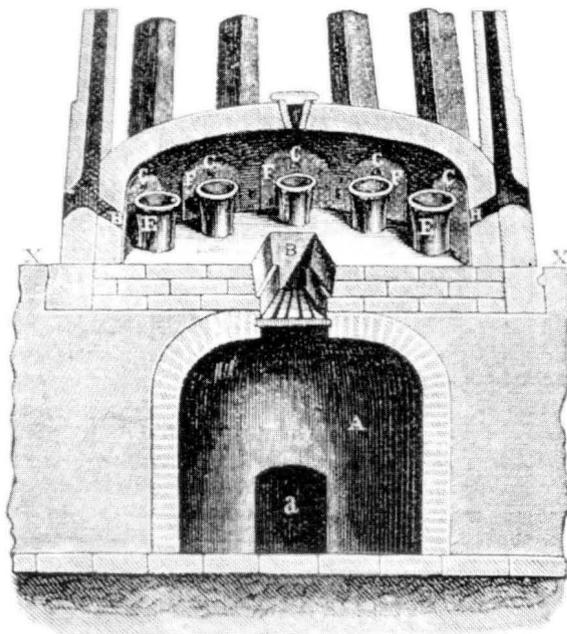
Fig. 5: early 19th-century illustration of a section through a glass furnace, taken from Diderot and D'Alembert

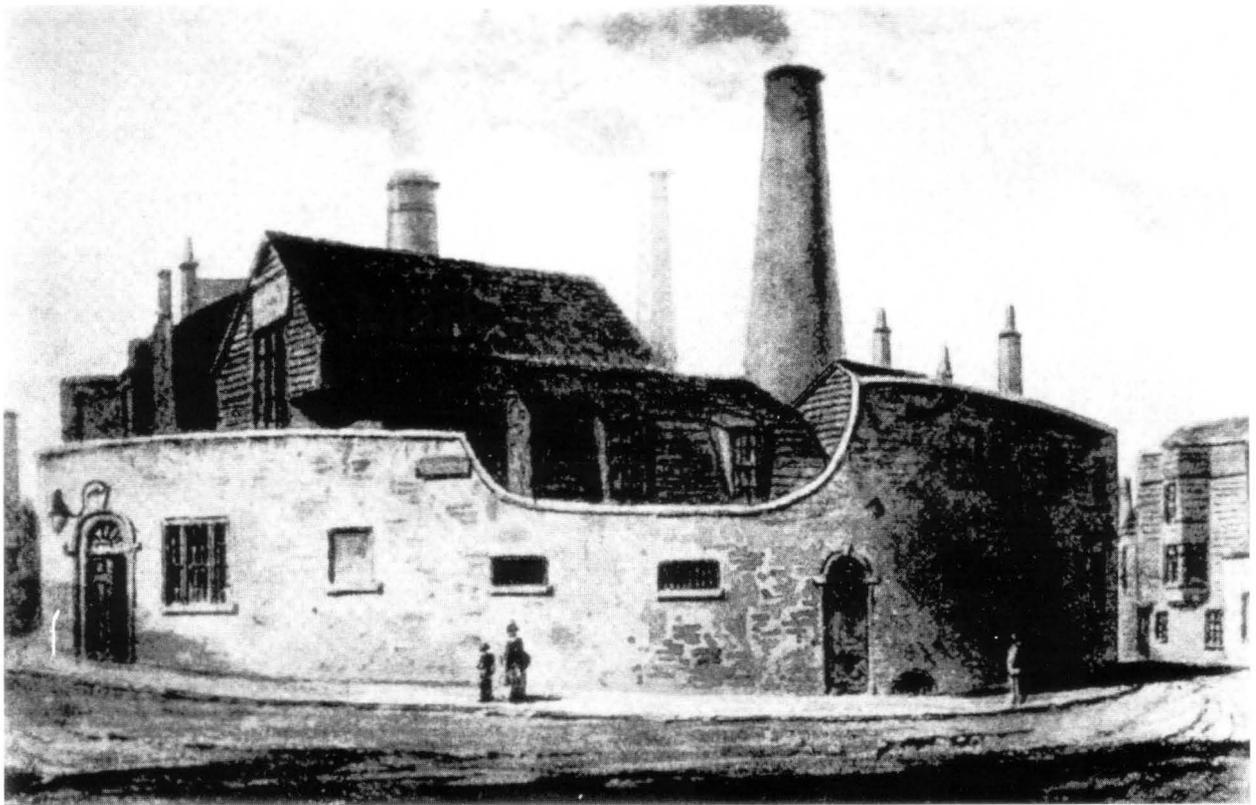
Fig. 6: 1827 view of Hopton Street exterior from the north

These remains were presumably part of the well-documented glasshouse of Pellatt and Green, known to have been built by at least 1814. It seems likely that after moving to the site, some time before 1803, Pellatt and Green at first made use of the existing structures and some of the later modifications to the early glasshouse may have been carried out by their partnership. However, this phase of construction represents a major redesigning and rebuilding of the glassworks and an illustration of 1827 shows at least two high chimneys on site (Fig. 6). Associated glass waste recovered
