Unearthing an air-raid shelter at Edgware Junior School

Gabriel Moshenska

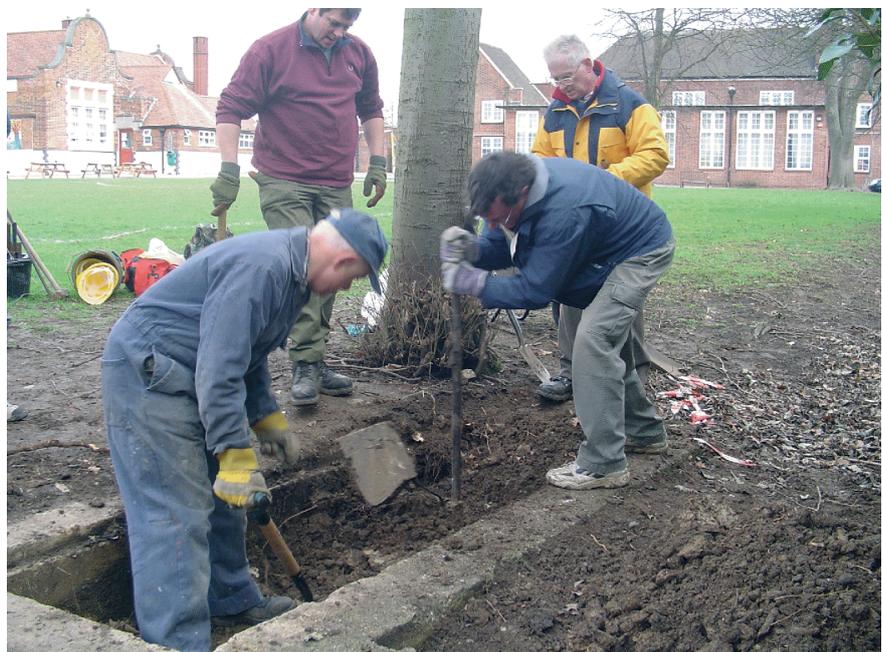
Fig. 1: excavation begins – removing the slabs of concrete

In the summer of 2005 the edge of a concrete structure was uncovered on the playing field of Edgware Junior School. The site was cordoned off, and the school contacted archaeologists. Staff at the school had been aware for some time that air-raid shelters had been built there during the Second World War, but their precise location had remained a mystery. Thus, in a freezing cold and very wet week in February 2006, a team of excavators from UCL and the Hendon and District Archaeological Society set out to unearth one of the air-raid shelter that lay beneath the playing field (Fig. 1).

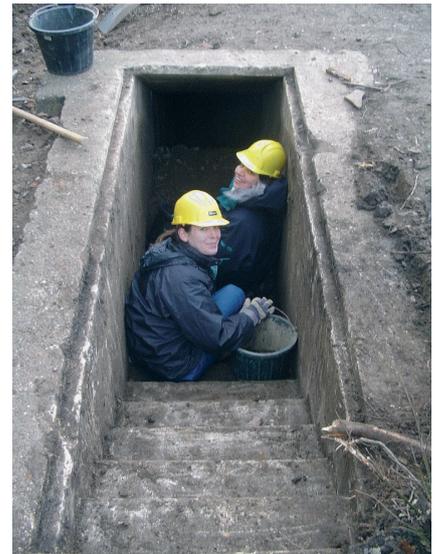
Fig. 3: clearing the staircase

The first and principal area of excavation was the clearing out of the staircase, which had been filled to the top with earth and rubble (Fig. 3). Wary of the reinforced concrete plug described in the documents, we had equipped ourselves with a sledge hammer and a mighty steel rod. In the event we found the concrete in fragments, with no piece larger than about 40 kg, mixed in with the soil. As the project took place within a school, our health and safety considerations were particularly stringent throughout the dig.

The excavation of the staircase continued apace, and it became clear that it was a single piece of concrete, either cast nearby or delivered as a preformed unit. A casting mark running at an angle of about 20° made it unlikely that it was cast in place. Tree roots had shifted the staircase slightly, so it was no longer exactly in alignment with the shelter. Two of the visible walls of the shelter were observed to be built from preformed panels of reinforced concrete approximately

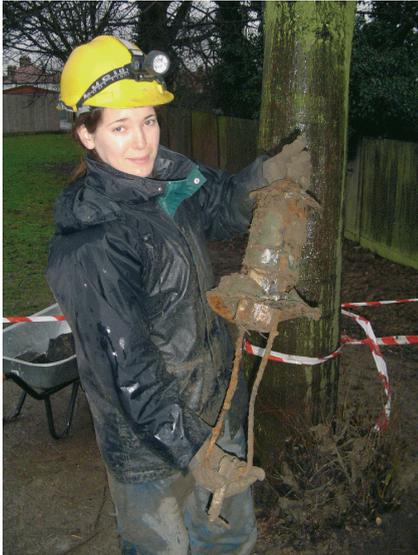
Fig. 4: lamp or heater buried inside the shelter

The first impression was of size: the shelter felt longer below ground than it had appeared in outline on the surface; it was almost 15 m long. The ceiling was covered in condensation and the floor was wet and slimy. Despite our hope for wonderful things, the shelter was rather bare: the benches had been removed, as had the chemical toilets (mercifully, I think). The two toilet cubicles remained, one at each end. At the far end there was a metal ladder leading up to an emergency exit, sealed with a concrete plug.¹⁴ A quantity of scrap metal, builders’ rubble and other rubbish had been piled below this, presumably thrown down. However, there were several remnants of the original contents: a fire bucket with flakes of red paint remaining, a hurricane lamp and an inkwell hidden in the corner. Some fragments of the electrical wiring remained, including the brackets for the distribution panel and several bakelite covers. A large, freestanding gas lamp/heater was found

buried at the bottom of steps and painstakingly excavated (Fig. 4).

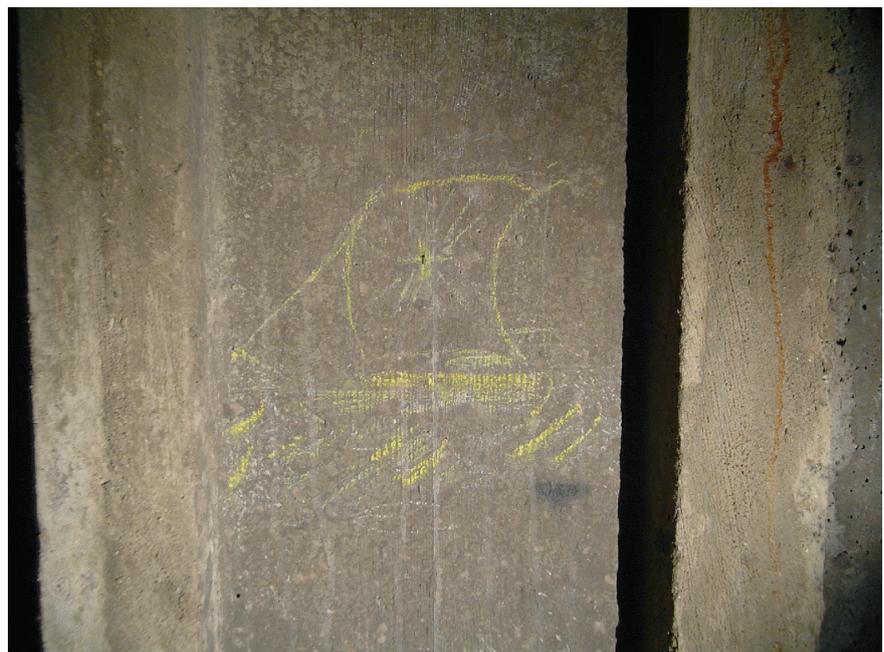
Fig. 5: graffiti of a sailing ship chalked on the wall

We had hoped to find graffiti on the walls, perhaps including the names of children who had sheltered there. In the event only one was found, a rather whimsical rendition of a sailing ship in yellow chalk, with a cross on the sail (Fig. 5). The toilet partition wall at the far end of the shelter revealed a whole series of maths problems chalked on the bricks, presumably the remains of a lesson meant for the children to copy down. The freshness and preservation of these ephemeral marks on the wall was remarkable, and it is hoped that they can be preserved. The shelter has been surveyed and recorded in detail, although the detailed examination of the interior for graffiti and other features can be an ongoing process, as the shelter is being kept open and accessible for the time being.
