Stopping the rot: subsidence and structural damage at Westminster Hall

George Nash¹

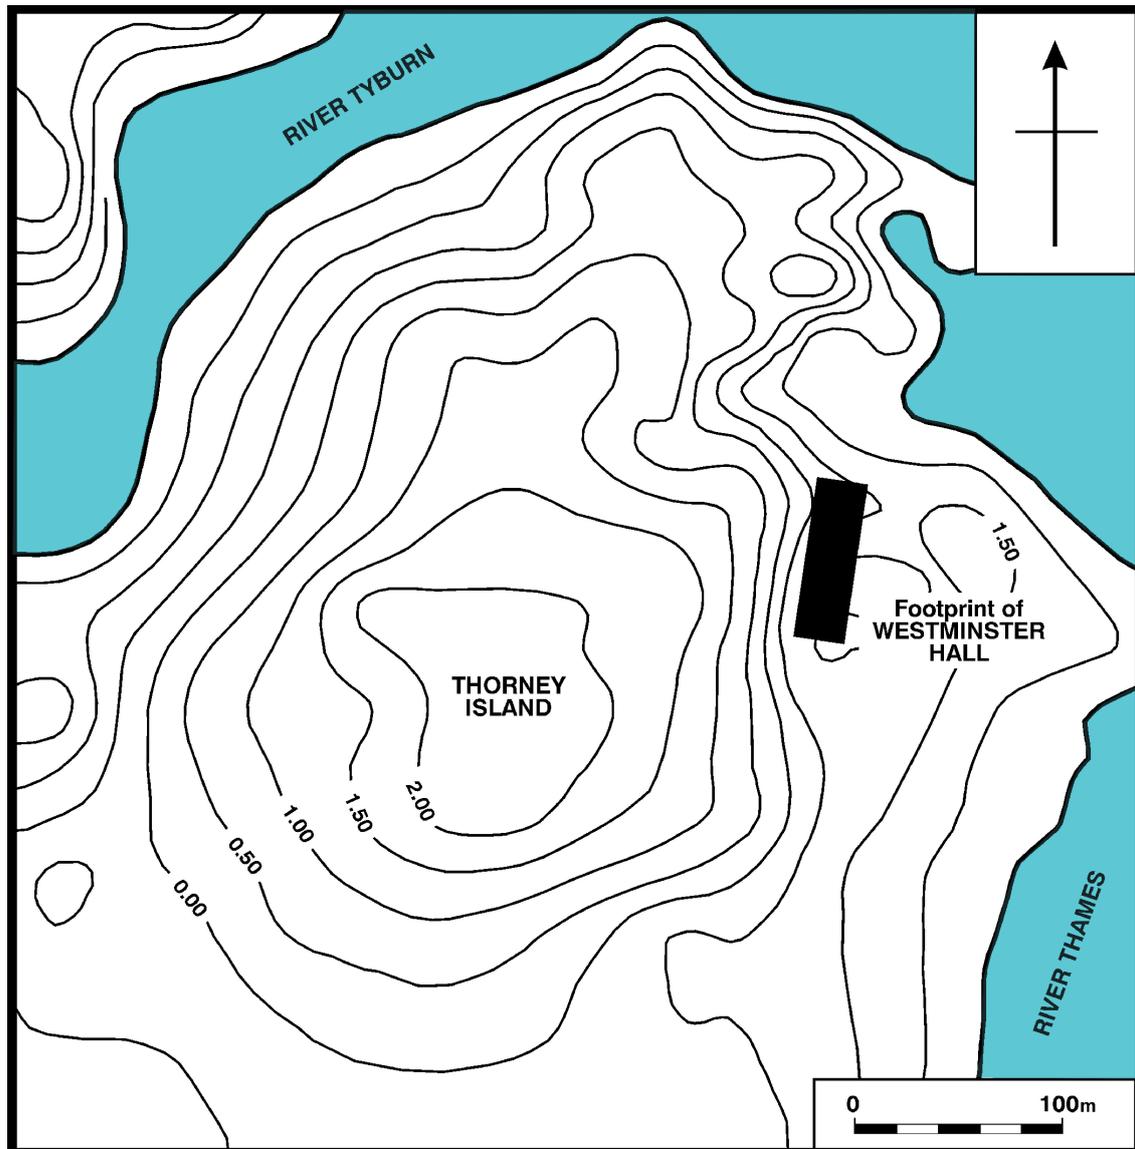
Fig. 1: contour map, showing location of Westminster Palace in relation to Thorney Island (adapted from The Final Sketch Plan (2006))

Westminster Hall and the adjoining Palace of Westminster both stand on Thorney Island (Fig. 1). The upper stratigraphy of the basal geology comprises alluvial deposition formed by river terracing. Underlying these deposits is the London Clay Formation.⁵ Seasonal groundwater was encountered at around 5 m below the present ground level of the floor.⁶

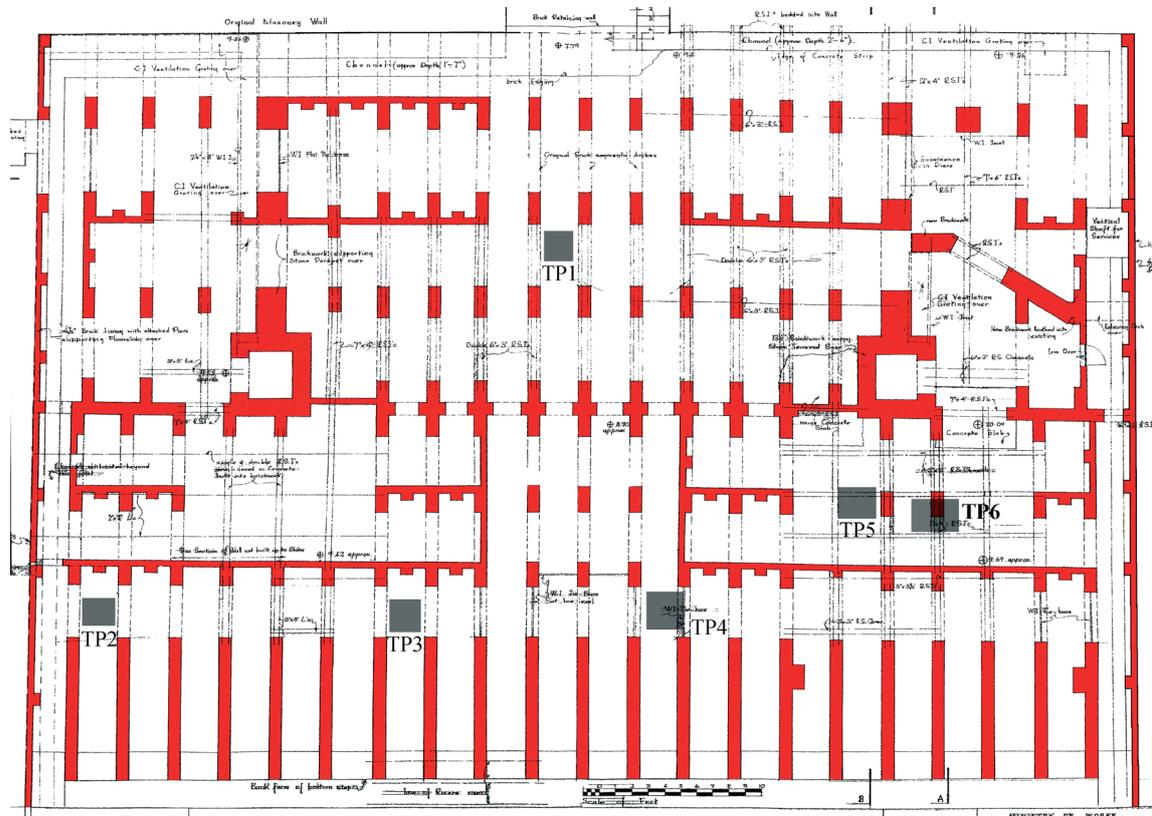
Fig. 2: plan of South Steps showing locations of Test Pits (from Barry c. 1850)

several alterations to Westminster Hall, including an arch which replaced the great south window, a large flight of steps which now lead from the Hall to St Stephen's Porch (Fig. 2) and strengthening and restoration of the roof. Gerhold suggests that the steps changed the ambience of the Hall from a room to effectively a corridor.²¹ Arguably, however, the steps do offer a certain elegance and have been used in the past by the monarch during formal occasions. Underneath the upper section of the steps leading to St Stephen's Porch is a brick-vaulted space that houses the central heating system. This area was later excavated in the Phase II programme and revealed significant structural remains of floors associated with the 18th-century floor, and Soane's door leading to the Law Courts. Other alterations, proposed by Barry but never executed, included large murals that would have hung on the walls of the Hall, and the construction of a wing that would have

The South Steps were designed and installed by Sir Charles Barry in 1850 (Fig. 2). The stone (Hopton Wood limestone) was supported by a complex

In the Phase 1 programme six small test pits, each approximately 0.50 m square, were excavated underneath the South Steps (see Fig. 2), where the greatest settlement of the floor had taken place. They all revealed a similar stratigraphy to that of the floor area, between 350 mm and 450 mm of concrete overlying a small but significant rubble deposit. The base of each test pit extended to this deposit and no deeper. However, within Test Pit No. 5, and partially supporting one of Barry's brick piers, was a large dressed piece of masonry, thought initially by the author to be a medieval widow tracery section, measuring 0.60 m by 0.40 m and constructed of Purbeck limestone. Closer inspection and verification from the Palace of Westminster's archivist Dr Mark Collins and Conservation Architect Adam Watrobski revealed that it was in fact a trestle section that once belonged to the King's Table, constructed during the 13th century, probably during the reign of Henry III or Edward I. This piece of furniture stood in the Hall until the Commonwealth years of the mid- to late-17th century (Figs. 8, 9). The trestle section (one of probably eight sections) is considered by archaeologists as a significant artefact. Indeed, one of the eight sections, discovered some years previously, is on display in the nearby Jewel Tower (Fig. 9). It is more than probable that yet again financial prudence was the order of the day, and that the trestle section was used as foundation material during Barry's construction of the South Steps around 1844.

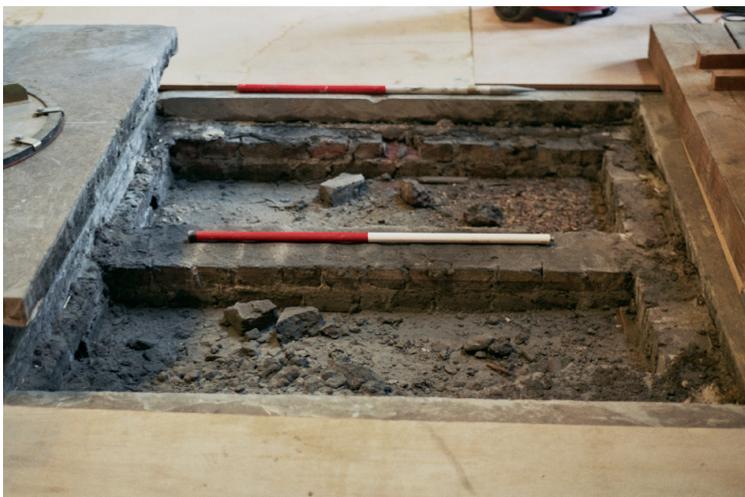
The previous floor, constructed between 1834 and 1837, comprised a concrete bed on which a series of brick-coursed sleeper walls were laid (Fig. 3), to support a surface of York Stone flags. In some areas brick sleeper walls had been replaced by concrete sleeper beams. This repair may date to the early 20th century and the restoration work of Sir Frank Baines. The concrete floor, measuring between 350 and 400 mm

Fig. 3: brick sleeper walls on concrete bed of previous floor

thick, overlay a brick and rubble foundation. The brick sleeper walls that supported the York Stone flags were constructed of brick types that were mainly reused and dating from the 16th/17th centuries. It is clear that these bricks were salvaged from dismantled building stock that either lay within or just outside the Hall, possibly the remains of coffee shops that stood within the Hall during the 18th century.

Most of the sleeper walls inspected showed little or no indication of settlement. However, an area immediately north of the South Steps showed severe cracks within the concrete floor on which the sleeper walls stood. Between 1992 and 2004 up to 16 mm settlement had been recorded within the area of the lower steps (Fig. 4). This settlement had acutely accelerated, compared with settlement recorded between 1989 and 1992 when only c. 1 mm had been recorded; however, irrespective of the rates recorded, settlement appears to have been an ongoing problem over the past 180 years.

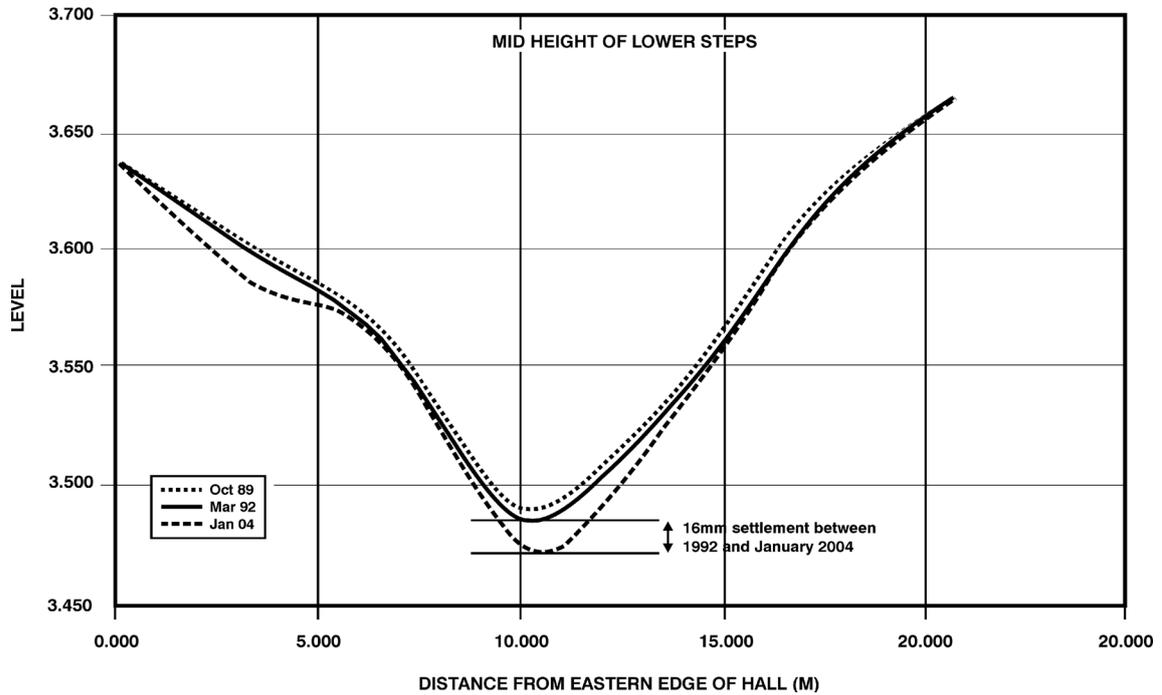
Fig. 4: graph showing settlement of the South Steps (adapted from The Final Sketch Plan (2006))

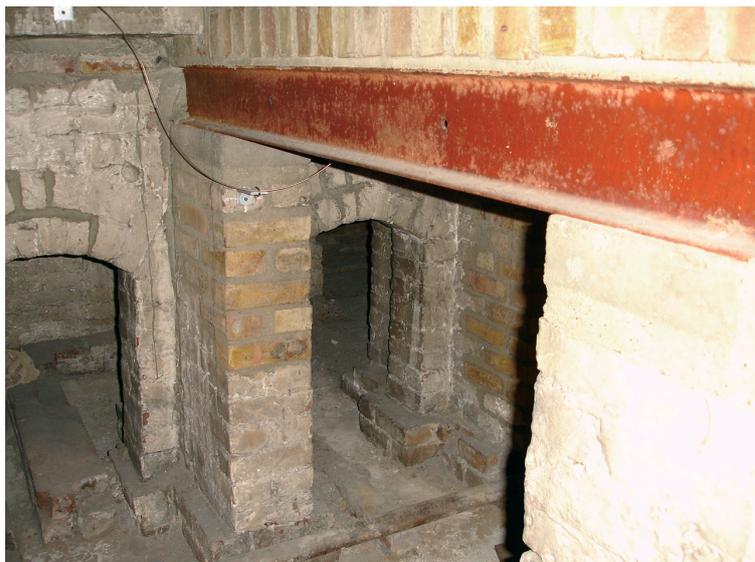
arrangement of brick piers and walls (Fig. 5). This brickwork sits on the same concrete floor that extends across the rest of the Hall. Based on the test pit investigations and documentary records the concrete floor dates to the Smirke restoration (c. 1834). Inspections of the

steps and the piers on which they stood showed that severe settlement in the form of diagonal, horizontal and shear cracking had occurred, especially around the area that supported the West Candelabra. Inspection of the spaces underneath the steps revealed that an

Fig. 5: steel reinforcing joists on piers supporting the South Steps

attempt to rectify the settlement had been made in the early 1960s, when steel reinforced joists had been inserted into the upper section of the brick piers (Fig. 5). However, some of the brick pier sections no longer provided support for the steps.

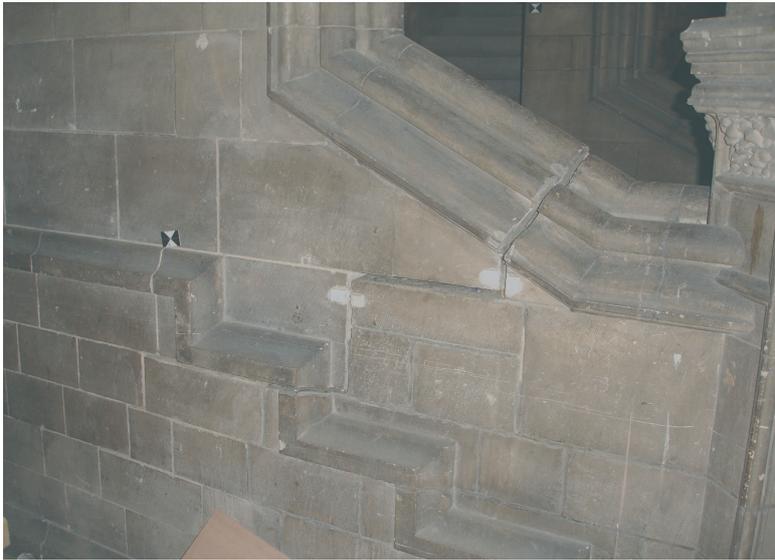
Fig. 6: West Steps, showing severe cracking

Within the western part of the Hall and located close to the South Steps are the West Steps, which were constructed by Pearson during his restoration programme, between 1883 and 1888. Recent investigations and monitoring has revealed severe cracking (Fig. 6). This ornate structure is also founded on the concrete bed that was probably laid some 50 years previously. Based on limited archaeological investigations in 2005, the area on which the steps are sited was once covered by York Stone flags. These were removed and Pearson laid a shallow concrete base, forming a foundation raft over Smirke's earlier concrete floor.

Next, an archaeological excavation was undertaken. The base section of the South Steps was removed and underlying deposits archaeologically excavated. This section of the floor was remediated using a mini-pile system. The floor at the southern end was stabilised using dry rather than moist soils in order to prevent any further settlement. Finally, the cracks in the West Steps were re-pointed.

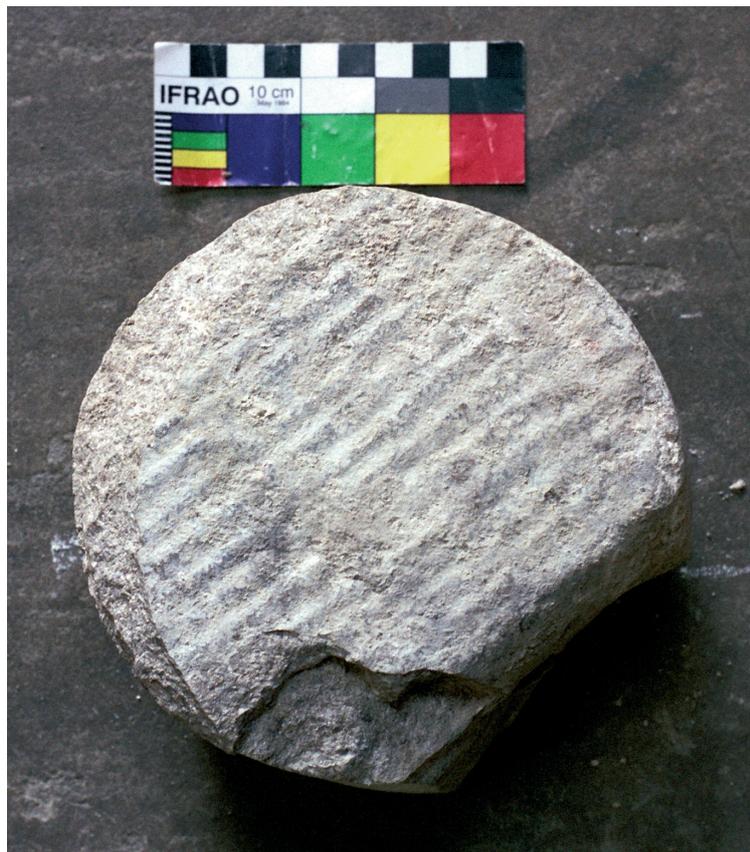
much brick and stone, some of it decorative and dressed, was reused in previous restoration programmes such as those directed by Smirke, Barry and Baines (see Fig. 7). Evidence for recycling, clearly seen with the materials used for the floor sleepers, suggest that nothing was left to waste. For example, underlying floor flags 6 and 8 were 17th/18th-century brick that had been used along with later unfrogged brick types. It is probable that this material originated from various demolished buildings within the Palace of Westminster precinct. It is clear that building materials were being stored on site and used accordingly. The prudence of successive parliamentary procurement departments appears to show awareness of the cost implications of purchase and transporting new building materials. Although the brick sleepers date to

Fig. 7: dressed medieval masonry cut from a floor section, underlying the current floor level, probably used as foundation material.

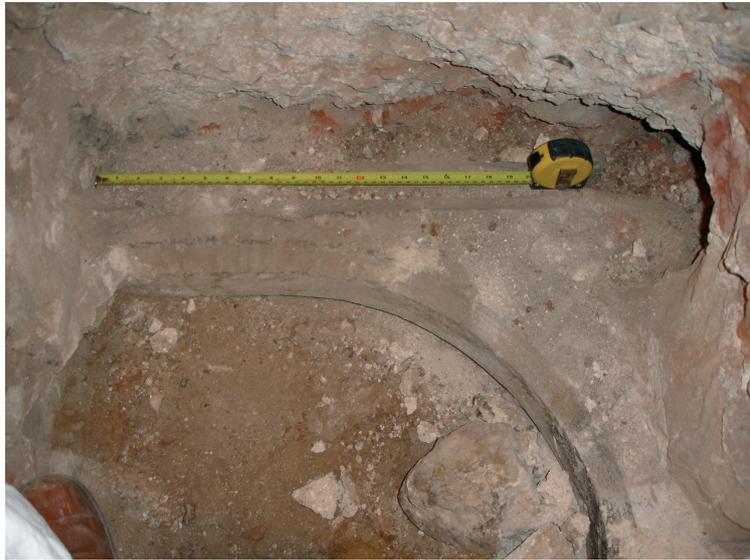
Fig. 8: trestle section of the King's Table, as found
