The Cowley Hole – what was it?

Colin Bowlt and Ken Pearce

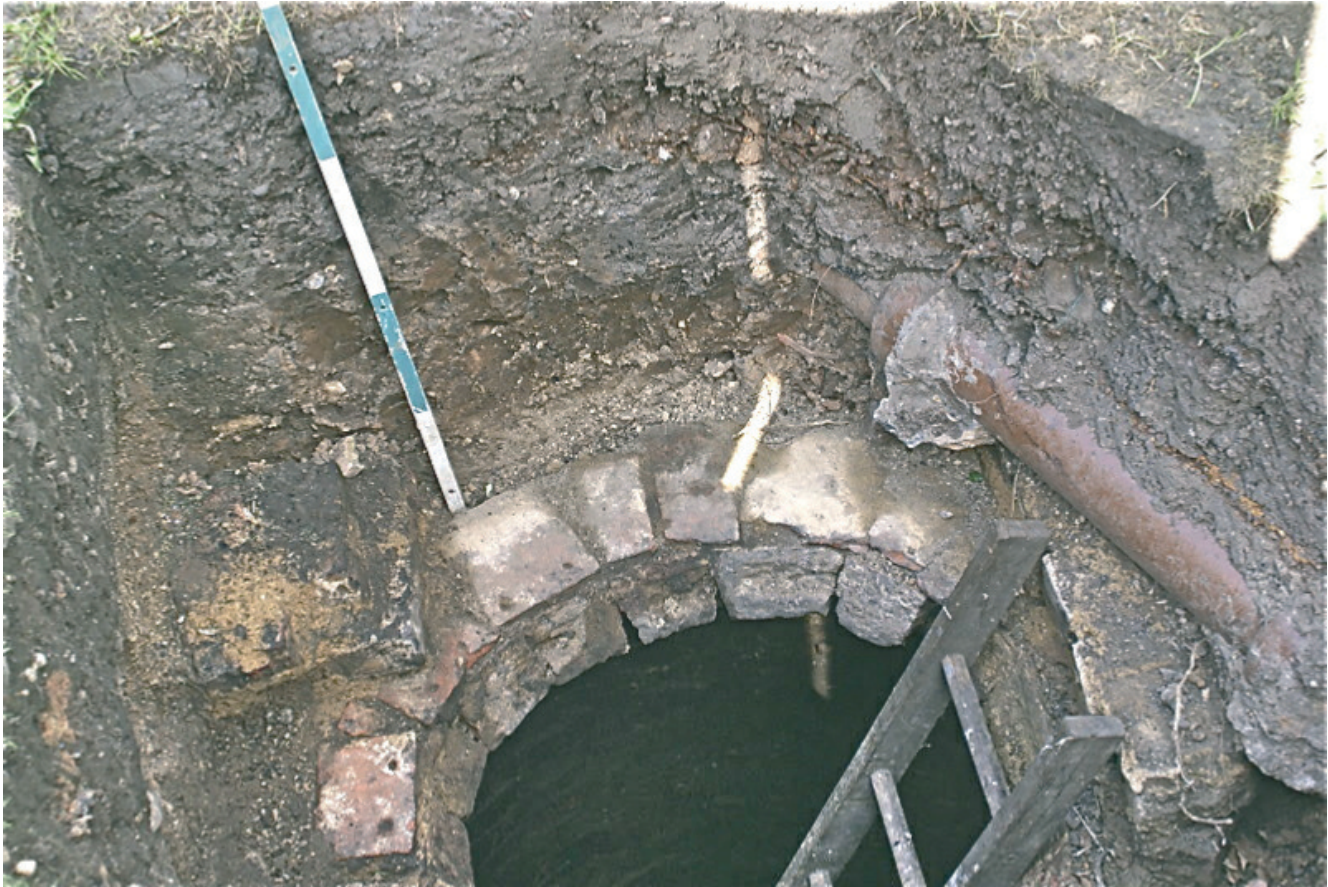
Fig. 1: domed entrance to the structure

In March 2009 the occupants of a 1950's house on Cowley Road, Hillingdon, Middlesex, (TQ 05440 82483) observed a hole developing in their back-garden lawn. Investigation revealed the top of a round brick structure at a depth of 0.74 m from the lawn surface. Further clearance revealed a domed top, with a circular opening of 0.60 m diameter (Fig. 1).

The entrance was set with tiles (see Fig. 1) with remains of some brickwork at the corners. There were no openings or pipes in the walls or floor for water to run in or out.

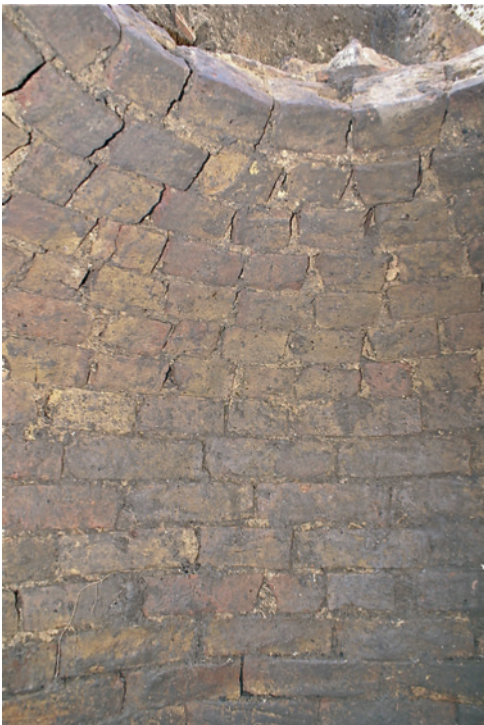
Fig. 3: inside view of the wall and domed top

The top of the structure was 0.74 m below the surface of the lawn. The garden soil is of made-up material, so that the structure may have been closer to the original surface. This brick well-like chamber is 1.40 m (55 inches) in diameter and 2.13 m (7 feet) in depth – sufficient for easy upright standing. The top is domed with six layers of largely half bricks, but with a circular opening of 0.62 m diameter (24 inches) – just wide enough to allow entry. The bricks are of dimension 9.0 by 4.50 by 2.25 inches without frogs, and laid in stretcher bond (Fig. 3). Some are yellow and softish and set in a sandy mortar. The floor of the structure is level and of brick. The chamber walls are of single brick thickness.
