# The Great Hall in the Inmost Ward, Tower of London

Geoffrey Parnell

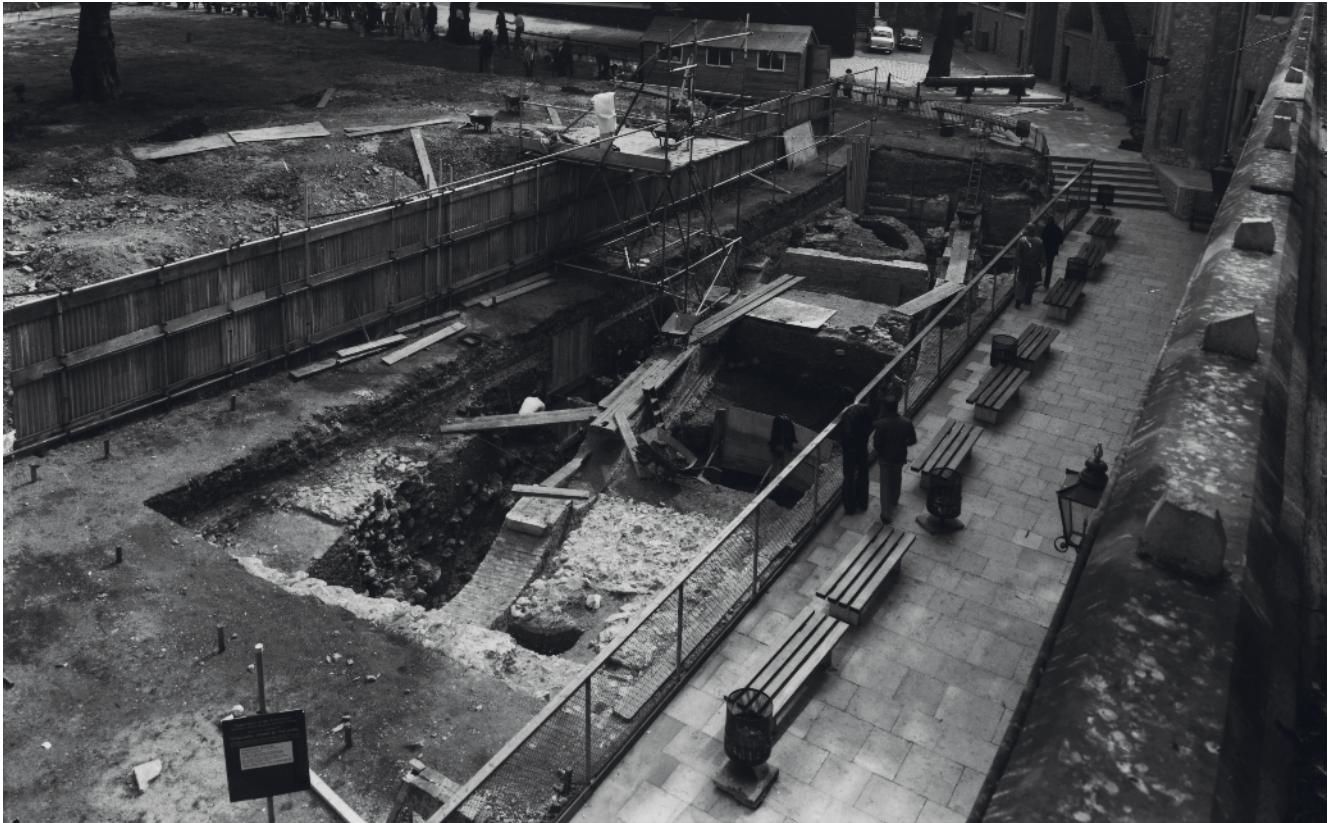
Fig. 1: general view of the main excavation trench looking east from the wall-walk of the south curtain. The massive rubble foundation in the foreground, aligned at a right angle to the trench, is thought to represent the western limits of the 12th-century great hall. The foundation on the same alignment and partly under the section nearest to the camera marks the eastern limit of the Ordnance storehouse (Fig. 4) that replaced Henry III's great hall in 1789.

Evidence for the rebuilding of the earlier hall was found during excavations in 1976 on the site of the building where a large early 12th-century foundation (Fig. 1) was found inside the western limits of Henry III's

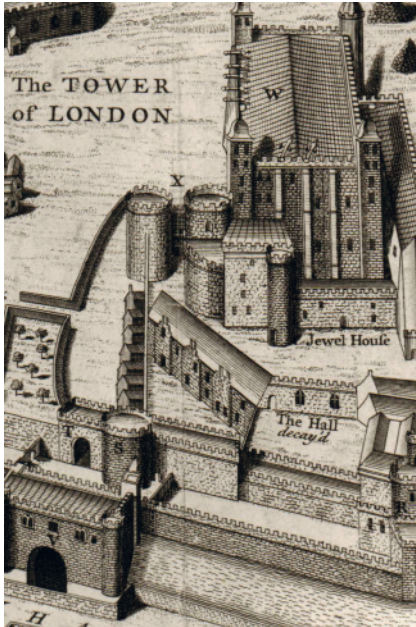
Fig. 2: detail of Haiward and Gascoyne's survey of 1597

are confirmed by items listed in official accounts of repairs carried out in 1603/4, in advance of James I's final royal occupation of the fortress for three nights beginning 12 March, 1604. The most interesting account concerning the Great Hall is the 'Frameinge and setting upp of a sidewall and a roof over the olde hall and raftinge it with great firpoles to beare a Canvas coveringe being lxx foote in legthe and xxv foote in bredthe boording upp one side-wall'.<sup>8</sup> The size of the canvas suggests that it was intended to cover one side of the hall's pitched roof which, from numerous 16th- to 18th-century illustrations, can be seen rising above the south curtain wall on an east-west alignment.<sup>9</sup>

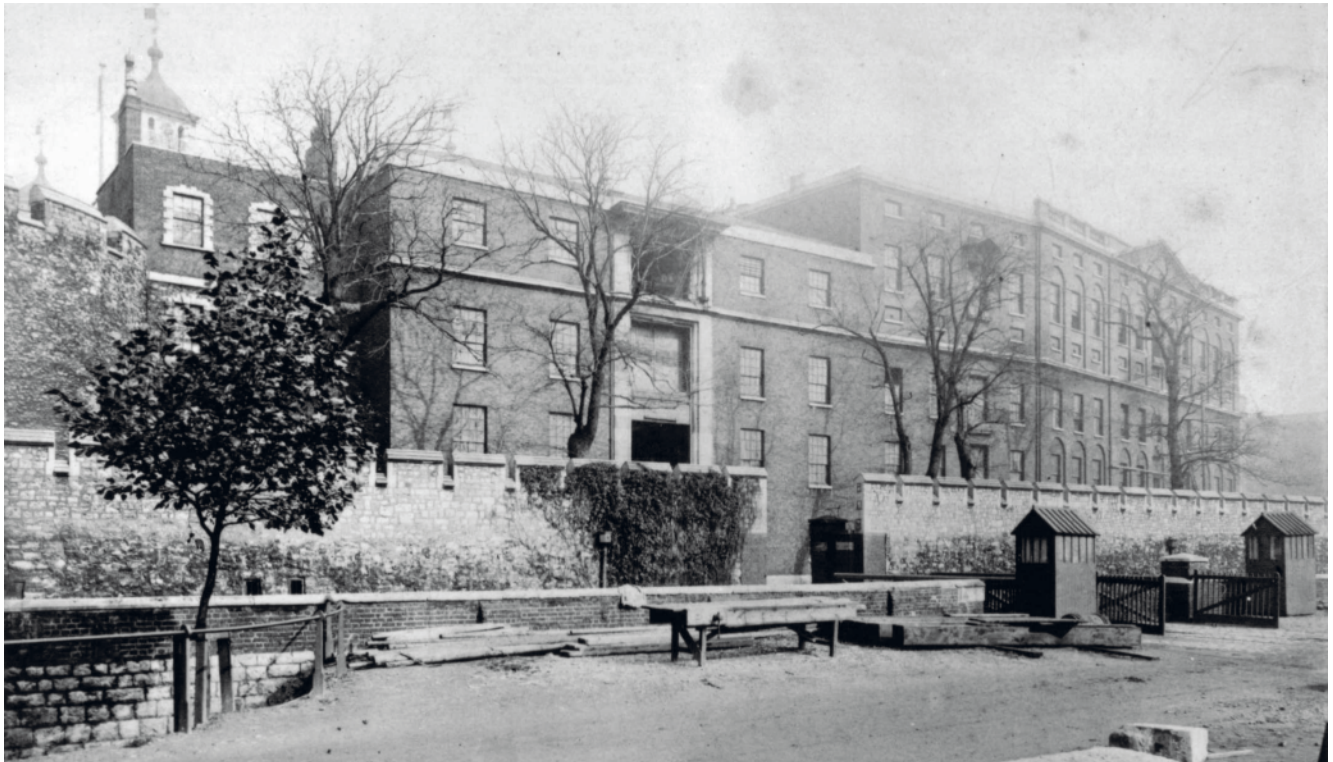
**Fig. 5:** this fascinating photograph of the buildings arranged along the south side of the Inmost Ward was taken by the royal photographers, Bedford Lemere, in 1882, shortly before most of the complex was demolished. From left to right this comprised Henry III's Wakefield Tower with part of a contemporary adjoining chamber block that later formed part of the Record Office of the Tower. The three-storied building to the right is the Ordnance Storehouse built in 1789–92 with a large central entrance with loading bays above. In 1834 the entrance was modified to accommodate a tramway that ferried munitions from the Wharf to the basement of the White Tower. The opening that can be seen in the outer curtain, together with the Middle Drawbridge crossing the moat, was formed at the same time. The lower part of the gigantic building beyond is the Ordnance administrative office built in 1776–80 with the adjoining 1789–92 extension on the left. The upper floor of the building was added in 1854 while the Crimean War was raging and at a time when the office was converted into a storehouse.

next conflagration of 23 July 1788 when the adjoining new Ordnance administrative office was gutted by fire. Having been demolished, the site of Henry III's Great Hall was shared between an enlarged Ordnance office and a new storehouse (Fig. 5), whose west wall seemed to contain a good deal of re-used medieval masonry in its foundations when I uncovered part of it during excavations in 1976.
