**KELSEY PARK & LAND ADJACENT TO NORTH DRIVE, BECKENHAM**  
**LONDON BOROUGH OF BROMLEY**

**ARCHAEOLOGICAL OBSERVATION AND RECORDING**  
**ON BEHALF OF THAMES WATER UTILITIES**  
**(OVERBURY AVENUE SEWER & FLOOD ALLEVIATION SCHEME)**

February 2006

SITE CODE: KYP05  
SITE CENTRE NGR: TQ 37860 68725 & TQ 37955 68415

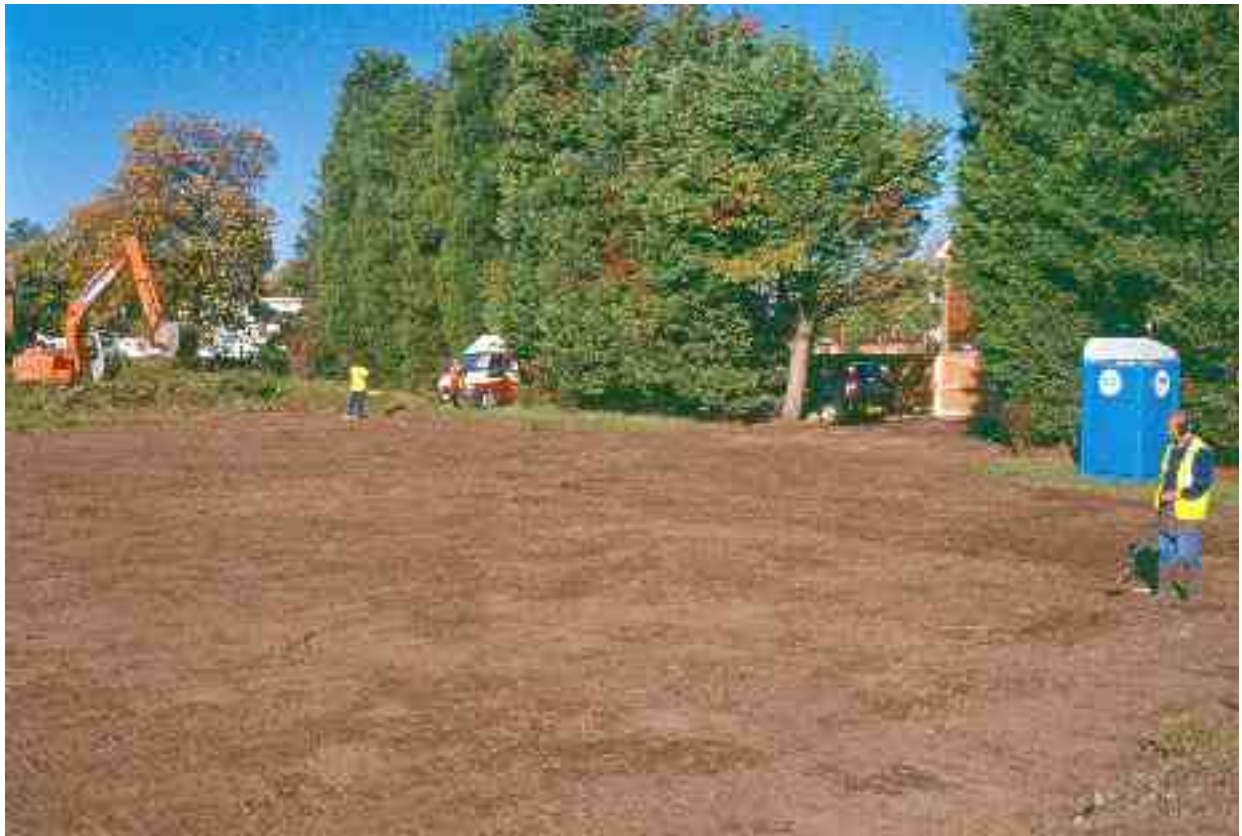
Fig 2 View towards South Eden Park Road across the northern part of the area stripped for the site compound

The exposed ground was quite firm and consequently the topsoil strip was very shallow, typically 60mm to 120mm in depth. This removed a dark sandy silt topsoil and some subsoil, generally exposing a mid to light brown silty sand with pebbles (*cf.* Figure 2). In some areas (particularly to the south) there was a much more gravely horizon that may represent the top of the underlying natural deposit. Elsewhere there were patches of darker more humic material reflecting root action and also some localised areas of disturbance or infill, including some shallow layers of ashy or burnt material near the southern boundary.

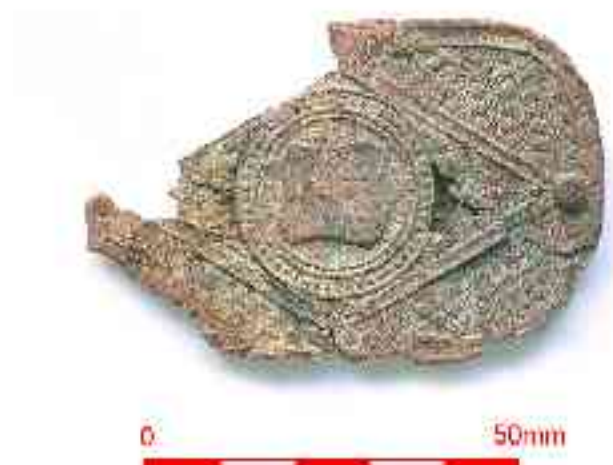
Fig 3 Decorated copper alloy object found during metal detecting in the area of the site compound. *Shown actual size: see Appendix I <4>*

There were no obvious finds apart from a few fragments of recent pottery and glass, occasional ceramic building material (brick, tile and occasional pipe) and two pieces of burnt flint, all of which were derived from the reworked soil horizon. However, a metal detector survey of the reduced area did produce some further post-medieval items. Not all of these were retained but the more interesting and/or dateable included one 18<sup>th</sup> century coin, one ?early 20<sup>th</sup> century Fire Service button, and one composite copper alloy artefact of uncertain function (Figure 3). A more detailed description is given below in Appendix I.

- <1> Lead musket ball: *c* 12.5mm diam., weight 10gms.
- <2> Cu alloy coin, 25mm diam. Heavily worn/corroded: halfpenny of ?George I (1714-27); reverse almost illegible but could be Britannia.
- <3> Fire Service brass button, 25mm diam: corroded but the front element clearly embossed with the word *BRITANNIA*. Maker's name just visible on rear. Probably early 20<sup>th</sup> century.
- <4> Two thin sheets of copper alloy held together by a rivet, either side of what appears to be a piece of card, *c* 69.5mm x 45mm x 3.5mm thick. The metal is thin and fragmentary but both sides bear an identical embossed design (*see Figure 3*). One end is lost but it is likely that this would have mirrored the extant end, to give an overall length of 72mm plus a further rivet.

Function is unknown but this could relate to something like the handle for a large bookmark or a fan. General form & condition (including the surviving card) would suggest a fairly recent date, perhaps 19<sup>th</sup> century.
- <5> Copper alloy disc, *c* 35mm diam.: thin & badly distorted but has an embossed design at the centre of which is a bird sitting on a branch. Function unknown but form and condition suggest a quite recent date, perhaps part of a lid to a scent bottle or similar.
- <6> Brass surround for keyhole, height 22mm: originally inset on a drawer front or other furniture.
- <7> Bronze fragment of shrapnel showing screw thread at base of nose, weight 6gms.
- <8> Brass .303 cartridge case
- <9> Circular brass key tag or similar, 26mm diam, stamped with the figure 50.

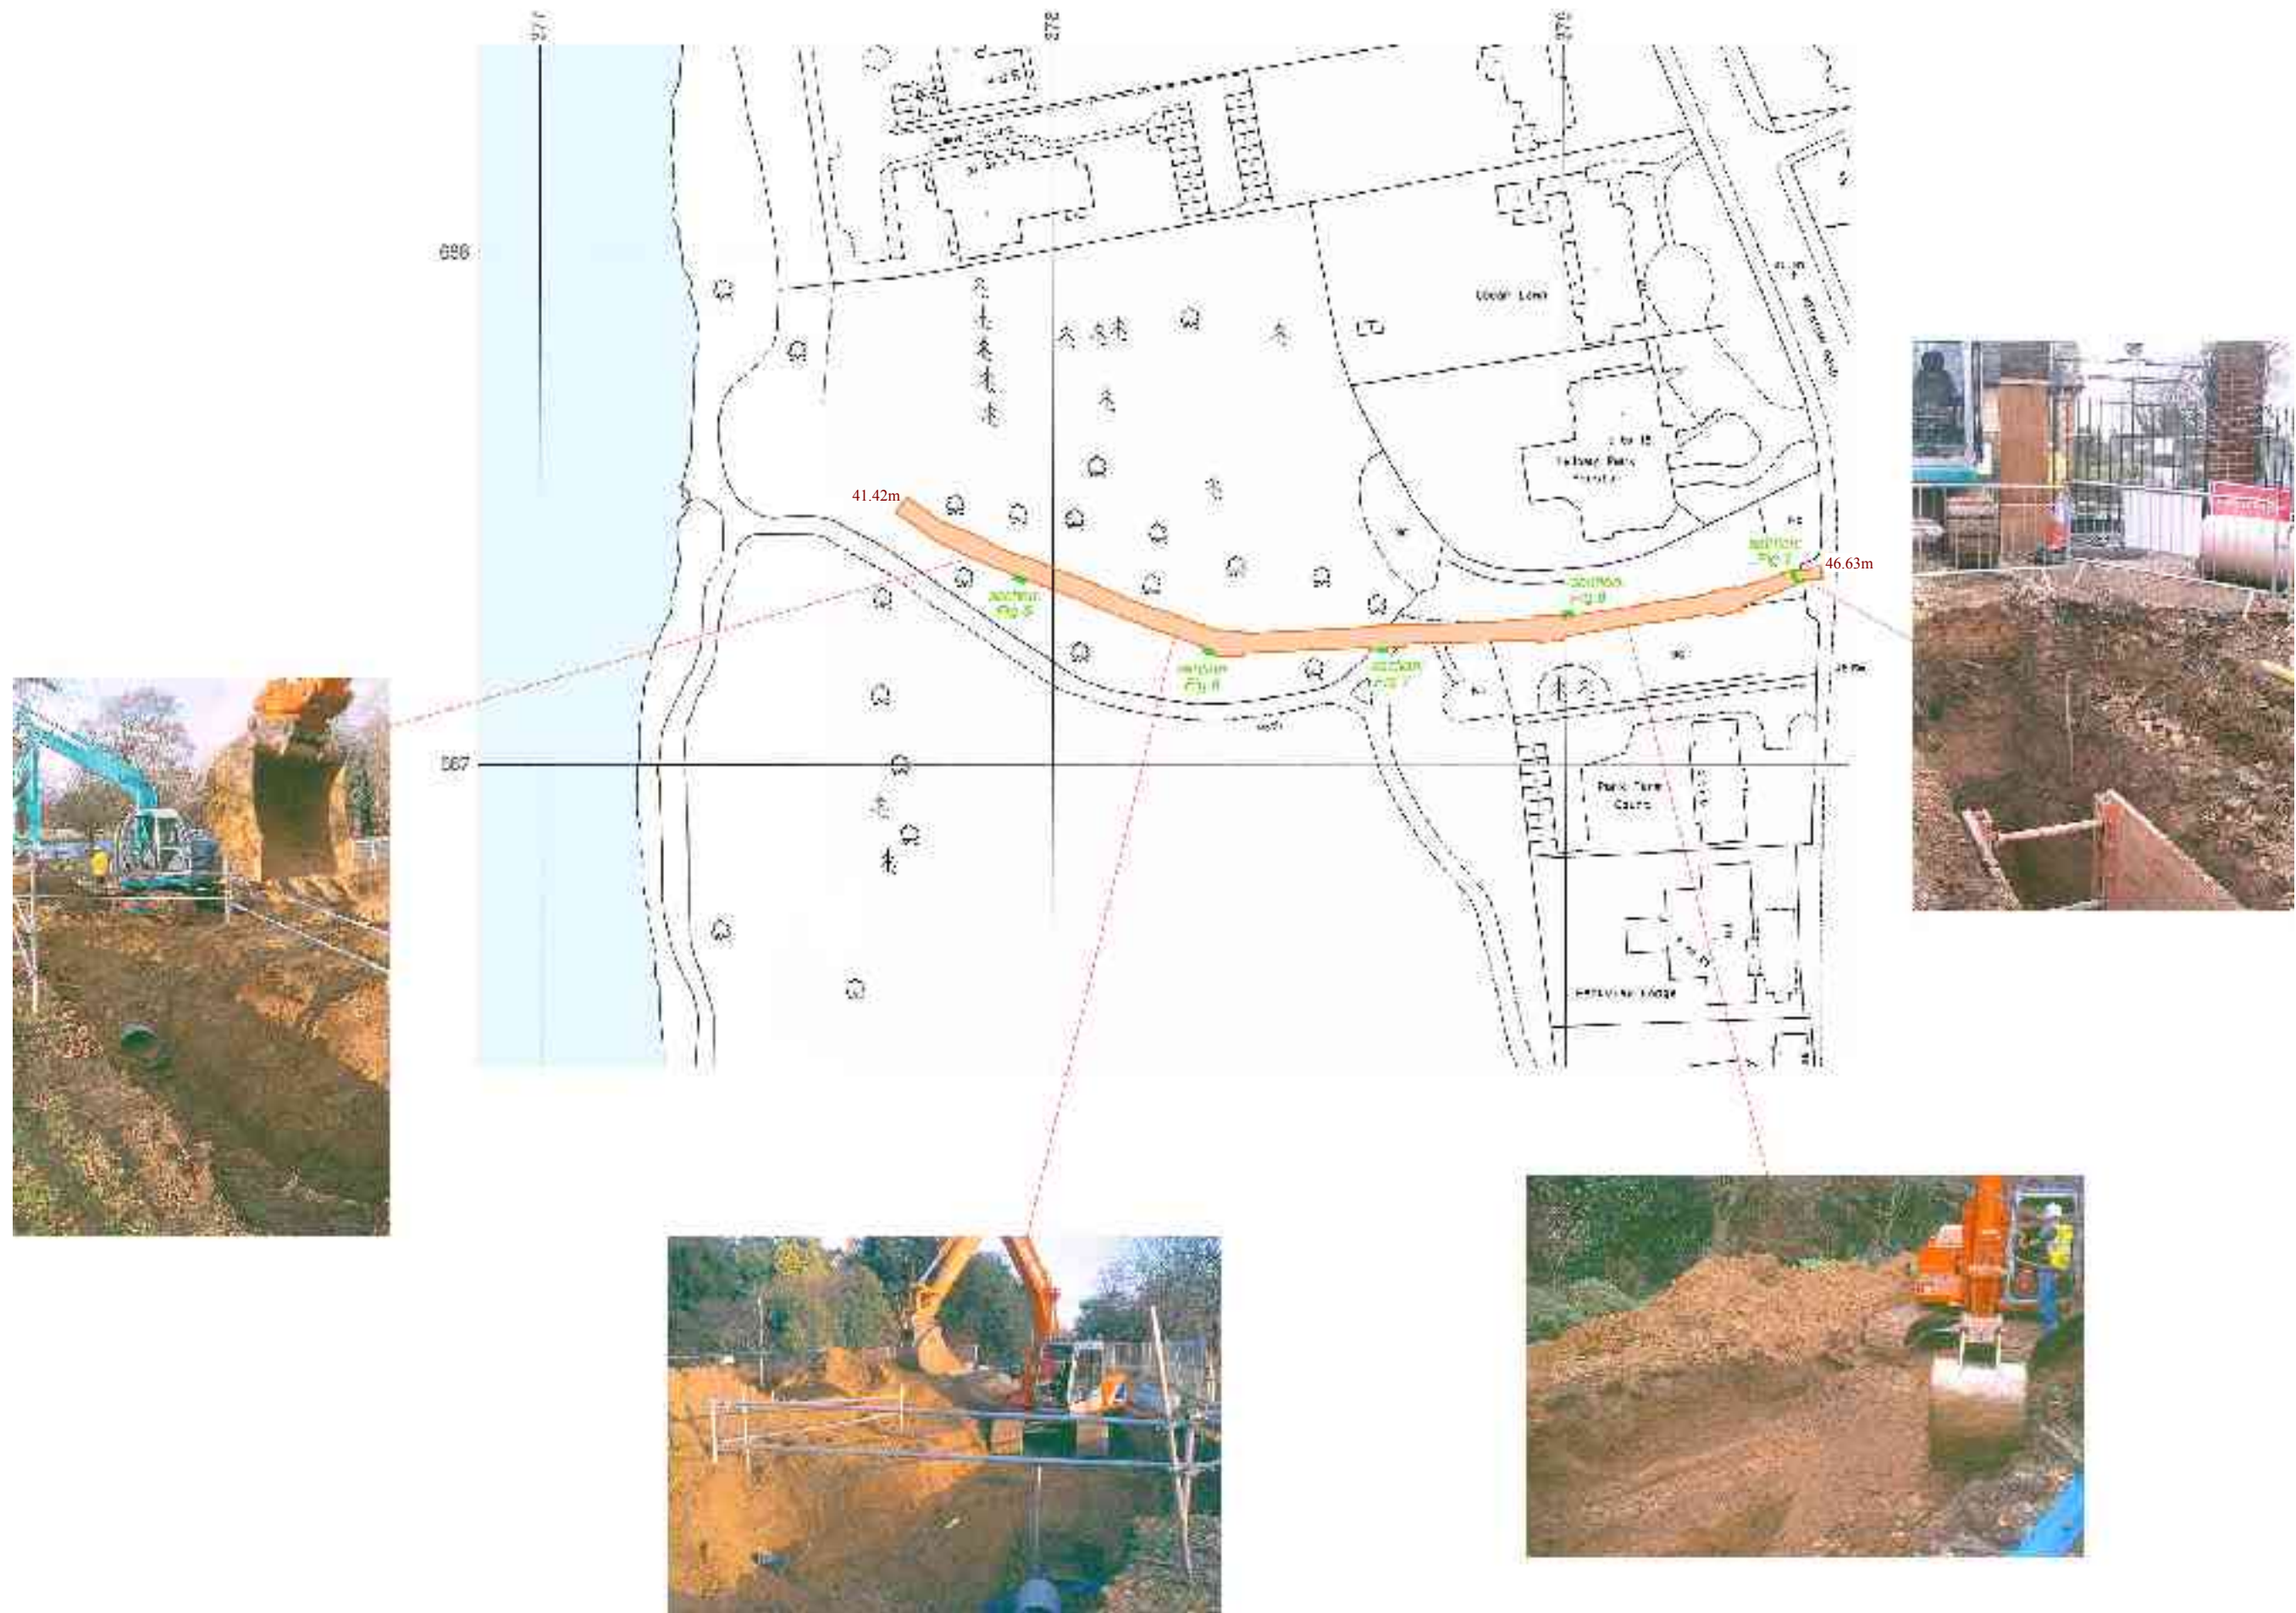
Fig 4 1:1250 plan showing the route of the pipe trench excavation across Kelsey Park, plus views of work in progress and location of detailed sections (Figs 5 to 9) overleaf

**3.2** The new pipe trench was located on the eastern side of Kelsey Park, covering a distance of nearly 190m from a point just east of the Lake to the edge of Wickham Road (Figure 4; centred at National Grid Reference TQ 37860 68725).

The subsequent excavation of the replacement pipe trench across Kelsey Park took place over an approximate a five-week period from early December 2005. The works joined up with an existing pipe to the west and to the east were continued by further groundworks along the line of Wickham Road. As already noted, the trench was generally about 3m to 4m wide, with the sides stepped at slightly less than 1m to a final central depth of at least 2.5m. The excavation ground level also rose by just over 5m from west to east (*cf.* spot heights on Figure 4).

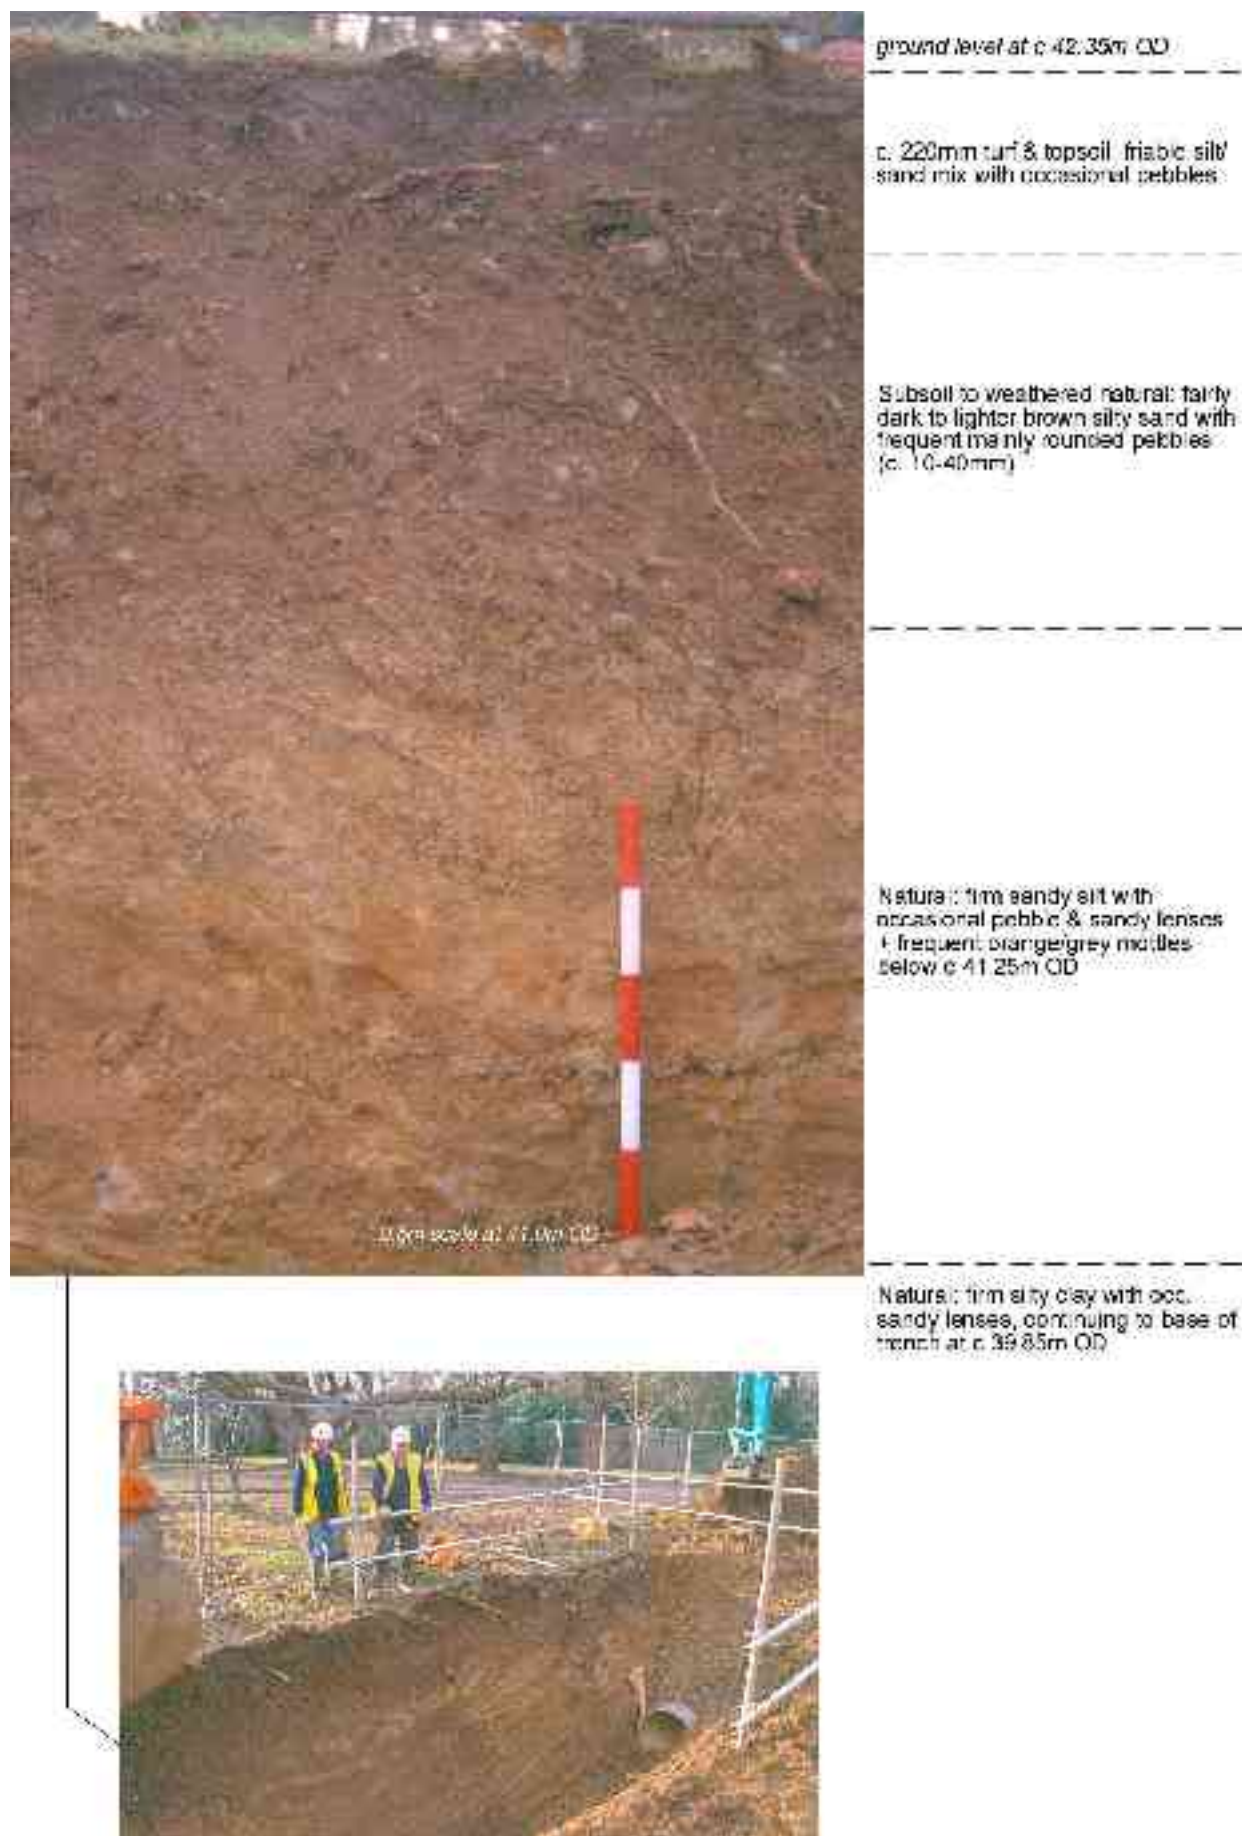
Fig 5 Detail of exposed section and general view towards the western end of the pipe trench excavation in Kelsey Park, looking south /southeast (for location see Fig 4)

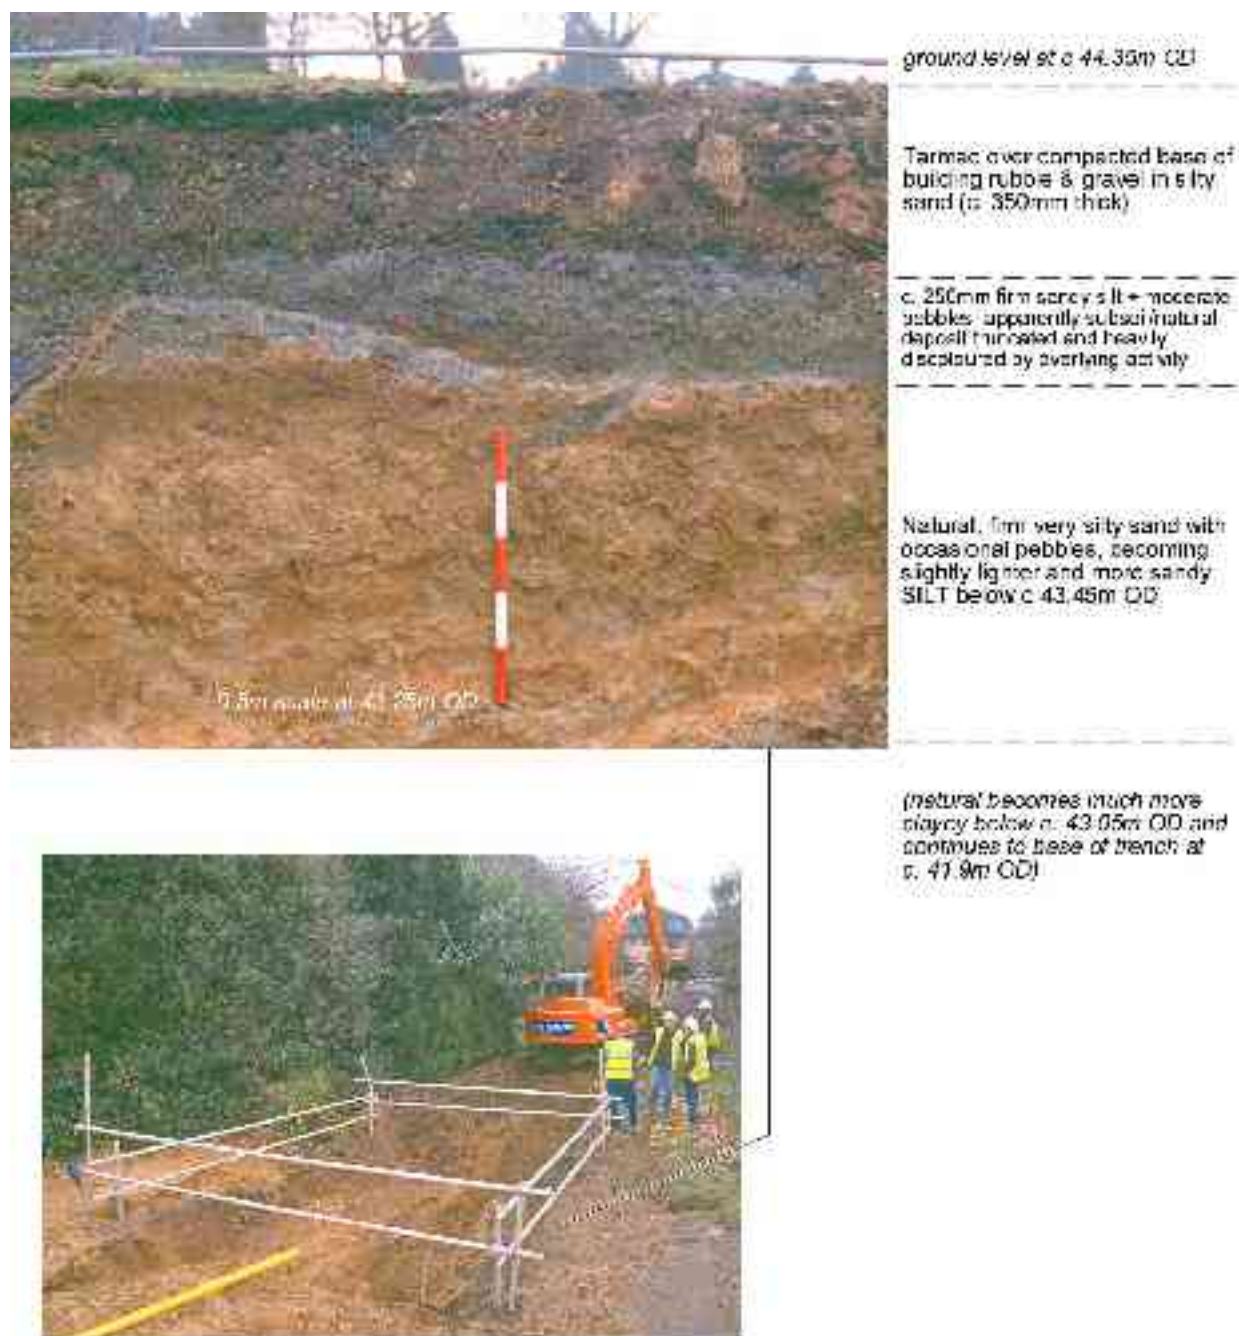
Fig 7 Detail of exposed section and general view of pipe trench cutting the pedestrian path at the approximate mid-point of the excavation, looking south and east (*for location see Fig 4*)

In general the natural sand/silt was overlain by a mid to darker brown silty sand with variable amounts of pebbles, which in some places became more frequent with depth (*cf.* Figure 6). This horizon appears to represent a weathered natural grading upwards to reworked subsoil, and was of fairly uniform depth, generally about 400mm to 650mm. At the eastern end of the pipe trench and close to Wickham Road the sequence was somewhat different, in that the layer was clearly divided into a distinct band of gravel in a firm silty matrix overlain by sandy silt with few pebbles (Figure 9). In the central part of the trench the layer was also significantly disturbed and truncated by modern activity (*cf.* Figure 7).

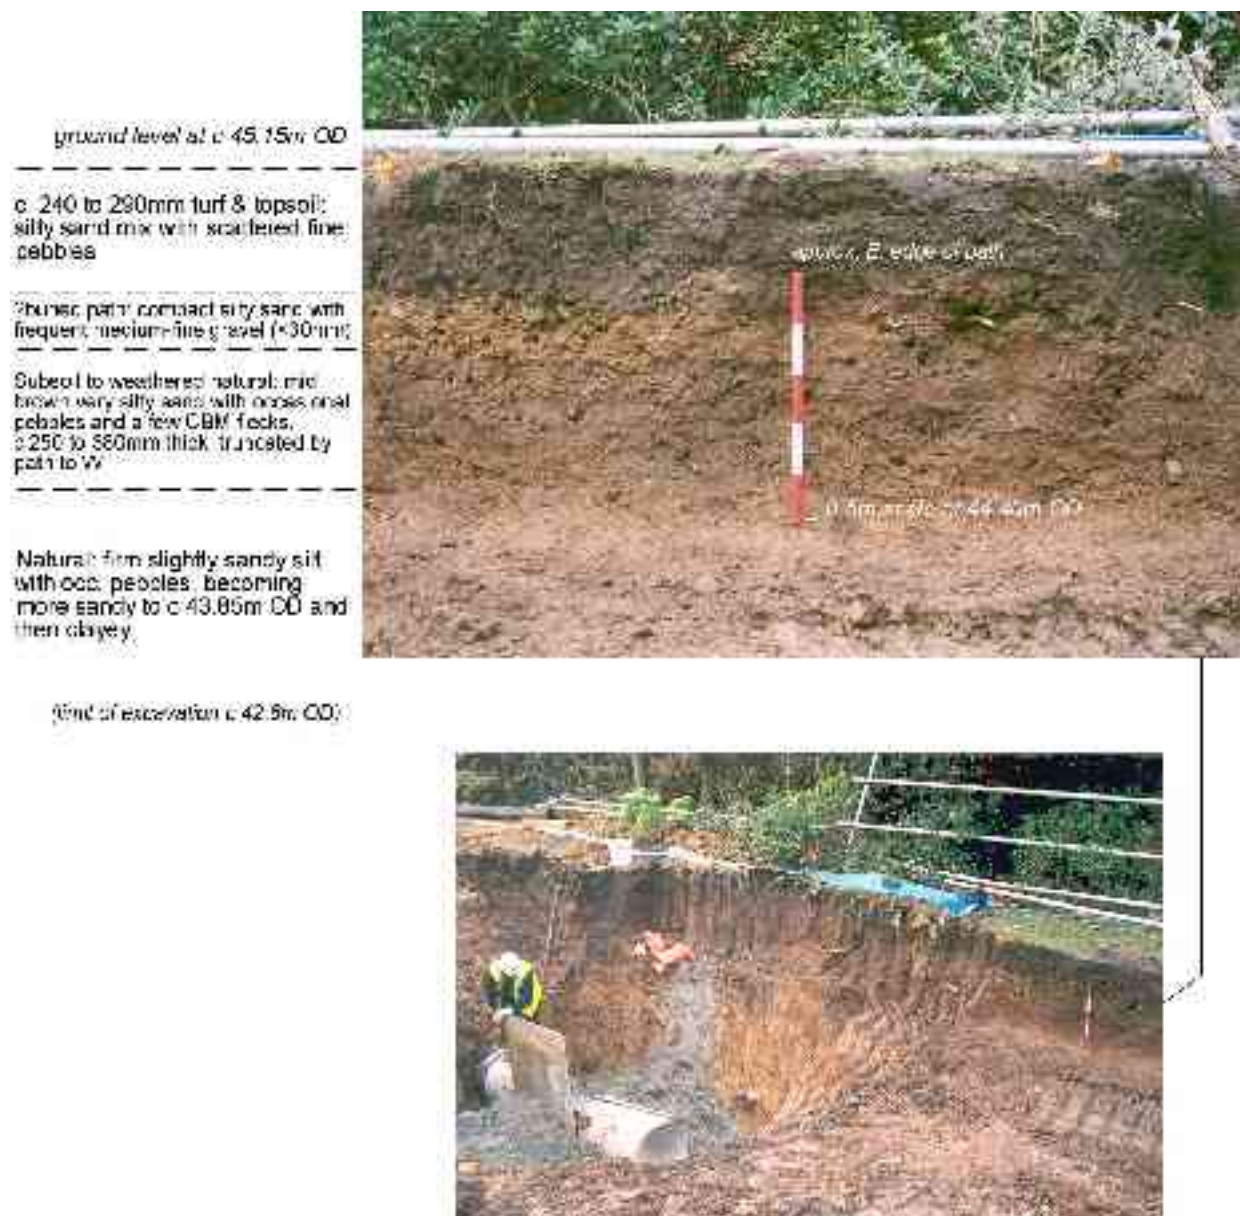
Fig 8 Detail of exposed section and general view of pipe trench and adjacent inspection chamber excavation, looking north and northwest (*for location see Fig 4*)
