GROVE MILL & FORMER CROWN MILL SITE

475 LONDON ROAD, MITCHAM CR4

**AN ARCHAEOLOGICAL EVALUATION, WATCHING BRIEF AND
STANDING BUILDING RECORD**

SITE CODE: GCM04

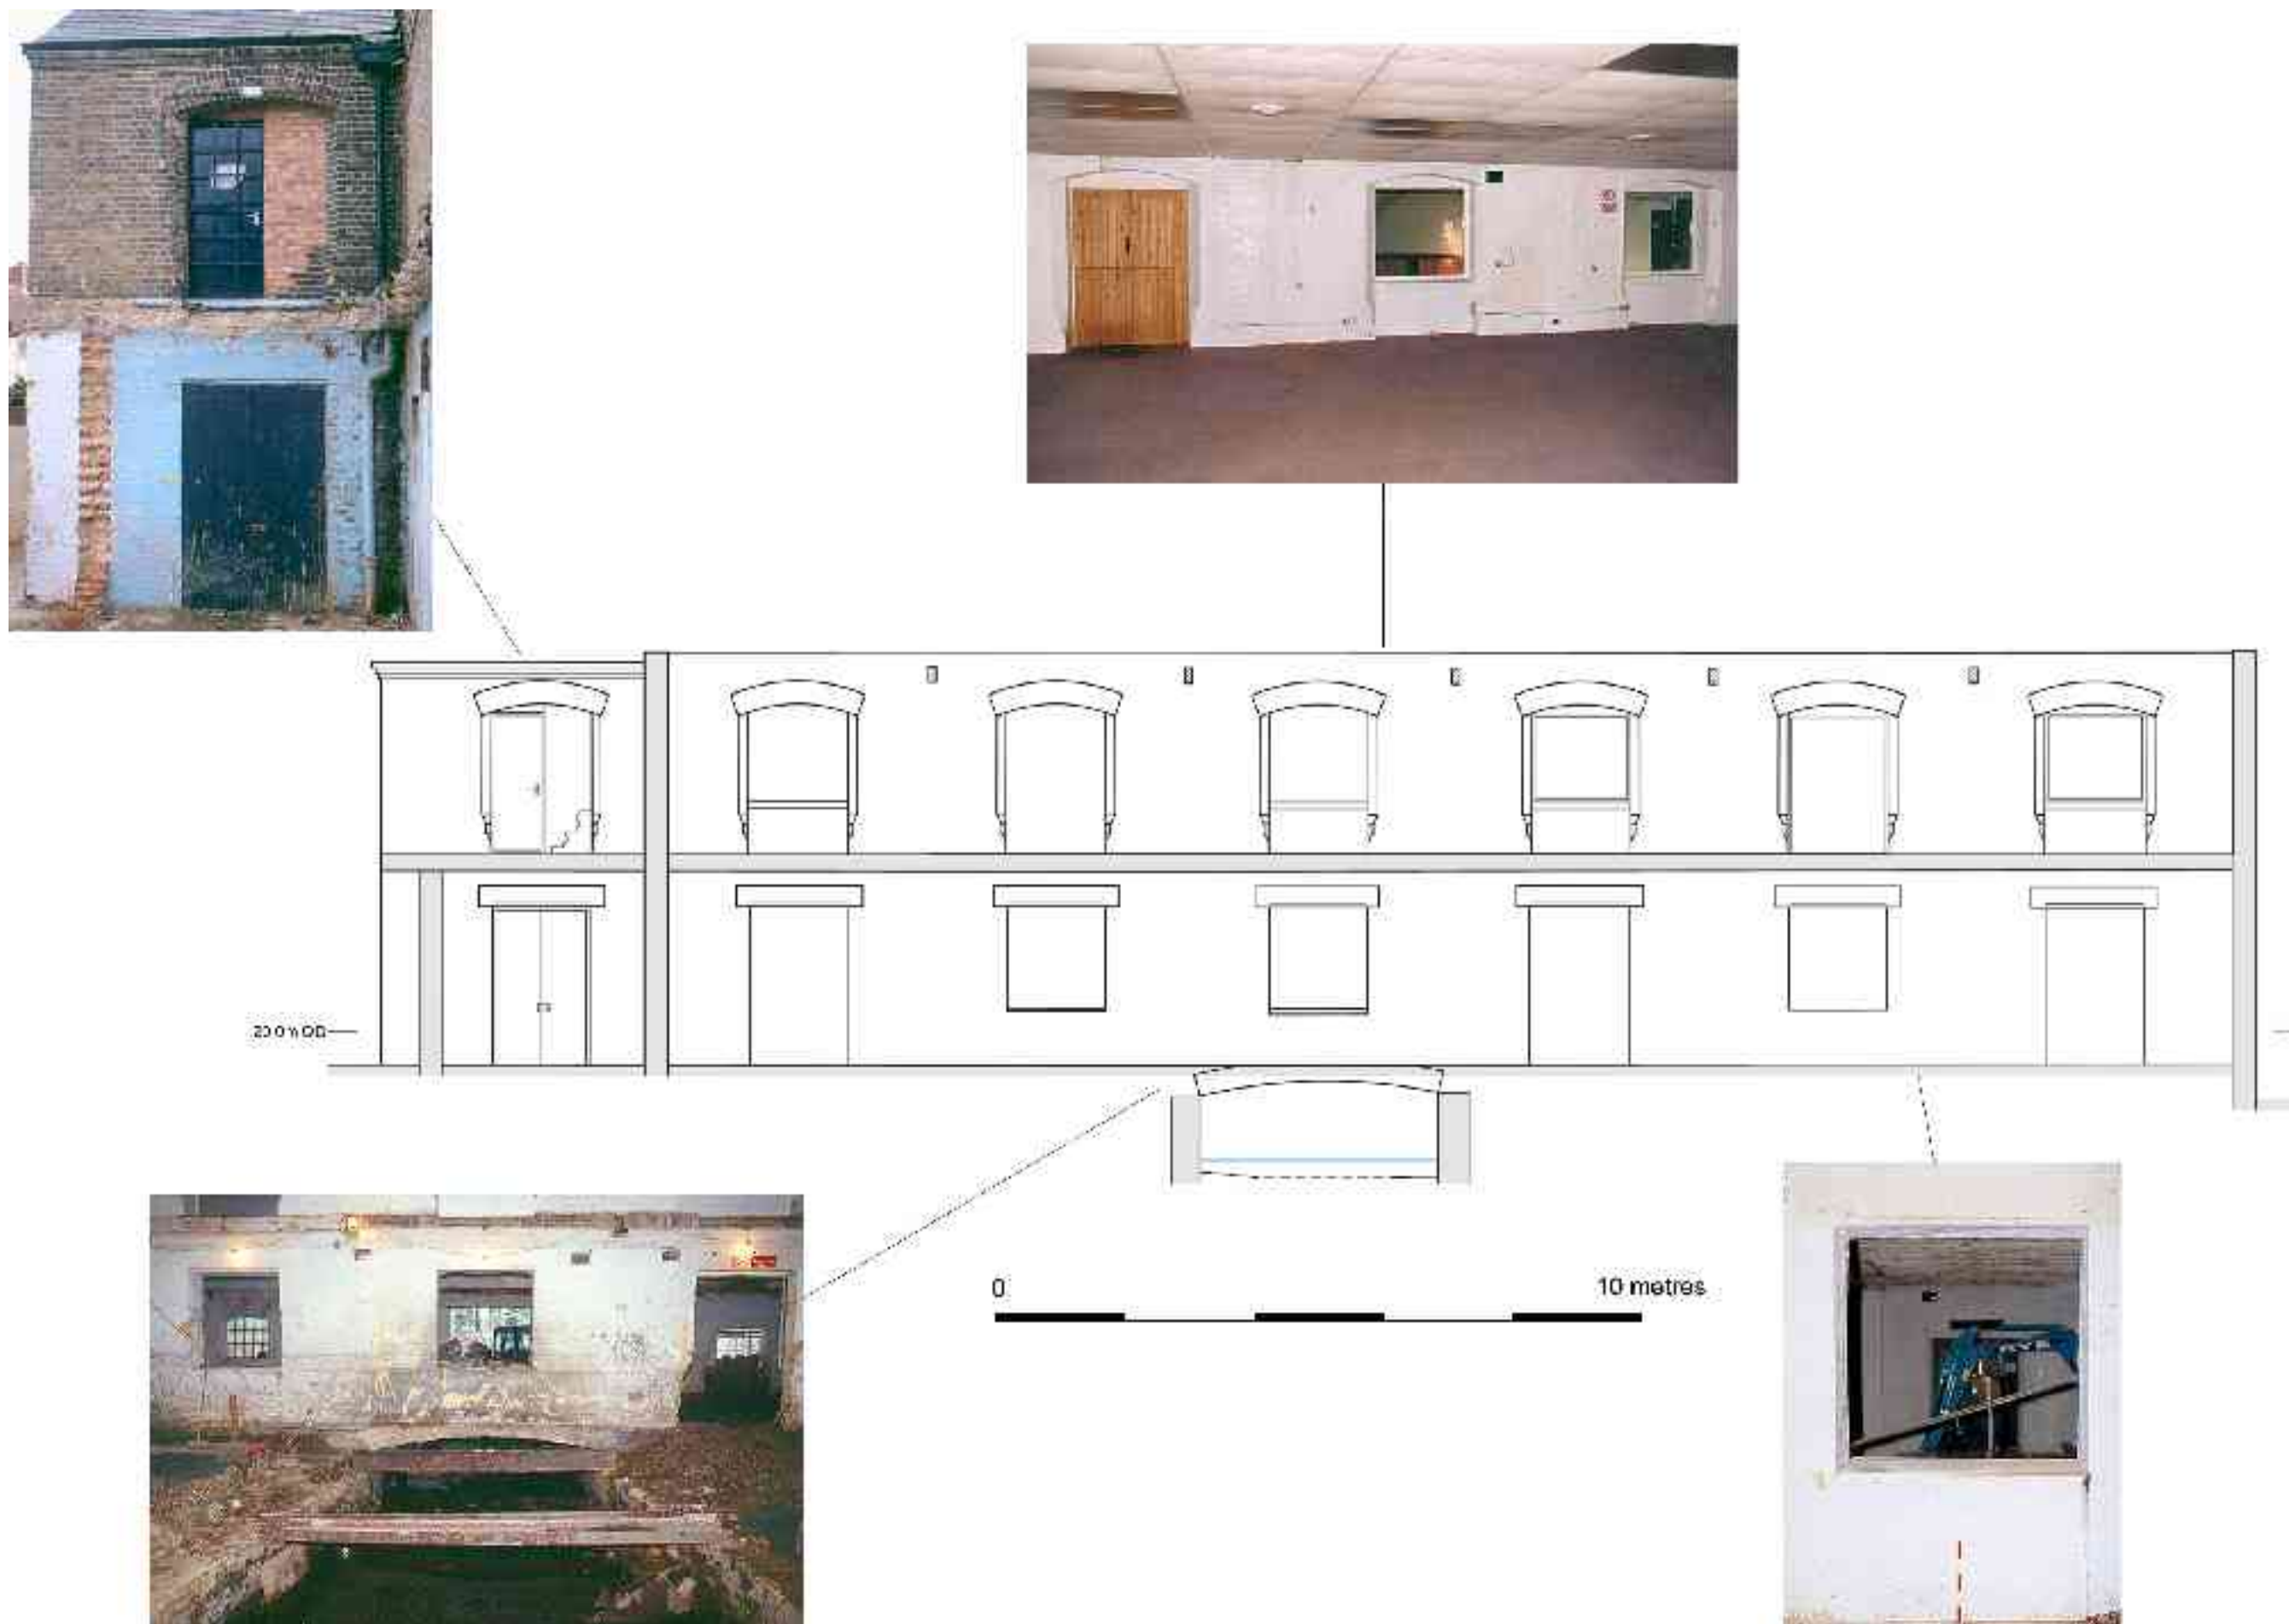
Fig 7 Elevation and views of the west face of the 1860s Grove Mill, now forming the central wall within the extended building. The photo at lower left shows the exposed millrace after removal of the floor slab

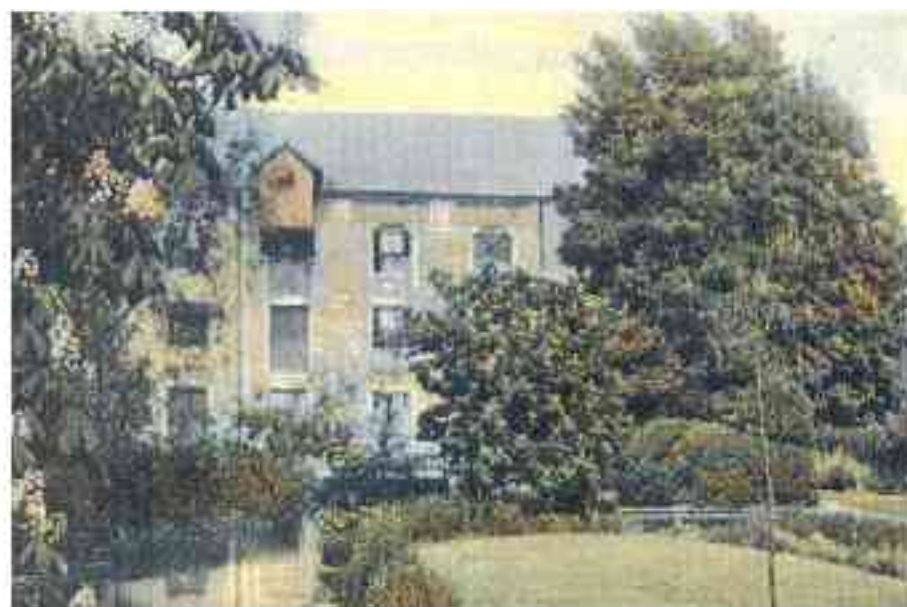
Fig 8 Reconstructed elevation of the west face of the 1860s Grove Mill, showing the demolished third floor and original form of the second floor windows. The illustrations above include two later 19th century views and one view (C) taken immediately after the building was gutted in the fire of 1907

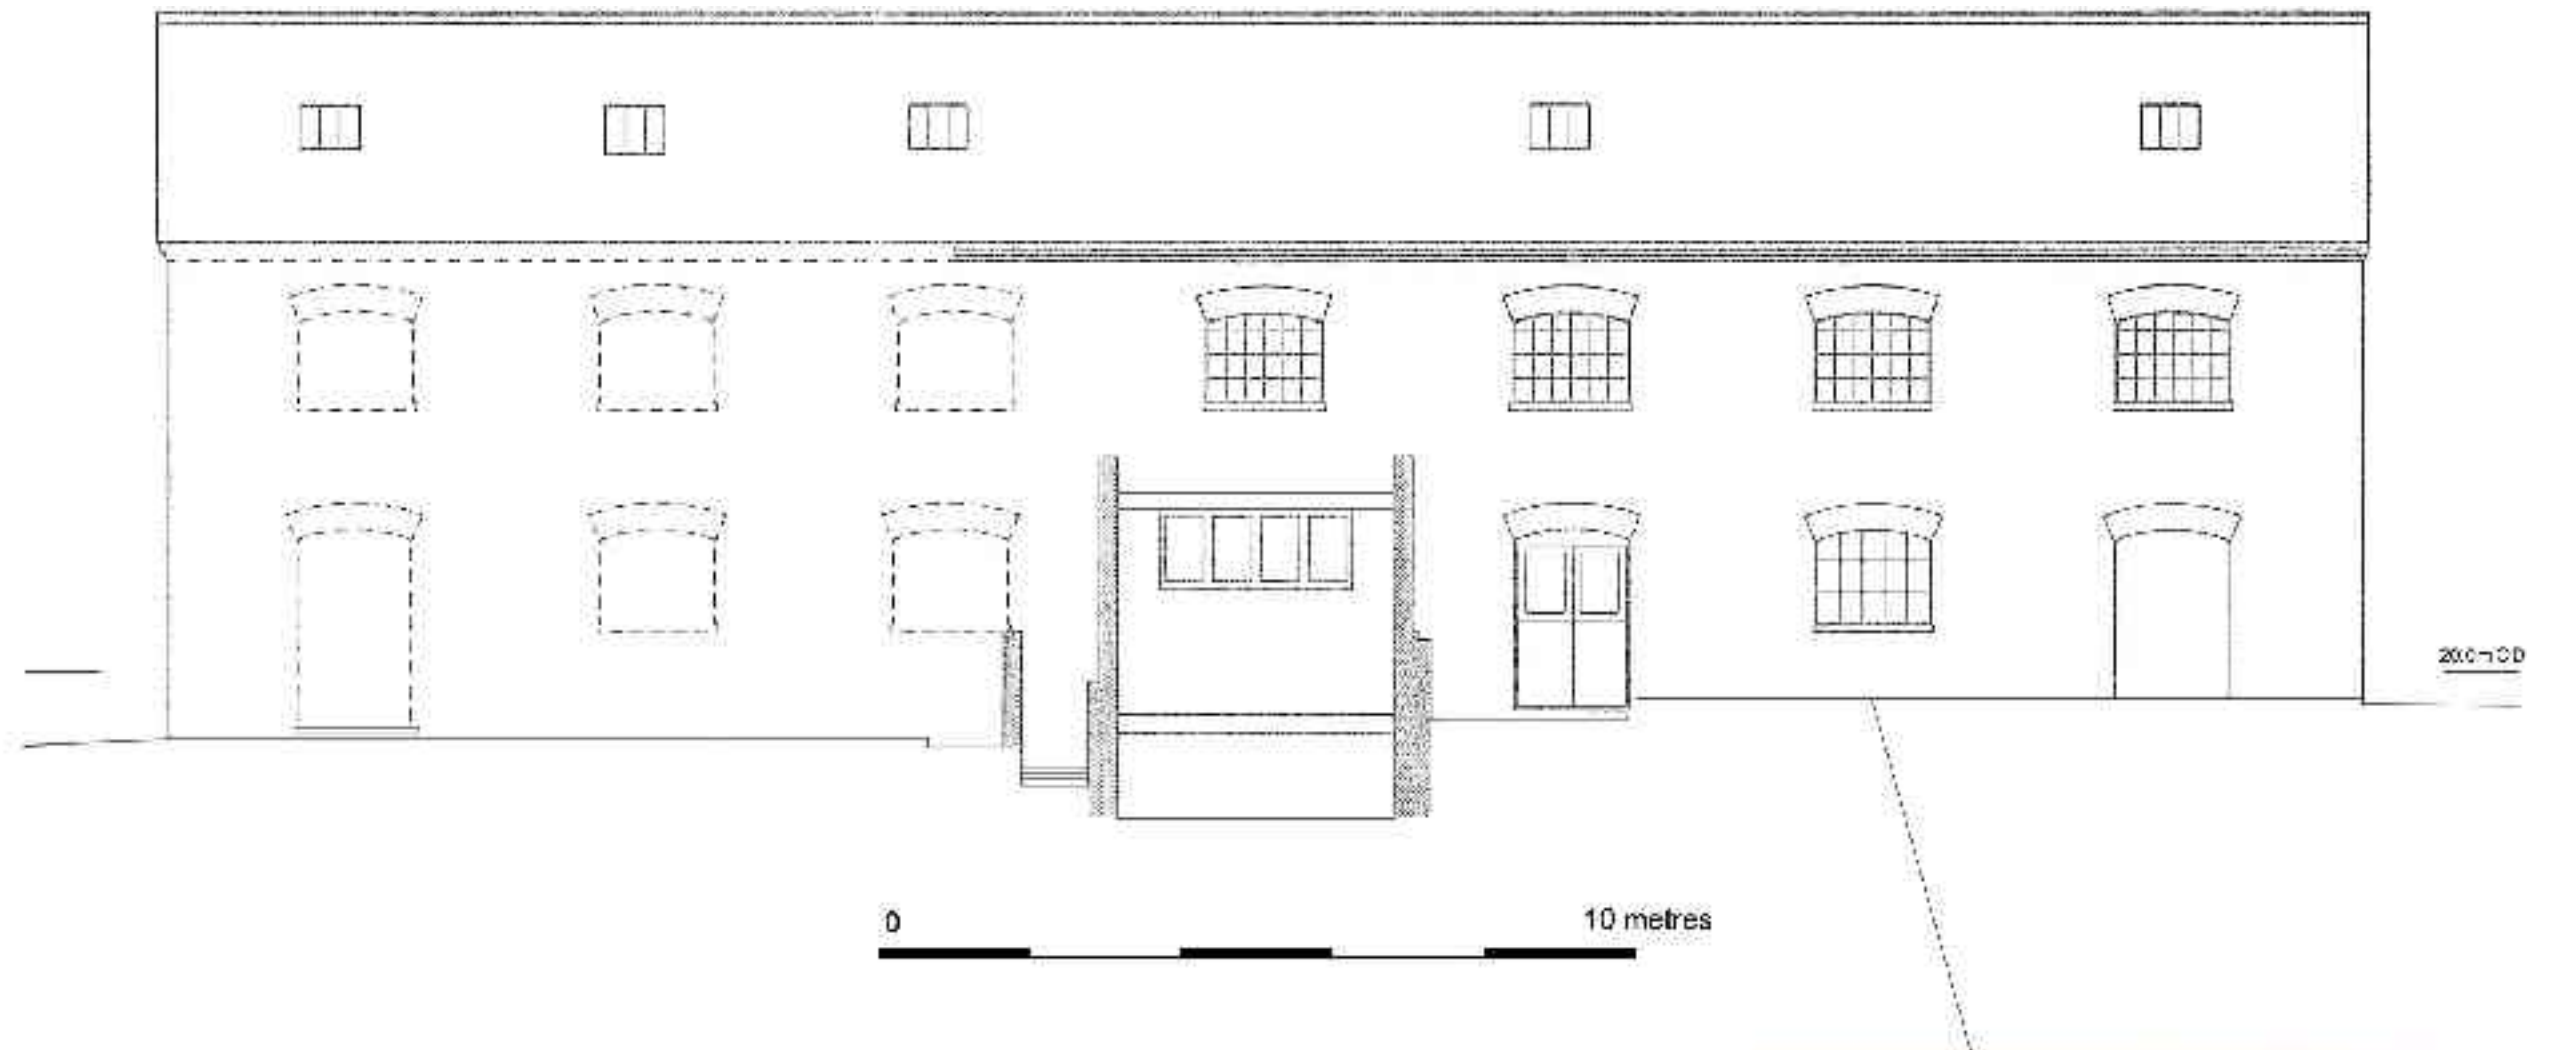
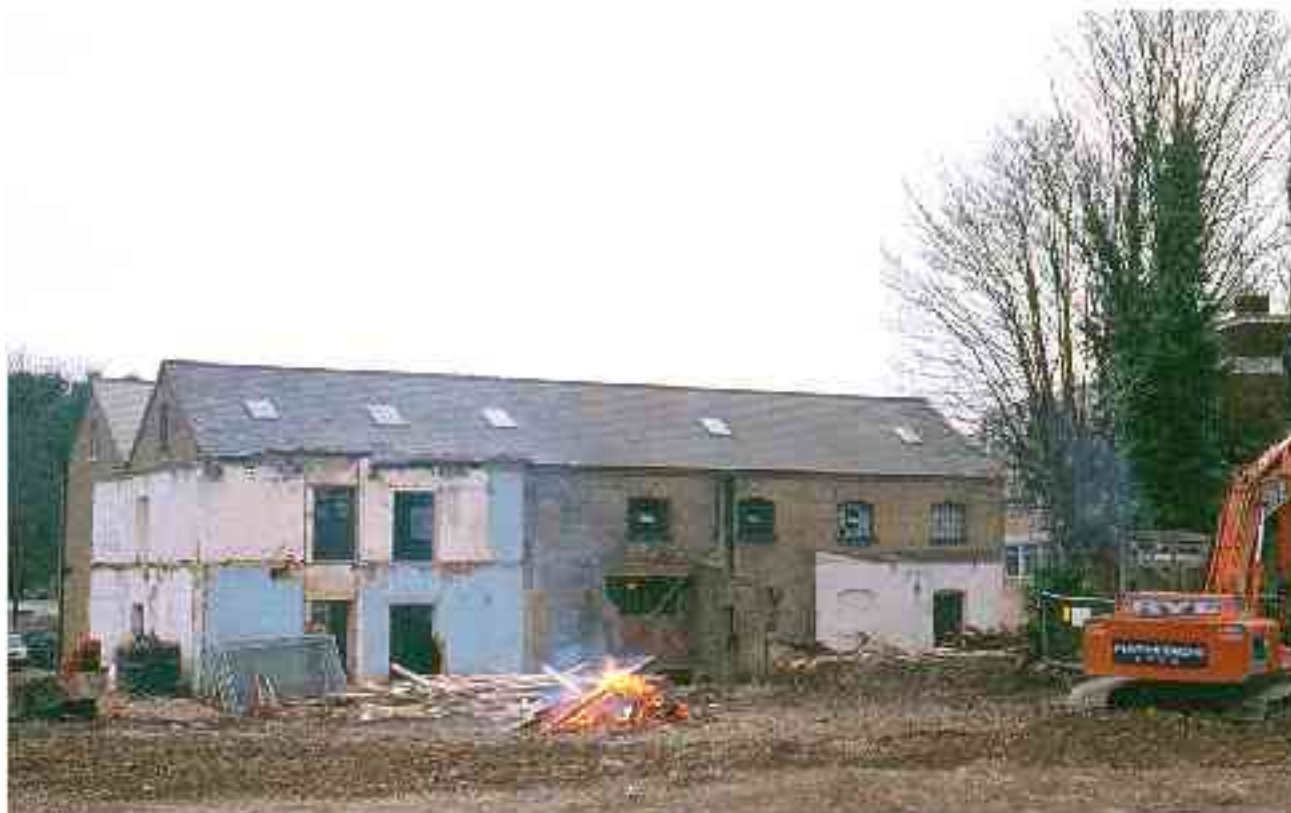
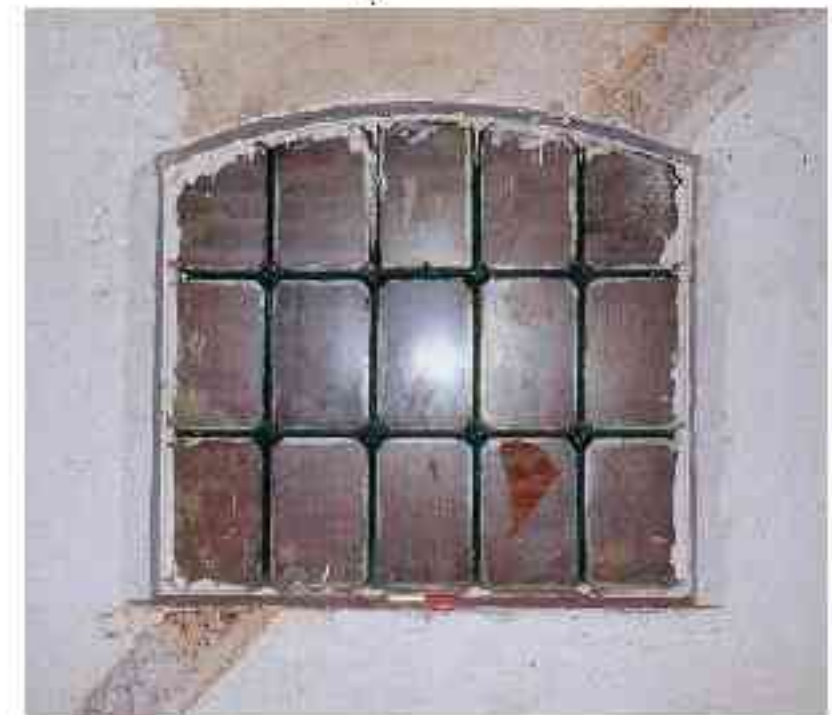
Fig 9 Elevation of the east face of the 1860s Grove Mill, including partial reconstruction of the original layout (omitting the third floor & showing later wheelhouse alterations). The general view at lower left was taken during the current redevelopment after removal of the later additions: the picture to the right shows internal detail of a probable original ground floor window (*0.2m scale*)

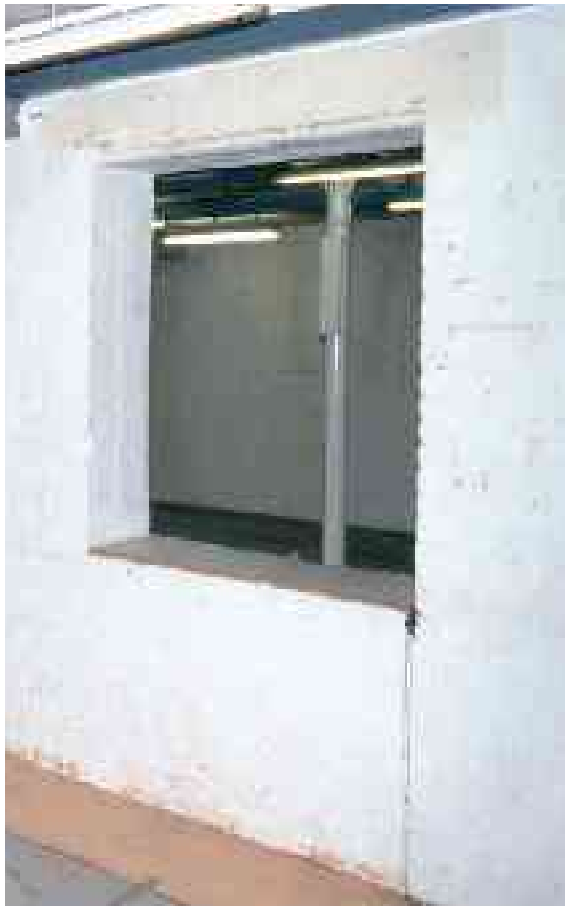
Fig 11 Ground floor opening within the west face of the 1860s Grove Mill, prior to redevelopment (left) and as a blind window immediately after the 1907 fire (*see also Figs 7 & 8*)

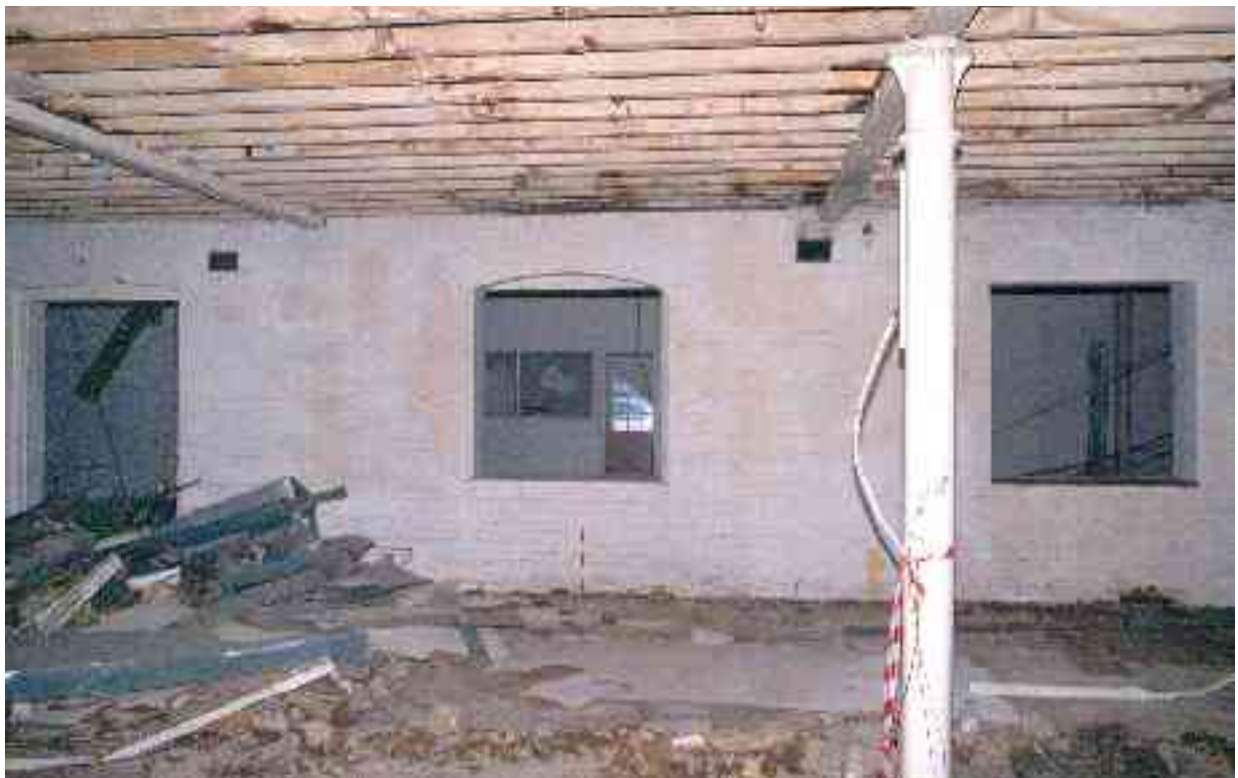
Fig 12 The internal face of the 1860s west front of Grove Mill (the same area as in Fig 7 but viewed from the inside). Note the variation in window/door head design (l-r) from shallow to fuller arch to flat, reflecting the original layout as door, window and blind window

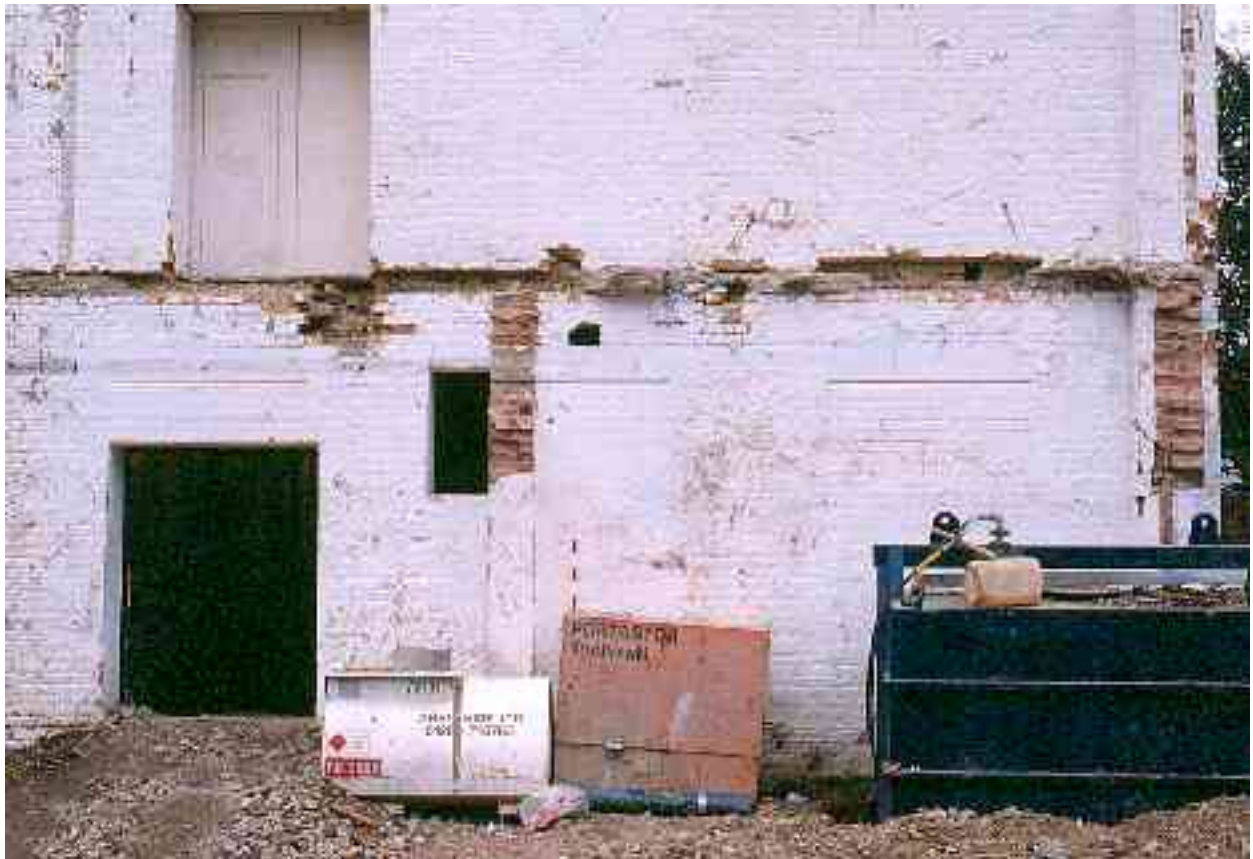
Fig 13 The southern end of the 1860s Grove Mill after removal of the later additions, showing the stone lintels and probable lines of three original ground floor windows

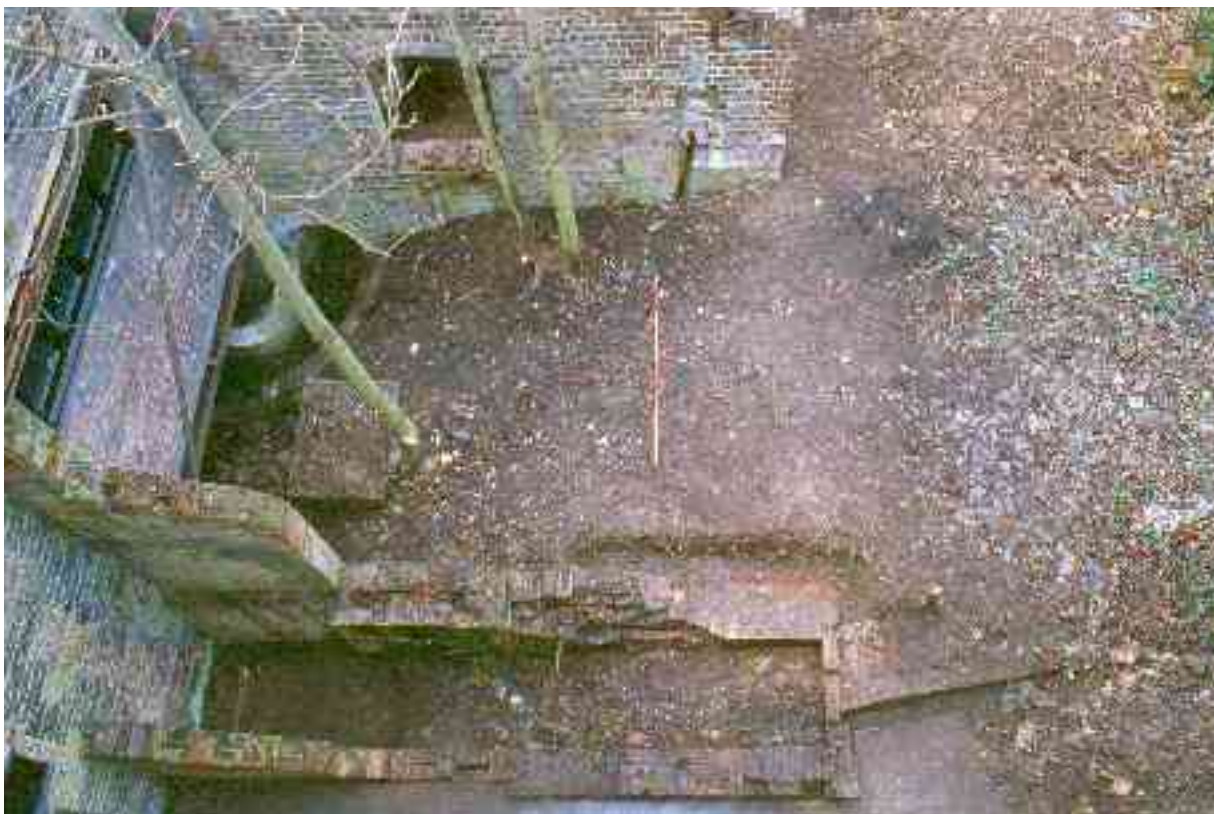
Fig 15 Overhead view of the wheelhouse remains before full excavation. The 2m scale lies on the line of the sluice gate

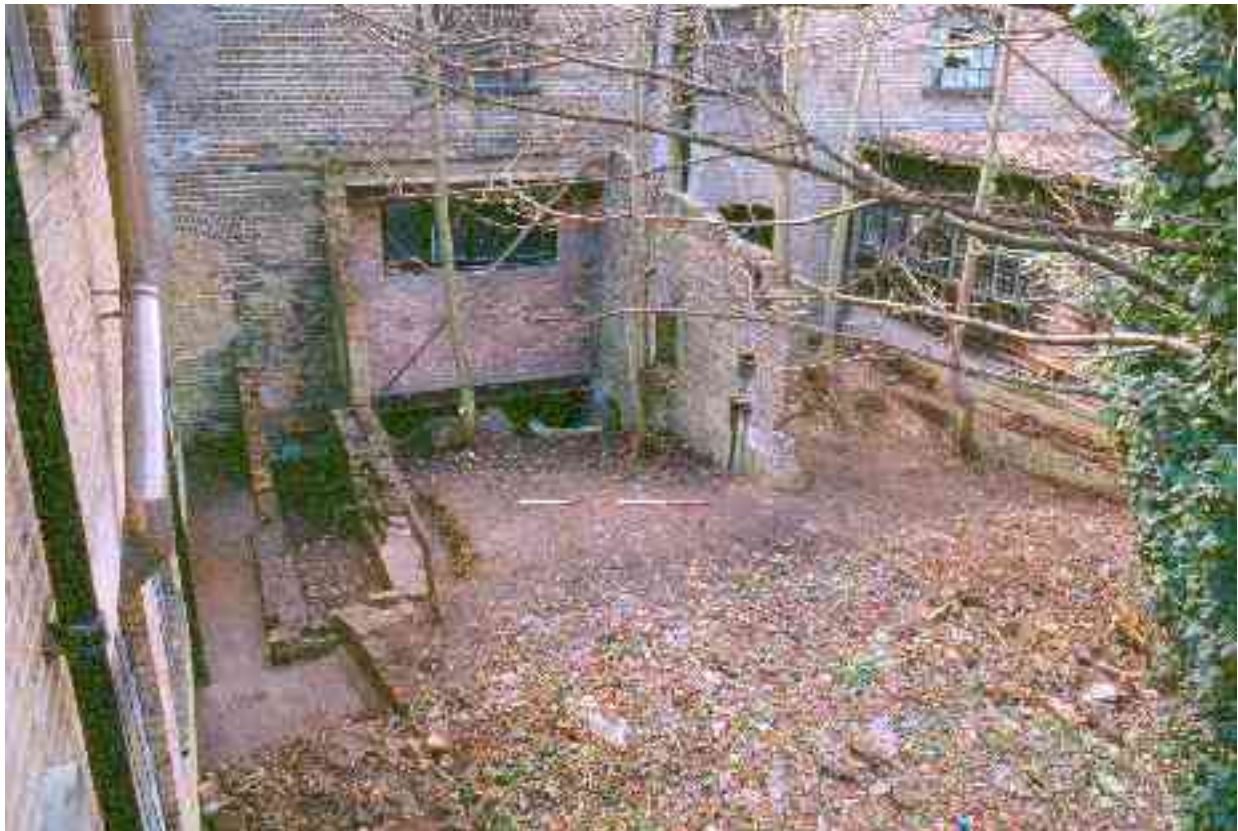
Fig 16 The remains of the wheelhouse and machine pit, looking west towards the earlier part of Grove Mill (2m scale). The central red brick blocking wall and window are also of 20th century date

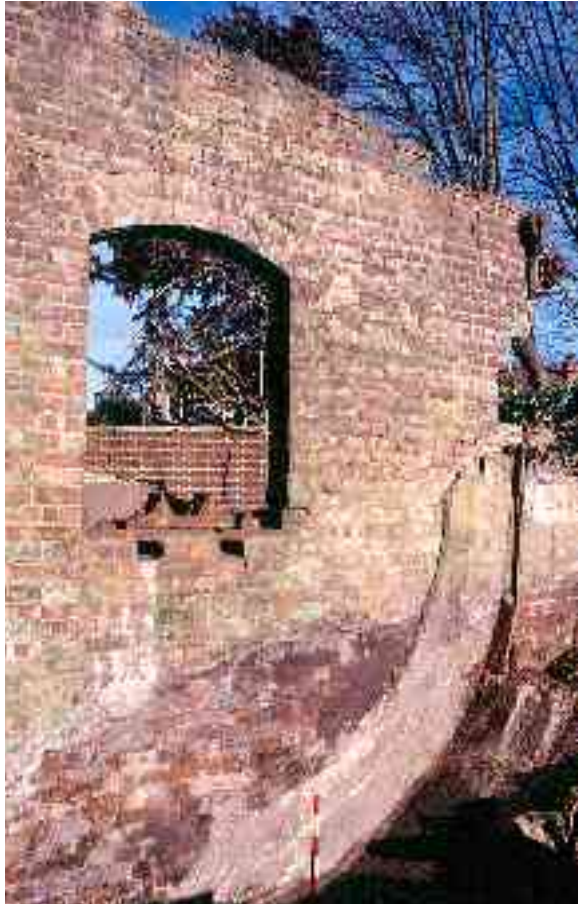
Fig 21 The northern side of wheelhouse after excavation (*0.5m scale*)

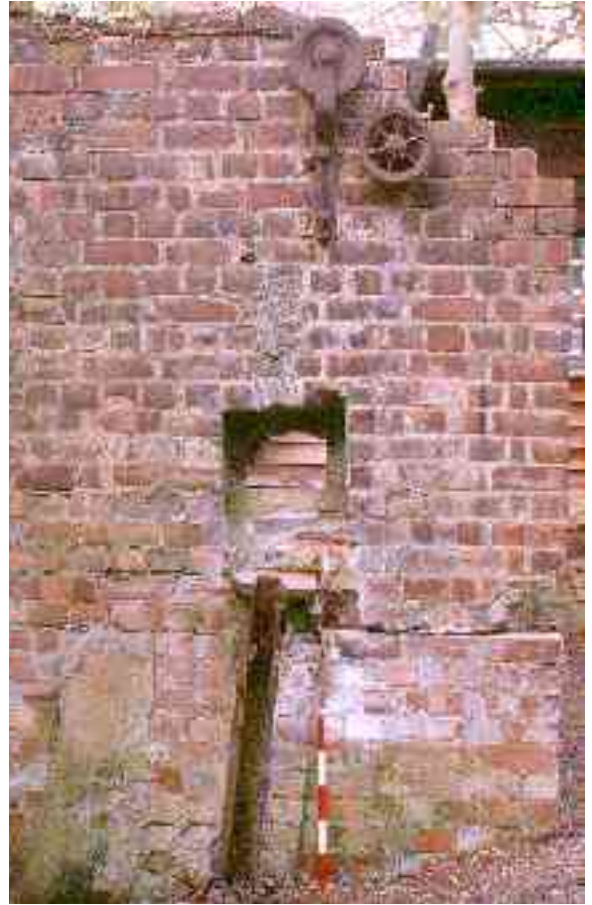
Fig 22 Remains of the sluice, including a cast iron channel for the gate

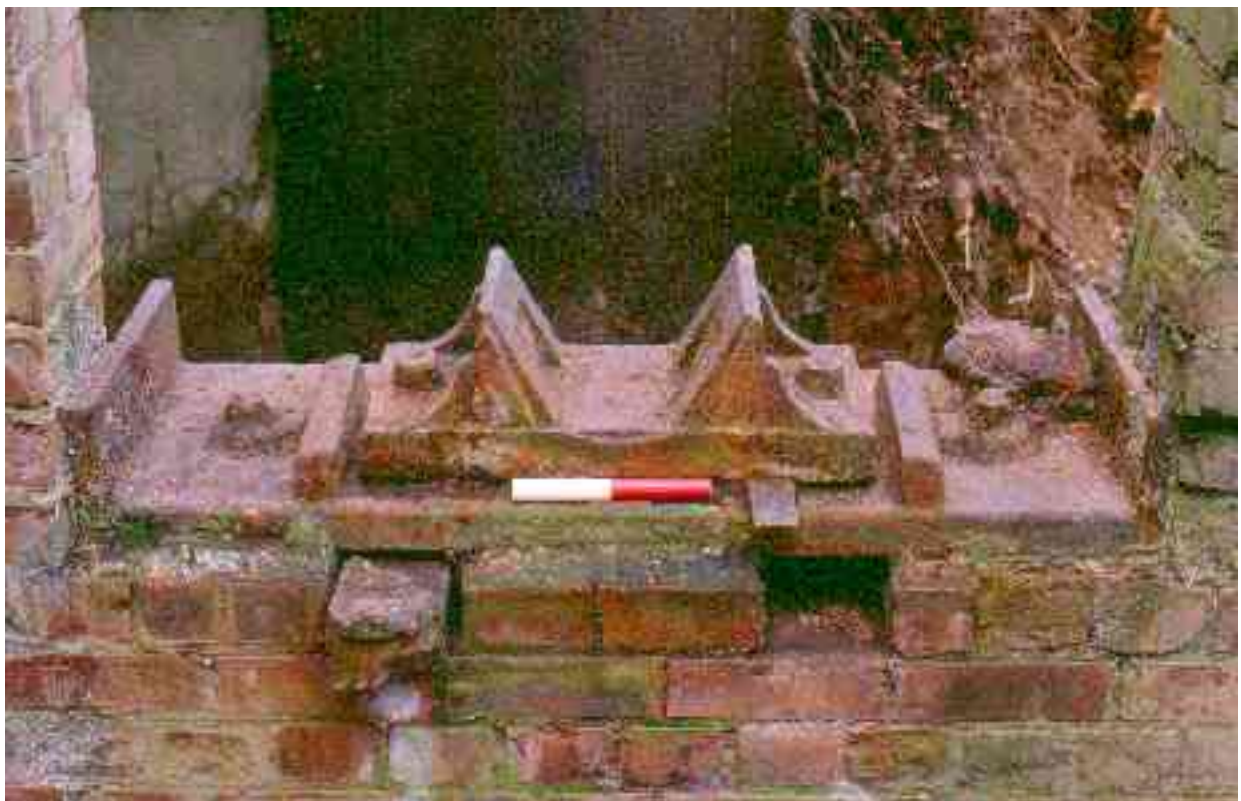
Fig 23 Cast iron bracket or plummer-block for the northern end of the waterwheel axle. A levelling bar for fine adjustment projects just to the right of the 0.2m scale

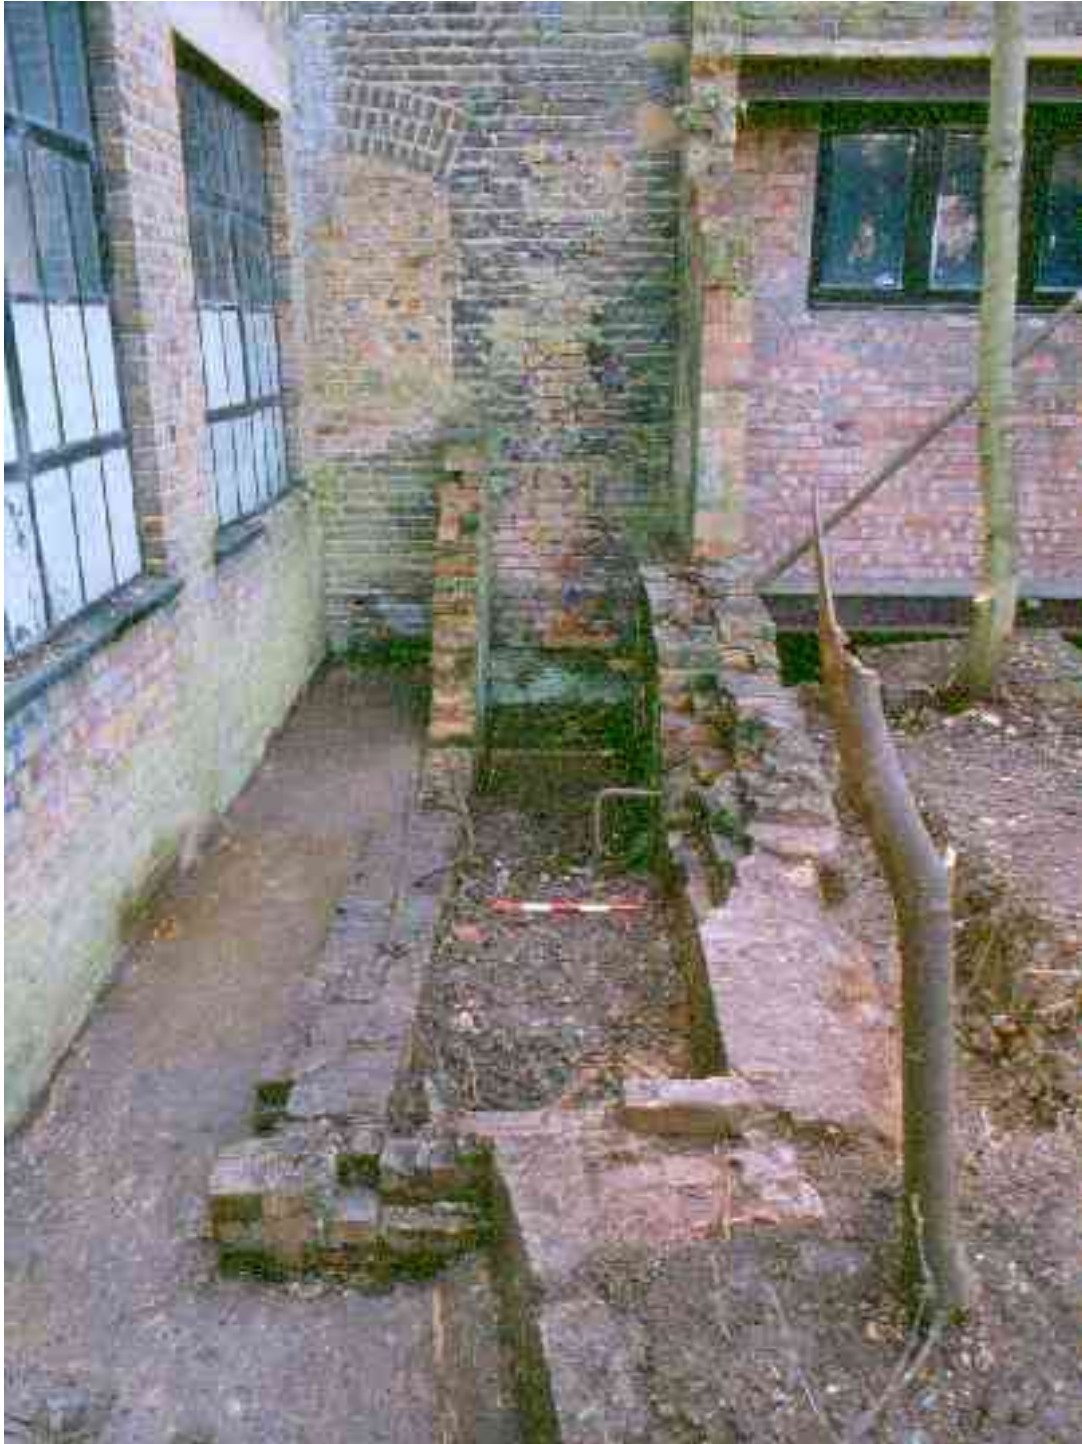
Fig 24 Machine pit on the southern side of the waterwheel (*0.5m scale; see Figs 14 & 17*). The 19th century mill wall in the background has a blocked window to the left and smaller areas of blocking above the pit that would have taken the drive shaft from waterwheel

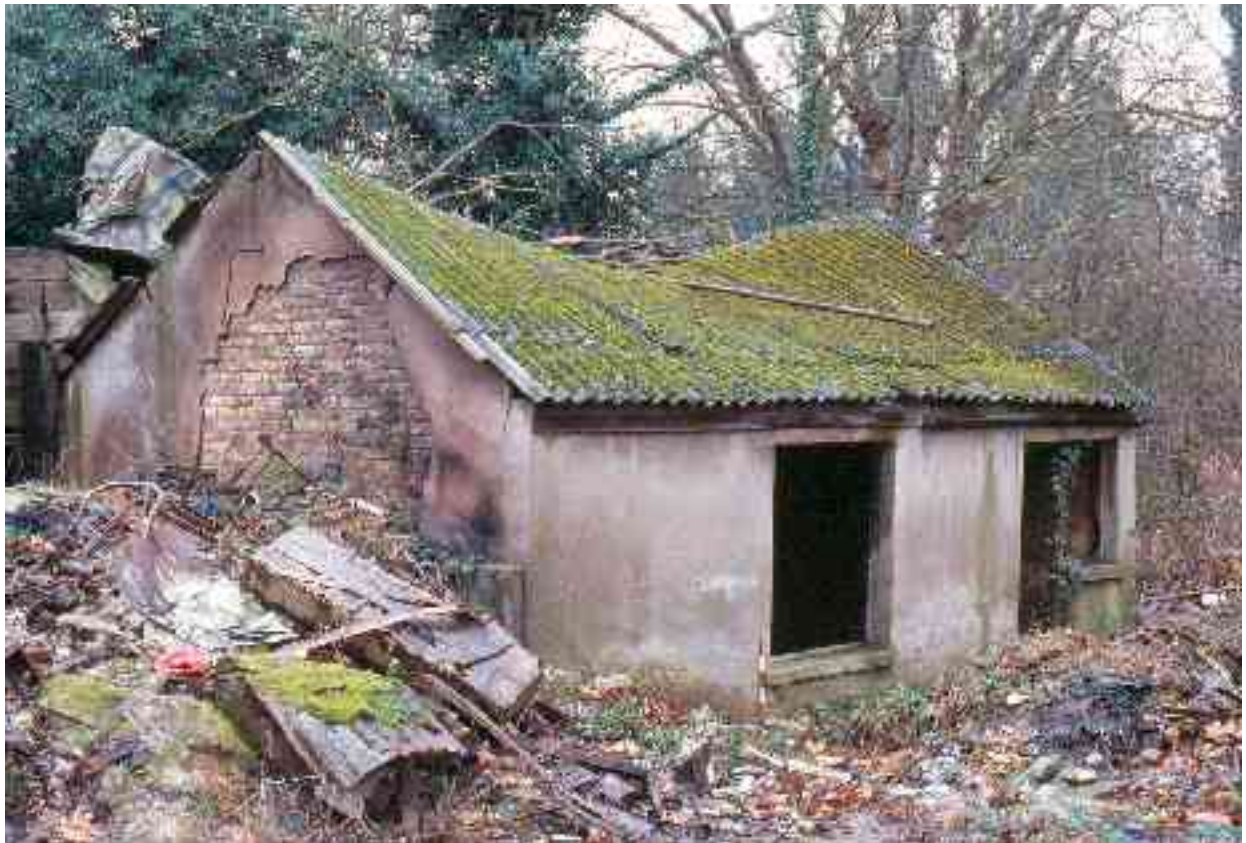
Fig 25 Northern and western faces of the single room later 19th century Building B (*0.5m scale*)

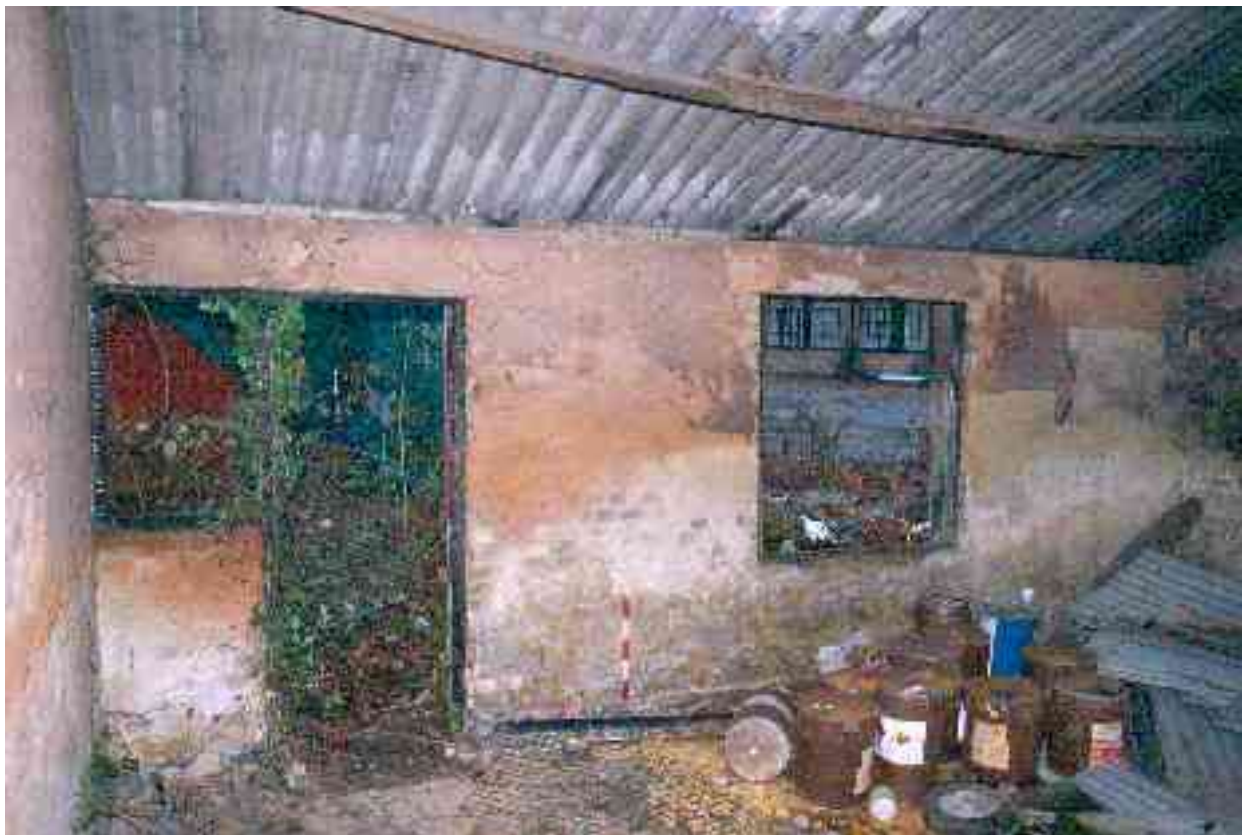
Fig 26 Interior of Building B, looking towards the west face and showing the minimal structure of the replacement roof

The building had been fire damaged and very hastily repaired, with a roof constructed from two rows of scaffold boards and re-used corrugated asbestos sheeting. There were two opposed window openings on the northwest and southeast faces, plus a door opening and further window near the south-western corner. The window and door surrounds were either missing or heavily charred, and had not been replaced.

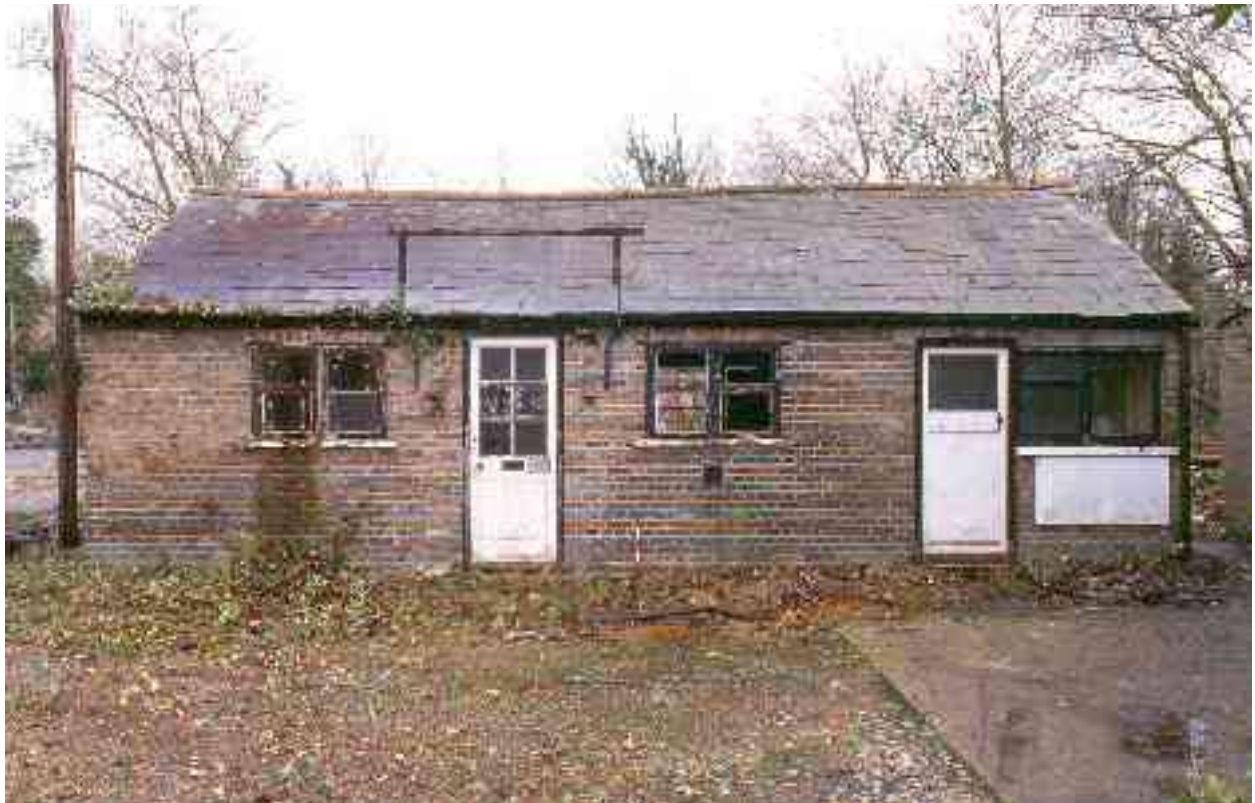
Fig 27 The western side of the 19th century Building C (*0.5m scale*). The two door openings are original but the central window has been widened and those at either end are later insertions. The frame over the left-hand door previously held the sign *Mitcham Hair & Fibre Mills*

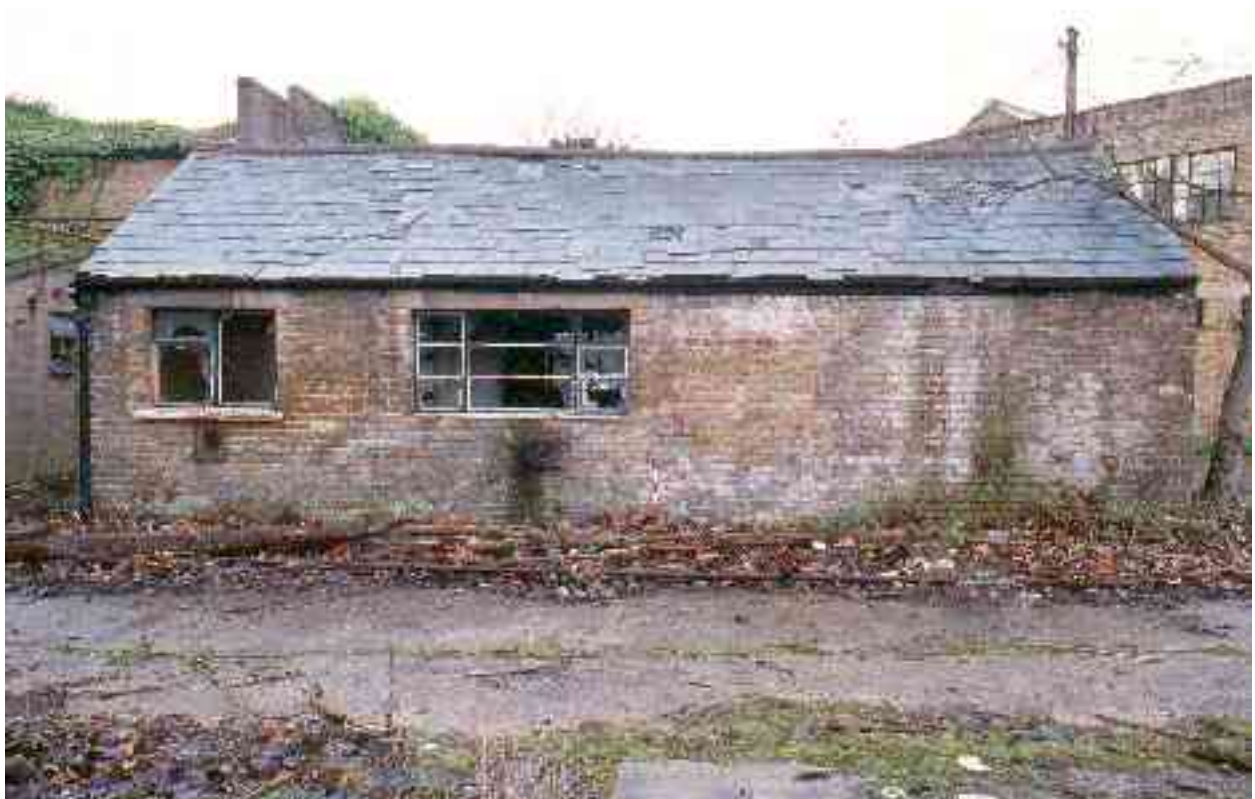
Fig 28 The eastern side of Building C, again showing later window insertions with concrete lintels and a blocked arched opening immediately to the right of the 0.5m scale. This wall previously fronted onto an open north-south channel

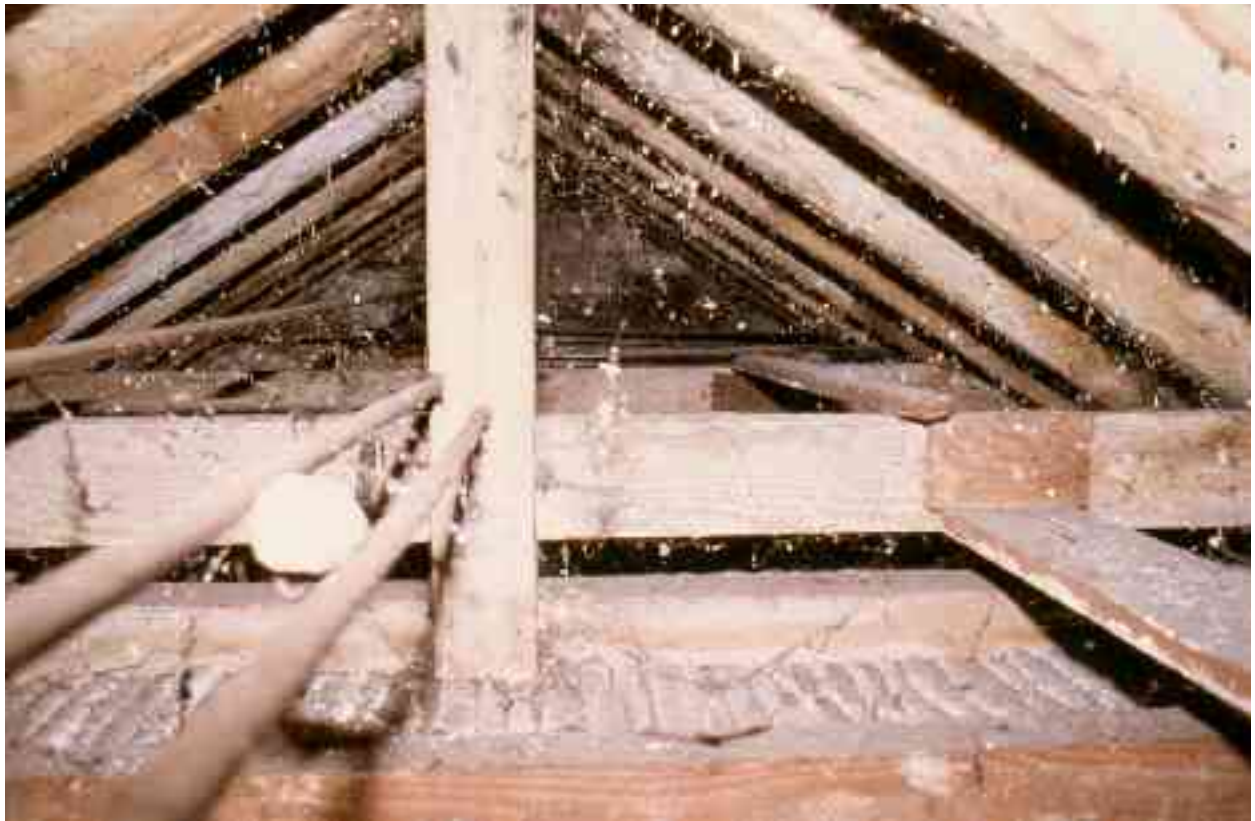
Fig 29 The roof construction of Building C, looking north. White paintwork is visible on several of the timbers, with a later lathe-and-plaster ceiling in the foreground
