GROVE MILL & FORMER CROWN MILL SITE

475 LONDON ROAD, MITCHAM CR4

**AN ARCHAEOLOGICAL EVALUATION, WATCHING BRIEF AND
STANDING BUILDING RECORD**

SITE CODE: GCM04

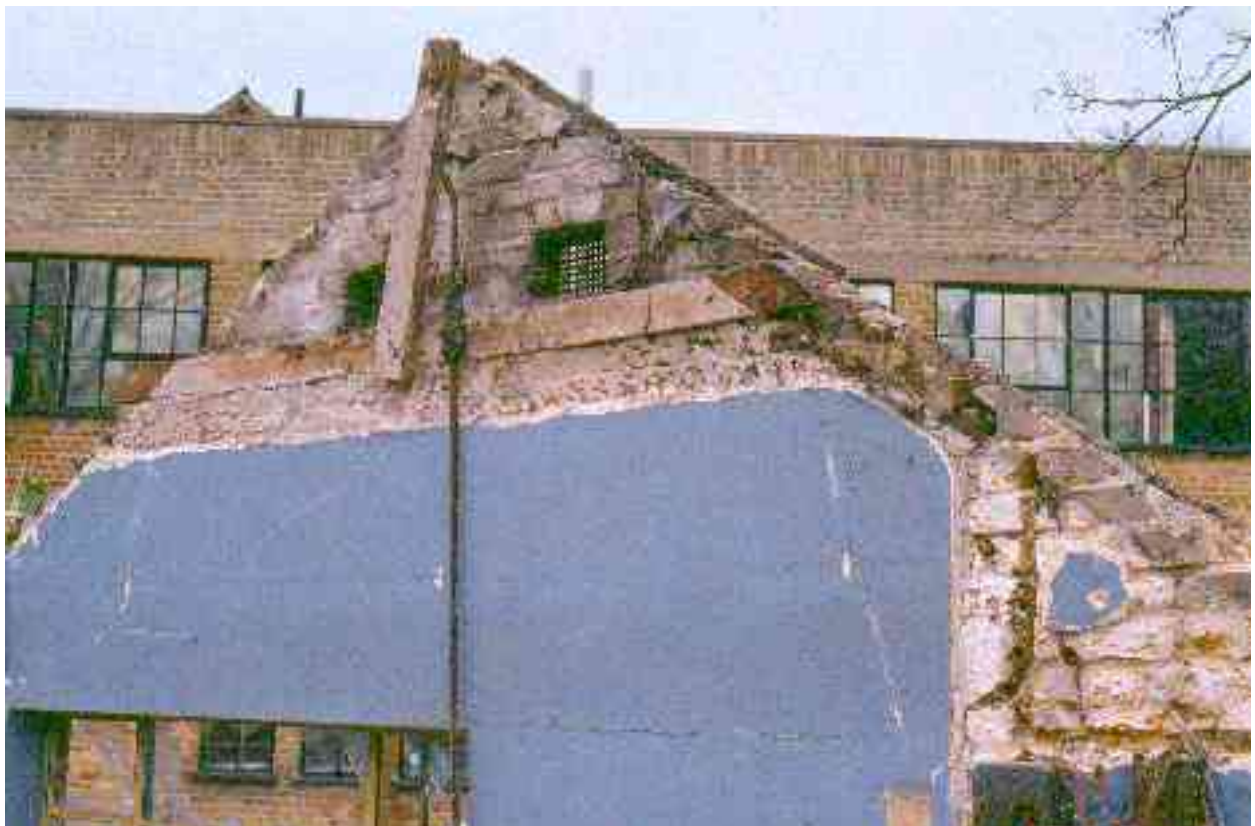
Fig 30 The northern gable end of Building C during demolition. This internal view shows the original full-height limewashed brick face, subsequently obscured by plasterwork and ceilings

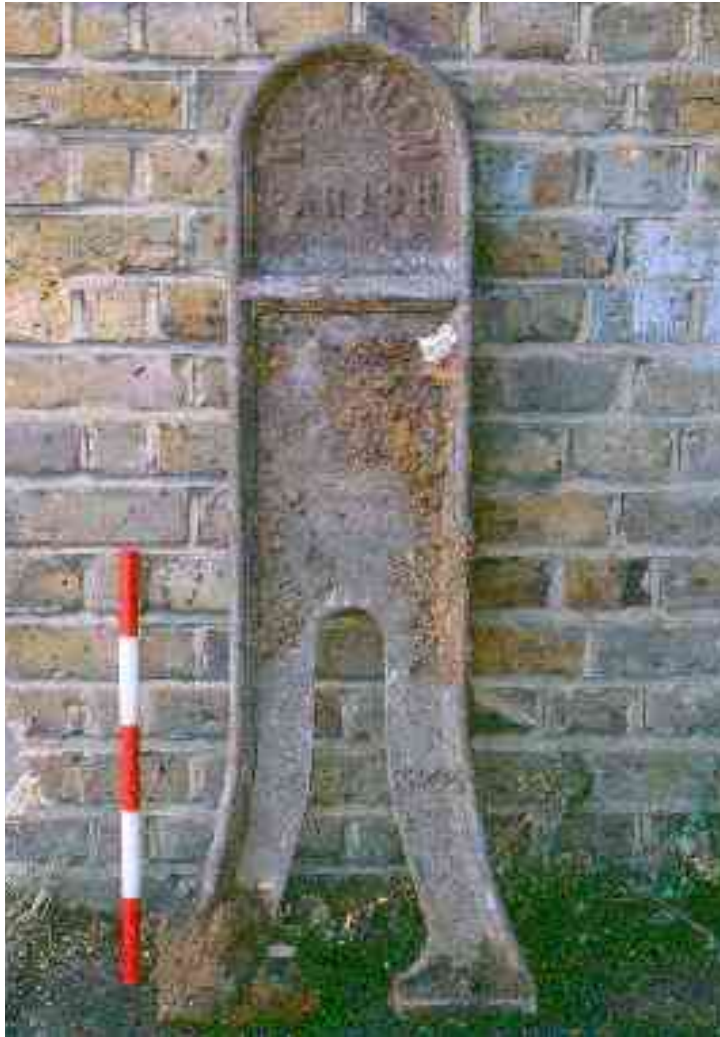
Fig 31 Cast iron boundary marker 'Mitcham Parish' from just south of Building B (0.5m scale)

Clearance work in the area immediately to the south of Building B produced a cast iron boundary marker for Mitcham Parish (Fig 31). This appears to be the feature recorded as *BP* on Ordnance Survey maps after 1910, and may have replaced an earlier boundary stone.

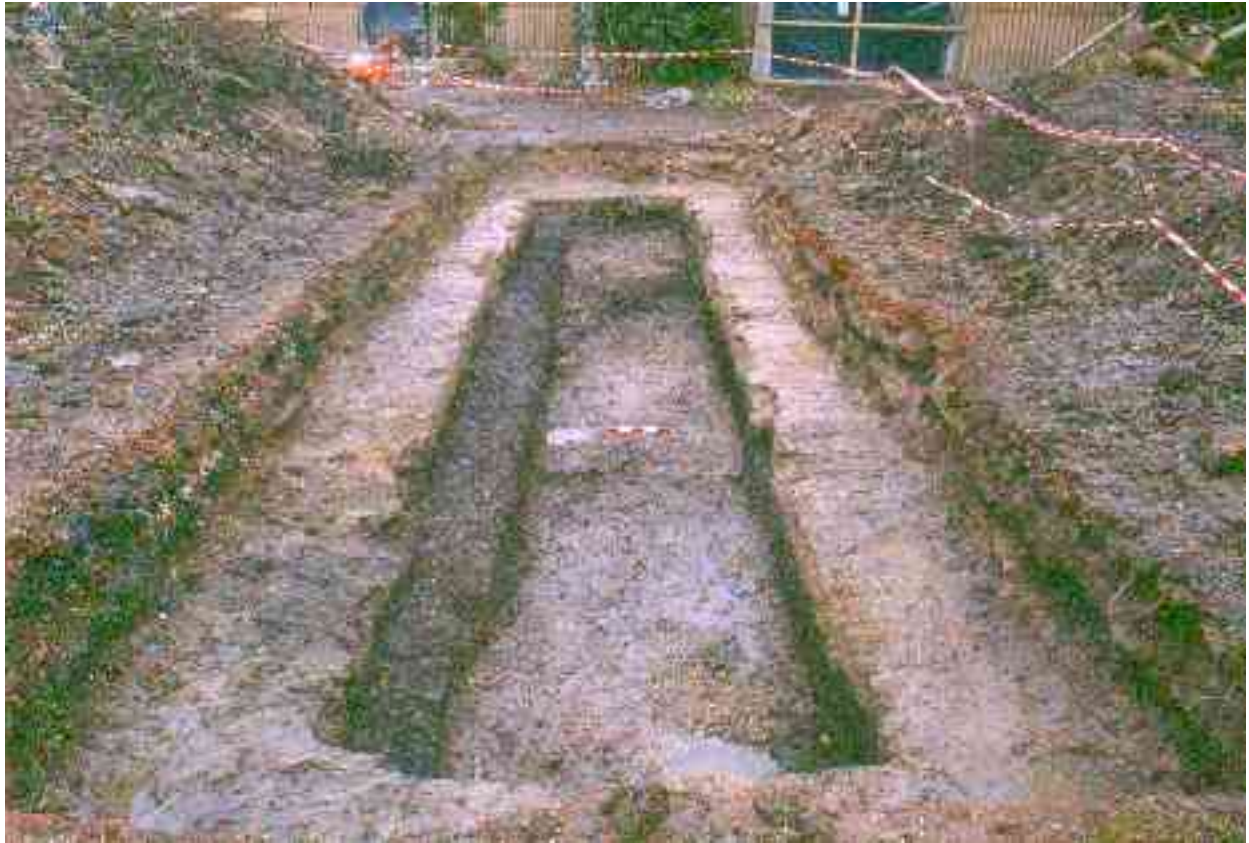
Fig 35 Trench 1 looking north. The central area has been excavated to natural gravel, with the dark grey surface of [3] visible in the step to left of the 0.5m scale (*see Fig 32 for location*)

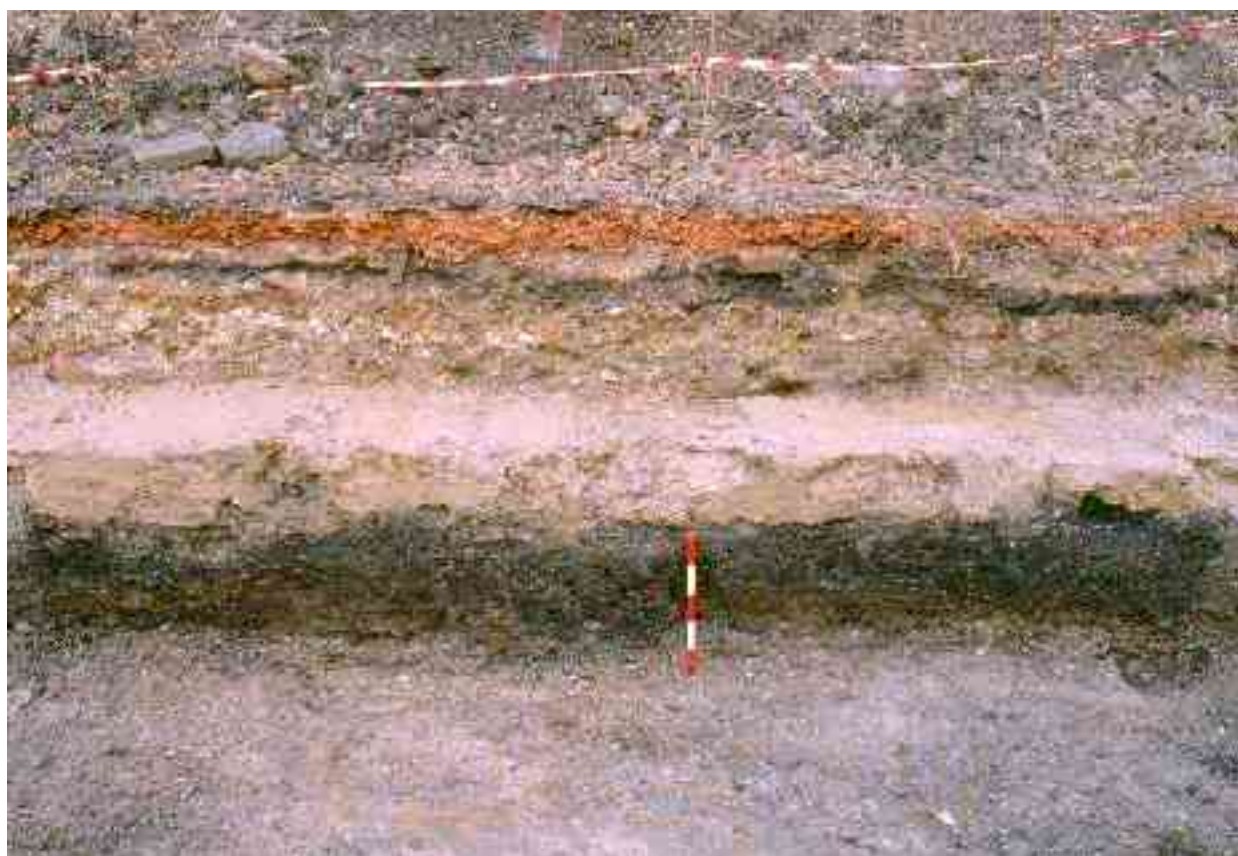
Fig 38 View of the deposits shown in Figure 37. The surface of context [3] is approximately level with the top of the 0.5m scale, with recent made ground over

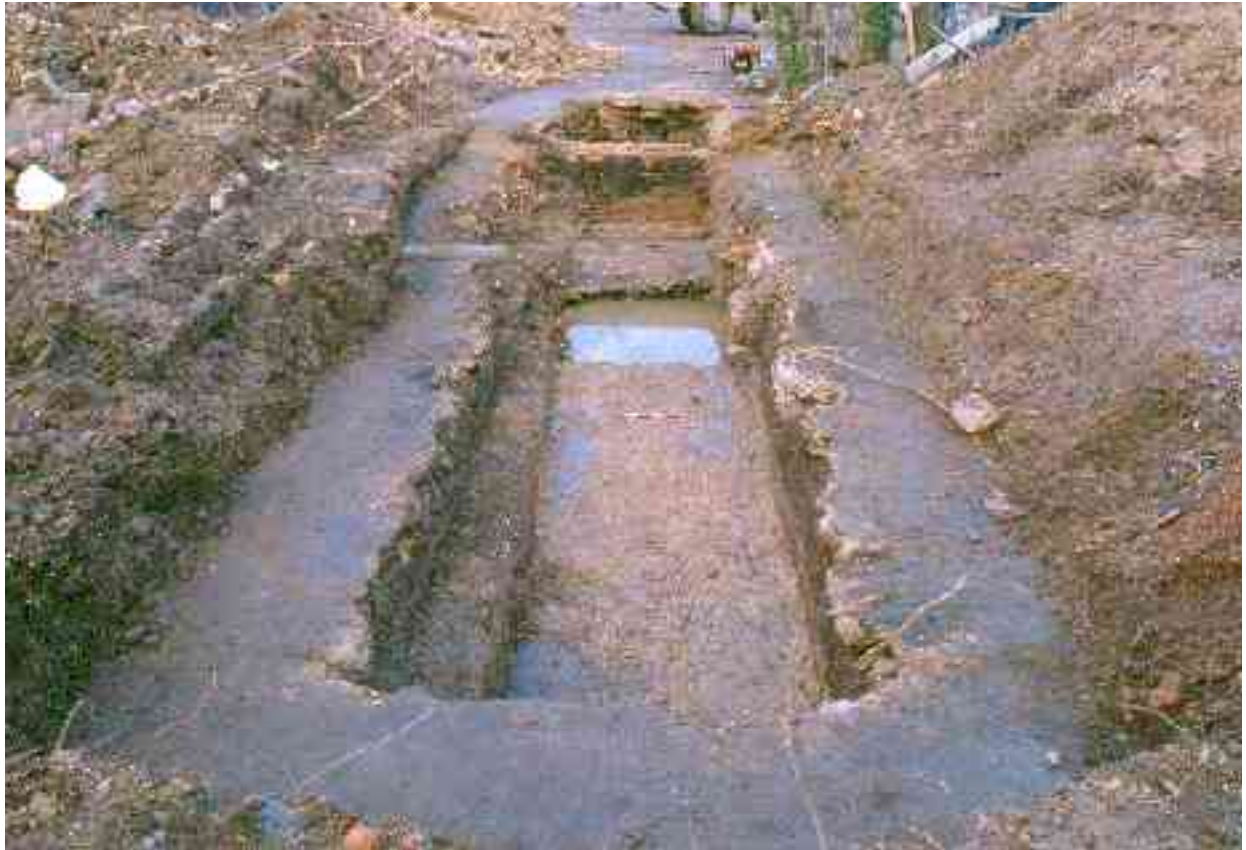
Fig 39 Trench 2 looking west. The foreground centre has been excavated to natural gravel, with the surface of [6] visible in the step to left of the 0.5m scale (*see Fig 32 for location*)

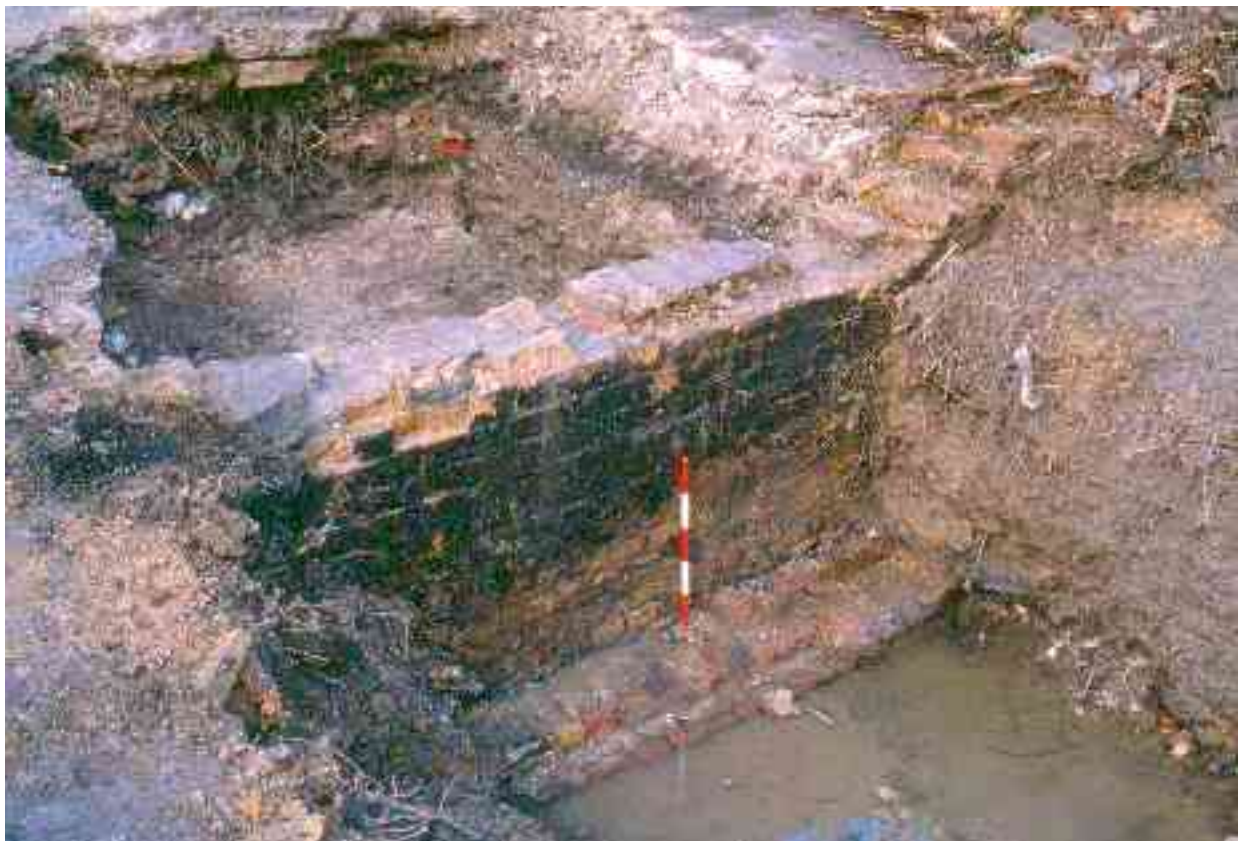
Fig 40 Trench 2, view across the backfilled channel to the east wall of Crown Mill (*0.5m scale*)

The later 19th century Crown Mill was represented by the continuation of the north-south brick wall [12] seen in Trench 2, and by an adjacent internal stone floor and make-up [25]. However, the external face of the wall had been reinforced to foundation level by concrete [18] so removing any direct association with deposits and features to the east.

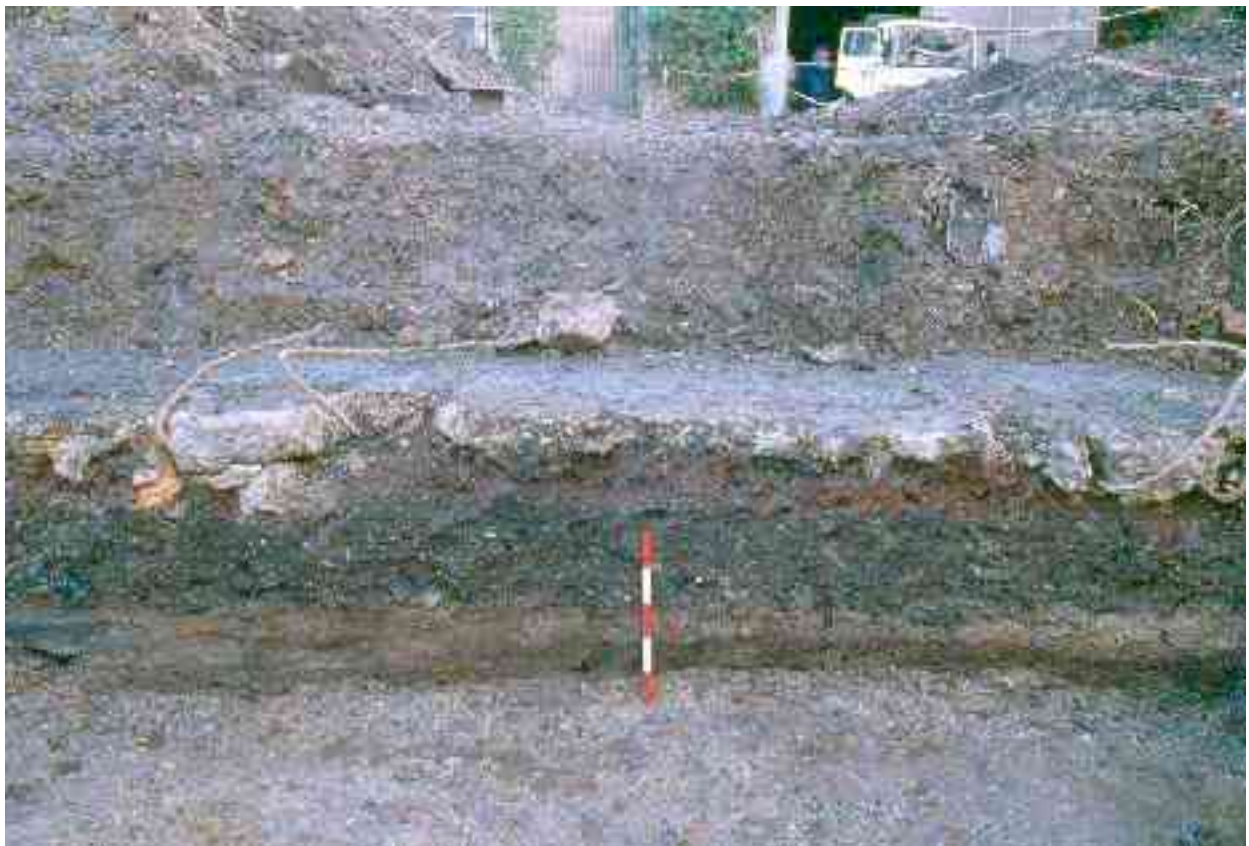
Fig 44 View of the deposits shown in Figure 43. The surface of context [6] is just above the top of the 0.5m scale, with recent made ground and slab over

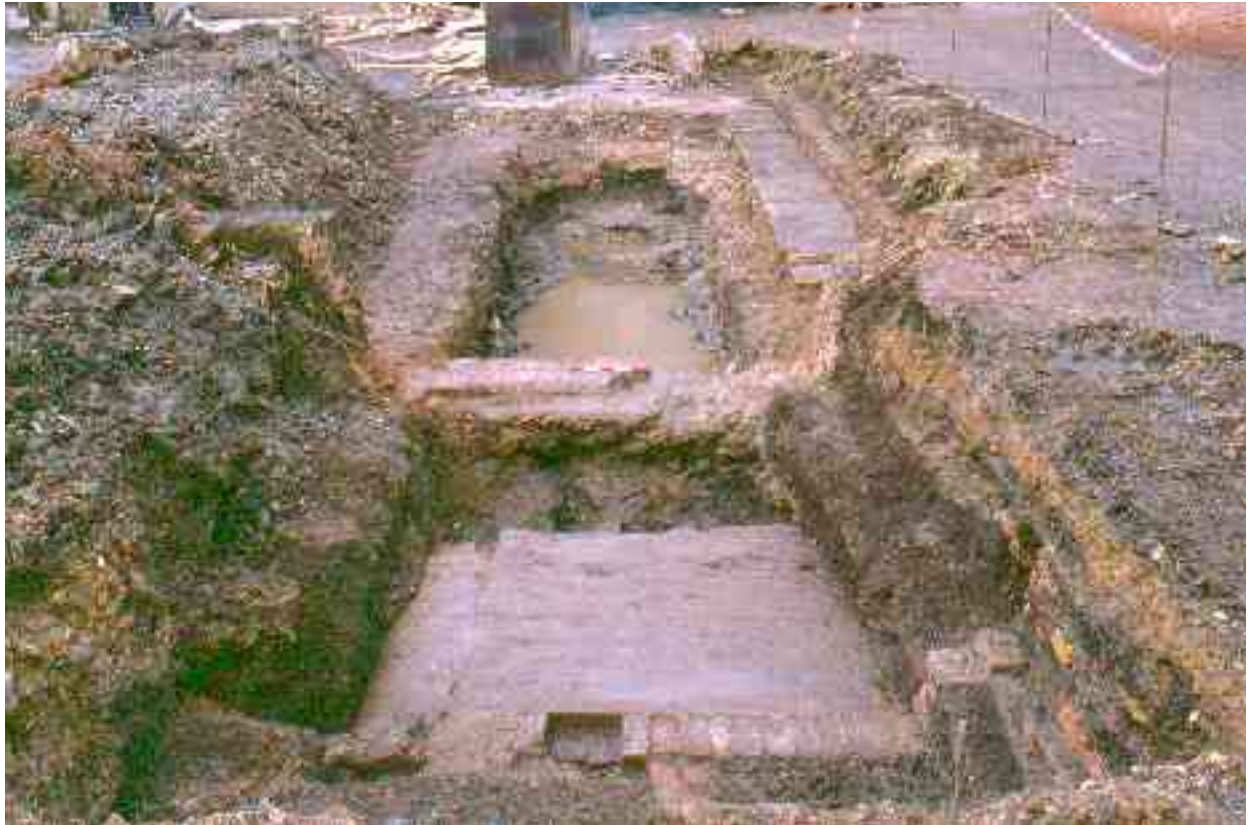
Fig 45 Trench 3 looking west across the brick channel floor [19], with the 0.5m scale resting on the foundation for the eastern wall of Crown Mill (*see Fig 32 for location*)

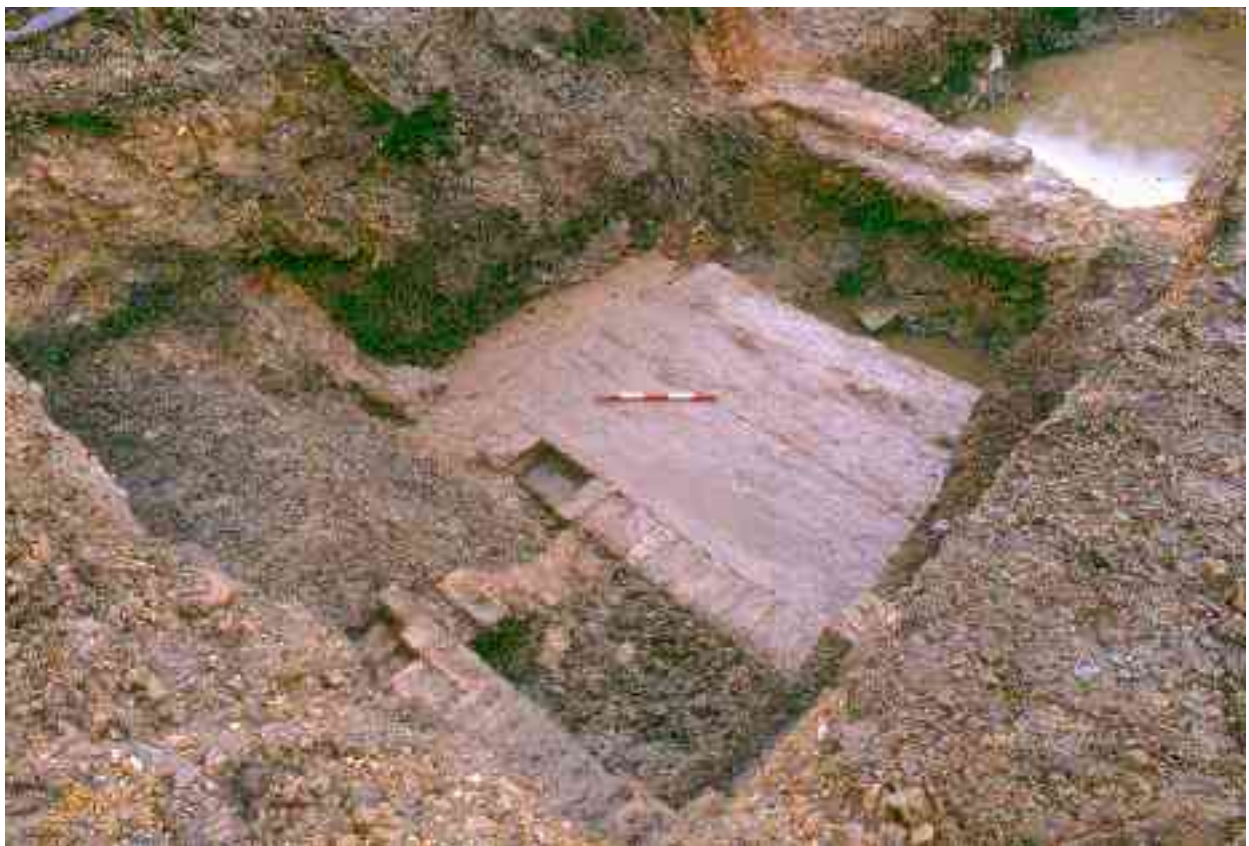
Fig 46 Trench 3 looking southwest. The frogged brick base in the foreground probably supported a footbridge, indicated on the map of 1894 and marked *FB* on those of 1910 & 1932 (*Fig 32*)

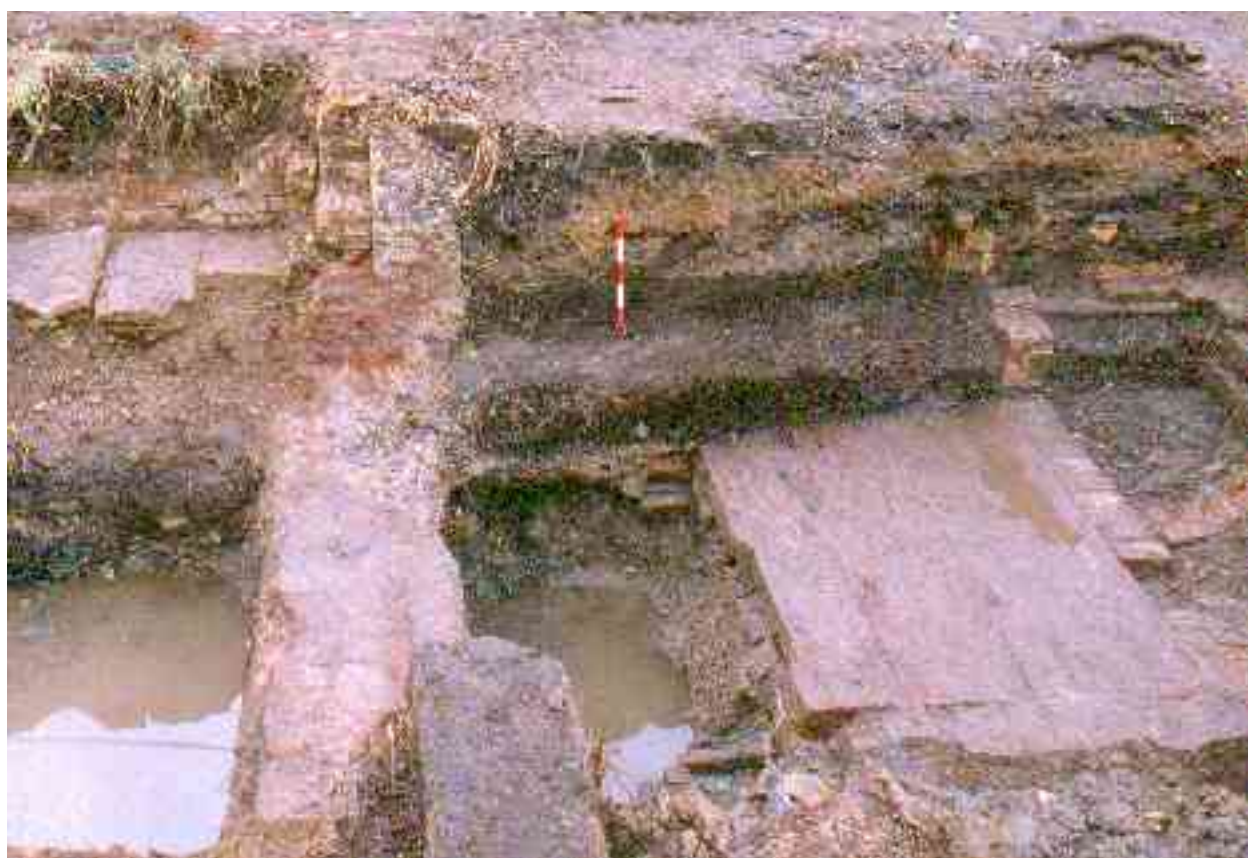
Fig 48 View of the deposits shown in Figure 47, with the backfilled channel in the centre right of the frame and Crown Mill to the left (0.5m scale)

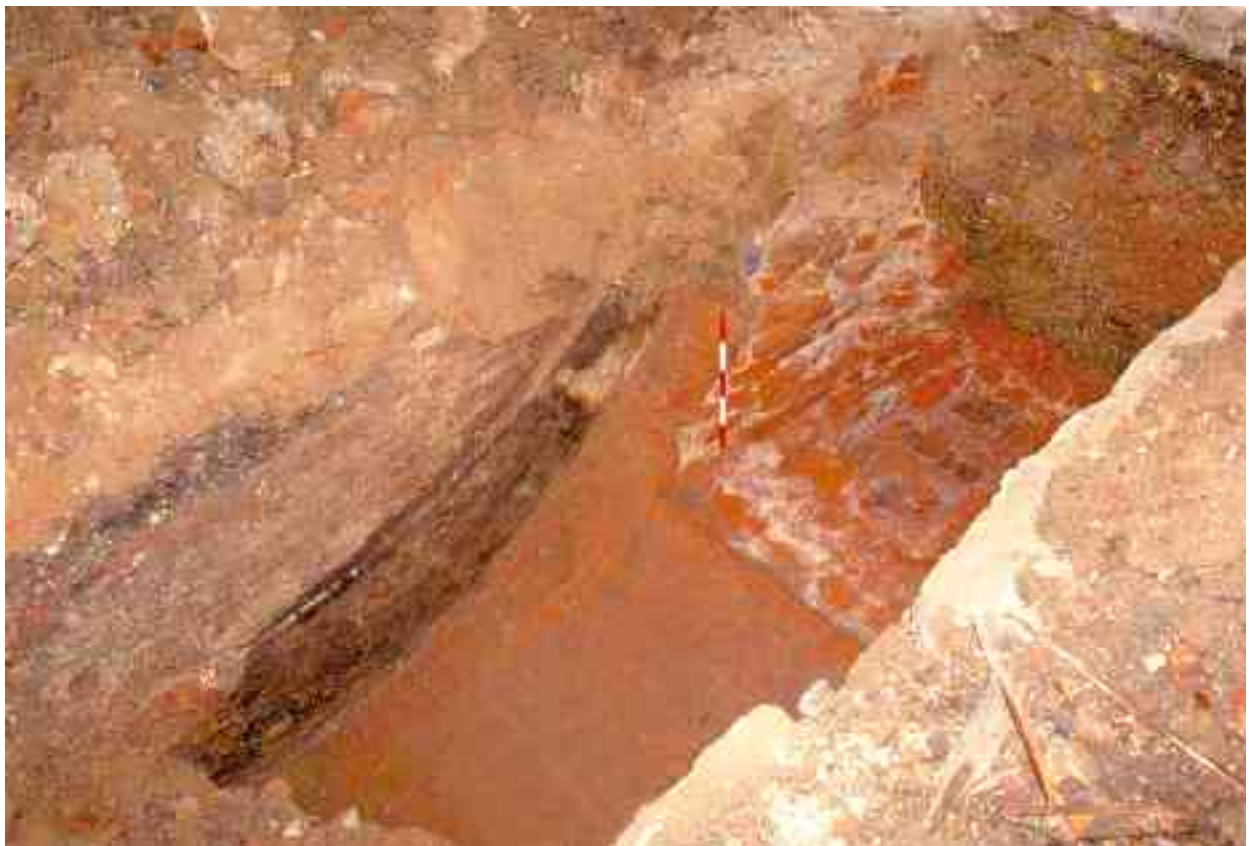
Fig 51 Northern side of the waterwheel housing [47], looking northeast (*0.5m scale*)

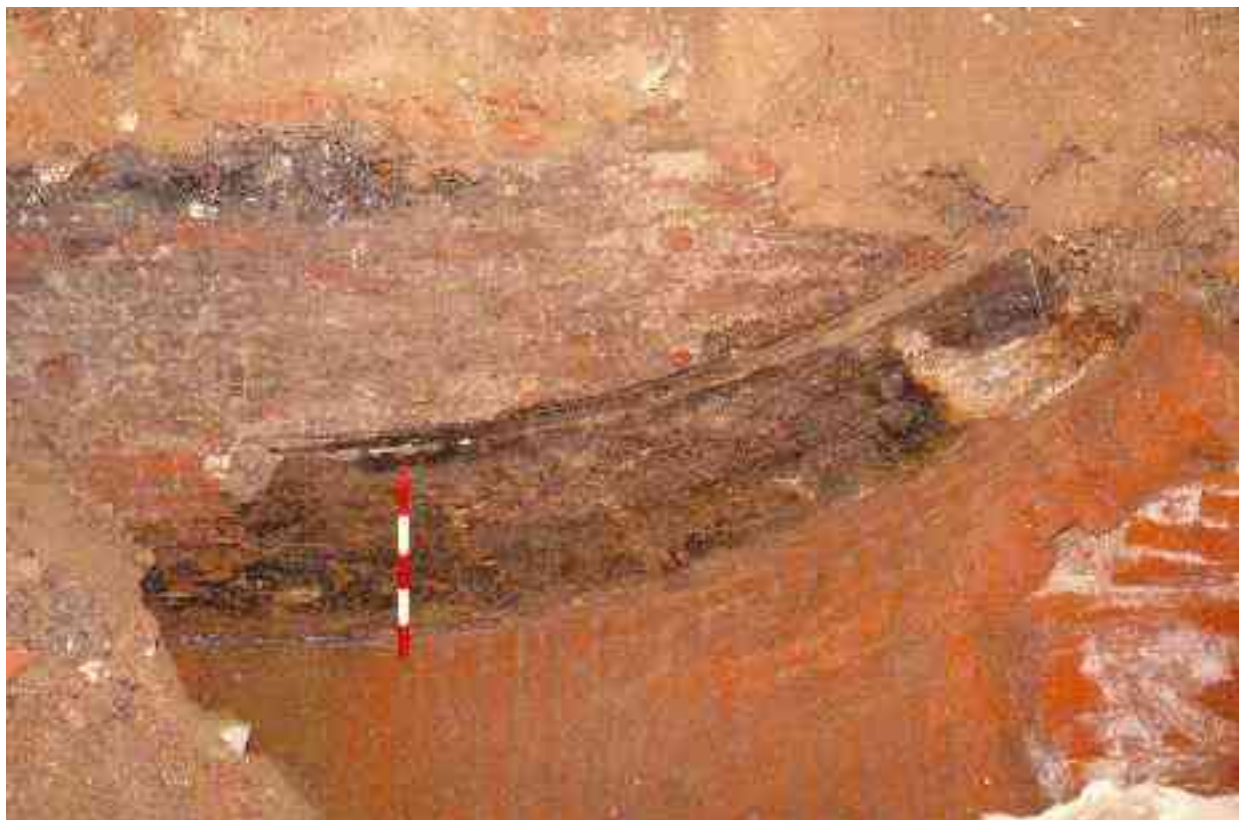
Fig 53 Detailed view of the structure shown in Figure 52 (*0.5m scale*)

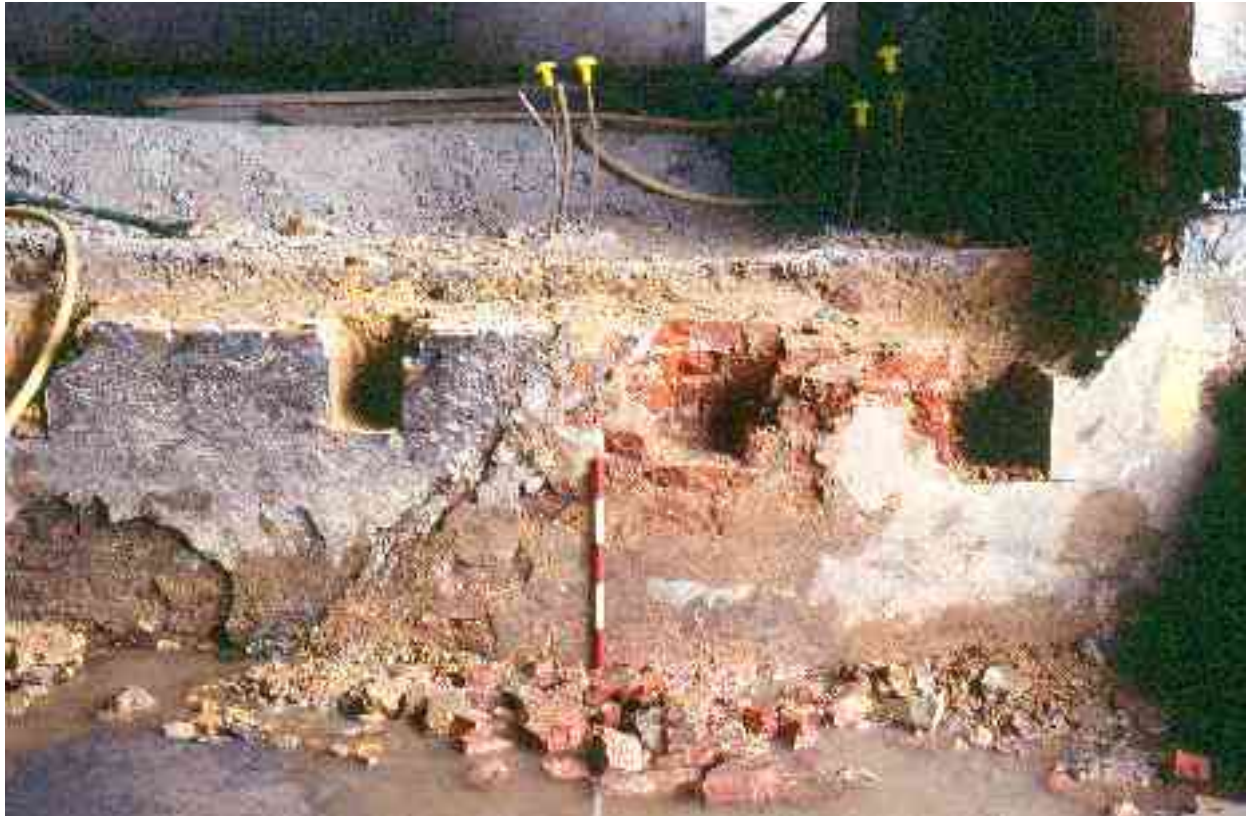
Fig 54 The truncated southern side of the red brick structure [47], incorporated into the 1860s yellow stock wall [33]. The line of the earlier waterwheel is visible just to the left of the 0.5m scale

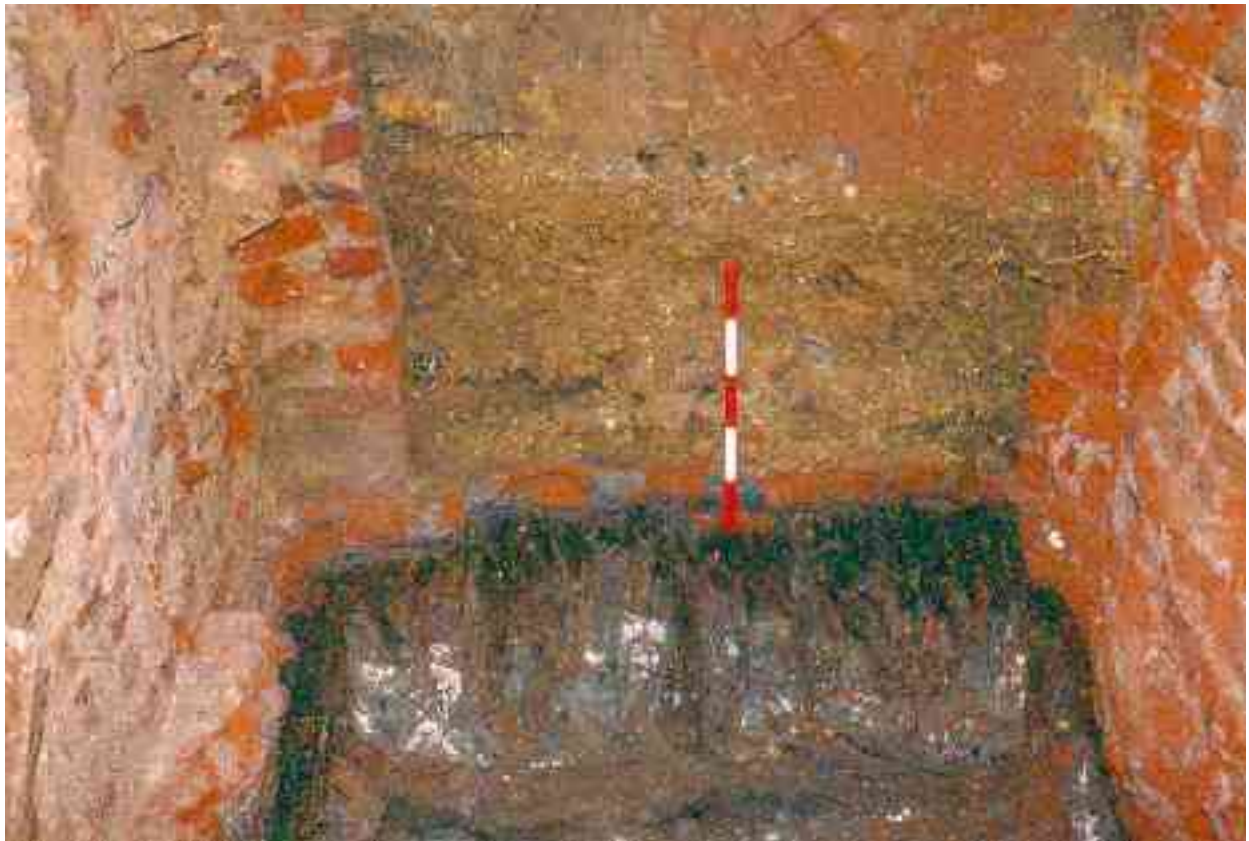
Fig 55 Exposed oak plank foundation [48] below the eastern end of the wheel housing [47]. Immediately behind the 0.5m scale and below the present Mill wall is the infilled millrace

The northern waterwheel housing [47] was constructed on a substantial timber raft [48], with north-south sleepers supporting a series of 0.3m wide oak planks laid at right angles. This construction was set into the relatively soft underlying alluvial clay/silt [49], and may well have been reiterated to the south (below [44]) although not directly observed.

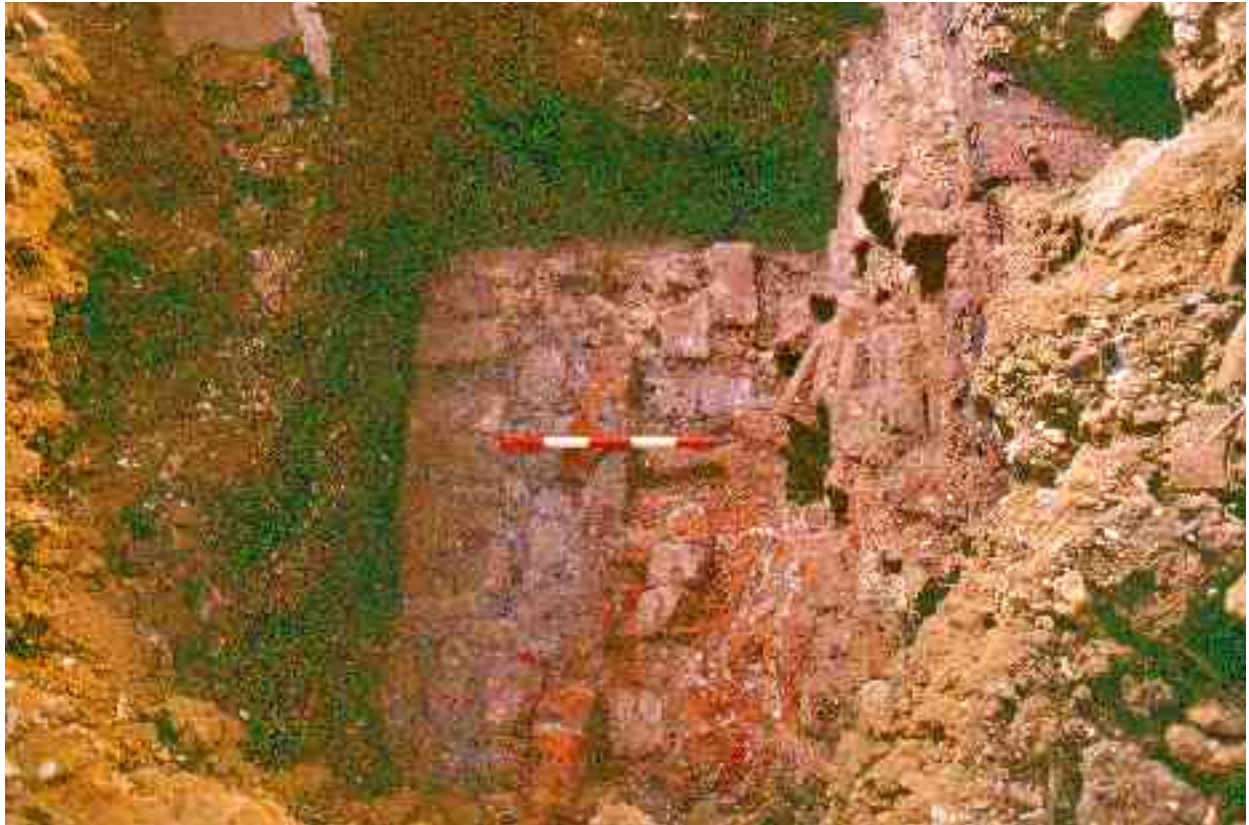
Fig 56 Brick foundation [40], overhead view from the north with wall [41] on the right of the frame (*0.5m scale*)

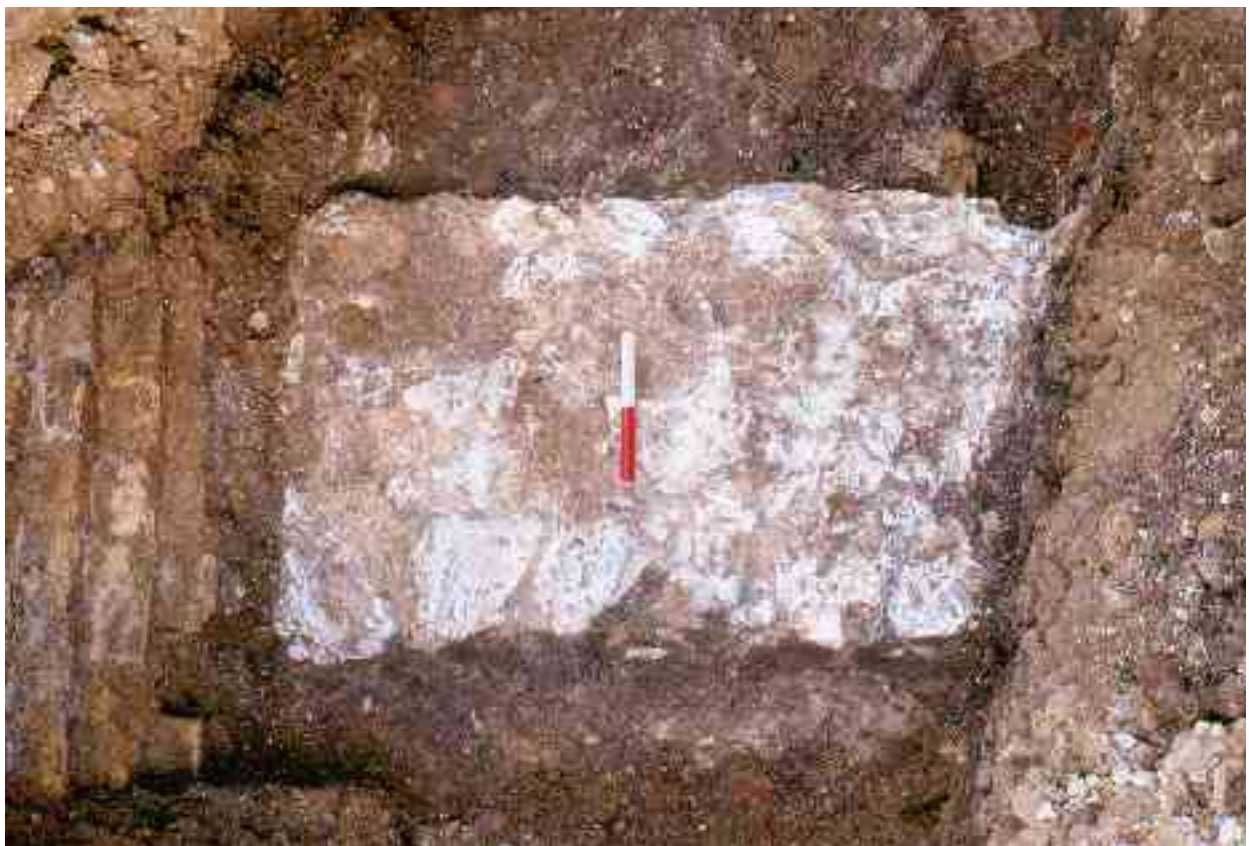
Fig 57 East-west chalk wall footing [54] (*0.2m scale*). This probably represents the northern extent of the 18th century mill. The s brick footing of the present Mill is on the left of the frame

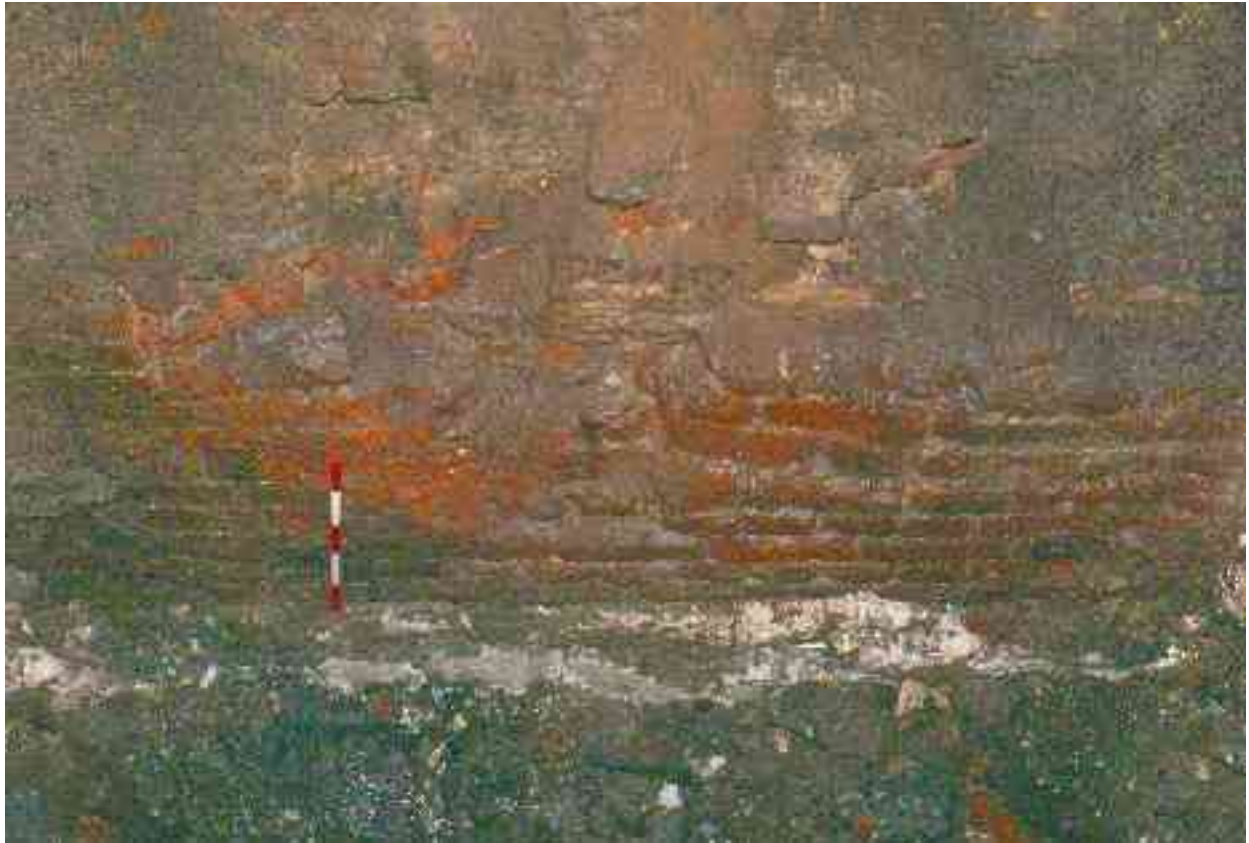
Fig 58 East-west brick wall [58] over chalk block footing, forming the northern side of the tailrace. This section appears to have remained in use for some time after the construction of the 1860s Mill, the base of the oblique wall [35] being just visible on the right-hand edge of the frame (*0.5m scale*)

A number of the brick walls appeared to be founded directly on earlier post-medieval dumped or waterlain deposits (eg. [41] & [51]). Wall [58] to the west – apparently revetting one side of the tailrace – had the deepest foundation, which was composed of a single course of large chalk blocks *c* 0.4m high and founded some 2.9m below present floor level.

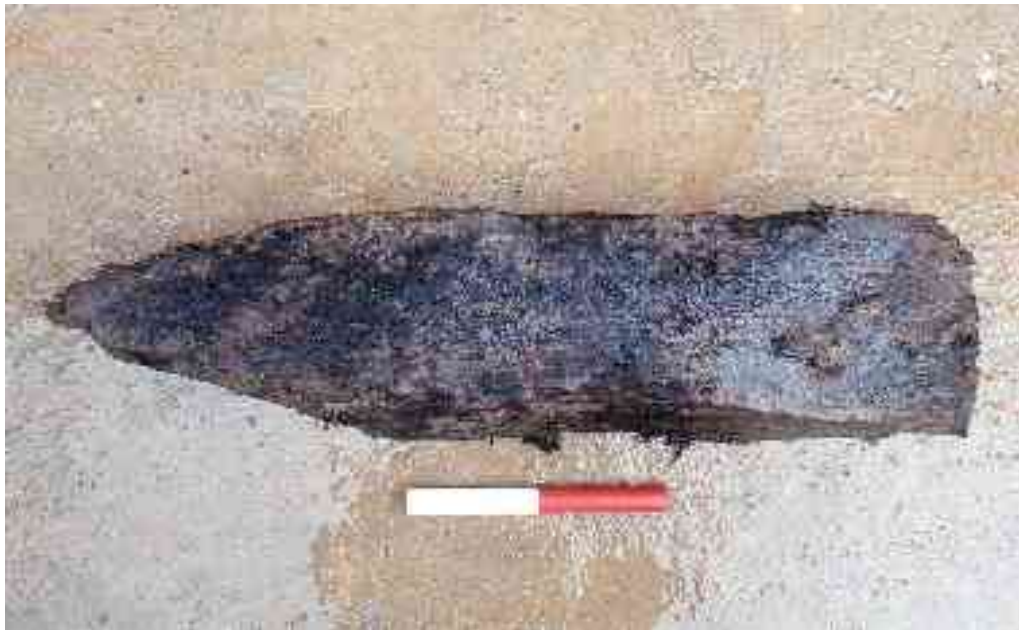
Fig 59 Oak post forming part of the foundation for the planked surface [60], below the ?later tailrace wall [58] (*0.2m scale*)

Also apparently preceding the 1789 construction was the timber platform or raft [60], underling wall [58] on the western side of the site. This feature was only briefly observed over 3m below ground level, but was formed by a series of roughly worked planks (or horizontal timbers) laid north-south over upright timber posts which had been driven into the existing alluvial deposits (Fig 59). Although tentative, this may represent part of an earlier mill, perhaps at the base of a channel to prevent water erosion in proximity to a sluice or waterwheel (and therefore similar to the brick 'floor' [19] in evaluation Trench 3).
