SYBOURN NURSERY SCHOOL, 170 LEA BRIDGE ROAD, LONDON E10

AN ARCHAEOLOGICAL EVALUATION

March 2005

SITE CODE: LAI 05

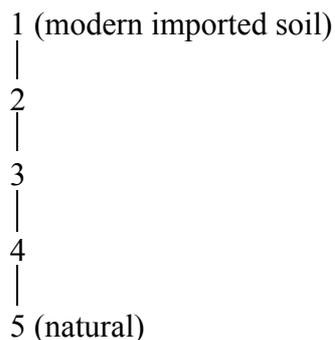
6.4 Matrix to show stratigraphic relationship of contexts

Context	Description	Interpretation
1	Dark brownish grey sandy silt with frequent mixed gravel. Occasional clinker, coal, CBM, slate, glass & pot (not retained)	Imported soil, deposited following stripping of the site (assumed late 19 th century)
2	Roughly circular cut (approx. 1.25m diam.) containing mixed slightly sandy clay with some gravel. Includes a few brick & pot frags.	Pit plus fill, possibly related to the 19 th century horticultural use of site
3	Firm mottled yellow-brown clay-silt with occasional fine gravel, otherwise sterile	Natural alluvial deposit, undated and probably truncated by stripping
4	Apparently linear feature, up to 0.8m wide & aligned NE to SW, filled and sealed by alluvium [3]	Assumed to be a natural erosion gully, ancient but otherwise undated
5	Mottled yellow-brown silty medium/fine gravel, becoming more cleaner & more sandy with depth	Top of natural River Terrace deposit (Kempton Park)

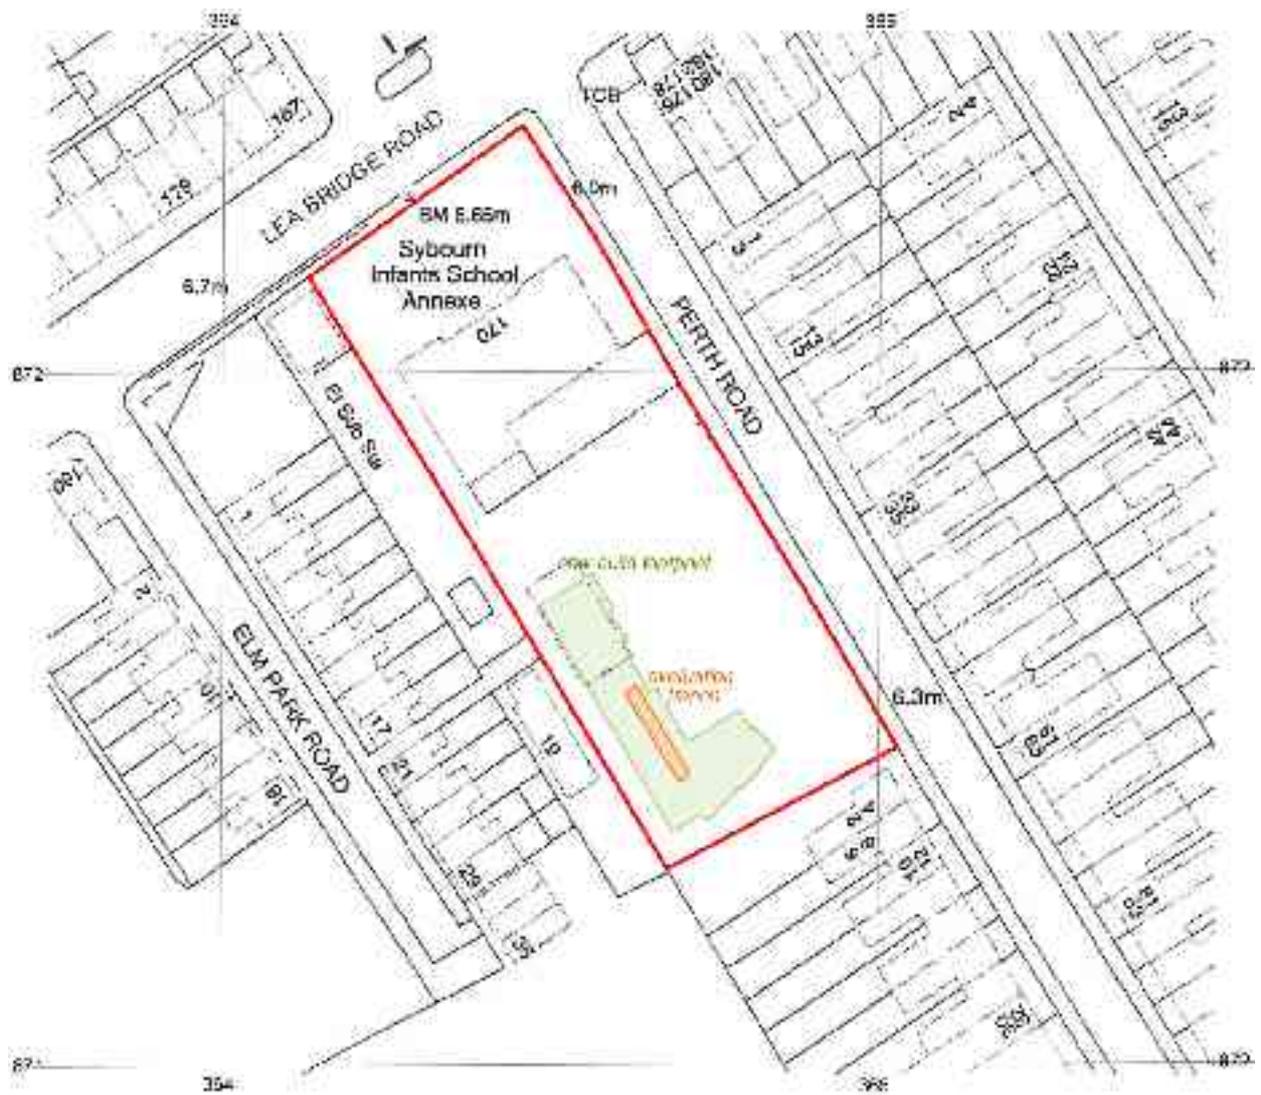
Fig 1 Site location, also showing the position of the evaluation trench in relation to the proposed new build

5.2 The evaluation comprised one trial trench measuring *c* 2m by 15m in plan. The trench was laid out on an approximate north-south alignment within the area of proposed development, as shown in Figure 1.

5.3 The deposits and features exposed in the evaluation were recorded on *pro-forma* context sheets and by scaled plan and section, supplemented by 35mm photography. Levels were derived from an OSBM located at the front of the School and facing onto Lea Bridge Road, value 6.65m OD (Fig 1). A TBM was established on a manhole to the north of the evaluation trench, value 5.89m (Fig 2).

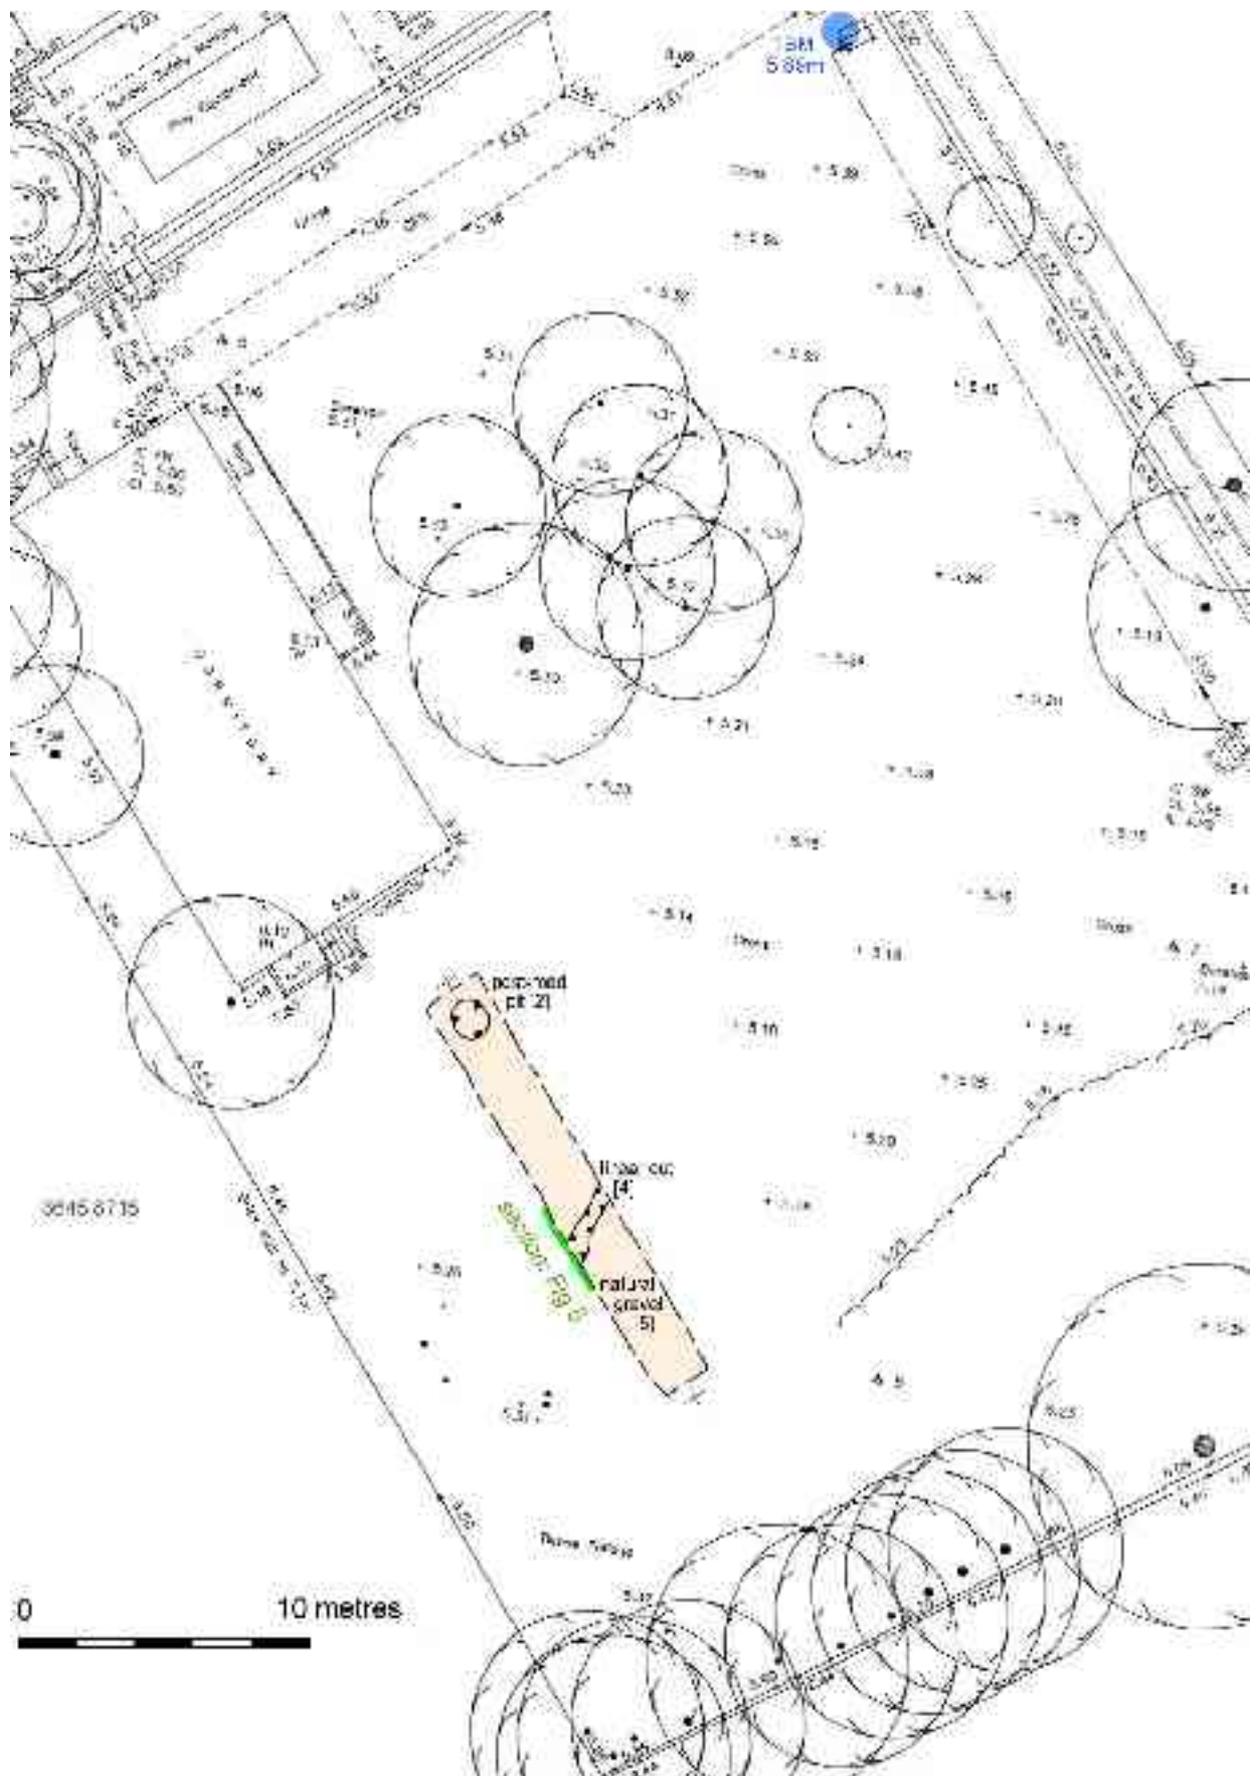
Fig 2 Location of the evaluation trench and principal features in relation to the topographical survey (scale 1:250), also showing local grid points and location of drawn section

The evaluation trench position was located onto the existing site survey by taped measurement. This was in turn related as a 'best fit' to the Ordnance Survey grid as derived from the 1:1250 plan. The OS coordinates to nearest metre for the local evaluation trench grid (Fig 2) are as follows:

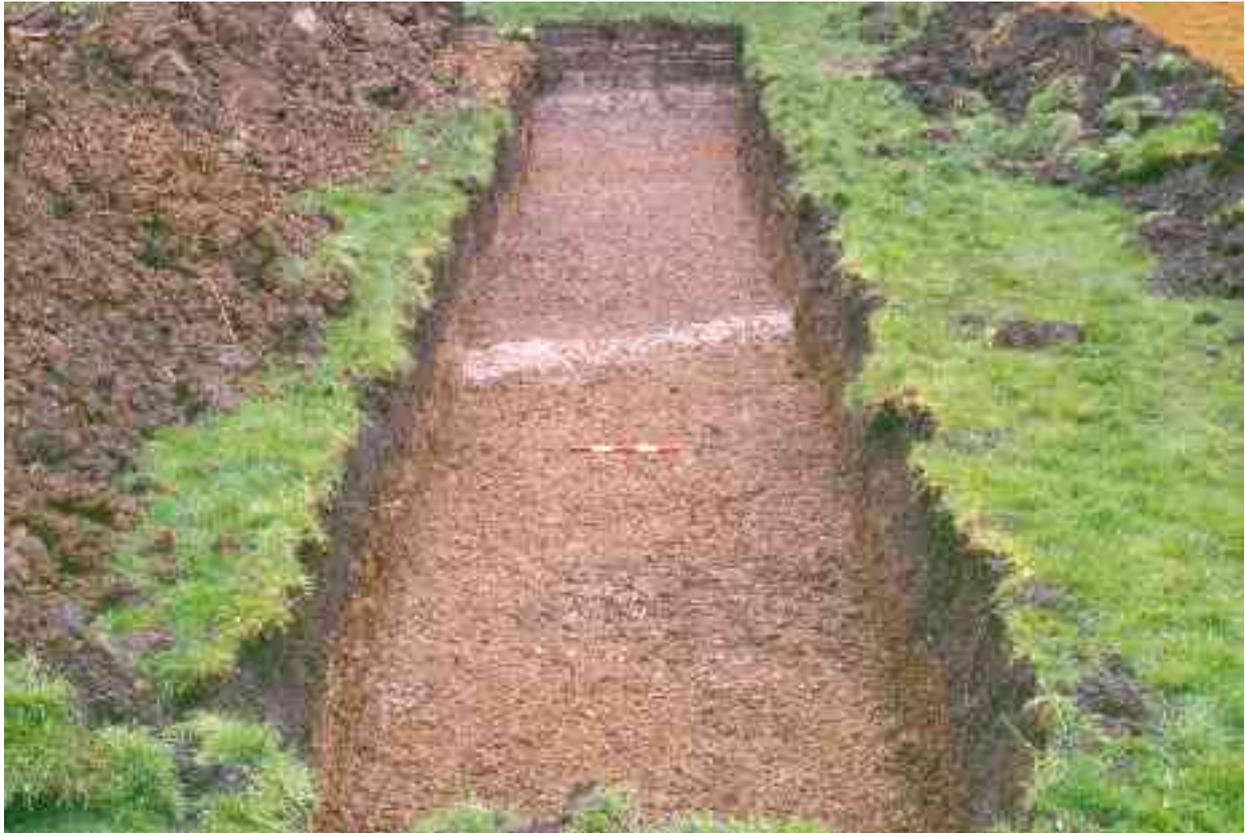
The natural River Terrace deposit comprised a fairly compact silty to sandy gravel [5], taken to represent the top of the Kempton Park Terrace. This was exposed at about 4.40m to 4.55m OD, the surface rising slightly to the south but generally about 0.7m below present ground level. Although superficially weathered the gravel was quite sterile, and examination of the surface did not produce any evidence for prehistoric activity.

The gravel was cut from northeast to southwest by a small gully-type feature [4]. This was some 0.5m to 0.8m wide and bowl-shaped in profile, becoming broader and flatter to the southwest. The feature was filled and overlain by alluvium [3] and is assumed to be of natural origin.

Fig 3 General view of the evaluation trench looking east, showing the infilled feature [4] cutting the surface of the natural River Terrace gravel [5] (*0.5m scale*)

The alluvium also filled and sealed a small gully-type feature [4], which is assumed to represent a natural cutting into the gravel.

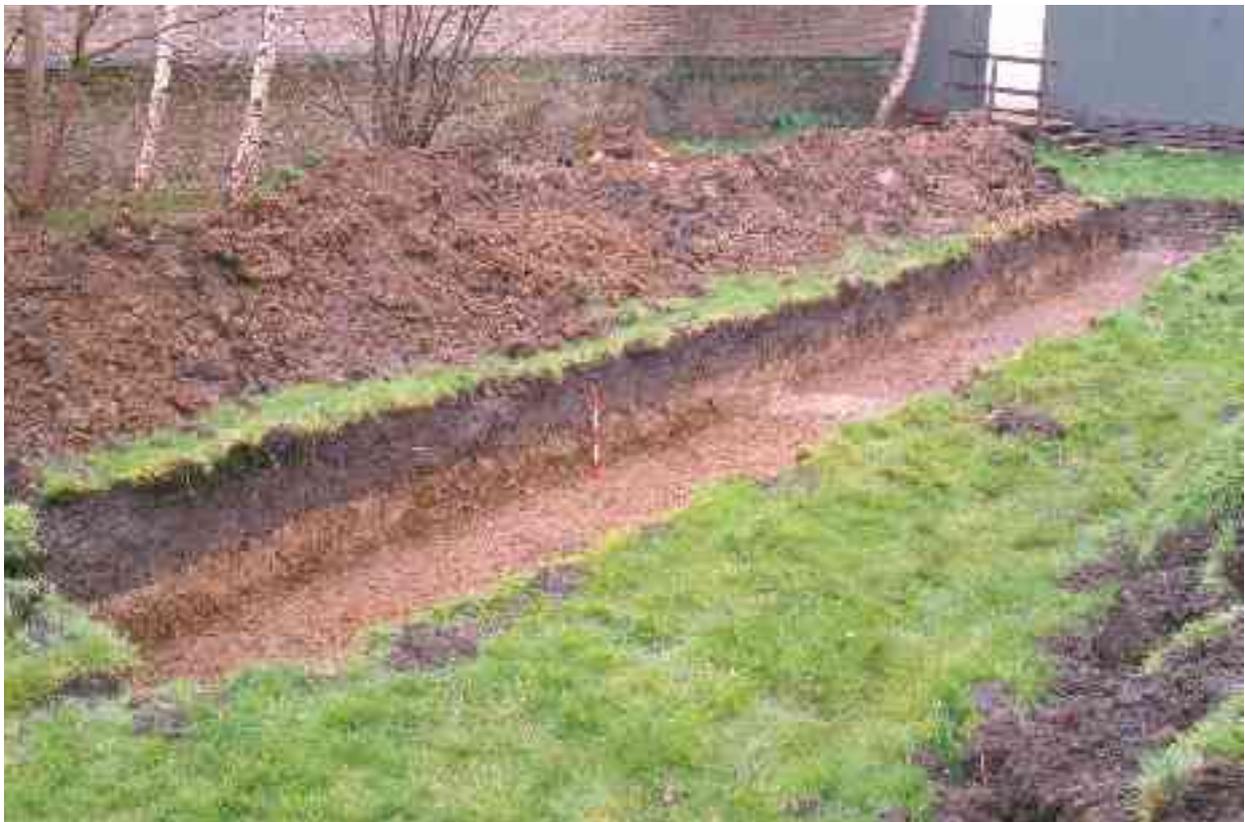
The alluvium [3] formed a continuous layer throughout the trench, thickening slightly to the north from about 0.15m to 0.3m. The deposit comprised a clean, fairly light-coloured and quite homogeneous clay-silt, with occasional gravel and darker mottles but no other inclusions. The surface was fairly level at about 4.75m OD, but it may well have been truncated in recent times.

Overlying the pit fill [2] and alluvium [3], and forming the present land surface, was a dark greyish sandy silt with gravel [1]. Although internally well-mixed this layer was quite sharply demarcated from the underlying alluvium and is considered to be a made ground deposit which has been imported on to the site, rather than a soil horizon (see below, 7.4).

Fig 4 Oblique view of the trench looking northeast, with alluvium [3] and overlying made ground [1] seen in section (*0.5m scale*)

The uppermost layer [1] is considered to have been imported onto the site and to have replaced original and much deeper soil horizons that had been removed. There are several points to support this:

- The layer itself is well mixed and appears to be a simple made ground, with recent inclusions throughout and a sharp interface onto the (?truncated) surface of the alluvium. There is no evidence of gradation into topsoil, subsoil, etc.
- The land on which the site is located is fairly level but rises up to 1 metre at its western, southern and eastern boundaries, and similarly to the north to the existing School.

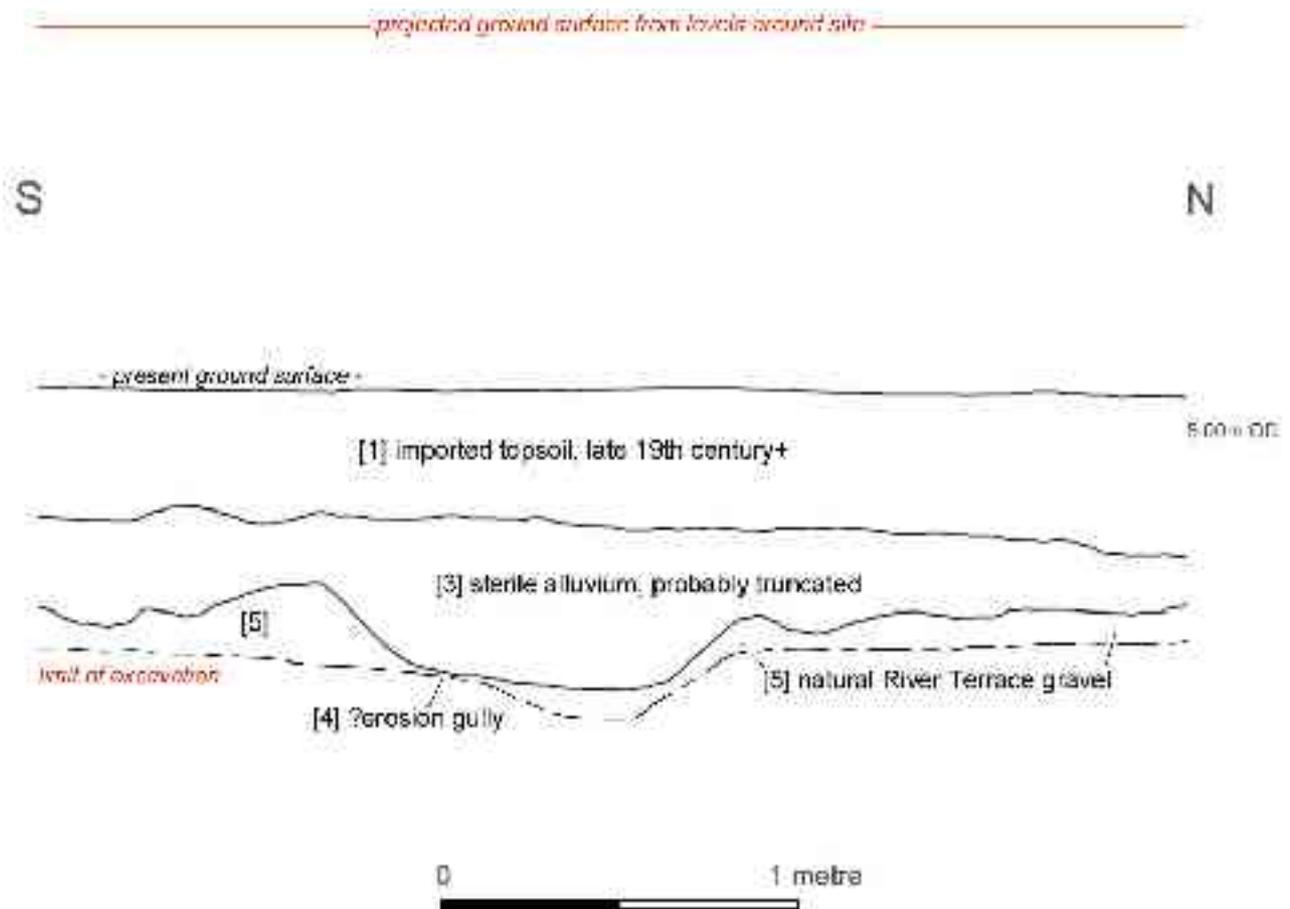
Fig 5 Part of the western section of the trench, located on Figure 2 and showing recorded deposits plus probable extent of previous truncation (*c* 1900)

A number of features (including the nature of context [1]) indicate that the site has undergone significant truncation, apparently as the result of stripping of the original soil profile. Additionally, the entire site area is nearly 1 metre below the level of the surrounding land, outside the boundaries and adjacent to the main School. These points are discussed in further detail below (7.4).

Further consideration of these deposits in conjunction with local topography would indicate that the whole site has been severely truncated and has lost all its original soil horizons, the present upper layer representing an imported made ground deposited over the surviving alluvium. This event probably took place around 1900.

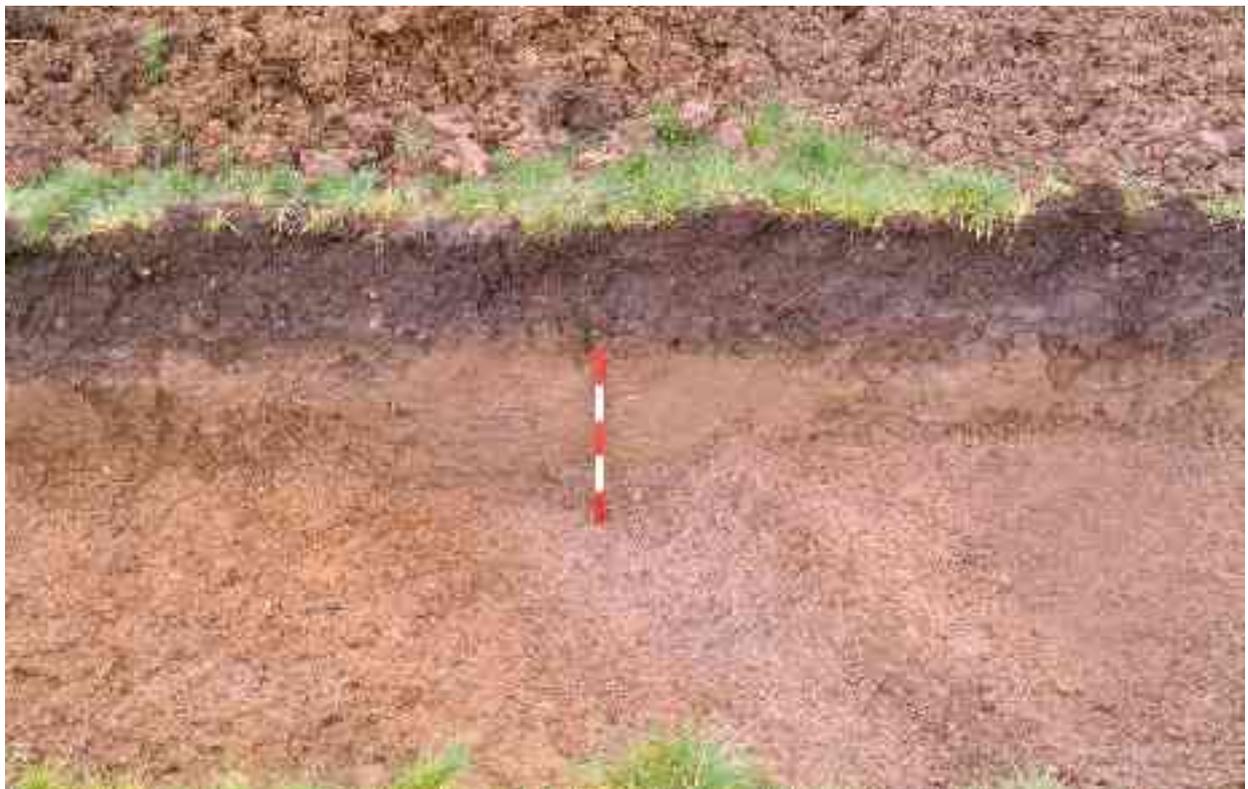
Fig 6 View of deposits shown in Figure 5 (*0.5m* scale)
