DANSON PARK POLLUTION & FLOOD ALLEVIATION SCHEME

ARCHAEOLOGICAL OBSERVATION AND RECORDING

ON BEHALF OF THAMES WATER UTILITIES

SITE CODE: DPK05

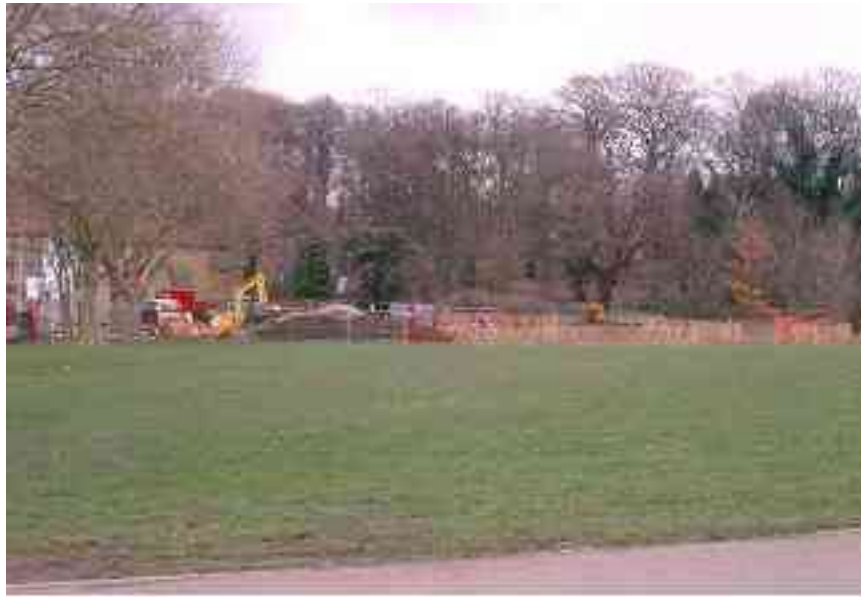
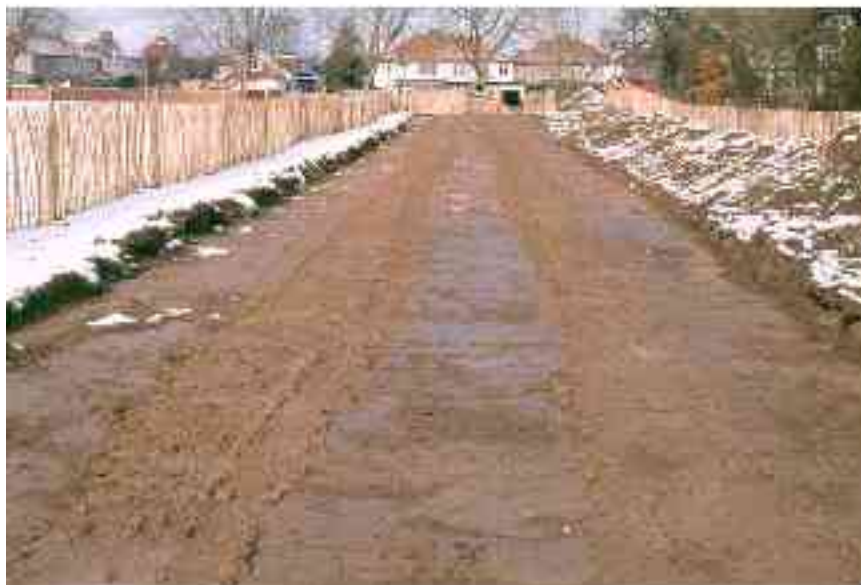
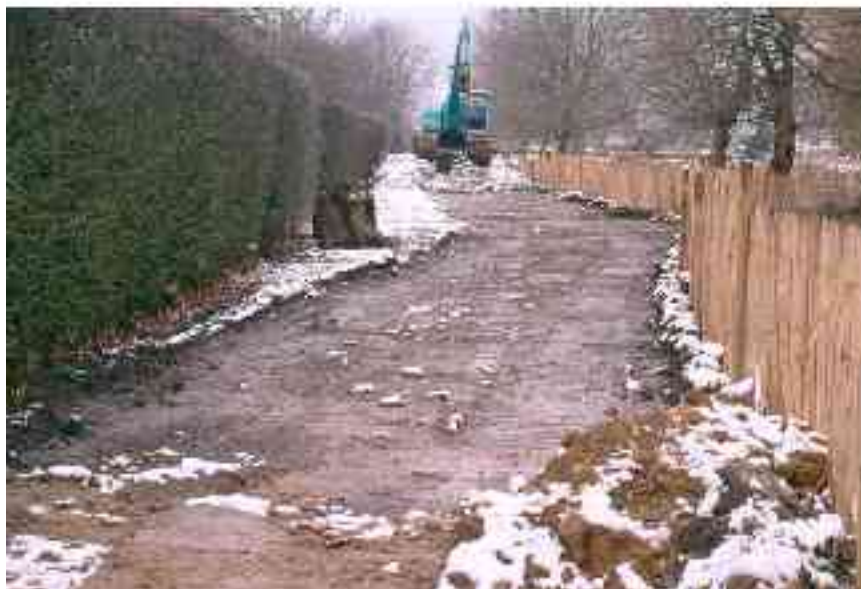
Fig 2 Views of the site during the initial topsoil strip and a 1:1250 plan showing the extent of groundworks, spot heights and location of Figures 3-9

Following the topsoil strip excavation of the principal (sewer replacement) pipe trench proceeded from the southern end of the site. The trench was generally about 1.35m wide and from 2.2m to 2.5m deep, although at a few points (F1-F7 on Figure 2) between 2m and 4m wide.

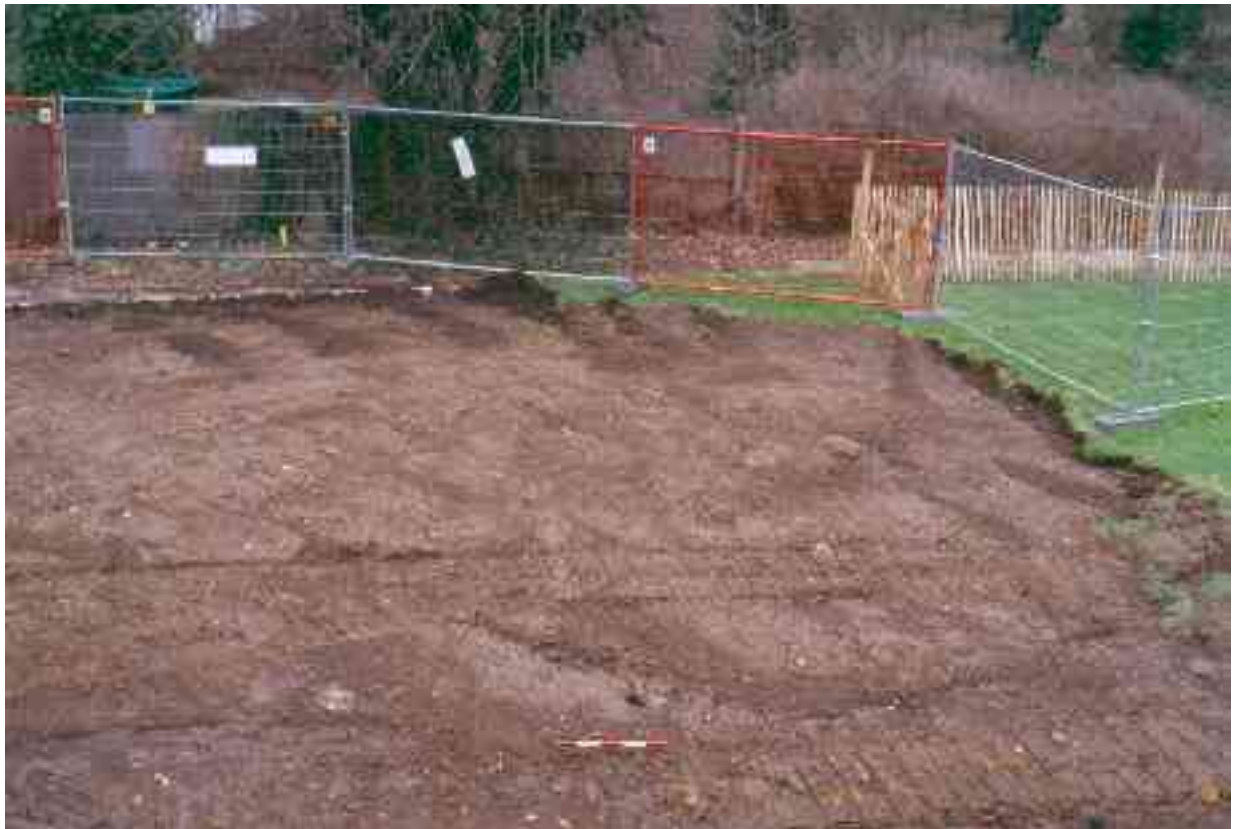
Fig 3 View looking east across the southern end of the site compound. The line of the culverted stream is marked by a concrete slab which is just visible below the fence line

The topsoil strip was quite shallow, typically 180mm to 300mm in depth, and removed the existing turf, dark sand/silt topsoil and generally the upper level of the subsoil. In most areas the strip exposed a surface of light-coloured and fairly clean sandy silt, although with some evidence of root action, reworking and occasional finds. The main exception to this was in the compound area to the northeast, where the land surface had been progressively levelled up to the east by recent (probably earlier to mid 20th century) made ground. This clearly reflects the line of the historic stream flowing in from Danson Lane, which in this area is now culverted and capped by a concrete slab. The overall depth of made ground was not determined but to the east was clearly in excess of 300mm.

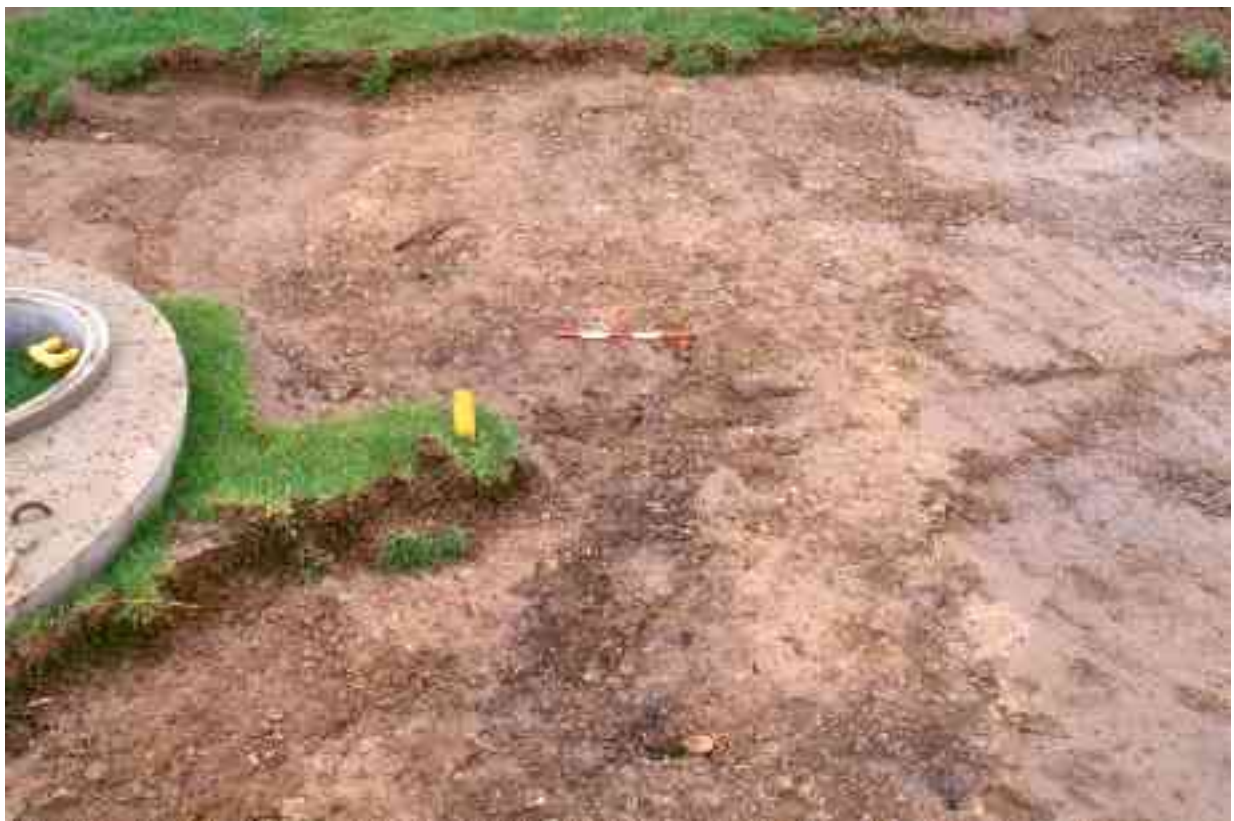
Fig 4 View at the northwestern corner of the site, looking east after topsoil stripping for the clean water pipe installation. This area is crossed by a modern east-west drain, identified by the lighter gravelly deposit below the 0.5m scale (*see Fig 2 for location*)

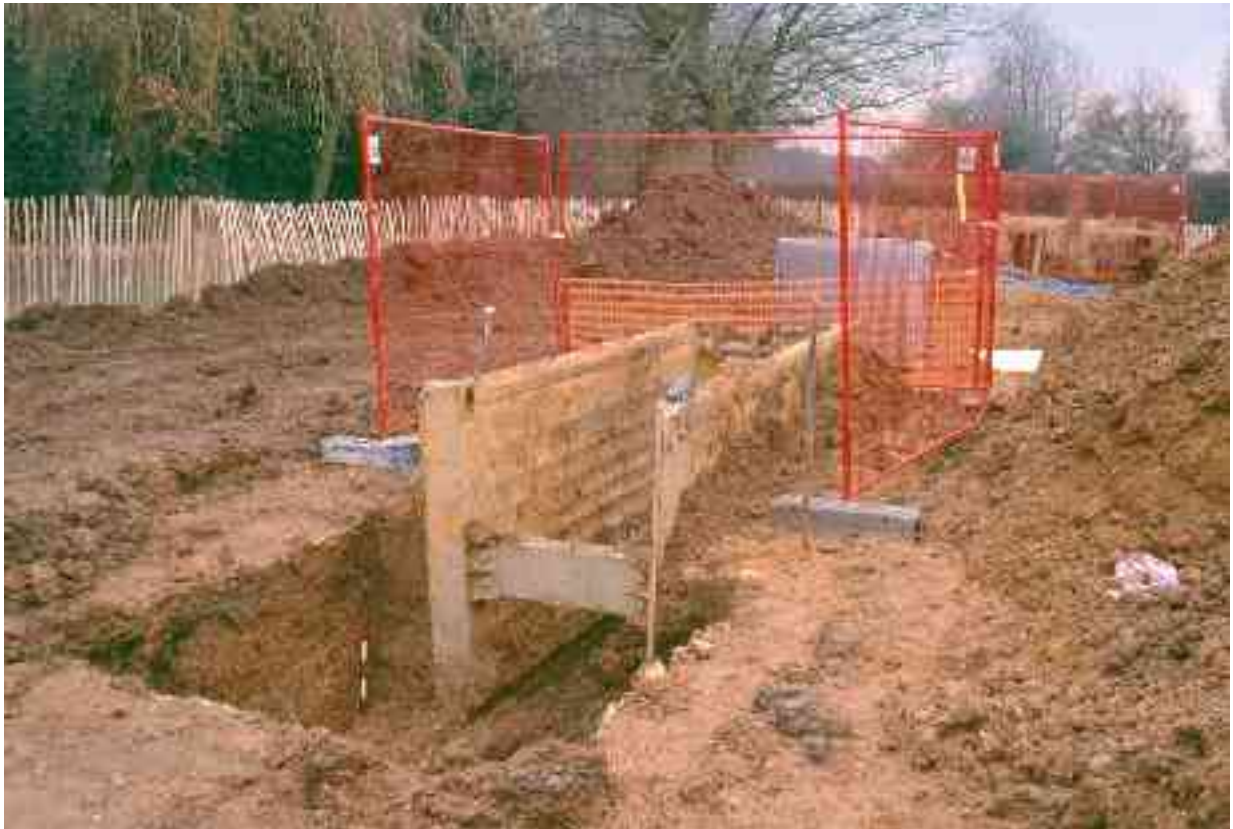
Fig 5 View of the sewer pipe trench excavation at point F4, looking southeast

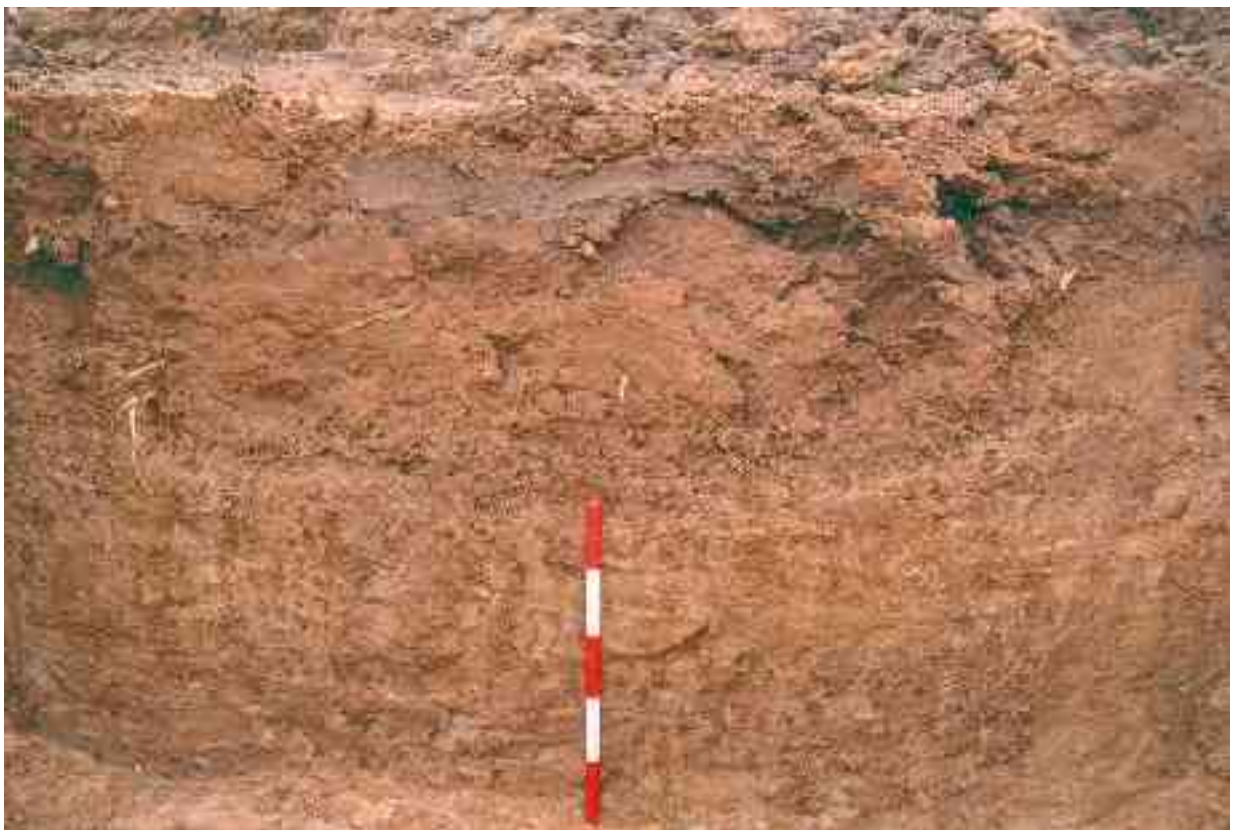
Fig 6 Detail of the exposed section seen in the foreground of Figure 5. A shallow layer of disturbed subsoil overlies natural: the latter changes from firm sandy silt to a lighter, much more sandy deposit at c 36.4m OD (approx. the top of the 0.5m scale)

The subsoil became cleaner and slightly lighter with depth and in all areas overlay a firm and homogeneous light orange-brown sandy silt, which is identified from the Geological Survey as the top of the Blackheath Beds. In several areas this deposit continued to the base of the trench, although it frequently became more sandy at a depth of between

0.45m and 0.65m. In several areas on the eastern side of the site a further change was noted at about 1.40m to 1.75m, to a much more gravely deposit within a matrix that varied from clay-silt to very sandy silt (*cf.* Figure 7).
