84-86 DEODAR ROAD, LONDON SW15
LONDON BOROUGH OF WANDSWORTH
AN ARCHAEOLOGICAL EVALUATION

July 2005

SITE CODE: DDR05
SITE CENTRE NGR: TQ 24565 75342
PLANNING REF: 2004/1313

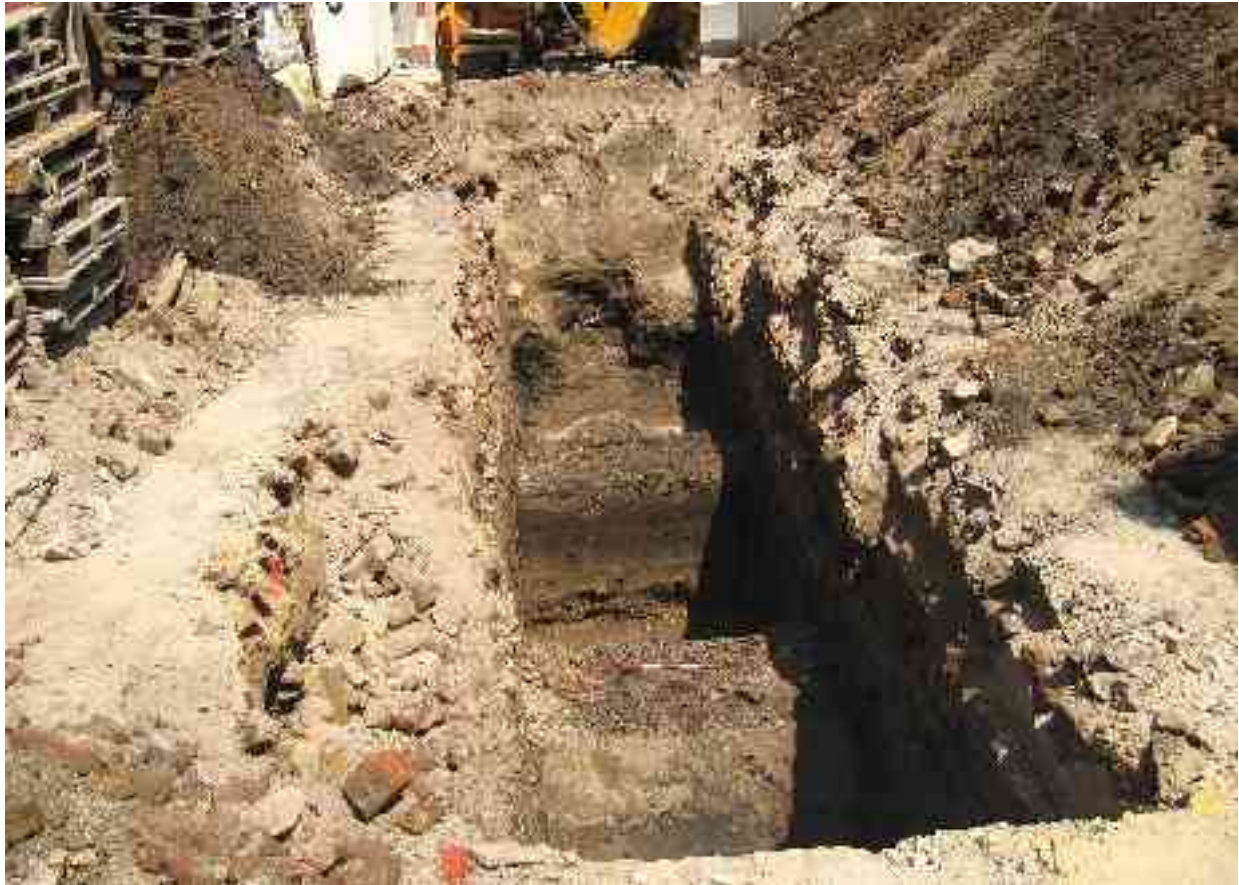
Fig 4 View of the evaluation trench looking north (*0.5m scale*)

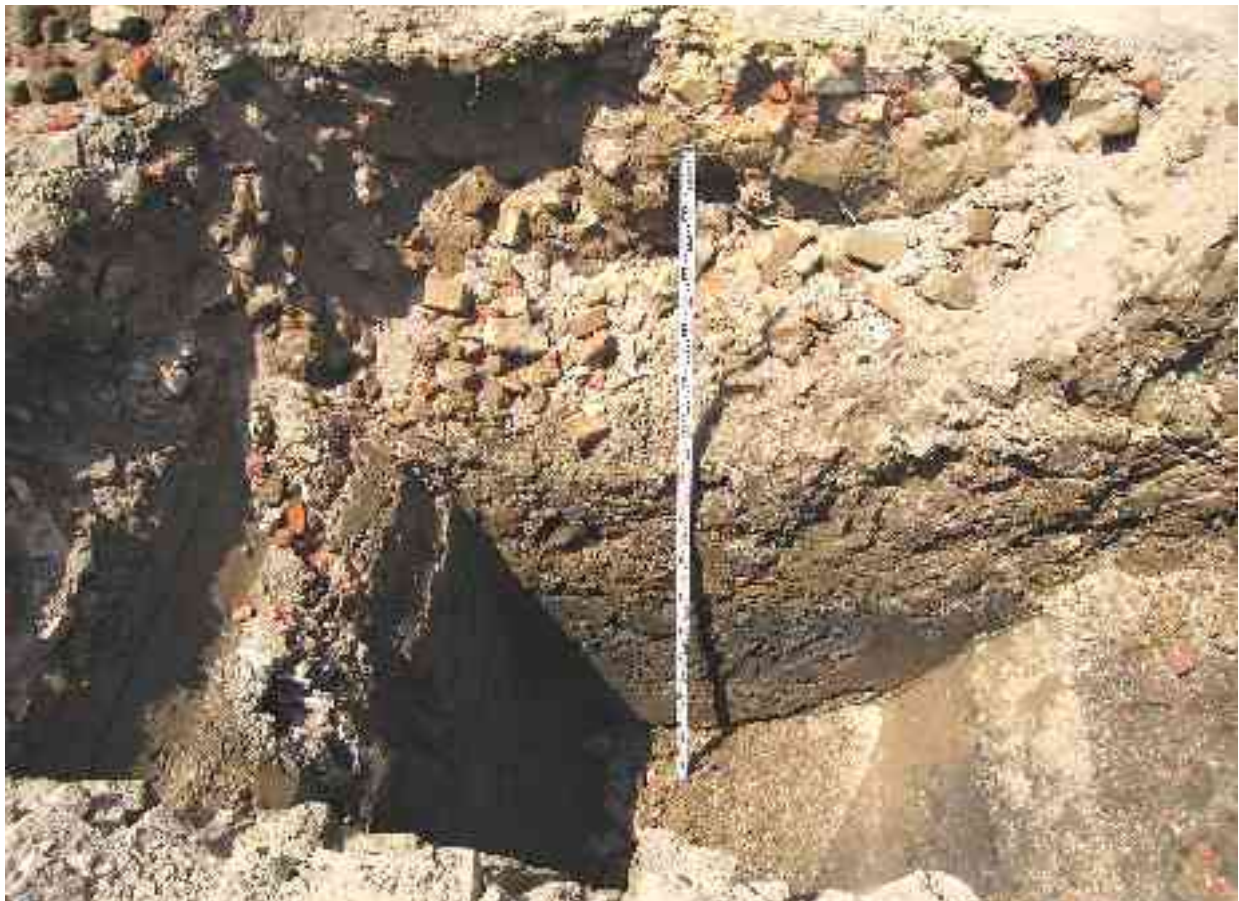
Fig 5 The southern end of the trench looking west. The staff height is 3m, with natural gravel at base

6.2.1 Excavation to the full depth of made ground deposits exposed a clean and compact sandy gravel that was clearly the top of the natural River Terrace deposit (identified as Kempton Park Gravel by the *British Geological Survey* Sheet 270).

The natural gravel was exposed at just above 5m OD, and up to 3.25m below the present land surface. The top of the deposit appeared to be fairly level but was overlain by made ground and clearly truncated. By contrast previous observations just to the south revealed an undisturbed natural surface at a depth of approximately 1.2m, sealed by a buried soil profile (*Compass Archaeology: site code PBG03*).

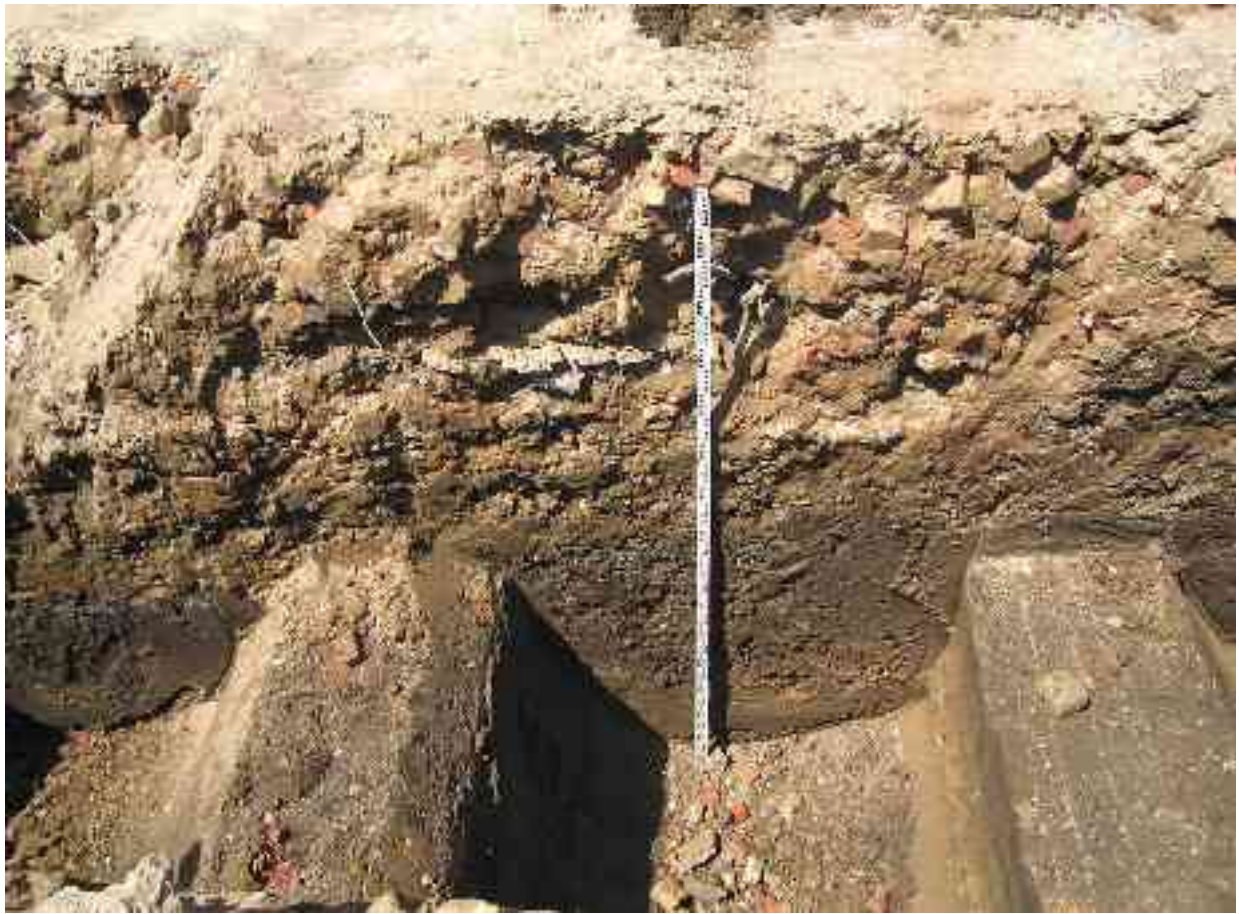
Fig 6 The central part of the evaluation trench looking west, again showing deep made ground deposits overlain by brick rubble. Staff height is 3m

6.2.3 The deposits directly overlying natural and infilling the presumed gravel pit comprised mainly a dark grey sandy silt with scattered pebbles, interleaved with mid brown slightly sandy silt. Both layers contained occasional brick and mortar fragments, but no readily identifiable material. The brick was mainly red with a few pieces of yellow stock, and of broadly 19th century date.

At a higher level (*c* 6.5m to 6.8m OD) the fill changed to a lighter coloured mixed silty sand with frequent gravel and building rubble. This deposit was at least 0.6m thick, but cut at its upper level by a disused north-south ceramic pipe. The latter ran the length of the trench, and included a concrete capping.

- 6.2.5** The uppermost deposits within the trench consisted of primarily of brick and mortar rubble, evidently demolition material from the buildings that had stood on the site. This was sealed by the unmade surface of the present yard.
