**An Archaeological Evaluation at
St Mary's Church,
Ticehurst, East Sussex**

**An Archaeological Evaluation at
St Mary's Church,
Ticehurst, East Sussex, TN5 7AB**

Site Code SMT 06

Project No. 2395

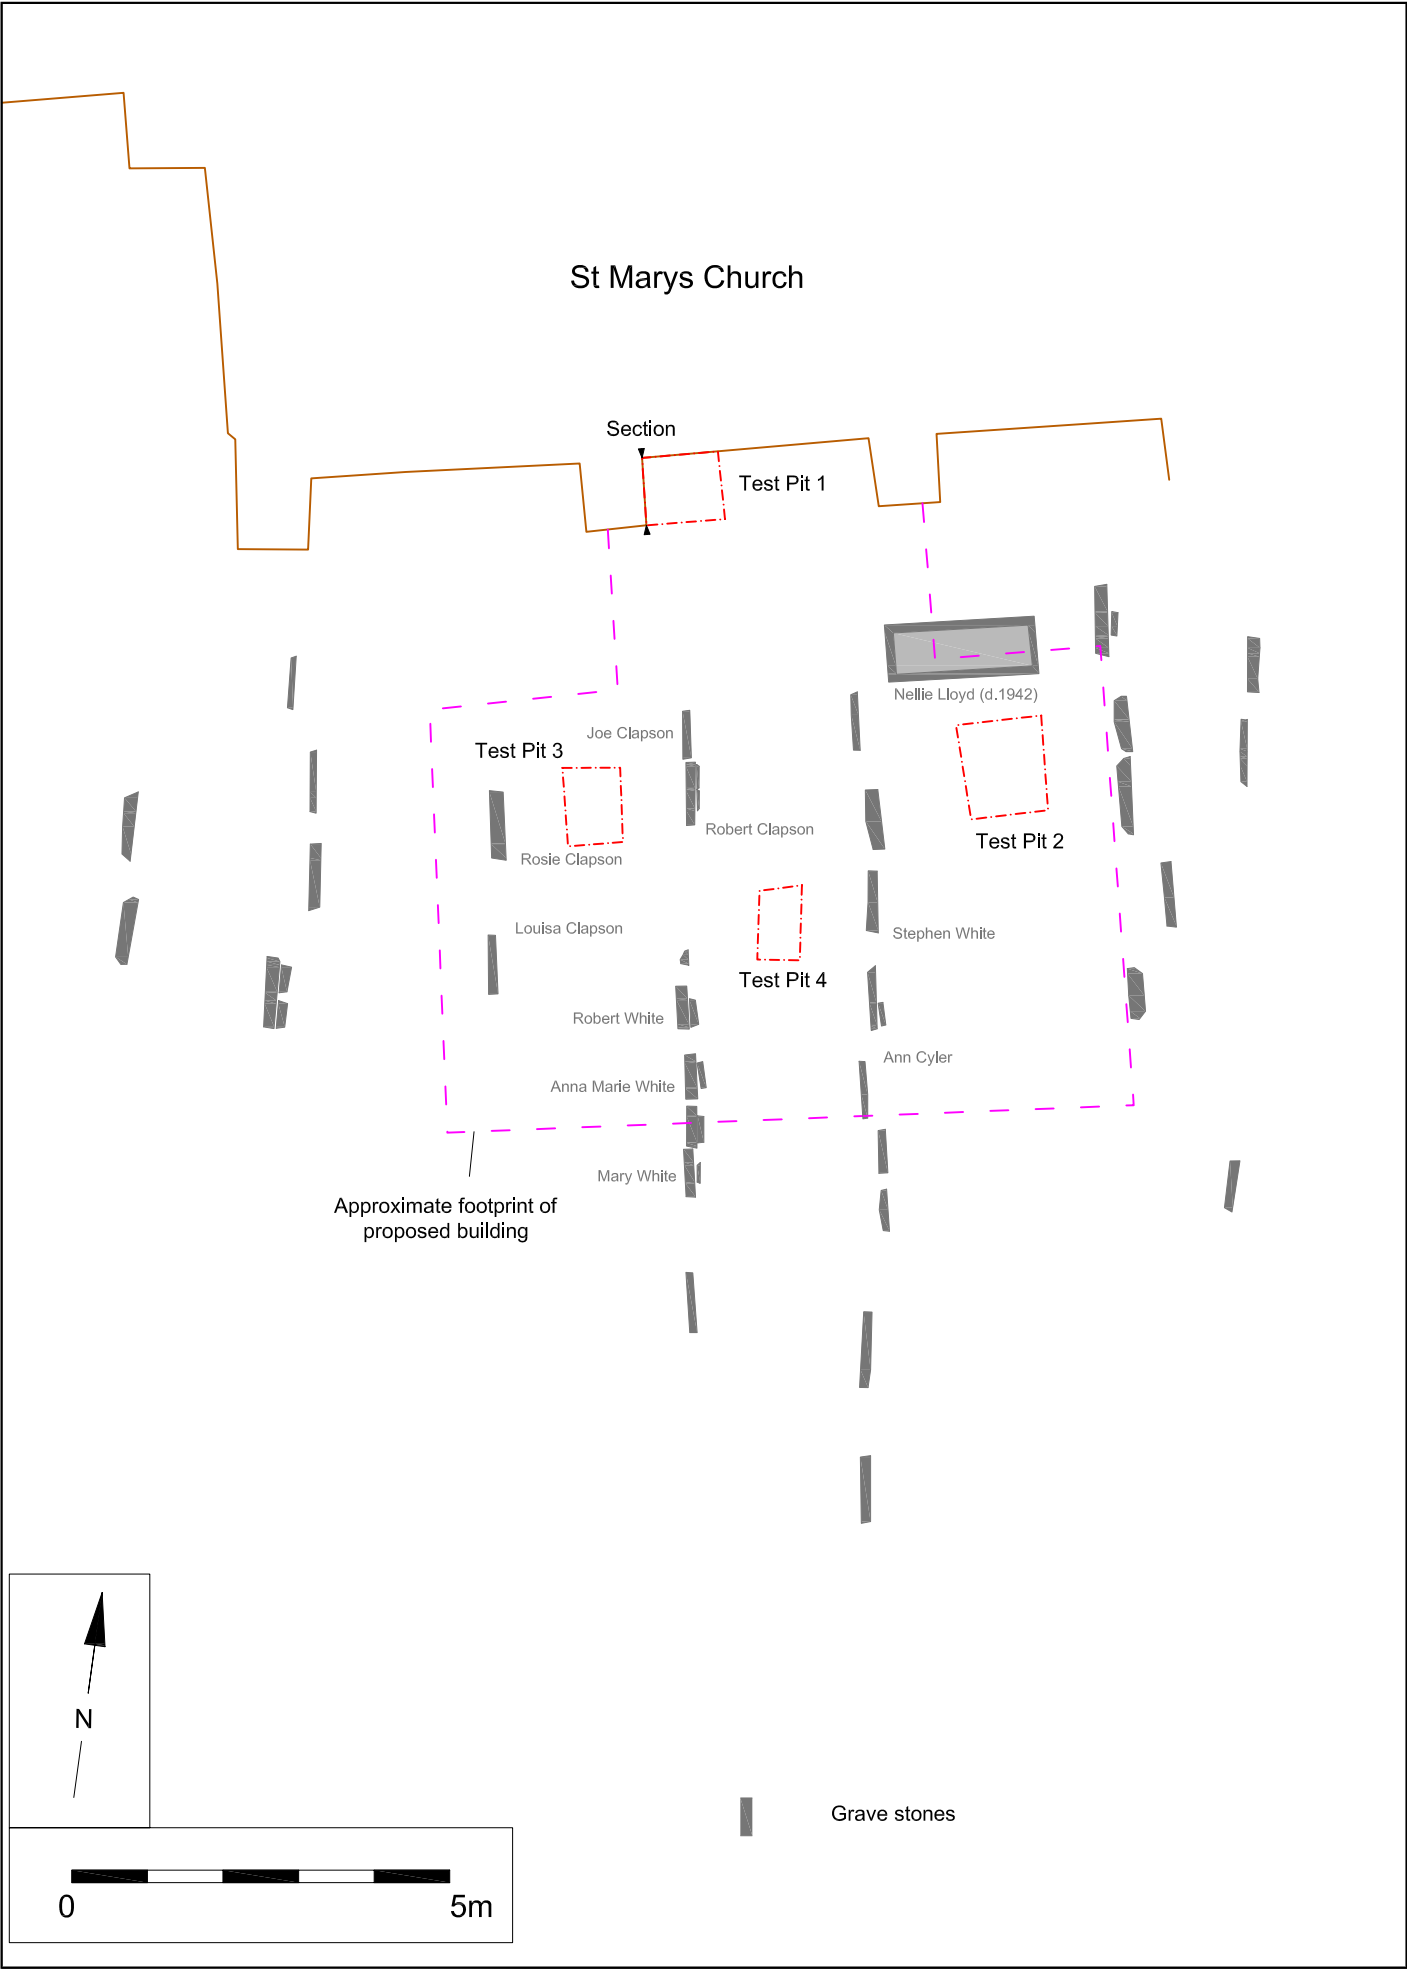
Figure 2: Test Pit and grave-stone location plan

- 4.1** TP 1 was excavated immediately against the south aisle wall and buttress (Fig. 2). The purpose of TP 1 was to ascertain the depth and nature of the foundations of the south aisle wall and buttresses and to establish whether archaeological deposits were present. The test pit was excavated to a depth of 1.20m below existing ground level (108.87mAOD) and the foundations of both elements of masonry were seen to continue below the limits of excavation (107.67mAOD), although the buttress foundations appeared to be coming to an end at this depth (Fig. 3). In this test pit a clayish dark grey-brown topsoil [1/2] c. 0.40m thick containing occasional fragments of CBM overlay a c. 0.30m thick layer of dirty clay [1/3] that contained occasional fragments of pottery, roof slate, CBM, iron slag and a small piece of molded stone –probably window tracery. This deposit overlay a light brown clay [1/4] with frequent flecks of charcoal at 0.70m below ground surface (108.17mAOD). This final deposit continued below the limit of excavation in TP 1 at 107.67mAOD.

- 4.2** TP 2 (Fig. 2) was excavated to a depth of 1.10m below existing ground level (108.68mAOD). The uppermost deposit was a clayish topsoil [2/2] c. 0.20m thick with occasional fragments of CBM. This overlay mid-yellowish clay [2/3] with occasional fragments of disarticulated human and animal bone and CBM, which continued to the base of the limits of excavation. At the base of the test pit (107.58mAOD), the articulated remains of a small individual were partly exposed –namely pelvis, right leg and feet. The remains were poorly preserved and lay within a barely discernable grave cut, the backfill of which was not distinguished from the surrounding matrix. Jutting out from the south section of TP 2 was what appeared to be a broken-off gravestone (Plate 1).

- 4.3** TP 3 (Fig. 2) was excavated to a depth of 1.20m below existing ground level (108.75mAOD). Clayey topsoil [3/2] c. 0.20m thick overlay light-brown clay [3/3] containing occasional disarticulated human bone, iron slag and CBM. This deposit continued below the limit of excavation (107.55mAOD). At the base of the test pit a badly preserved timber coffin was recorded (Plate 2). No grave cut was visible.

- 4.4** TP 4 (Fig. 2) was excavated to a depth of 1.20m below existing ground level (108.65mAOD). Clayey topsoil [4/2] c. 0.15m thick overlay clean mid-orangey brown clay [4/3] containing occasional CBM, disarticulated human bone, clay tobacco pipe and a lump of ferrous material. At the base of the test pit (107.45mAOD) the partial remains of two poorly preserved adult burials were recorded. The first individual, in the northern half of TP 4 lay with the head to the west, with bones of upper body to just above the knee exposed. The

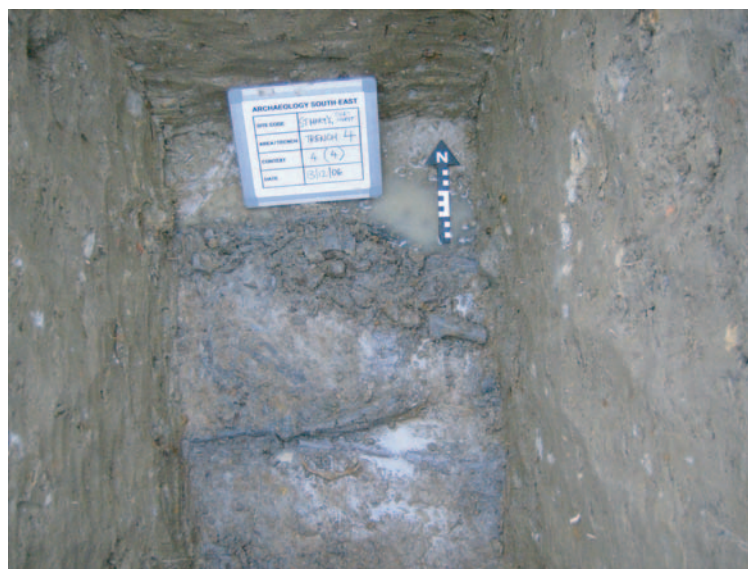
Plate 3: Test pit 4

second individual lay with the head to the east, with only the leg bones exposed (Plate 3). No grave cut was detected in either burial.
