18 & 19 GEORGE STREET, ST ALBANS

HISTORIC BUILDING APPRAISAL

ARCHAEOLOGICAL SOLUTIONS (CONTRACTS) LTD
Report Number 1506

January 2004

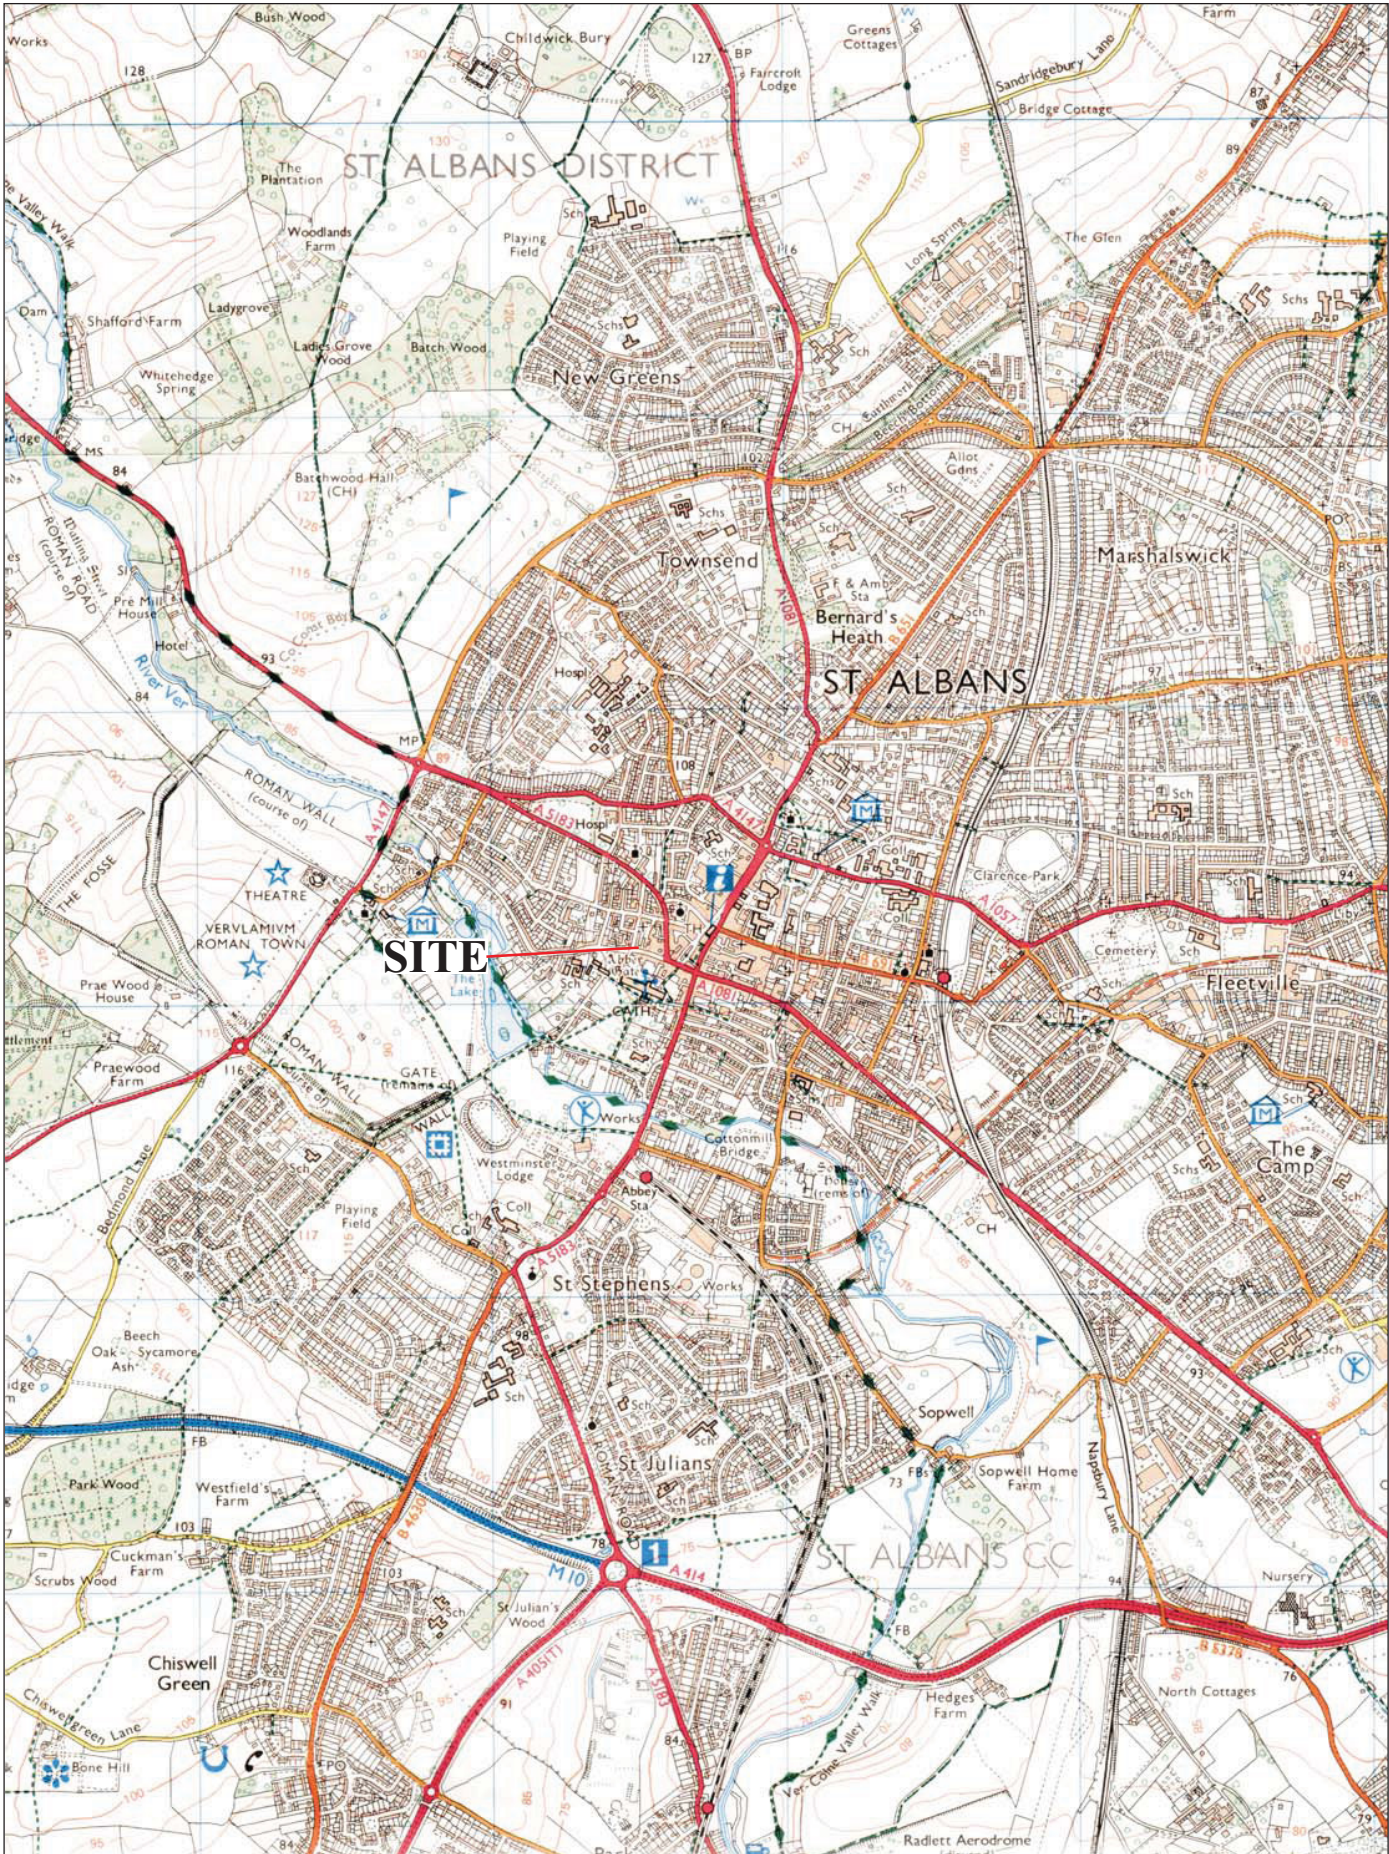
Plate 2 Red paint on brace to east of no.18 taken from the SW (DP 3)

4.10 The ground floor of number 19 contains two binding joists and a middle rail. The chamfered joist to the south has lambs tongue stops, suggesting a late 16th-early 17th century date (Plate 2). The one to the north is a reused timber with redundant mortices and a side lap joint. It rests on a post on the west consisting of two timbers joined with a long splayed scarf with under-squinted butts, which in this usage as a vertical compression joint is not necessarily mediaeval. A large propping post has been inserted below to support the post when the cellar was dug. A chimney stack is located on the east wall with a tile hearth and appears to date to the 19th century.

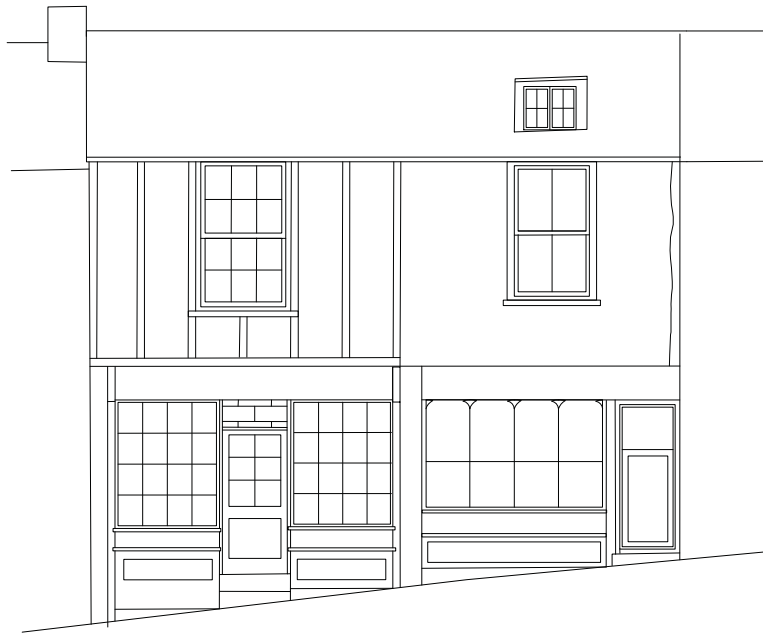
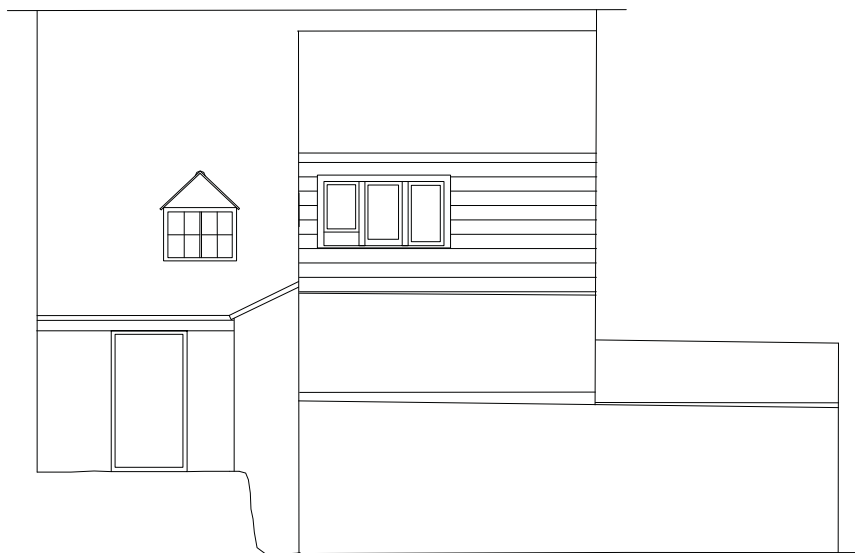
Front (South) Elevation

Rear (North) Elevation

3.2 Existing plans and elevations of the buildings provided by the client were checked and amended and are included (Figs.4-5).

4 THE BUILDING (Figs. 4 & 5)

4.1 The building consists of two adjoining shops facing south onto George Street, with a further shop adjoining to the east (20) and a red brick built drop-in centre abutting to the west. Number 18 consists of a ground floor shop front, thought to be early 19th century, with a jettied first floor rising to a red tile roof (Colour Plate 1). The shop front has a central doorway recessed within a small porch and contains a door with a lower flush bead moulded panel and four upper lights, with a plain overlight above. 3 x 5 pane wooden framed windows extend either side of the porch with wooden panels below and a brown tile floor. A further overlight with 'Chinese' fret design is located above the front of the porch, flush with the shop windows and is flanked by a simple wooden frame with chamfered cornice. The shop windows have lower moulded wooden panels and 4 x 4 pane thin wooden framed windows. A plain frieze extends above the shop windows with console brackets to the jettied first floor. To the west of the shop windows is a brick pier with an upper cogged band.

4.6 The east and west elevations adjoin the adjacent buildings. The north elevation faces onto a small yard (Plate 1). The ground floor consists of a 20th century Fletton brick wall with a central modern boarded door. The red tile roof of the building extends to the top of the ground floor and contains a two light dormer casement window at first floor level.
