Archaeological Observation
Investigation and Recording
at

**2 Corner Garth
Earswick Village
Earswick**

Watching Brief Report Number: 745
January 2005

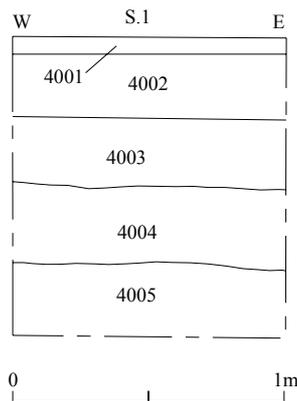
Figure 3 Sample profile section from Plot 4 to demonstrate the series of uniform natural deposits encountered across the site.

noted: [4001]/[5001] trample 0.20m thick over [4002]/[5002] remains of topsoil 0.30m thick, which in turn was over [4003]/[5003] mid grey sandy clays 0.25m thick. In between these layers and the natural red brown clays [4005]/[5005], lay [4004]/[5004] – a 0.30m thick layer of light yellow orange grey medium waterlogged sands, very clean with no inclusions (*Plates 10, 11*).

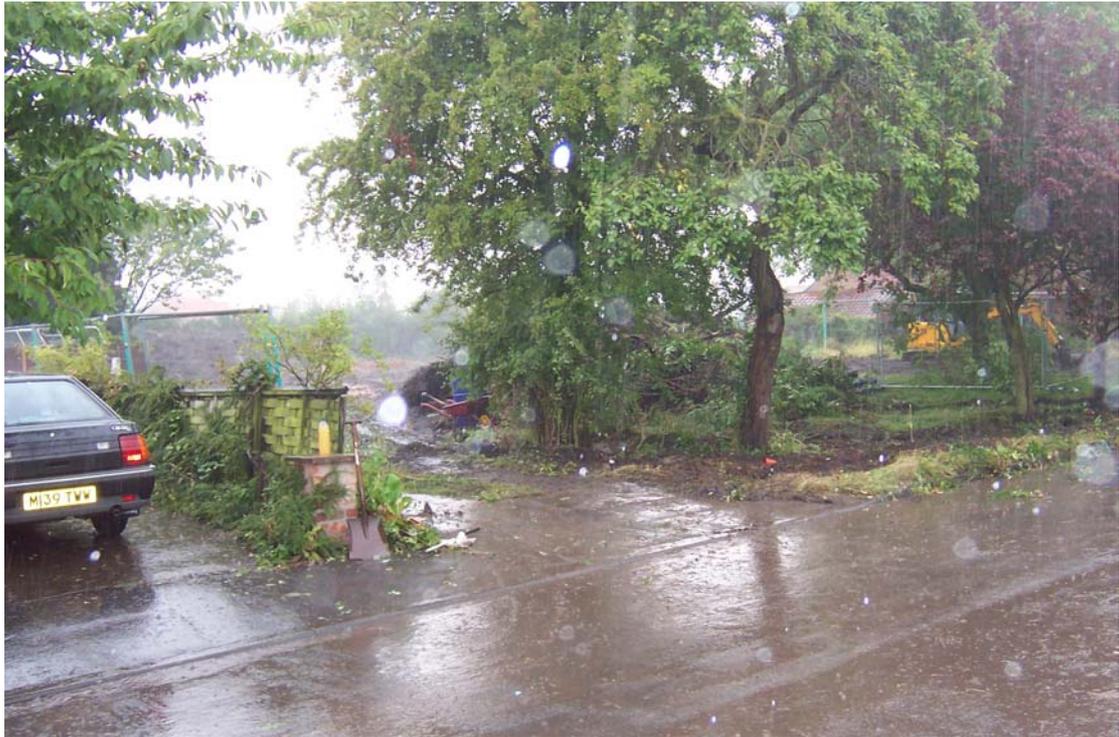
Plate 1 The entrance to the site, looking north-east.

This report presents the results of a programme of archaeological observation, investigation and recording undertaken by Humber Field Archaeology, on behalf of Hogg the Builder, during groundwork associated with the construction of 6 detached dwellings and garages including garage for existing dwelling and associated infrastructure on land at 2 Corner Garth, Earswick Village, Earswick, York, YO32 9SL (*Figure 1, Plate 1*).

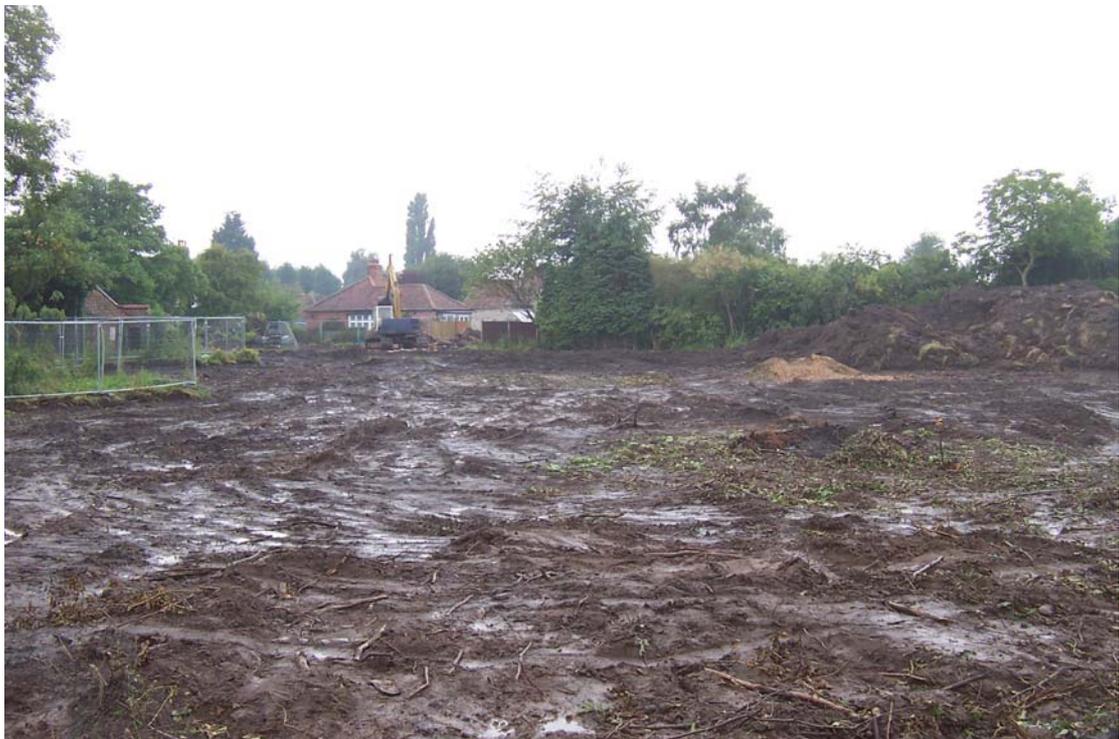
Plate 2 The stripped area, looking south-west.

The initial visit to the site oversaw the site strip. A walkover of the stripped area was undertaken by transects at 5m intervals, several sherds of pottery dating between the 12th and 20th centuries was recovered as well as fragments of clay tobacco pipe. At this time, only the topsoil [1001] was stripped. In addition, the weather was severely wet and the site was quite heavily waterlogged, the movement of the tracked machines on the site also disturbed the surface of the application area also. No archaeological features were identified. (*Plate 2*).

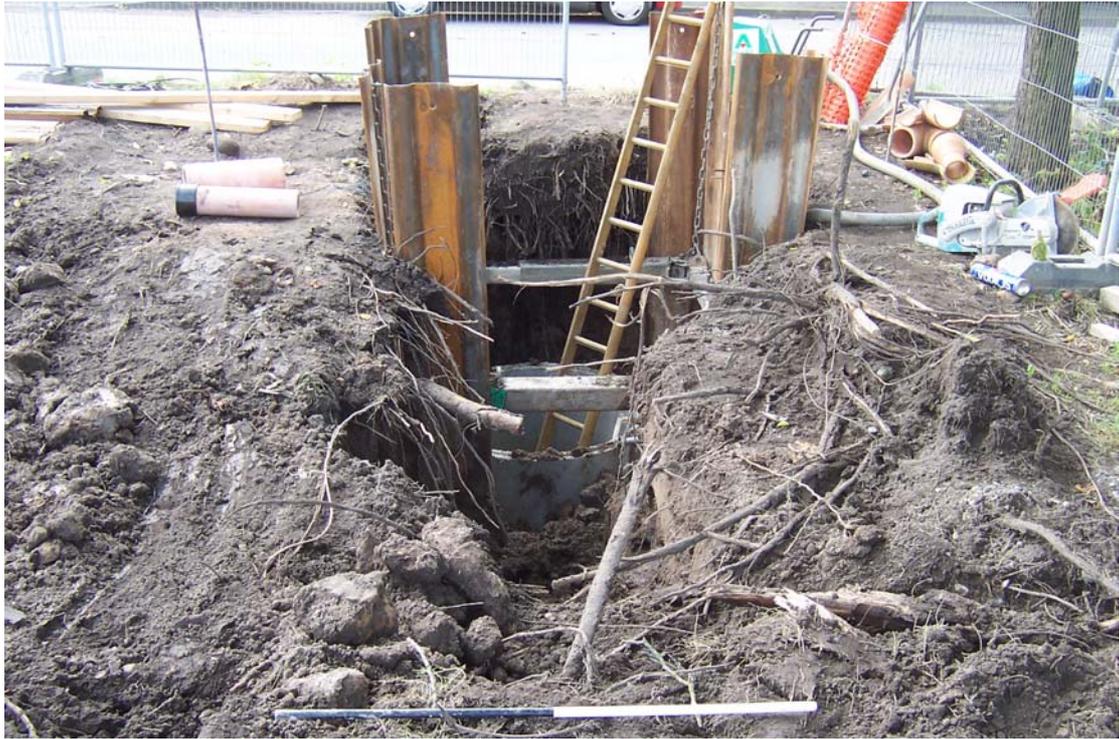
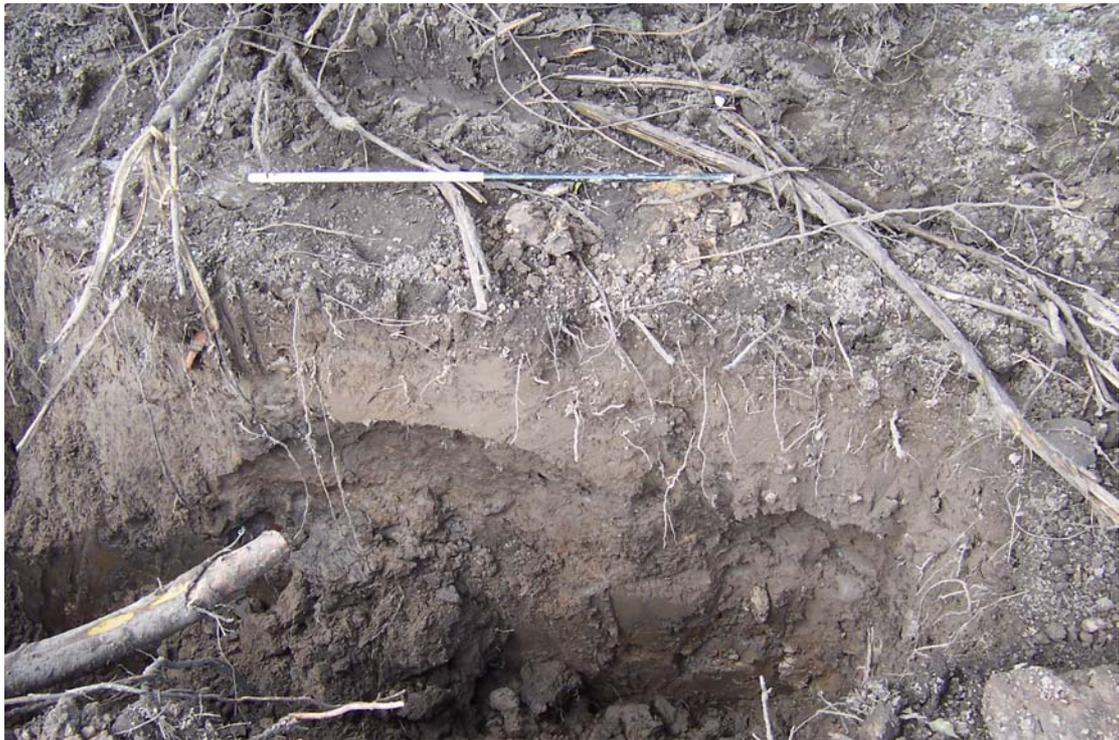
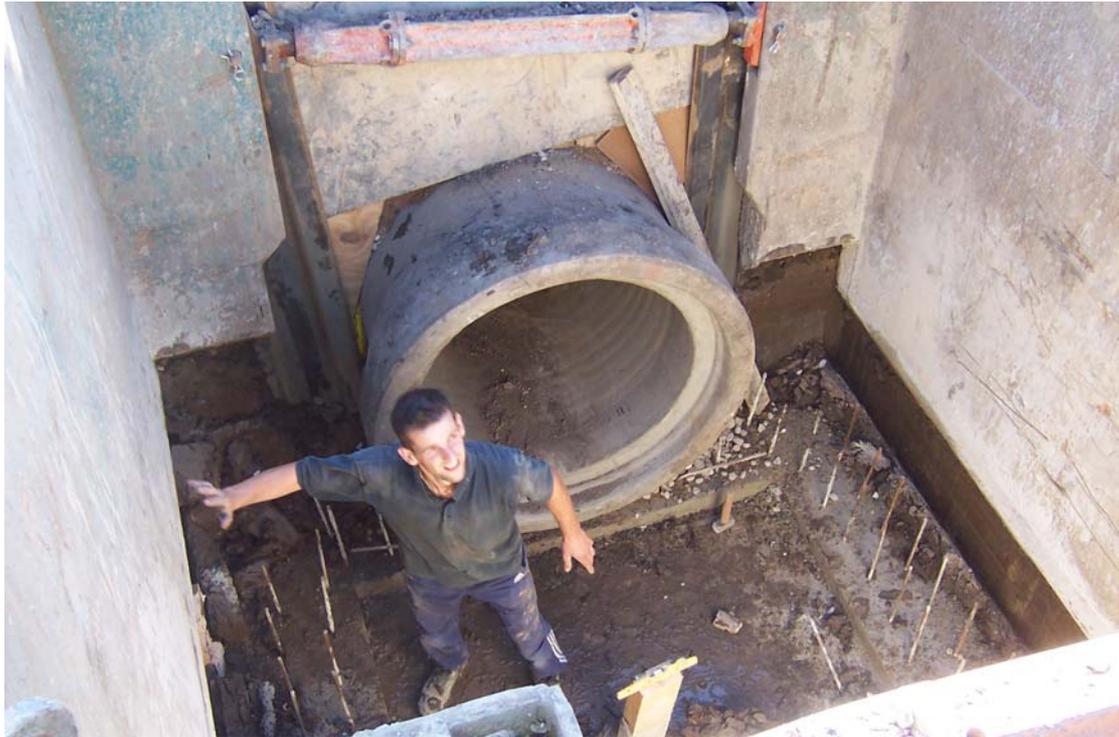
The next phase of the works concerned the excavation of the main services and road. The services began at the main eastern entrance to the site along the southern boundary. Here the trenches excavated were deep, ranging between 3 and 5m deep, the width being 1m wide expanding to 4m square at the periodic manhole/inspection chambers. In all cases, due to the method of safe excavation used (by use of immediate shoring and box-trenching), it was difficult to view the deposits in section in detail. However, it was apparent that underlying the remainder of the topsoil [7001] (same as [1001]), was a 0.25m to 0.50m thick layer of light brown grey silty/sandy clays [7002] which in turn overlay a layer of light coloured sands, probably glacial in origin [7002] up to 0.50m thick again. Below this lay natural red brown clays [7003] which ran to the base of the of service trench throughout (*Plates 3, 4, 5*).

Plate 3 The connection to the main road at the south, looking south.

Plate 4 Deposits exposed in section during the drainage works, looking west.

Plate 5 Deep service works, showing box-trenching safety measures.

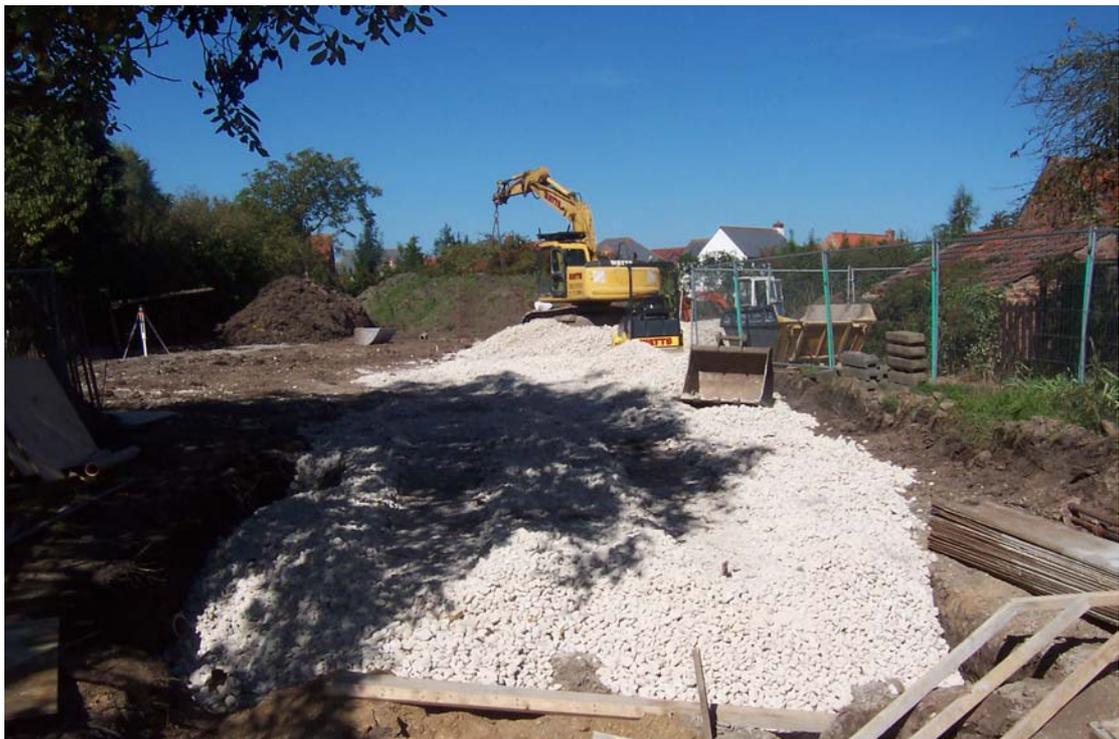
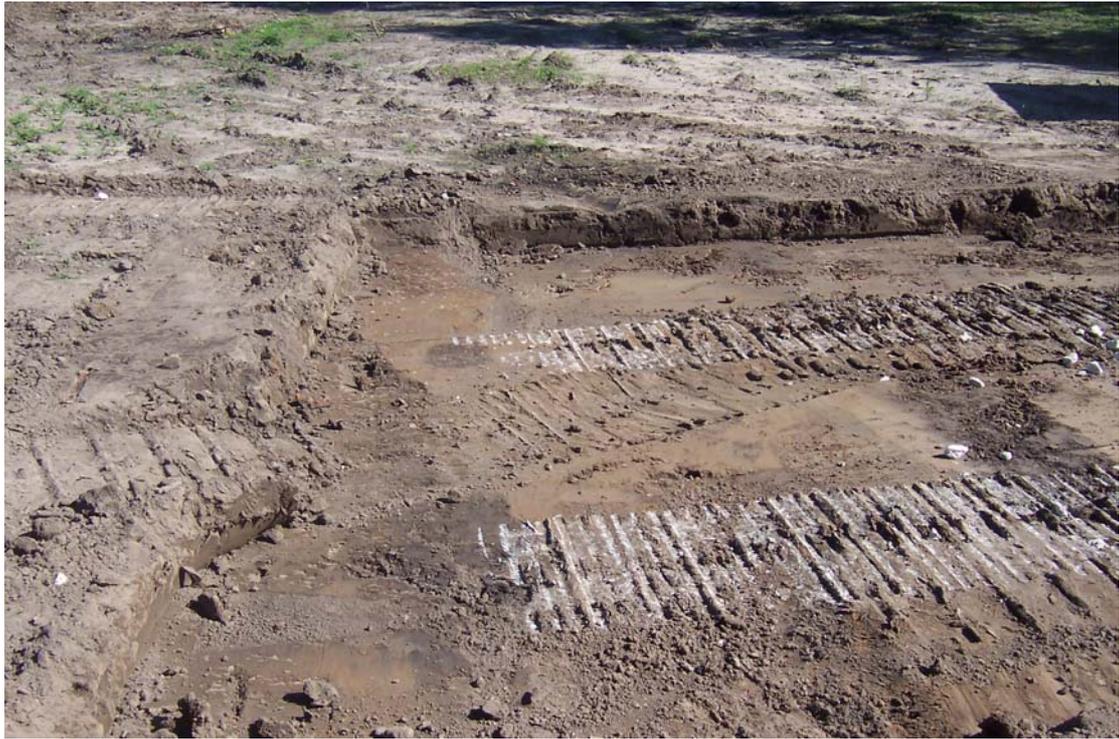
The access road was excavated to a depth of 0.50m. Only the remains of topsoil [7001] and the underlying light silty/sandy clays [7002] were noted, no other features or deposits were encountered (*Plates 6, 7*).

Plate 6 The backfilled access road, looking north.

Plate 7 The access road strip at the northern end of the site, looking east.

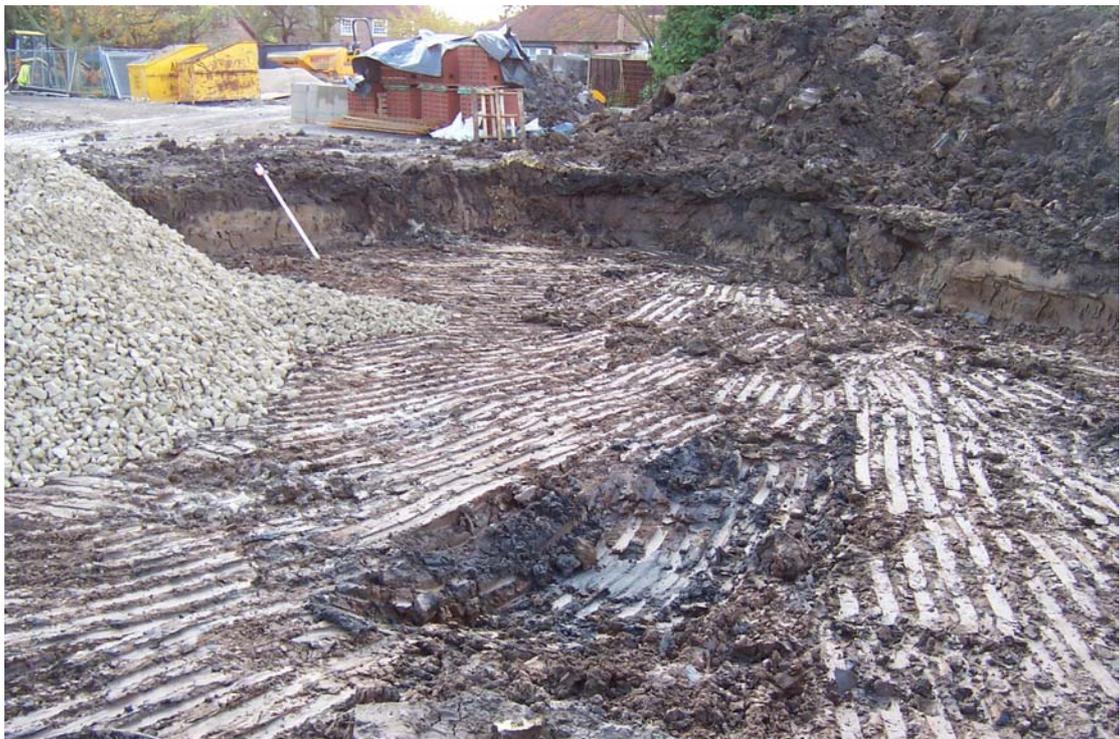
Plate 8 Plot 2, looking south-west.

Plot 2 (Middlethorpe) in the north-west corner of the site covered an area measuring 16m by 9m. Excavated as a raft foundation to be filled with Type 1 stone (this method was used for all the plots on this site), the deposits exposed here conformed to those viewed in the main service trench with the addition of an overlying surface layer. This surface layer [2004] consisted of the modern trample caused by the continual tracking of the machine, and was between 0.10m and 0.20m thick. This overlay the remains of the topsoil [2002] up to 0.30m thick. Below this lay a probable natural layer [2003] which consisted of mid grey very sandy clays with occasional medium to large rounded stone inclusions, up to 0.30m thick. This was over natural red brown clays [2003] visible up to 0.30m thick (*Plate 8*).

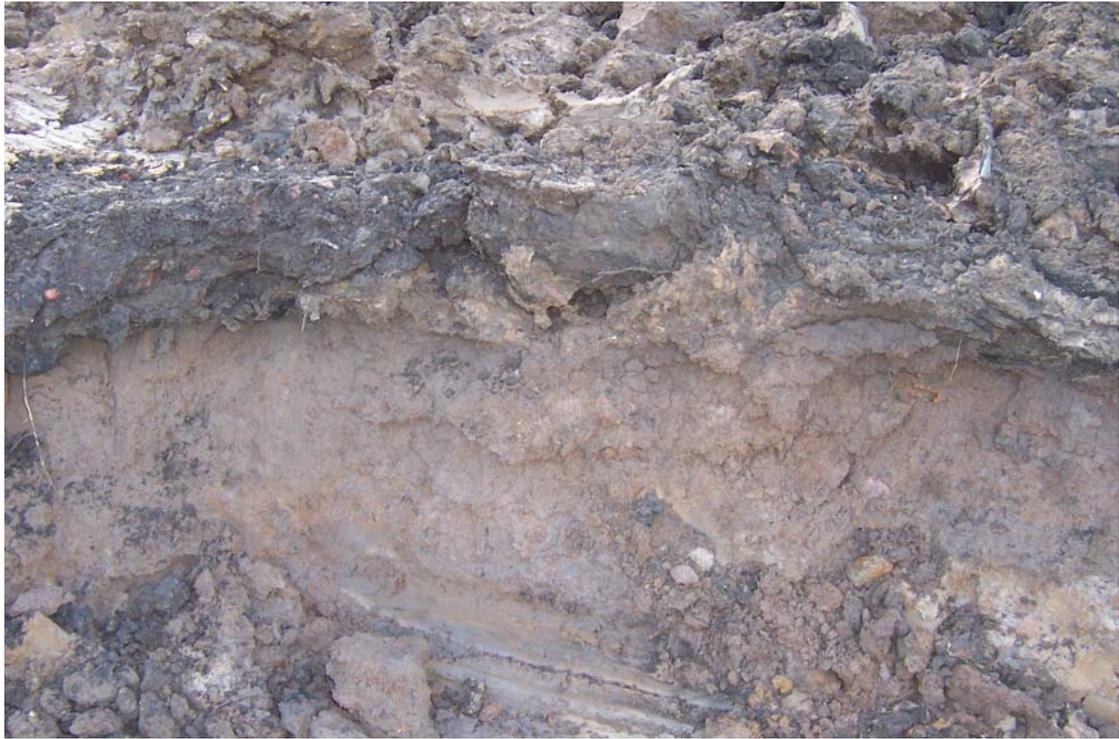
Plate 9 Deposits exposed in section in Plot 3, looking west.

Plot 3 (Glen Heworth) exhibited a similar stratigraphic makeup to that noted in plot 2. Covering an area measuring 12m by 14m only naturally occurring deposits were encountered, namely trample [3001] 0.20m thick, over topsoil [3002] 0.20m thick over the mid grey very sandy clays [3003] 0.50m thick. Occasionally the underlying natural clays [3004] were noted in the base of the raft foundation (*Plate 9*).

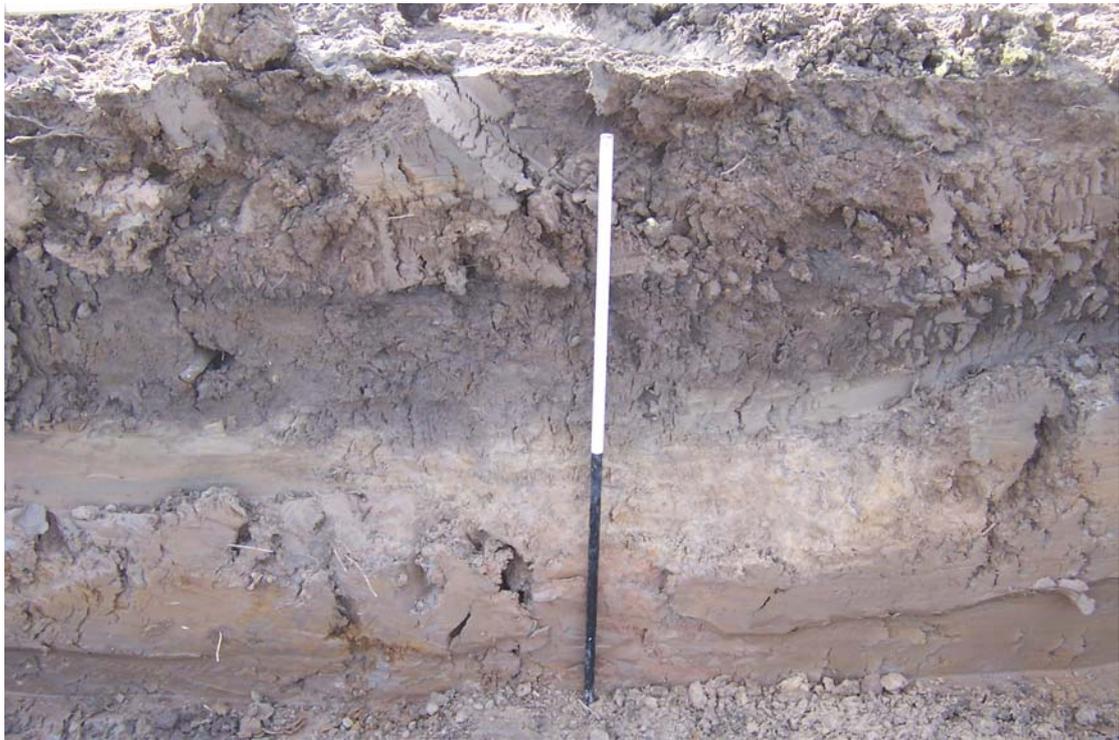
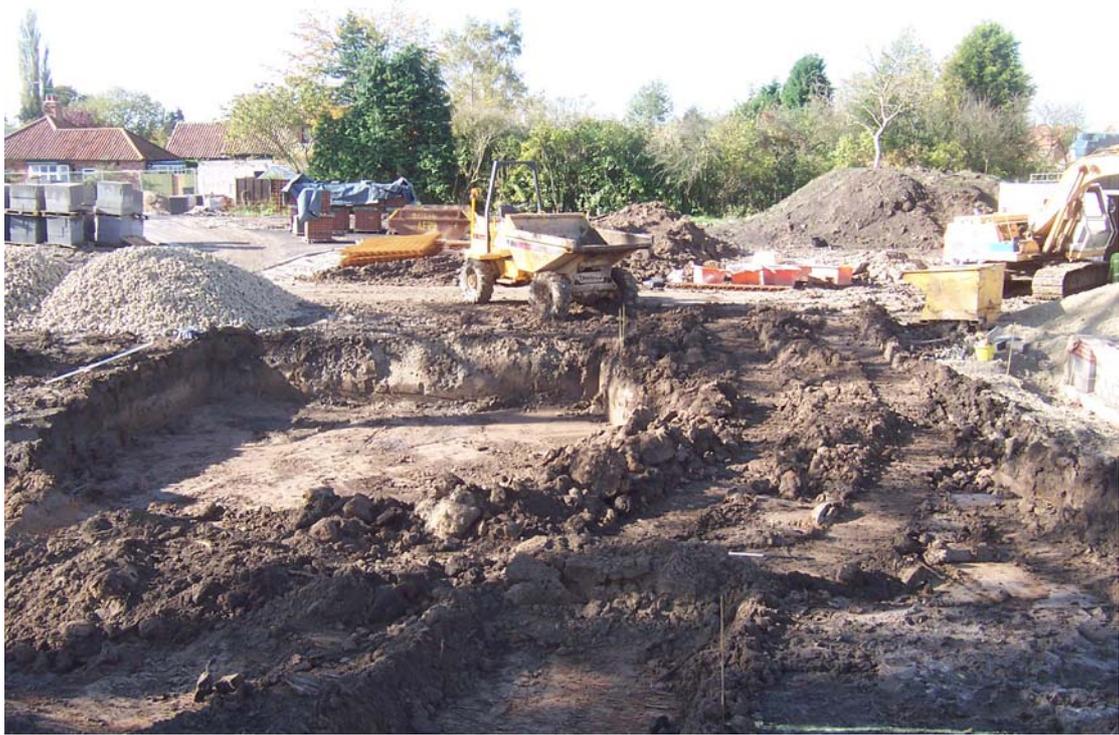
Plate 10 Deposits exposed in section in Plot 4, looking south.

Plate 11 Plot 5 fully excavated, looking west.

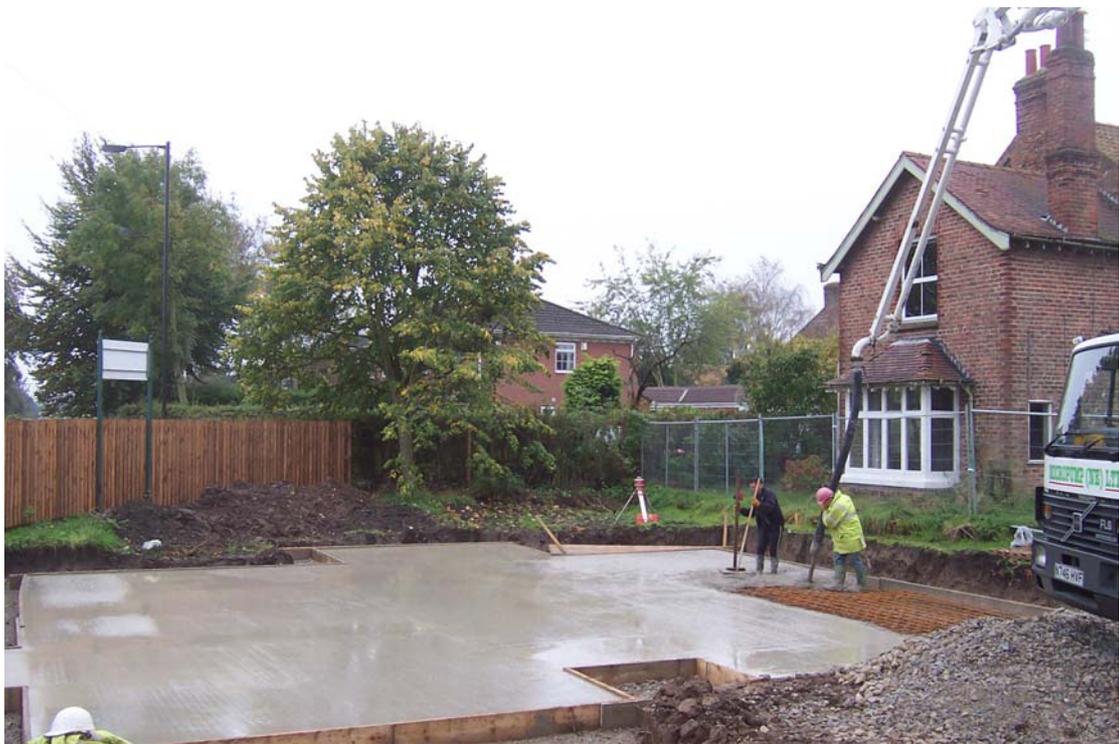
Plate 12 Plot 6 during concreting, looking south-west.

Plot 6 was partially filled with concrete during the inspection visit. This did not hinder the viewing of the profile sections of the plot however. Again, similar deposits to those viewed in plots 4 and 5 were noted, namely [6001] trample, [6002] remains of topsoil over [6003] sandy clays which in turn covered a thinner layer of waterlogged sands [6004] only 0.10m thick. The basal layer here was the same viewed elsewhere on the site, that being [6005] natural red brown clays (*Plate 12*).
