Excavation of a 19th Century Potworks at Silver End
Brierley Hill, West Midlands

Project No. 1095
January 2005

By
Kirsty Nichol and Stephanie Rátkai
With a contribution by Steve Litherland

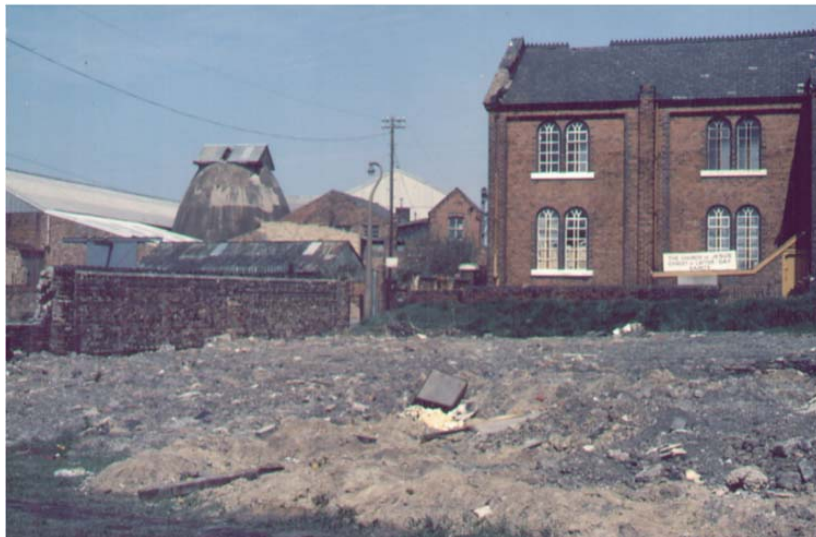
Plate 1 The dome of the hovel from the south (by kind permission of Ron Moss, Industrial Archaeology Group, Black Country Society)

The area affected by the development contained the upstanding remains of a bottle kiln (Plate 1), which had been listed locally, and several other industrial buildings of varied date and function. Brierley Hill is undoubtedly better known for its glass cones (the two best surviving examples being those at the Royal Brierley and the Redhouse Glassworks) rather than for its potworks. However, it was the high quality of the local underlying fire clays that initially attracted French glassmakers here as far back as the 17th century. The district went on to receive great acclaim for its glasswares, and continued to rely upon local potters to produce good quality glass-house pots for the production of their fine drinking glasses amongst other items. Thus, there were several potworks in the surrounding area, perhaps one of the finest examples being the Harris and Pearson works, to the west of the site, further along Brettell Lane. Glass-house pots, were dried rather than fired, and thus no kiln was necessary, however many other products, such as refractory bricks and gas retorts were produced by the same company, and the First Edition Ordnance Survey Map (dated 1884) depicts the arrangement of beehive-kilns within the factory complex. The significance of the kiln at Silver End is that it was neither a glass cone nor a beehive kiln, and appeared to be much more akin to the bottle kilns that gave The Potteries in Staffordshire its characteristic skyline. It was for these reasons that further work was recommended prior to demolition of the structure.

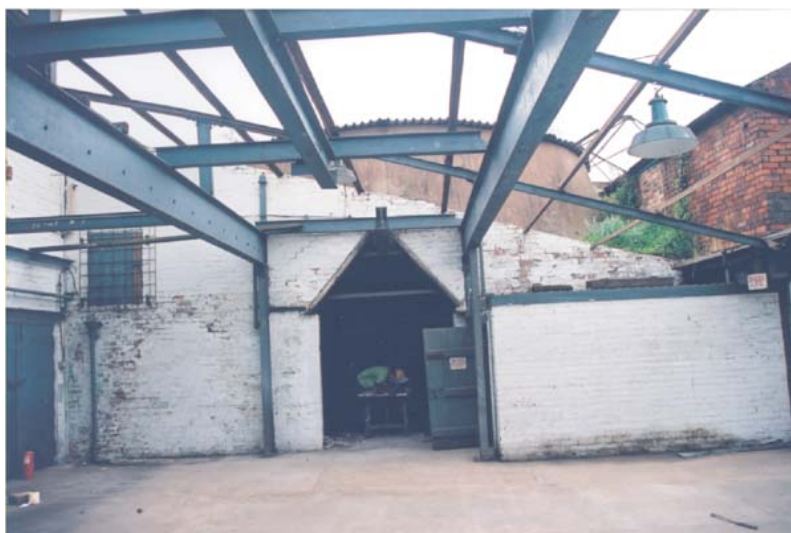
The lower section of the conical chimney of the hovel survived to a height of c.3m (Plate 2) and was set upon a 2m high square base that measured 10m by 10m. It was built from traditionally made red brick (of 9" x 4¼" x 2½") and was bonded with lime mortar. The base wall was 1½ bricks thick, and where the circular cone met the square base, the brickwork was carried upon cast-iron beams with a course of header bricks laid on edge above. Behind the

Plate 2 Southern elevation of the hovel prior to demolition

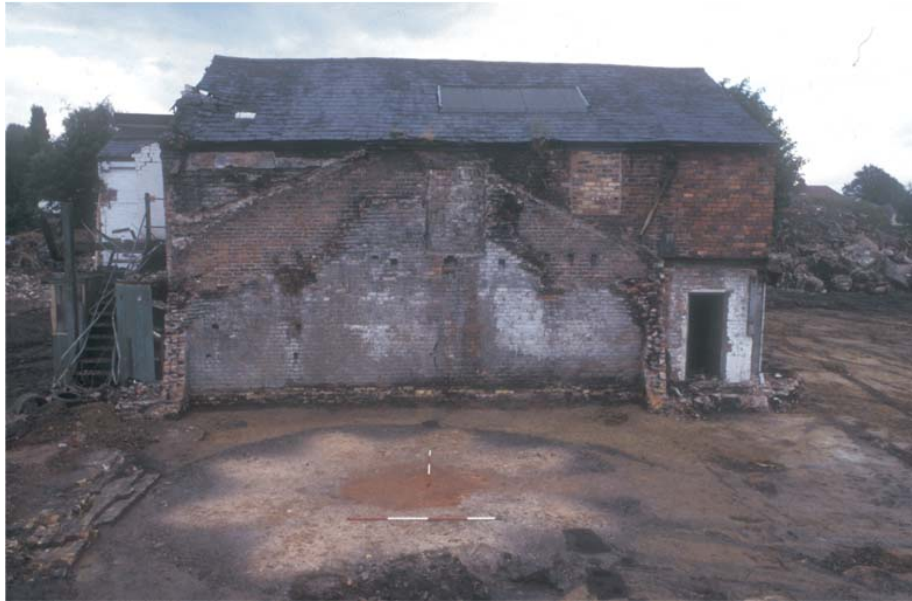
Plate 3 Pre-Excavation shot of the base of the oven F100, and party wall of the hovel and Structure B

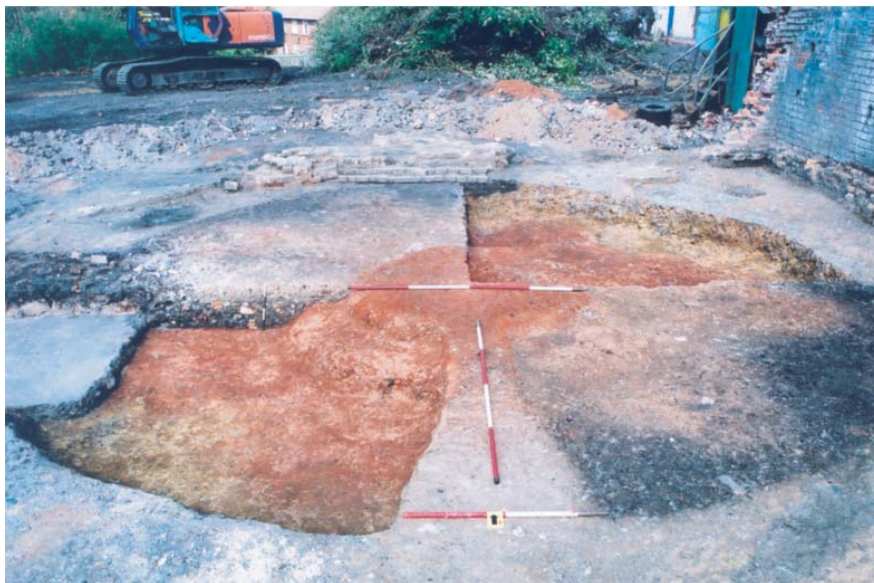
The base of the oven (F100, Plate 4) was defined by a ring-shaped foundation cut that measured approximately 6.8m in diameter, 2.4m wide and 0.5m deep. It had a flat base, a central pedestal that had a stepped profile, and a wedge of natural subsoil (denoting the entranceway) had been left *in-situ* (Fig. 7). It had been deliberately backfilled using pre-fired material containing quantities of charcoal, sand, broken and misfired pottery, and fragments of firebrick (1003/1004). In his *Treatise on Earthenware Manufacture* in 1901, Ernest Sandyman referred to this material as the 'cork' (Jon Goodwin pers. comm.). This was a mixture of materials that were pre-fired (and therefore moisture free) that would not expand or contract when repeatedly fired, and would therefore not undermine the stability of the oven superstructure. The layer of cork was laid to form the base and correct pitch of the flue system for the oven, with the brick superstructure being constructed on top of it (*ibid.*). Although there was no surviving evidence for any part of the oven superstructure it is possible to say, from scorch marks within the cork, that there were eight ash pits, denoted by the 'lobes' around the periphery of 1004 (Plate 3), and therefore eight fireboxes. The depth and intensity of scorching of the cork and underlying natural subsoil (1001) also suggests that the fire boxes and grates were relatively low down within the superstructure (David Barker pers. comm.). It may also be evidence for the oven being used intensively over a prolonged period of time, although this is less certain.

Plate 4 Post excavation shot of the base of the oven F100, showing the depth of the cork

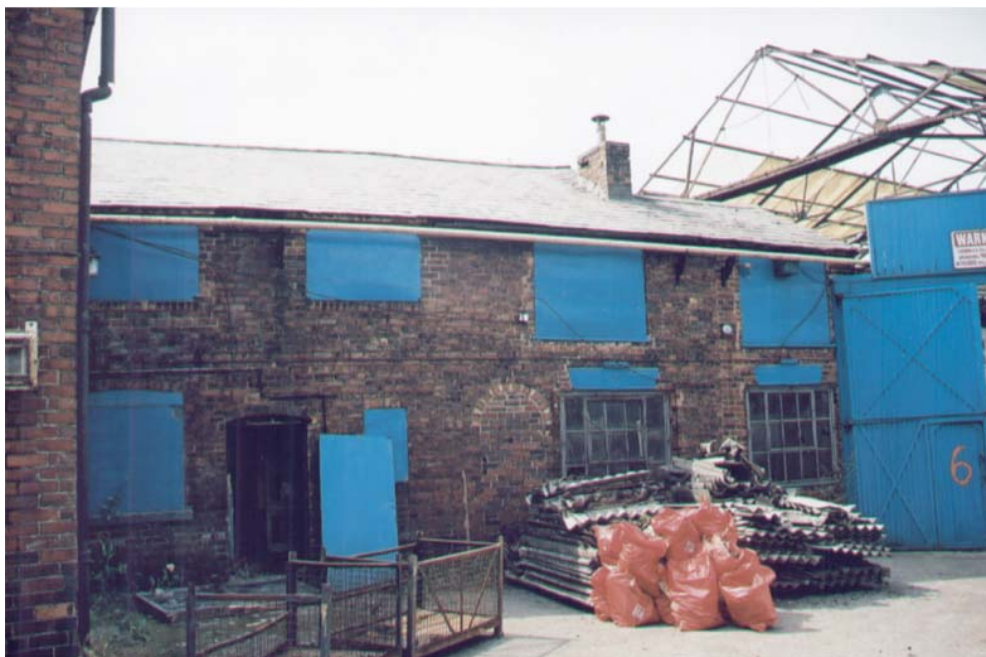
Plate 5 Eastern elevation of Structure B

A squat, mid to late 19th century, two-storey range fronted onto Silver Street and abutted the eastern side of the bottle kiln. It was extended in the early 20th century (see below) which was denoted by a vertical joint, and also underwent later alteration. The original build was of 9-9½" x 4¼" x 2¾-3" red bricks laid in Flemish stretcher bond, it had a slate saddleback roof with a brick stack to the south gable end. The building originally had a three-bay frontage, and there were doorways to the left and right of centre (Plate 5). The former had a segmental arch, the latter had a semicircular arch which was made of headers laid on edge in alternating red and yellow brick and there was a stone step, although the doorway had been blocked. An original segmental-arched ground-floor window survived to the left (south); it had a stone sill and, contained a frame of chamfered mullions and transoms. Other original fenestration, included a small centre window at ground level, and the upper storey windows appeared to originally have been relatively small and simple in design, fitting snugly under the eaves line of the roof. The other openings to the building all appeared to have been modified, and those of the frontage were either bricked or boarded up. The north-east and south-east corners of the building were both cut off to facilitate cart access and had corbelled-out heads. It also shared a party wall with the hovel to the west (Plate 6).

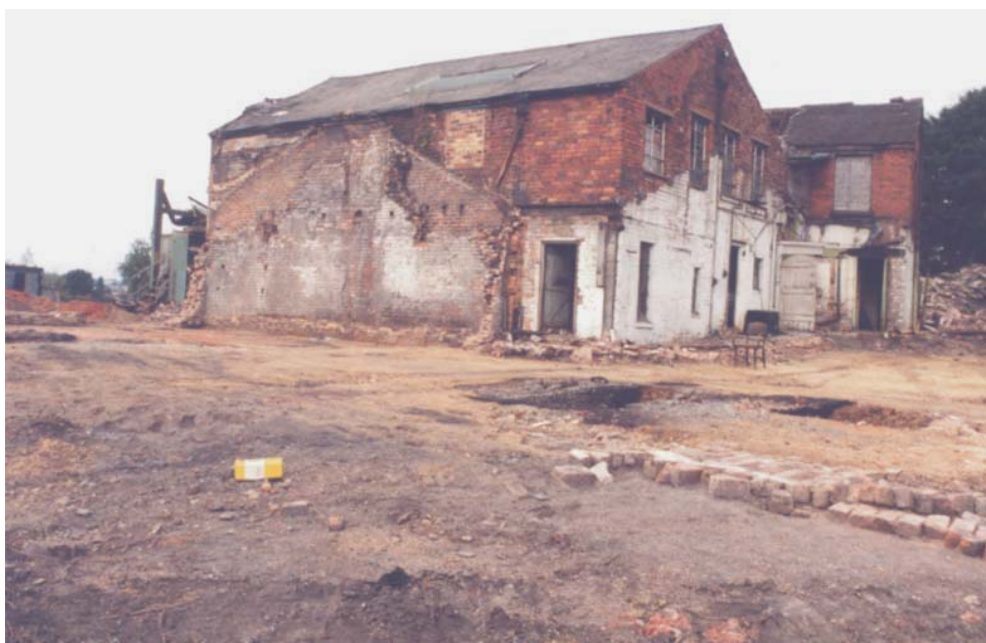
Plate 6 Structure B from the southwest, with Structure E to the right

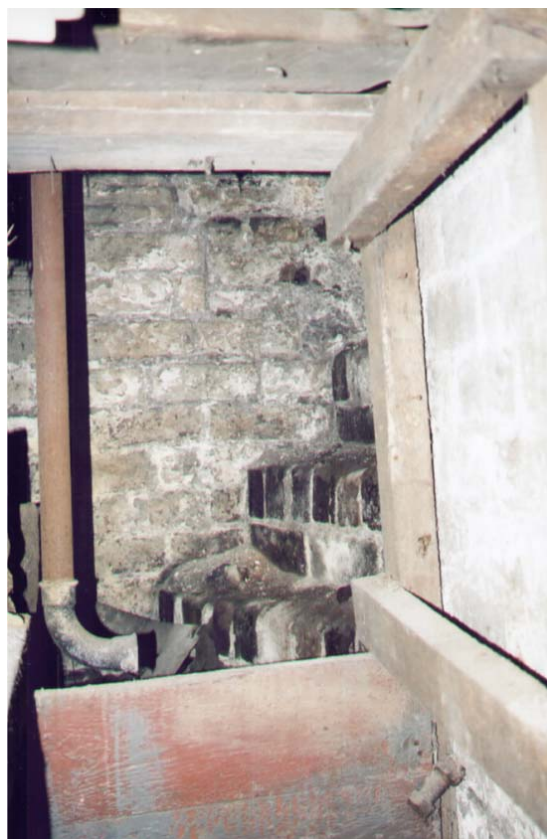
Plate 7 Cellar steps

The cellar was complex and the original access was from outside the building to the north where there was a brick staircase (Fig. 8, Plate 7). The foot of the stair communicated with a passage that led to a rectangular chamber, in the northwest corner of which was a deep recess. In the southeast corner an opening gave access to an L-shaped passage which was linked to a barrel-vaulted chamber situated to the north (and outside) of the building. The cellar, which was entered from the west, was constructed of brick and was covered with a basket-arch brick vault (Plate 8). Low quarry-tile covered plinths lined the southeast and part of the west wall. These may have been used to store the newly thrown pots, or *green wares*, in cool damp conditions, prior to their being fired. In the floor, at the northern end of the cellar, was a drain, and in the vault, at the southern end, a ceiling lantern or light well.

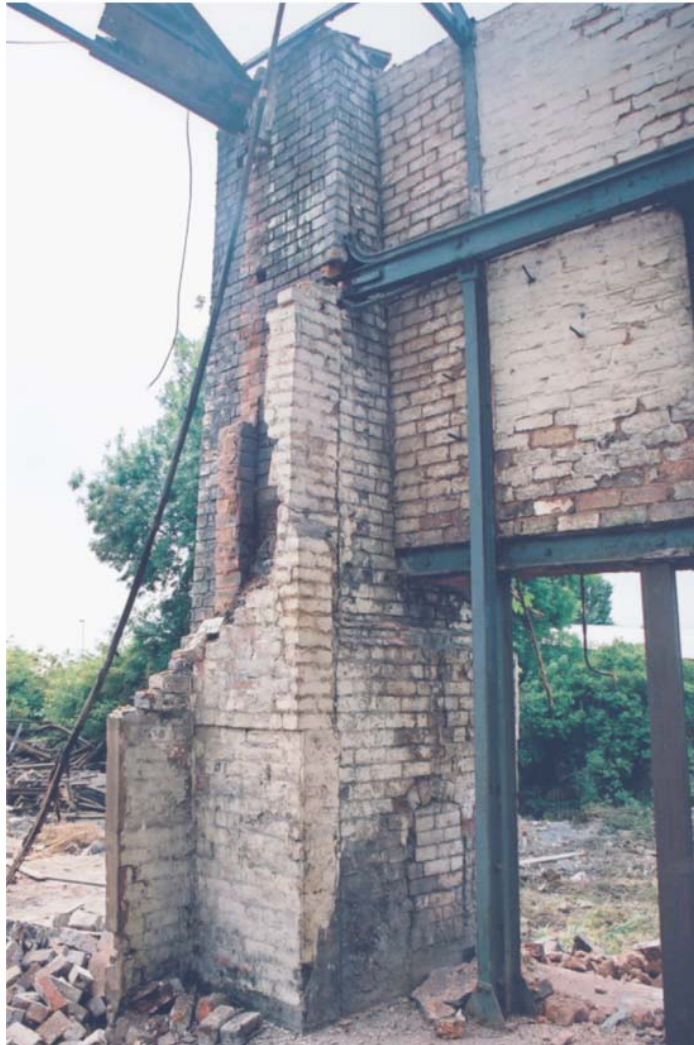
The base of a tapering chimney, approximately 6 feet (2m) square and roughly 5m high (Plate 9) stood to the southwest of the hovel. It was built from traditionally made 9½" x 4½" x 3" red brick, laid roughly in English Garden Wall bond and there was a single 16" (40cms) wide, low (blocked) opening with a segmental-arched head near its base. It has been suggested (David Barker pers. comm.) that it may have been part of a coal fired slip kiln, this may be further evidenced by what appears to be a bath-shaped tank adjacent to the stack that is depicted on the First Edition Ordnance Survey Map. This type of kiln was introduced by Ralph Shaw c.1730 replacing sun pans in the refining of raw *found* clay. The purpose of the process was to use heat to draw off excess water from newly mixed wet clay or *slurry*, and, as the name suggests, sun pans were most efficient during hot sunny weather. However, the introduction of the slip kiln meant that processed clay could be dried out in any weather.

Plate 9 Chimney (Structure C) associated with a slip kiln

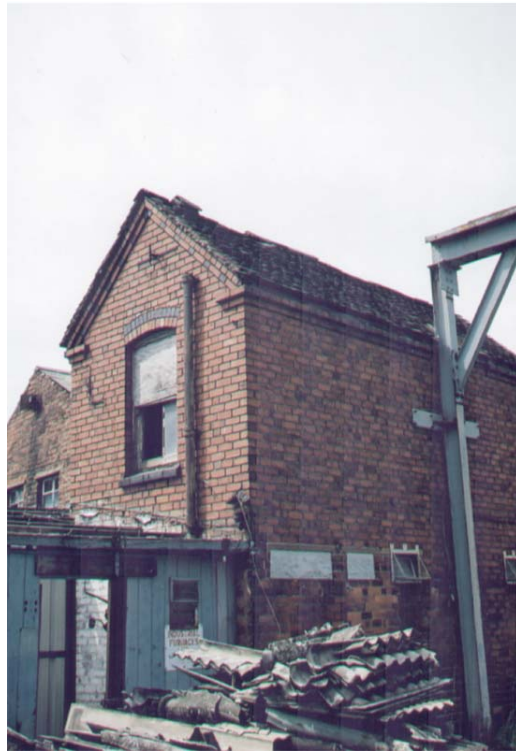
This tall narrow office building was constructed in 9" x 4¼" x 3" mass produced red brick laid in Flemish stretcher bond, and covered with a plain tile roof (Plate 10). The building was aligned north-south, with an entrance from the west. It was a two-storey structure with an eaves band continued around the gables to suggest open-base pediments. The east face was blind originally, but was pierced by small lavatory windows in the mid-20th century. There were segmental-arched windows in the southern and northern elevations made of two courses of headers laid on edge with the upper course picked out in blue engineering brick, they had stone sills. At ground level the building had been converted into lavatories during the later 20th-century and no original features survived. At first floor level there was an original fireplace in the east wall with a panelled and foliated iron surround.

Plate 10 Southern elevation of Structure E

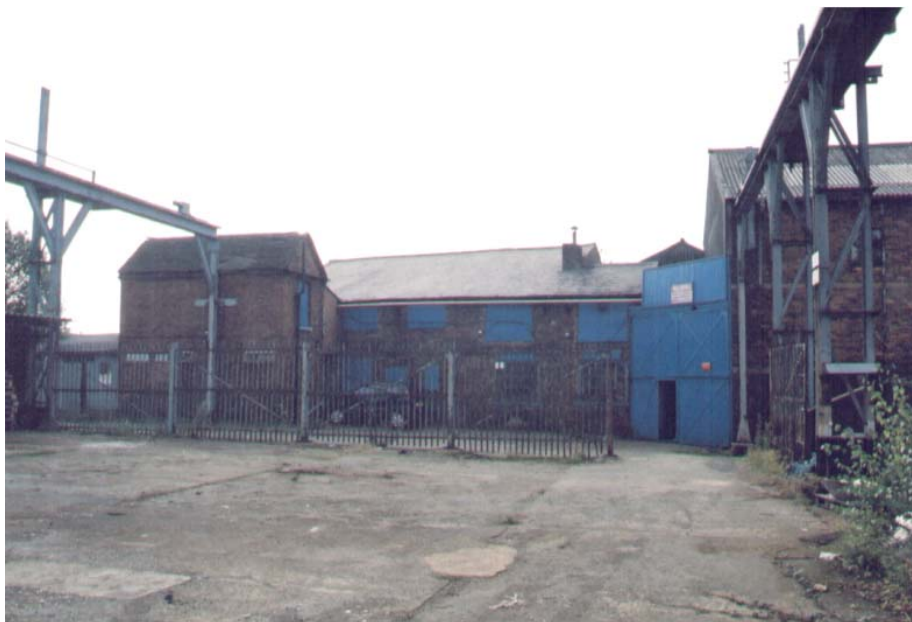
may suggest that it was designed and placed to have some sort of overseeing function within the works. Also, its location, immediately in front of Structure D and at the entrance to the main yard area, may imply that it superseded this earlier building in some sort of management function (Plate 11).

Plate 11 Eastern frontage of the complex onto Silver Street

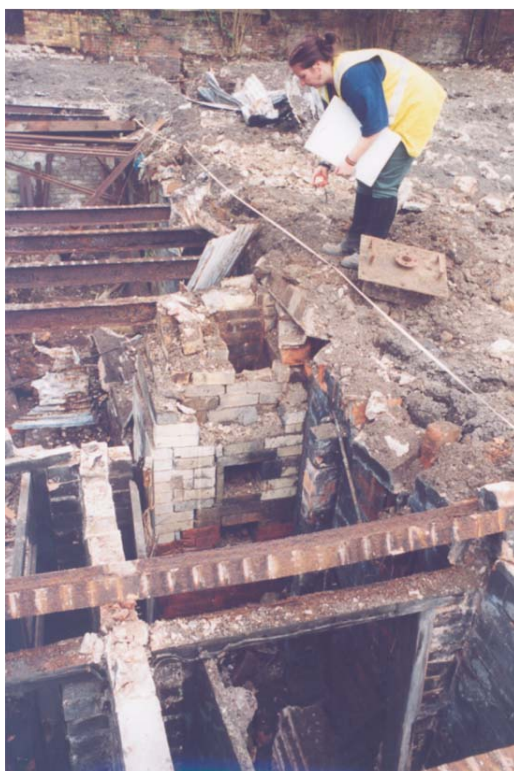
Internal features surviving *in-situ* included two toilets at the western end of the shelter that had a ventilated double door entrance. At the opposite end of the shelter, nearer to the entrance, was an electrical cabinet and control panel that probably controlled supply to the whole works, all the electric cabling was carried by metal ducting. Immediately adjacent to the toilets was a brick structure of unknown function (Plate 13). Constructed from a mixture of re-used bricks it had a total of four small openings, and may have been part of an elaborate ventilation scheme.

Plate 13 Possible brick ventilation structure in the air raid shelter (Structure P)

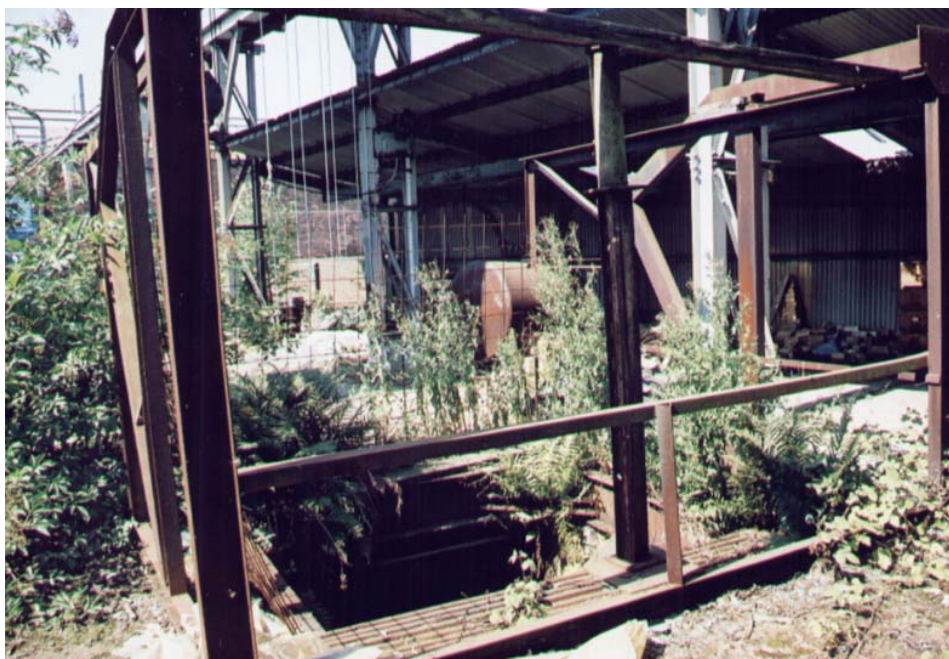
At some time in the post-war period a hole was cut through the roof in the centre of the air raid shelter (Structure P, Fig. 4), directly below the travelling crane (Structure L), and large I-beams were inserted around the opening to strengthen it. The shelter was also widened through the removal of a section of the wall, and there was a steel framed superstructure (Plate 14). Unfortunately it remains unknown what use the shelter was later put to.

Plate 14 Later opening in the air raid shelter roof showing superstructure

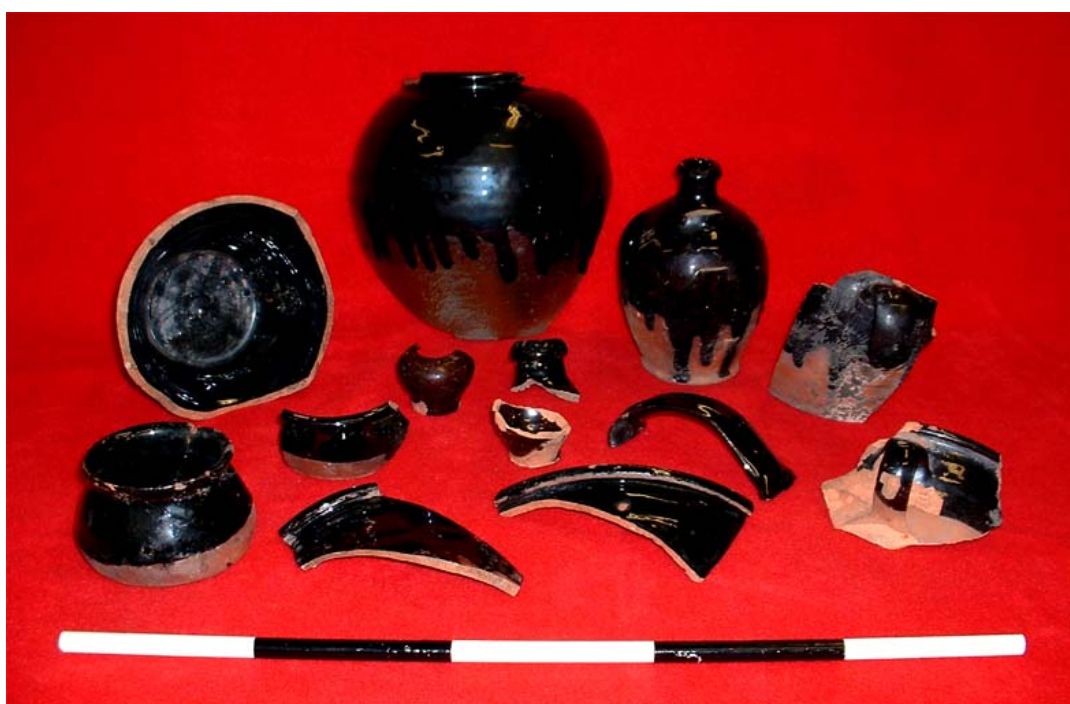
Plate 15 Sample of pottery from the potworks

The larger vessels were sometimes slipped beneath the glaze, some appeared to have an iron-rich wash beneath the glaze and sometimes a colourant had been added to the glaze. The smaller forms e.g. the hook and bead rim vessels belonged to the latter group. Most of the glazes were dark brown or black, although there were examples of mid-brown glazes (Plate 15).

8 THE POTTERY BY STEPHANIE RÁTKAI (PLATE 15)
