**Peddimore Hall Barns,
Minworth, West Midlands**

**Historic Building
Research and Recording
2006**

Project No. 1523.01
January 2007

In November 2006, Birmingham Archaeology carried out a programme of Historic Building Research and Recording at Peddimore Hall, Minworth, West Midlands (NGR SP 153 937). An identification of the historic fabric of the building was undertaken in order to inform design for a proposed conversion of the farm outbuildings to residential accommodation. The range of barns and outbuildings were phased using pre-existing architects plans, and a full photographic record of the buildings was made. The work done revealed a continuing pattern of development from the 17th-century onwards, with adaptation or addition of buildings at least once in each century. The survey found significant amount of 17th-century fabric surviving as either upstanding remains or as re-used roof timbers. It is proposed that prior to any conversion work, further work be carried out on the timber-framed elements of Buildings 4 & 7, comprising dendrochronological analysis of the timbers and a detailed survey and identification of the 17th-century components to assess the form and extent

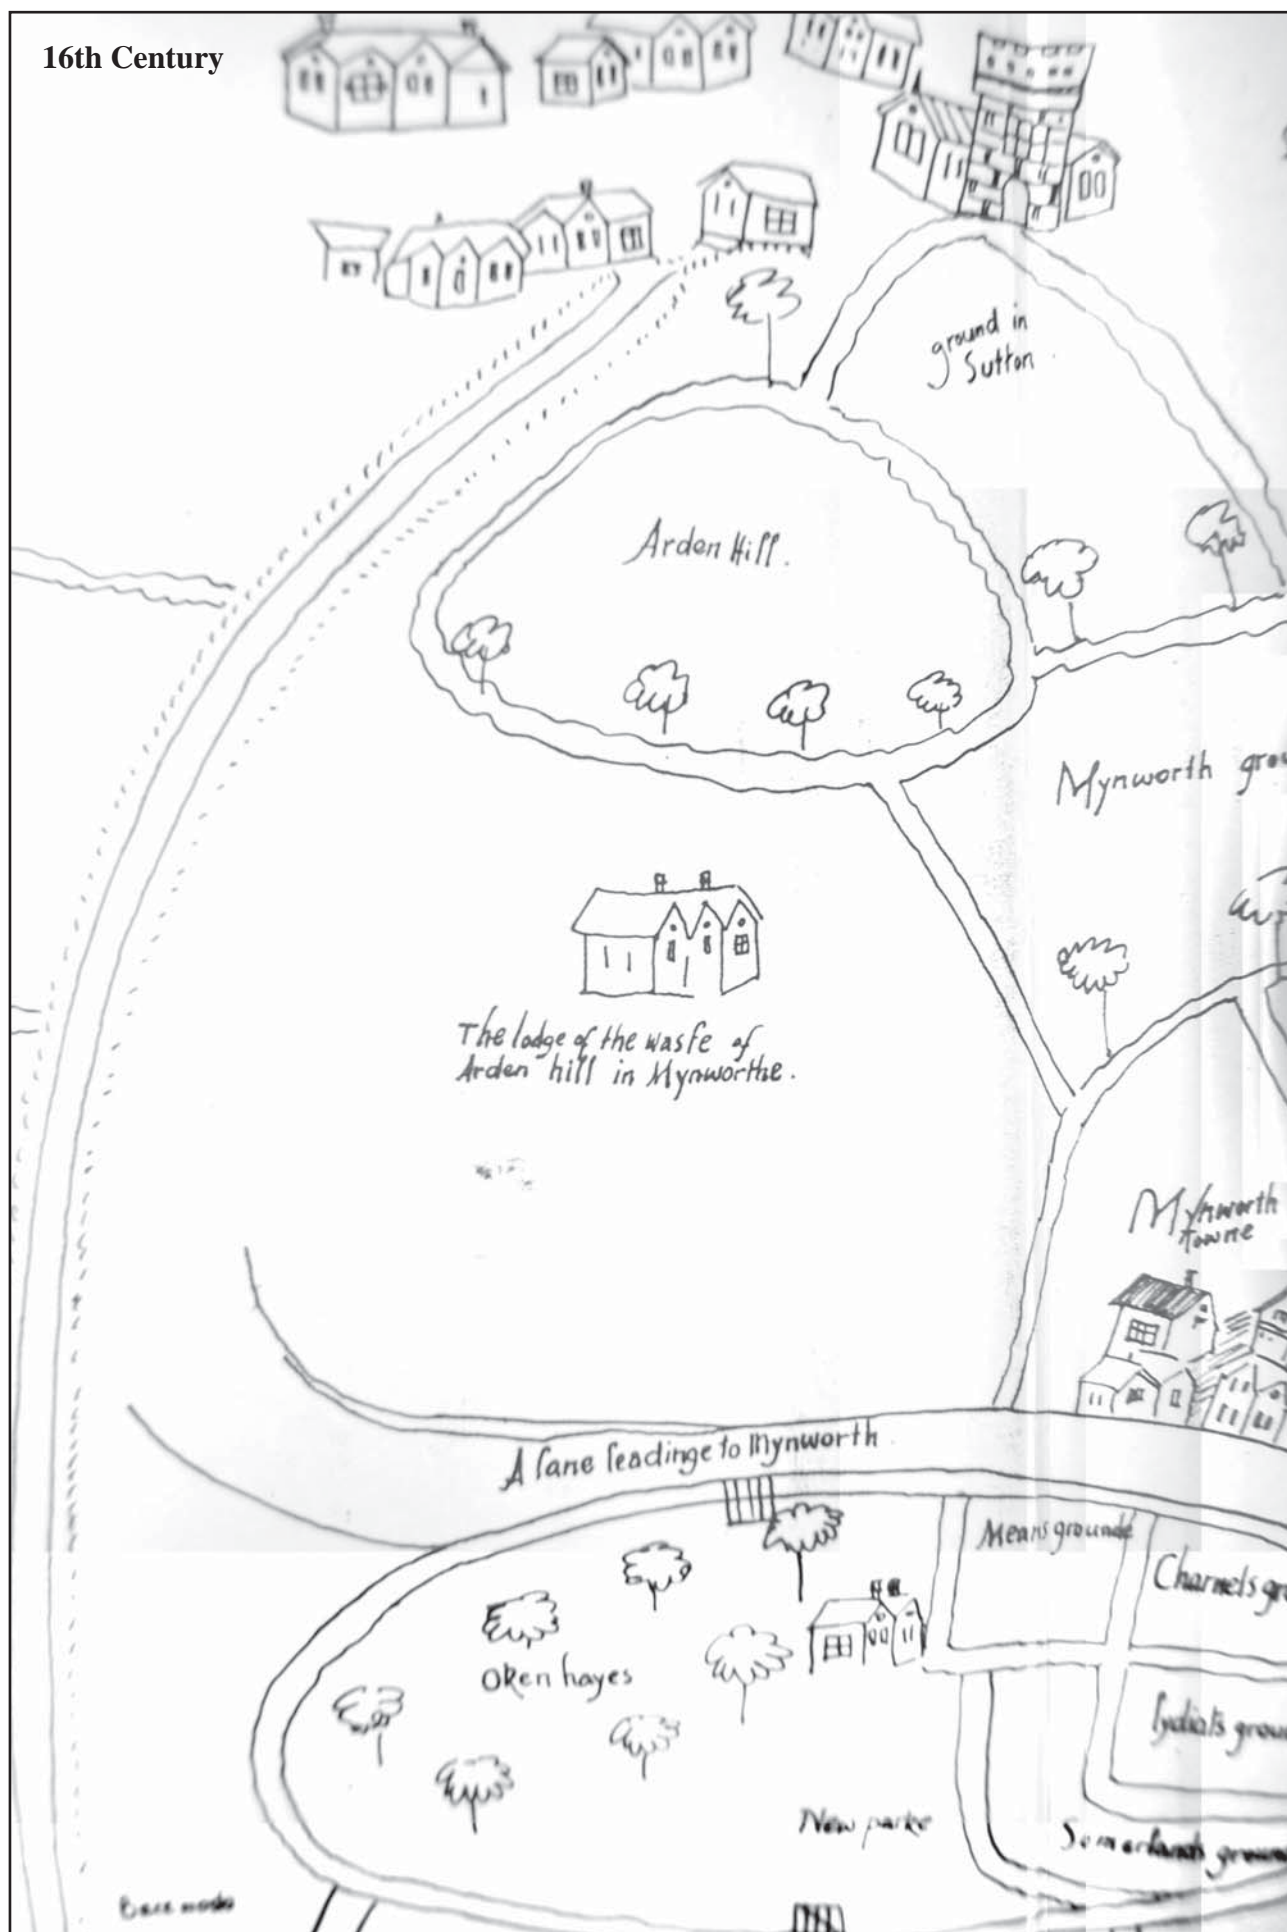
Fig.2

The earliest cartographic evidence for Peddimore Hall is from a 16th-century map of Minworth, which illustrates 'the lodge of the waste of Arden Hill in Mynworth' (Fig. 2). However, the map does not show either the moat or any associated buildings. The first map to show the associated buildings is the Corn Rent map of 1824 (Fig. 3) which depicts two main ranges built along the north and west sides of a central fold yard, and a smaller group of buildings at the southeast corner. By 1857, when the Poor Rate Valuation Map appeared, a gap on the east side of the complex had been filled so that the fold yard was entirely enclosed except for an entrance at the southwest corner. The O.S. maps of the site (Figs. 4-8) show no significant change to this pattern. A number of small blocks appear to have been added during the course of the 20th century. However, it is unclear whether these were permanent structures or merely temporary lean-tos.

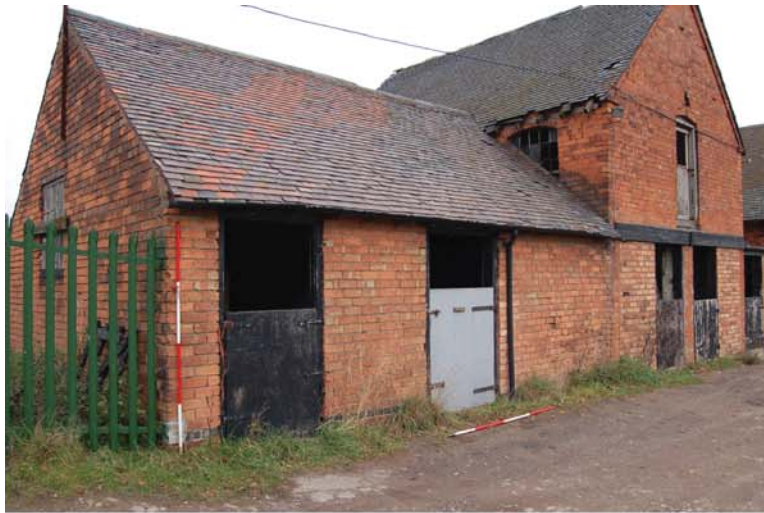
Plate 1

Single-storey 19th century stable block (Plate 1). At its east end the building abuts the west wall of Building 2, and appears to have been built as a later extension. The walls are composed of red brick (9¼"x3"x4 3/8") laid in a Flemish stretcher bond. The building has blue brick dressings, with a one-course band three courses from ground level running around the building, and blue brick sills. The interior of the building has two horse boxes, accessed from half-height stable doors on the south elevation (Plate 2). The west horsebox is narrow and lit by a window to the north of centre on the west elevation of the building. The horsebox to the east is much larger and is sub-divided by a east-west timber partition wall. A window central to the north wall of the building allows light to enter via a metal-framed fixed light (Plate 3). The two rooms appear to have originally interconnected, with a blocked up doorway with a timber lintel at the south end of the dividing wall. The floor of both rooms is composed of brick pavers sloping towards drains (Plate 4). The building has a single purlin roof supporting a tile covering. The east room has had joists inserted on top of the walls to form a low ceiling, most likely for insulation.

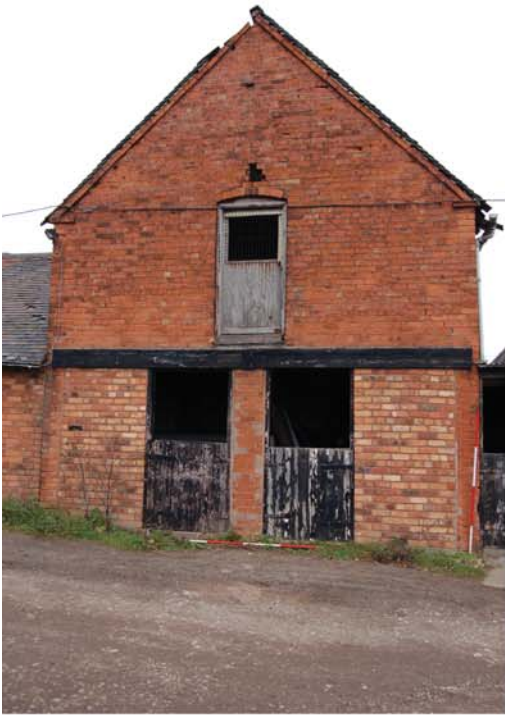
Plate 5

Two-storey 19th-century cartshed with granary above (Plate 5). Constructed from red brick (8¾"x3¼"x4¼") laid in stretcher bond with occasional headers. The south elevation has two large openings to either side of a central brick pillar with bevelled edges. These have been partially filled in with 20th-century brick (9"x3"x4½") to create a stable block (Plate 6). On the interior at ground floor level the original layout was a large open room for the accommodation of two or more farm vehicles. The room has since been subdivided by half-height walls to form four horse boxes. The central division is composed of painted breeze blocks, whilst those to either side are formed from painted brick. The east and west walls have two evenly spaced piers supporting two substantial wooden beams (9¼"x13¾") which support the joists of the room above. There is a further large beam supported on piers which supports the wall above the openings on the south wall. The piers supporting the

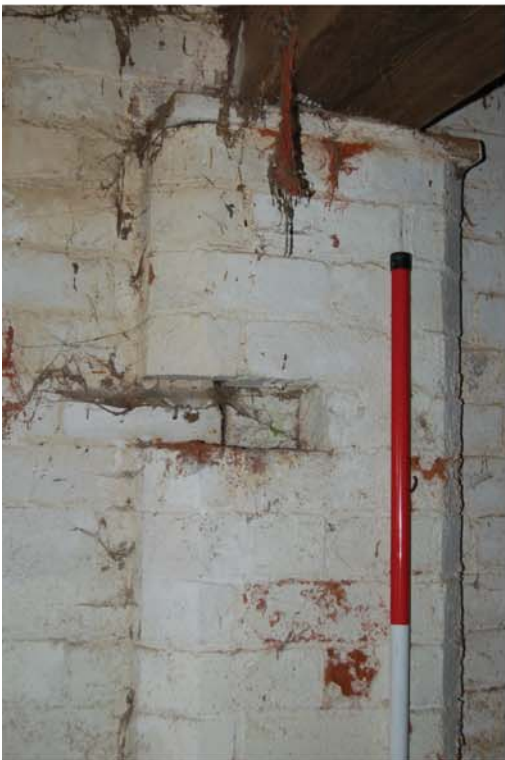
Plate 7

central beam are notched at c.1.7m height (Plate 7). On the south side of the north beam there is a metal hopper leading from the room above (Plate 8). The location of this would suggest that it was positioned above a waiting wagon, and its size would suggest that it was used to distribute grain or feed.

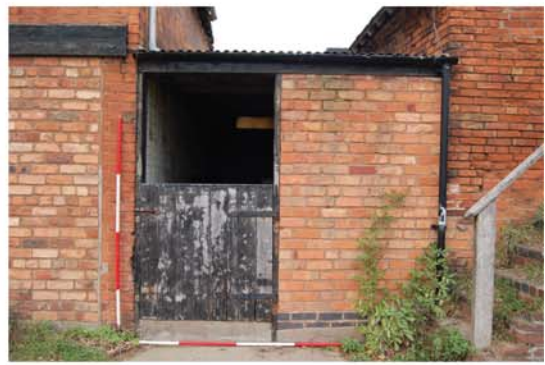
Plate 12

20th century stable block created by roofing the open space between Buildings 2 & 4 (Plate 12). The south wall is composed of 20th-century (9"x3"x4½") laid in stretcher bond, with a doorway at the west end. The north wall is composed of corrugated metal sheeting with a small window at its top. The interior of the building is painted brick with an inserted half-height partition halfway into the room, creating a horse box (Plate 13). The roof is composed of corrugated iron sheets supported by joists running east-west, resting on planks which have been nailed to the exterior walls of Buildings 2 & 4. Building 3 was surveyed as part of the wider collection of buildings but appears to be of no special interest.

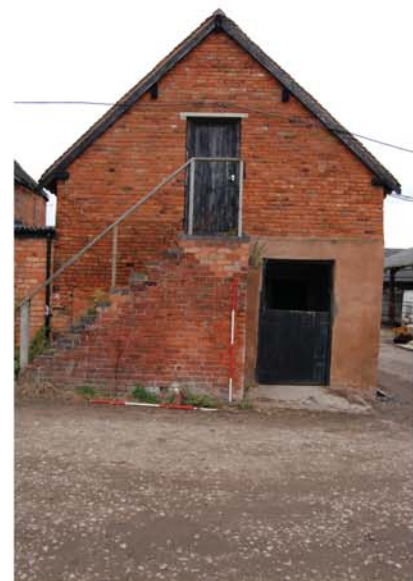
Plate 14

Building 4 is a one-storey 18th-century stable-block with an attic room above (Plate 14). The building is composed of red bricks (8¾"x2¼"x4¼") laid in a variation of English garden wall bond. At ground floor level the southeast corner of the building is covered by a plain render. The roof of the building is covered by red/brown tiles .

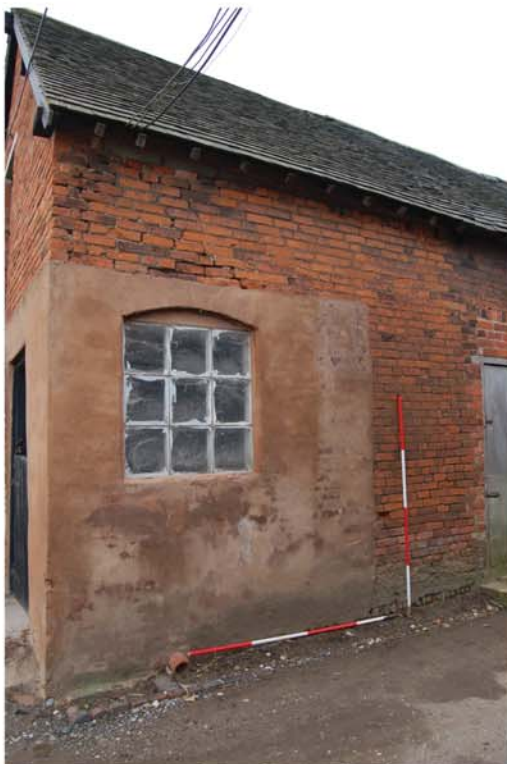
Plate 17

The east elevation co-joins the east elevation of Building 7 at its north end. The relationship between Buildings 4 & 7 is unclear, there appears to be a construction break between the two sections, although this may be due to the placement of Building 7 over the remains of an earlier building. At ground level, the building sits on a row of red brick headers, the wall above is laid in an irregular bond. The south end of the elevation at ground floor level is covered by a layer of render, containing a segmental-arched metal-framed, multi-pane window (Plate 17).

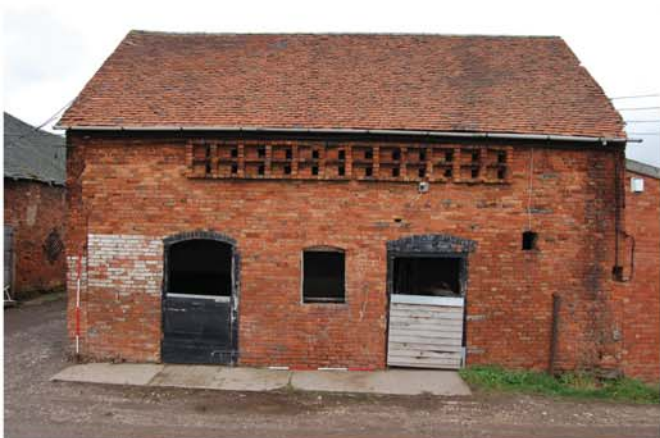
Plate 21

18th-century stables with dovecote and hayloft above (Plate 21). At ground level the building rests on a row of squared sandstone blocks, of identical character to those which lie at the base of the wall of Building 7 (Plates 22 & 23). This would appear to suggest that Building 5, like Building 7, may have been built on the sandstone footings of an earlier building, most likely a timber-framed barn. The sandstone blocks appear too well shaped for sill stones, and may have been re-used from an earlier medieval building. The remainder of the building is composed of red brick (9"x2½"x4¼") laid in English garden wall bond with blue brick dressings.

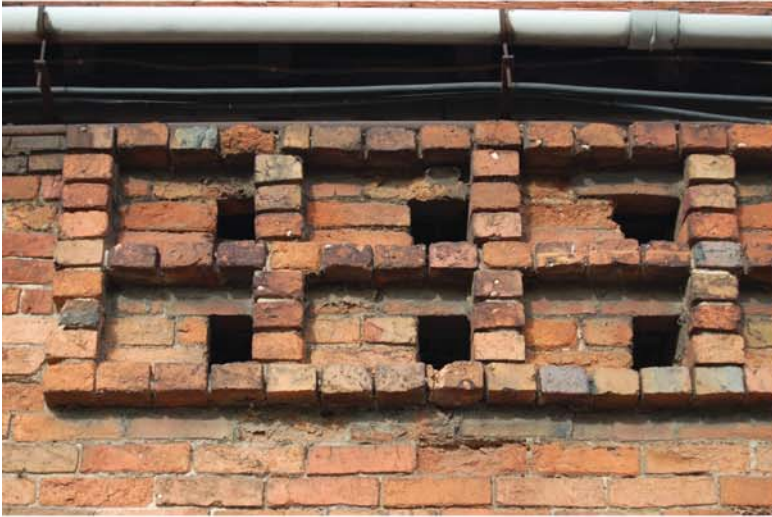
Plate 25

The south elevation of the building has a segmental-arched doorway in its western portion leading through to a loose box. To the east of this is a further doorway leading through to a pair of loose boxes, the doorway has been reduced from its original size. Between the two doorways is an unglazed segmental-arched window. To the east of the doorways is a small segmental-arched owl-hole (Plate 24). At first floor level the building has a dovecote built into the south elevation, comprising a set of twenty-four nesting boxes, with a ledge and hood composed of a projecting course of brick headers (Plate 25).

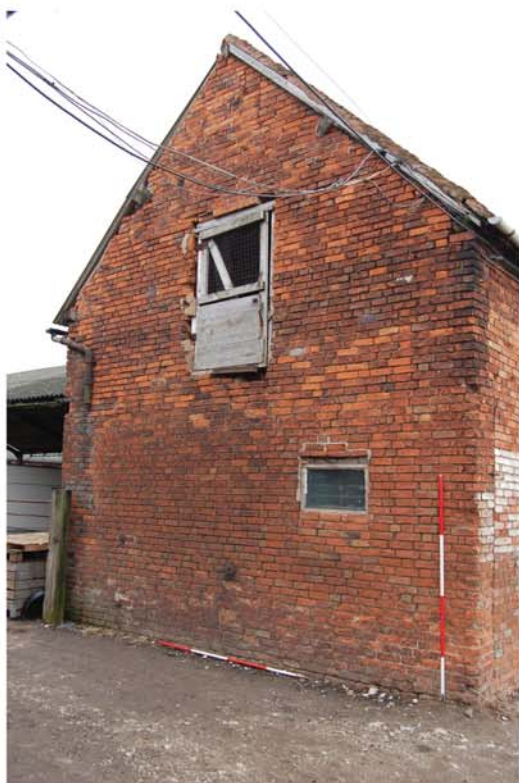
Plate 27

The west elevation of the building (Plate 27) has a short window at ground floor level towards its south end. This has a wooden frame and has been roughly inserted into the brickwork. To the north of the window, at various heights, are three wall ties (Plate 28). The presence of additional support to this portion of wall may indicate that the lower portion of the elevation represents an earlier wall incorporated into the structure. At first floor level the elevation has a central doorway, again roughly inserted into the brickwork, leading through to the attic room. Above this the wall is badly finished and in some areas rebuilt, suggesting the building has been re-roofed. The current roof structure is supported on a single purlin, and a timber wall-plate, both of which appear to have been crudely inserted into the wall.

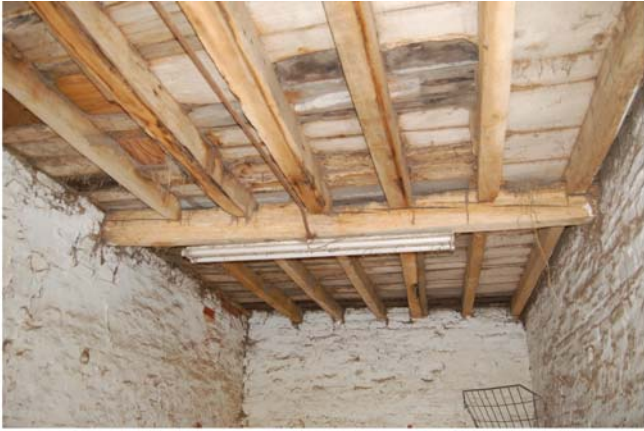
Plate 29

The interior of the building at ground floor level is divided between a narrow stable at the west end of the building, and a larger stable, split into two loose boxes at the east end of the building. The interior walls are of painted brick. The western room has a concrete floor, whilst that to the east is floored with brick pavers. The ceiling of both rooms is supported by a substantial timber beam running east-west through the building, supporting the joists of the first floor room (Plate 29).

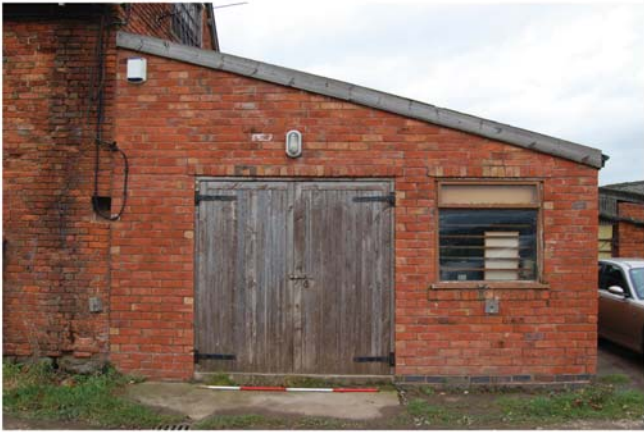
Plate 31

20th-century workshop/garage, built as a lean-to onto the east elevation of Building 5 (Plate 31). The walls are composed of red brick (9¼"x3"x4½") laid in stretcher bond, the roof above is corrugated sheets. The south elevation has a large set of double doors to the west of centre, with a window to the east. Both have lintels composed of brick headers. The east elevation of the building has a doorway leading through to the interior. Like Building 3, Building 6 was surveyed as part of the wider group of buildings, but is of no special interest.

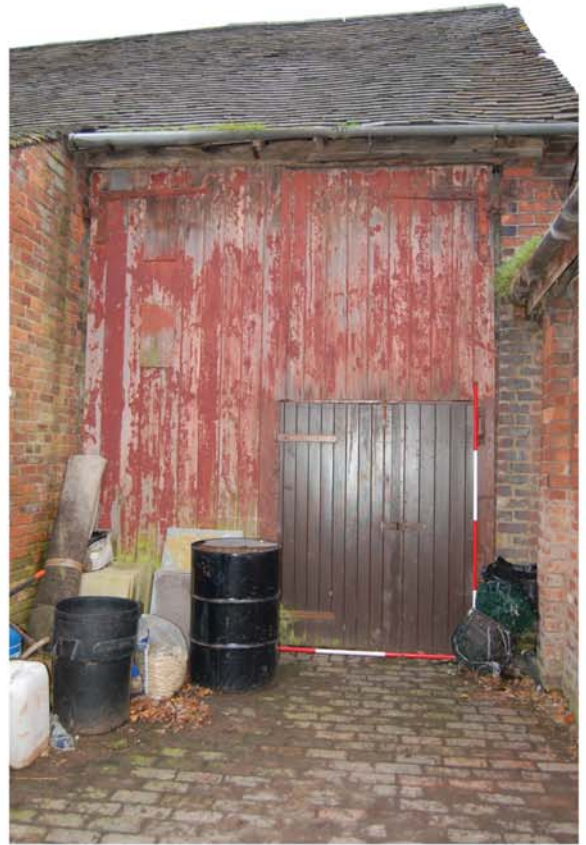
Plate 36

The east elevation of the building joins the east elevation of Building 4 at its south end (See 6.4 above). At the west end of the building there is a doorway through to the interior. This has been inserted into the brickwork directly below an earlier opening, the position of which is recognisable from a row of headers several courses above the doorway. Directly to the north of the doorway the elevation sits upon a row of shaped sandstone blocks at ground level, which run northwards until the south side of the main doorway (Plate 33). Above this there is a large diamond shaped air-vent seventeen course high, which has been blocked up on the interior (Plate 34). These were originally placed in the walls of barns to allow the air to circulate, preventing the interior from becoming mouldy (Peters 1981, p15). To the north of this there is an inserted narrow window with a tile sill and a timber lintel. To the north of this is an inserted doorway, reached by two brick built steps, with a plain timber frame surround. The insertion of the doorway has partially blocked a smaller diamond-shaped air-vent five courses high, directly to the north of the doorway. A large pair of central doors lie to the north of this, and rise from ground level upwards to the roof (Plate 35). This appears to be the original entrance to the threshing floor. The doorway is supported by brick piers on either side, the upper hinges of the door are supported on original sandstone hinge blocks. The lower hinge blocks have been replaced by brickwork. Directly to the north of the north pier, Building 8 protrudes forward from the main elevation. To the north of Building 8, Building 9 runs east-west. Between the two blocks are a large set of wooden doors leading into Building 7 (Plate 36).

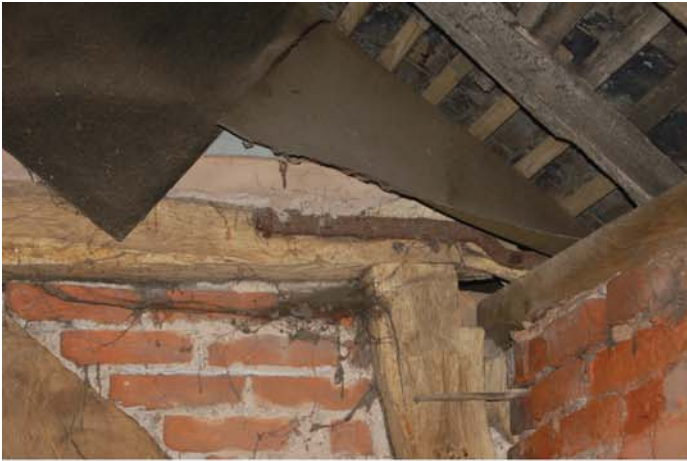
Plate 39

The interior of Building 7 was originally one large open space, reflecting its use as a threshing barn. Room G1 has been bricked off to first floor height, and is accessed via the doorway on the east elevation, and through the ground floor room in Building 4. The function of the room appears to have been for the preparation of feed. The north wall has a small central projecting chimney breast. The south wall of the room is formed from the other side of the timber-frame, which forms the north wall of Building 4 (See Section 6.4 above). The timber-frame tilts backwards at the top of the wall towards the south, the nogging has clearly been built to accommodate this, suggesting that the nogging is a later addition, most likely dating to the 18th-century rebuild of the barn (Plate 37). From G2, the timber-framing is visible above the level of this south room (Plate 38), the west wall-post is joined to the tie-beam by means of a large iron strap (Plate 39).

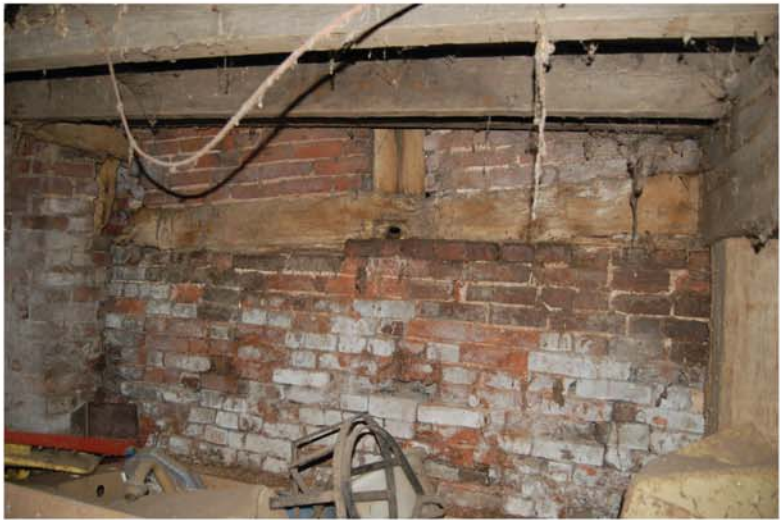
Plate 41

G2 has been separated from the rest of the barn by a 20th-century timber partition to the north, and the single-storey brick wall to the south. A large amount of the interior is taken up by single-storey 20th-century workshop, the interior of which was not seen. The roof of the room is composed of king-post trusses. The north truss, lying directly above the north partition wall, appears to be an earlier re-used truss, possibly from the earlier timber-framed barn, as it has mortice slots with peg holes on its soffit (Plate 40). The truss has a large central king-post with curved braces tenoned into the tie-beam, but lapped and pegged onto the principal rafters. The south truss is a bodged collection of re-used timbers resting upon the north wall of G1 (Plate 41). Above the trusses, several of the purlins appear to be re-used from an earlier structure.

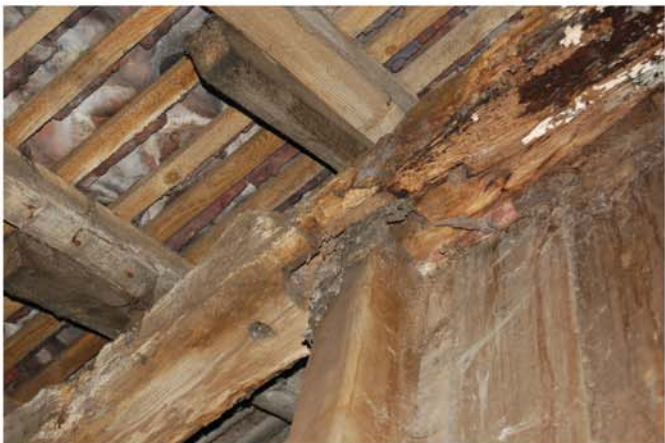
Plate 43

To the north of this lies G4. G4 is perhaps the most altered portion of the barn. The east wall has been removed with the addition of Building 8 in the 19th century. The room has been partitioned from those to the north and south and a first floor level added, supported on brick piers of nineteenth century date. The north half of the west wall is composed of timber-framing (Plate 42). It was not possible to conduct a full inspection of the timber-framing, as the exterior of this portion of the elevation was obscured, and the first floor level of G4 was not accessed. However, an earlier inspection of the building (Fentiman 1985) includes a sketch of the exterior of this portion and shows a greatly similar timber-frame pattern to that of the south wall of G1. This may represent another frame of the earlier timber-framed barn, or a portion of another timber-framed building. The roof of this portion of the room again contains large amounts of re-used timber from an earlier timber-framed building (Plate 43).

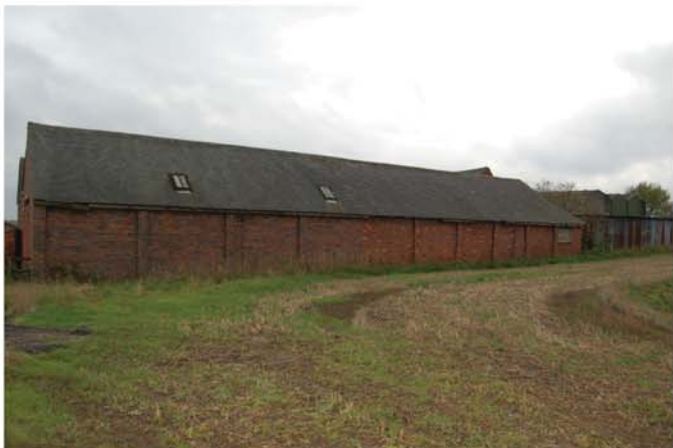
Plate 44

19th-century cowshed (Plate 44). The building is constructed from high-quality red brick laid in Flemish stretcher bond. The doors and windows have two-ring rough segmental arches, and the windows have bullnosed brick sills (Plate 45). The main range of the building runs east-west, and is subdivided into four stables of differing size. A drainage channel runs the length of the building at the south end. The eastern room has a large set of doors on the east elevation, and may also have functioned as a coach-house. A small one-cell block protrudes from the south side of the building at the east end. This appears to have been a tap room to provide water for the animals. The roof of the building is supported on large 19th-century king post trusses (Plate 46). At the west end of the building the roof turns through 90° to join the roof of Building 7.

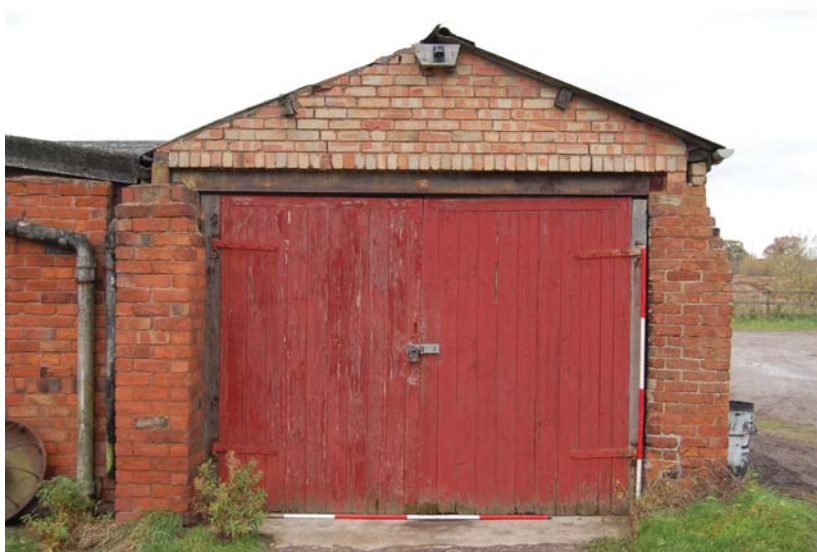
Plate 47

Building 10 is not really a building, but rather a shed constructed from two parallel walls (Plate 47). These both appear to be of 19th-century character, but are from two distinct structures. The wall to the west was originally much lower, and has been raised to the same level as the east wall by the addition of several courses of modern brick (Plate 48). The supporting piers for the wall are on the interior of the building. The wall appears to have been the east wall of the low building marked on earlier O.S. maps, and from its height was most likely a piggery. The east wall of the building may originally have been a boundary wall to the farmyard. It is supported by piers on its exterior, two of which are 20th-century additions, of the same period as the north wall of the building. The wall has a bricked up opening at its south end, and an inserted window at its north end.
