FORMER SOHO GLASSWORKS,
LODGE ROAD, WINSON GREEN,
BIRMINGHAM, WEST MIDLANDS

Historic Building Record and
Archaeological Evaluation,
February 2008

Project No. 1753

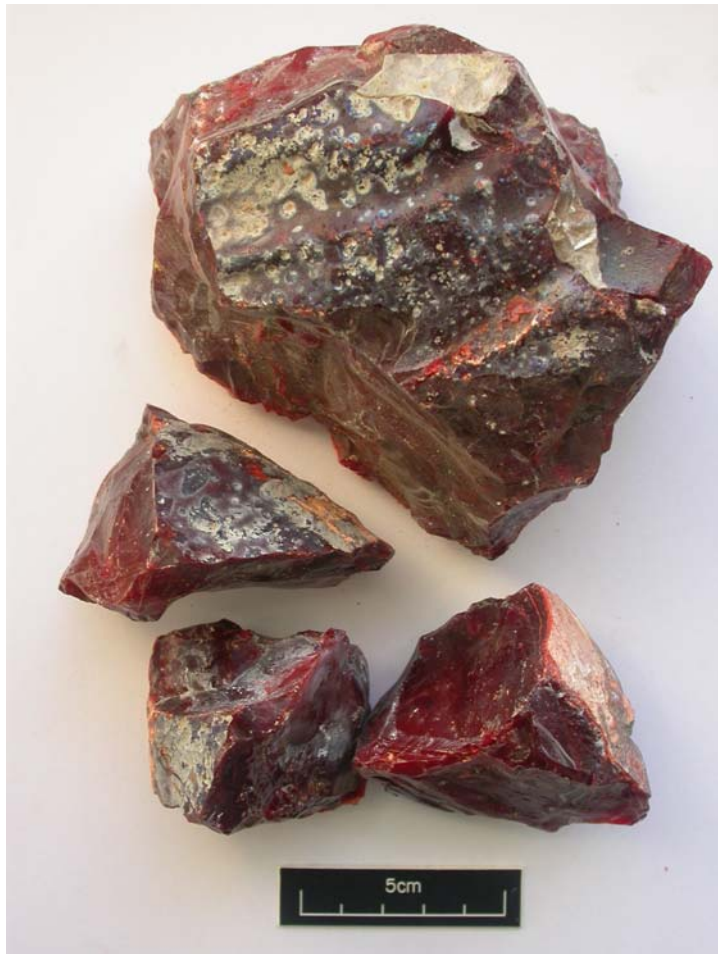
Figure 5. Lump of red glass

The large lump of red glass (#02) has a composition which is unparalleled among samples recovered from archaeological excavations of historic glasshouses. It contains much higher levels of soda than are normally seen and appears to be deficient in stabiliser oxides (in most glasses the stabilisers are MgO, CaO and/or PbO). The zinc (ZnO) in this sample may have helped to give the glass some stability. The red colour of this glass appears to be due to the presence of cadmium and selenium. The use of these oxides as colourants in glass is not known to have been common before the beginning of the 20th century.

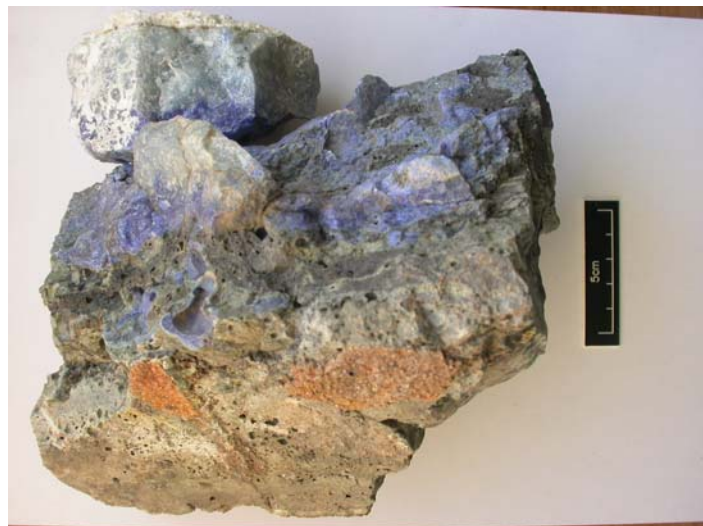
Figure 6. Samples 1a (bottom) and 1b (top)

Samples 1 and 7 appear to be fragments of furnace bricks, coated and/or impregnated with glass. These samples contain a wide range of oxides, some of which derive from the refractory clays used to manufacture furnace bricks and some of which certainly derive from the glass(es) melted.

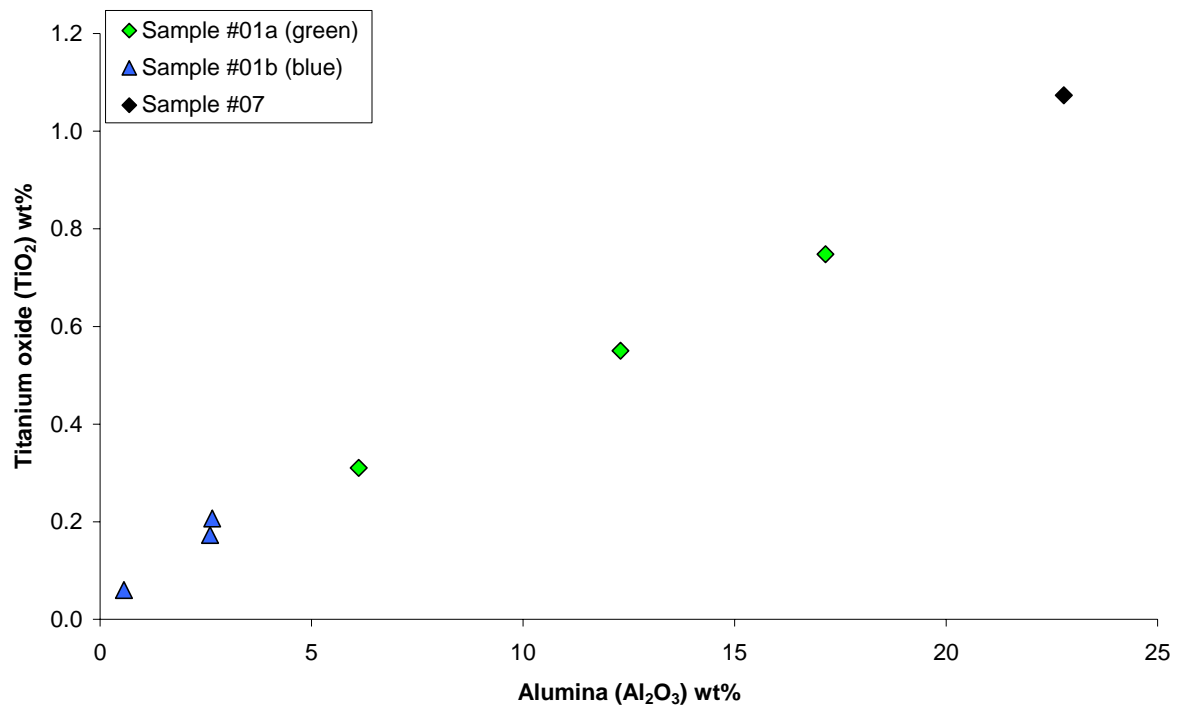
Figure 7. Alumina and titanium oxide content of samples 1 and 7

Oxides that are usually associated with refractory clays are strongly correlated in these samples (Figure 7). The other oxides present in these samples, which are likely to derive from the glasses melted, are numerous (including soda, potash, lime and lead oxide) and may not relate to a single glass type produced on this site. These oxides may have derived from multiple spillages of several different types of glass. The microstructures of both sample #01a and #01b are varied and

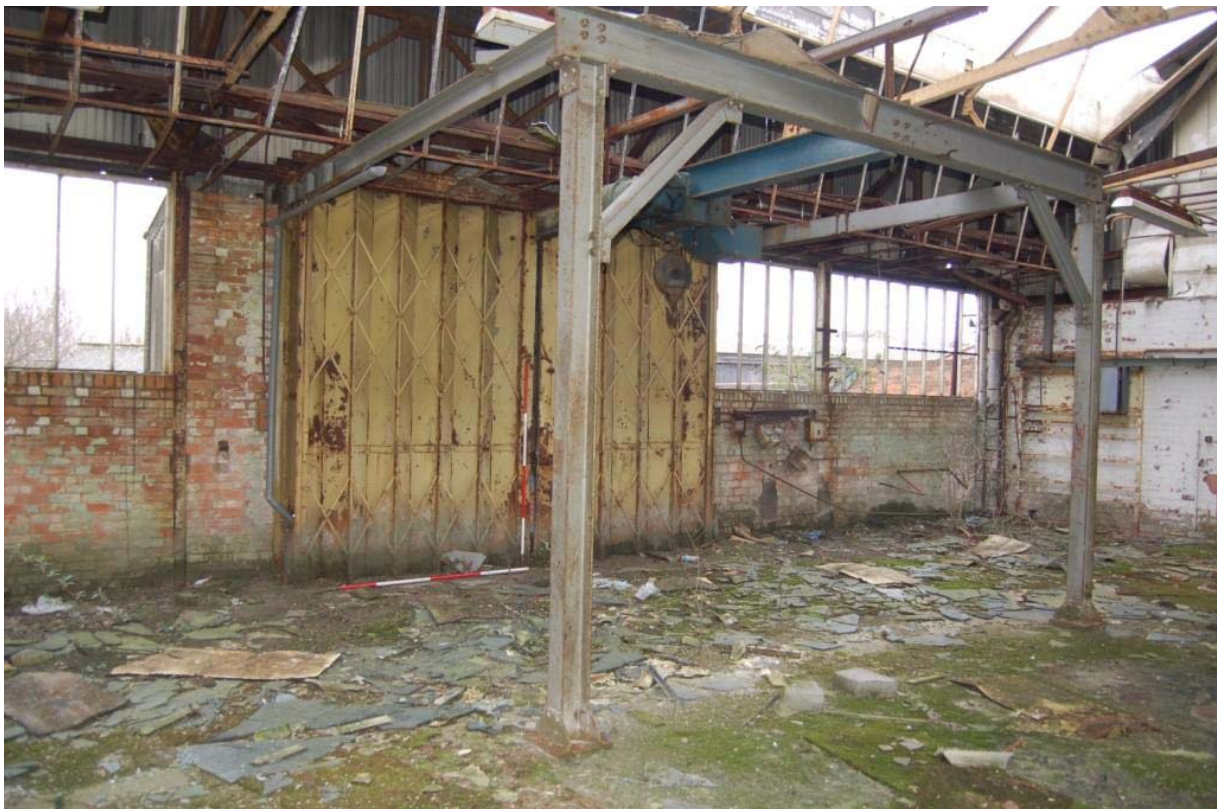
Plate 41: Building G, first floor (E); hoist mechanism

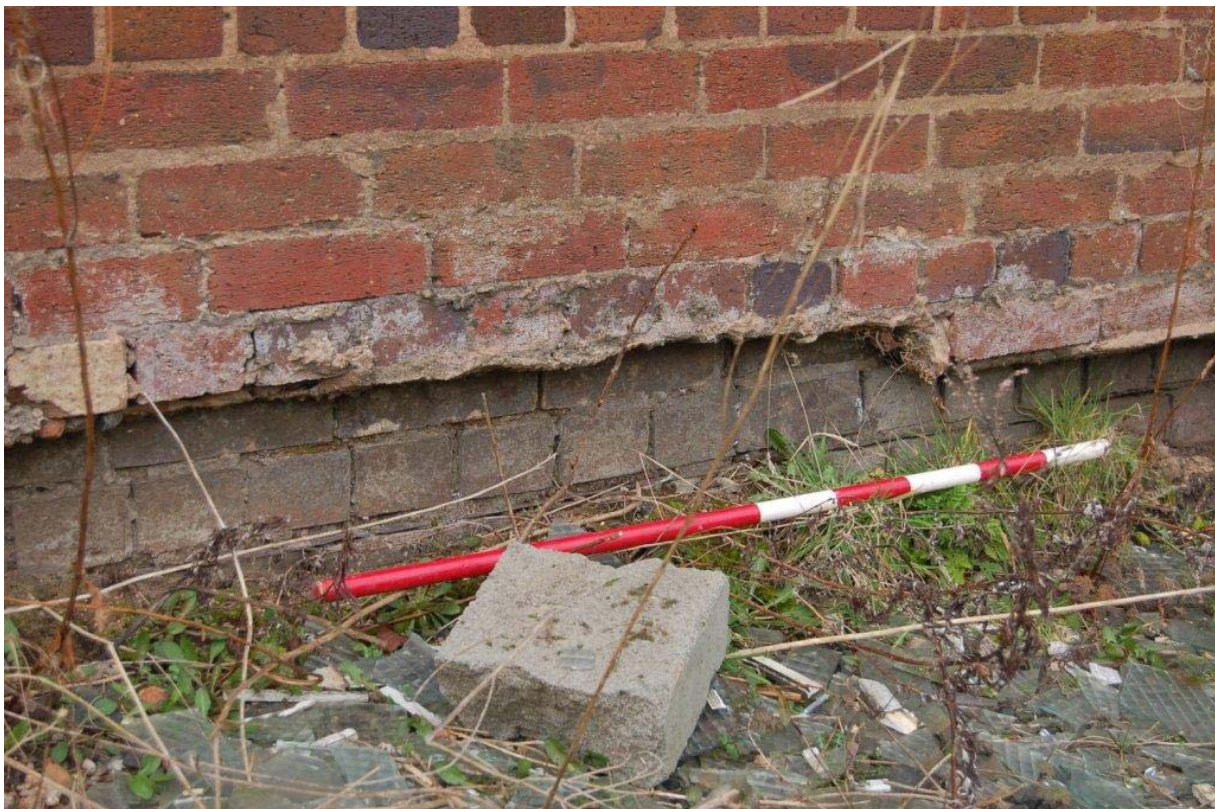
Plate 43: Building H, east elevation; (early ? C19th) English bond brickwork exposed at base of wall.

Building H is difficult to date precisely in its present form; as noted above the line of the eastern elevation reflects a historic alignment, evident on the earliest plans of the glassworks, and the southern section at least of the present building would appear to be enclosed by the time of the Ordnance Survey 1st edition of 1889. The block plan accompanying design proposals of 1930 (Figure 10) suggest an open yard area and coal bunkers associated with the small glass house occupying the northern part of the building footprint, though this is shown to be enclosed by the time of design proposals of 1934 (Figure 12). This secondary glass house would have been constructed to the modern standards of the day within a roofed building rather than a glasshouse cone and it is likely to have been gas rather than coal fired. It is apparent that the eastern, exterior wall was rebuilt/ refaced during the radical, early 1950s reordering of the site.

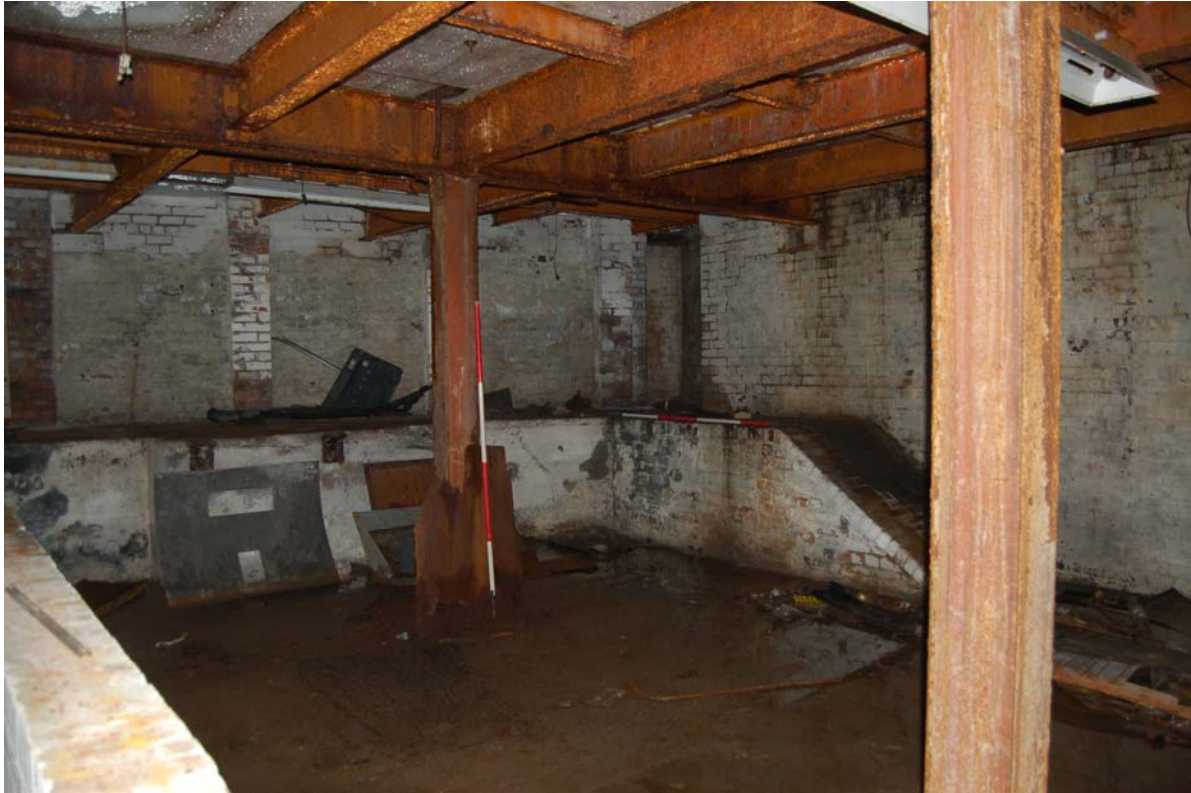
Plate 66: Tunnel complex beneath building H, Area H1, looking south

The principle central room (Area H1) was orientated northwest to southeast and included the current main access comprising an open, corroded stairway with a handrail made up of tubular steel. There were steps leading to a raised platform area on the northeastern side of the room, a scar on the wall suggesting these had replaced a shallow ramp. There was a steep ramp on the opposing side of the room (Plate 66). A blocked semi-circular arch was identified on the base of the southern facing elevation (Plate 65). This was likely to be a blocked airway leading to one of the glass furnaces.

The roof of this area was in the form of flat roofing of a concrete construction supported on transverse RSJs and carried by RSCs, contemporary with the construction of the 20th century steel framed Building H above. The RSC foundations of which had been sunk through the cellar at various intervals.

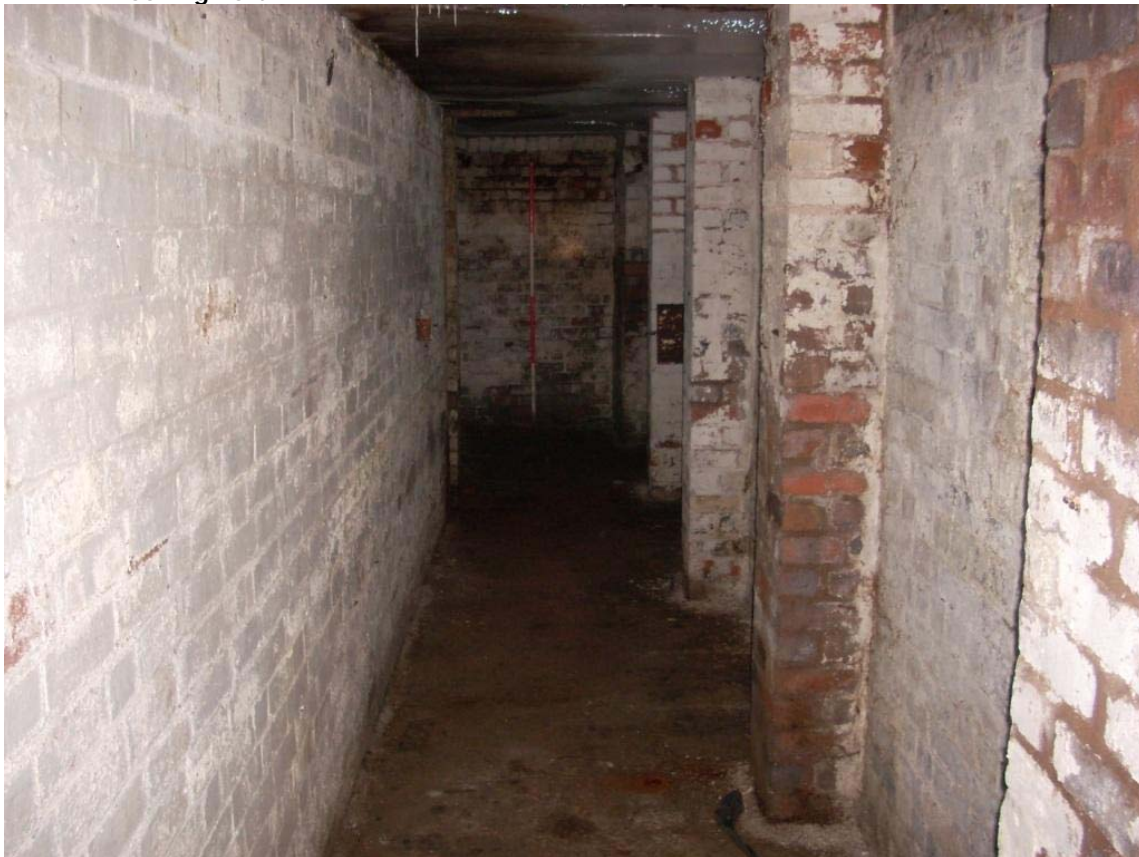
Plate 70: Tunnel complex beneath building H, Corridor H5, looking northeast

Corridor H5 was orientated northeast to southwest and was directly linked to areas H1 and H4. The location of corridor H5 was adjacent to the former Soho branch of the canal which suggests the raw materials were being off loaded from the barges and barrowed directly to the centre of the glass cones. The principle central room would be the logical location for the storage of these materials. Regular brick column projections were noted along the southern elevation of this corridor (Plate 70). This tunnel is likely to have fed the '*small glass house*' constructed between 1855 and 1889. The date of this tunnel was therefore slightly later than that beneath the main glass cone.

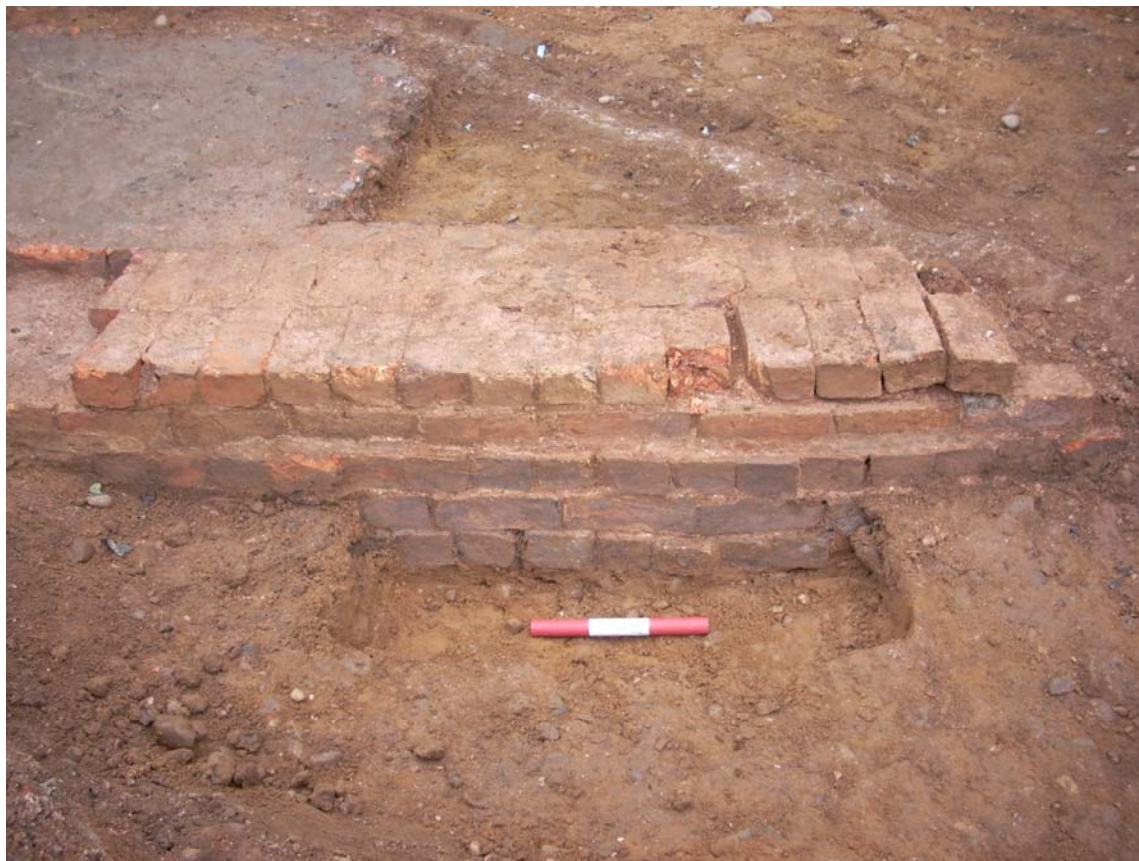
Plate 73: Trench 2, glass-cone foundations, looking south

The truncated foundations of the circular glass cone, along with the remains of a building extension attached to its exterior were exposed in Trench 2. The identified remains are likely to represent two phases of construction from this early-19th century period. A series of brick floor surfaces constructed over the early-19th to 20th century periods, were exposed in Trenches 3 and 4. These represent the remains of workshop buildings likely to have housed the glass finishing processes. Further structural evidence, of 19th to 20th century origin, was identified within Trench 5.
