## 2.8 Prim Gap

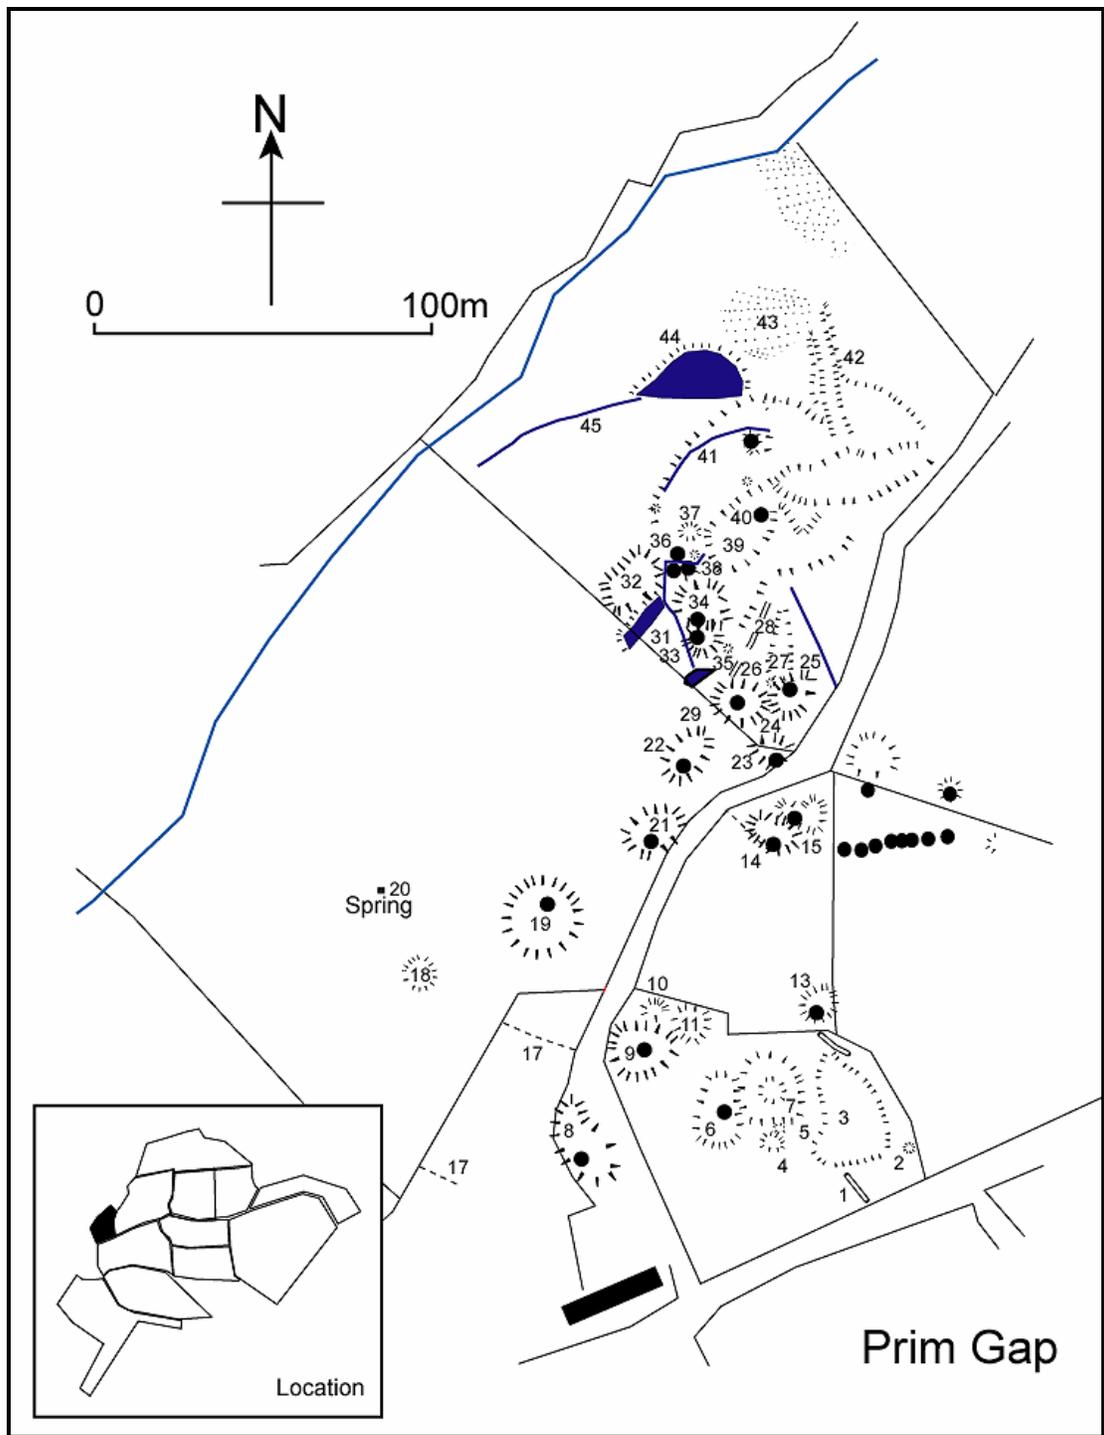
Fig.36 Prim Gap

This compact area sits on gently sloping ground either side of a footpath running from the main road to Stripe Lane. Features in this area mark the western edge of the mineralisation.

The first group of features at the south of the area are a series of shafts associated with the end of the Prim Gap Vein. A shallow quarry like feature 3 may also be connected with working this vein. Shafts 6, 8, and 19 have flat tops and an off centre shaft suggesting the use of a horse gin, but as with other area no evidence remains. Moving north 14 and 15 are closely spaced shaft mounds typical of meer working, the line of which continues through the boundary.

The main area of activity is within the northern most enclosure and consists of a number of shafts and large opencuts where the topography drops off. Associated is a large dam and two distinct ore dressing areas. The main open cut 39 is a large open fronted trench on two levels, which suggests two phases of operation. The sides of the trench are marked by large spoil heaps, the scale of which may suggest a modern origin, although there is currently no evidence of the use of mechanised plant. The foot of the trench is cut by a smaller feature 42, which has probably been excavated by hand and may be contemporary with the higher part of 39.
