# KENTMERE HORSESHOE, LAKE DISTRICT NATIONAL PARK, CUMBRIA

Archaeological Evaluation

Client: Lake District National  
Park Authority  
NGR: NY 4325 0911

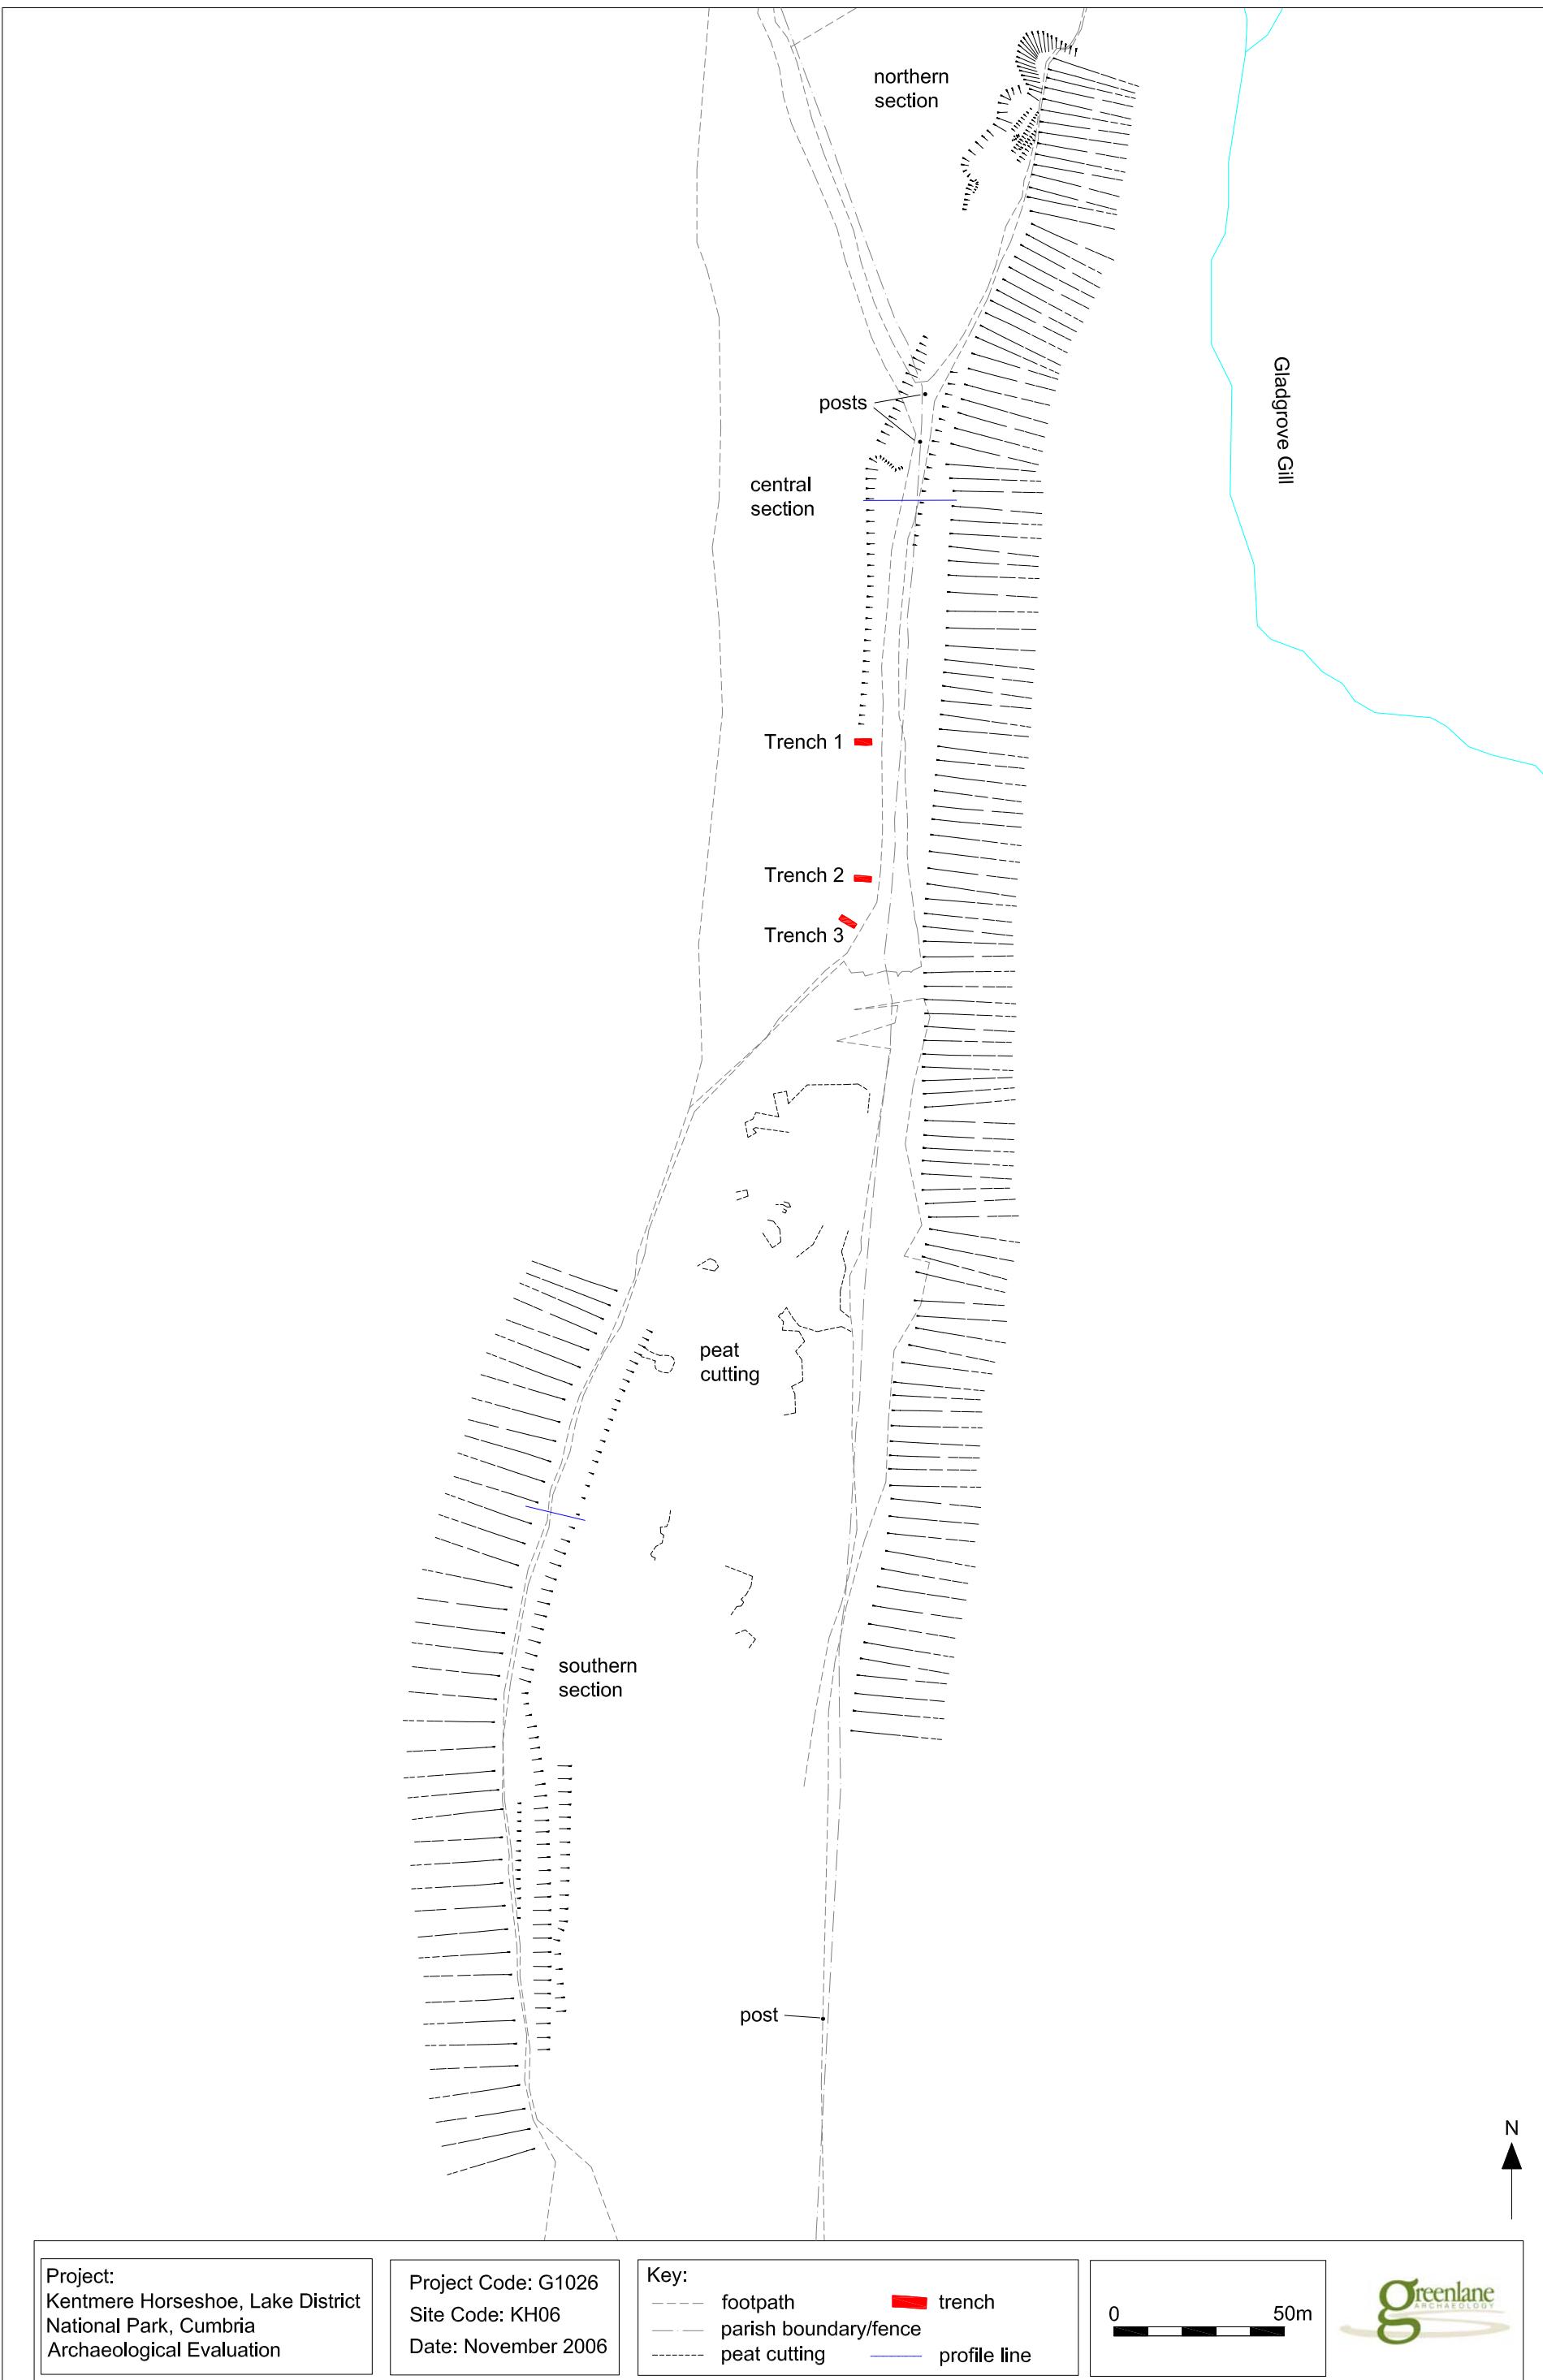
Figure 3: Plan of earthwork features

4.2.1 The earthworks along the line of the Roman road were found to be in three distinct groups, as identified during the site visit (see Section 4.1, above), and have been described below as northern, central and southern.

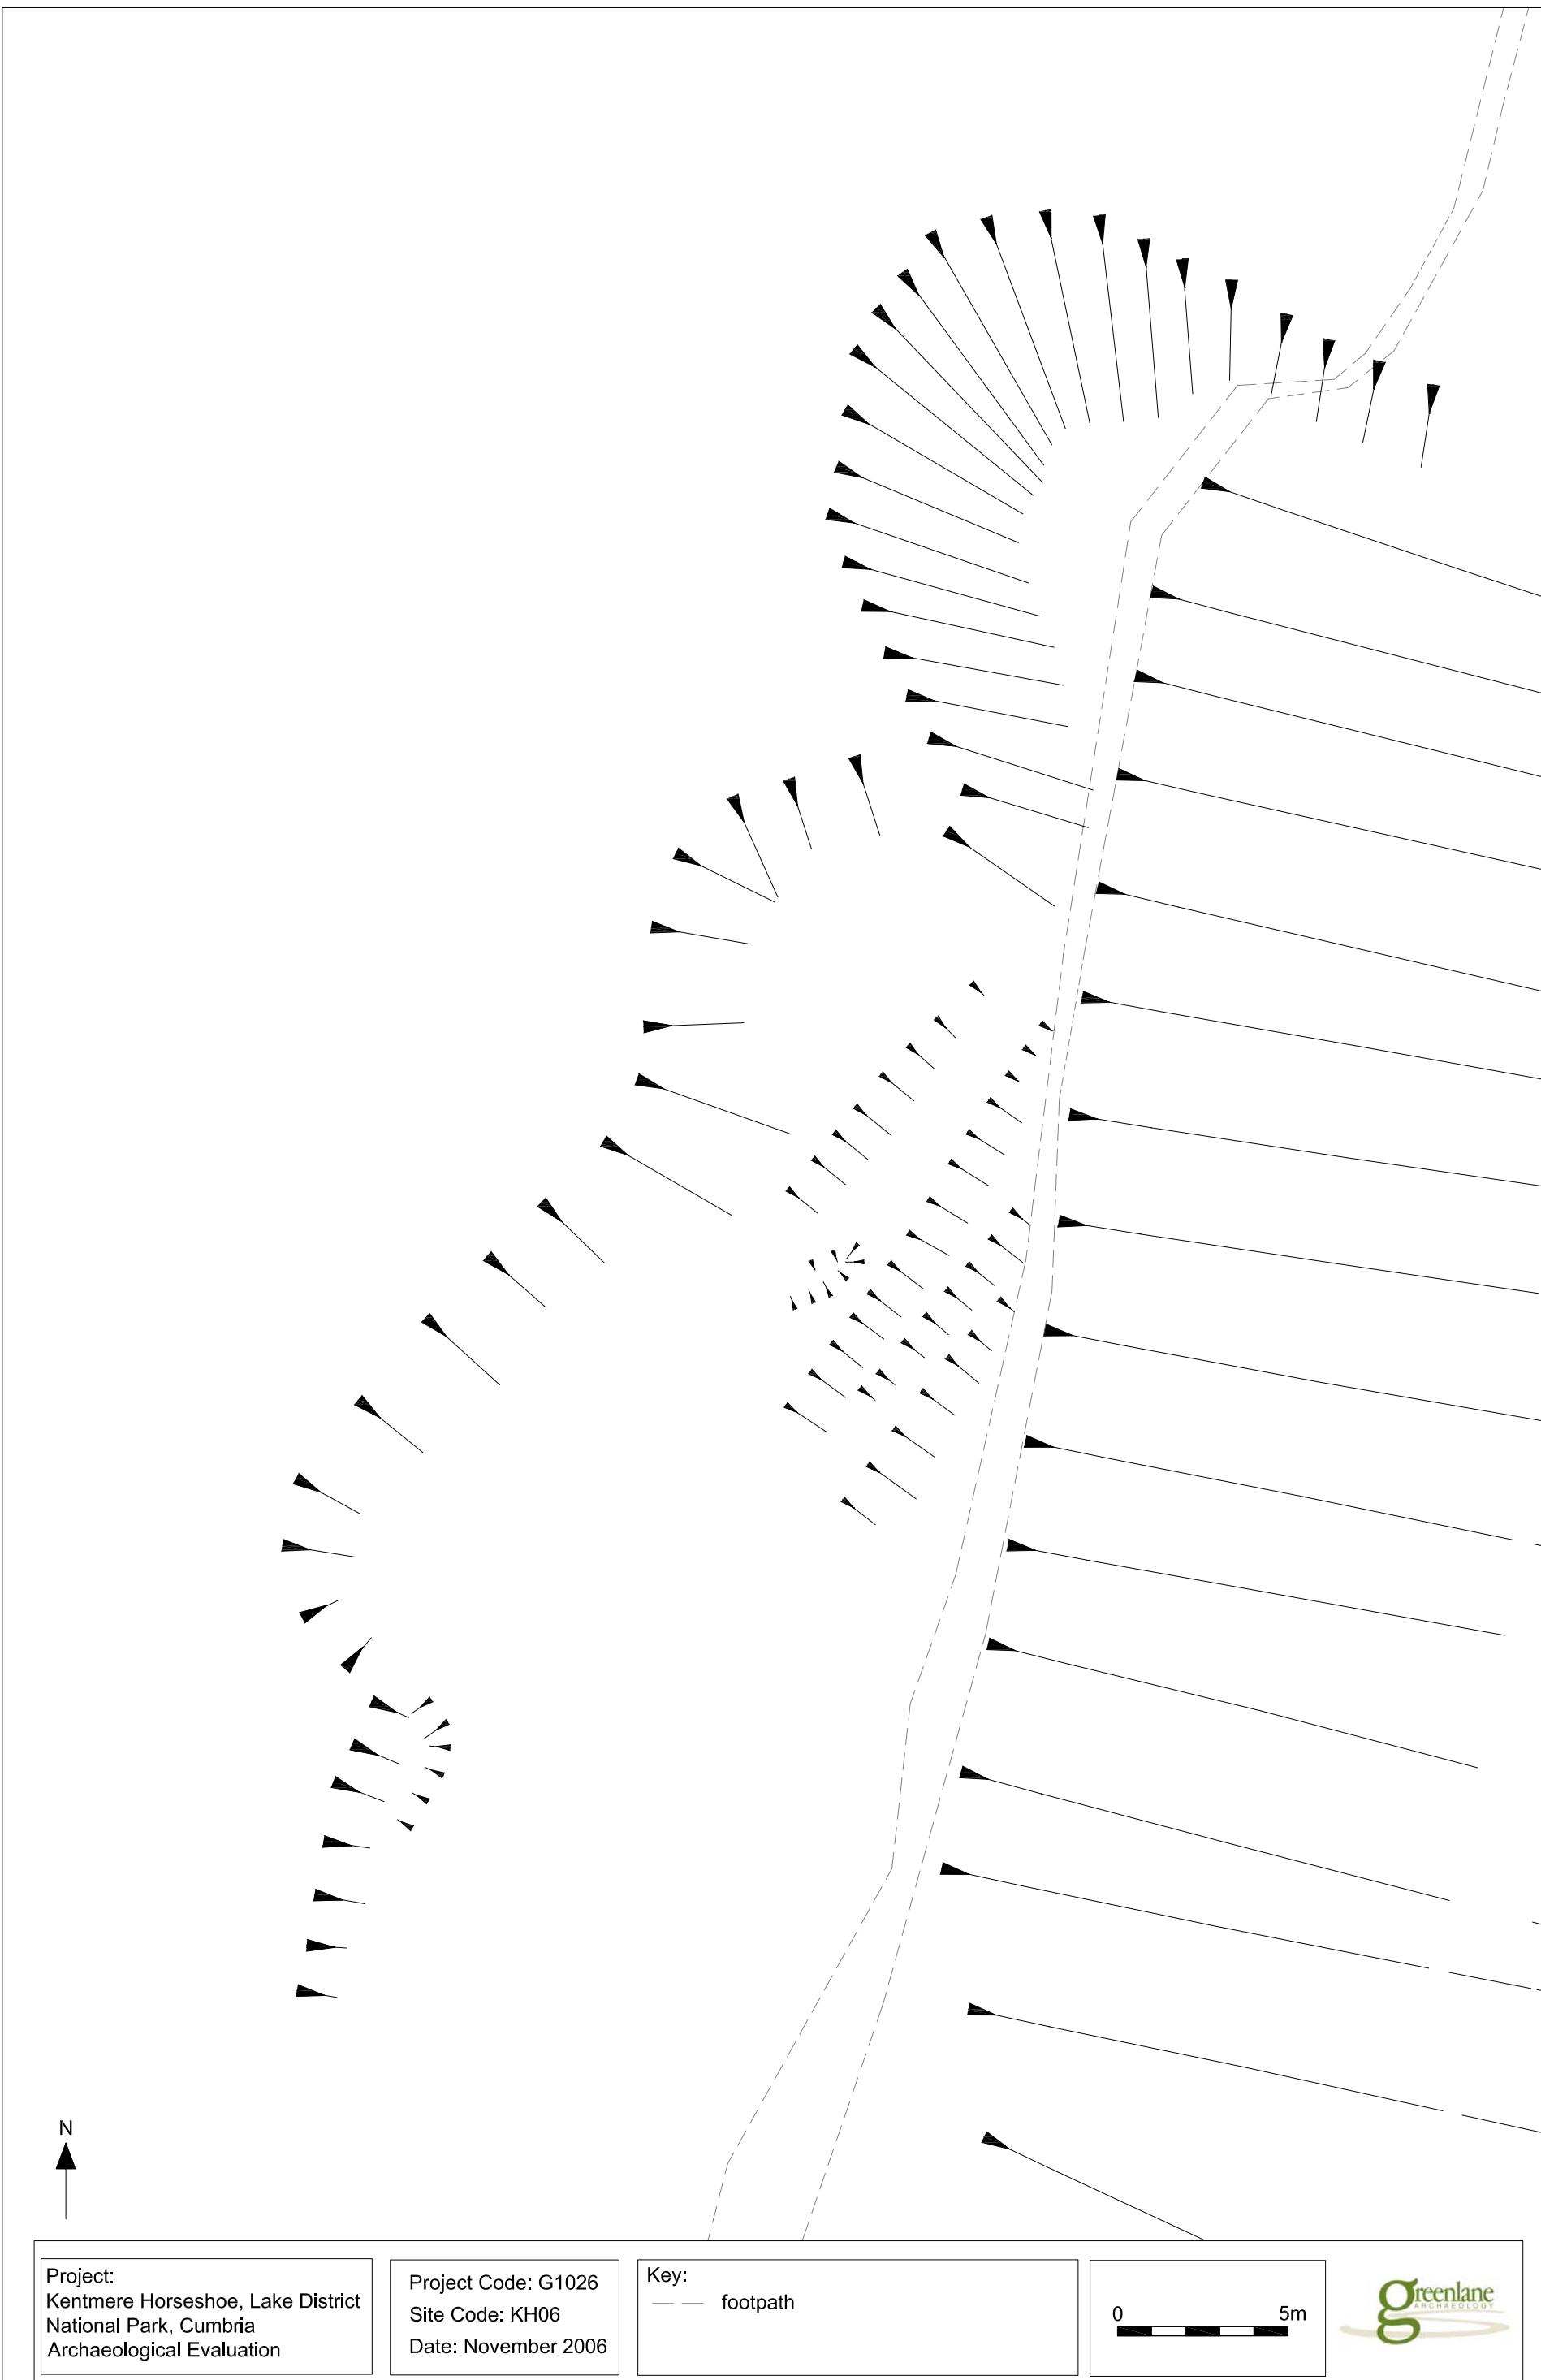
Figure 4: Detail of earthwork features in northern section

4.1.1 The site visit identified three areas of earthworks thought to relate to the line of the Roman road in proximity to the area of footpath repairs. The most northerly of these comprised a series of semi-circular scoops cut into the slope, associated with low terraces on the southern edge of a collapse gulley. Immediately south-west of these the line of the road was visible as a shallow L-shaped terrace cut into the slope, crossed and eroded by the line of a footpath, and then lost in an area of boggy ground at its south end. The remaining visible section was towards the south-west end of the affected area, and comprised a linear collection of earthworks, again formed by a terrace cut into the slope. On the east side of the southern section, between the line of the road and the present footpath, are a collection of shallow irregular and sub-rectangular scoops cut into the ground, which appear to be the remains of areas of peat cutting. Between the two areas of visible earthworks the line of the road is not visible, but it is assumed to follow the line of the present footpath towards Troutbeck.

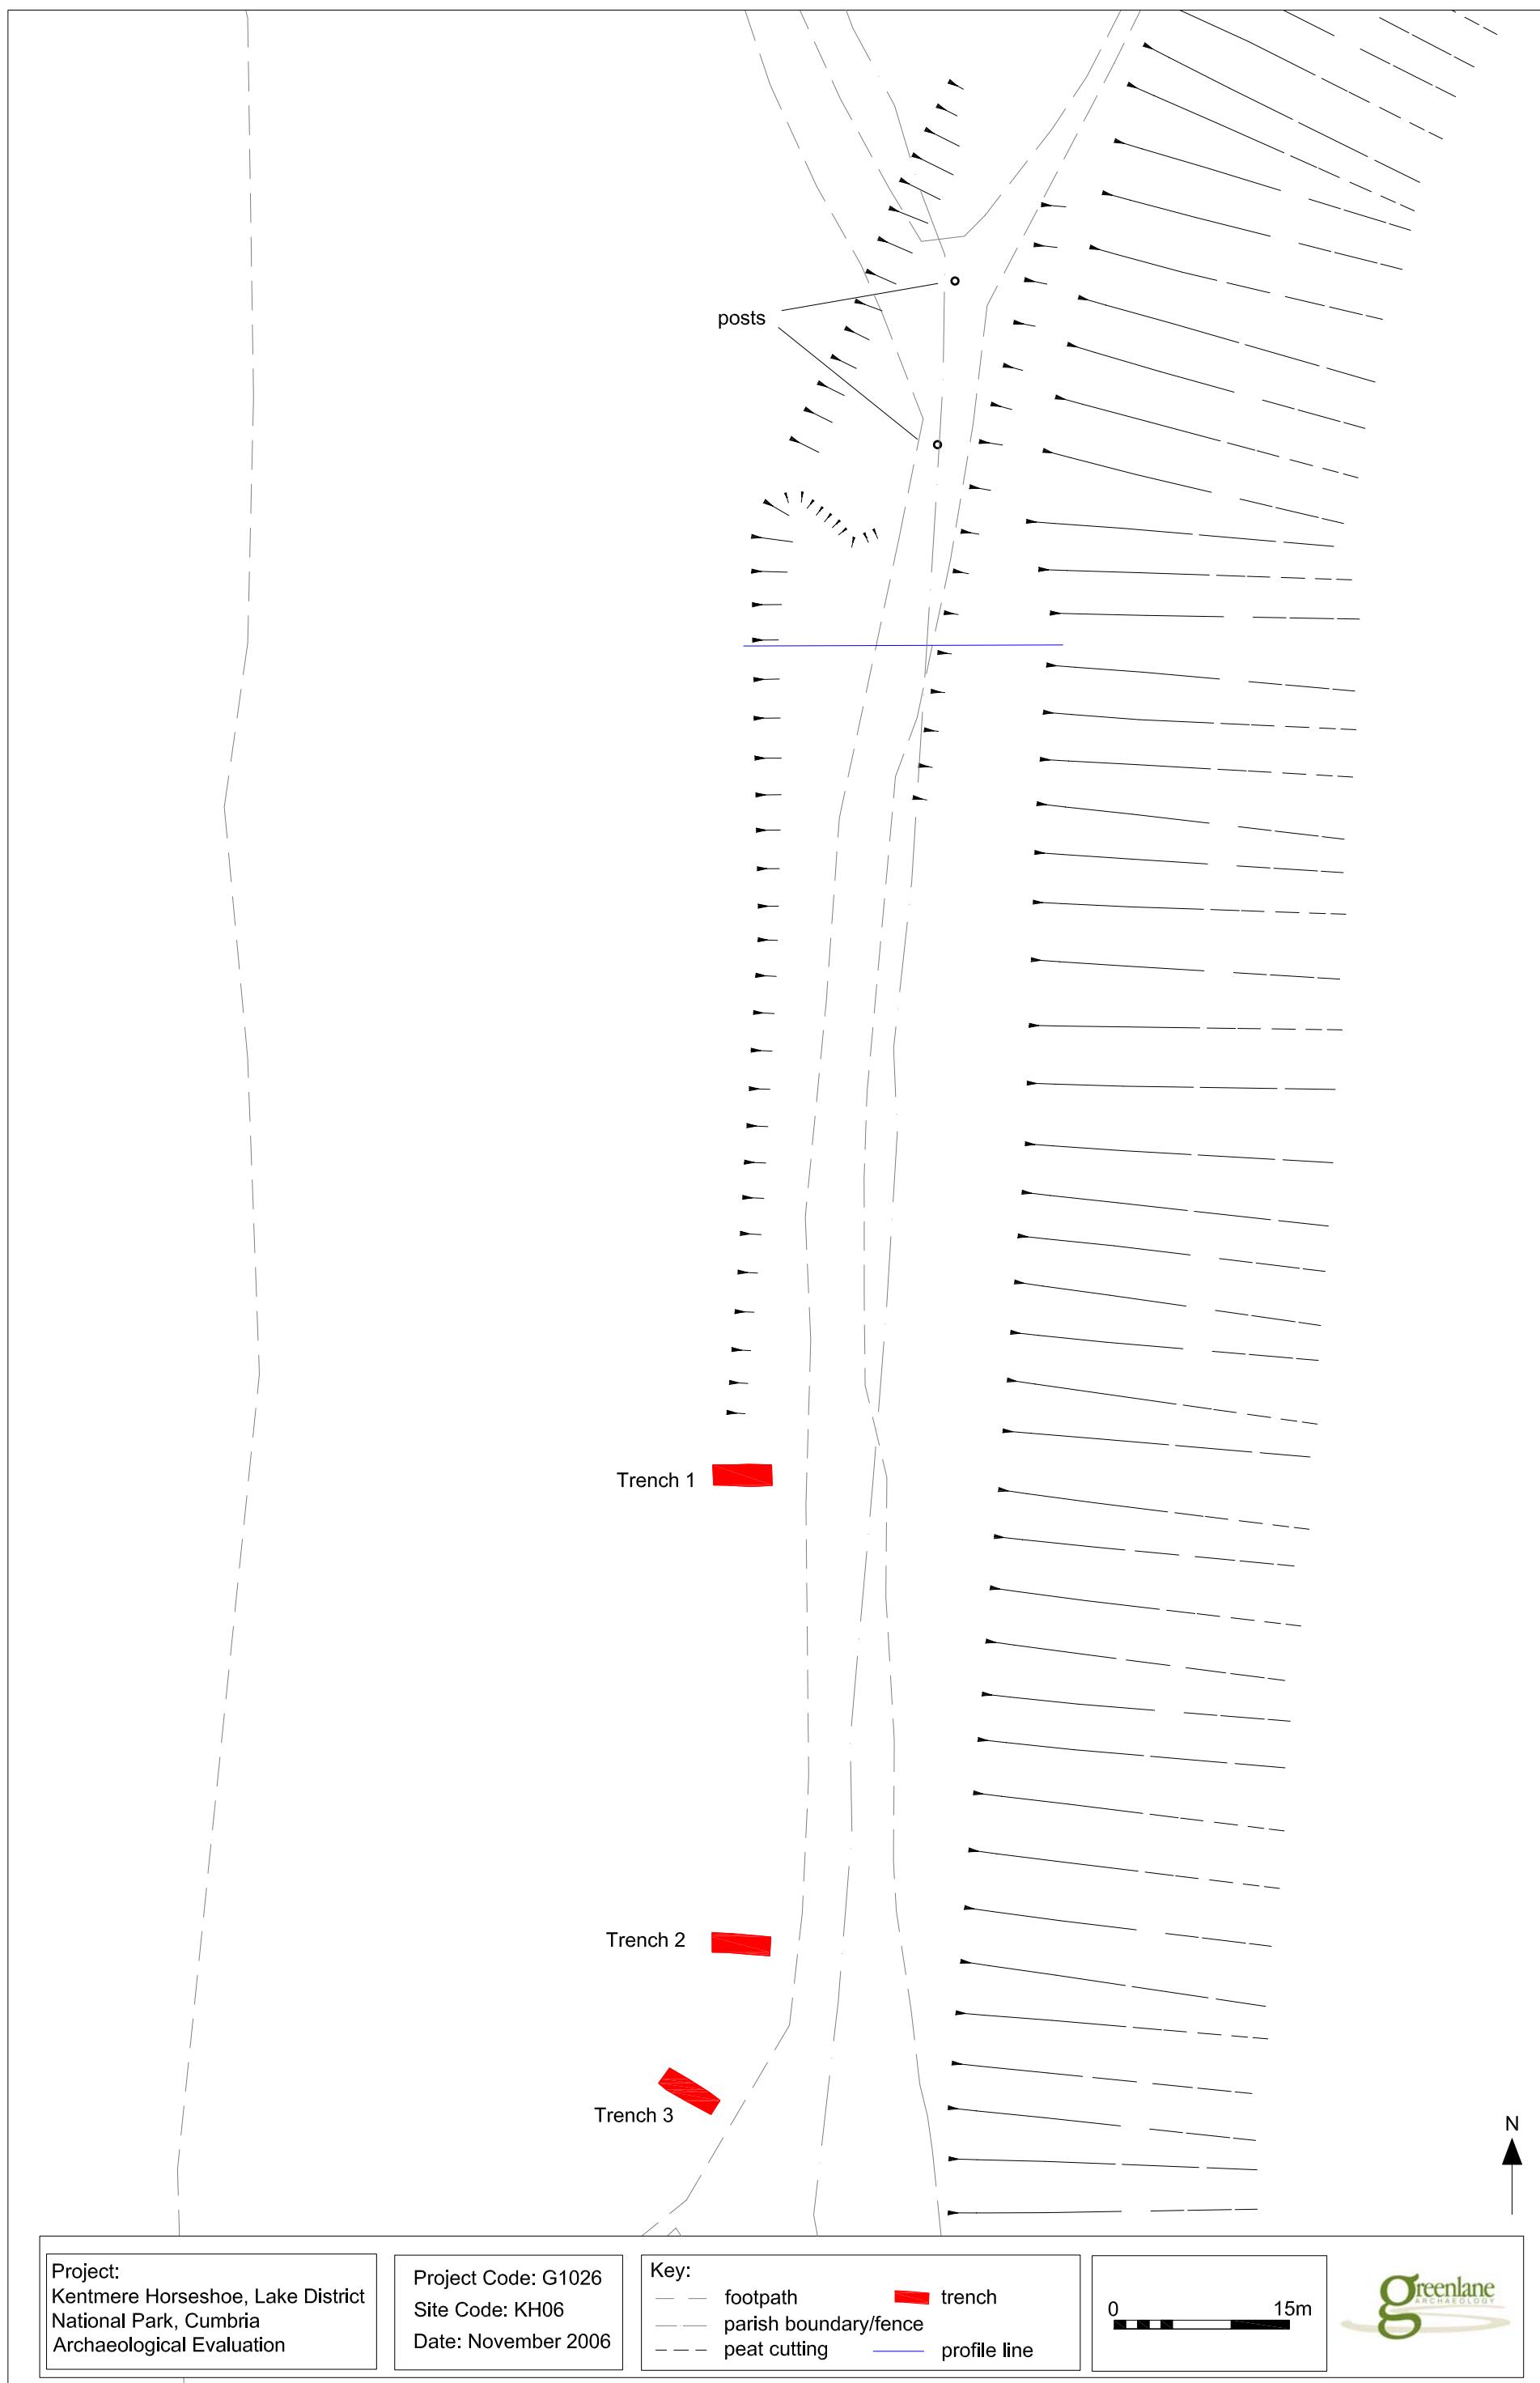
Figure 5: Detail of earthwork features in central section

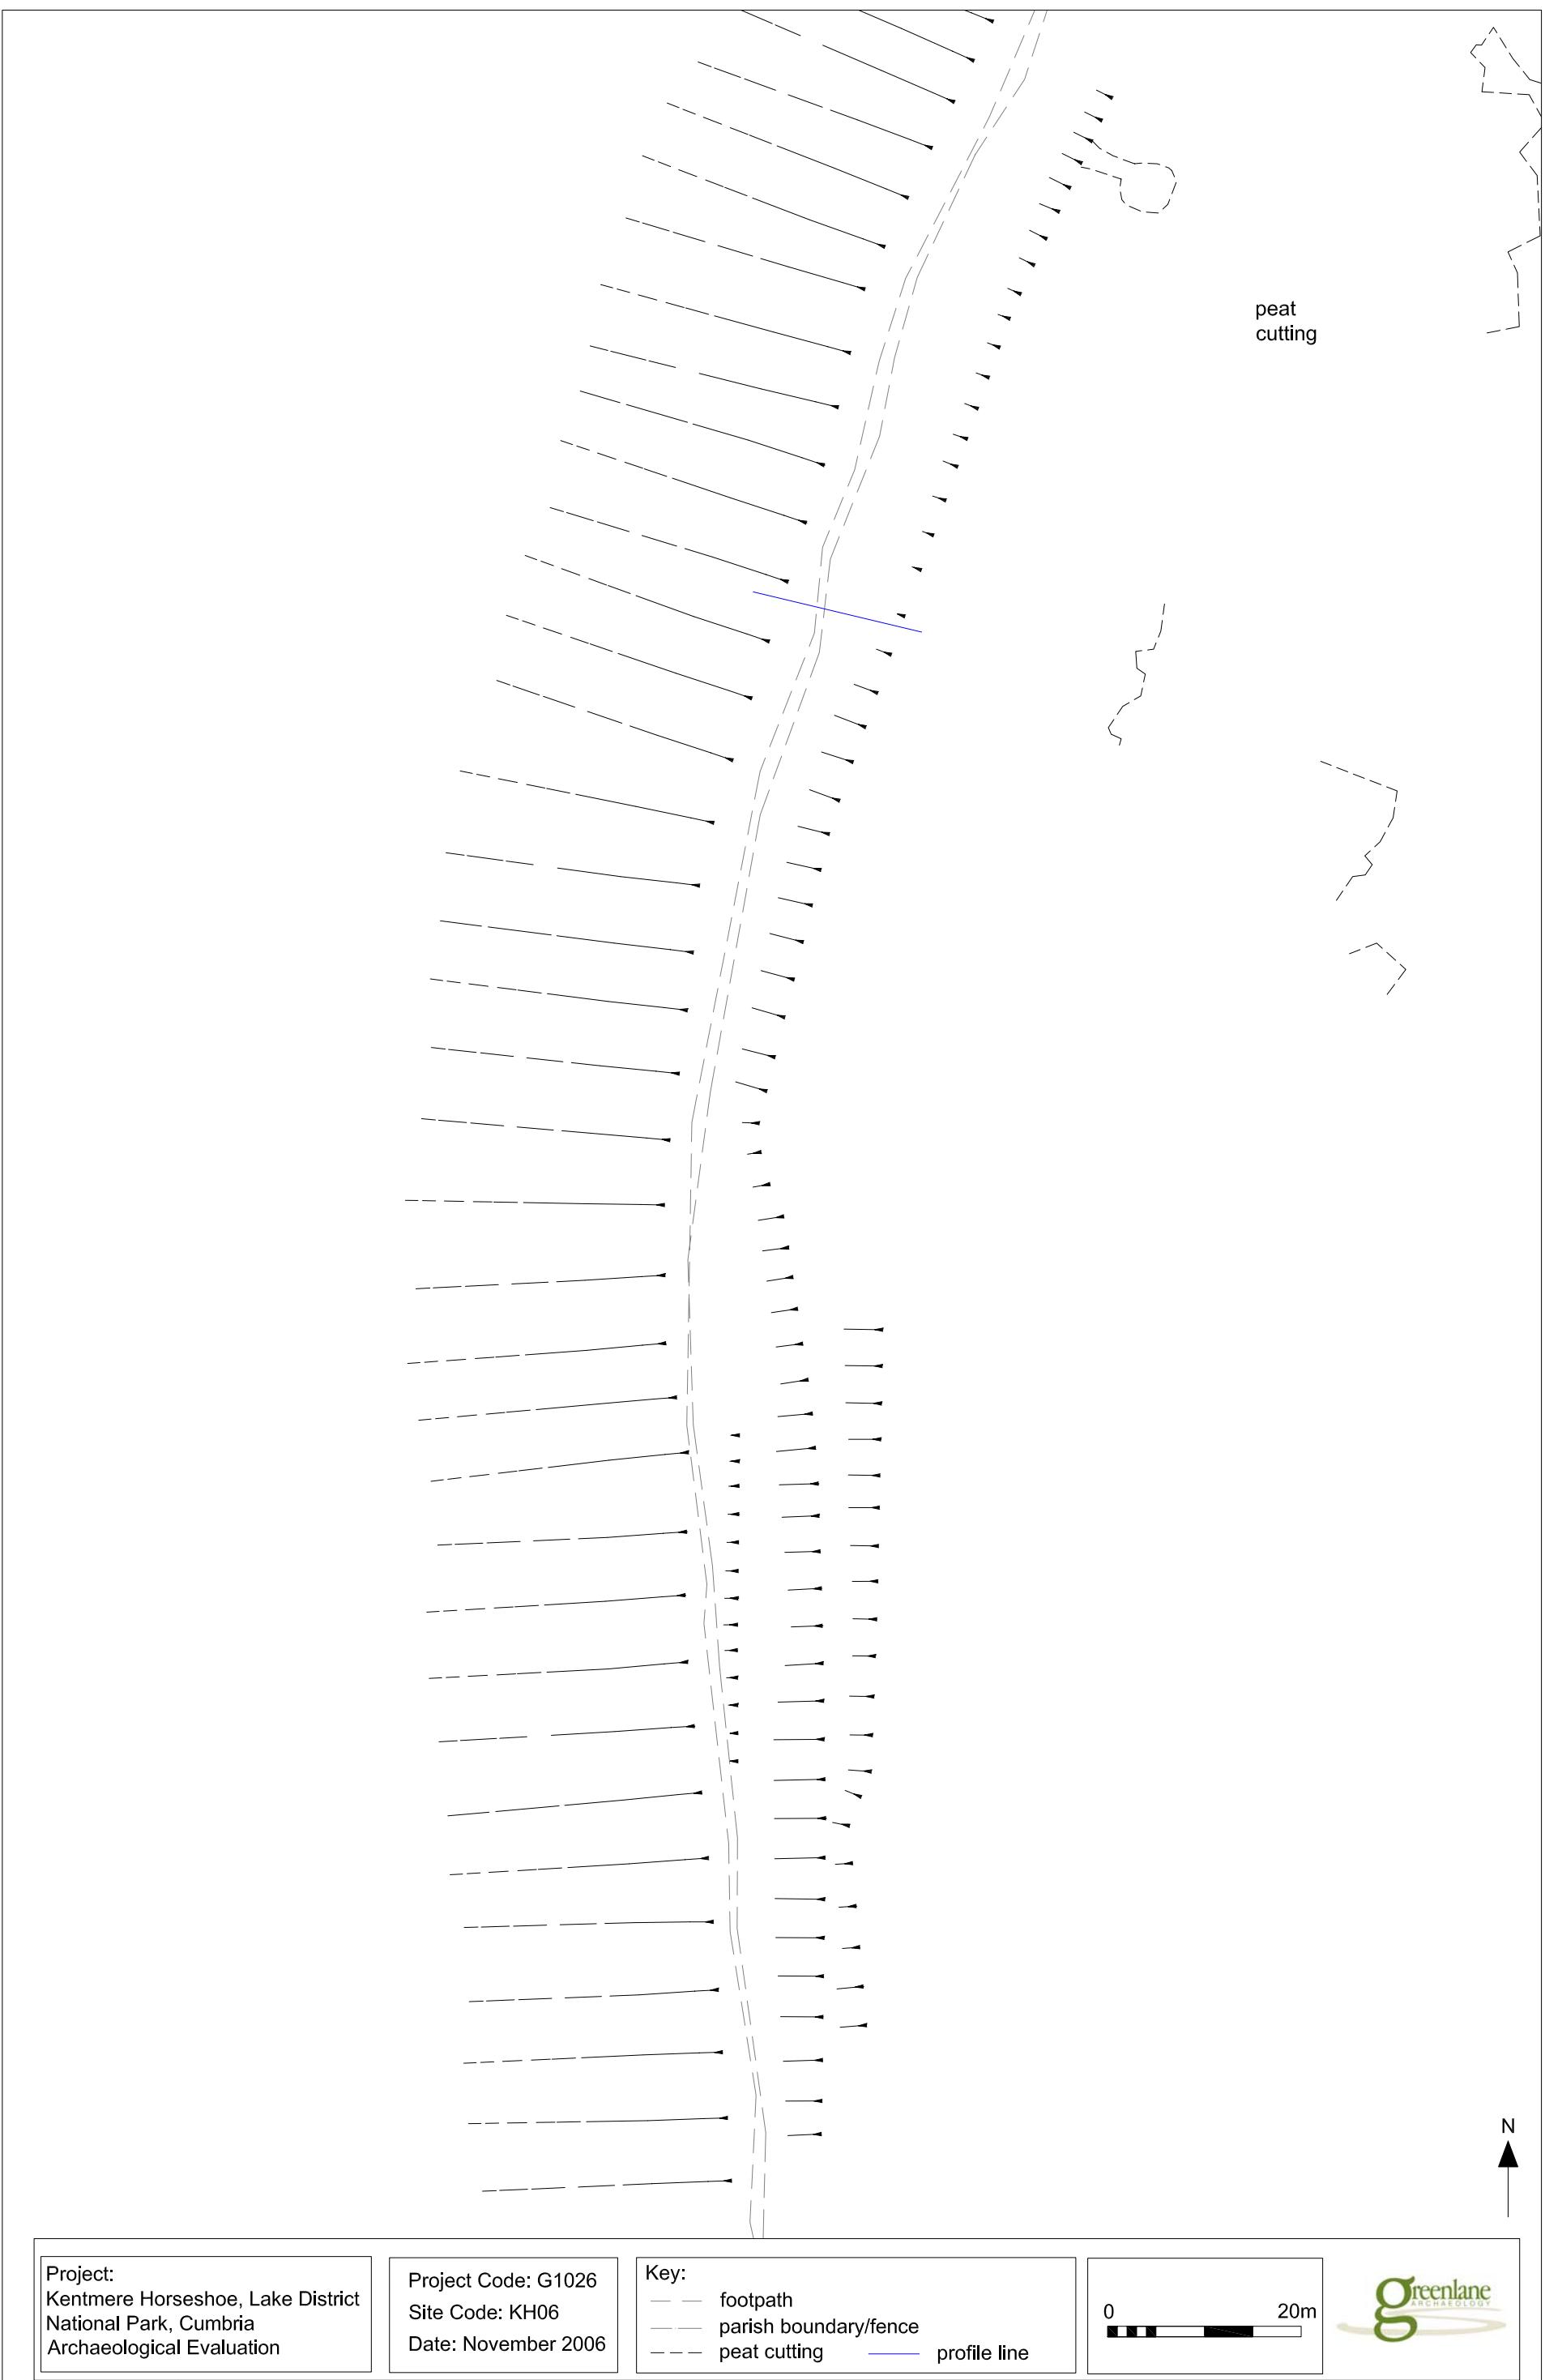
Figure 6: Detail of earthwork features in southern section

4.3.2 The earthworks between the southern section and the present footpath almost certainly represent the remains of peat cutting. This may explain the disappearance of the route of the road between the central and southern sections of earthworks, as it has been buried beneath spoil. However, it was also observed that there was a dark green patch of vegetation in this area, apparently representing a particularly boggy part of the hillside, which may be partially responsible for this.

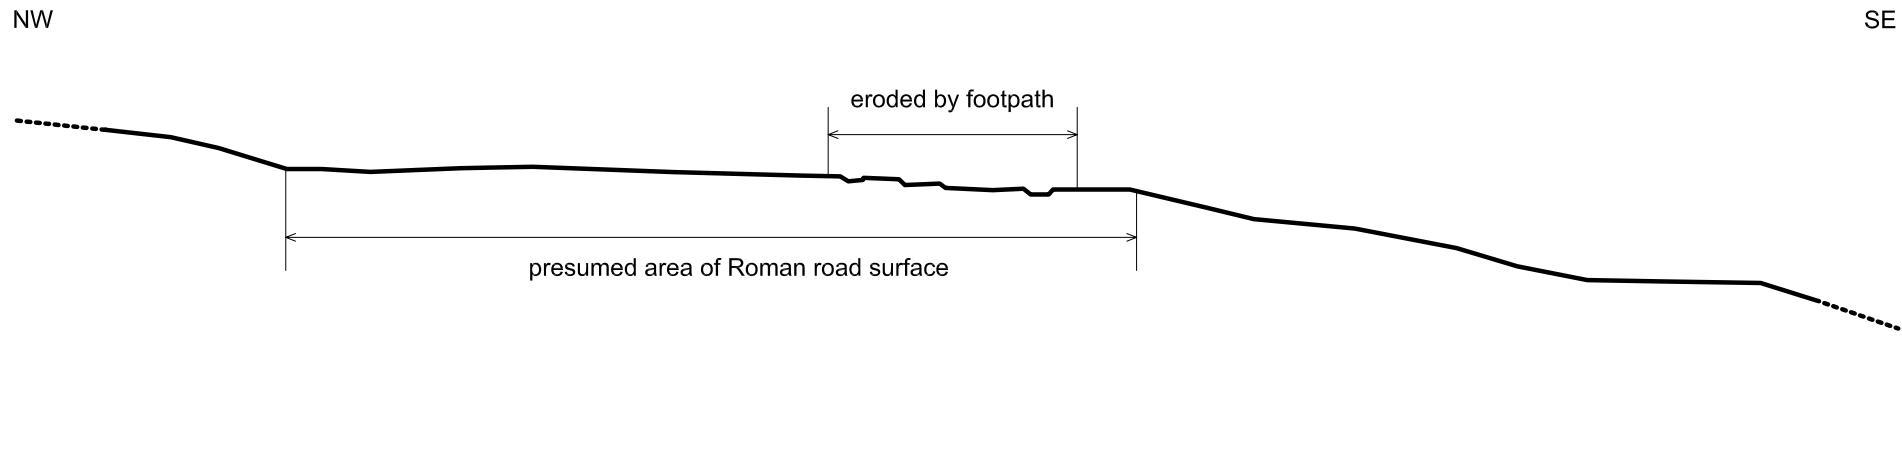
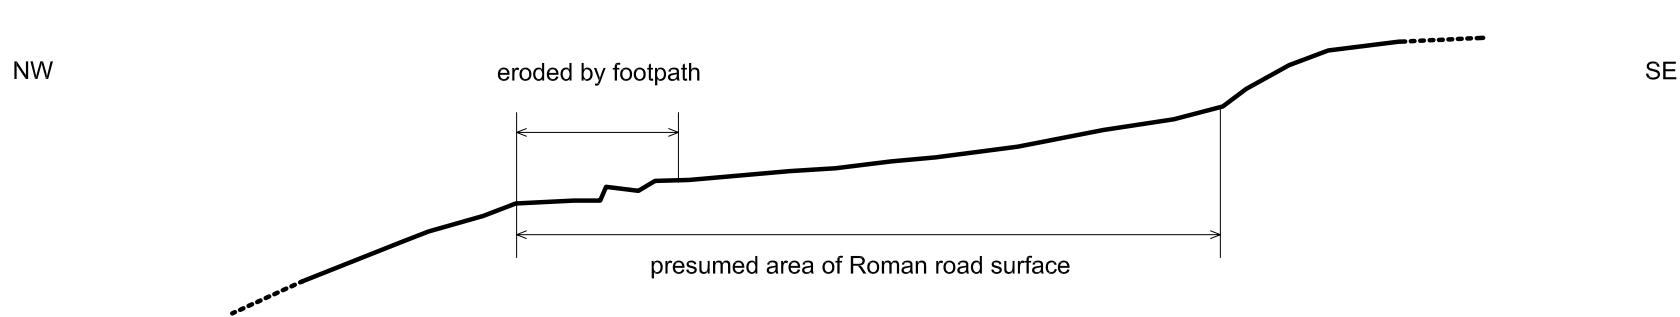
South-west facing profile through north section of road

South-west facing profile through south section of road

Figure 7: Profiles taken through the road

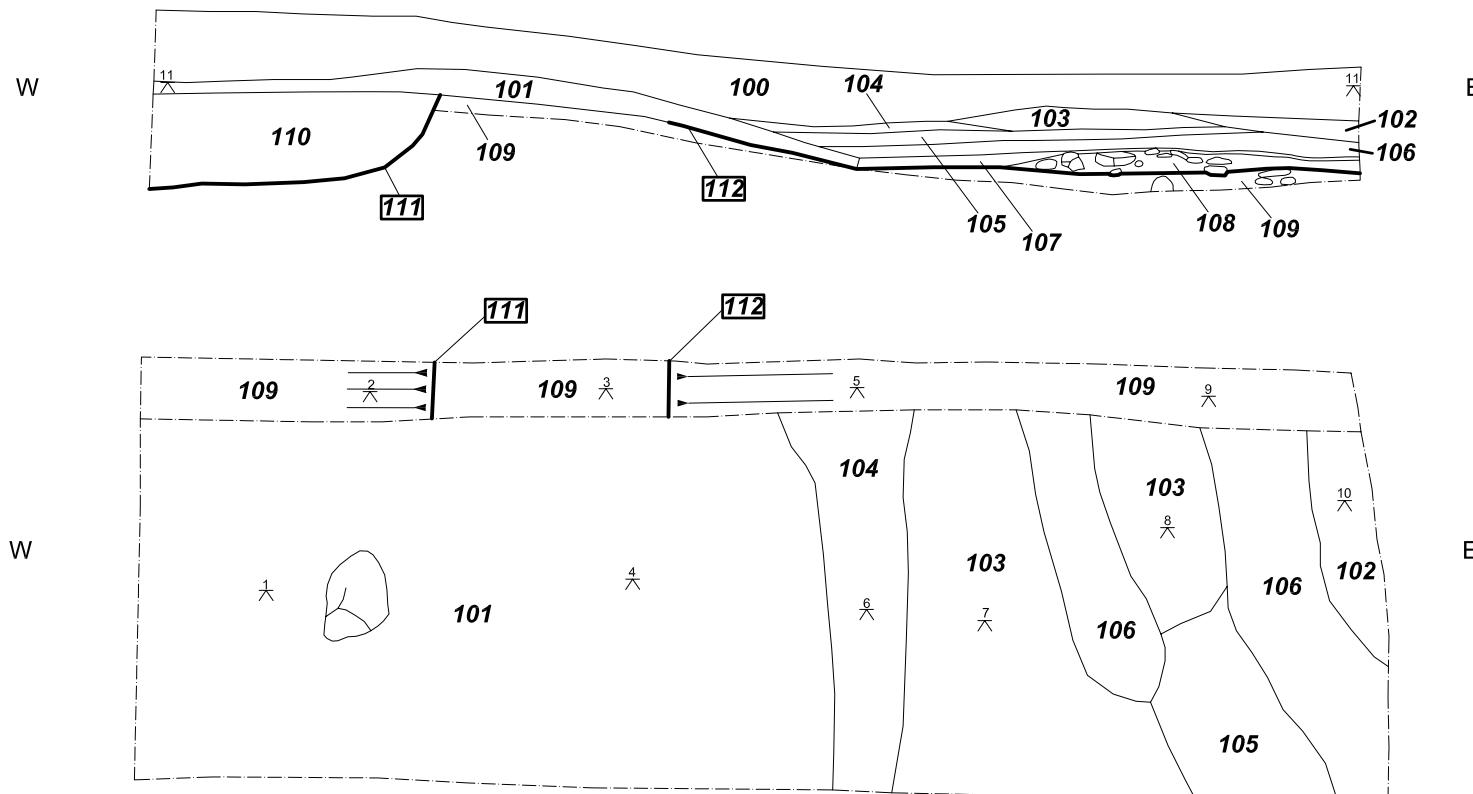
Figure 8: Trench plan and south facing section of Trench 1

5.2.2 A sondage was cut along the north side of the trench which demonstrated that these deposits were formed in several layers, which had been worn through on the surface. The upper layer was, in effect, formed by deposits **102**, **103**, and **104**, which was not actually a linear feature. Beneath these was layer **105**, followed by **106**, beneath which was a mid grey-brown soft silt up to 0.1m thick, but little more than 0.02m thick at the east end (**107**). This sealed a smaller layer of pale greenish and orange-green soft silty clay (**108**), which contained approximately 45% sub-round and angular gravels and pebbles. This was on top of a loose pale greyish or yellowish green sandy silt, containing 20% angular gravels and pebbles (**109**), considered to be the underlying natural. A shallow depression forming a roughly level terrace had been cut into this surface (**112**), on top of which the layers making the road surface had been laid. At the west end of the trench, beneath layer **101**, was a steep-sided U-shaped ditch at least 1m wide and up to 0.4m deep (**111**), cut into the natural **109** (Plate 12). This had been filled with a loose mid orange-brown sandy clay containing 98% sub-angular and rounded gravels and pebbles (**110**).

- **Phase 2:** the earliest stage in construction of the road seems to have been the cutting of a shallow slope (**112**) into the hillside to create a level terrace on which the road could be laid. At approximately the same time a large ditch (**111**) was excavated along the north-west side of the road running parallel with it, which was almost immediately filled with loose gravely soil (**110**);

- **Phase 4:** a thin layer of stones and clay developed across the north-west side of the trench (**101**), sealing the filled ditch **111**. This appears to be contemporary with a thin grey-brown silt that developed across the south-east side of the trench (**107**). It is not certain what this phase represents, but it may be related to the ongoing construction of features related to the road, rather than the road surface itself, which caused the build-up of a stony deposit (**101**) on the uphill side (perhaps deliberately laid) and allowed a thin silt (**107**) to gather on the proposed road surface;

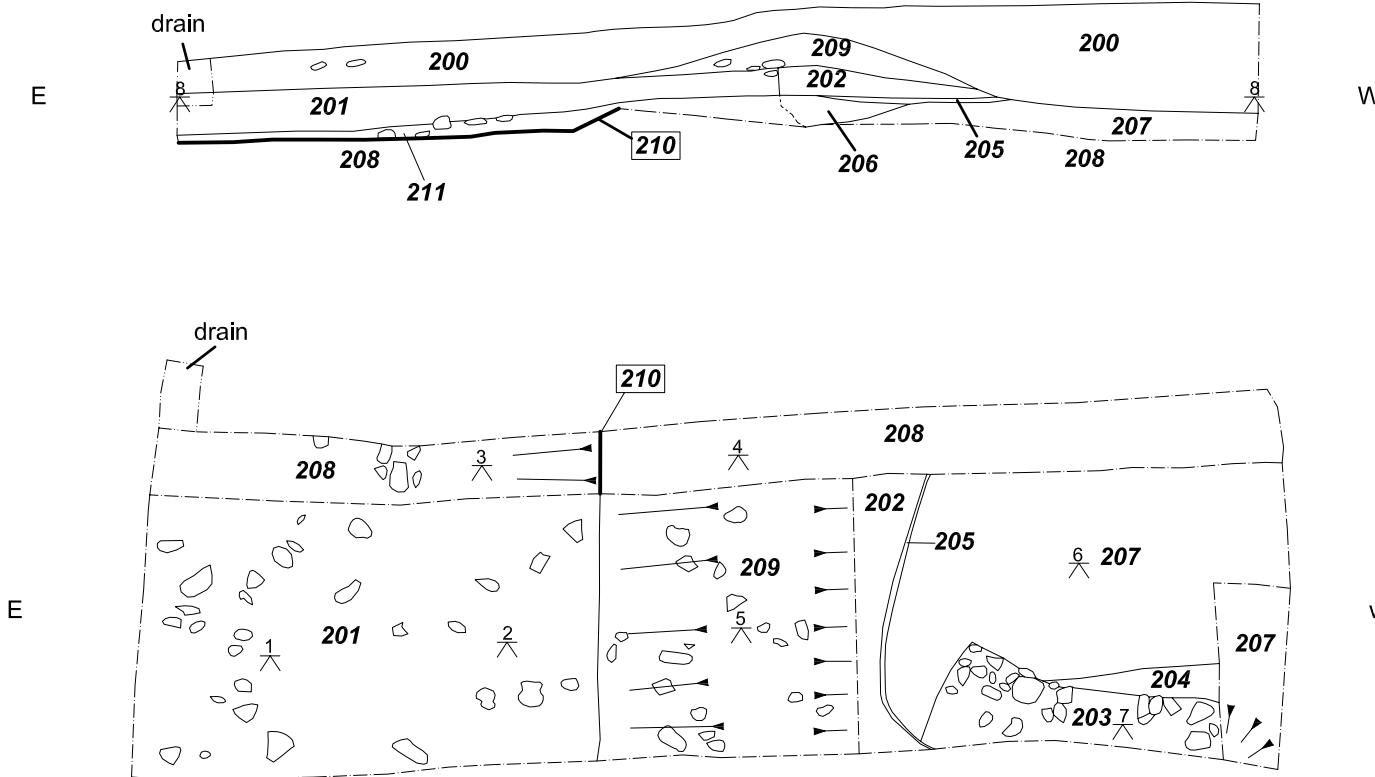
Figure 9: Trench plan and north facing section of Trench 2

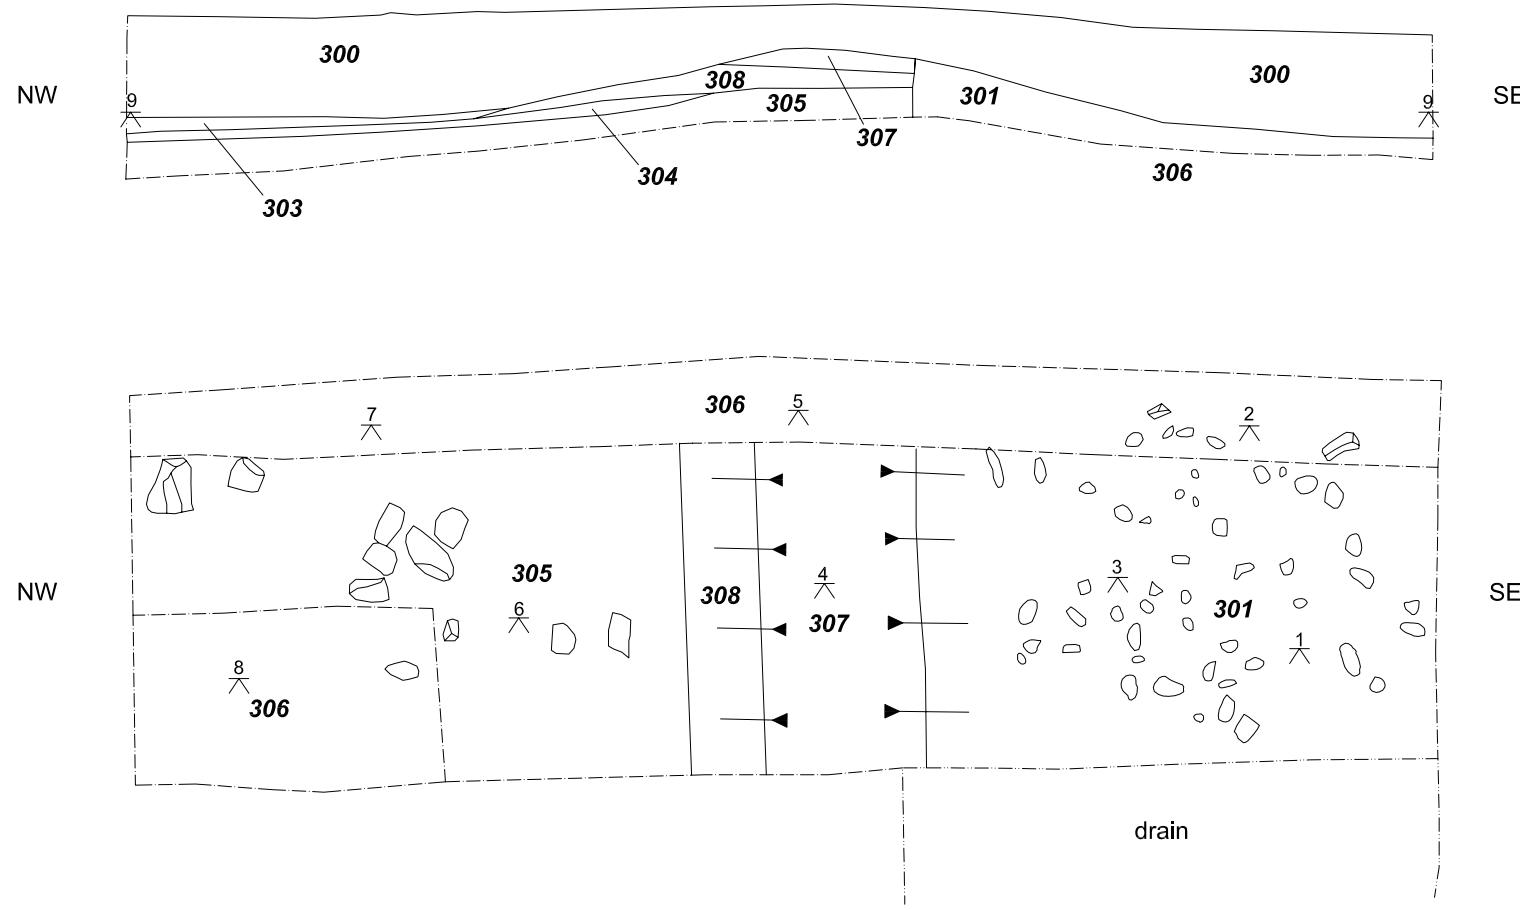
Figure 10: Trench plan and south-west facing section of Trench 3

5.2.5 **Trench 3:** this too was approximately 5m long and 1.6m wide, but was orientated approximately north-west/south-east (Fig 10). Beneath the turf was a thick layer of soft dark brown or black peat covering the entire trench (**300**). Beneath this, at the south end of the trench was a layer of mid orange-brown firm sandy clay containing 98% sub-angular gravels and pebbles (**301**), which was assumed to be the surface of the road. At the north end of the trench, beneath peat **300**, was a layer of soft dark brownish-grey peat with 20% fragments of decayed gravels and pebbles, up to 0.04m thick (**303**). The north-west and south-east ends of the trench were divided by a raised bank constructed from a soft mid orange-brown silty clay with 10% angular and sub-angular gravels and pebbles up to 0.15m thick (**307**; Plates 16 and 18).

5.2.6 A sondage excavated along the north-east side of the trench revealed that the presumed road surface **301** was laid on a firm light orangey-brown silty clay containing a small amount of degraded gravels and pebbles, thought to be the natural (**306**). To the north-west of the bank, peat **303** was found to lie on another layer of dark brownish grey peat with no inclusions, up to 0.06m thick (**304**), which in turn lay on another layer of dark greyish-brown silty clay peat with 20% degraded gravel and pebble fragments and some rounded cobbles (**305**; Plates 17 and 19). The top of the bank **307** was laid on a thin lense of yellowish grey soft silty clay (**302**), which was then laid on a firm mid orange-brown silty clay containing 98% angular gravels and pebbles typically 0.05m thick (**308**), very similar to **301**, which was on top of **304** and **305**. An additional sondage was cut through **305** in the north-west corner of the trench, which confirmed the arrangement of deposits here was the same as on the east side of the trench. Due to excessive flooding a large drain was excavated using the machine in the south-west corner to allow water to escape.

- **Phase 4:** additional layers of clay (**308**) and stony clay (**307**) were heaped along the north side of the road forming a bank. The lower of these was apparently dumped on top of the peat (**304**) that had developed or been deposited since the road had been constructed. This bank effectively raised the north side of the road above the level of the peat beyond, and may have replaced curb stones;

- **Phase 5:** following the construction of the bank a thin layer of peat developed or was deposited against the north side of it (303). The presence of stone flecks within it suggests that it was present during construction or repair of some element of the road or bank building, but it appears to overly the lower edge of the bank and so presumably post-dates it;
- **Phase 6:** following the abandonment of the road a thick layer of peat developed across it (300).
