# KENTMERE HORSESHOE, LAKE DISTRICT NATIONAL PARK, CUMBRIA

Archaeological Evaluation

Client: Lake District National  
Park Authority  
NGR: NY 4325 0911

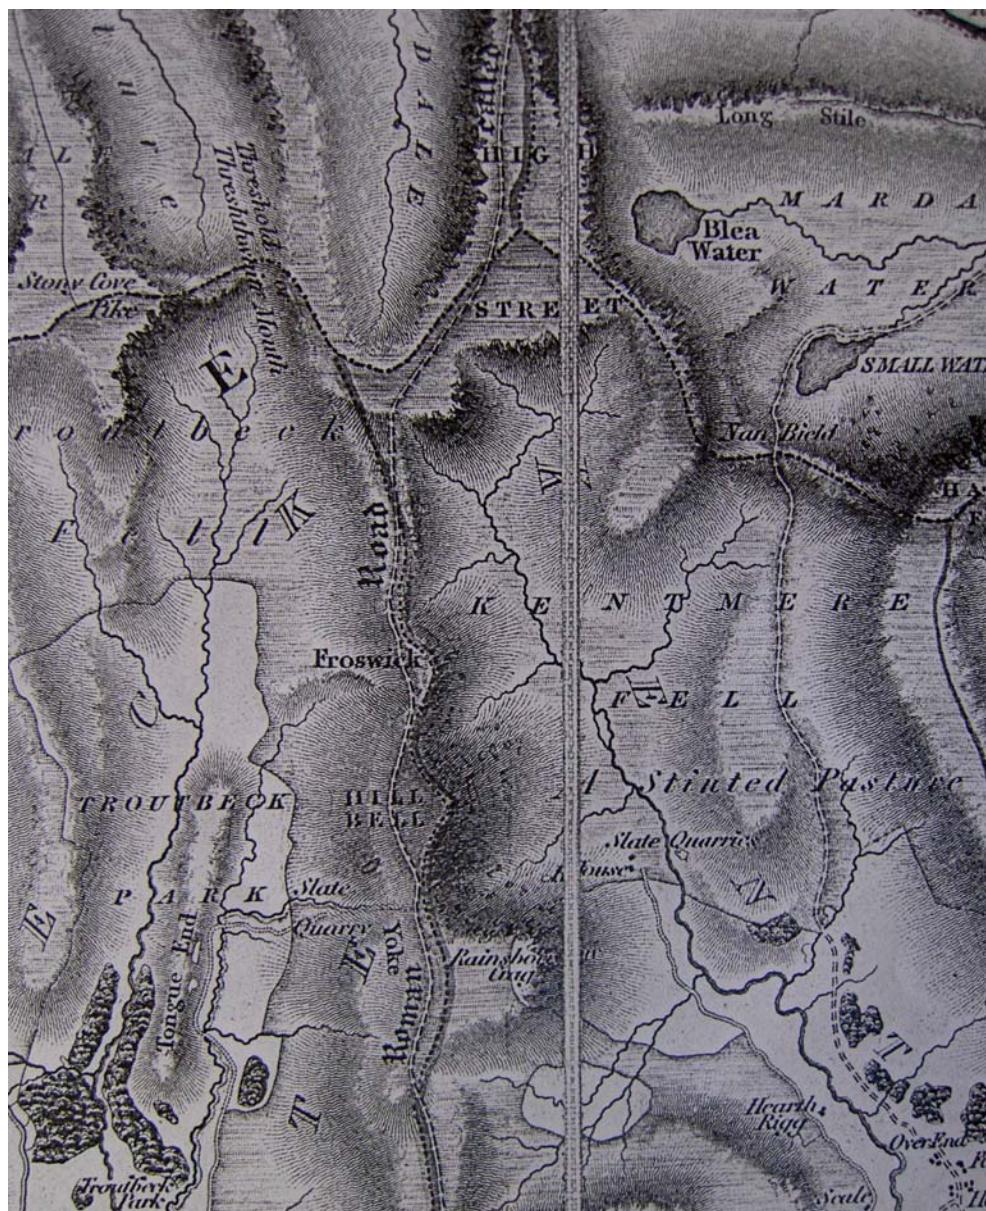
Plate 1: Part of Hodgson's plan of 1828 showing the line of the Roman road

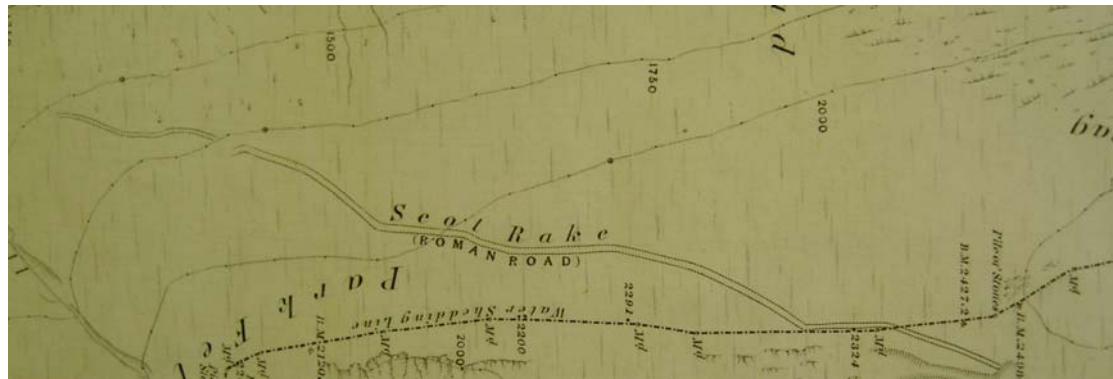
Plate 4: Part of the Ordnance Survey map of 1863 showing the route of the 'Scot Rake' (north is to the right)

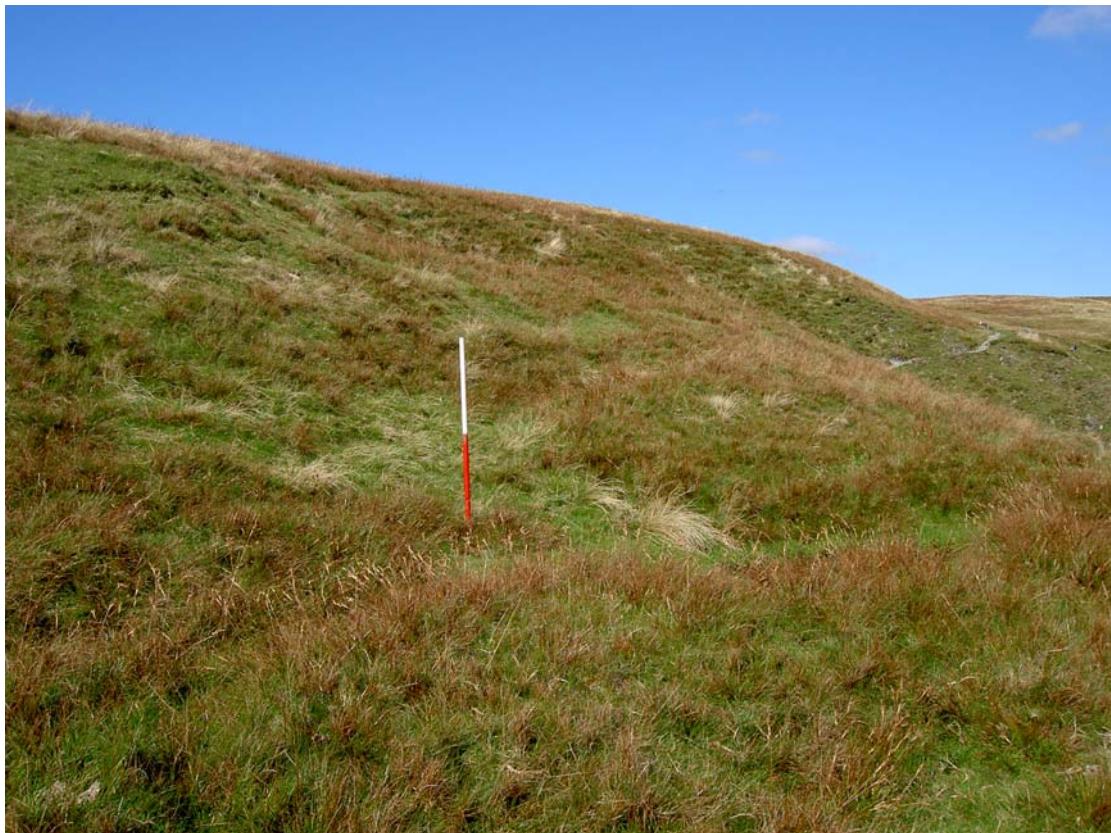
Plate 7: Probable quarries at the north end of the survey area, looking north

4.1.1 The site visit identified three areas of earthworks thought to relate to the line of the Roman road in proximity to the area of footpath repairs. The most northerly of these comprised a series of semi-circular scoops cut into the slope, associated with low terraces on the southern edge of a collapse gulley. Immediately south-west of these the line of the road was visible as a shallow L-shaped terrace cut into the slope, crossed and eroded by the line of a footpath, and then lost in an area of boggy ground at its south end. The remaining visible section was towards the south-west end of the affected area, and comprised a linear collection of earthworks, again formed by a terrace cut into the slope. On the east side of the southern section, between the line of the road and the present footpath, are a collection of shallow irregular and sub-rectangular scoops cut into the ground, which appear to be the remains of areas of peat cutting. Between the two areas of visible earthworks the line of the road is not visible, but it is assumed to follow the line of the present footpath towards Troutbeck.

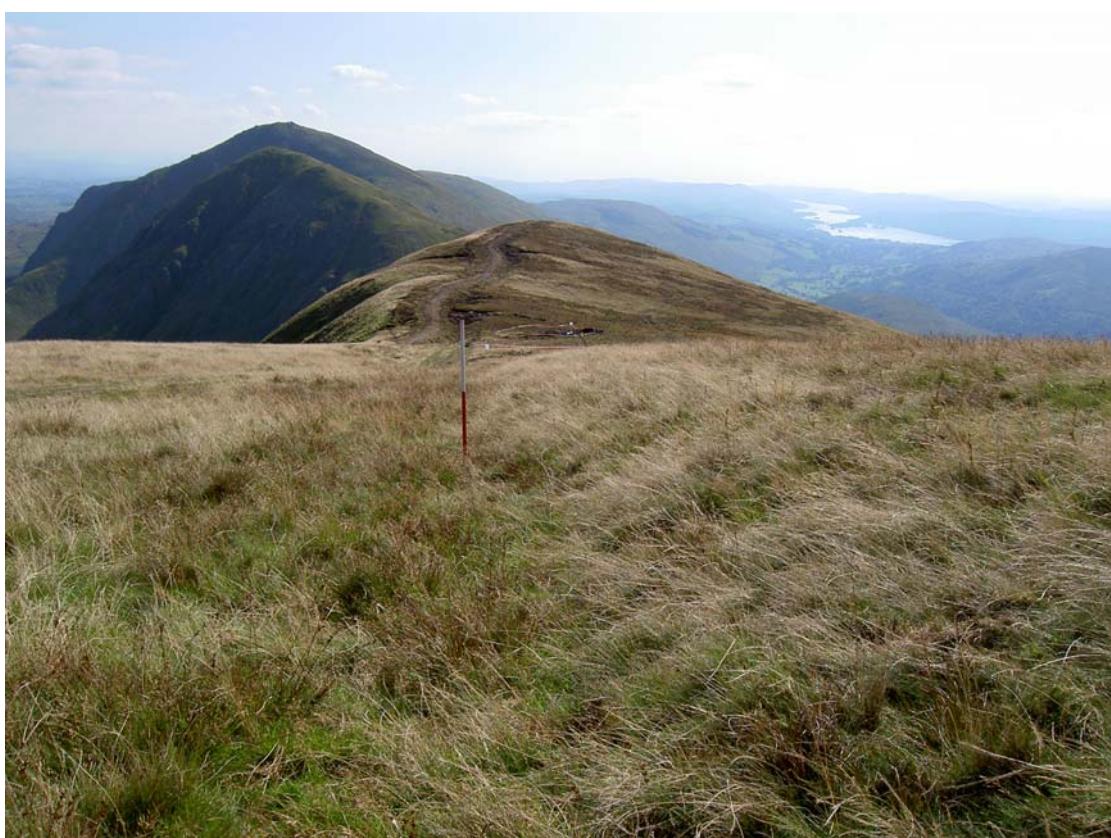
Plate 8: Earthwork forming the central road section, looking south

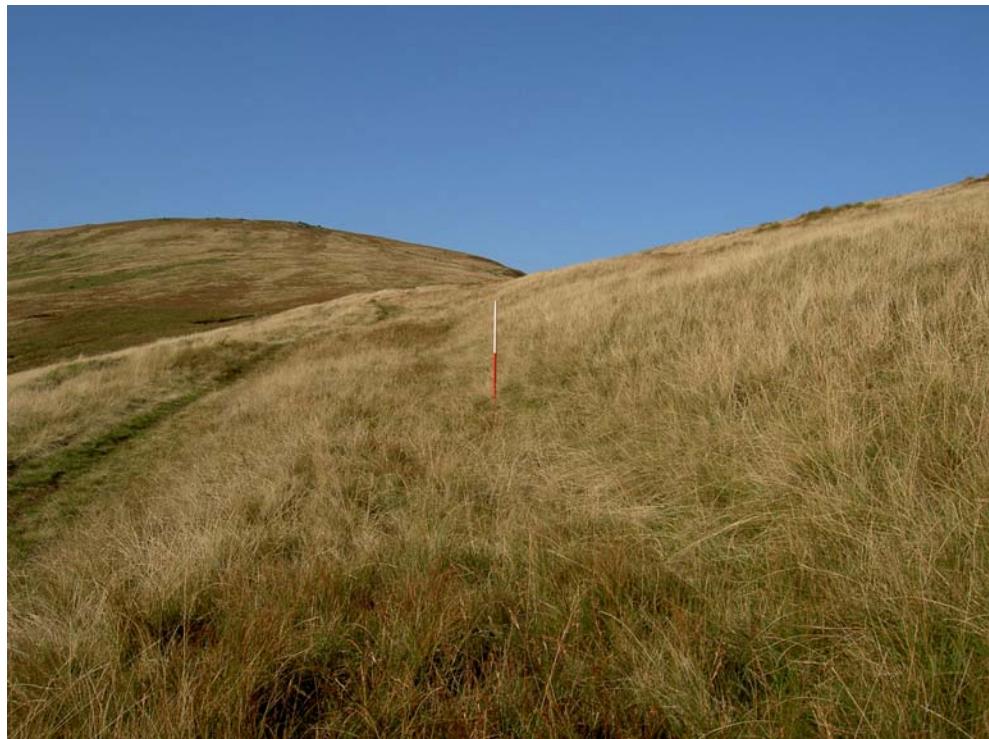
Plate 9: Earthworks forming the southern road section, looking north

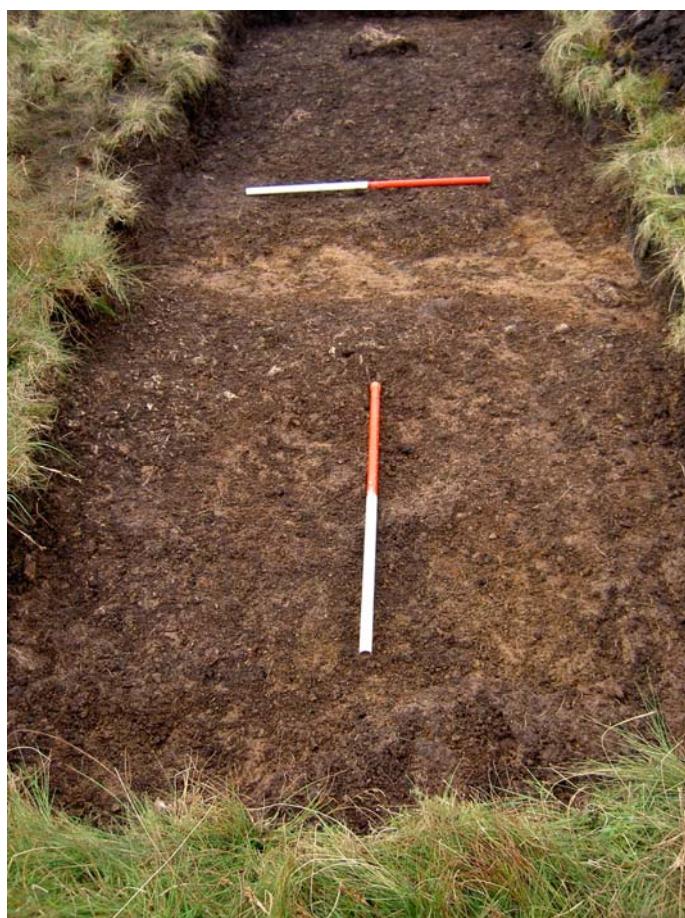
Plate 10: Road surface, linear feature 104 and surface 101 in Trench 1, looking west

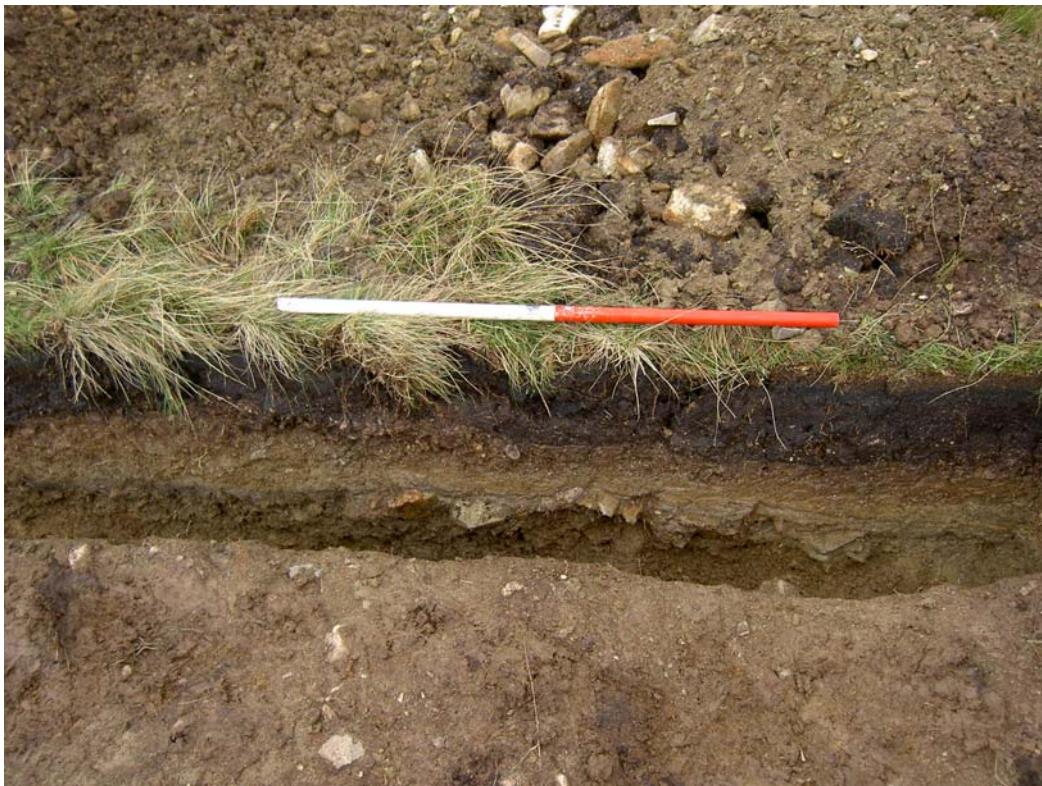
Plate 11: Section through the road surface in Trench 1, looking north

5.2.2 A sondage was cut along the north side of the trench which demonstrated that these deposits were formed in several layers, which had been worn through on the surface. The upper layer was, in effect, formed by deposits **102**, **103**, and **104**, which was not actually a linear feature. Beneath these was layer **105**, followed by **106**, beneath which was a mid grey-brown soft silt up to 0.1m thick, but little more than 0.02m thick at the east end (**107**). This sealed a smaller layer of pale greenish and orange-green soft silty clay (**108**), which contained approximately 45% sub-round and angular gravels and pebbles. This was on top of a loose pale greyish or yellowish green sandy silt, containing 20% angular gravels and pebbles (**109**), considered to be the underlying natural. A shallow depression forming a roughly level terrace had been cut into this surface (**112**), on top of which the layers making the road surface had been laid. At the west end of the trench, beneath layer **101**, was a steep-sided U-shaped ditch at least 1m wide and up to 0.4m deep (**111**), cut into the natural **109** (Plate 12). This had been filled with a loose mid orange-brown sandy clay containing 98% sub-angular and rounded gravels and pebbles (**110**).

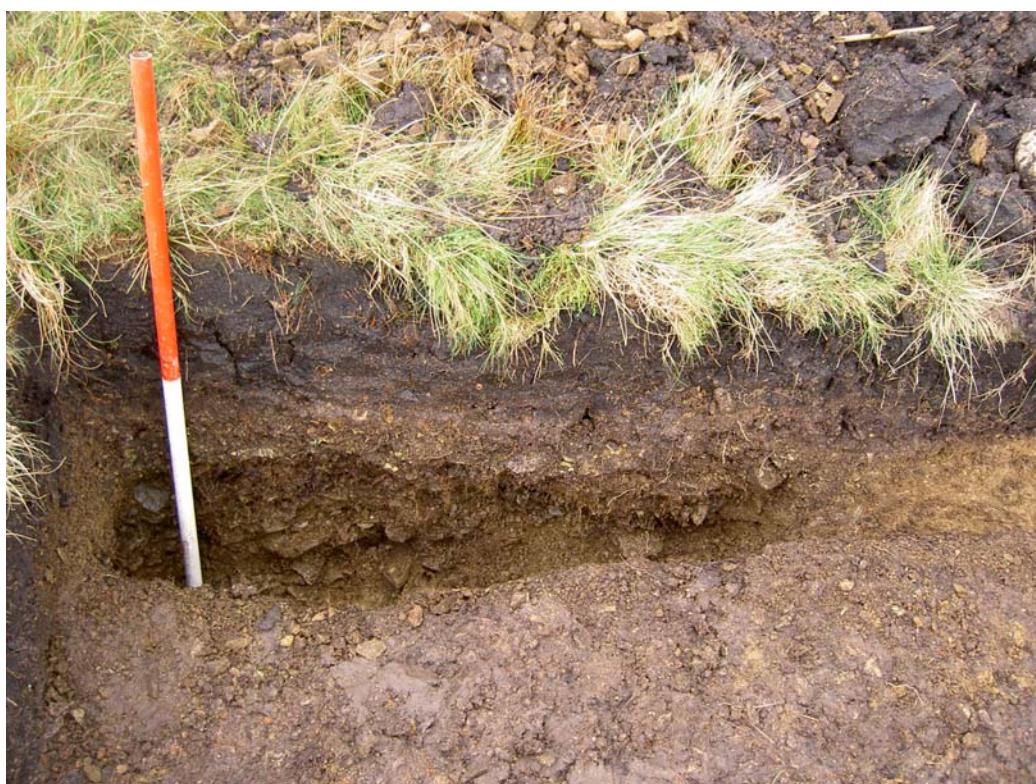
Plate 12: Section through ditch 111, in Trench 1, looking north

- **Phase 2:** the earliest stage in construction of the road seems to have been the cutting of a shallow slope (**112**) into the hillside to create a level terrace on which the road could be laid. At approximately the same time a large ditch (**111**) was excavated along the north-west side of the road running parallel with it, which was almost immediately filled with loose gravely soil (**110**);

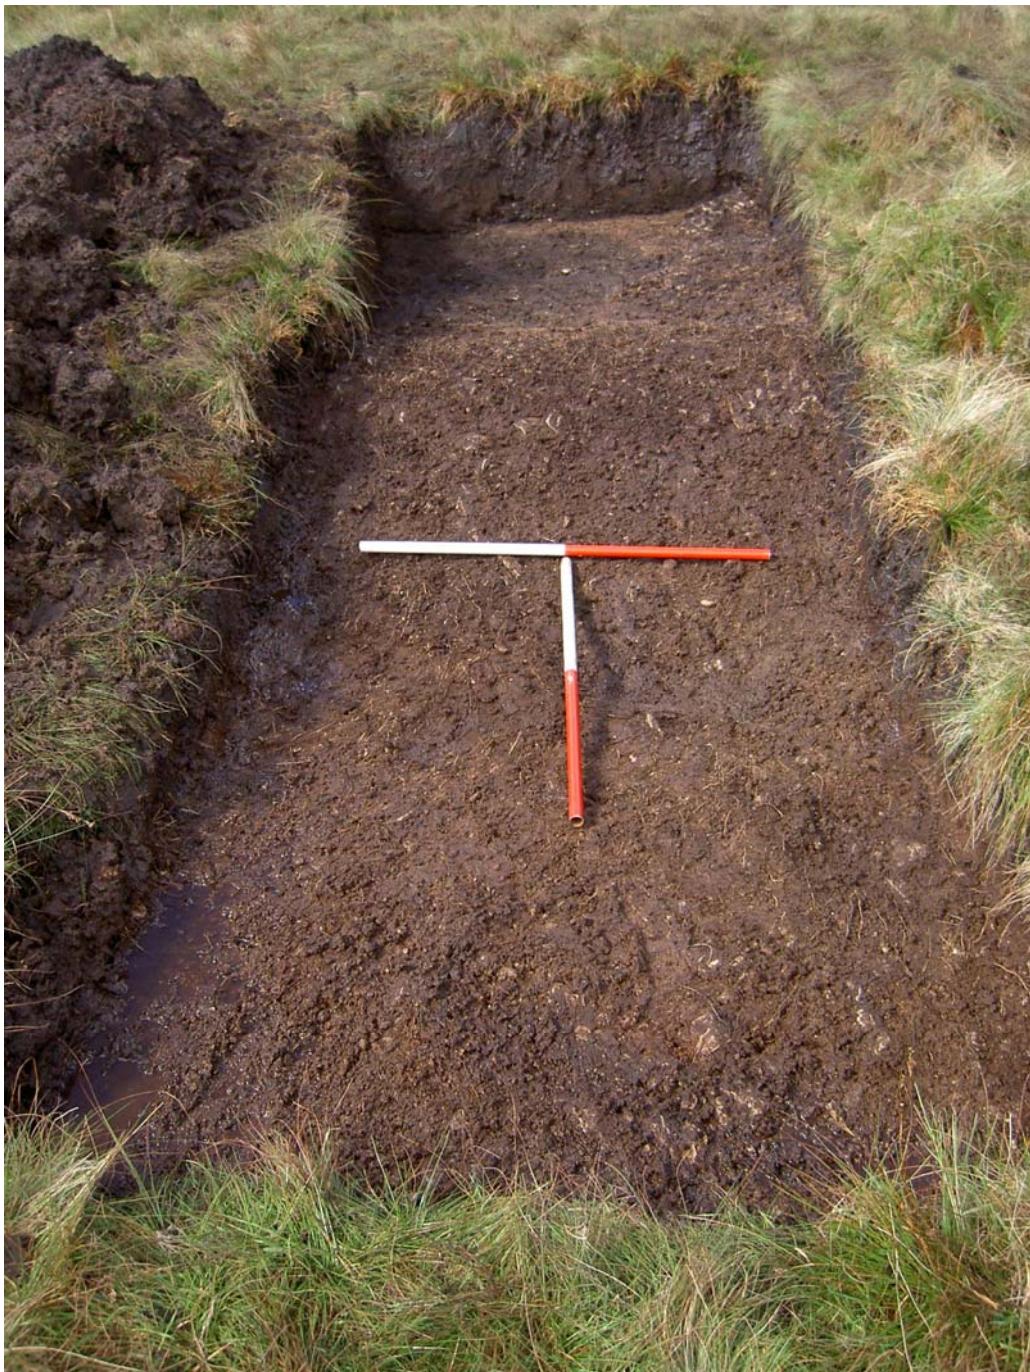
Plate 13: Road surface **201** and bank **209** in Trench 2, looking west

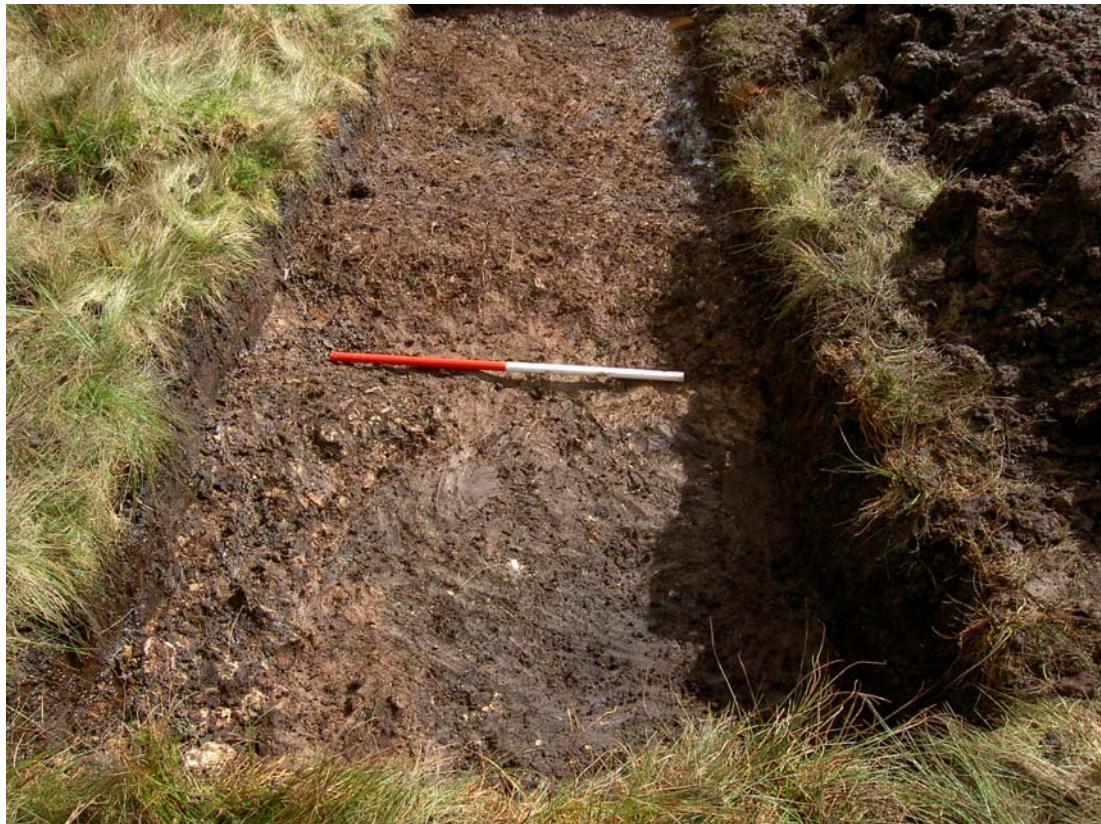
Plate 14: Peat layer **207**, surface **203** and bank **209** in Trench 2, looking east

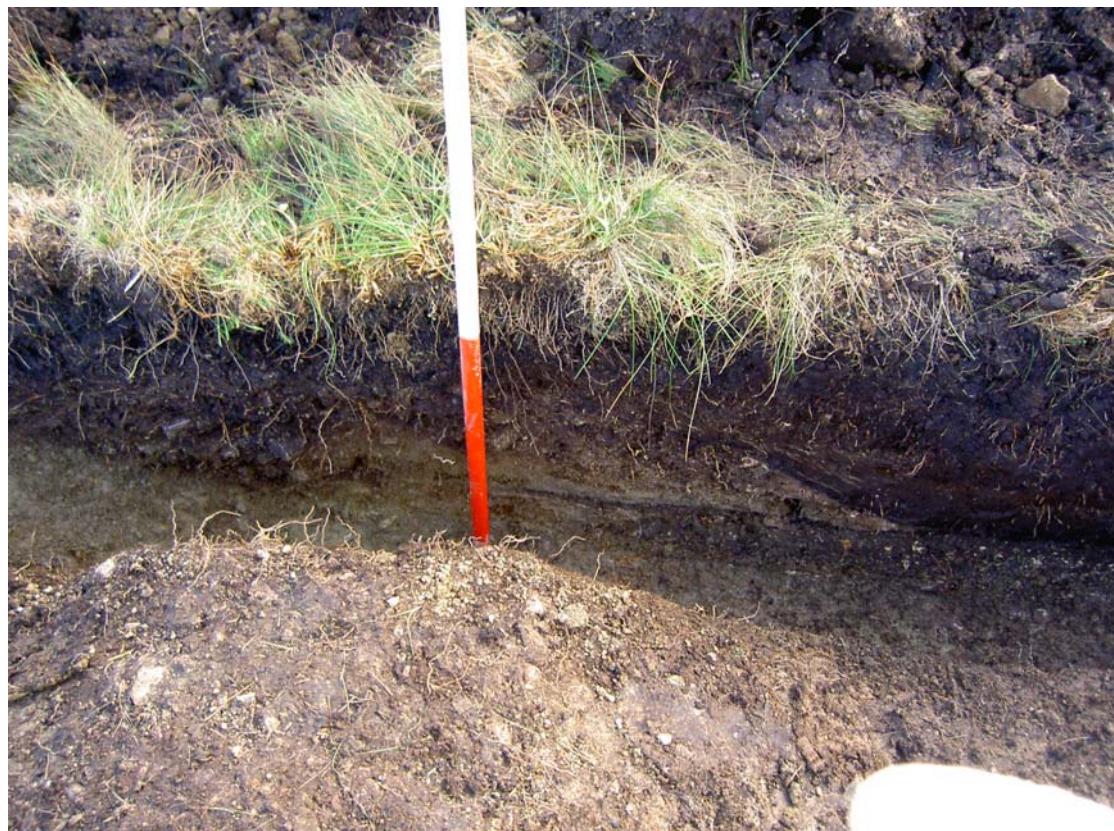
Plate 15: Section through bank **209** in Trench 2, looking south

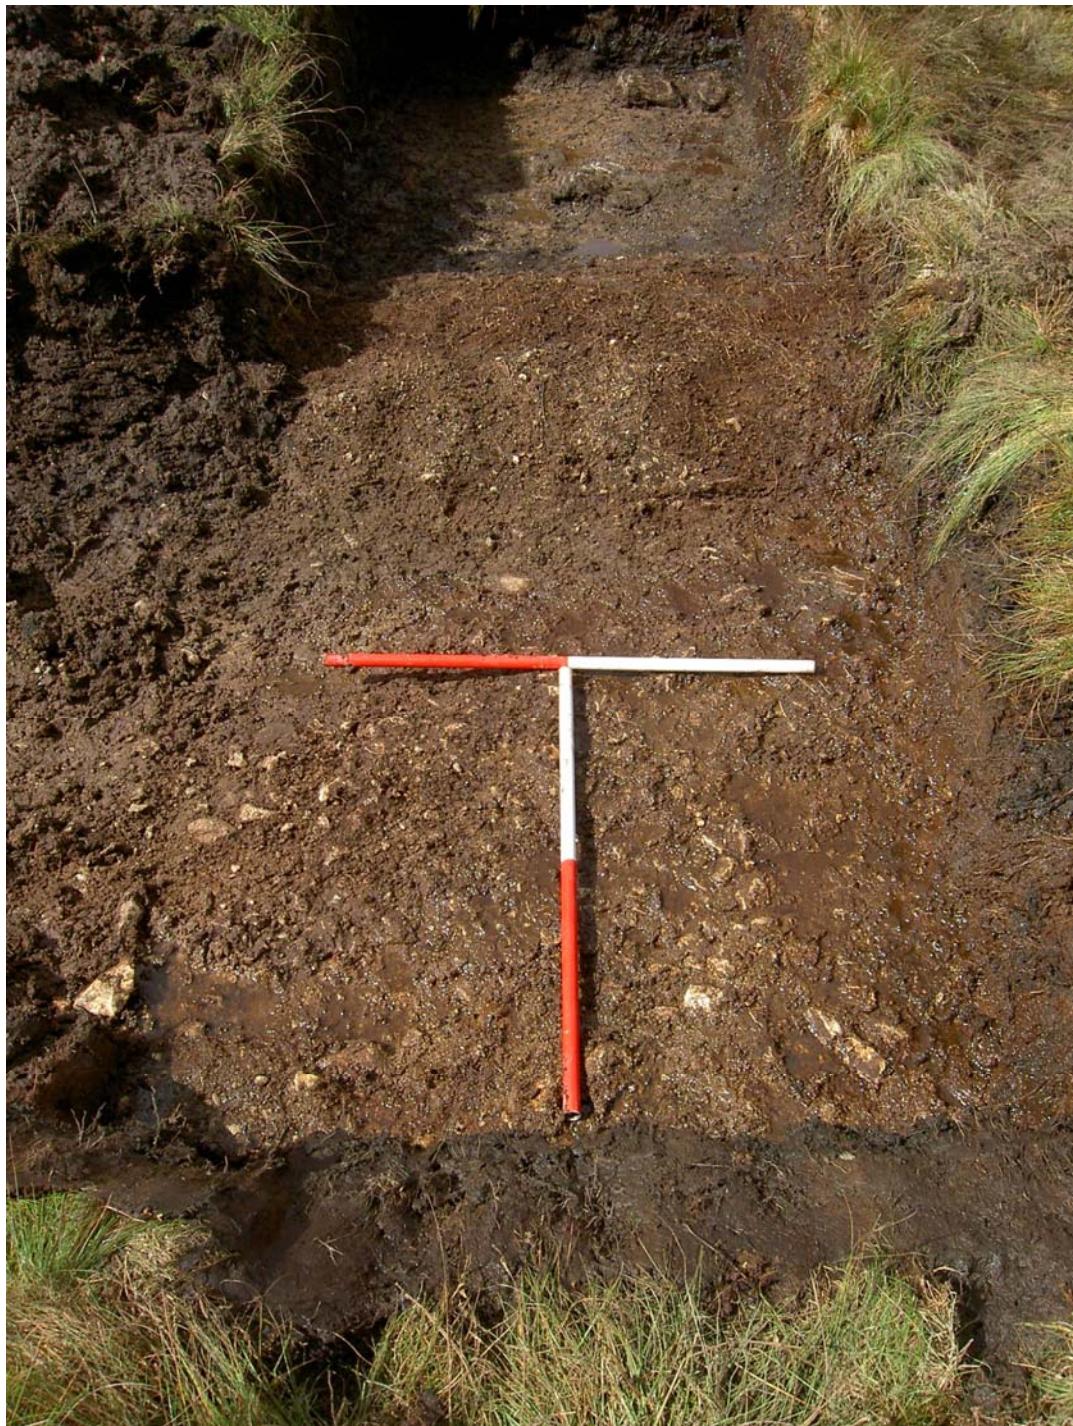
Plate 16: Road surface 301 and bank 307 in Trench 3, looking north-west

5.2.5 **Trench 3:** this too was approximately 5m long and 1.6m wide, but was orientated approximately north-west/south-east (Fig 10). Beneath the turf was a thick layer of soft dark brown or black peat covering the entire trench (**300**). Beneath this, at the south end of the trench was a layer of mid orange-brown firm sandy clay containing 98% sub-angular gravels and pebbles (**301**), which was assumed to be the surface of the road. At the north end of the trench, beneath peat **300**, was a layer of soft dark brownish-grey peat with 20% fragments of decayed gravels and pebbles, up to 0.04m thick (**303**). The north-west and south-east ends of the trench were divided by a raised bank constructed from a soft mid orange-brown silty clay with 10% angular and sub-angular gravels and pebbles up to 0.15m thick (**307**; Plates 16 and 18).

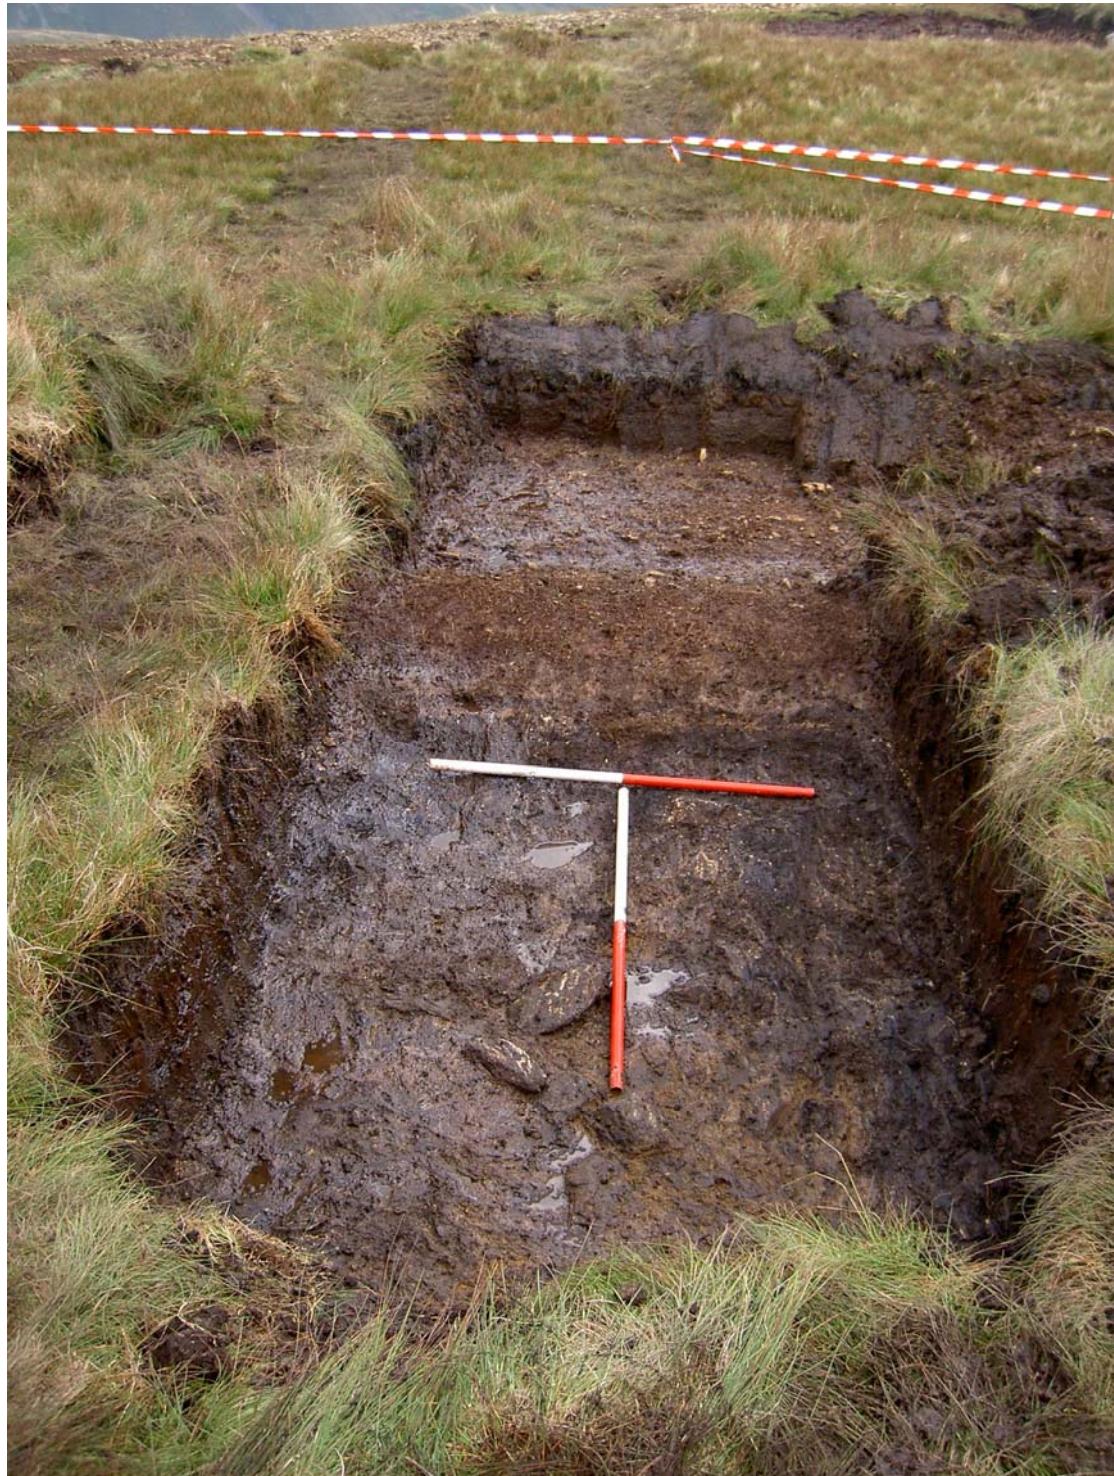
Plate 17: Peat layer **305** and bank **307** in Trench 3, looking south-east

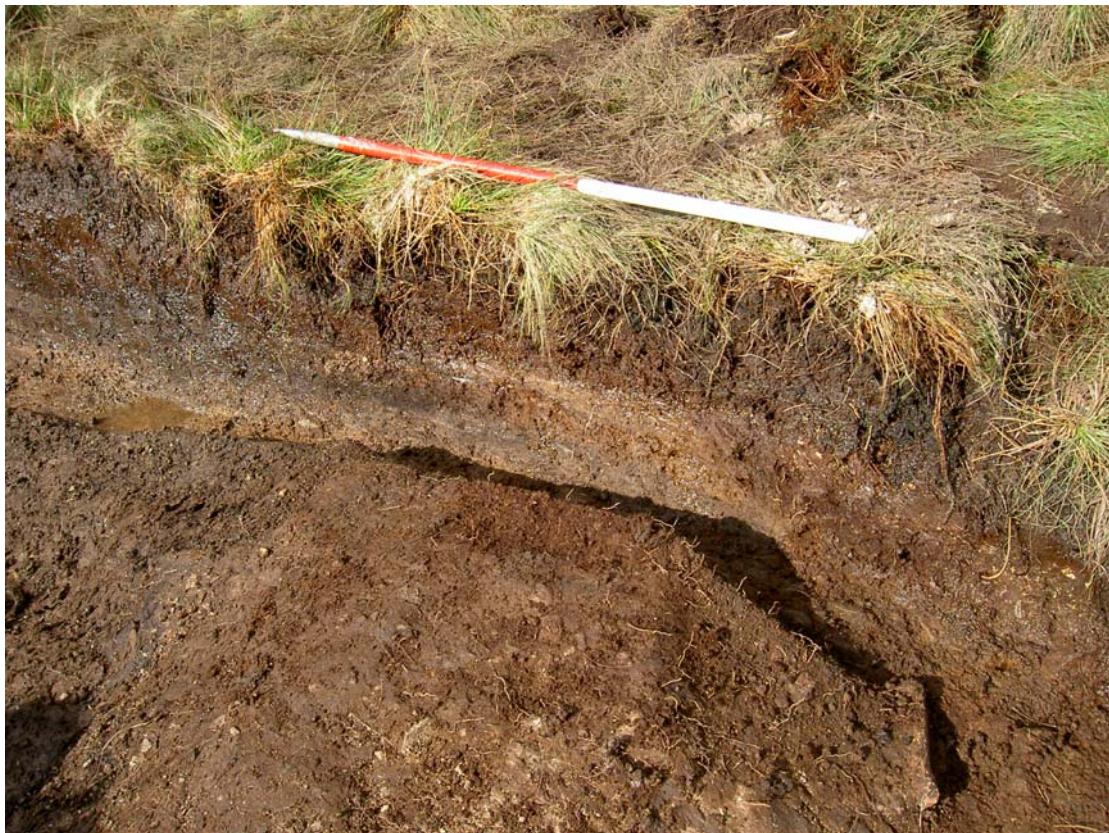
Plate 18: Section through bank **307** in Trench 3, looking north-east

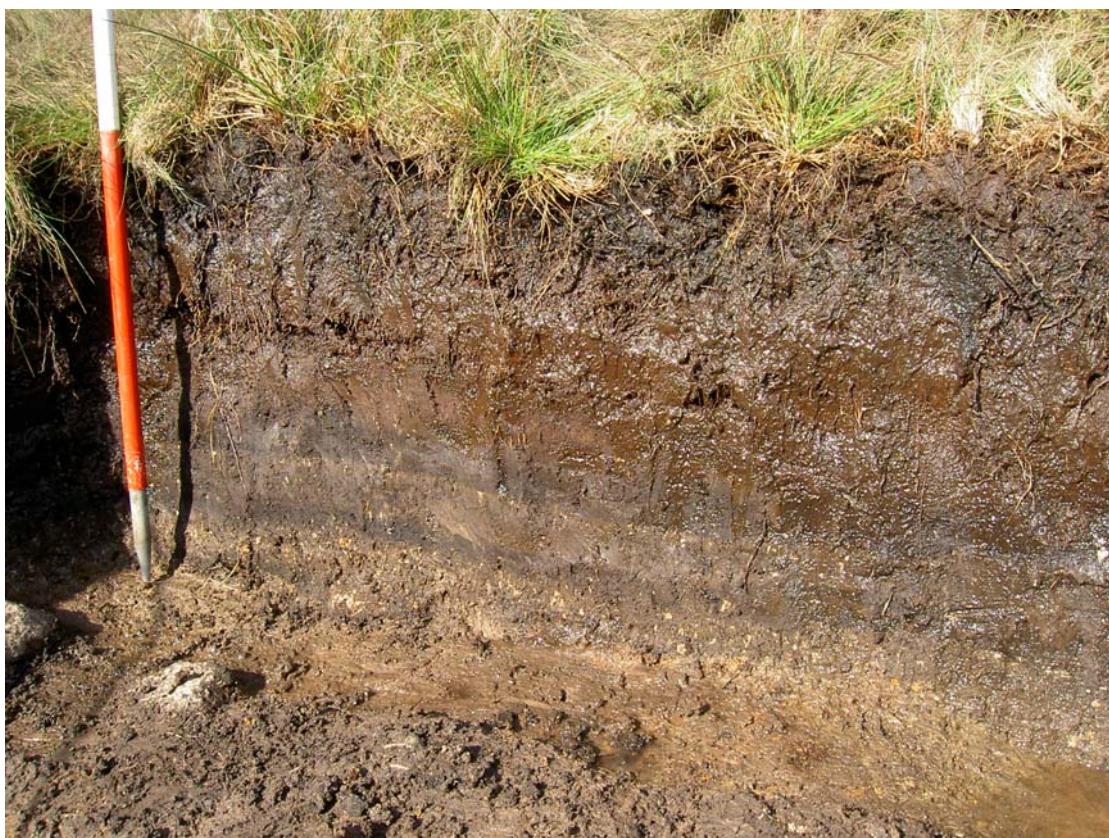
Plate 19: Layers of peat **300, 303-305** at north-west end of Trench 3, looking north

- **Phase 5:** following the construction of the bank a thin layer of peat developed or was deposited against the north side of it (303). The presence of stone flecks within it suggests that it was present during construction or repair of some element of the road or bank building, but it appears to overly the lower edge of the bank and so presumably post-dates it;
- **Phase 6:** following the abandonment of the road a thick layer of peat developed across it (300).
