# BIGGINS HOME FARM, HIGH BIGGINS, KIRKBY LONSDALE, CUMBRIA

Archaeological Building Recording

Client: Brian Anderson  
Planning Ap. Ref.: 5/06/0576  
NGR: SD 59750 78015

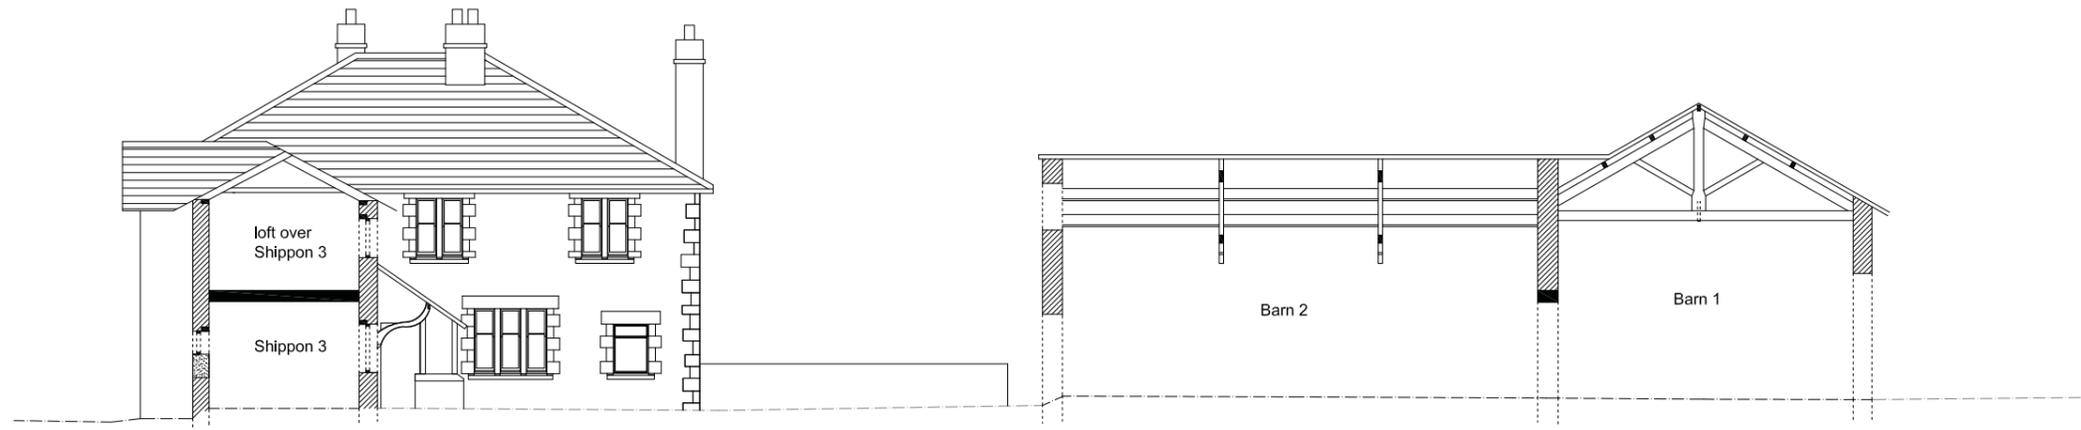
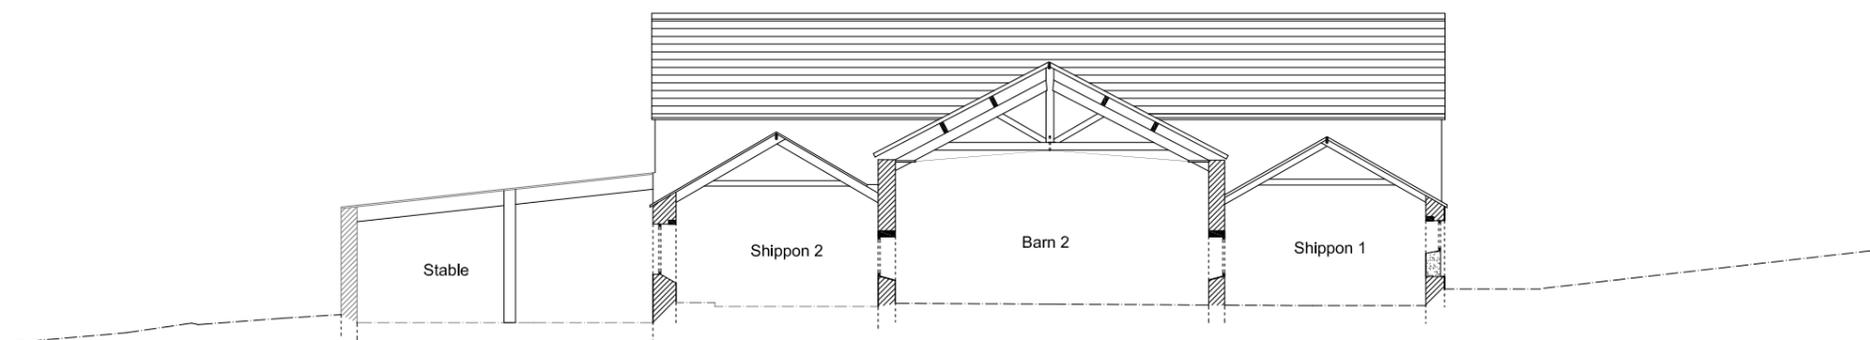
Figure 5: Sections A-A and B-B

South-facing section through Shippon 3 and Barns 1 and 2 (A-A)

West-facing section through Barn 2 and Shippens 1 and 2 (B-B)

plasterboard but its structure is the same as Shippon 1: numerous light-weight trusses with a bolted collar (Fig 5) covered by lathe and plaster and the tiles. The walls are all finished with whitewash above a concrete skim. The north elevation has five apertures, each with sliding shutters constructed from tongue and groove planks on a single rail (Plate 26), and a doorway into Barn 2 at the west. The west elevation is plain, and the south elevation has three windows on the west side, all with sills sloping into the room and four-light timber casements with night-vent openings. There is a smaller aperture at the east end with splayed jambs, a concrete sill, timber lintel and a double-door hatch made from beaded tongue and groove boards. The east elevation has two doorways, with only the north door remaining, which comprises split tongue and groove planks and timber lintels. There is a central window with a railway sleeper forming the lintel and a six-light timber fixed casement and a sloping concrete sill. There are electrical light fittings attached to the east elevation and water pipes attached to the west.

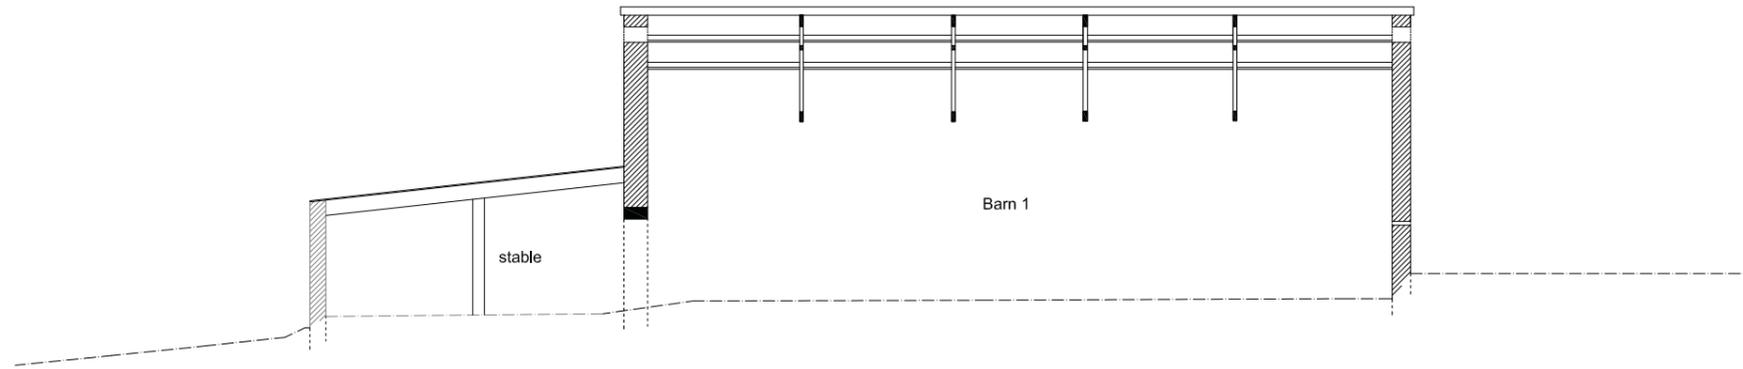
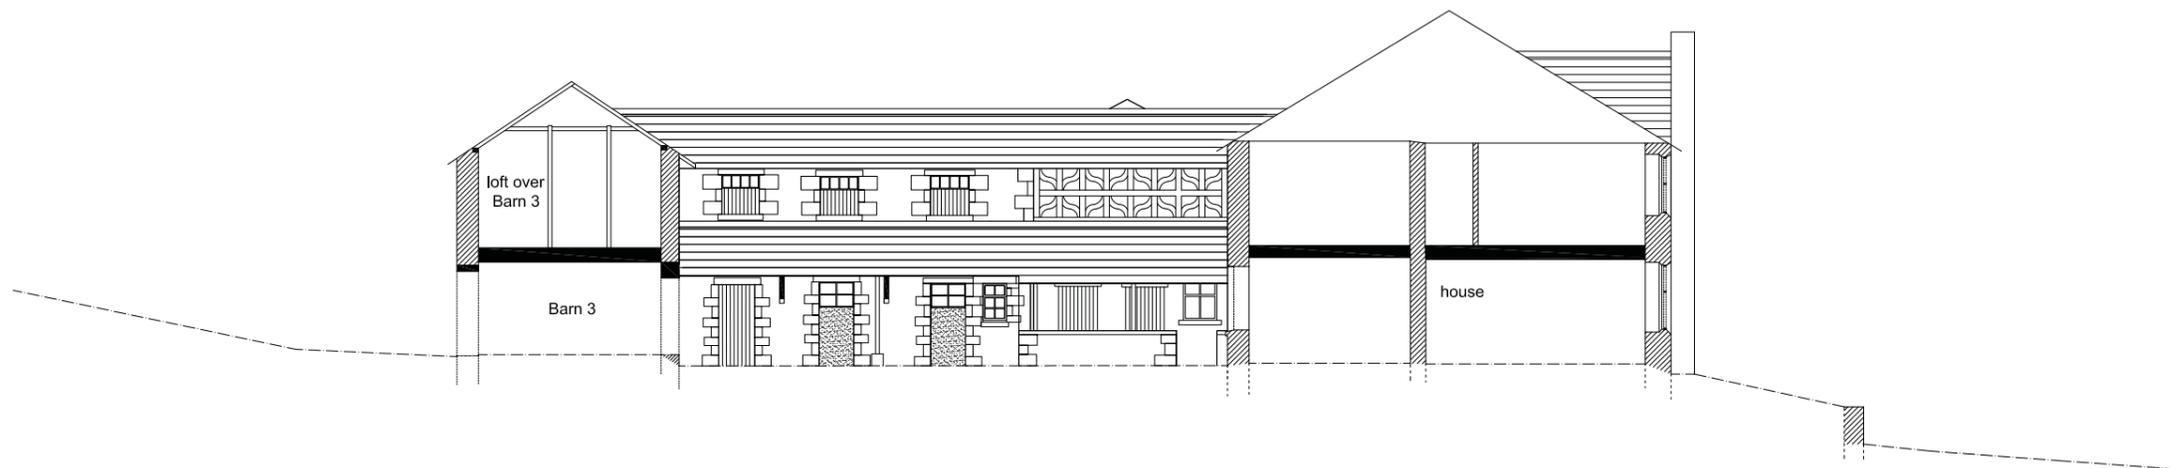
Figure 6: Sections C-C and D-D

West-facing section through Barn 1 and stable (C-C)

East-facing section through Barn 1 and house (D-D)

soffitted to meet the principal rafters and joggled to fit angled braces (Figs 3 and 6; Plate 20). The king posts and principal rafters are bolted to the tie beam. There are two purlins per pitch, plus the ridge purlin, and all of the timber is machine cut. There are eight single-light skylights in the east pitch of the roof and it is hipped to meet the roof of Barn 2 on the east side. The north elevation has six ceramic pipe vents inserted into the wall and there is an owl hole below the apex. The east and west elevations have possible scars of fittings, perhaps indicating the position of animal stalls, and there is an inserted wagon doorway in the centre with a possible railway sleeper forming the lintel. Two sets of three ceramic pipe vents have been inserted through the wall within the hipped section. The south elevation has an owl hole below the apex and a large inserted doorway with two possible railway sleepers forming the lintel. The west elevation has 12 ceramic pipe vents inserted through the wall, six either side of the central wagon doorway. Like the east elevation there are possible scars for stalls across the whole elevation.

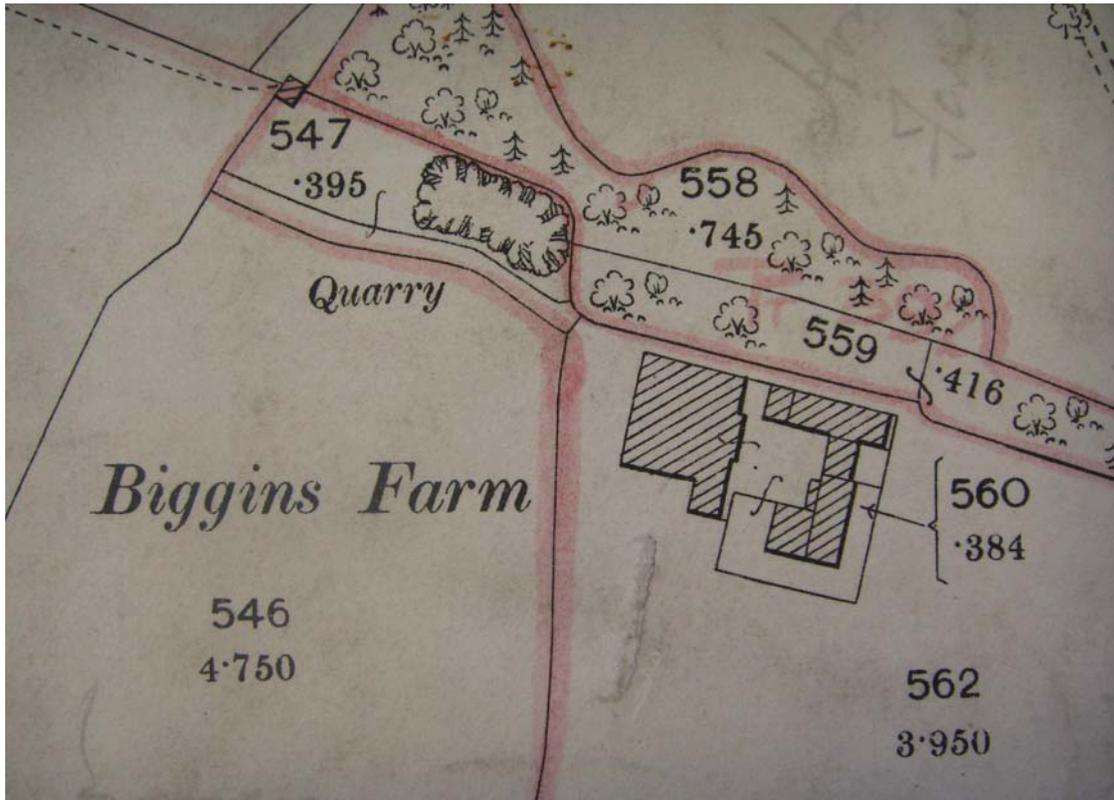
Plate 1: Part of the Ordnance Survey map of 1898 showing 'Biggins Farm'

- **Ordnance Survey 1898:** by this date the farm has been constructed and it has essentially its present form (Plate 1). Some of the divisions between the individual buildings are clearly inaccurate, however, as the agricultural buildings of the east range are shown running southwards into the house.

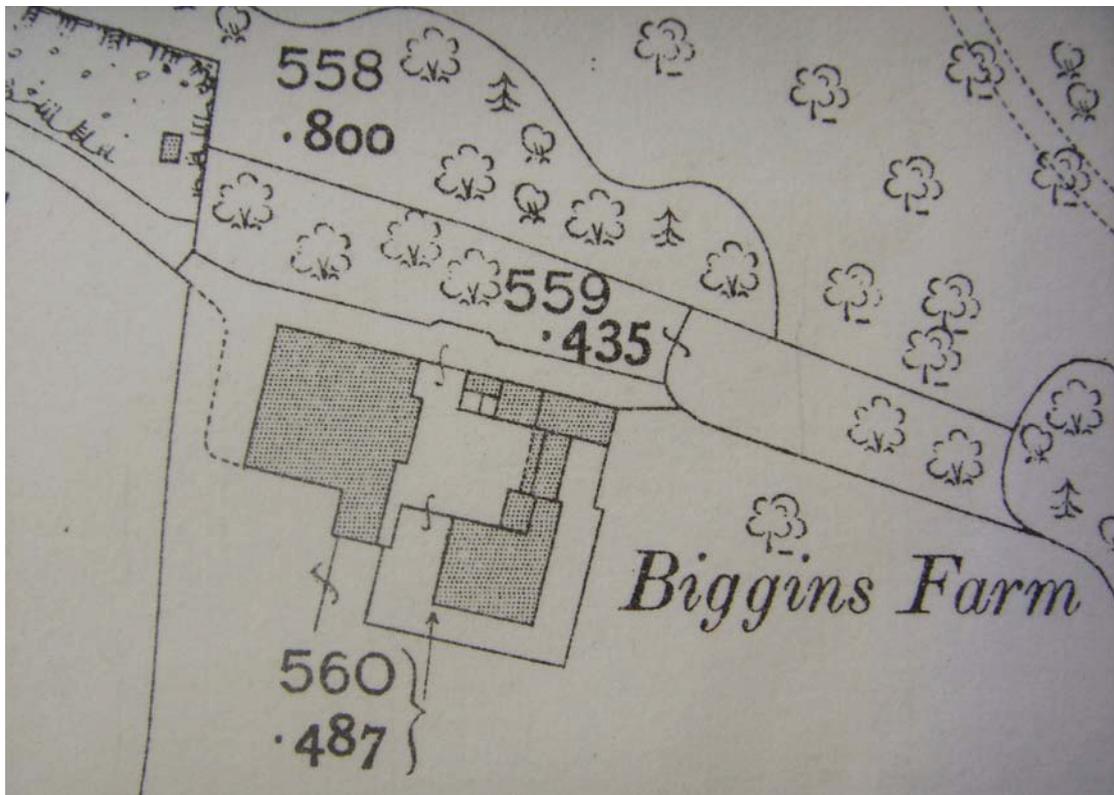
Plate 2: Part of the Ordnance Survey map of 1914 showing 'Biggins Farm'

- **Ordnance Survey 1914:** this shows much of the same detail, although the mistaken internal divisions shown on the previous map have been corrected (Plate 2). There appears to have been some alteration made to the west end of the eastern range, as the south side of this is shown as a pair of open yards, rather than covered as it was in 1898 and is at present.

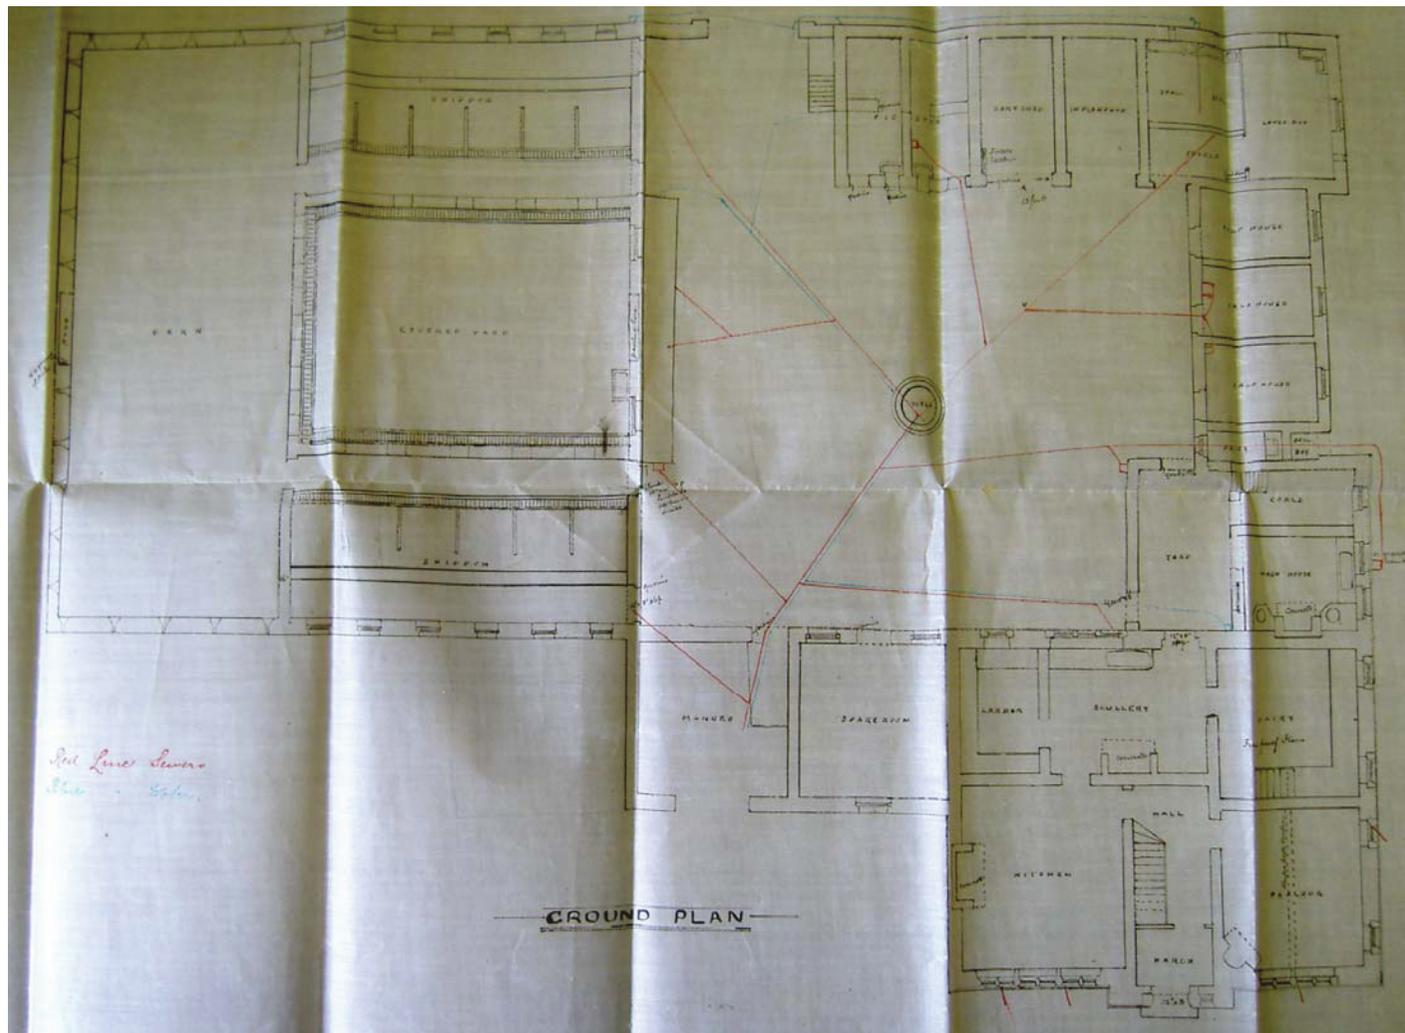
Plate 3: An undated plan of 'Biggins Farm' showing clean and foul water pipes, possibly in the 1950s (CRO(K) WD/BIG/2/17 1952-6)

- **Specifications for services 1950s:** an undated plan showing clean and foul water pipes at the farm, within a bundle of papers dating from between 1952 and 1956 and relating to the installation of electricity, show the site in some detail and indicate what the various buildings were being used for at this time (Plate 3). It shows that in the west range Barn 1 and Shippons 1 and 2 had their most recent function, while Barn 2 is described as a covered yard. The east range was considerably different with the calf pen forming two pig sties, the dairy divided into a cart shed and implement store, Barn 2 being used as a stable and loose box and Shippon 3 divided into three calf houses. Closer to the house the toilet was present and the scullery is described as a wash house, although the entrance to the stairs was used as a coal store and the empty alcove on the east side of the east range was a 'soil box'. In the centre of the yard there was a large well.

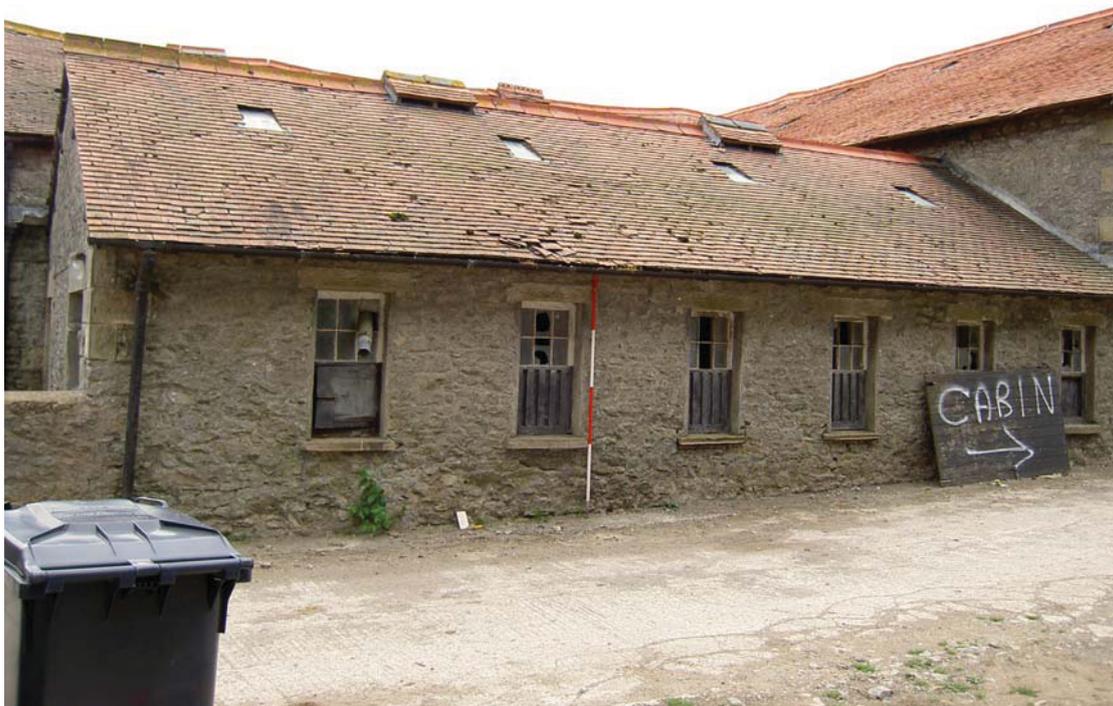
Plate 5: The west end of the north elevation (Shippon 1)

4.3.3 The eastern part of the western half of the north elevation comprises the single storey side of Shippon 1 (Plate 5). The walls and roof are of the same fabric as that seen elsewhere in the building, although there are two tiled louvres built onto the ridge and four single light skylights in the north pitch. A plastic gutter and iron downpipe are also attached. There are six windows arranged across the elevation, each with a six-light upper section and a filled but recessed lower section covered by timber slats. The easternmost is not filled, however, and is filled by a small hatch. To the east of Shippon 1 the elevation is made up of the gable of Barn 1 (Plate 6). This is very plain, and of the same build as the rest, with dressed sandstone quoins at the corners. In addition, there is a circular owl hole below the apex, formed by two neatly dressed pieces of sandstone; a single purlin end is visible projecting through the wall and six ceramic pipe ventilators have been inserted through the wall.

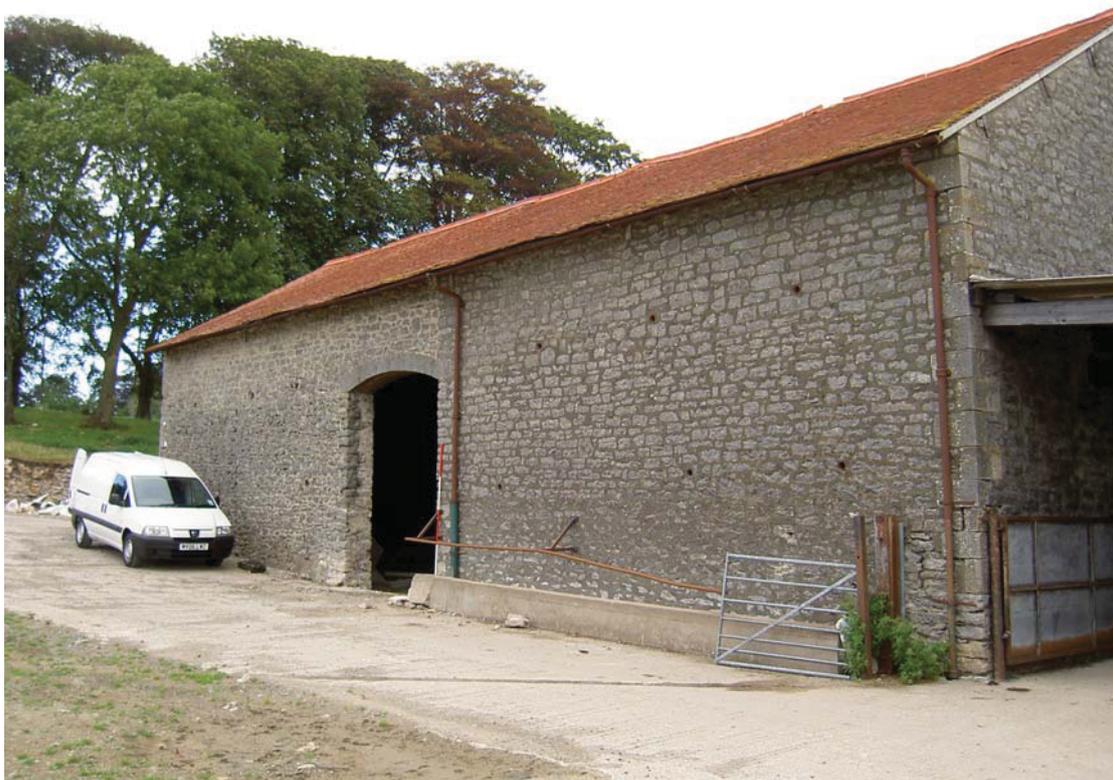
Plate 7: the west external elevation (Barn 1)

4.3.4 **West elevation:** the majority of this comprises the side of Barn 1 (Fig 3; Plate 7). This is of the same build as seen elsewhere, although with quoins only present at either end and not around the central doorway. The roof has cast iron rainwater goods. In the centre is a large wagon doorway with a round voussoir stone arch and across the elevation 12 ceramic pipe ventilators have been inserted – the six to the south of the doorway are slightly smaller in diameter and a darker red in colour than those to the north. Above and to the north of the wagon doorway is evidence for a considerable amount of repointing. The south end of the elevation continues into a simple concrete block structure presently used as a stable. This has a monopitch corrugated concrete roof supported by round timber posts and beams (Plate 8). The north side is effectively open, although it has been partially covered by modern plywood and a metal gate.

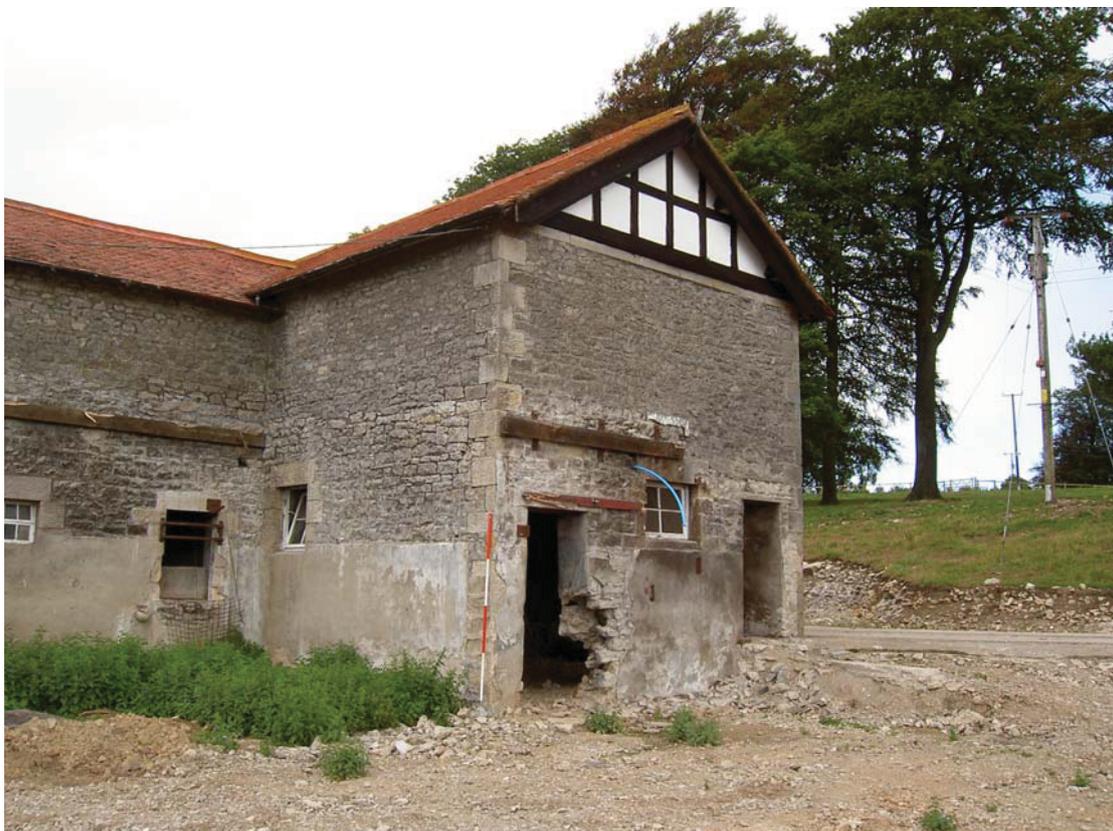
Plate 13: The east elevation of Barn 3

4.3.7 At the north end the wall returns to form the end of Barn 3 (Plate 13). There is a single window within the return with a four-light casement with a night vent opening, and the lower part of the wall is again covered by a concrete skim. The gable of Barn 3 is of the same build as the rest of the complex. The upper section has a string course of dressed ashlar blocks below a timber framed fascia and the ends of the purlins project through behind a barge board. On the ground floor there are two inserted doorways with concrete lintels either side of a window with dressed quoins and an iron four-light casement. The lower part of the elevation is covered by a concrete skim and part of the north jamb of the southern doorway has collapsed, presumably as a result of the demolition of the attached modern buildings. There is a large timber beam attached to the wall above the doors and a smaller batten below along with smaller iron brackets, all of which presumably relate to the buildings originally situated to the west.

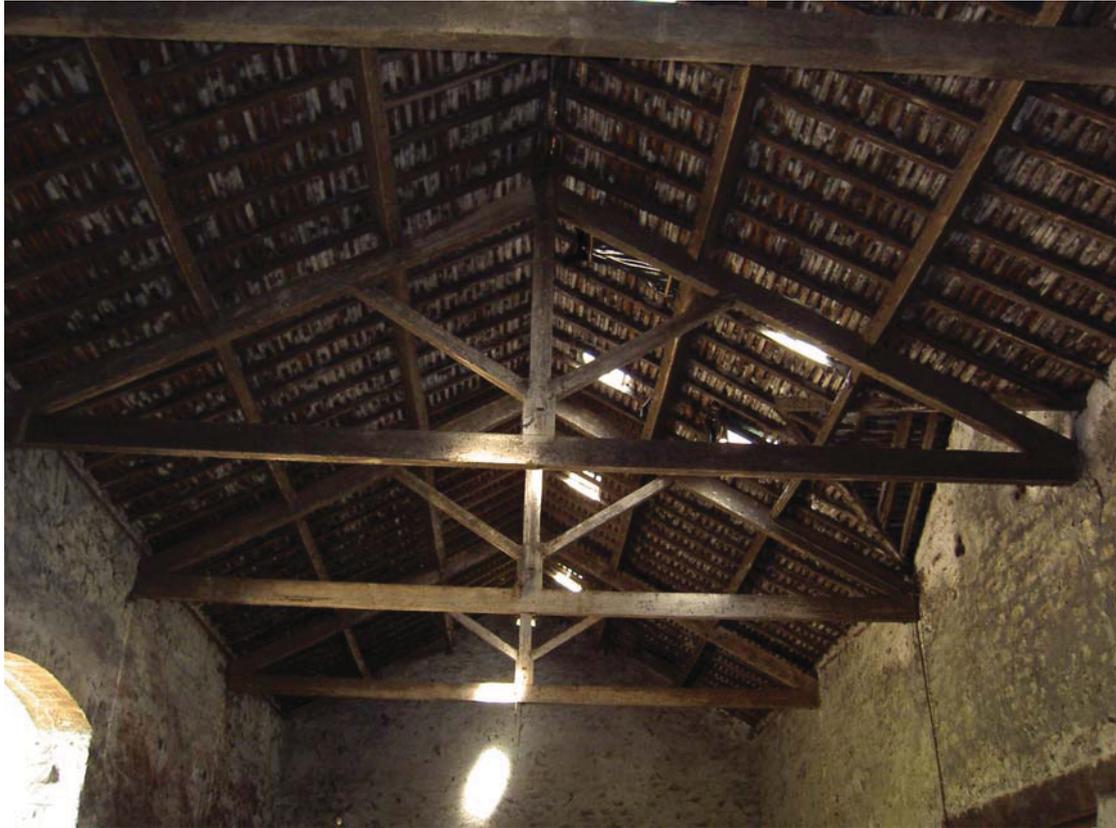
Plate 20: The trusses within Barn 1

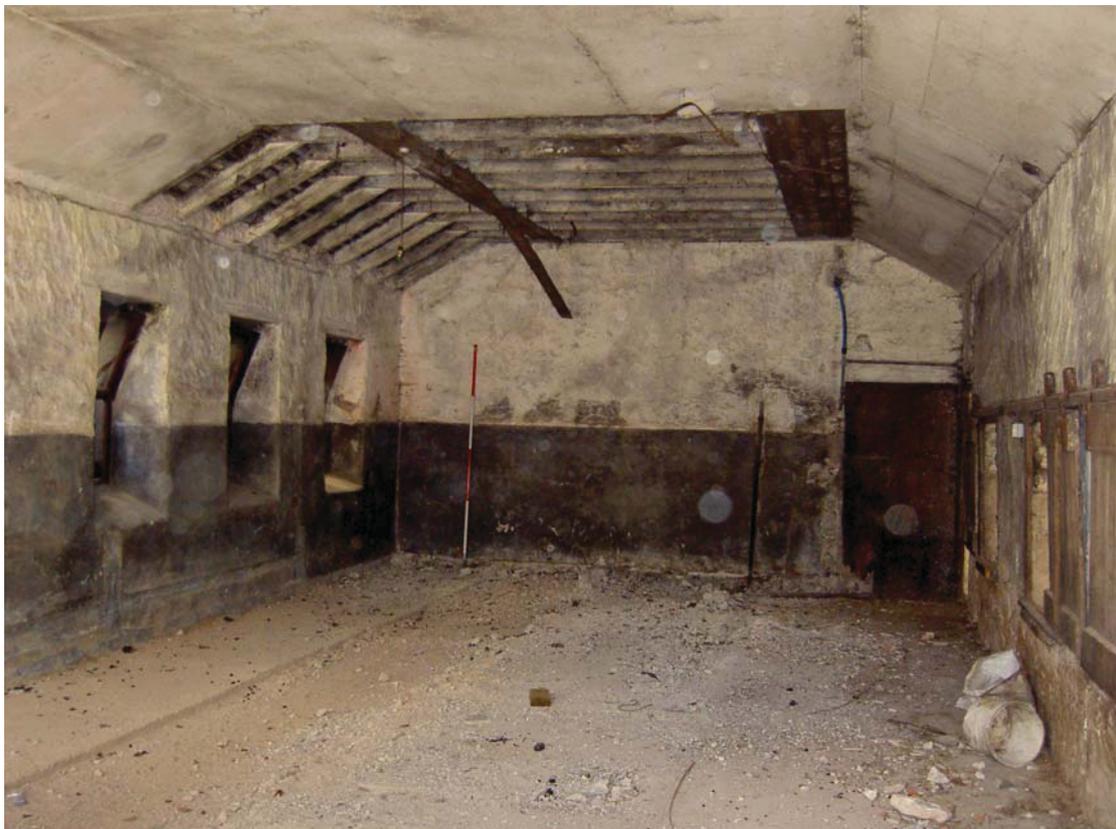
Plate 25: General view of Shippon 2

4.4.5 **Shippon 2:** although this is essentially a mirror image of Shippon 1, there are numerous differences. The concrete floor is still present, and there are scars of possible stalls perpendicular to the north elevation, which were evidently constructed from concrete with iron reinforcing (Plate 25). The majority of the roof is covered by

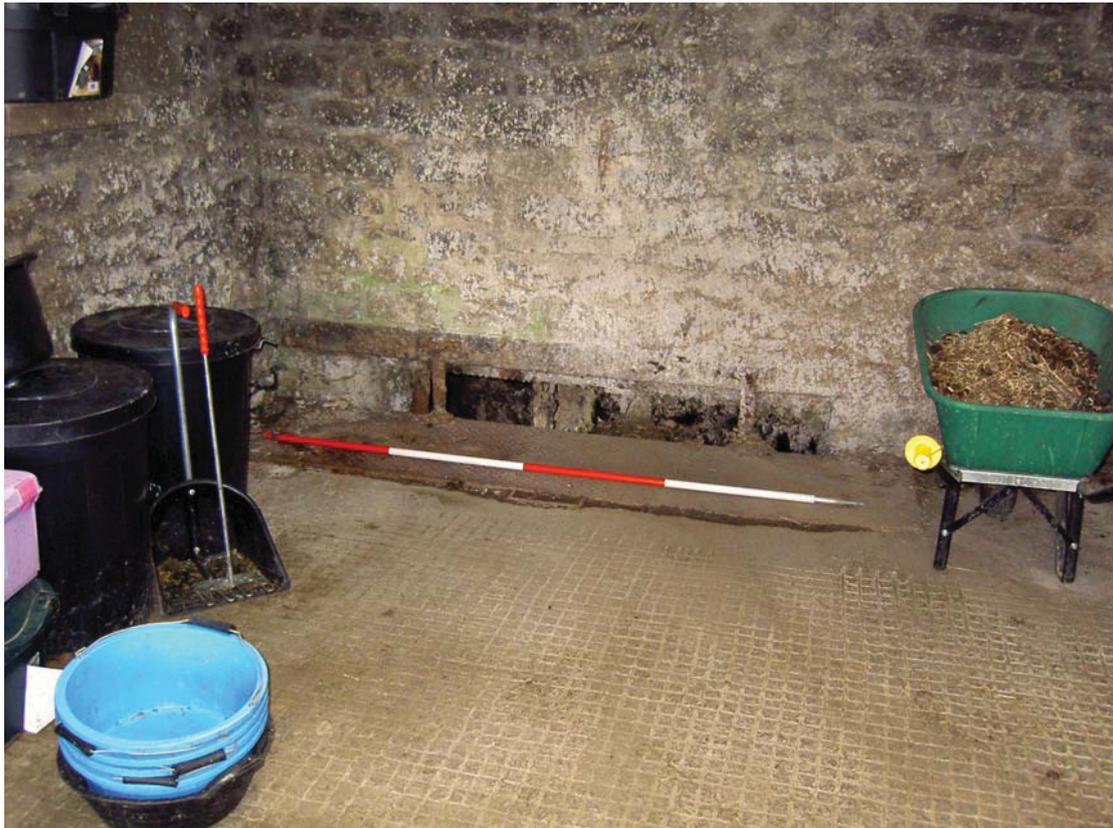
Plate 30: Chute from the east side of the stables into the midden

4.4.8 **Stables:** these are situated to the south of Barn 1. The floor is concrete with an impressed grid pattern, while the monopitch roof is built of corrugated concrete on six beams orientated north/south which are inserted into the wall of Barn 1 to the north and supported by round posts (Figs 5 and 6) . The north elevation has three windows looking into Shippon 2, all of which have stone sills and lintels and four-light night-vent opening casements (Plate 29). There is a large inserted doorway to the west, the jambs of which are built up with concrete blocks and two railway sleepers have been used for the lintel. The south wall is built concrete block, as is the southern half of the east wall; the northern half being made up of the wall of the loose box. There is a low-level aperture through this wall into the midden below (Plate 30).

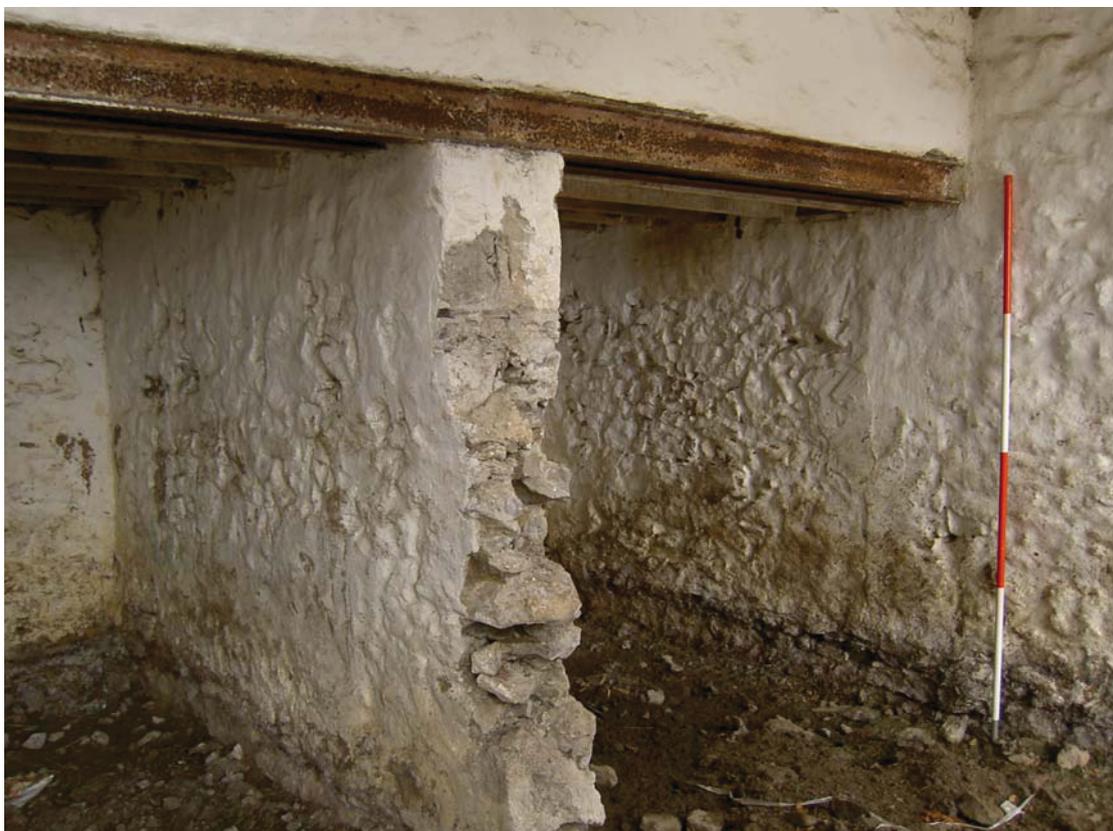
Plate 31: Iron beam supporting the north side of the ceiling of the calf pen

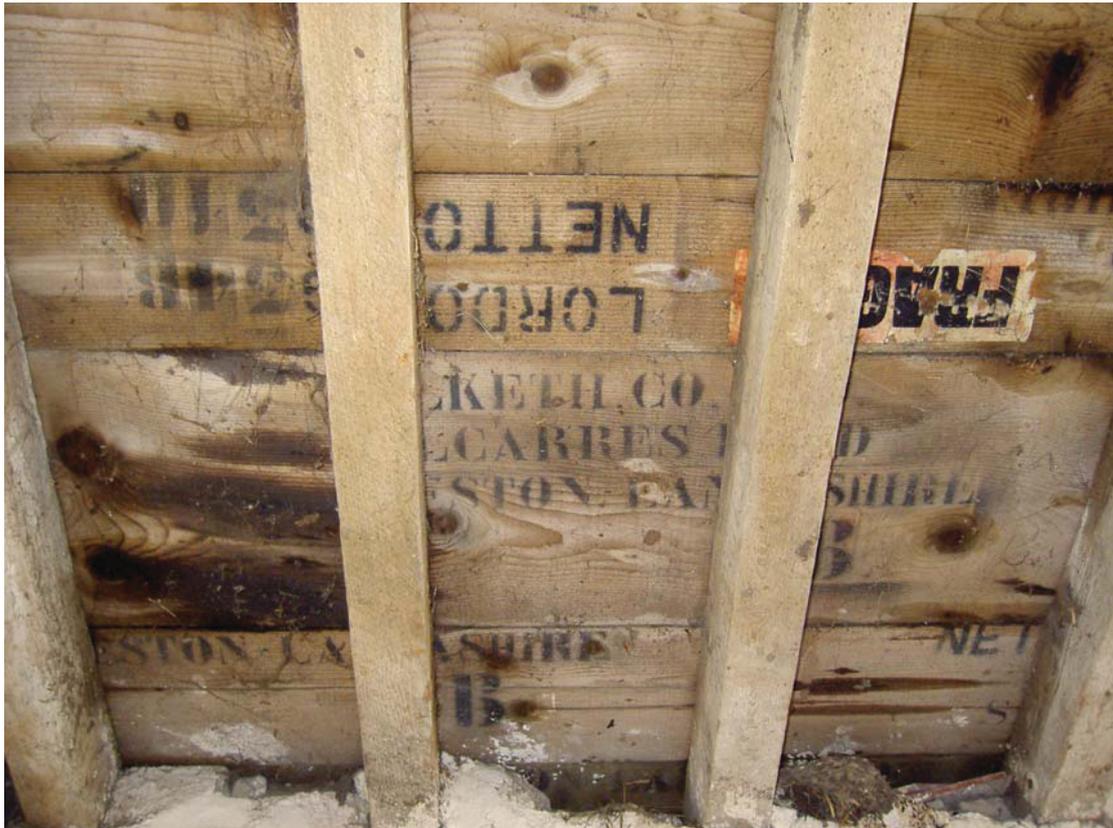
Plate 32: Details of packing crates used in ceiling of calf pen

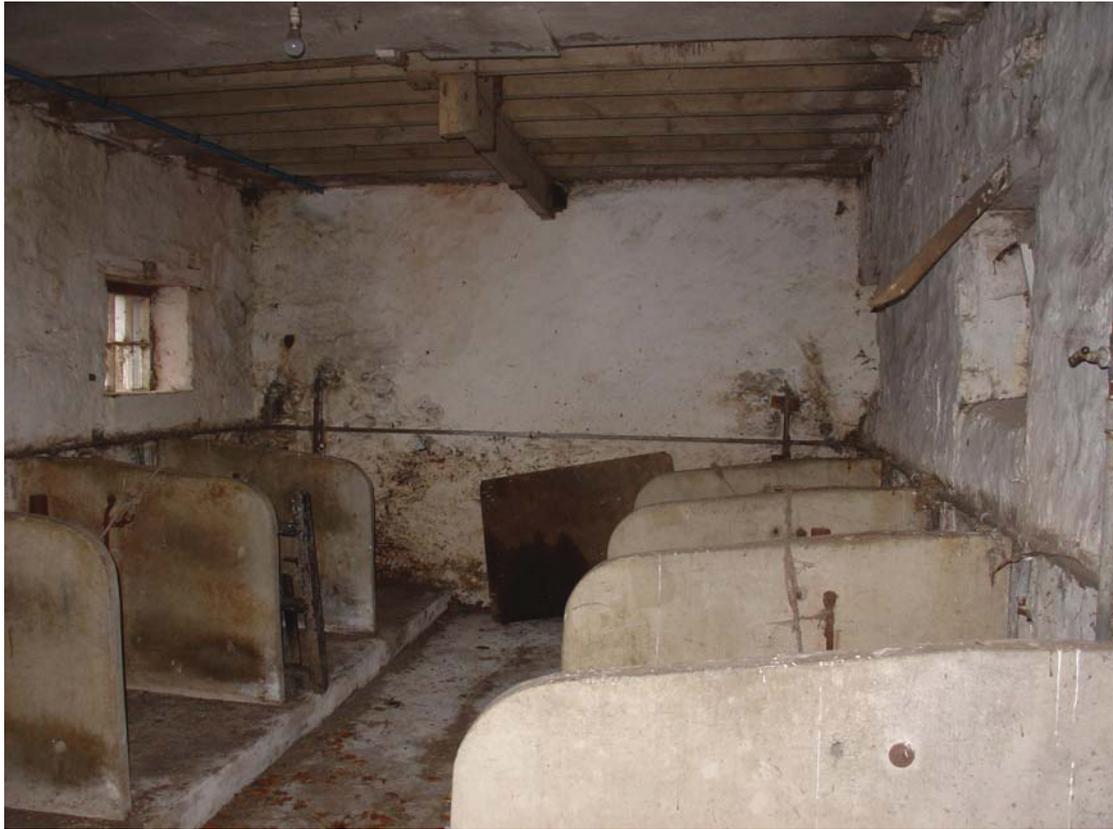
Plate 40: Shippon 3 prior to removal of stalls, looking south

- **Shippon 3:** concrete stalls were positioned along the east and west wall (four per side; Plate 40). The floor was concrete, with a dung channel orientated north/south, which turned to the west at the north end. There was a ladder in the north-west corner attached to the north wall.

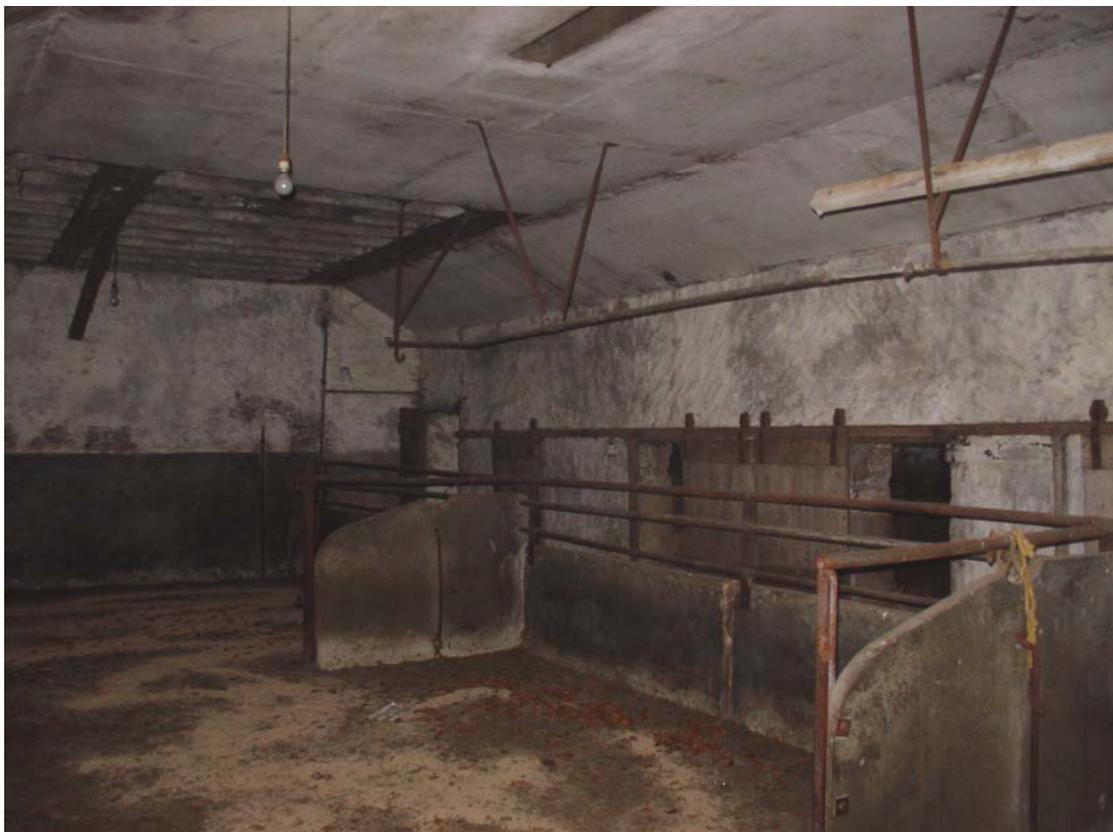
Plate 41: Shippon 2 prior to removal of stalls, looking west

- **Shippon 2:** two concrete stalls with associated iron rails were positioned along the north wall and a concrete trough below an iron manger was positioned against the south wall (Plate 41);
