FORMER ROGERS AND TYSON WAREHOUSE, BUXTON PLACE, ULVERSTON, CUMBRIA

Archaeological Building Recording

Client: JG Black Polymers Ltd
Planning Ap. Ref.: SL/2007/0452-3
NGR: SD 28684 78493

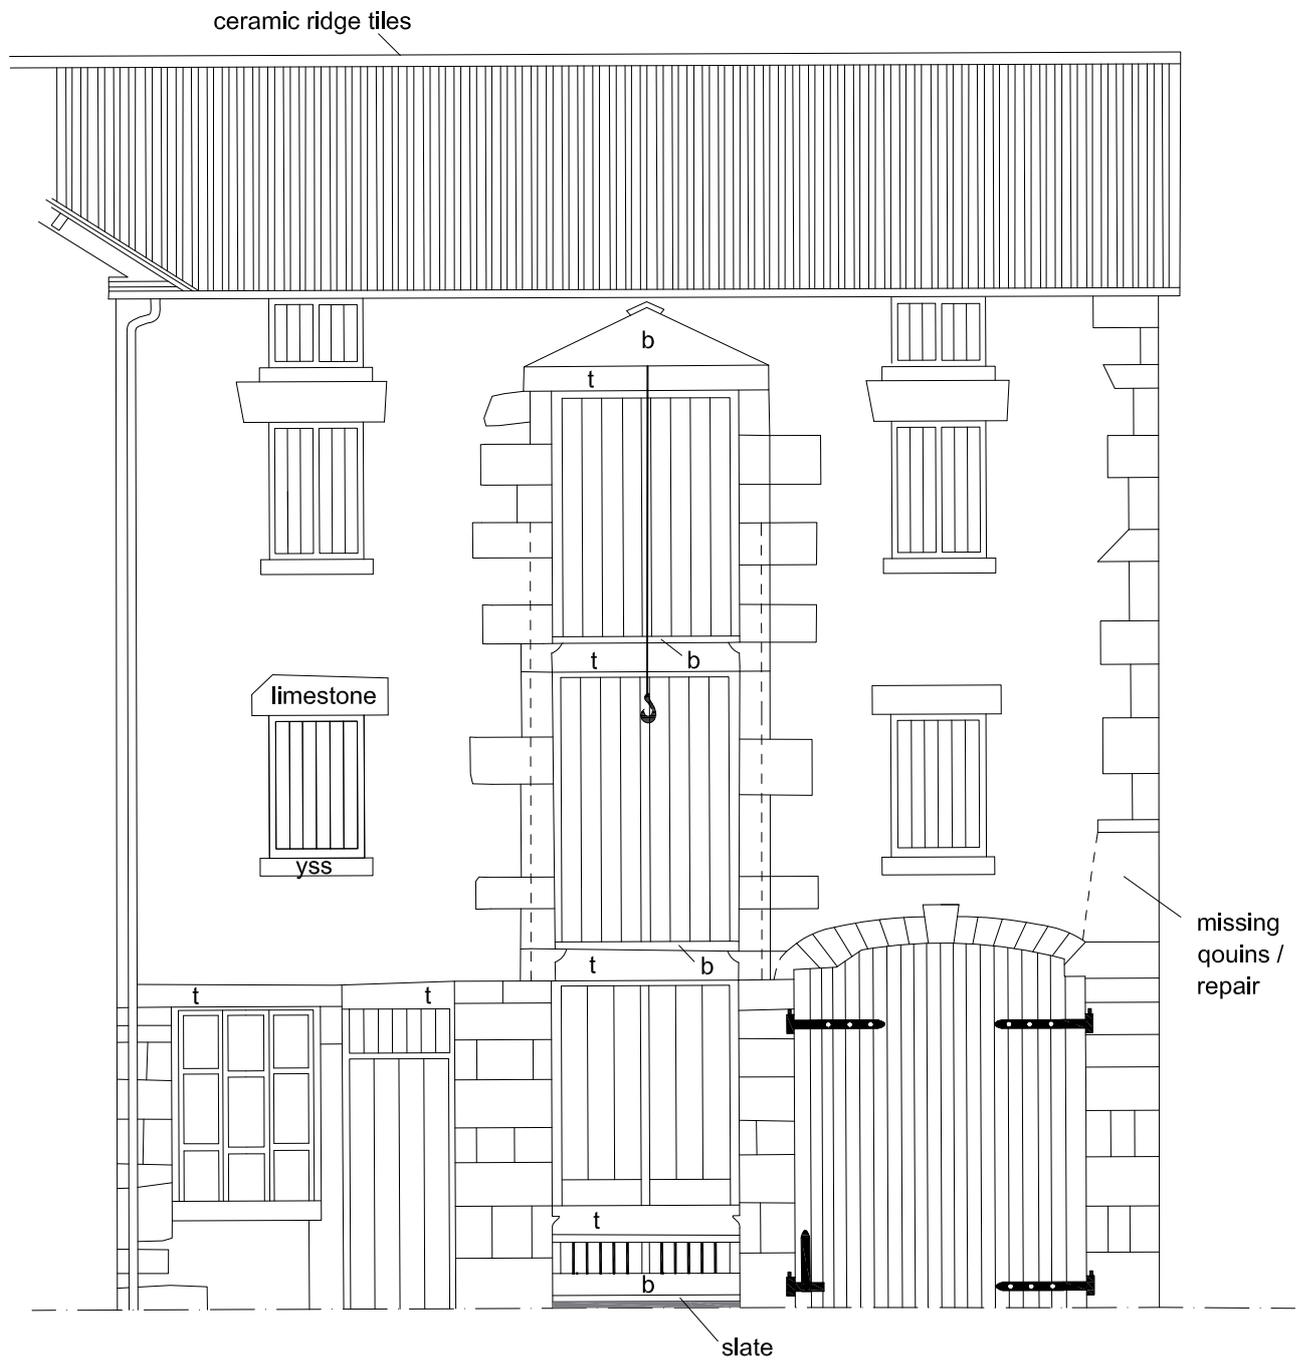
Figure 3: North external elevation

4.3.1 **North elevation (Fig 3; Plate 4):** the upper two floors and the loft are lit with casement windows with vertical timber bars/divisions. The loft windows are half the height of those below and this level appears to be a later addition; the stonework around the hoist canopy certainly appears to have been re-built. There are three tiers of central loading doors beneath a canopied hoist, the first and second floor doors are seated above timber platforms carried on corbelled quoins. The lower door is raised above street level and sits above an oak beam, below which is an inward opening hinged board flap that is barred externally. There is a single bay either side of the ground floor loading slot; to the west there is a wagon doorway beneath an elliptical arch with a keystone and limestone voussoirs, and to the east there is a pedestrian entrance and a boarded window. There is a grey plastic downpipe at the eastern end of this elevation that is fed from plastic guttering. All the timber boards and panels have been painted an orange-brown, and the wagon entrance doors open outwards and are hung on large iron strap hinges.

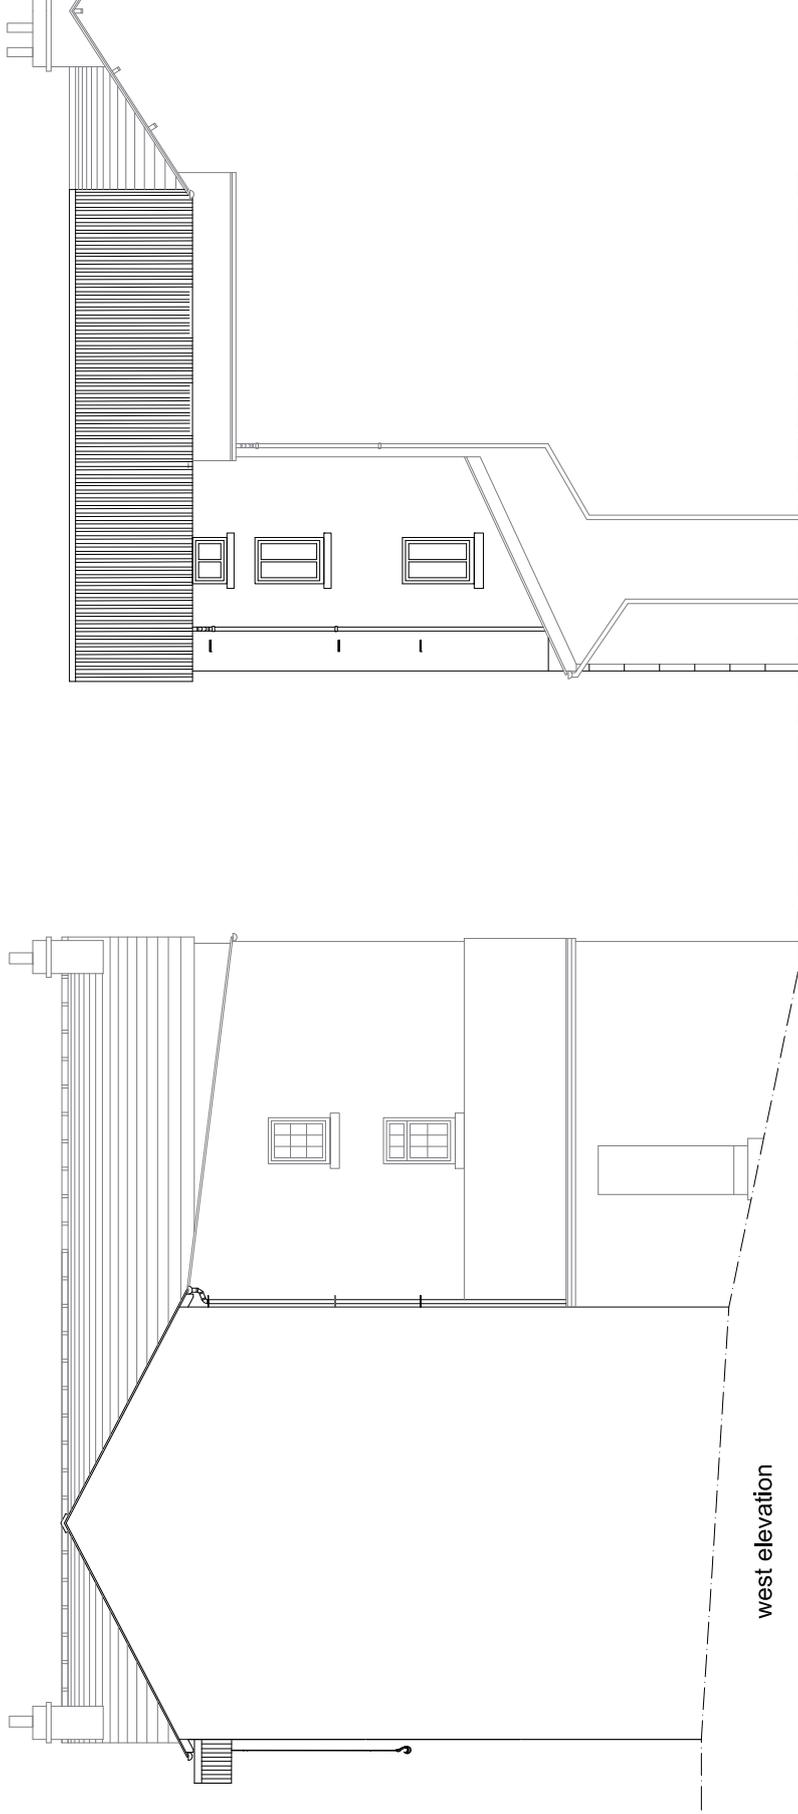
Figure 4: South and west external elevations

4.3.2 **West elevation (Fig 4; Plate 5):** this elevation is entirely plain and coated with a gritty render. There is a patch of recent smooth grey cement render halfway up the north side of the elevation, and a strip of pinkish pale brown render along the entire base of the elevation up to a height of about 0.70m. There is lead flashing along the roofline.

4.3.3 **South elevation (Fig 4; Plate 6):** all that is visible of this elevation is the upper two floors and loft on the west side. There is one window per floor, the loft level window being half the height of the two below. All the lintels are hidden behind the

render but each window has a hard yellow-grey sandstone sill. The windows are orange-brown painted timber fixed casements with two vertical panes. A black plastic downpipe runs down the west side of the elevation and drains into the guttering on the monopitch roof of No.1's extension. Along the roofline and down to the west of the downpipe are iron hooks indicating the line of the original guttering system.

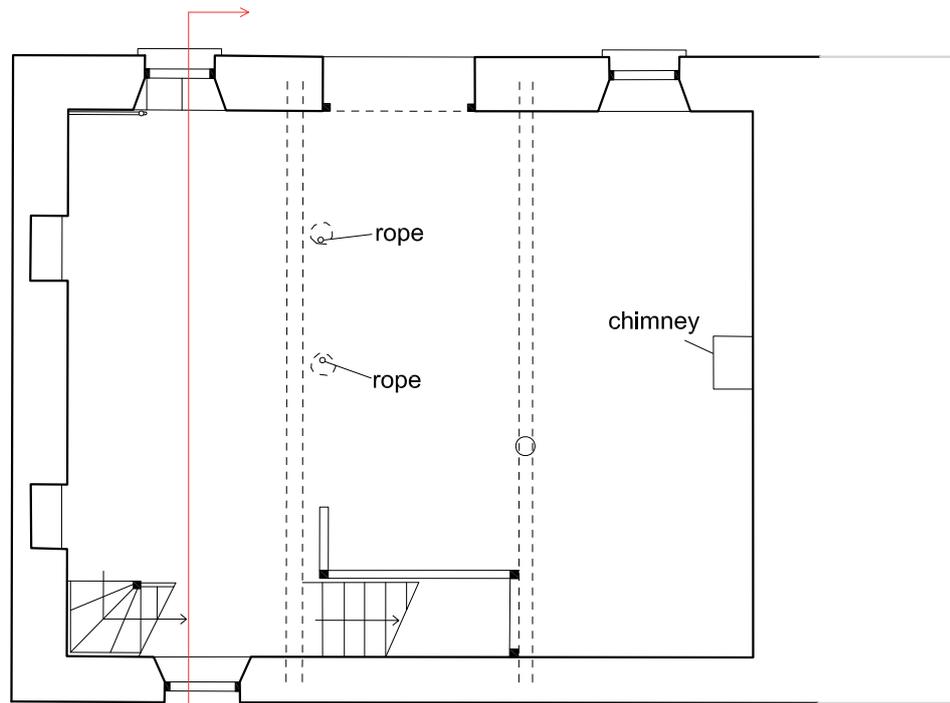
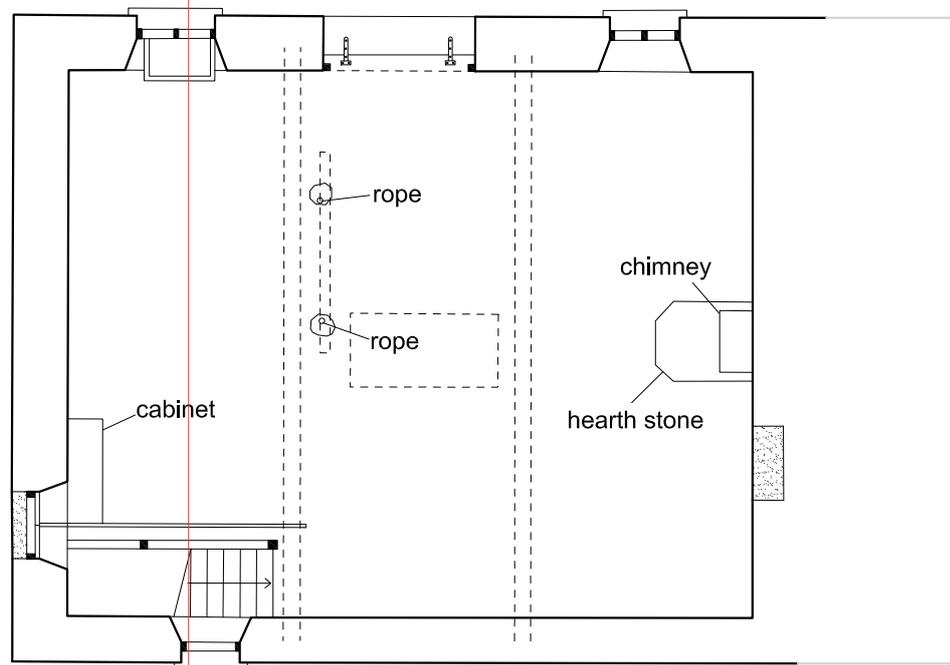
Figure 6: First and second floor plans

4.6.1 *North elevation*: this elevation features matching windows with splayed jambs either side of the central loading doors, and the walls are covered in pink painted plaster. The windows are modern with fixed casements constructed from machine cut stained timber, and have five vertical struts holding glass that is reinforced with wire mesh. The west window has a recess in the sill area that probably housed a sink; the recess is 0.35m deep north to south, 0.35m wide east to west and 0.40m in height.

4.6.3 *South elevation*: in the centre of this elevation stained pinewood panelling and posts have been used to box off the stairs that lead down to the ground floor. The panels are tongue and groove, extend to the ceiling, and are braced against the beam and joists. This panelling prevents access to the stairs from any direction except the west. To the west of the stairs there is a fixed casement window with two lights divided vertically; it is constructed from the same hardwood as the modern windows on the north elevation and they are probably all contemporary. This window has splayed jambs and a timber board sill, while the lintel is hidden behind the plasterwork. To the west of the window the stairs rise to the second floor.

4.6.5 *Floor*: the boards are typically 0.20m wide and there are frequent replacements, especially in the region immediately south of the loading doors. There is also a circular hole cut through the floor boards towards the southern end of the beam below and under the east beam on this floor, the function of which is unknown. Lying loose on this floor is an iron derrick, which is triangular in shape with a pulley on one corner. The other two corners were probably originally attached to the exterior of the building and as the chain with goods attached runs through the pulley lateral movement could be added to the hoisting process.

4.7.1 *North elevation*: this is almost identical to the floor below with the central loading doors flanked by windows, and the wall showing pink painted plaster in various states of decay. The window to the west has a simple fixed casement with a brown painted frame and a central vertical strut separating the two panes. Each pane is protected by two vertical iron bars on the exterior. No lintel could be observed due to the plaster. There is a broken yellow ceramic bowl in the sill area that is 0.10m

4.7.3 South elevation: over the stairs to the first floor, at the west end of this elevation, there is a window with splayed jambs and a board sill. The inserted fixed casement is of the same stained hardwood as those on the floor below, and has two vertically divided panes. Recent plasterwork can be observed in the area of the lintel and there is a skim of recent looking cement in the jambs.

4.7.5 Floor: where the sandstone slab has been added at the base of the chimney to the east the ceiling of the floor below has been reinforced with perpendicular joist braces to accommodate this. The floor boards have holes to allow the pulley rope through, as described in *Section 4.6.6*. Lying loose on this floor is a timber hoist arm with a pulley at one end, presumably the forerunner of the one still protruding from the northern elevation at loft level.

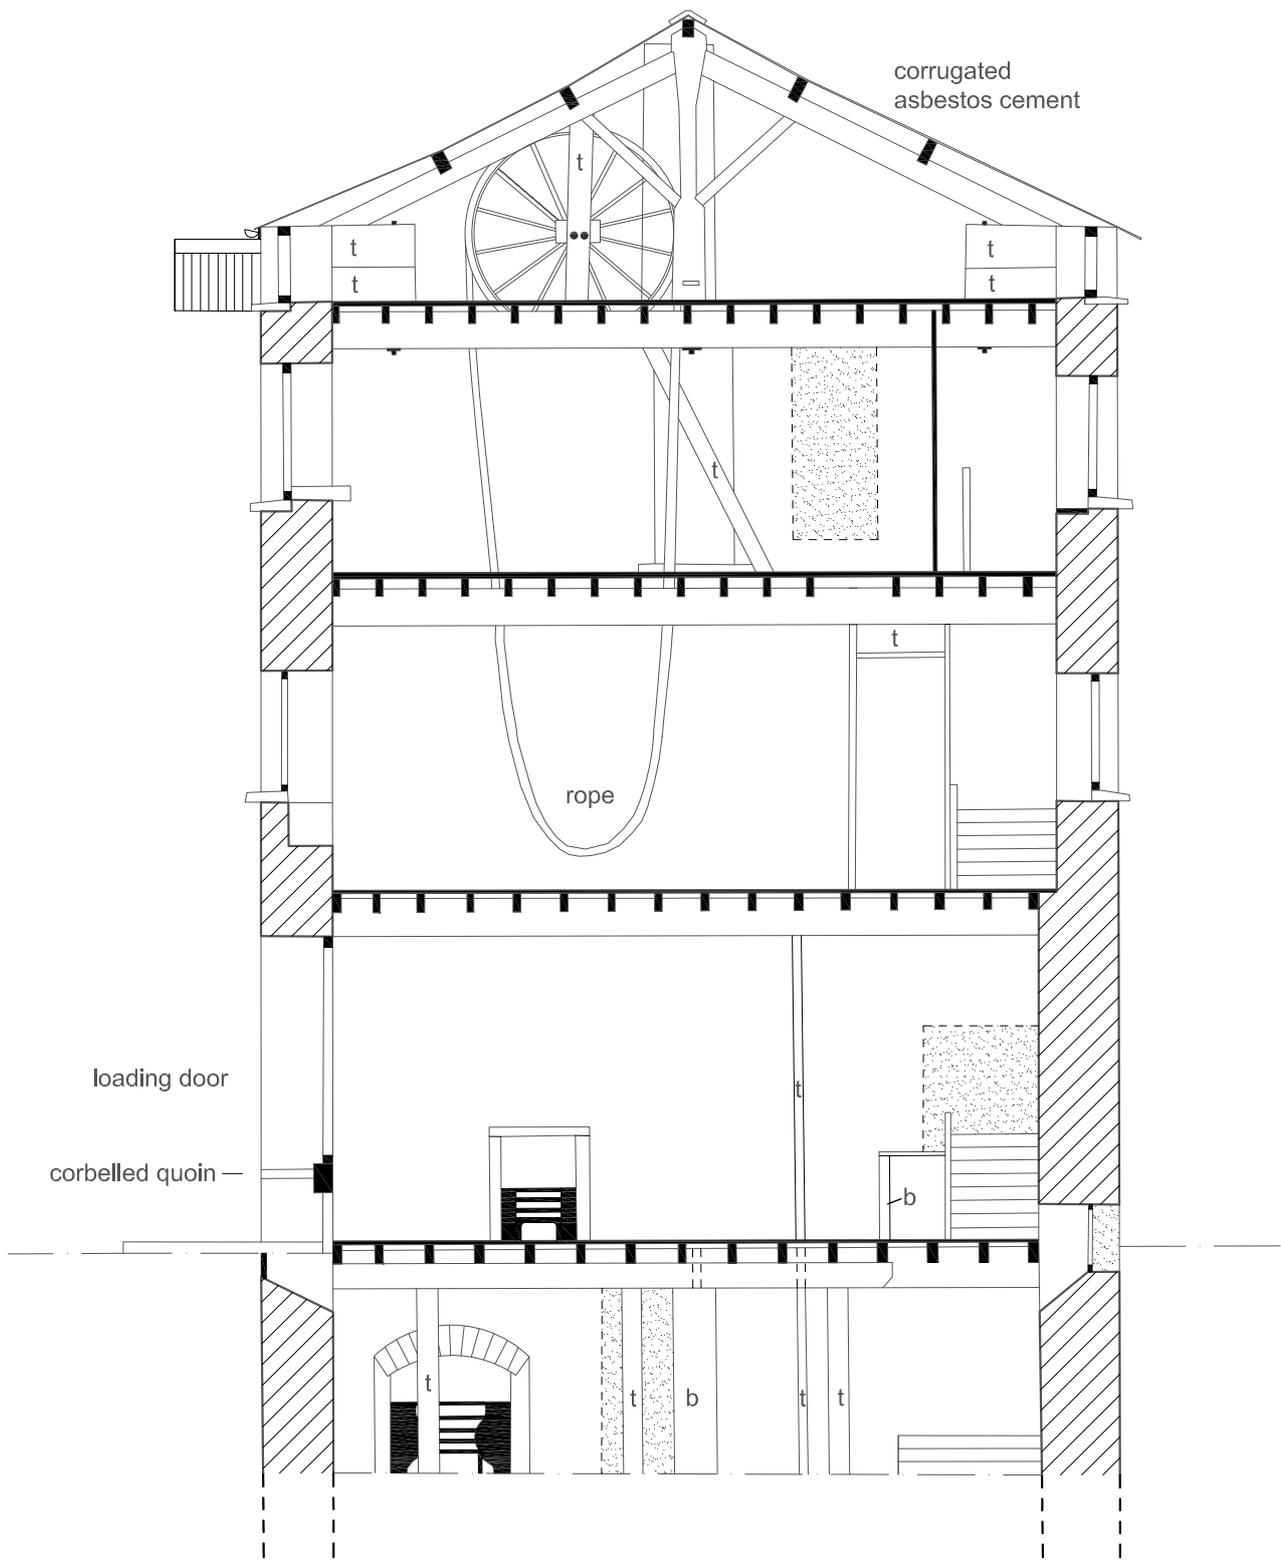
Figure 8: East-facing cross-section

- **Drawings**: drawings were produced by hand-annotating 'as existing' illustrations of the building drawn by the client's architect, who provided them digitally at 1:1 (1:100 at A3). These comprised plans of all three main floors, and also of the loft and basement, and three external elevations. In addition, a cross section of the building was produced by hand, specifically showing the details of the hoist (Fig 8);

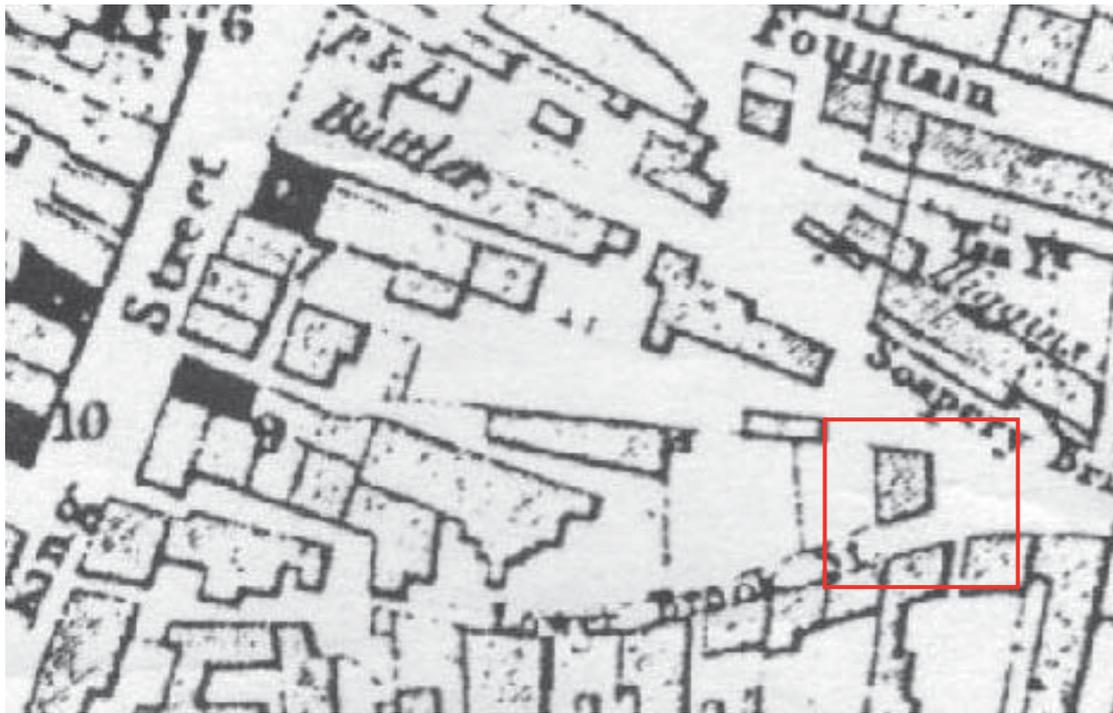
Plate 1: Extract from Plan of Ulverston, John Wood 1832

3.4.2 **John Wood 1832 (Plate 1):** this plan clearly depicts the Buxton Place area, and a building can be seen in the vicinity of the site. It would appear that this building is not the warehouse but its adjoining building. It is perhaps more likely that this is depicting an earlier building that was demolished before the present 'complex' of buildings was erected. The area of Buxton Place is known as Soapery Bridge at this time.

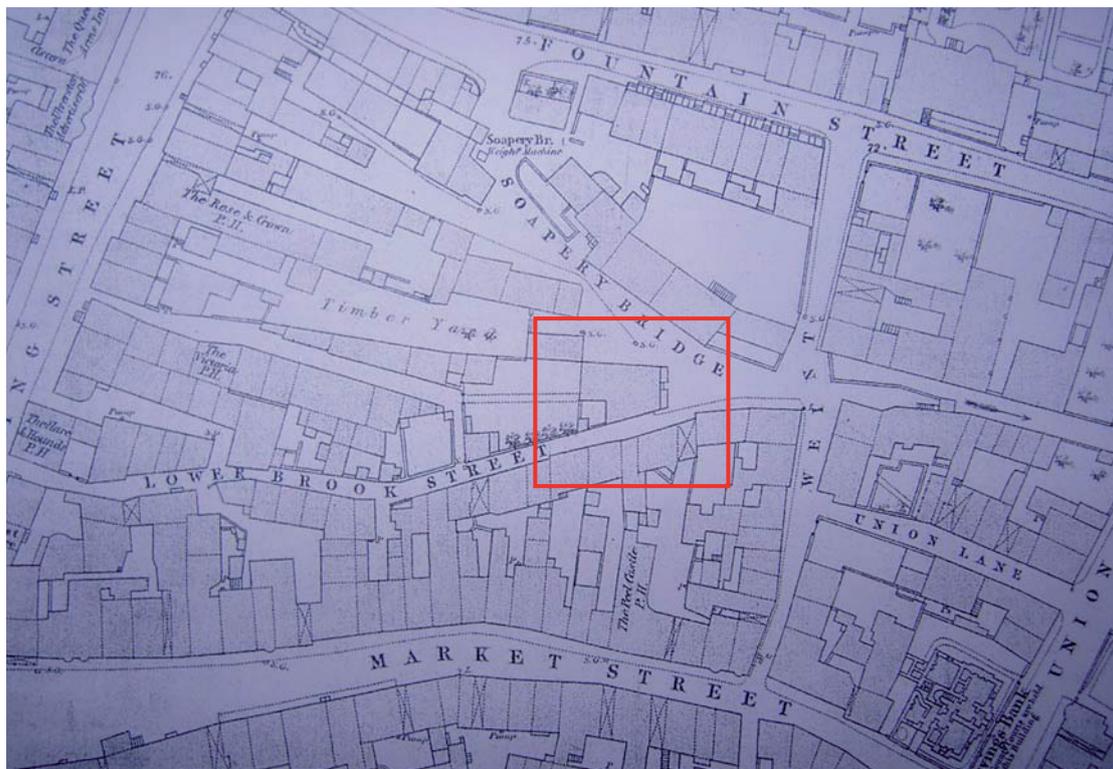
Plate 2: Extract from Ordnance Survey map 1852

3.4.3 **Ordnance Survey 1852 (Plate 2):** this is the first map to depict the warehouse; it shows the two main buildings of this complex both exist at this date,

but the smaller building in the south-west corner of the block has yet to be added. There is also a smaller building butting the north-west corner of the warehouse.

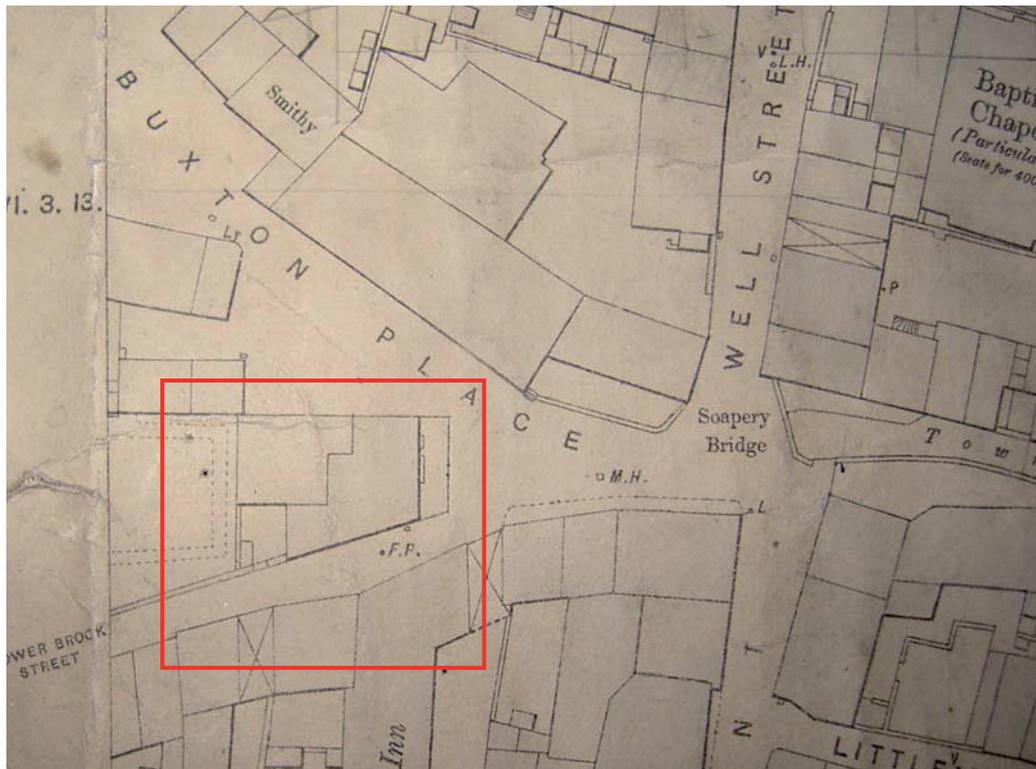
Plate 3: Extract from Ordnance Survey map 1890

3.4.3 Ordnance Survey 1890 (Plate 3): the warehouse remains unchanged from 1852 to 1890, however this map is more detailed than the previous map, so the property divisions are now visible. The main development on this map is the change in name from Soapery Bridge to Buxton Place. The northern half of the Weint also becomes Well Street sometime between 1850 and 1889.

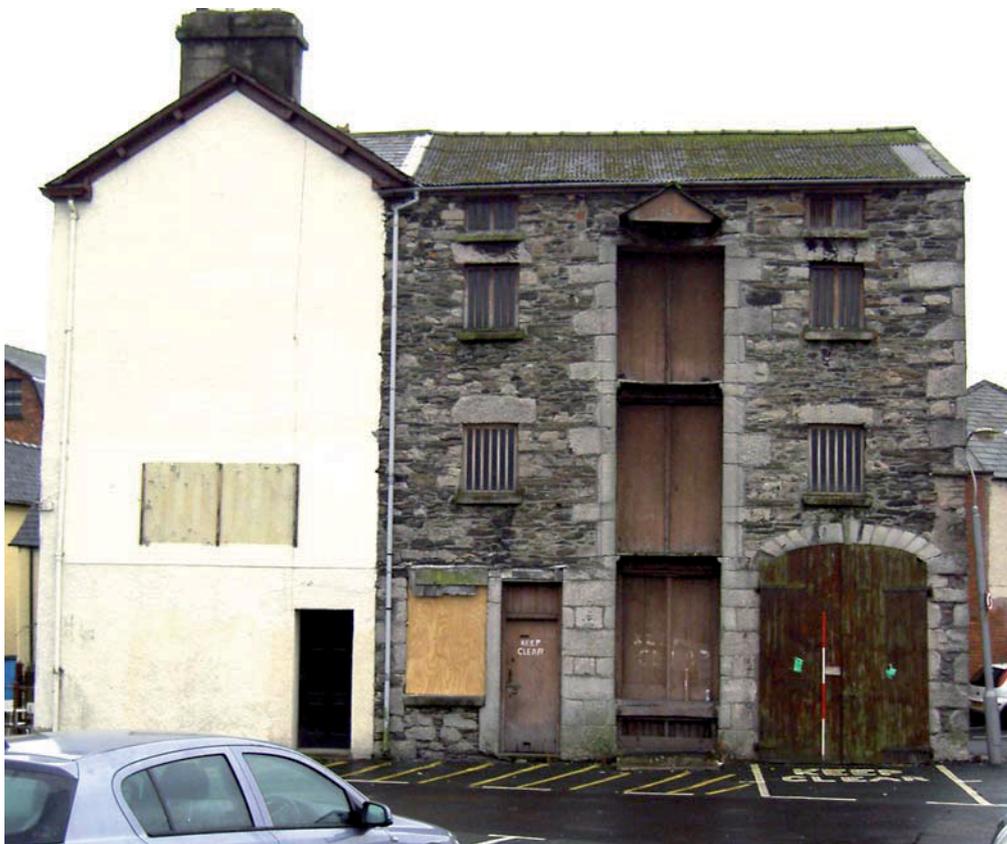
Plate 4: North external elevation of warehouse, with No.1 Buxton Place to the left (east)

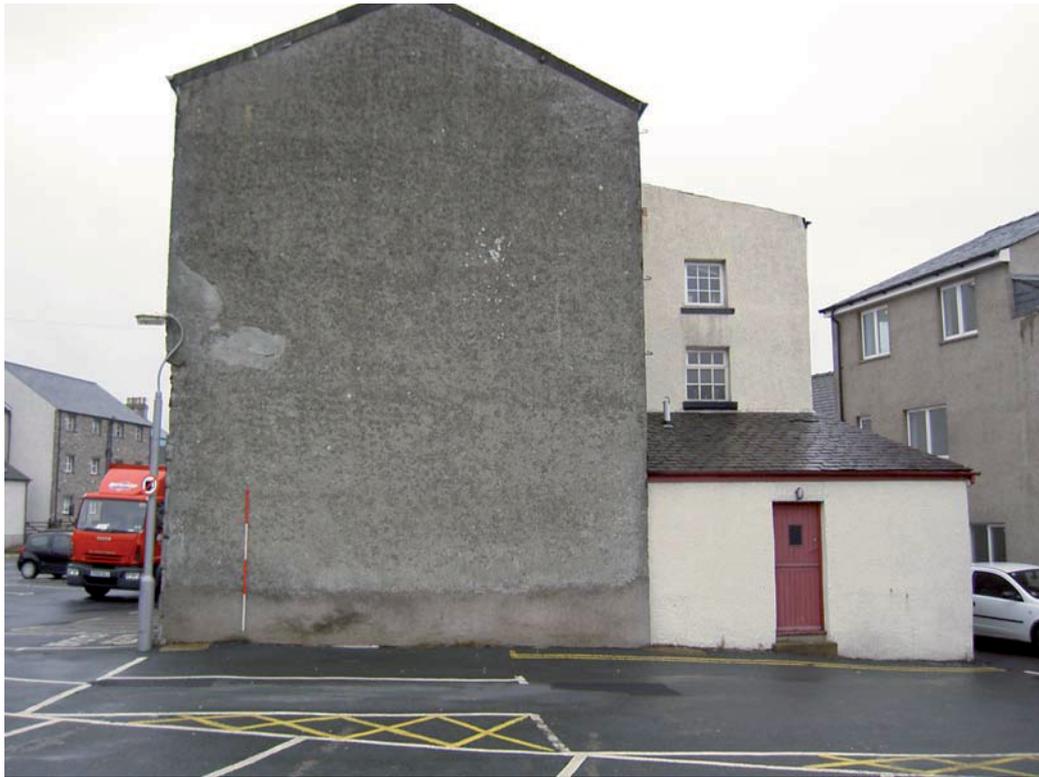
Plate 5: West external elevation

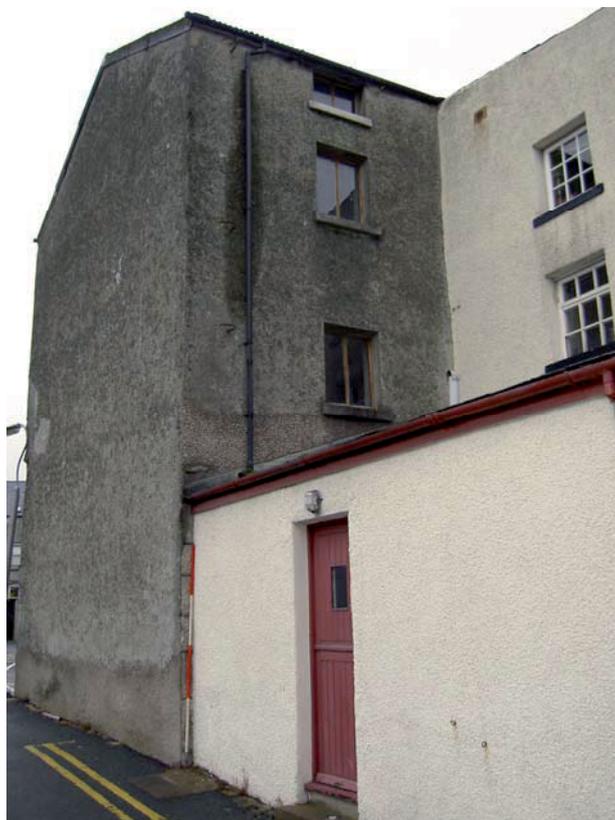
Plate 6: South elevation, showing recent ground floor addition to No.1

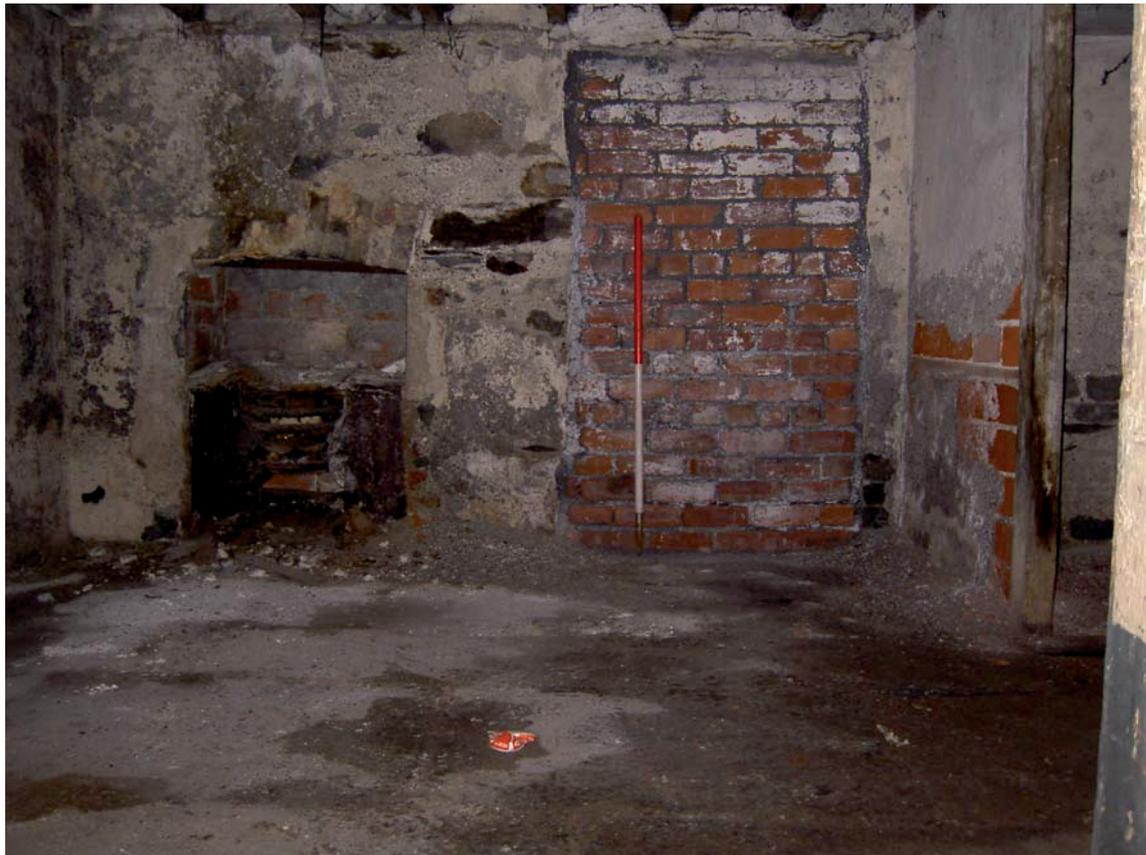
4.4.3 *East elevation:* there is a fireplace at the north end with the original cast iron hob grate still in place (Plate 7). The surround of the opening is finished with brick and this includes an arch over the top which has originally been rendered. South of the fireplace there is a doorway blocked in un-rendered red brick that would have led to No.1 Buxton Place, which therefore must also have a cellar, or at least cellar access. South of the blocked doorway is a brick wall that extends 1.10m west from the wall and forms the north end of a partition that runs 3m to the south end of the building. This area has a doorway to the south of the east/west wall, but there is no evidence of a door in the square cut softwood jambs. The partition is constructed from un-frogged red bricks which have been rendered with a greyish gravelly cement and then whitewashed.

Plate 7: Fireplace, blocked door, and partition in cellar

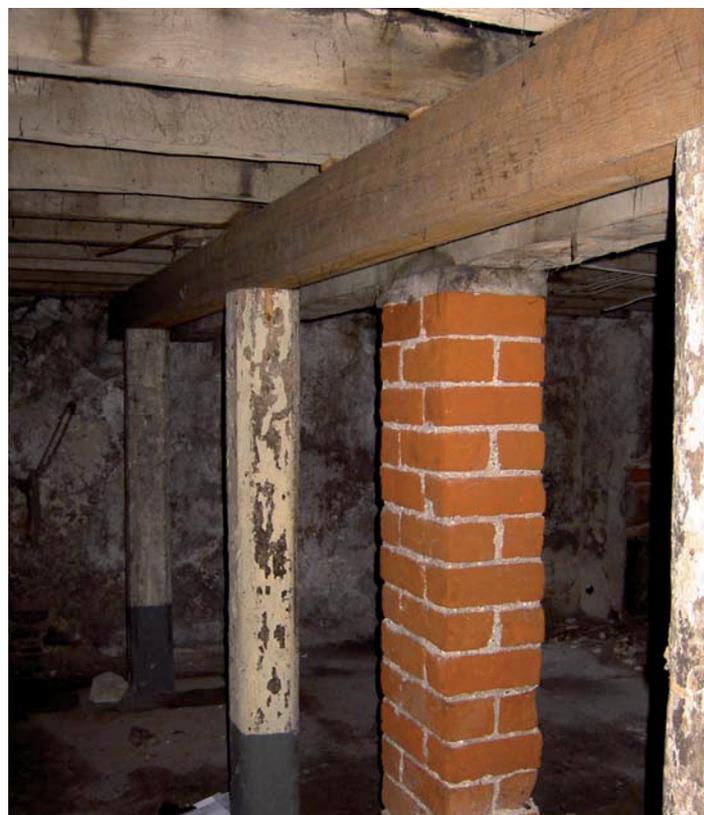
4.4.7 *Ceiling:* the main oak beam is keyed into the north and south walls, holds all the joists, and is supported on a central brick column. A second narrower beam has been added that is not keyed in to the walls and holds no joists; this is a reddish coloured softwood (Plate 8). The second beam does not run the full length of the room, stopping north of the stairs, and is supported on three re-used timber posts that are stop chamfered and have been cut down for this new function. Between the top of the new beam and the joists occasional small timber wedges have been inserted. The pale pine joists have some Baltic timber marks suggesting a late 18th or early 19th century date, and therefore that they were probably original (Greene 1995;

Plate 8: Inserted beam in cellar

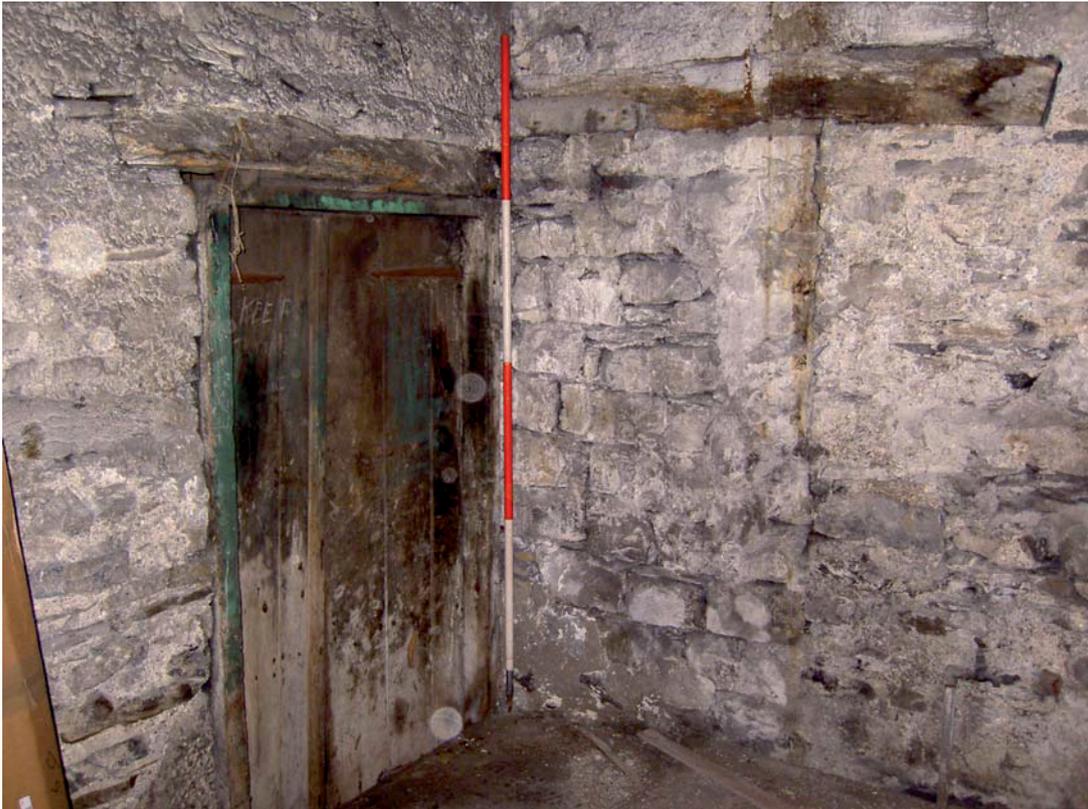
4.5.3 *East elevation:* this internal wall is stone built with whitewashed roughcast render. The double doorway to the basement at the south end of the elevation appears to be original, and sits under a roughly squared oak lintel. The softwood timber frame is partly painted green and has a number of gouge marks in the frame on the north side. The doors each consist of three tongue and groove oak panels with a pair of strap hinges. One door sits in front of the other; they bolt together, and extend down to the level of the first step down into the basement. Midway along this elevation a missing stone has been utilised as a nook, in which is stored numerous candle stubs, matches, an empty Woodbine packet, a Littlewoods credit offer note, and part of a door handle. There is another crevice near to the wagon doors that holds a timber peg with various lengths of string attached, nails, bolts, an advertisement for a prize draw in 1971 for the Barrow-in-Furness and South Cumberland 'Society for the Blind', and a copy of the North-West Evening Mail dated 3rd August 1955. Also near to these doors is an iron hook attached to the wall to secure the original doors open and/or shut.

4.5.4 *South elevation:* there is a blocked door under a roughly squared oak lintel at the east side of this elevation, which was presumably made redundant when the building to the rear was added (Plate 9). The un-pointed and un-rendered blocking consists of fairly regular approximately square limestone blocks, although the odd red brick can also be seen under the whitewash. In the centre of this elevation a waterpipe with attached tap projects up through the floor to a height of about 0.40m.

Plate 9: Ground floor west side showing entrance to cellar and blocked door in southern elevation

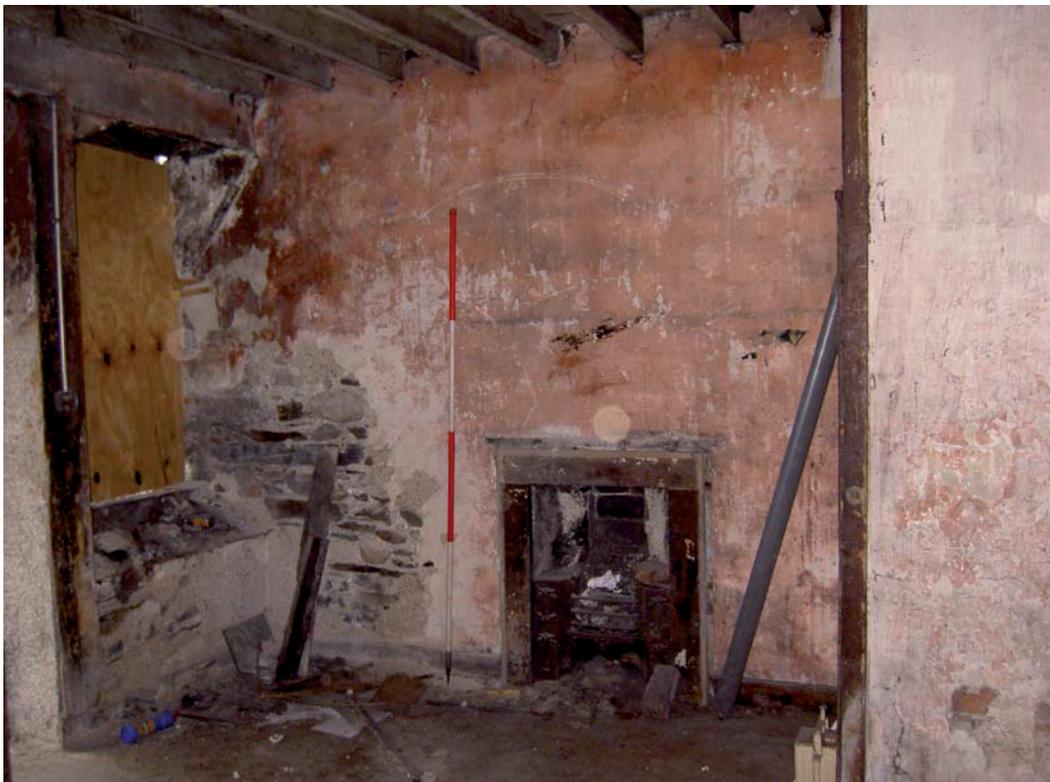
Plate 10: Ground floor east side, showing window, fireplace, and partition wall in north-east corner

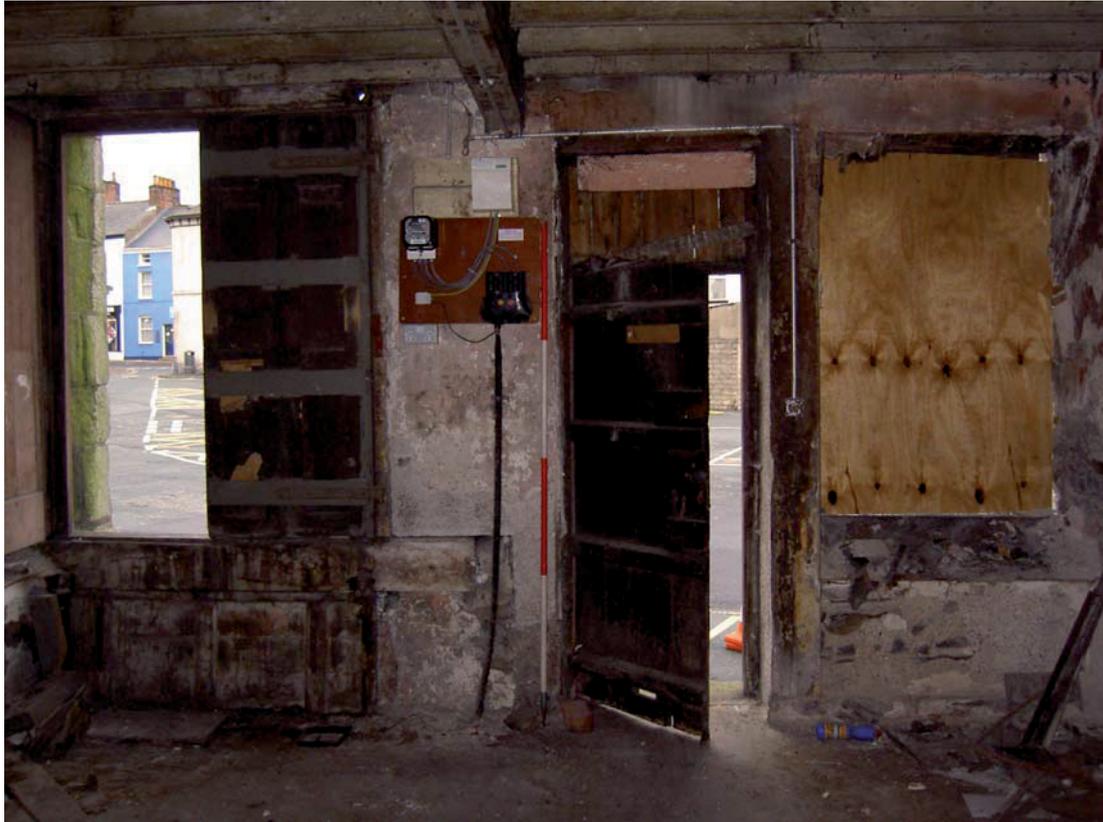
4.5.9 *North elevation (Plate 11)*: this room seems to be rendered internally with a fine gravelly cement which has then been plastered and painted pink. All the timber fittings are painted pinkish-brown. There is a large original window at the east whose upper half projects outwards before running down vertically flush with the exterior wall. The window has an iron framed fixed casement comprising five rows of four lights. The lintel is board over a roughly squared oak timber and the level sill is covered by a board. Beneath the window is an area of unpainted wall which may have just degraded more quickly than other areas or may have originally been panelled. To the west of the window is a pedestrian doorway. The doorframe includes tongue and groove oak boarding above the door to ceiling height. The door is constructed from four tongue and groove oak boards secured with four horizontal batten braces. It has two strap hinges and formerly had three locks, although at the time of survey it was secured with a bolt and padlock. To the west of the access door are the ground floor loading doors whose sills are formed by a horizontal beam approximately 0.75m above the floor level. The doors are constructed from tongue and groove oak boards that extend to ceiling height and have the appearance of huge shutters. Beneath the doors and hinged to the underside of the horizontal beam is a flap made of boards, which opens inwards and upwards and has vertical iron bars on the exterior side.

Plate 11: Interior of east side of ground floor looking north

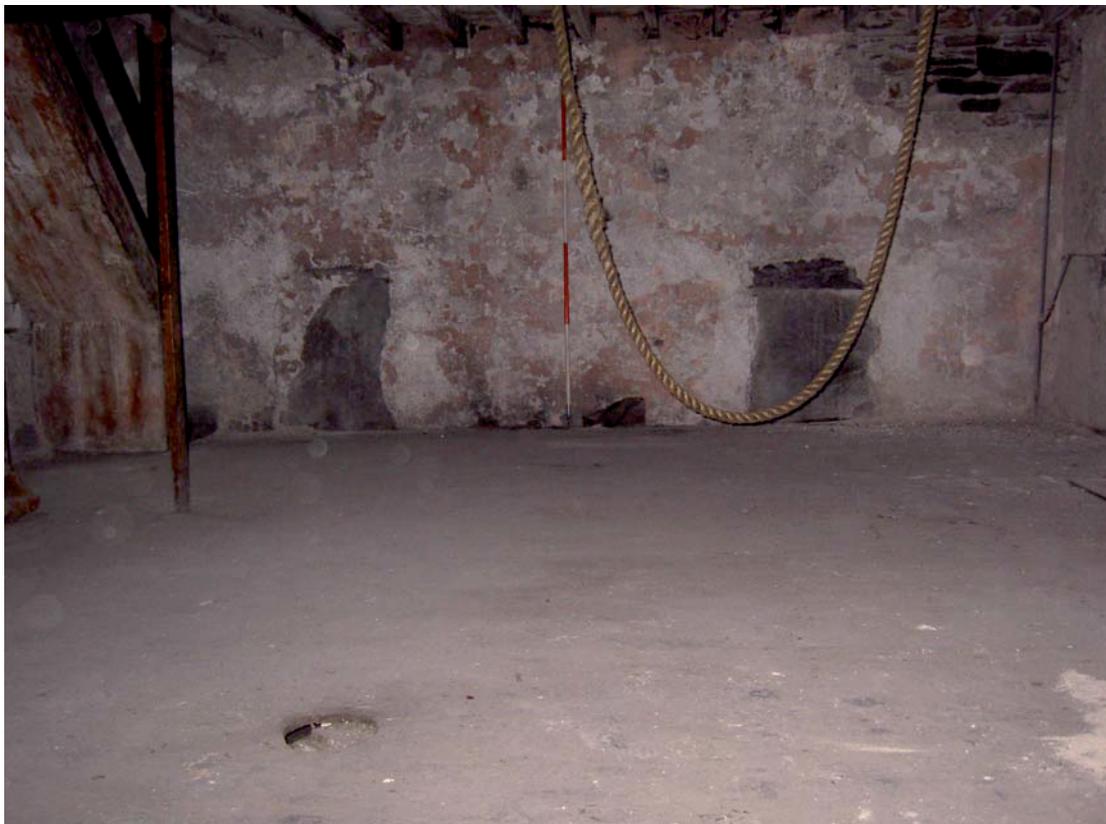
Plate 12: Blocked apertures in west wall of first floor

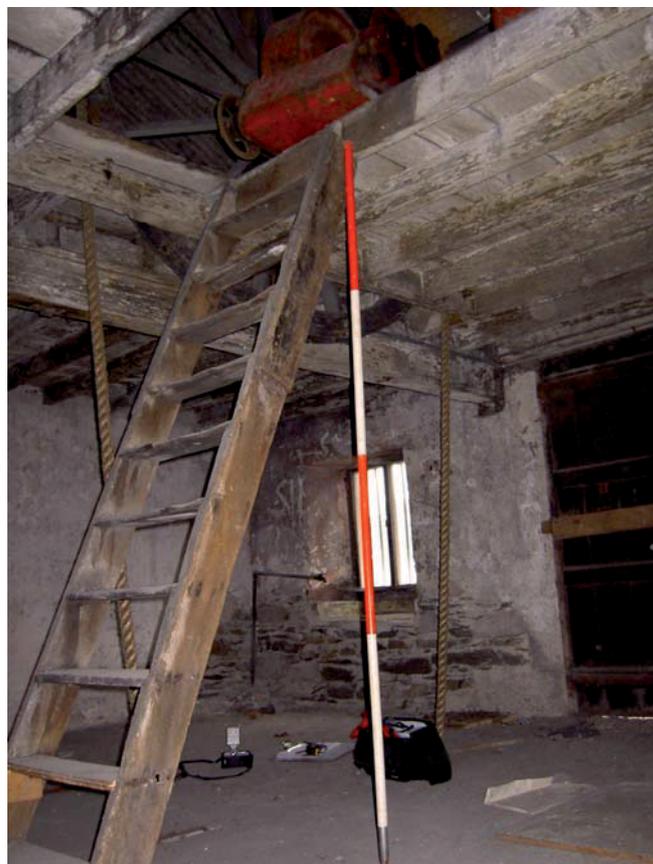
Plate 16: Loft access from second floor, looking north-west

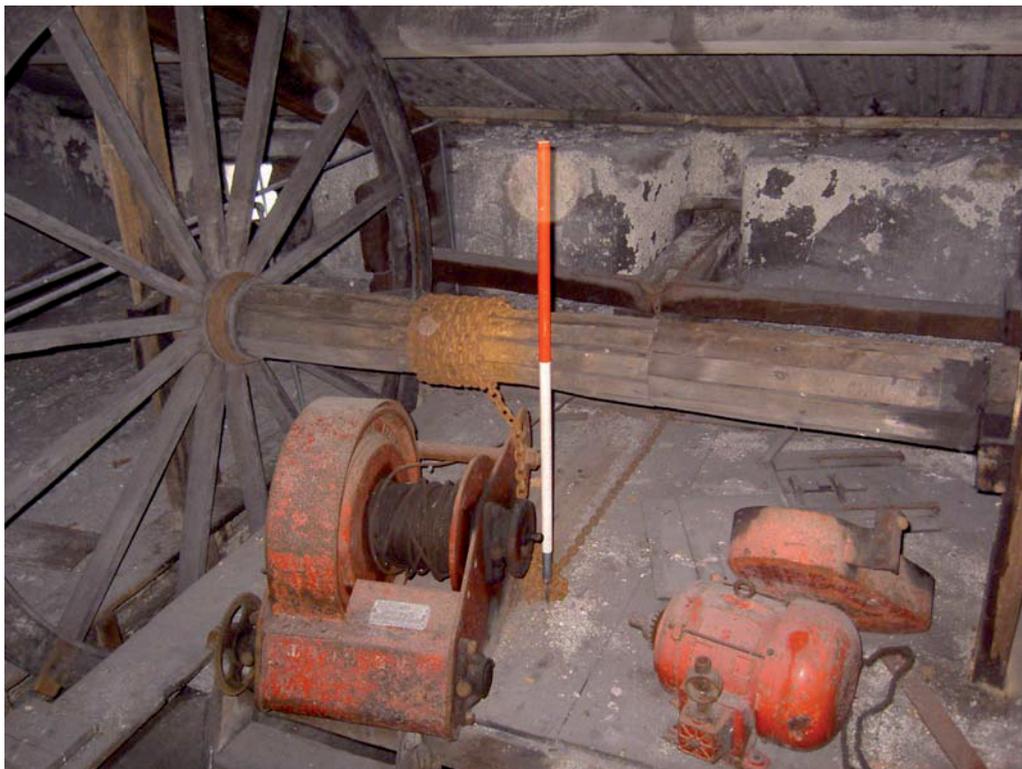
Plate 17: Hoist apparatus in loft

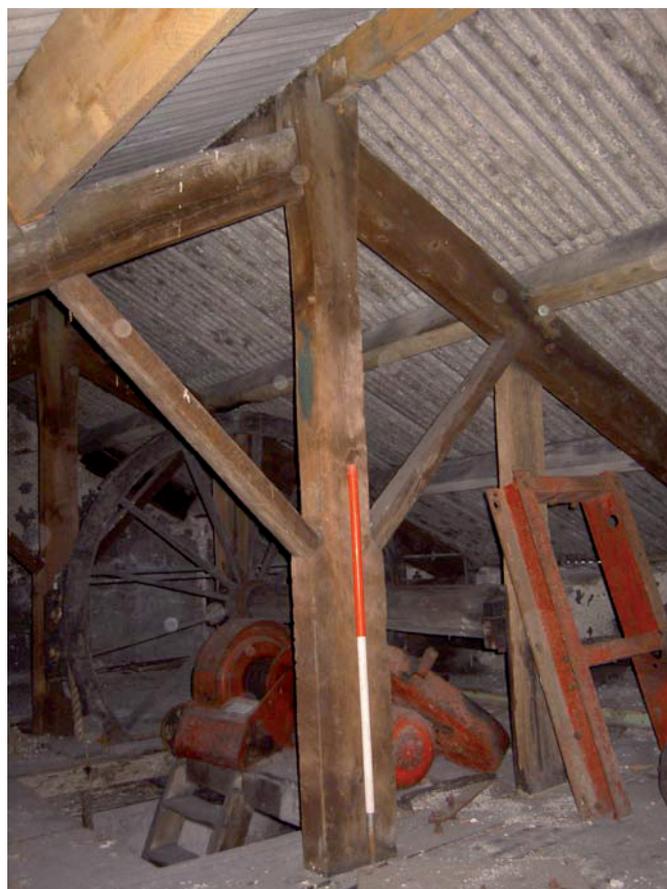
Plate 18: East truss

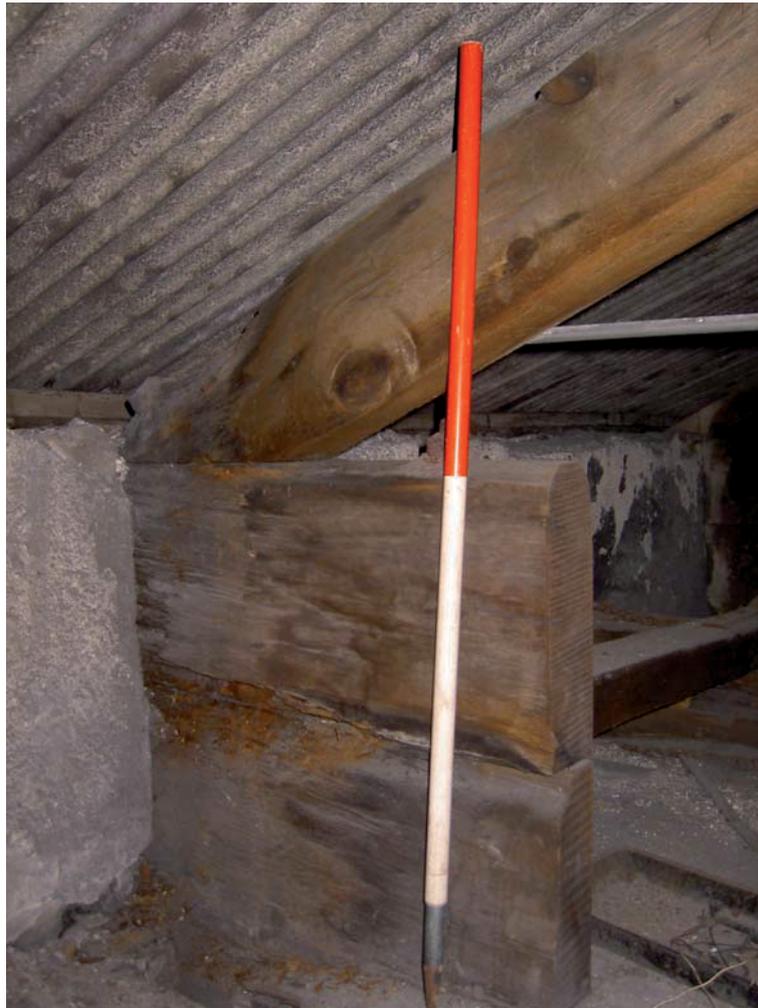
Plate 19: Spacers between tie-beam and principals
