SOWERBY HALL FARM, BANK LANE, BARROW-IN-FURNESS, CUMBRIA

Archaeological Building Recording

Client: Mr and Mrs Curtis
Planning Ap. Ref.:
B06/2007/1005 and
B15/2007/1006
NGR: SD 19862 72467

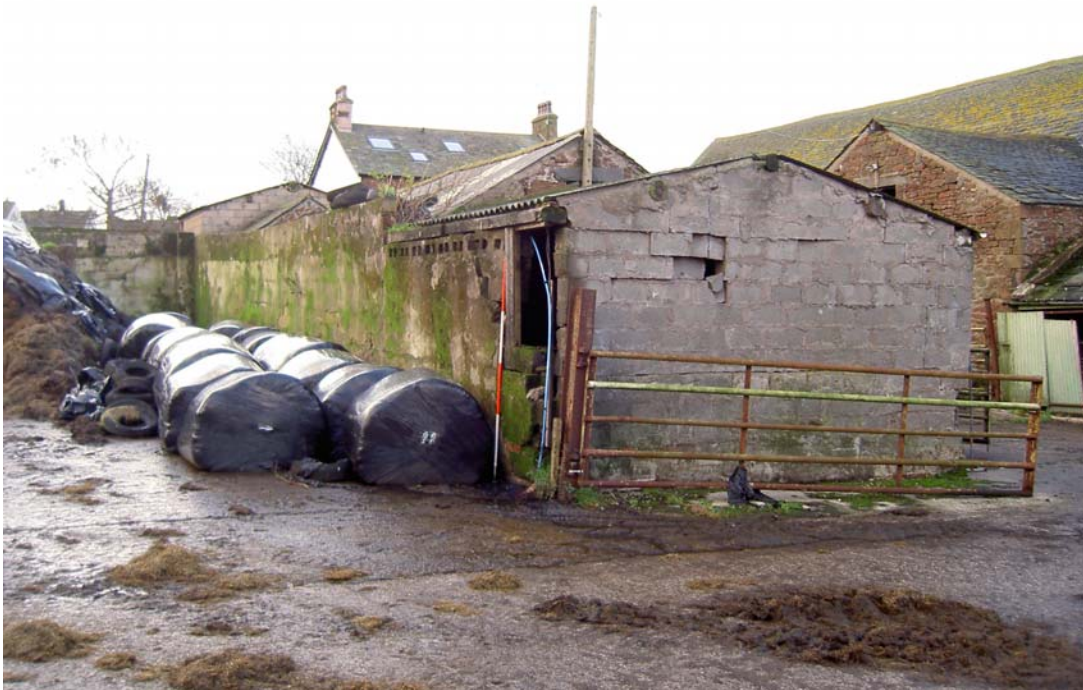
Plate 11: The north external elevation and the north end of the east external elevation of the dairy

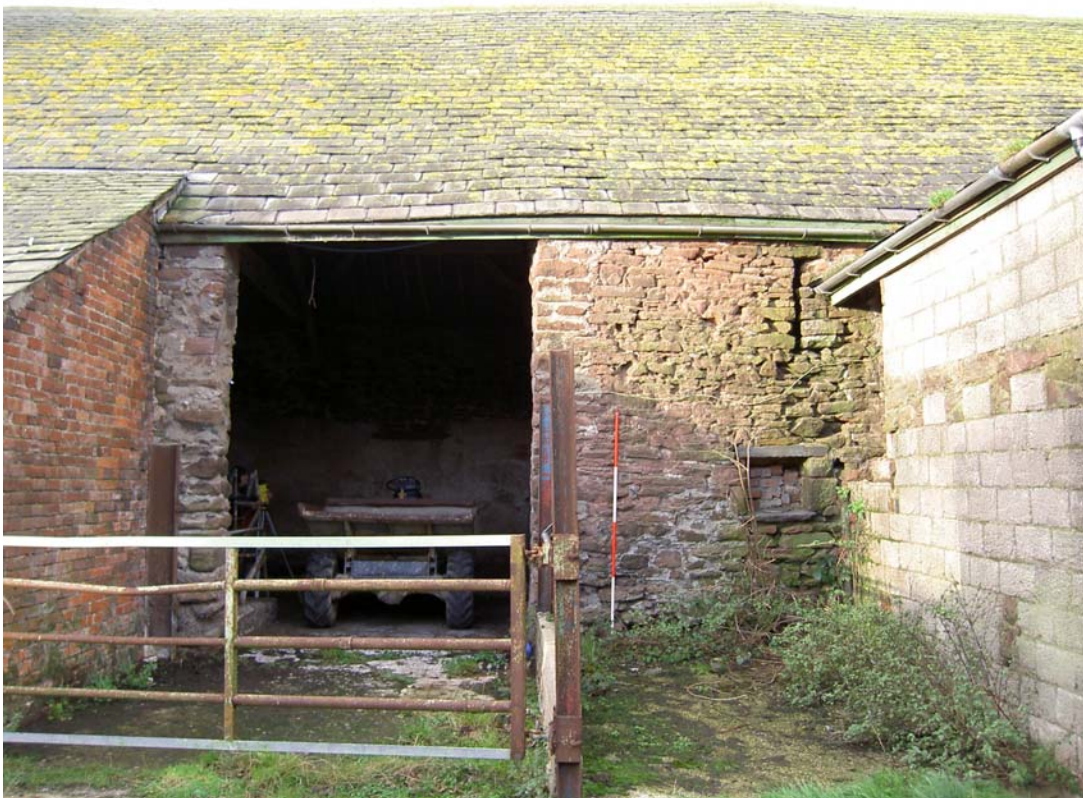
Plate 22: The wagon doorway in the centre of the east external elevation of the barn

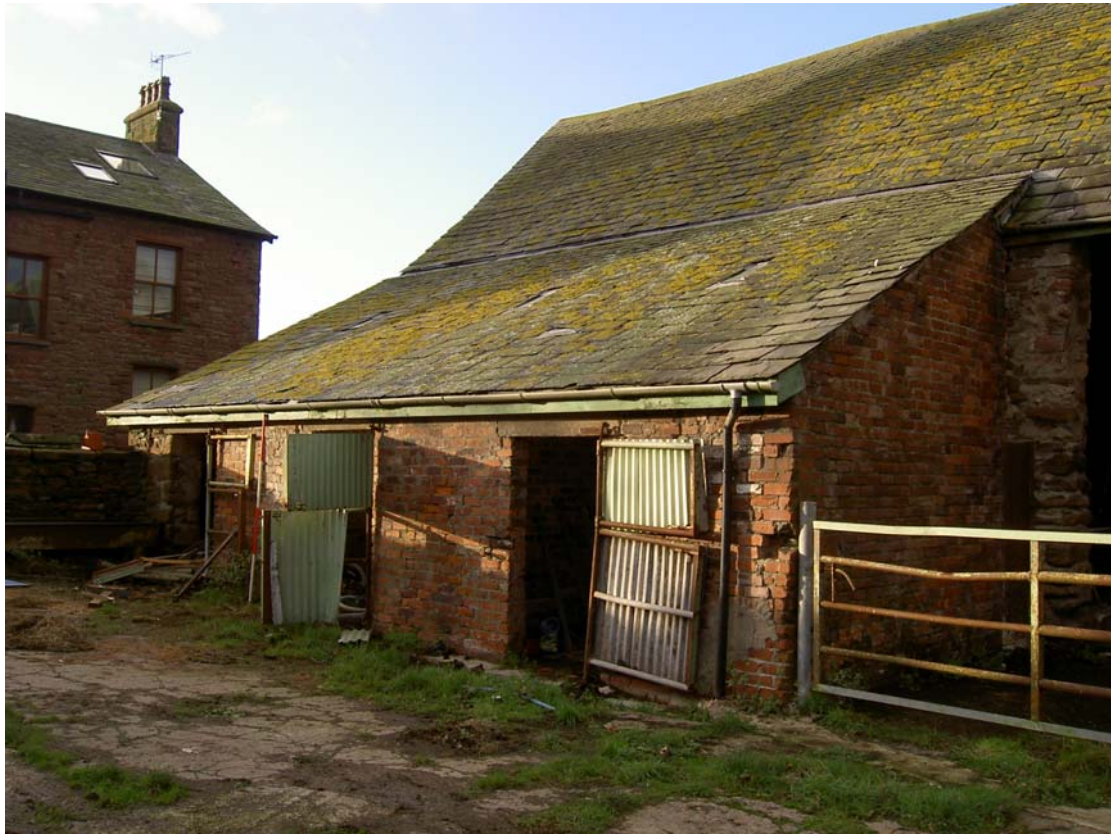
Plate 23: The outshut at the south end of the east external elevation of the barn

4.7.8 **South-east outshut:** this is divided into three rooms, which were probably originally used as loose boxes. The floor of the southern of these was largely obscured by firewood but is most likely constructed from concrete and is raised on the western side. The roof is monopitch and supported by a single purlin orientated north/south with additional timber forming wall plates on the east and west sides, all of which are machine cut. The walls are all roughly whitewashed and all but the south, which is sandstone, are built of brick. The north elevation is plain, and butts the west, while the east has a doorway on the south side with a machine cut timber lintel; the southern jamb has large sandstone quoins. The south elevation is built of rough courses of sandstone with two small alcoves (perhaps bee boles?) in the centre, each with timber lintels, which have been blocked with brick. The wall butts the west elevation, which forms part of the side of the barn. There is a tall narrow ventilation slot at high level within the wall and a timber manger below attached to the wall, with an inserted ceramic pipe vent immediately above it. There are two iron rods fixed between the south side of the elevation and the west end of the south elevation, presumably acting as ties to pull the two buildings together.

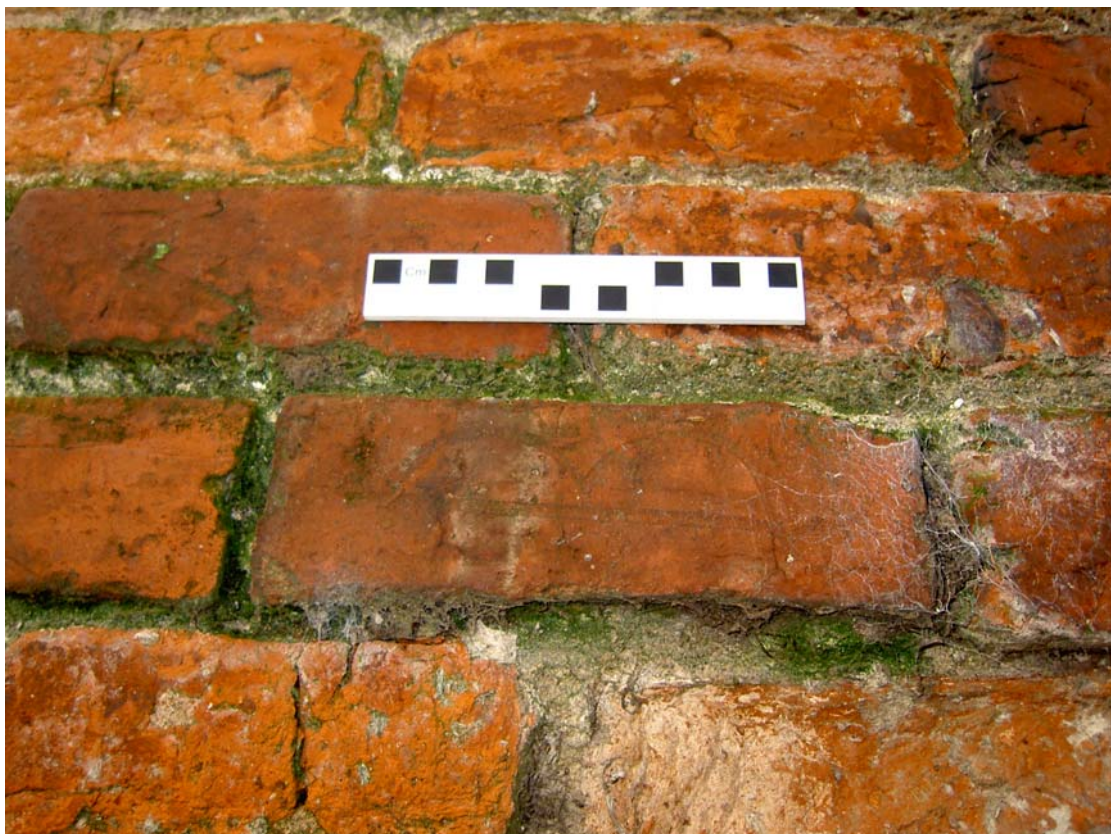
Plate 24: Brick inscribed with a 'B' in the north elevation of the south-eastern outshut

4.4.3 To the south of the wagon doorway the elevation returns to form a monopitch outshut. The north wall of this is brick built with six rows of stretchers to one row of alternating headers and stretchers. Curiously, one brick has the letter 'B' inscribed into its side; this appears have been scratched into the brick prior to being fired. Beneath the eaves the chamfered ends of the purlins project through the wall. The east elevation of the outshut has three doorways, all of which have concrete lintels and two of which have corrugated metal doors. There is some evidence for repair and/or rebuild around the doors, and the southern jamb of the southern door is formed by stone walling with large quoins, which continues into the south elevation of the barn.

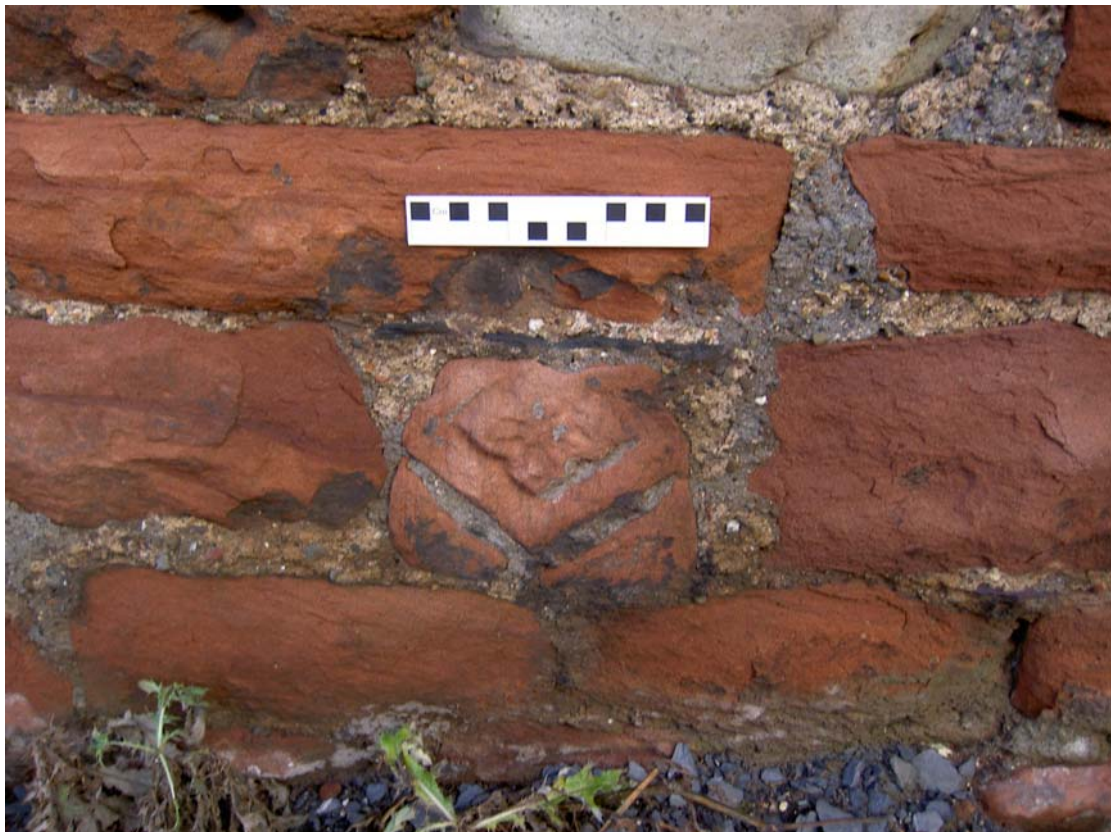
Plate 26: The re-used moulded stone decorated with petals enclosed by a rhombus in the south external elevation of the south-eastern outshut attached to the barn

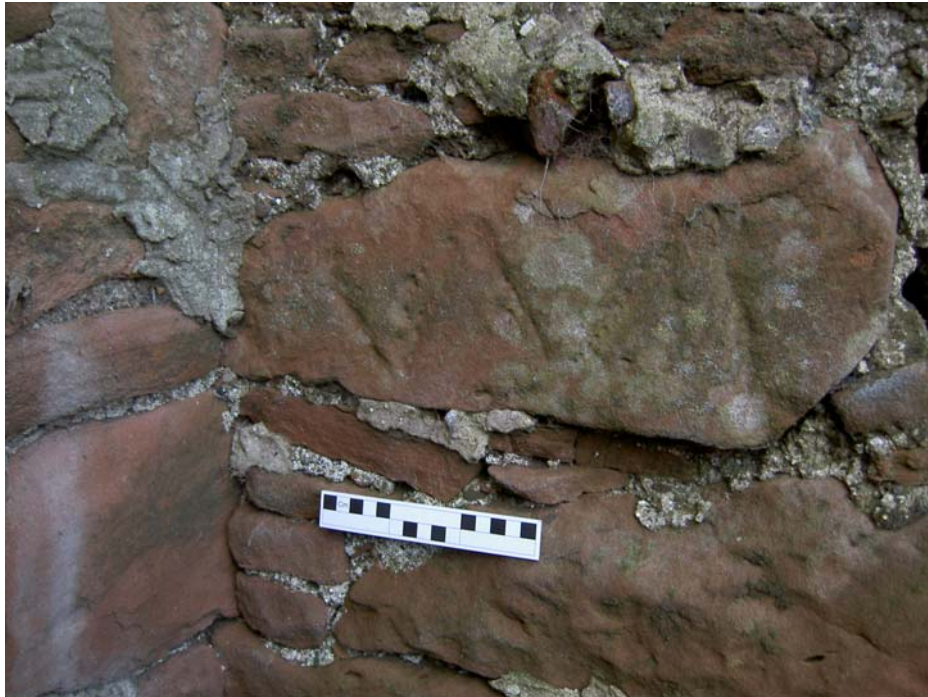
Plate 29: Re-used stone decorated with inscribed chevrons incorporated into the buttress utilised by the south-west outshut attached to the west external elevation of the barn

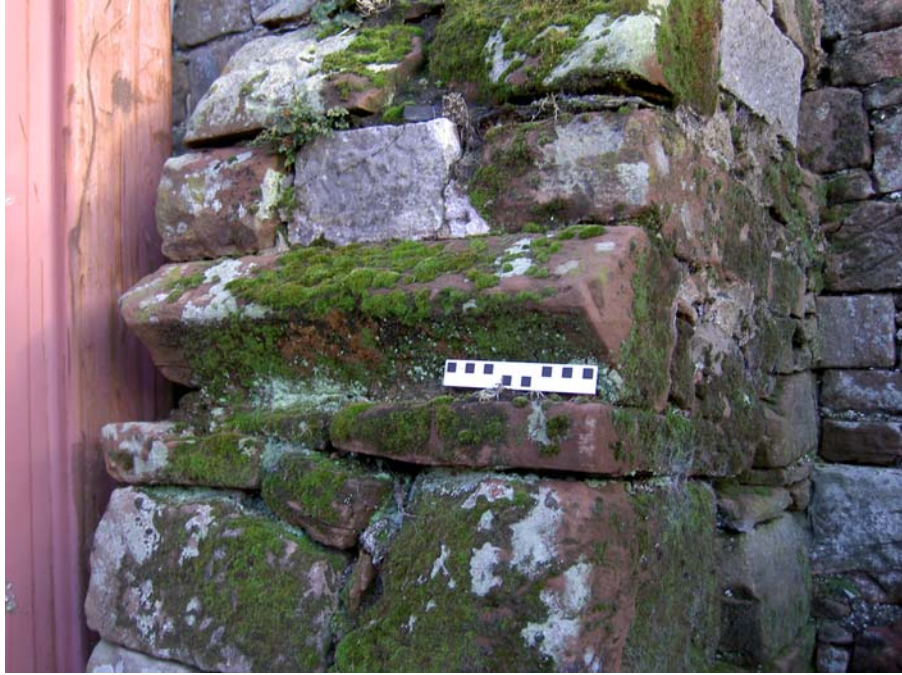
Plate 31: Re-used chamfered stone incorporated into the central buttress against the west external elevation of the barn

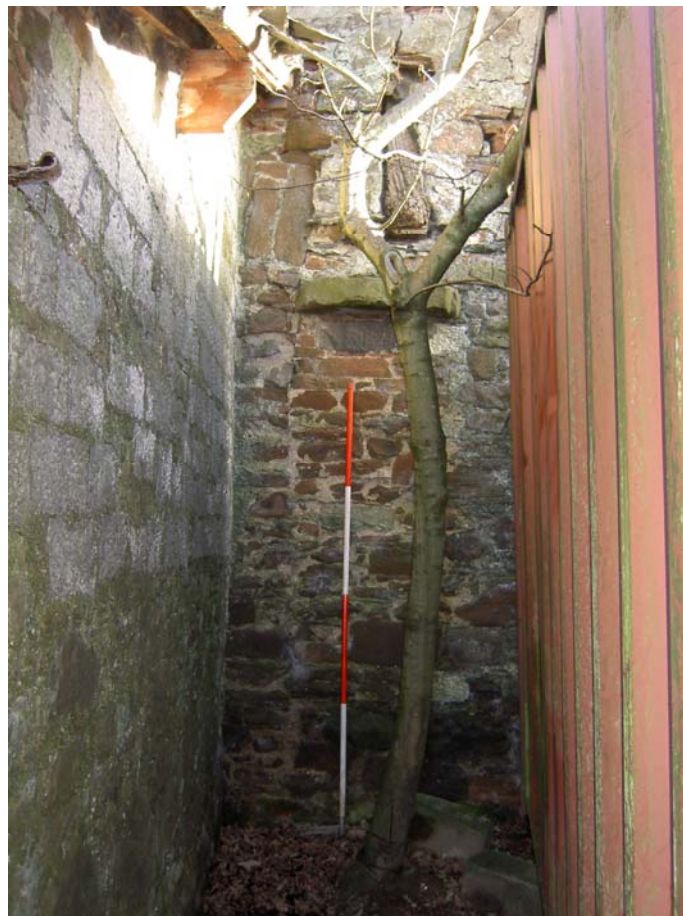
Plate 32: Blocked wagon doorway and projecting cruck base in the west external elevation of the barn

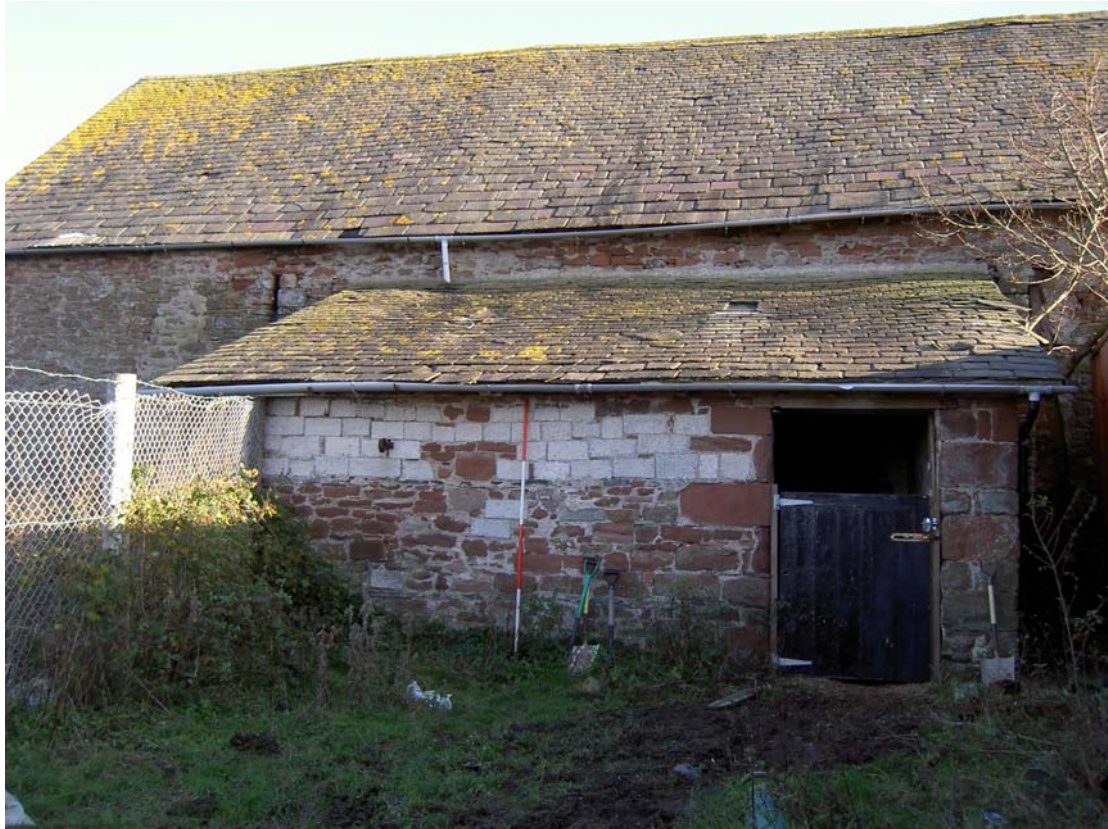
Plate 33: North-west outshut attached to the west external elevation of the barn

4.7.11 **North-west outshut:** this forms a small stable, calf pen, or loose box. The floor is largely obscured but is evidently concrete and has a dung channel orientated north/south, with a return at the south end towards the doorway in the west elevation. The roof is supported by a single half truss comprising a tie beam and angled principal rafter that supports a single purlin with a wedge adding additional support. All of the timbers are machine cut, and the walls are finished with rough render and are evidently constructed from a large number of neatly finished blocks of sandstone. The north elevation has a rough plaster finish and there is an evident junction with the buttress on the east side, which has at least one obvious plinth but that detail is obscured. There are low brick blocks built against the wall at ground level that probably originally supported a manger or trough. The east elevation is the side of the barn and is built of rougher stone laid in more random courses. There is a window to the north with a grey sandstone lintel and sill, which is presumably inserted and has evidently been blocked internally with brick. The north side of a large wagon doorway is evident to the south, which has a sandstone arch. This has been subsequently blocked with stone to form a smaller doorway with a machine cut timber lintel, although this has subsequently been blocked with brick. The south elevation has a rough render finish and there are several neatly dressed blocks of stone evident. There is some modern graffiti on one of these blocks: 'KIDDY 1982'. The west elevation has a doorway on the south side with a machine cut timber lintel and surround and a split beaded tongue and groove board door with stop chamfer battens. The rest of the wall is plain, with numerous neatly dressed blocks.

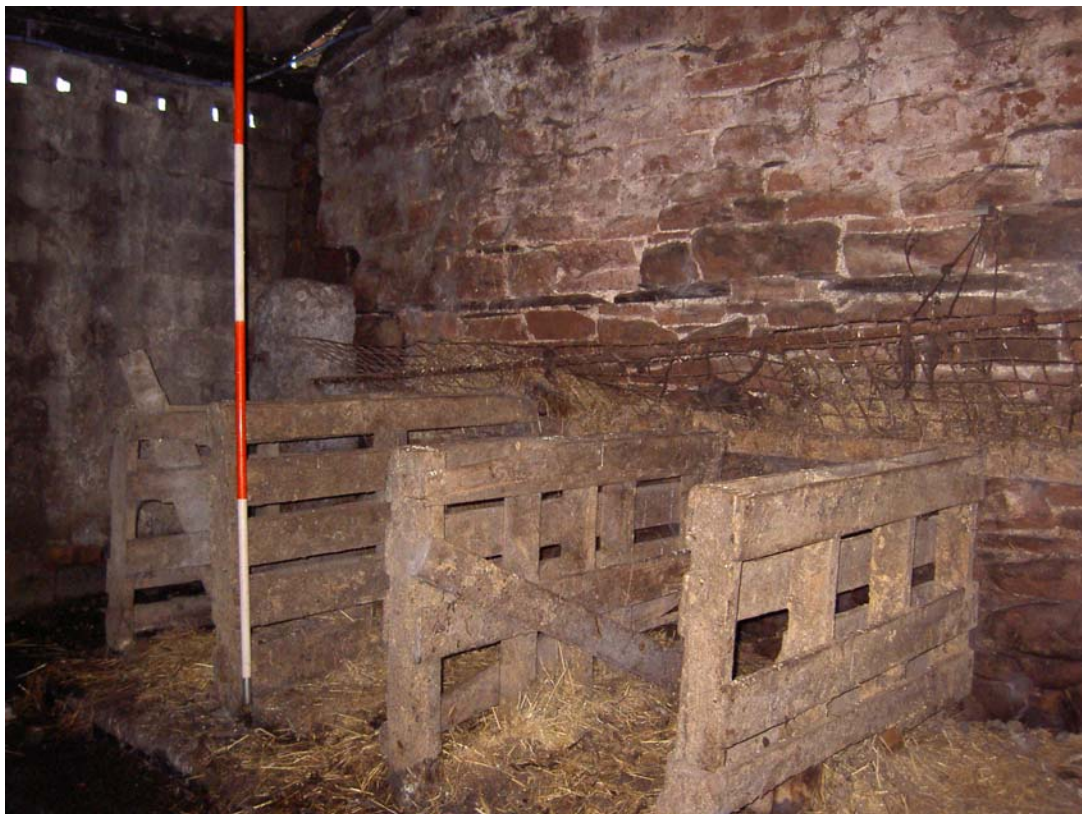
Plate 34: Stalls constructed from re-used pallets on the south side of Room 1 of the dairy

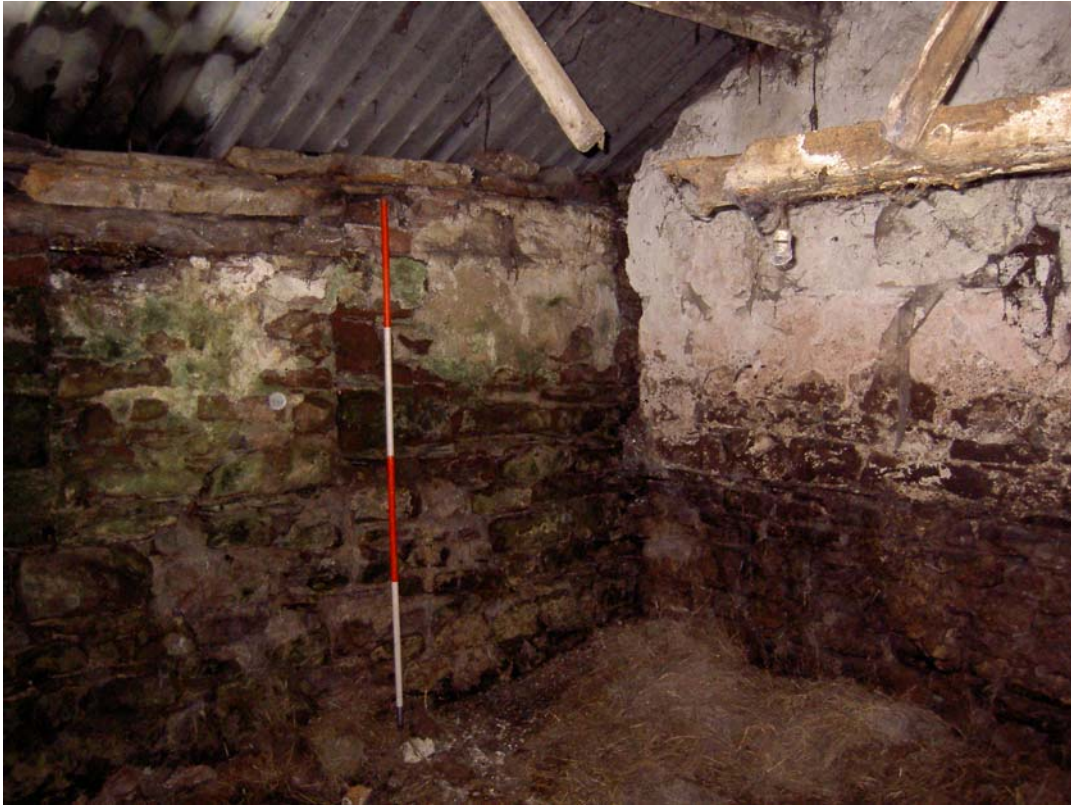
Plate 35: General view of the south-east corner of Room 2 of the dairy showing the blocked window, the butt joint between the south and east walls, and the truss

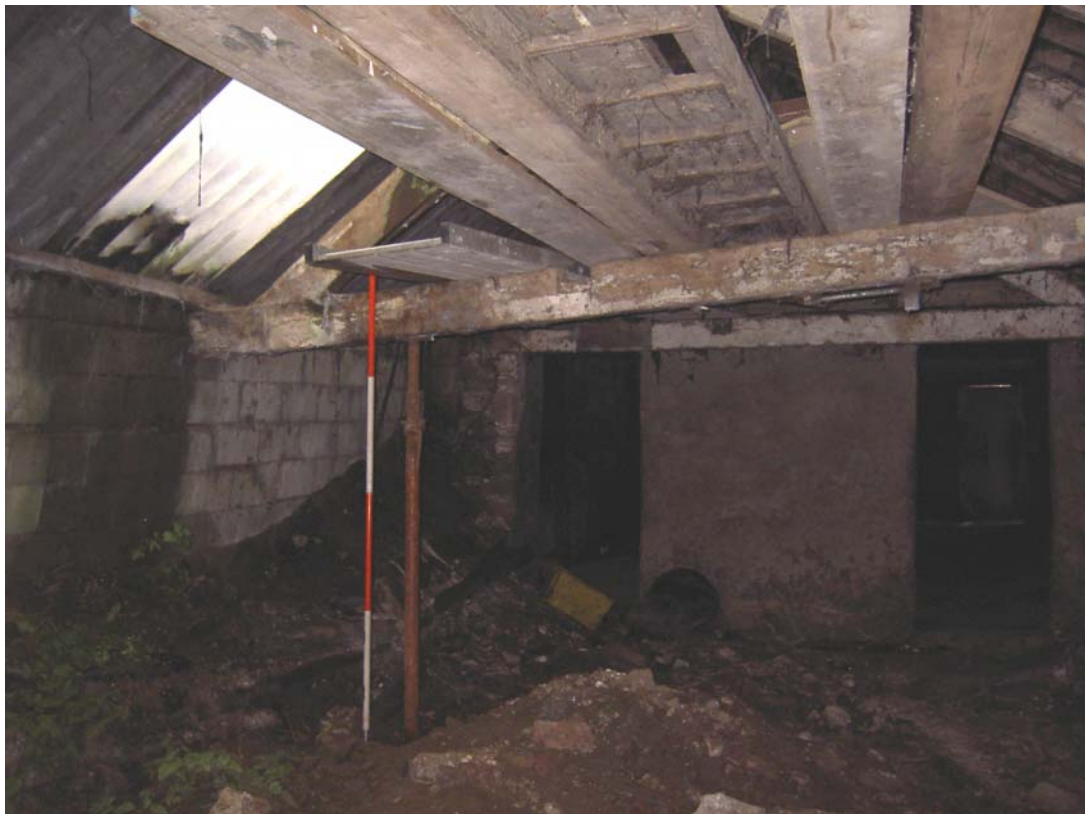
Plate 36: General view of the south end of Room 3 of the dairy showing the collapsed wall and trusses

brick walls forming the east and north elevations of the south-east outshut attached to the barn were also added during this period, and the space converted into three loose boxes or similar. The present iron stalls situated within the barn were also added at this time, but only after the western wagon doorway had been blocked, although it initially retained a smaller doorway, and the north-west outshut was built against it. At the same time it is apparent that the central buttress was repaired using some of the same limestone blocks utilised in the north-west outshut, but during this phase three buttresses must have been removed; the possible scar of one remains. The larger building to the north of the south-west outshut was removed, and this presumably became a toilet at this time. More recently, probably within the last 30 years (Jimmy Curtis pers comm.) several alterations in concrete blocks were made. These include the rebuilding of the south elevation of the north-east outshut, the addition of a first floor room extension to the north end of the dairy, and the addition of a buttress against the south end of the barn. The slurry pit to the west of the barn and shippon was also created at this time, and corresponding pits covered with slatted concrete were added to the barn/shippon and dairy. The construction of a silage store to the east of the centre of the dairy subsequently led to the collapse of part of the east wall.

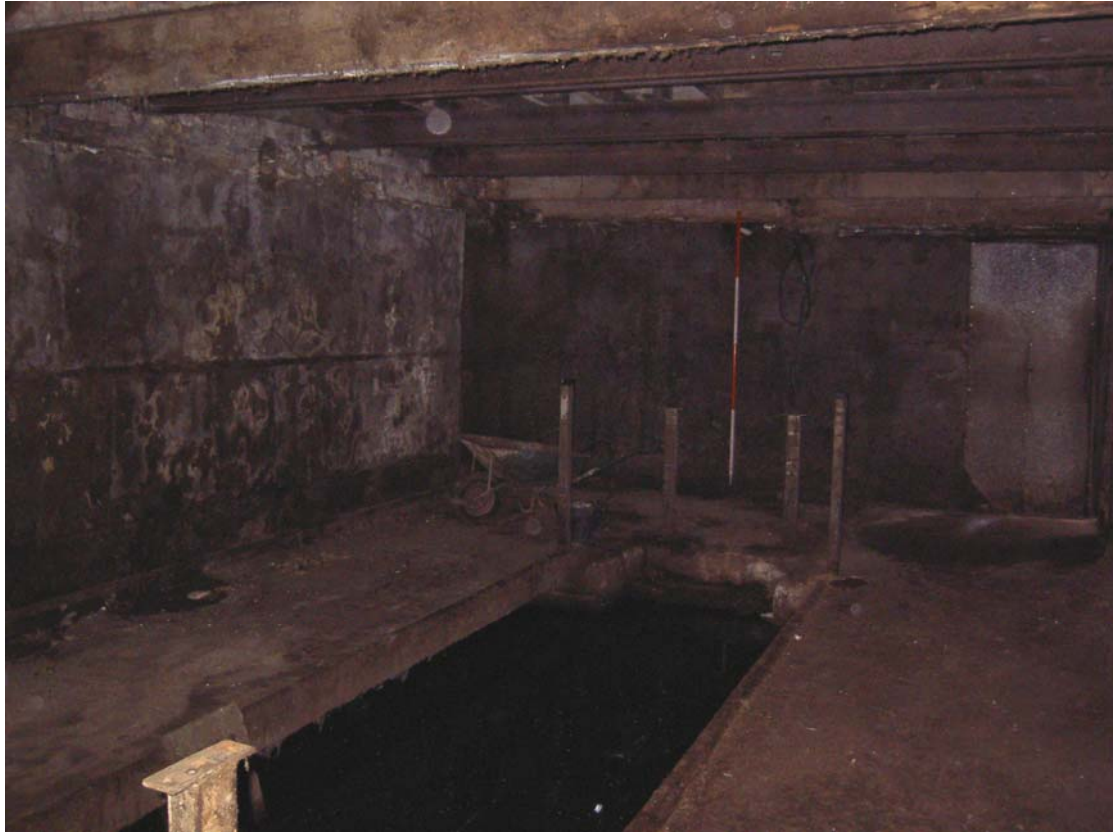
Plate 37: General view of the south end of Room 4 of the dairy showing the large pit

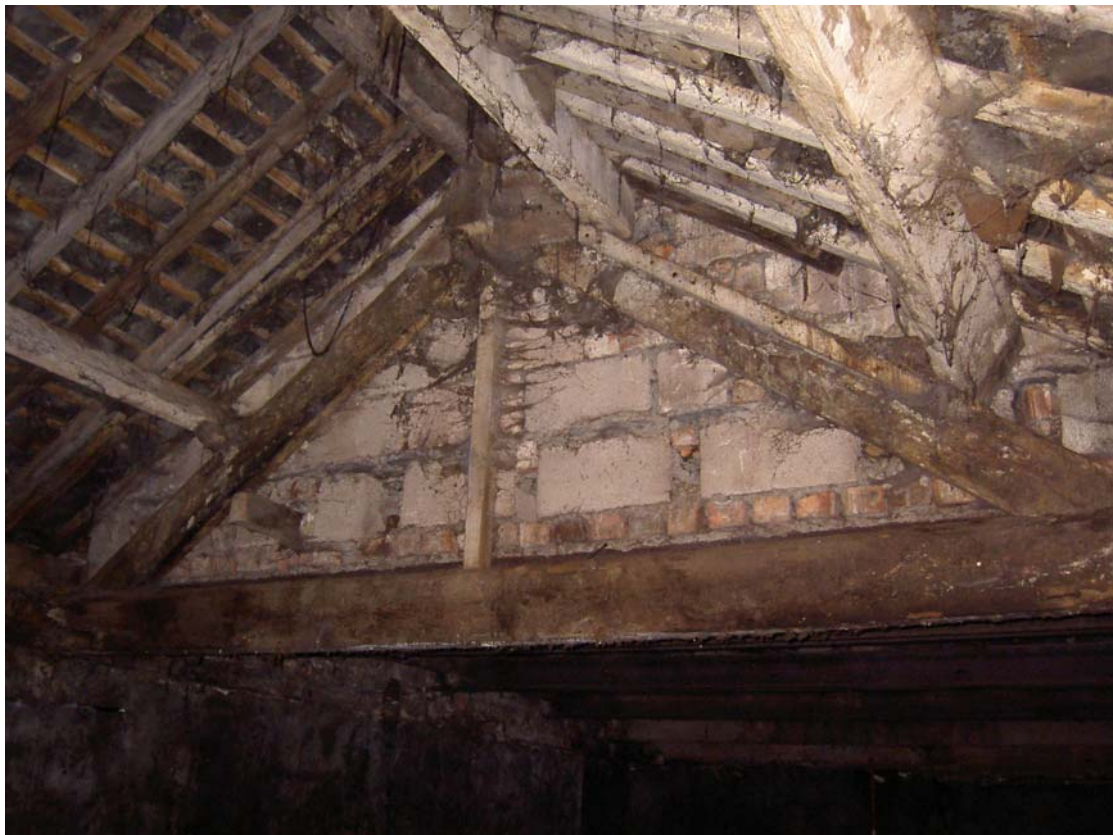
Plate 38: North side of truss within Room 4 of the dairy

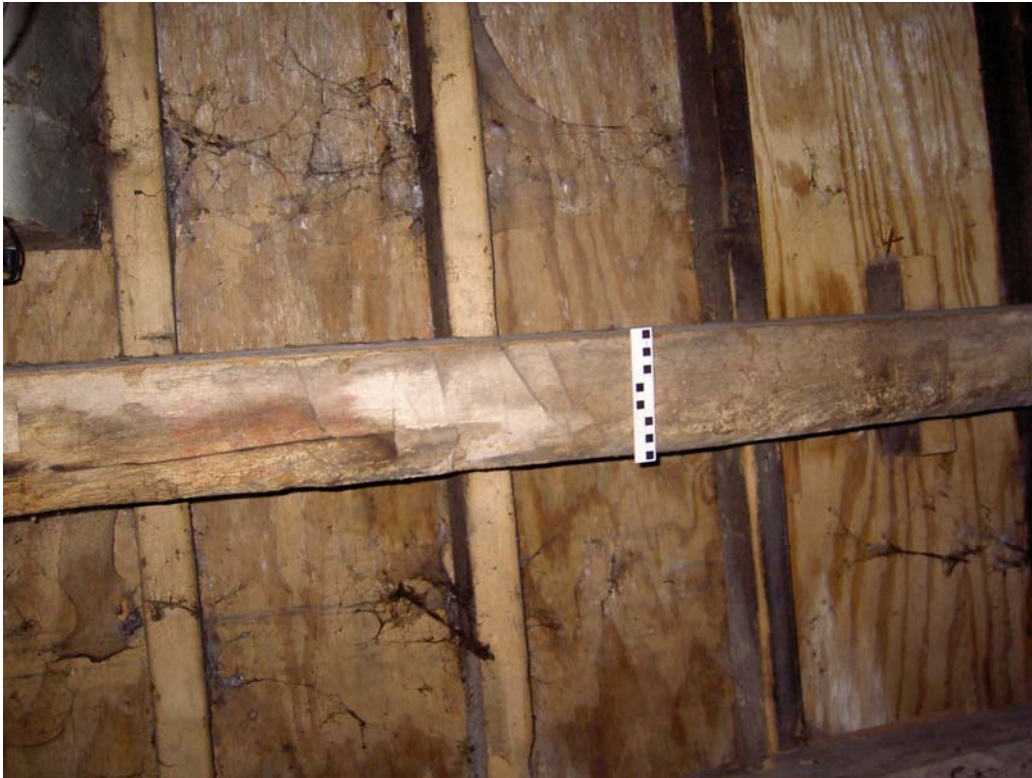
Plate 39: Baltic timber marks in the ceiling of Room 4 of the dairy

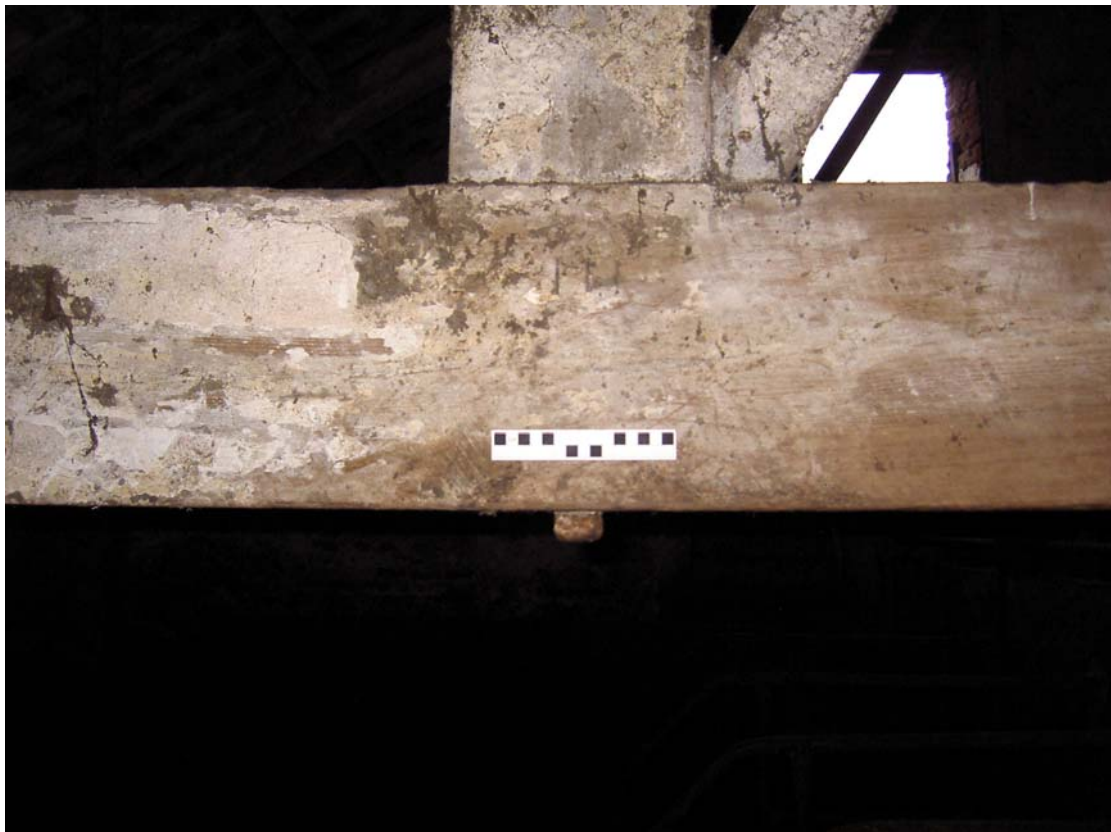
Plate 42: Carpenter's mark on the south face of Truss III

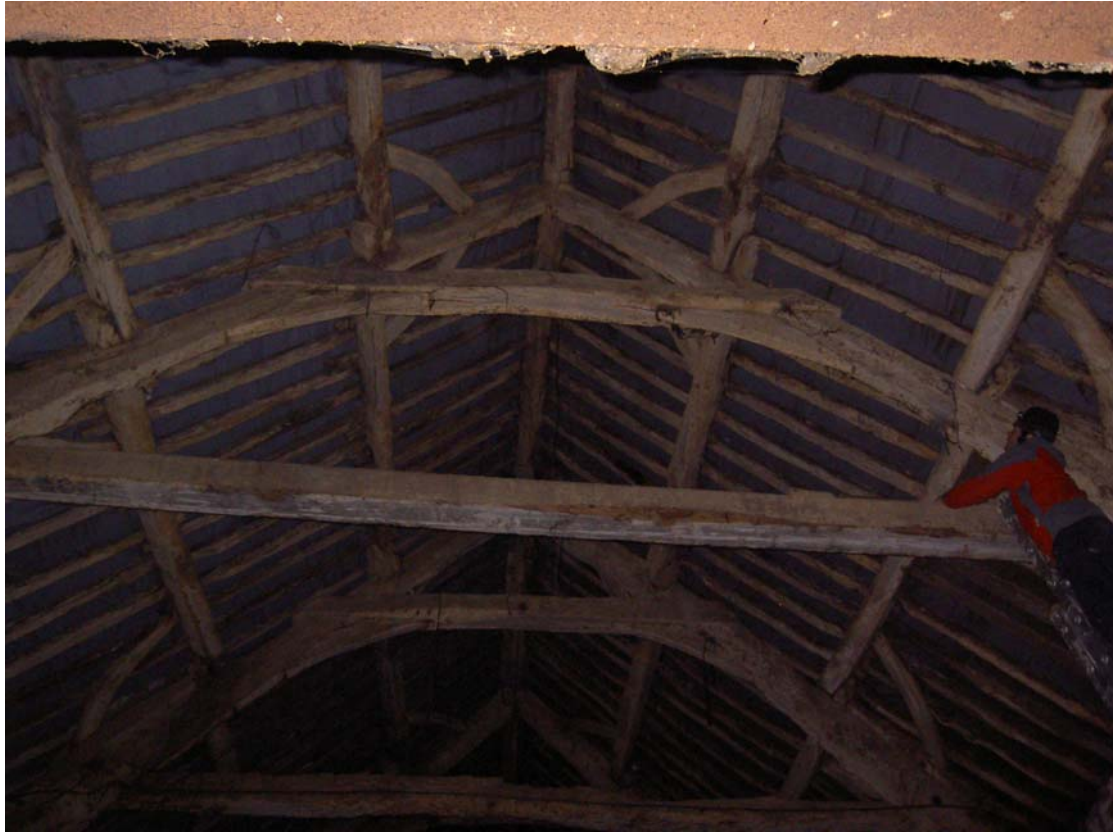
Plate 45: North faces of Trusses 1 and 2 within the barn

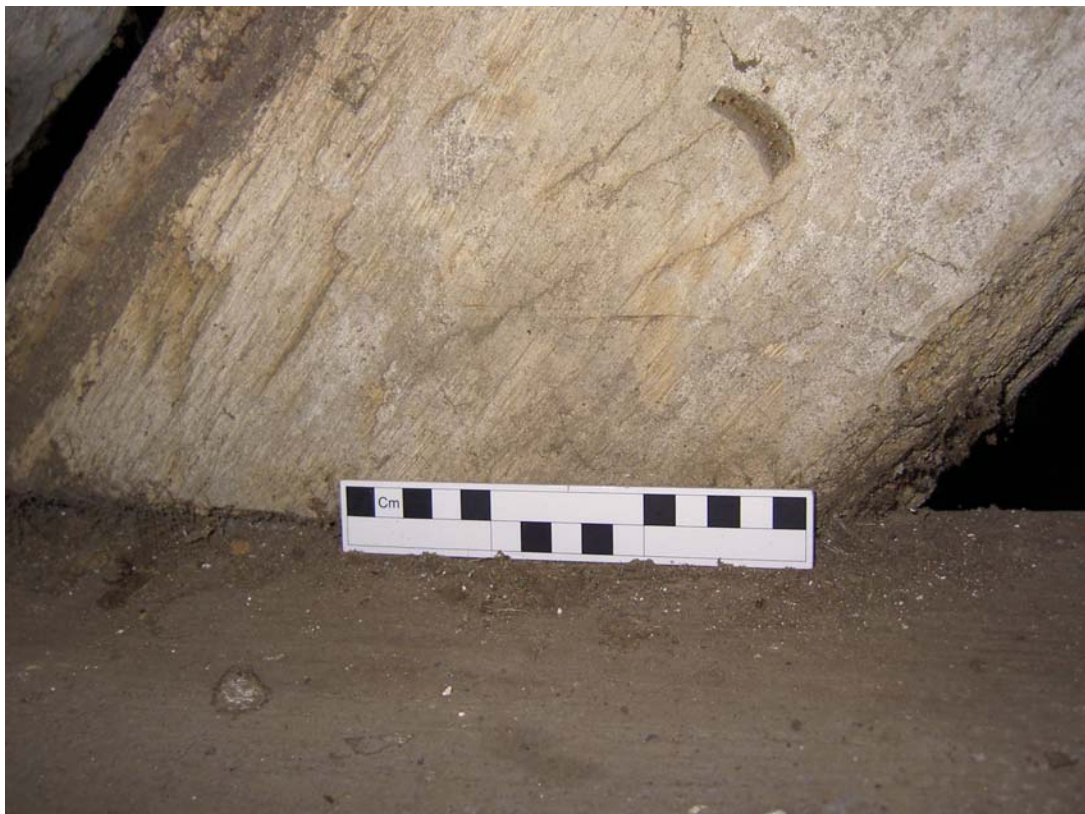
Plate 46: Punched carpenter's mark 'I' on the west side of Truss 1 within the barn

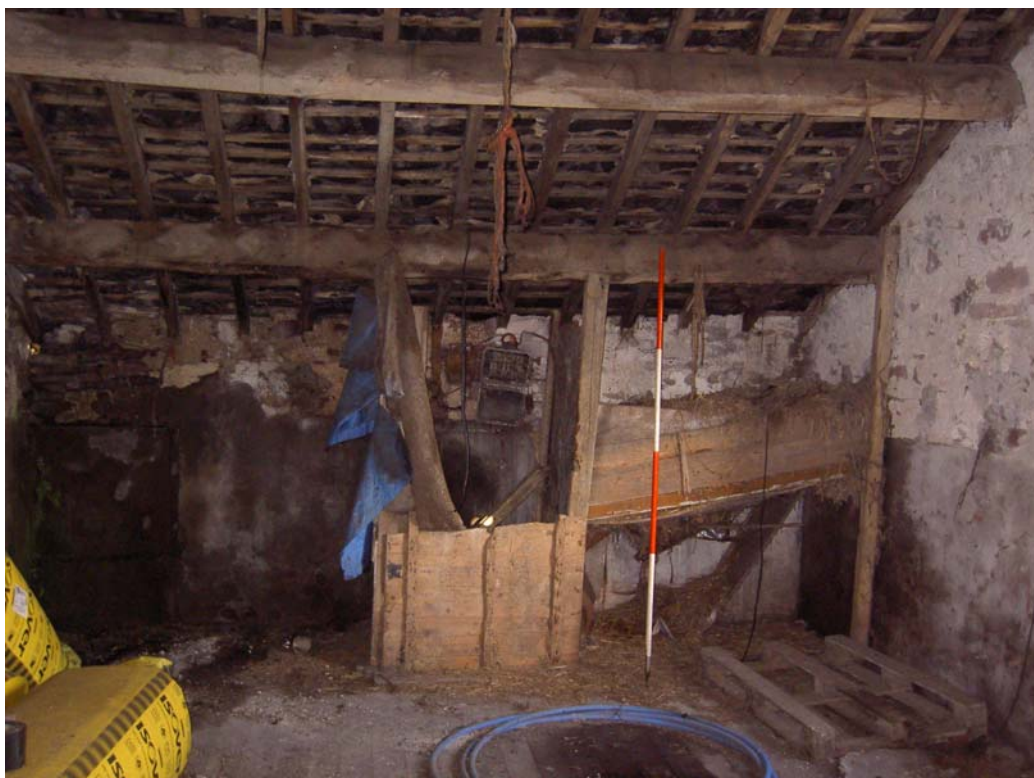
Plate 50: North side of the first floor of the north-east outshut attached to the barn showing the inserted walls associated with the grain crusher

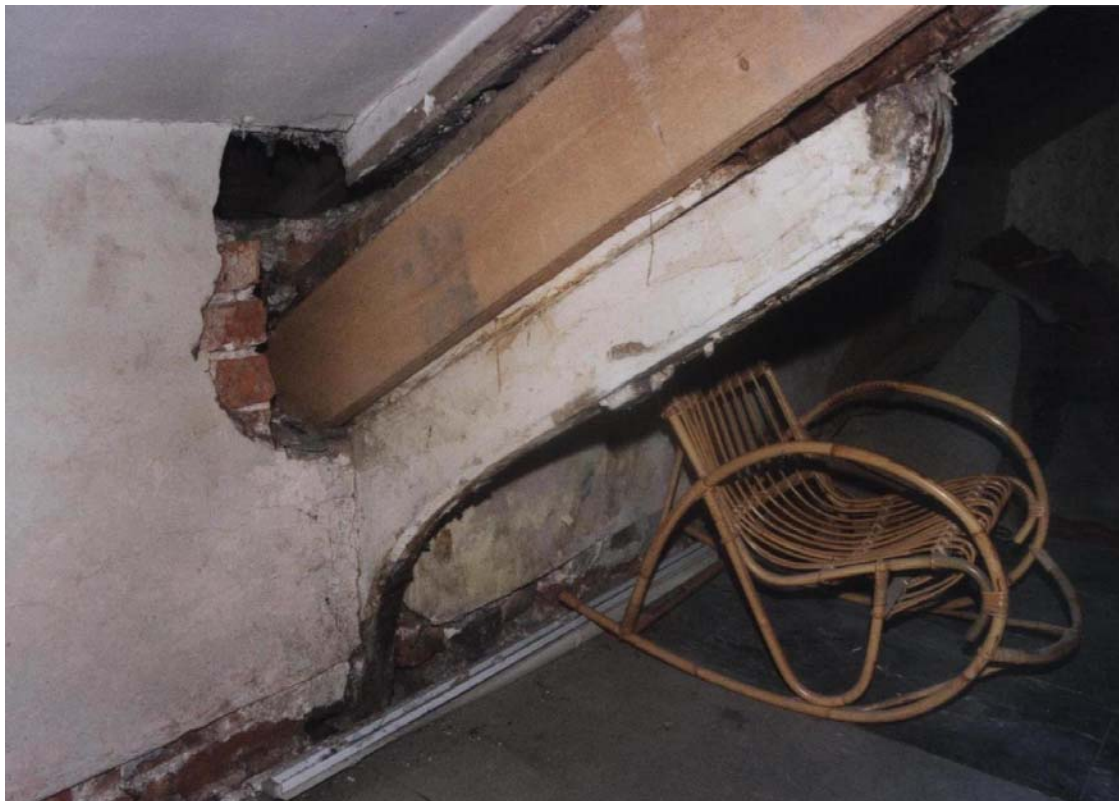
Plate 56: Angled brace bolted to a truss at 16 Queen Street, Ulverston

The angled braces bolted between the cruck blades and the collars of several of the trusses were undoubtedly also added at this time. Similar examples known from Ulverston are within a building thought to date to the late 18th or early 19th century, which again fits with this period (see *Section 5.4.4* below and Plate 56). It is tempting to see these alterations as a result of the repairs proposed in 1826, for which a Mr Webster provided costs (see *Section 3.2.3*) but this cannot be stated with any certainty. The reference from 1826 also mentions the suggestion that the house be rebuilt close to the barn, and the mention of this building alone might be taken as evidence that the dairy had not been built at this time.
