Client Report No. CP 413/06

February 2007

**ARCHAEOLOGICAL
BUILDING RECORDING
AT
BLACKCLEUGH BASTLE,
SWINHOPE, ALLENDALE,
NORTHUMBRLAND**

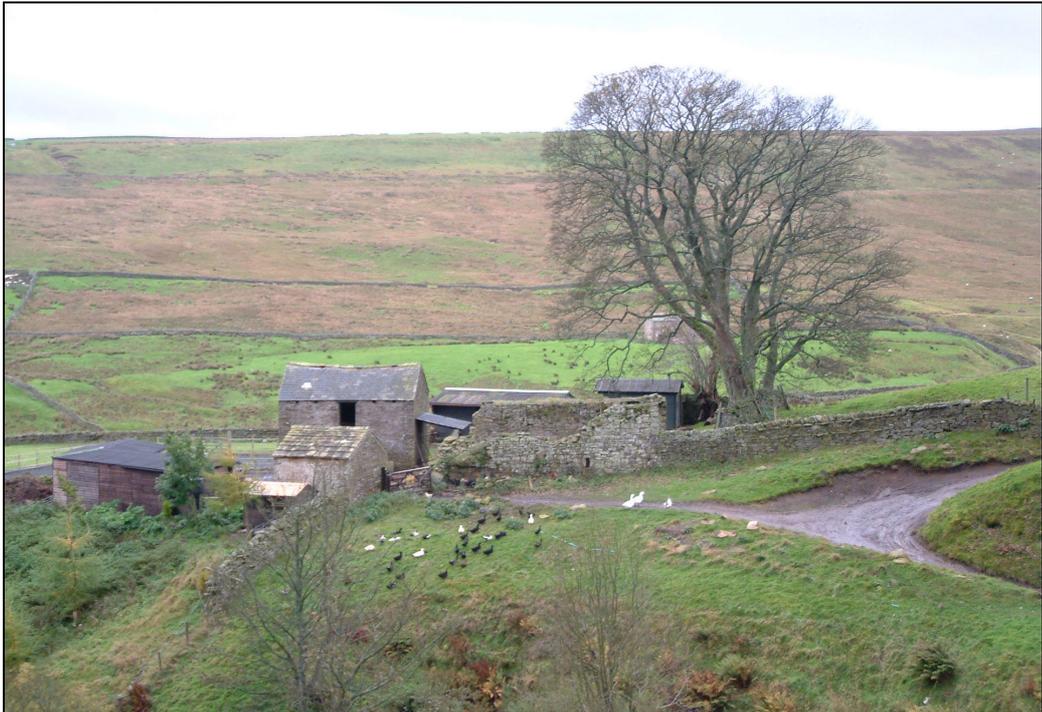
Plate 1. Blackcleugh, showing the bastle (right) and later farm buildings (looking south)

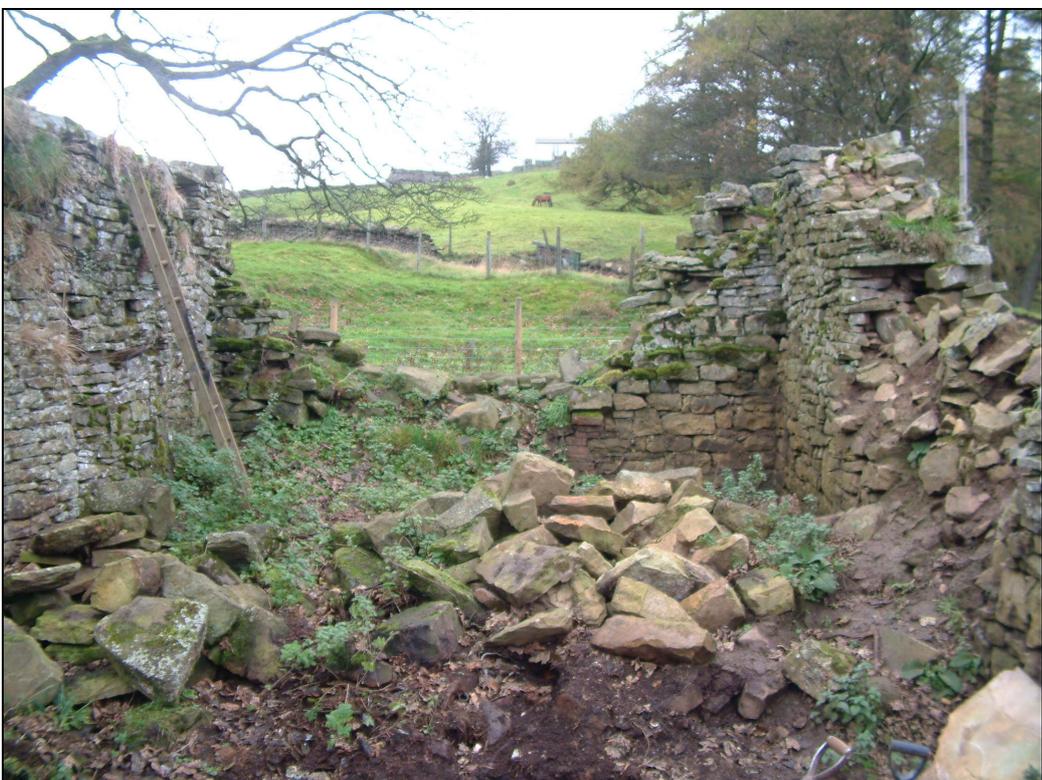
Plate 2. The interior of Blackcleugh Bastle prior to the removal of soil and stone rubble (looking west)

- 3.1.1 An initial site visit was undertaken on 30th October 2006 in order to assess the condition of the building, and identify any impediments to the building survey. At that time the interior of the building was filled with an accumulation of stone rubble and soil, which was gradually being cleared by hand by the owner (Plate 2). The building survey commenced following the removal of these deposits, to ensure that the full extent of the interior walls was visible when the recording took place.

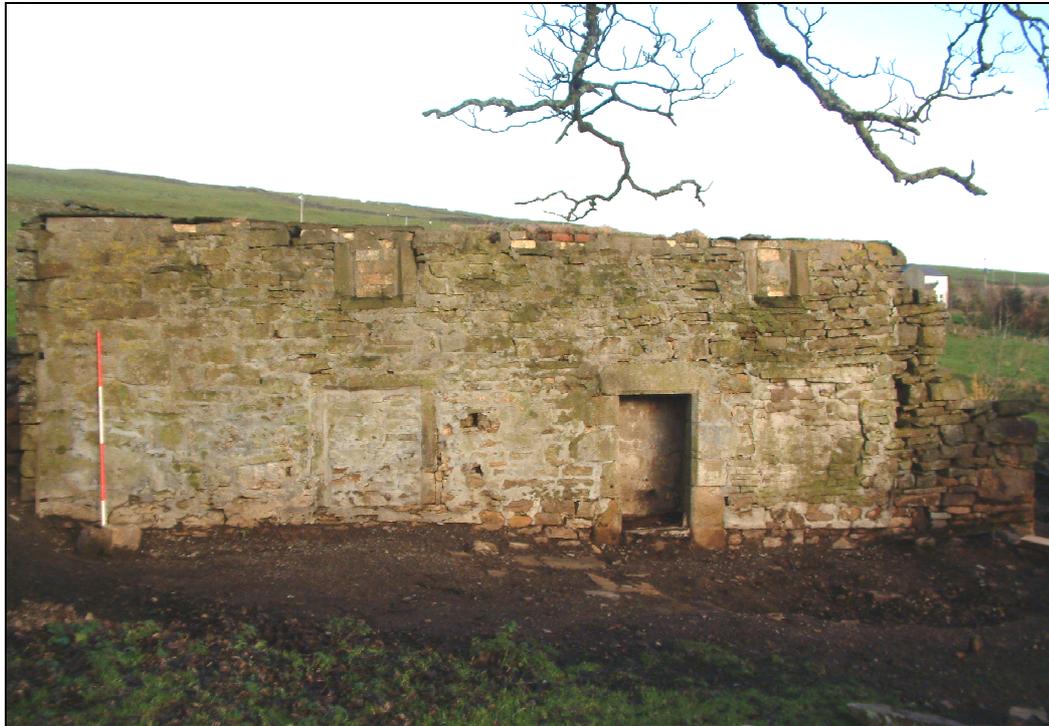
- 3.2.3 The south wall of the building was the best-preserved being up to 3.2m high (Plate 3). A ground-floor entrance, two ground-floor windows and two first floor windows were visible in this wall. These had been blocked (presumably when the former shed was constructed), the entrance having been used as a storage space. The outer wall surface had also been plastered, masking much of the stonework. A number of timber slots were identified in the wall, which had been used to tie the former shed to the wall of

the building. The eastern end of the south wall had suffered damage, due to the collapse of the east wall (Figure 2).

Plate 3. South elevation showing blocked windows and entrance of the former farmhouse

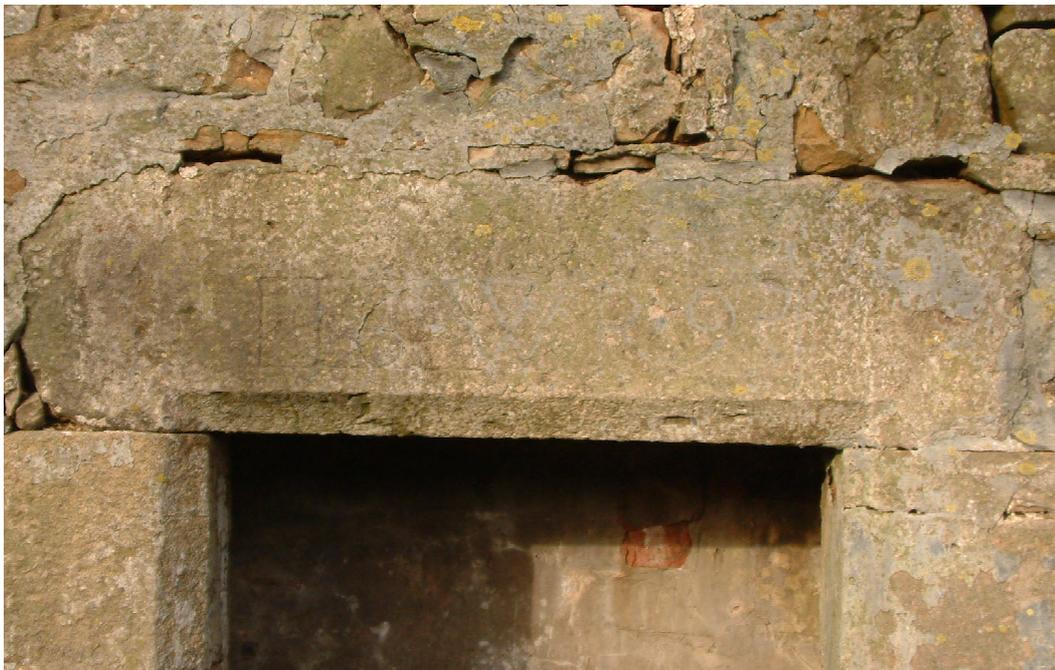
Plate 4. Lintel above the ground floor entrance inscribed: “16·WR·95”

- 3.2.4 The entrance had a surround formed from large sandstone blocks measuring up to 0.4m thick by 0.65m long, with a 0.05m chamfered outer edge. The doorway was square-headed with a lintel which bore the inscription: “16·WR·95”, although this was very worn (Plate 4). Two iron hinge pins were located inside the doorway on the east side.

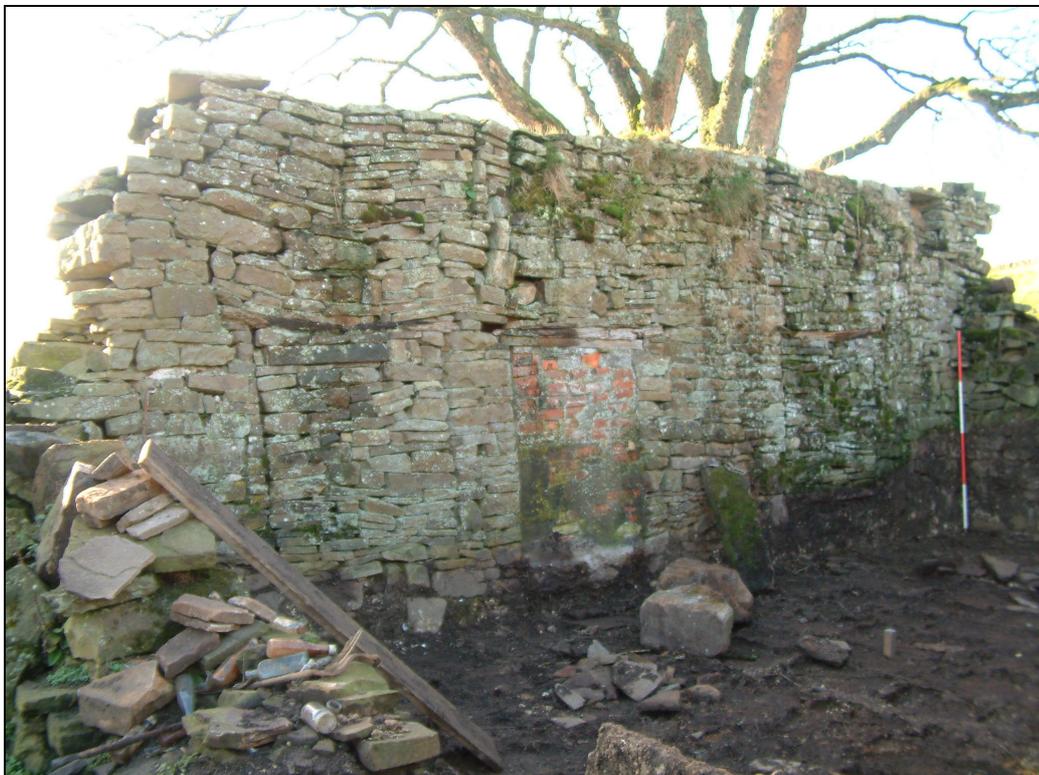
- 3.2.6 The interior of the south wall showed a high degree of remodeling and in-filling (Figure 3). Traces of plaster were identified on the inner surface of this wall. The ground-floor entrance and flanking windows had internal timber lintels. The entrance had been bricked-up, whilst the ground floor and first floor windows were in-filled with stone (Plate 5). A possible straight joint above the eastern jamb of the doorway has been sited as evidence for the presence of a possible upper doorway (Ryder 1995). However, the structural evidence for this was unconvincing.

Plate 5. Interior of the south wall showing blocked openings

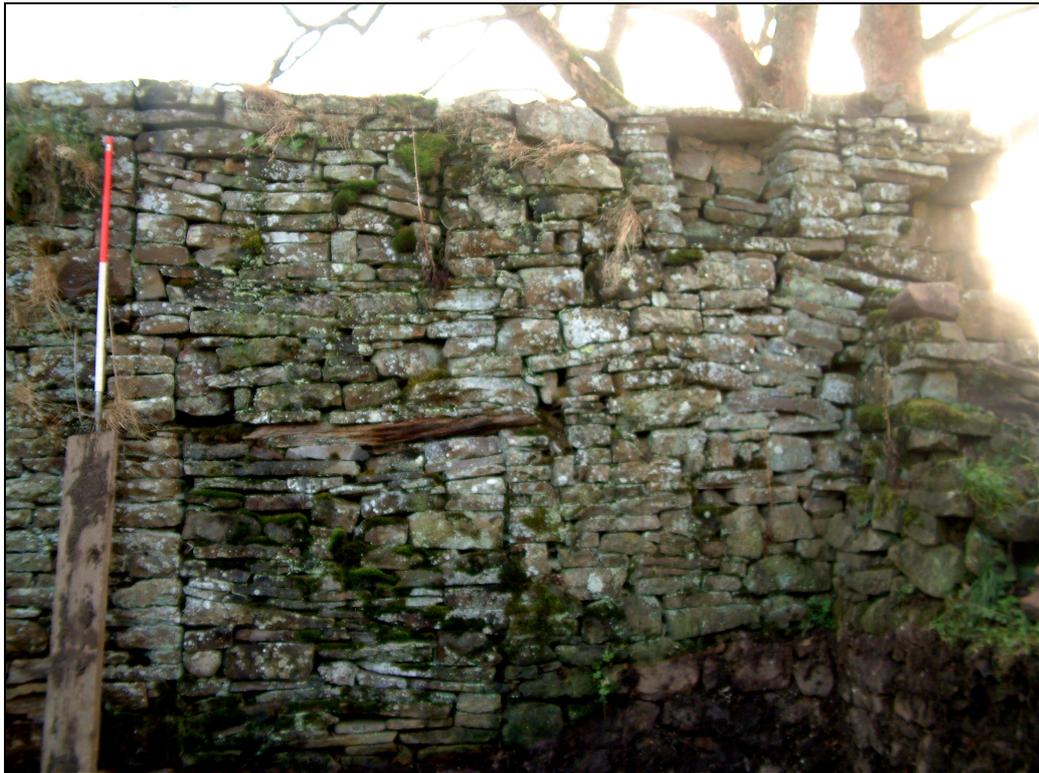
- 3.2.7 An opening at the western end of the south wall at first floor level marked the location of a former window, that was not visible in the wall exterior. The opening measured 0.5m by 0.5m, with roughly-shaped stone surrounds and a 0.06m-thick stone lintel and sill (Plate 6).

Plate 6. West end of the south wall interior showing the location of a former window (top right)

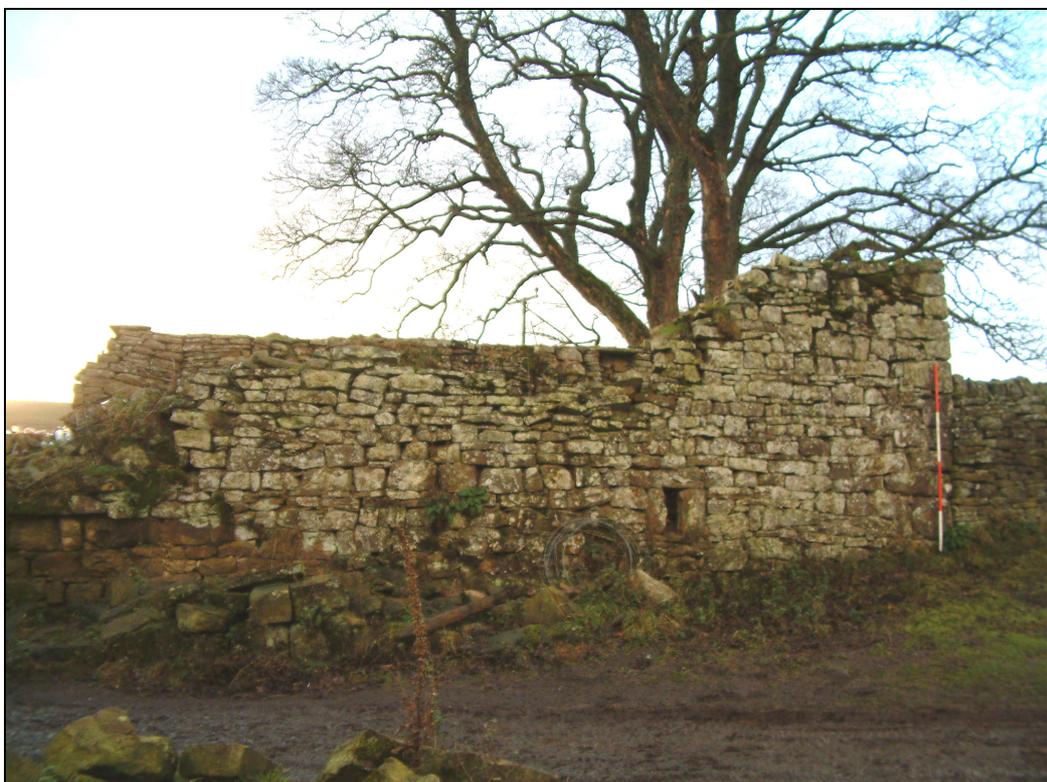
Plate 7. North elevation showing an original slit window

- 3.2.8 The north wall of the building was incomplete, having collapsed over much of its length. The west end of the wall was most well preserved, being 3m high and containing many original quoin stones. In contrast, the eastern end only survived to a height of 0.7m (Plate 7). An original slit window was located at ground floor level towards the western end of this wall, made from large roughly-shaped sandstone blocks (Plate 8). Regular stone courses were visible in both sides of this wall. Three roughly-shaped stones marked the location of the slit window on the inside of the north wall where it had been infilled with stone. The interior central section of this wall has suffered badly from collapse and was in an unsafe condition at the time of the survey (Plate 9).

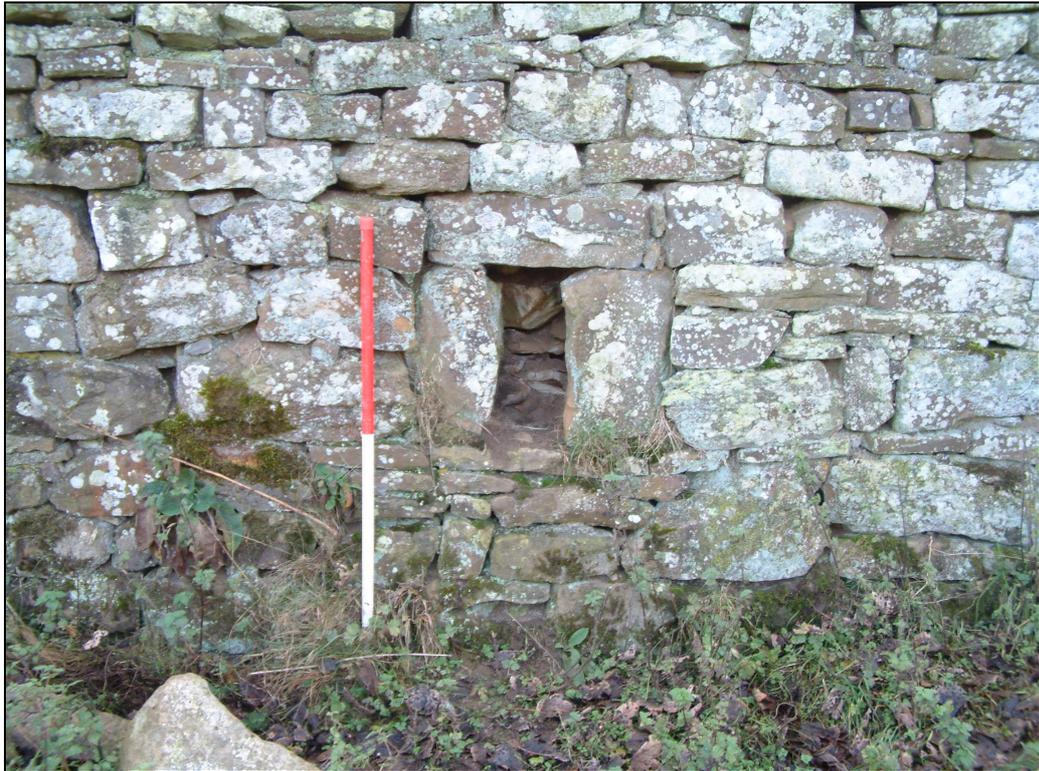
Plate 8. Blocked slit window in the north wall exterior

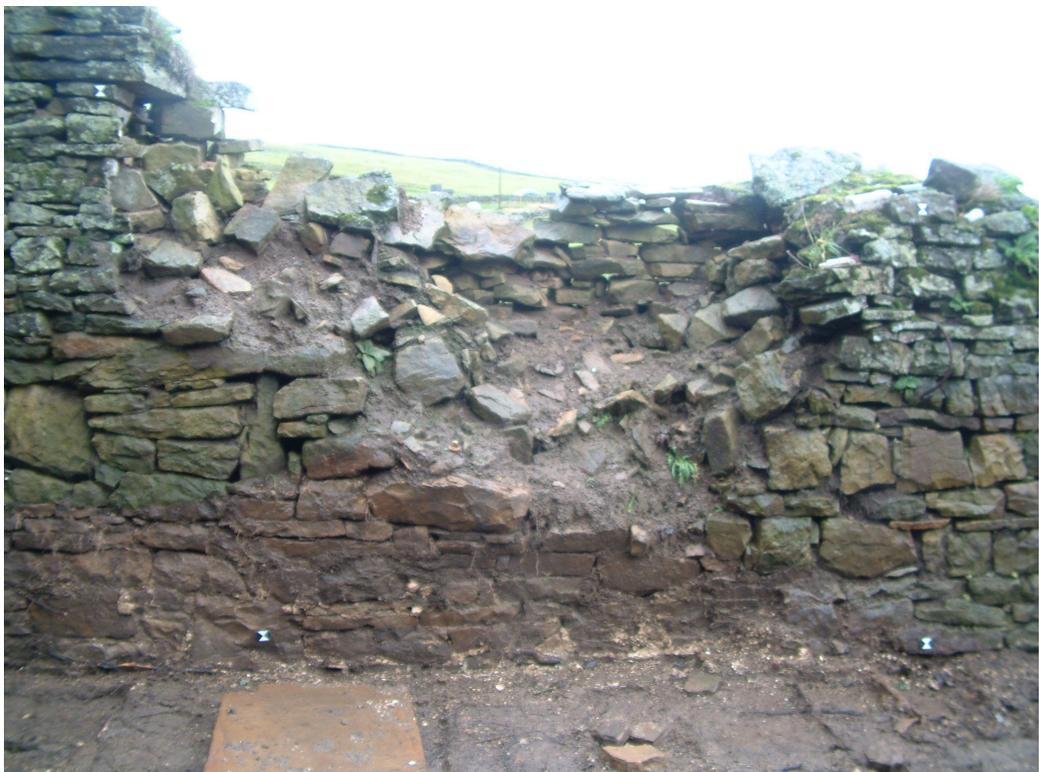
Plate 9. Interior of the north wall showing collapsed central section and blocked window opening (left)

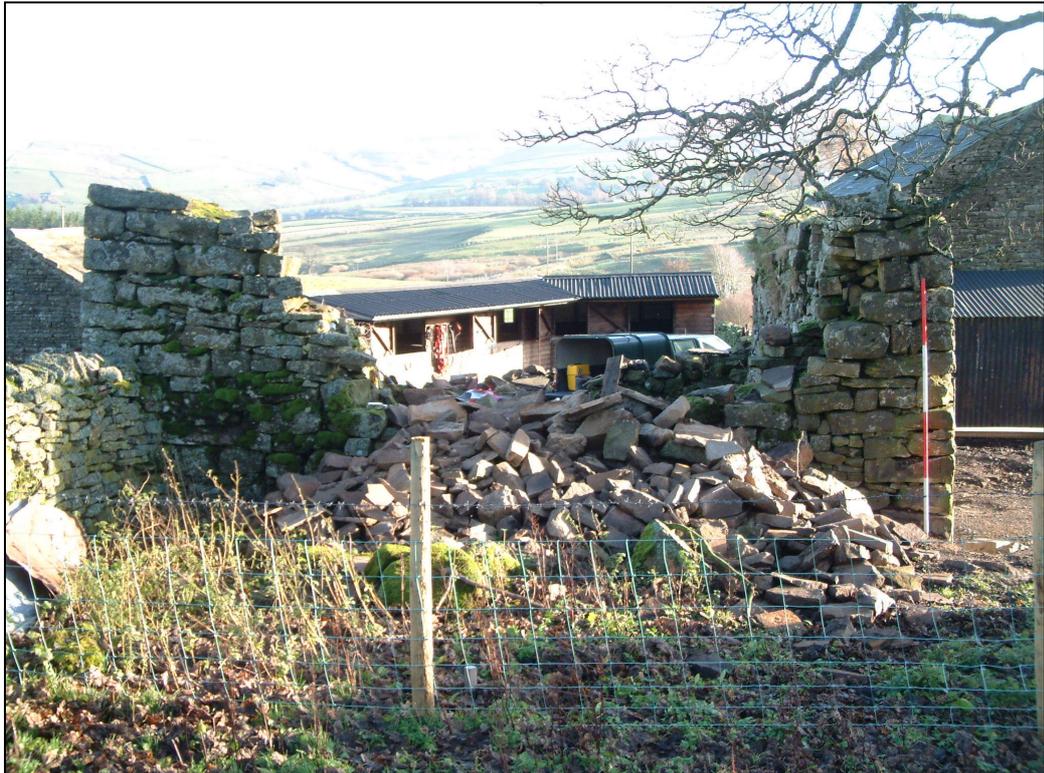
- 3.2.9 The east and west walls were the most poorly. The west wall survived to a height of 2.6m on the north side, although the central section had collapsed badly. At the time of the survey stone rubble, cleared from the interior, was covering the central part of this wall on the outside (Plate 10). The interior of this wall extended 1.3m below the present ground surface, which was marked by a layer of turf and soil (Figure 4). The inner surface also showed evidence of a former opening, lined in brick, although the exact nature of this opening was uncertain (Plate 11).

Plate 10. West wall of the building showing collapsed central section (looking east)

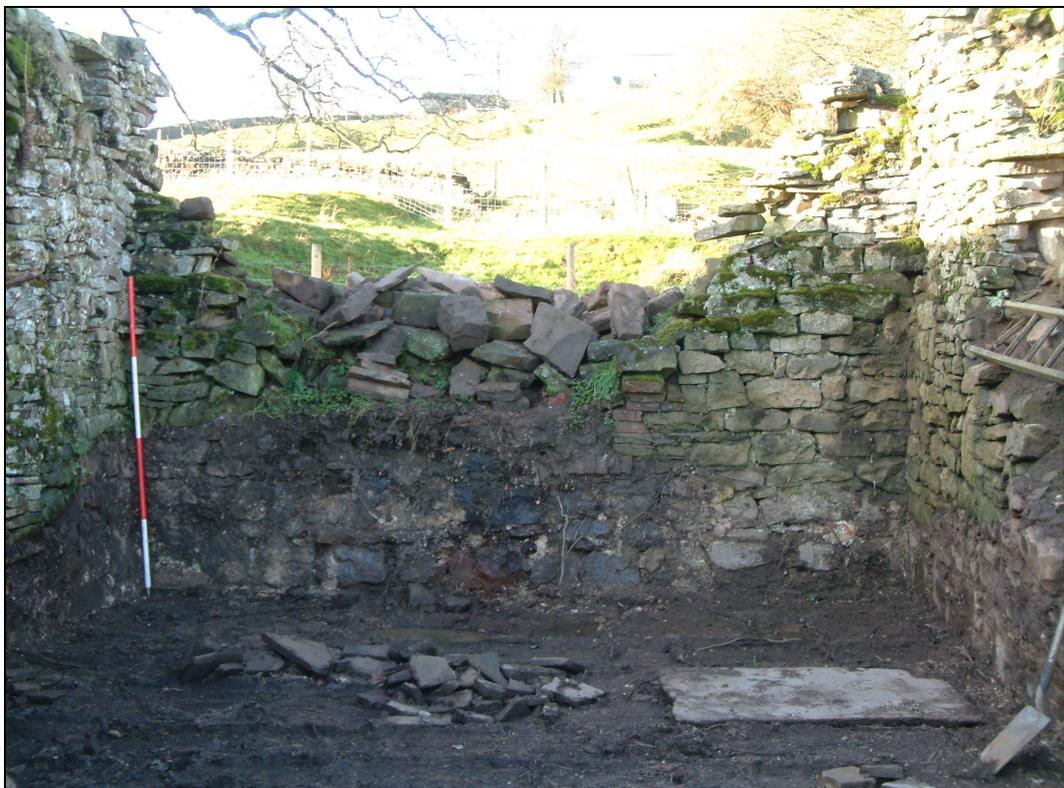
Plate 11. The west wall interior (looking west)

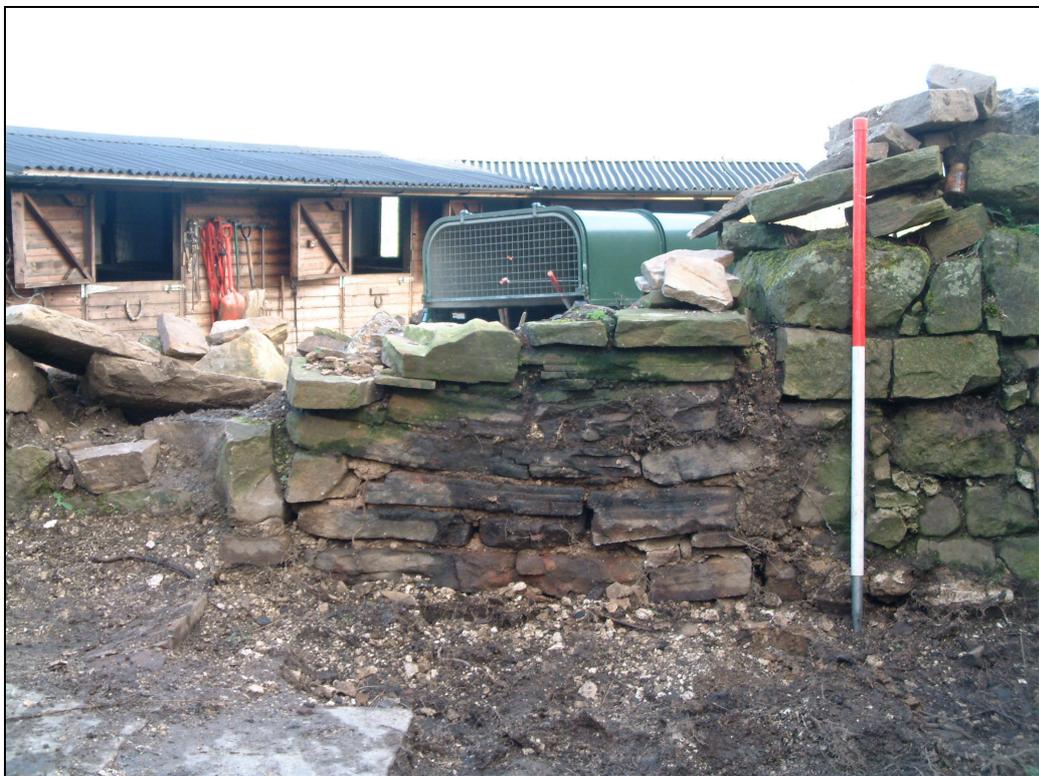
- 3.2.10 The east wall only survived to a height of 1.3m, and was hidden by collapsed stone on the outside (Plate 12). A blocked doorway was visible in the centre of this wall, where the stone had been cleared from the interior. This is likely to be the original bastle byre doorway (Plate 13). The entrance was 1m wide and survives to 0.6m high. It was framed by coarse roughly-shaped stones of various sizes.

Plate 13. Blocked byre doorway in the east wall of the building

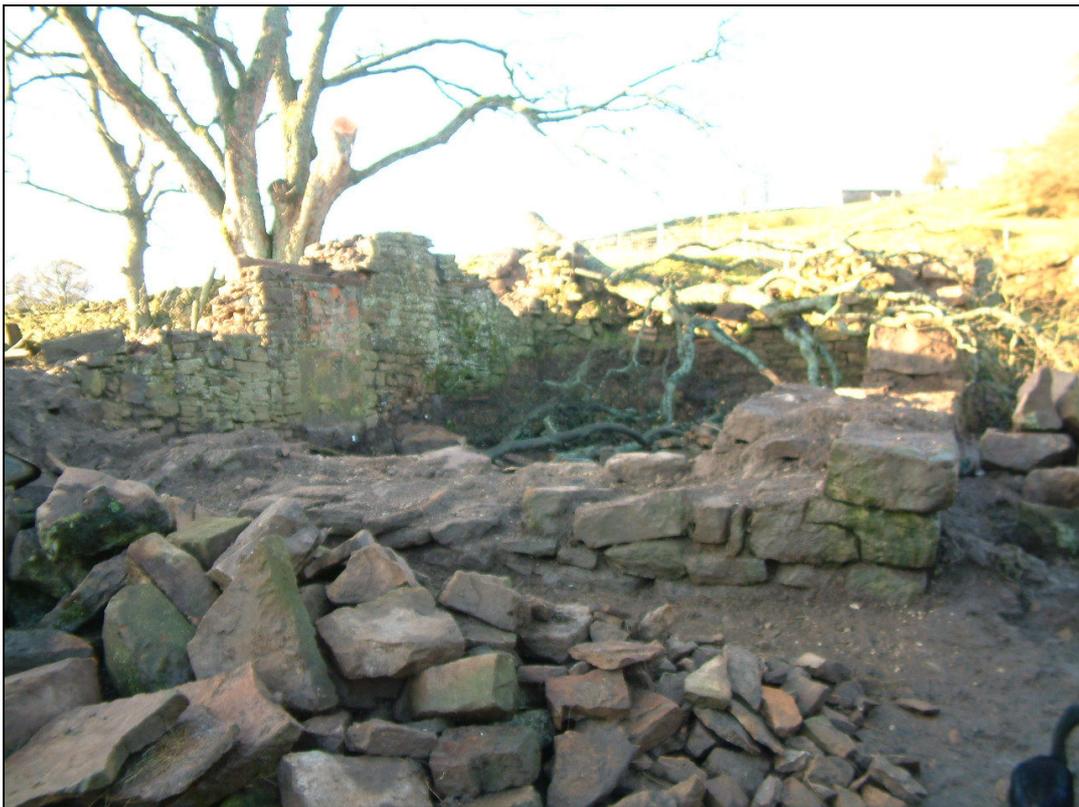
Plate 14. Blackcleugh Bastle with parts of the north, east and south walls removed (looking west)

- 3.4.4 All dismantling work is to be done by hand and heavy work will be undertaken using a pulley system to avoid damaging the stone. Monitoring visits will be agreed with the client and timed to coincide with the dismantling of the walls, to examine the building foundations, and during any associated excavation work. If further features are revealed during the dismantling of the building, North Pennines Archaeology will record these. The final monitoring visit will be undertaken to identify and photograph the locations of re-used structural features in the new building.

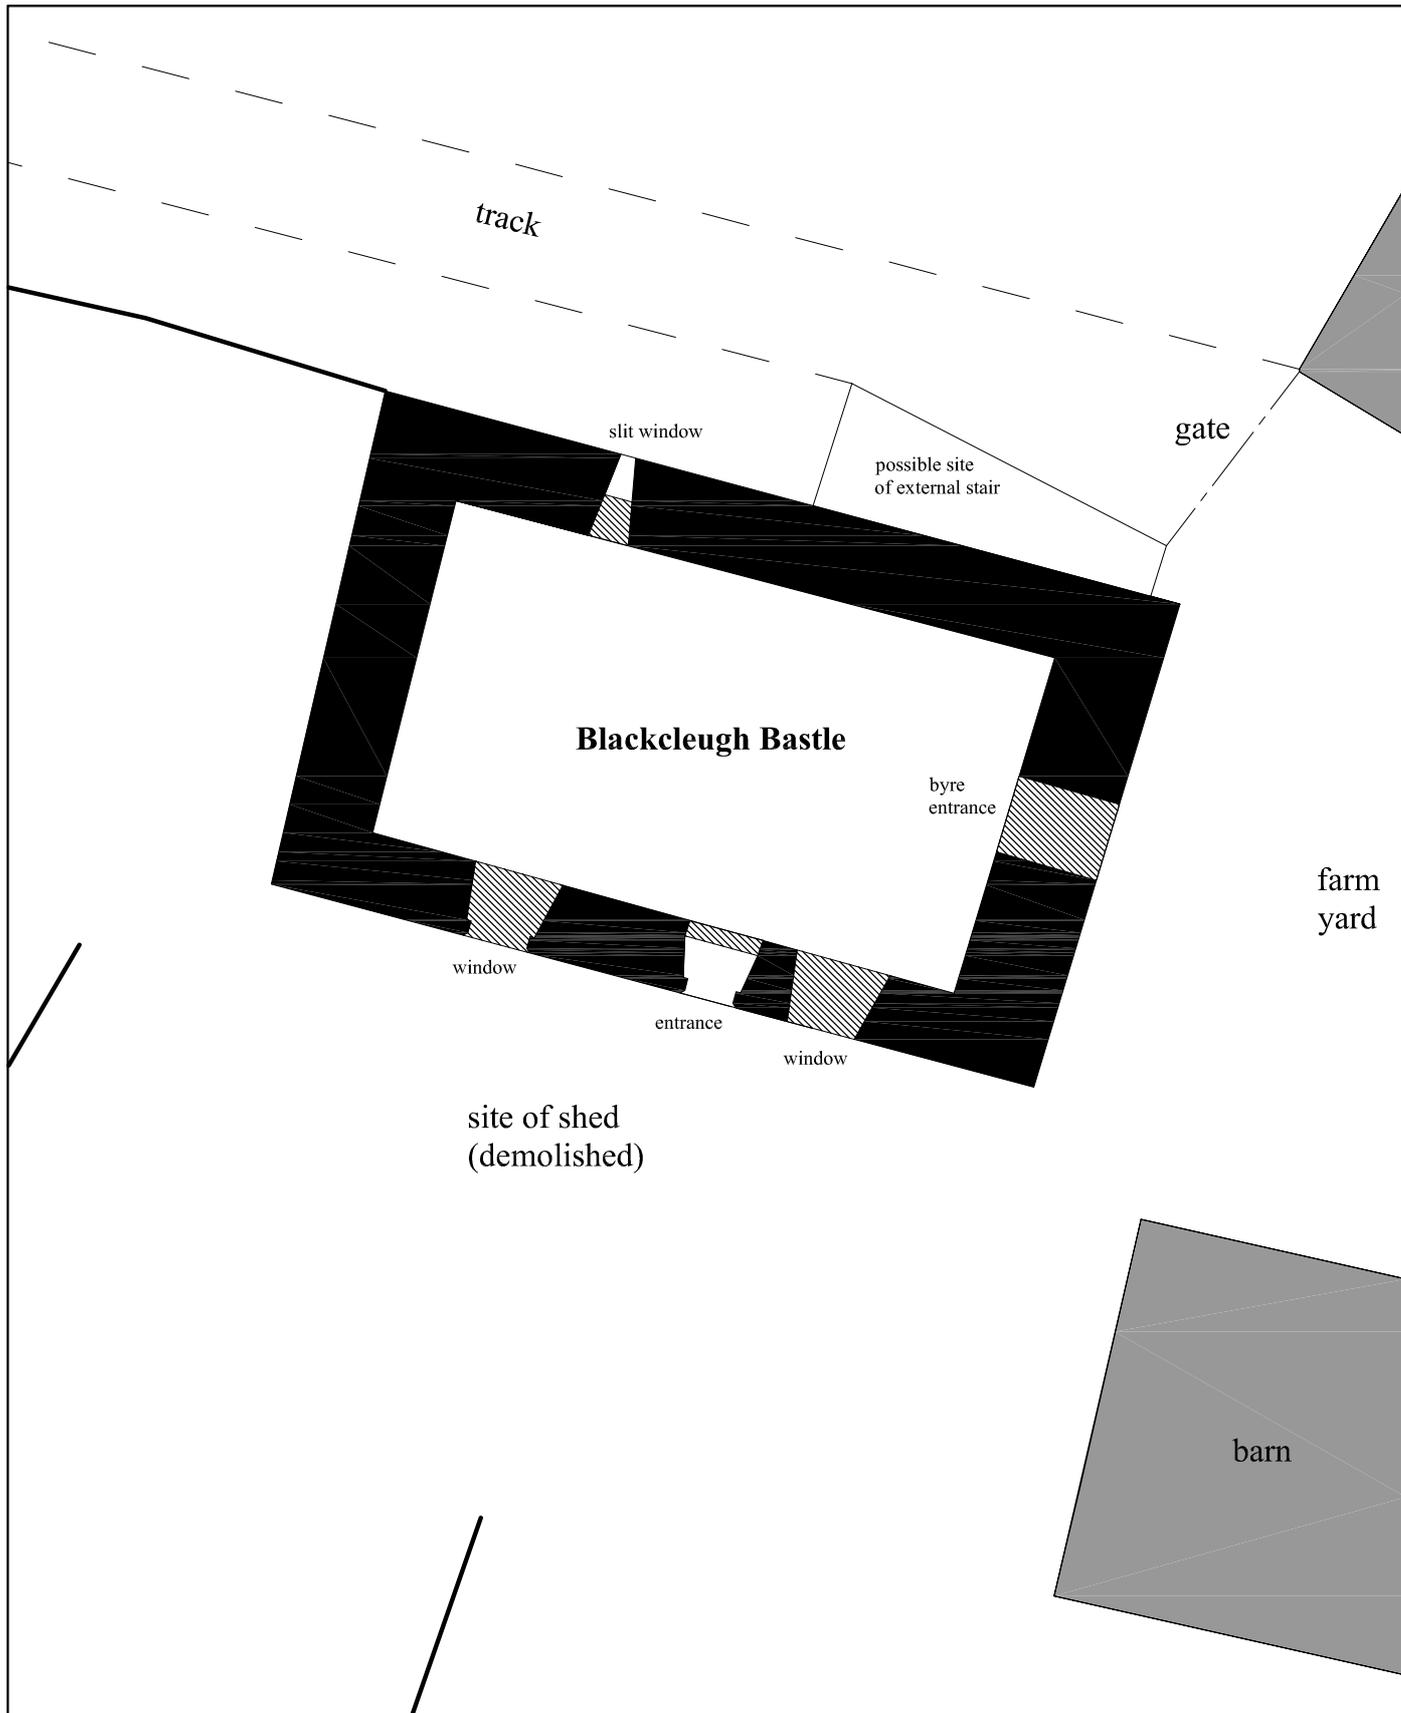
Figure 2 : Plan of Blackcleugh Bastle

- 3.1.3 The building was surveyed in plan using a Trimble 3605 Reflectorless Total Station and is illustrated in Figure 2. The elevations were recorded using a combination of metric survey and rectified photography. The resulting external elevation drawings are illustrated in Figure 3, and the internal elevations are shown in Figure 4. A standard datum line is shown in each elevation. The value is arbitrarily set at 400m, as no Ordnance Survey benchmark was available close to the site.

- 3.2.1 Blackcleugh Bastle comprised a rectangular roofless ruin measuring 10.5m by 6.7m with walls of coursed undressed sandstone and roughly shaped quoins. The building was situated on the south side of a farm track, close to a later 19th century barn and shed. Until recently a pent-roofed shed was built against the south side of the building, but this has since been demolished (Figure 2).

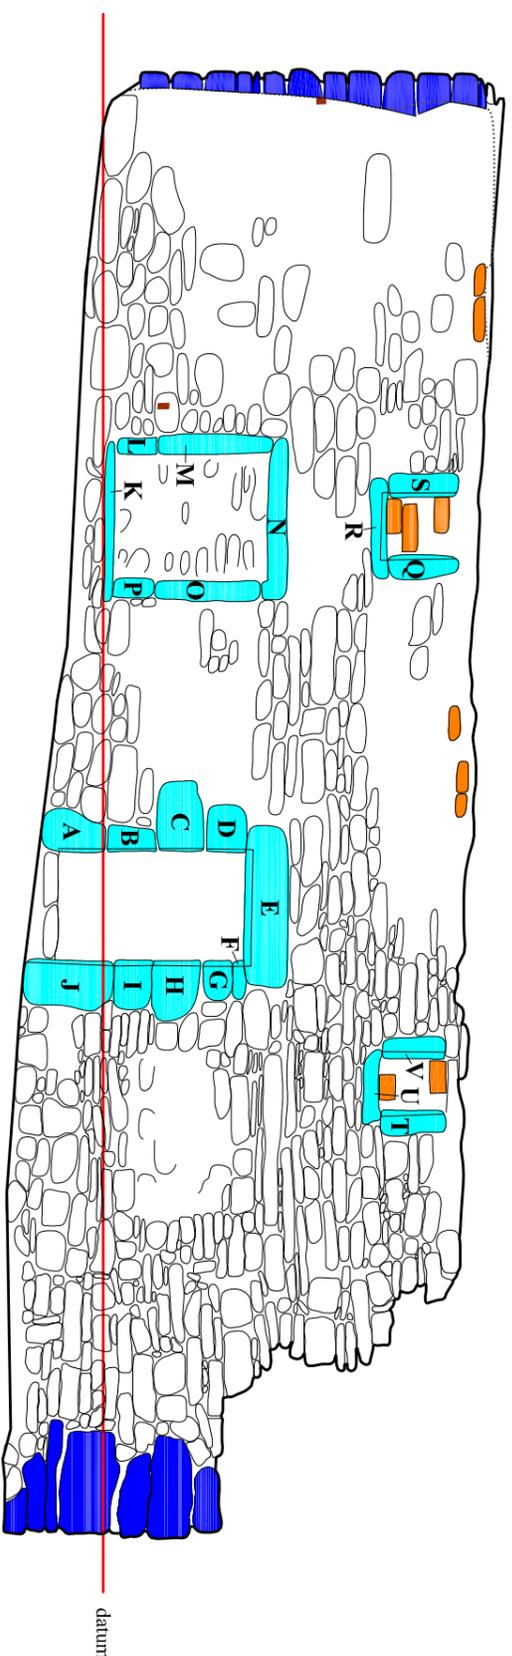
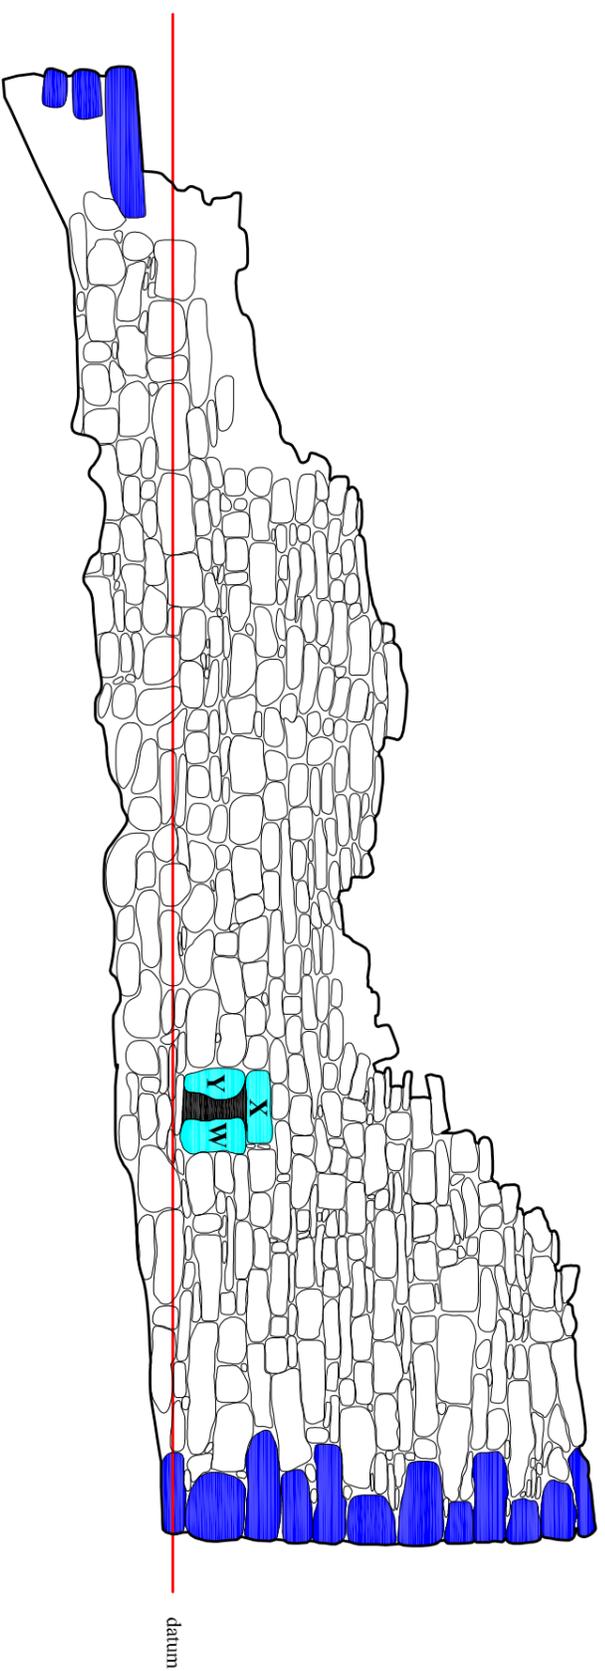
Figure 5 : North and south elevations showing stones to be retained for re-use in new build

- 3.1.4 A third visit was undertaken on 28th November 2006 to identify key structural stones, which were to be retained for re-use in the new building *in situ*. These were marked on the elevation drawings (shown in Figure 5), and are listed in Appendix 1.

- 3.4.1 The existing building can be broken down into a number of key elements: the main body of the bastle is made up of coursed undressed stone, with angled roughly shaped quoins (Figure 5). It is proposed that the quoin stones, which are a distinctive element of the original building, be stored separately during the dismantling process, and are re-used as quoins in the new building. The stones of the flag floor have already been removed and have been stacked separately for re-use.

- 3.4.3 The only dressed stones used in the present building date from *c.*1695. These frame the entrance and three windows in the south wall (all dressed stone from the fourth window having been removed in the past) and includes the inscribed lintel above the entrance. These stones are labeled in Figure 5 and are cross-referenced to an index of stones in Appendix 1. It is proposed that these stones be labeled, as indicated, during the dismantling of the present building, and are stored on pallets until they are re-used in the same locations within the new building. The first floor mullion window lintels, which have been located on site, will also be incorporated in the new building.
