NORTH PENNINES ARCHAEOLOGY LTD

Client Reports No. CP/779/08

**ARCHAEOLOGICAL
WATCHING BRIEF
ON LAND AT THE SITE OF
THE FORMER NEWPORT
IRON WORKS,
NORTH MIDDLESBROUGH
ACCESSIBILITY SCHEME,
TEESSIDE**

January 2009

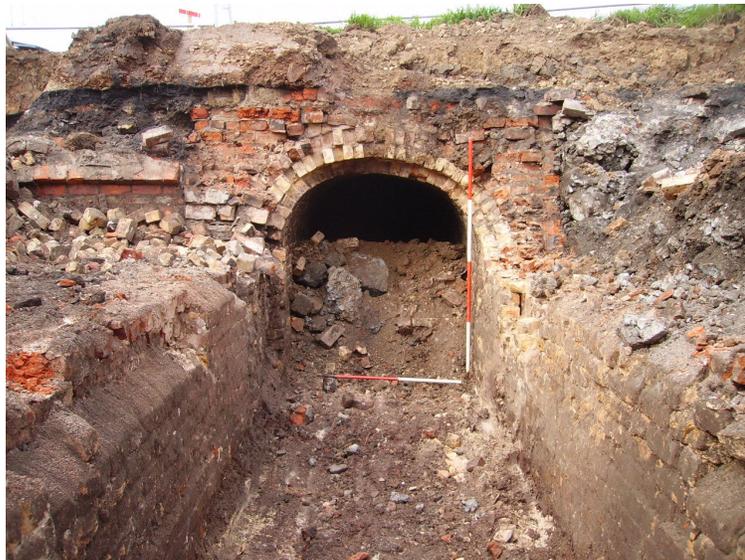
4.2.1 The archaeological watching brief was initiated following the truncation of a large structure during ground reduction at the northern extent of the proposed development area. The structure (**106**) was made up of three courses of red/yellow brick forming a *c.*2.2m high x *c.*2.4m wide arched flue encased in a squared red brick structure (**115**) which measured *c.*2.6m in height and *c.*3.2m in width and probably acted as an external support for the flue (**106**) (Plate 1). The external casing support (**115**) was below *c.*0.08m of tarmac (**103**) which was further below a *c.*0.5m deposit of sandy clay subsoil (**102**) and *c.*0.25m of topsoil (**100**). The flue structure (**106**) was on a northeast – southwest alignment and was filled by a rubble backfill mixed with silty clay (**108**) (Plate 1), although it is unclear whether the backfill (**108**) extended along the full length of the flue or whether it only occurred sporadically, possibly where parts of the structure had previously collapsed. The base of the flue structure (**106**) was made up of a well laid red brick surface (**114**) (Figure 3).

Plate 1: *Northeast elevation of flue structure (106)
with associated structures and deposits*

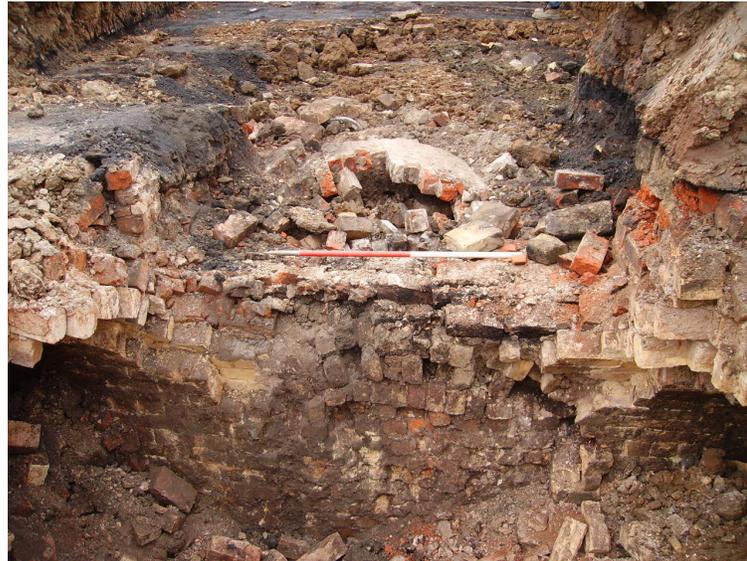
- 4.2.2 The exposed area also revealed a further arched structure extending in an east-southeast direction from the east wall of the flue structure (106) (Figure 3). This second arched structure (107) measured *c.*2.1m in height, *c.* 1.6m in length and *c.*1.5m in width, the opening of which had been blocked at some point with red brick (Plate 2). It is probable that the structure (107) served as one of several access points into the flue. The structure (107) had been backfilled with rubble mixed with silty clay (109).

Plate 2: *West-northwest elevation of structure (107)*

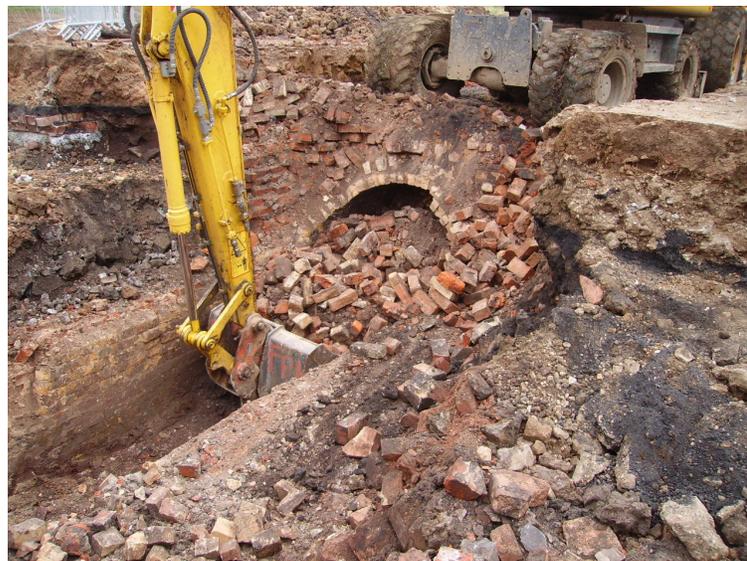
- 4.2.3 After some deliberation, the decision was taken to extend the excavated area in order to uncover the extent of the archaeological structures and to assess the areas suitability for construction purposes. However, this required the removal of the upper section of the flue structure (106) and outer casing (115), and the excavation of the backfill material (108) by mechanical excavator (Plate 3).

Plate 3: *Structure (106) during mechanical excavation*

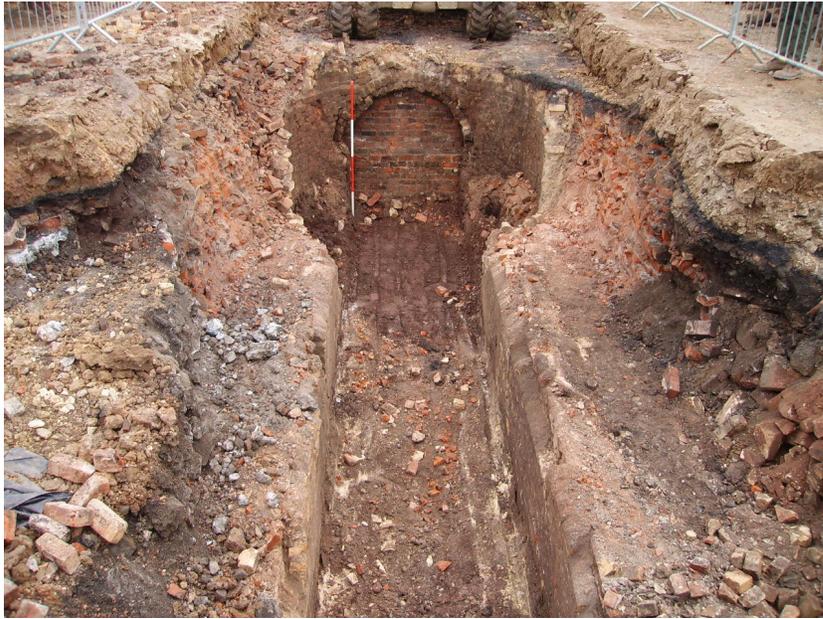
4.2.4 The exposure and removal of the top of the flue structure (106) continued in a northeast direction for c.6.6m at which point the flue led into the remains of a chimney (Figure 3) (Plate 4). The chimney was c.3.1m in diameter and survived to a height of c.2.25m. The inner flue of the chimney (111) was encased in a large square red brick structure (113) which measured c.6.6m in length, c.5m in width and c.2.6m in height, and would have acted as the external stack for the chimney (Figure 3) (Plate 5). Although the flue (106) continued northeast past the chimney (111) (113), this junction between the two structures had been blocked by two courses of red brick (Plate 6). It is unclear why the decision was taken to block the northern opening into the chimney unless the flue system employed was insufficient or had become obsolete.

Plate 4: *View northeast of flue (106) leading into chimney (111)*

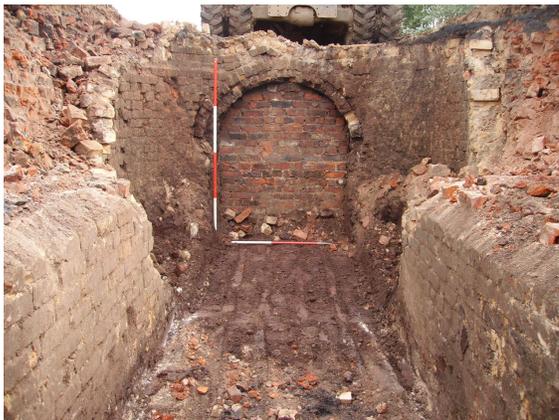
Plate 5: *Southwest elevation of chimney flue (111) with blocked entrance*

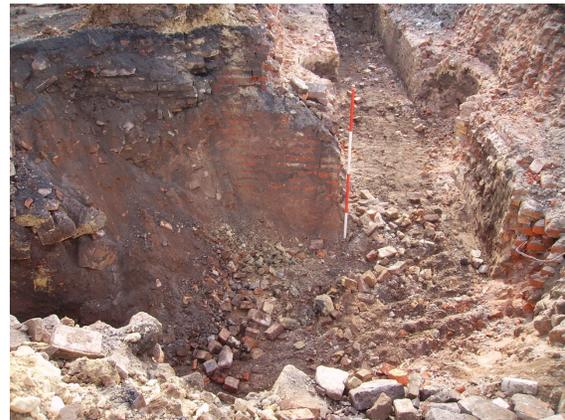
Plate 6: *Northeast elevation of chimney stack (113)*

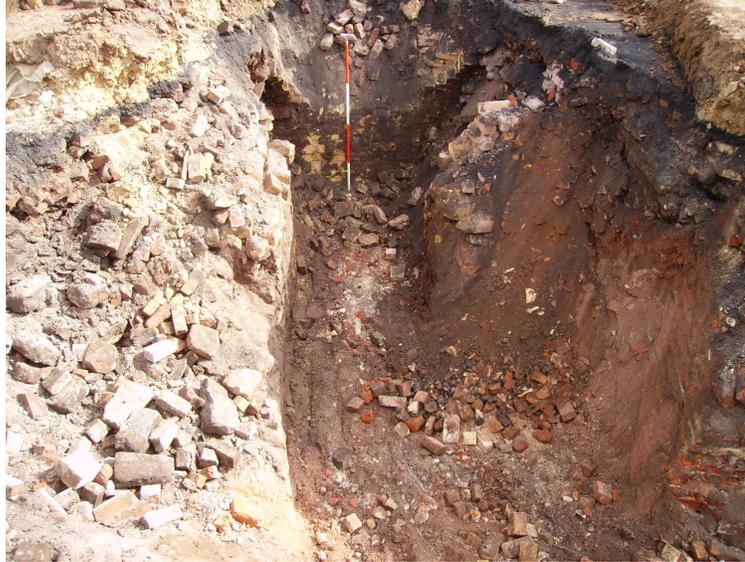
- 4.2.5 As the excavation continued *c.*0.6m northeast past the chimney stack (113), the flue (106) turned sharply in an easterly direction for *c.*4.5m until it terminated at a junction with a further north-northeast – south-southwest aligned flue or chamber (117) (Figure 3) (Plate 7). Immediately east of where the flue (106) turned east, a further blocked entrance (120) was noted within the structures north wall (Figure 3). However, this entire section collapsed during excavation before any accurate recording of the entrance (120) could commence, although several sections of a consolidated wall were noted during excavations north of the flue (106) which were probably associated with the entrance (120).

Plate 7: *View east of junction between structures (106) and (117)*

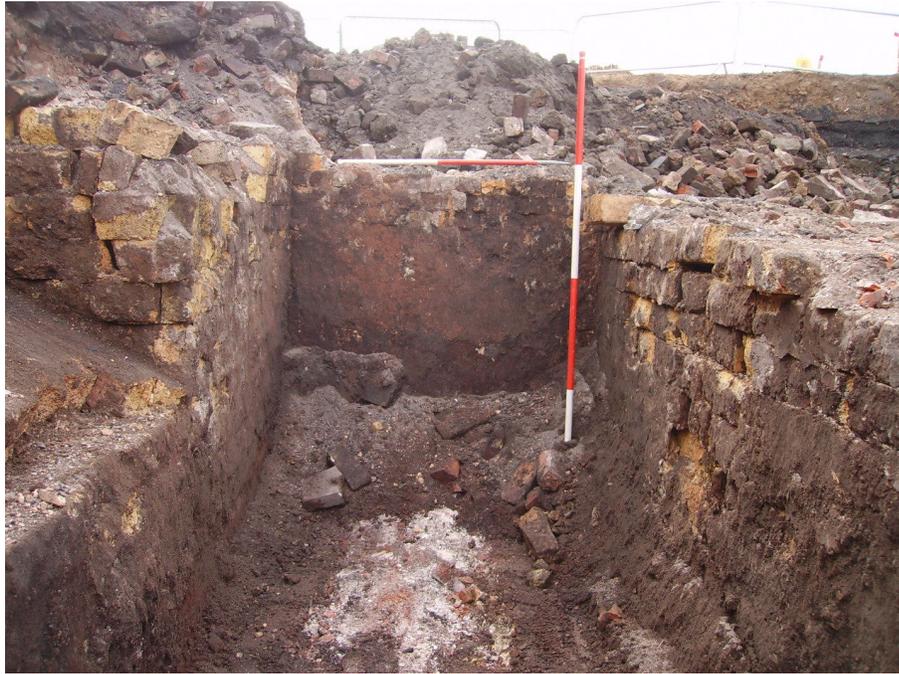
Plate 8: *View south-southwest
of south boundary wall (124)*

- 4.2.6 Once the eastern extent of the flue (106) had been reached, work continued with the excavation both in a north-northeast and south-southwest direction in an attempt to expose the extent of the structure (117). The form and dimensions of the structure (117) were very similar to the flue (106) with a similar brick surface (121) and external casing support (133), although the structure (117) only continued in a south-southwest direction past the junction with the flue (106) for a further *c.*8m before a wall (124) marking the southern extent of the structure (117) was reached (Figure 3), which survived to a height of *c.*1.5m (Plate 8). The excavation continued in a north-northeast direction for *c.*7m until a further physical barrier marking the northern extent of the structure (117) was reached (Figure 3). However, unlike the southern wall (124), the northern barrier (130) was made up of a large deposit of compact slag-like material which reached a height of *c.*1.2m (Plate 9) and continued in a north-northeast direction for a further *c.*7m. It is probable that the northern barrier (130) was deposited after the construction of the structure (117) as the northern extent of both the eastern and western walls of the structure (117) appeared to have been truncated at this point (Plate 10), possibly suggesting that the structure (117) originally extended further north (see paragraph 4.2.9 below).

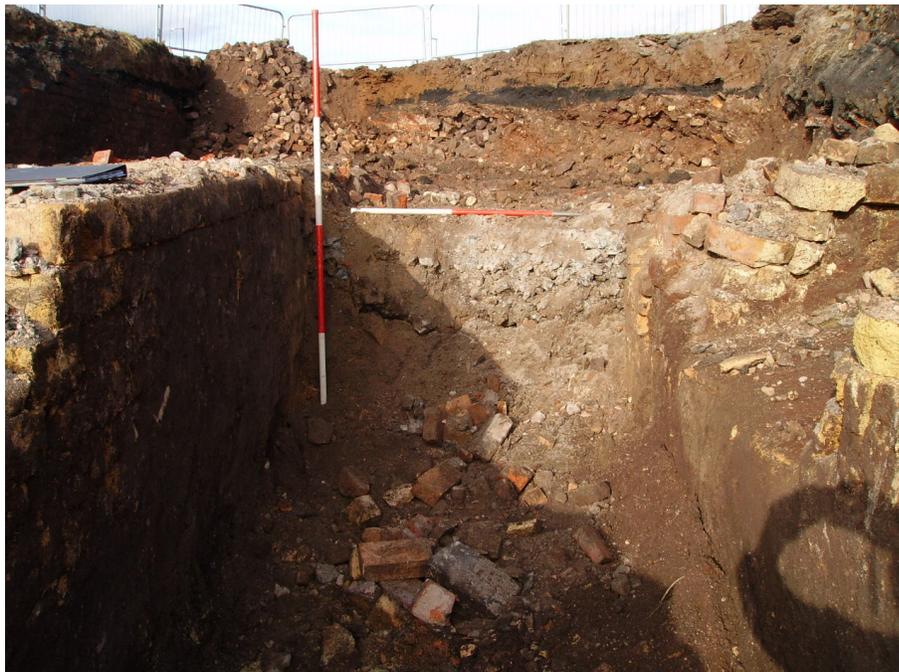
Plate 9: *View north-northeast of northern barrier (130)*

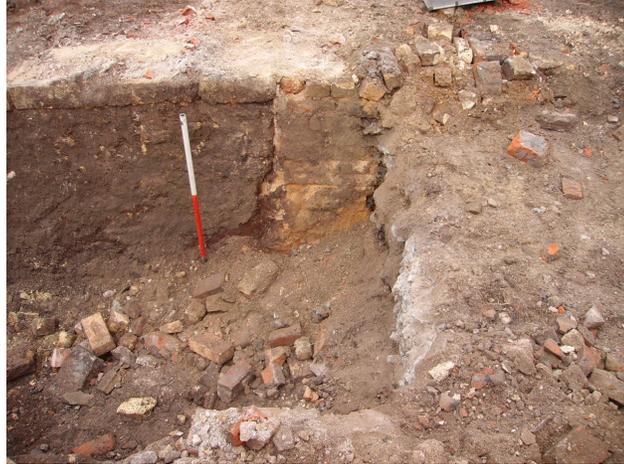
Plate 10: *View west-northwest of northern extent of western wall of structure (117)*

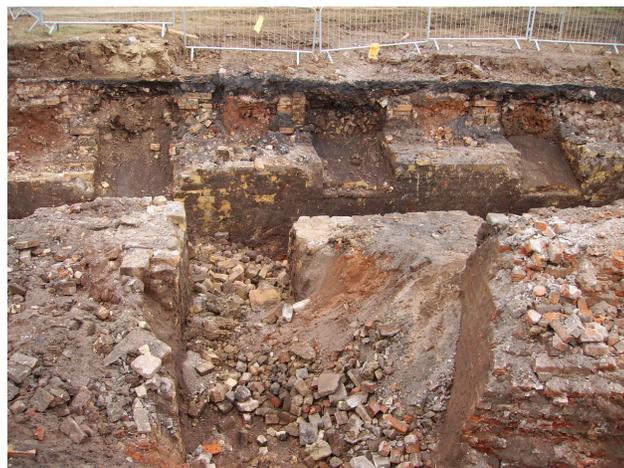
- 4.2.7 At this time, the function of the structure (117) remains uncertain. However, six associated features were noted during excavation. Four of these features were located within the eastern wall of the structure and appeared to be vents that served an unknown function (Figure 3). The vents (122), (123), (128) and (129) were constructed from red/yellow brick with finely cut slabs forming the base which increased at a gradient of $c.35^\circ$ for $c.1.8\text{m}$ as they extended east-southeast from the structure (117), before levelling out and continuing for a further $c.1.9\text{m}$. The vents were evenly spaced along the eastern wall (Plate 11) and measured $c.1.4\text{m}$ in height and $c.2.2\text{m}$ in width, and were filled by a very black silty clay material mixed with rubble (138) (Plate 12). The other two features were located within the western wall of the structure (117), both to the north-northeast and south-southwest of the junction with the flue (106) (Figure 3). The southern most feature (126) measured $c.0.38\text{m}$ in height, $c.0.72\text{m}$ in width and $c.0.36\text{m}$ in depth (Plate 13), whilst the northern most feature (127) measured $c.0.76\text{m}$ in height, $c.0.66\text{m}$ in width and $c.0.43\text{m}$ in depth. Both of these features appeared to be recesses, possibly serving as storage areas when access into the structure (117) was required.

Plate 11: *View east-southeast of vents within eastern wall of structure (117)*

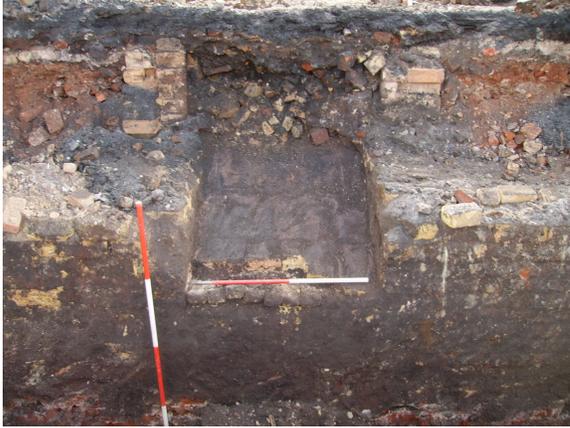
Plate 12: Vent (122) within east wall of structure (117)

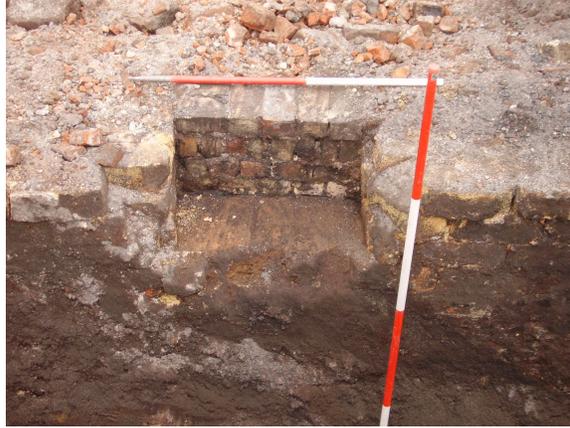
Plate 13: Southern recess (126) within west wall of structure (117)

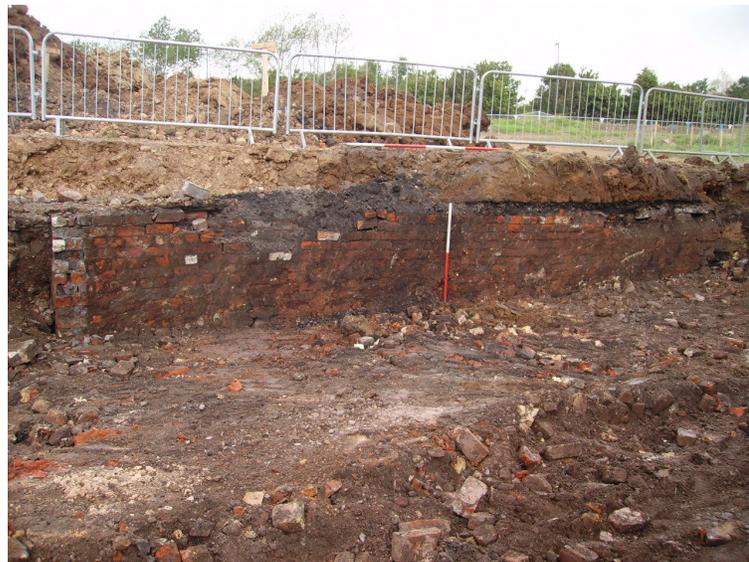
- 4.2.8 The excavation continued north-northeast of the flue (106) exposing rubble backfill (134) for c.7m until a wall and associated floor surface was reached (Figure 3). The floor surface (132) was comprised of two courses of red brick and measured c.9m in length and c.3m in width, although it may have originally covered a much larger area as remnants of a brick surface were noted directly above the slag deposit (130), north-northeast of the structure (117) (Plate 14). The associated wall (131) was aligned north-northeast – south-southwest and was located within the east facing section of the excavated area, at the western edge of the floor surface (132). The wall (131) was comprised of red brick and measured c.8.5m in length and survived to a height of c.1m (Plate 14). It is probable that the wall (131) and floor surface (132) had once formed part of a larger building situated immediately north of structures (106) and (117) as the remnants of a further east-southeast – west-northwest aligned wall were noted abutting the southern extent of the floor surface (132).

Plate 14: East facing section of excavated area showing wall (131) (remnants of floor surface (132) in foreground)

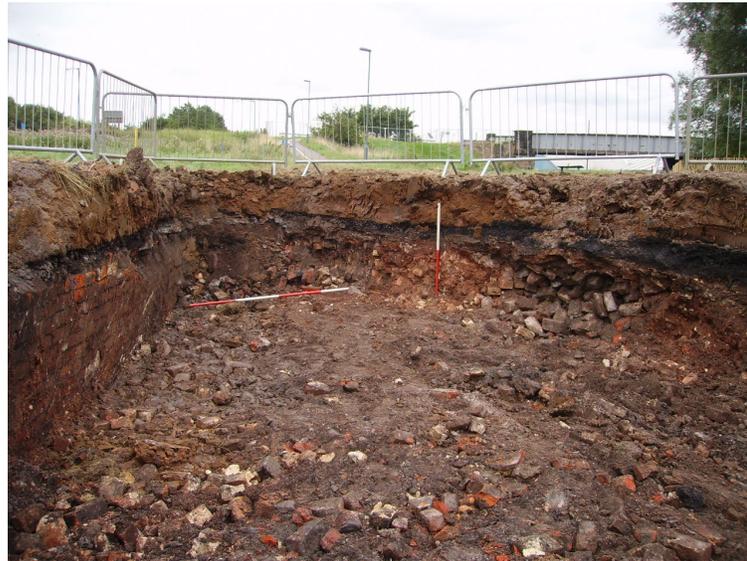
- 4.2.9 A further two possible vents were also noted within the south-southwest facing section of the northern excavated area (Figure 3). The two features (135) measured *c.*0.6m in height and *c.*1.22m in width and were separated by *c.*1.4m of rubble backfill (134) (Plate 15). The two features (135) were poorly preserved, but were filled by a black silty clay mixed with rubble (138) similar to the vents noted within the east wall of the structure (117), suggesting that the structure (117) once continued in a north-northwest direction. However, the two features (135) appeared to be above the floor surface (132), which had been constructed directly above the slag deposit (130) which was in turn, probably later than the structure (117), suggesting that the features (135) were similar to, but not associated with the vents observed within the east wall of the structure (117).

Plate 15: *South-southwest facing section of excavated area showing features (135)*

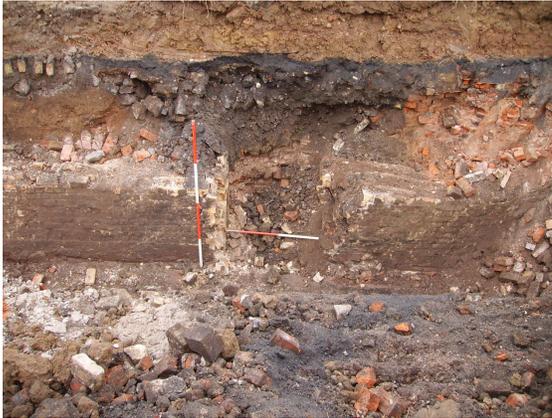
- 4.2.10 Work continued at the southwest corner of the excavated area with the exposure of a further *c.*1.1m of the flue (106). During this section of the excavation, a further entrance was noted within the east wall of the flue (106), *c.*3.5m southwest of the entrance (107) (Figure 3). The newly exposed entrance (136) measured *c.*1.2m in height and *c.*1.2m in width but unlike the other two entrances into the flue, (107) and (120), entrance (136) did not appear to have been bricked up (Plate 16). The flue (106) continued in a southwest direction for a further *c.*2m past the entrance (136), before turning south-southwest for a further *c.*5.5m (Figure 3) until the excavation within the area ceased. A further structure was also noted within the east-southeast facing section of the final *c.*4.2m of the excavated area (Figure 3). The square red brick structure (137) was located *c.*1.2m west-northwest of the western wall of the flue (106) and survived to a height of *c.*0.9m (Plate 17).

Plate 16: *Entrance (136) within east wall of structure (106)*

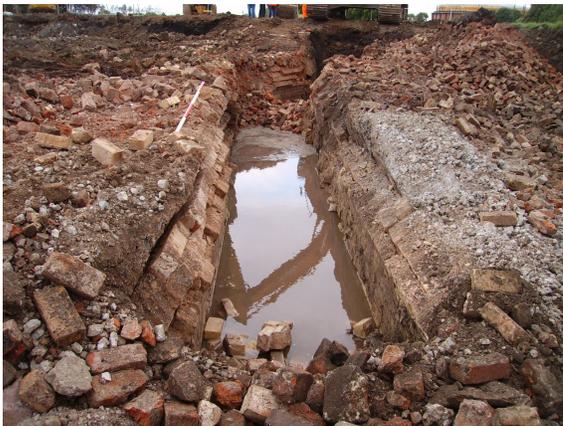
4.2.11 Further excavations were also conducted over a larger area at the southern extremity of the proposed development site. However, the archaeology within this area was poorly preserved, largely being made up of demolition material and industrial debris with only one discernable feature noted. This feature (**116**) was similar to the flue (**106**) further north, although it was impossible to accurately record the structure due to the amount of demolition material and the presence of ground water within the immediate vicinity (Plates 20 & 21). The structure (**116**) extended northwards for *c.*10m before turning northeast for a further *c.*2m and then north-northeast for a further *c.*4m at which point, the edge of the proposed excavated area was reached. The structure (**116**) measured *c.*1.3m in width and survived to a height of *c.*1.2m, and probably represents the remains of a flue, possibly serving one of the several blast furnaces within the area.

Plate 20: *Structure (116) looking north*

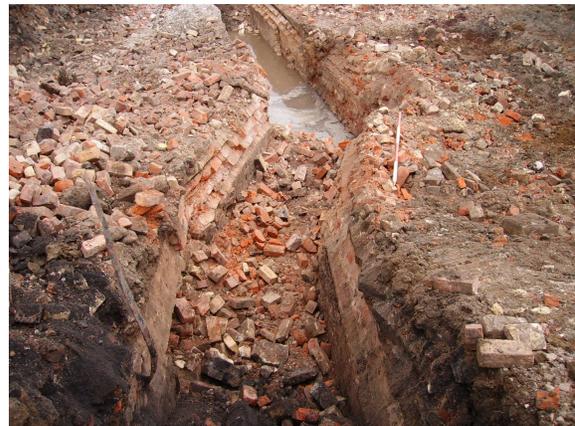
Plate 21: *Structure (116) looking south-southwest*

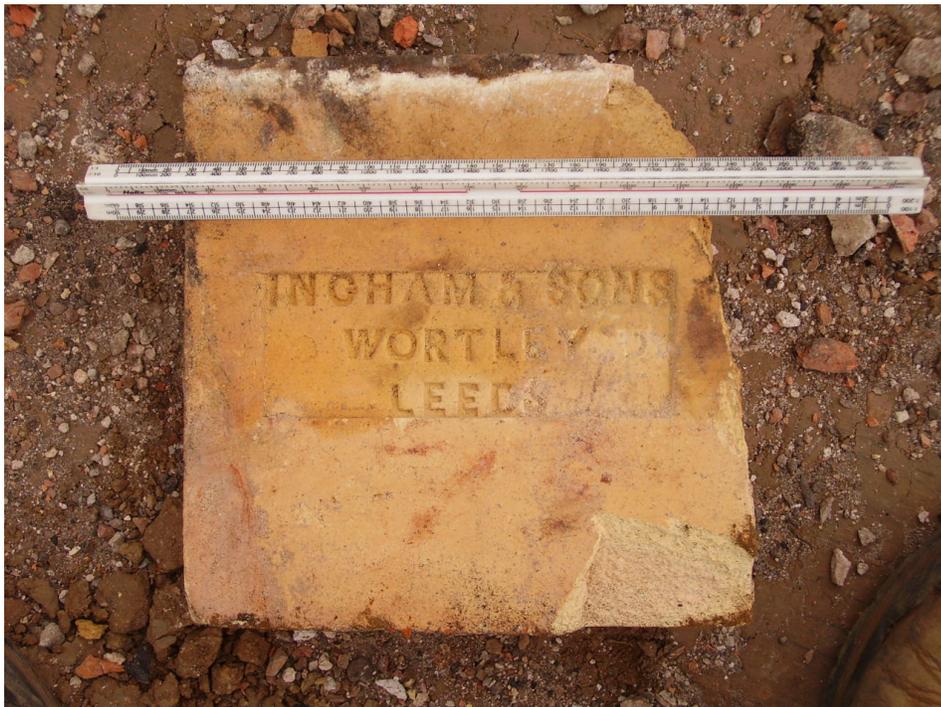
- 5.1.1 No finds were recovered during the watching brief, although it is worth noting at this point that several large yellow bricks used in the construction of the roof of the flue (106) were noted to retain a stamp which read 'INGHAM & SONS, WORTLEY, LEEDS' (Plate 22).

Plate 22: Example of a stamped brick used in the construction of the flue (106)
