NORTH PENNINES HERITAGE TRUST

Project Designs and Client Reports No.CP59/03

**REPORT ON
A LEVEL 2
BUILDING SURVEY AT
TARN, FELL END
NEAR RAVENSTONEDALE
CUMBRIA**

NGR: SD 7196 9758
Planning Application Reference No.3/03/0277

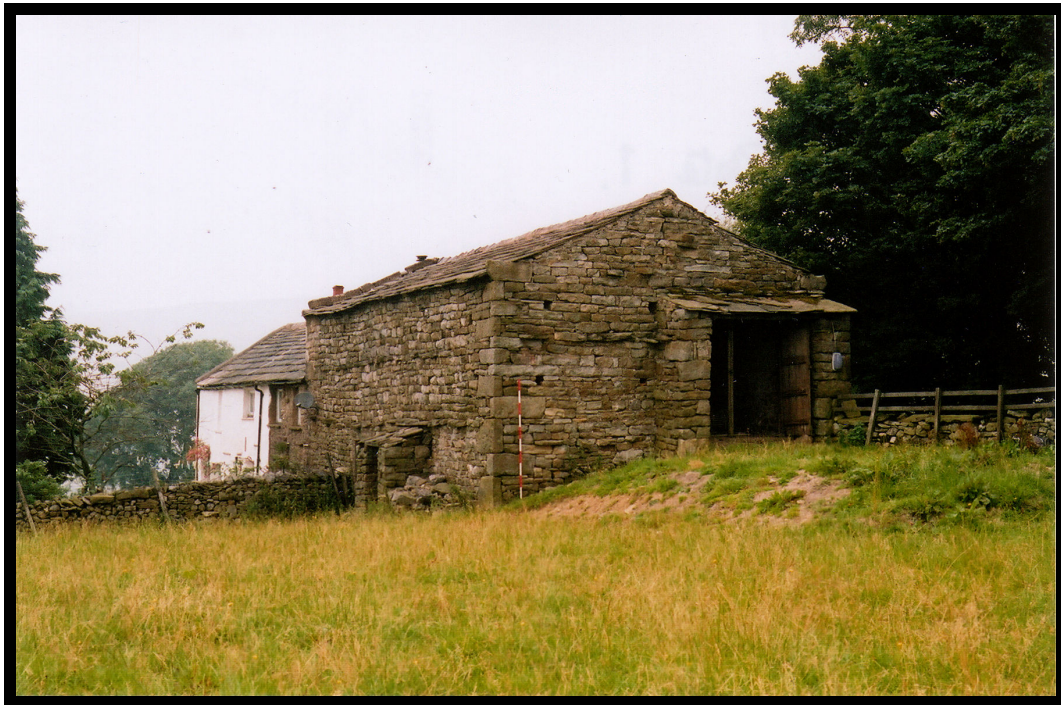
Plate 1

General view of the farm buildings from the south-east. The scale measures 2 metres.
(Photograph: P. Cracknell)

- 1.3 The barn, adjoining Tarn, Fell End (Plate 1) in the Parish of Ravenstonedale is not designated as a listed building, but is recorded on the County Sites and Monuments Record, reference 40002. The building is in a good state of repair and is currently used as a general-purpose storehouse.

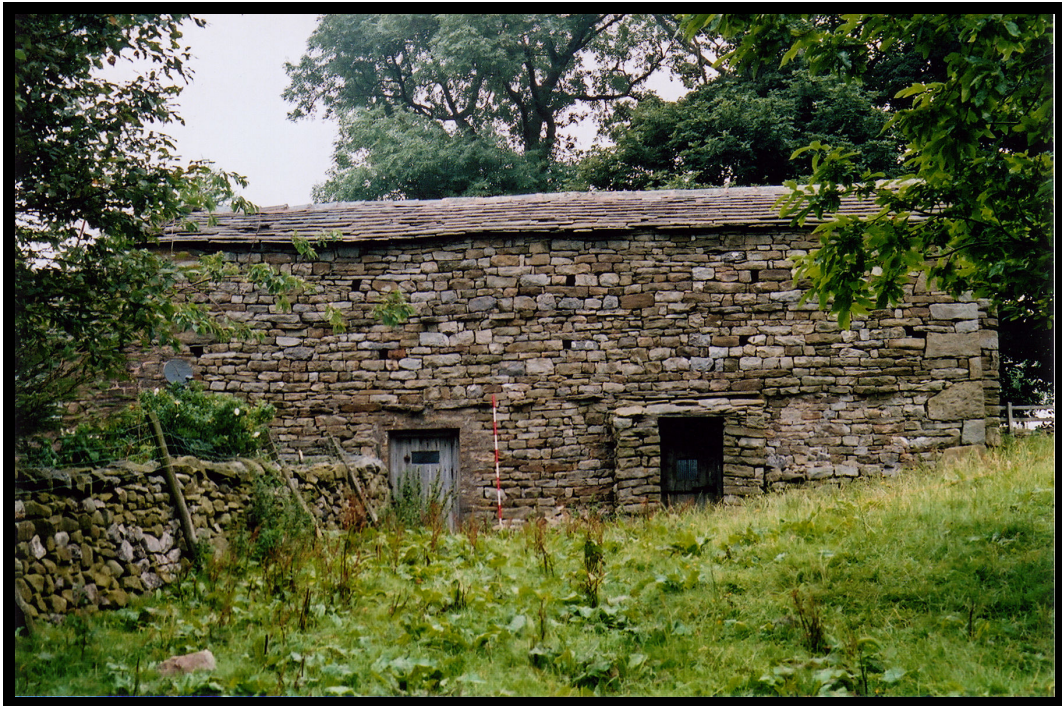
Plate 2

The southern elevation of the barn. The scale measures 2 metres.
(Photograph: P. Cracknell)

- 5.1.1 The building is rectangular, measuring c.13 metres by c.6.50 metres with a large porch and double doors in the eastern gable end (Plate 3), and a smaller porch on the southern elevation (Plate 2). The range of farm buildings including the barn, are built along the contour line of the steep valley side, aligned virtually east-west.

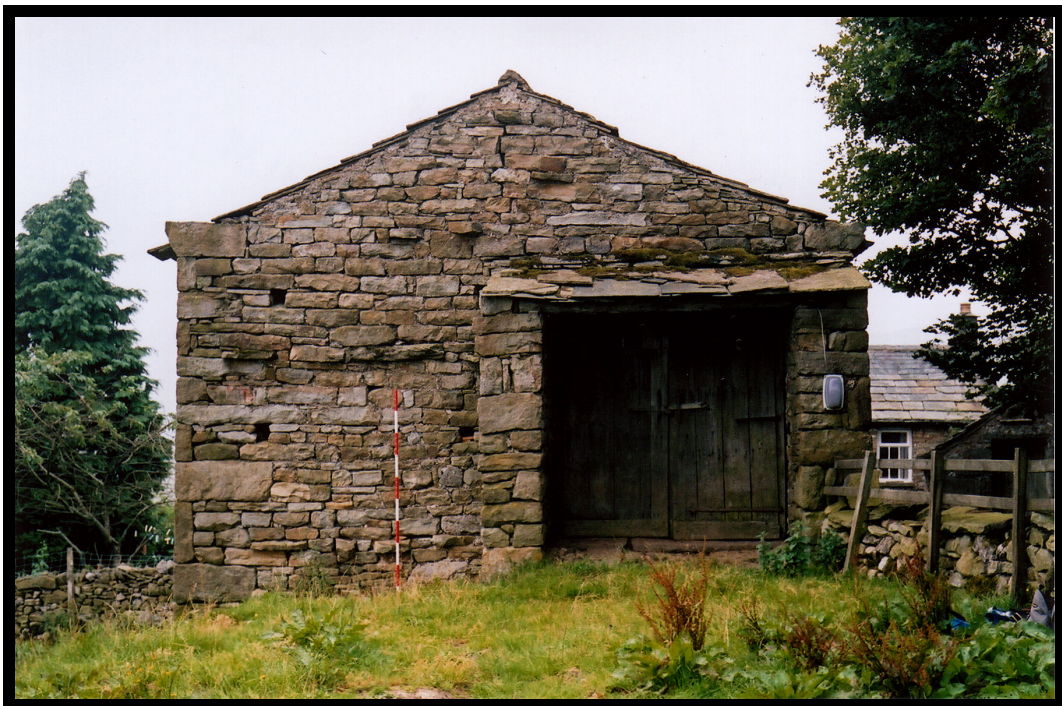
Plate 3

The eastern elevation of the barn. The scale measures 2 metres. (Photograph: P. Cracknell)

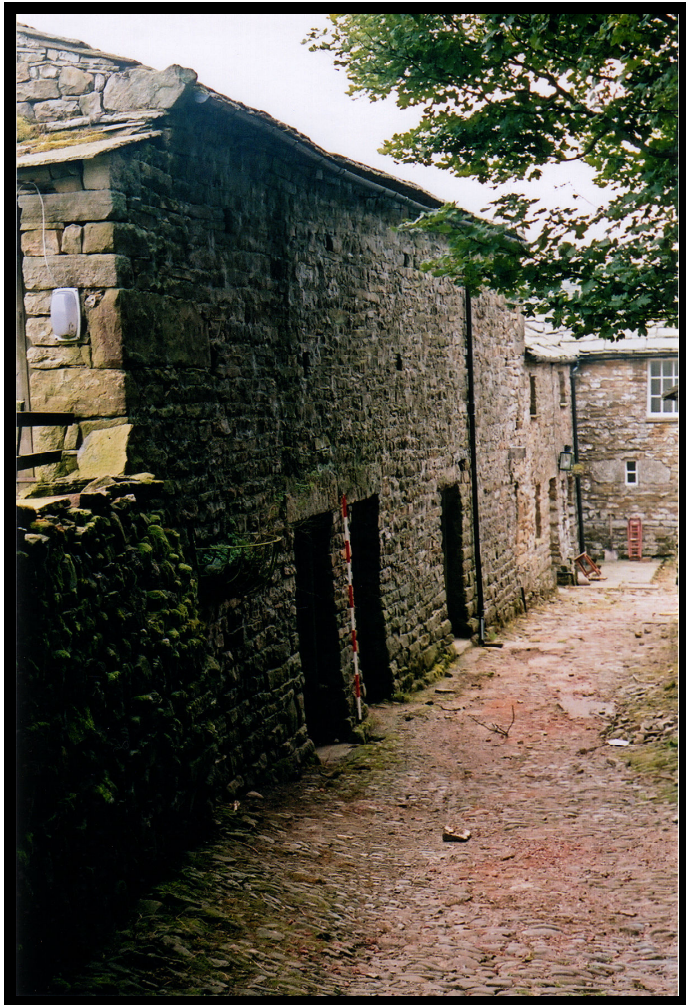
Plate 4

The northern elevation of the barn from the north-east. The scale measures 2 metres.
(Photograph: P. Cracknell)

- 5.1.2 The farm and barn are built of coursed limestone rubble masonry. The ground floor of the barn (Figure 3a) is divided up into three rooms with three doors allowing access on the northern elevation (Plate 4) and two doors on the southern elevation (Plate 2). The first floor is open and of four bays (Figure 3b) with the only access via the double doors in the eastern elevation (Plate 3). The barn is of two storeys throughout.

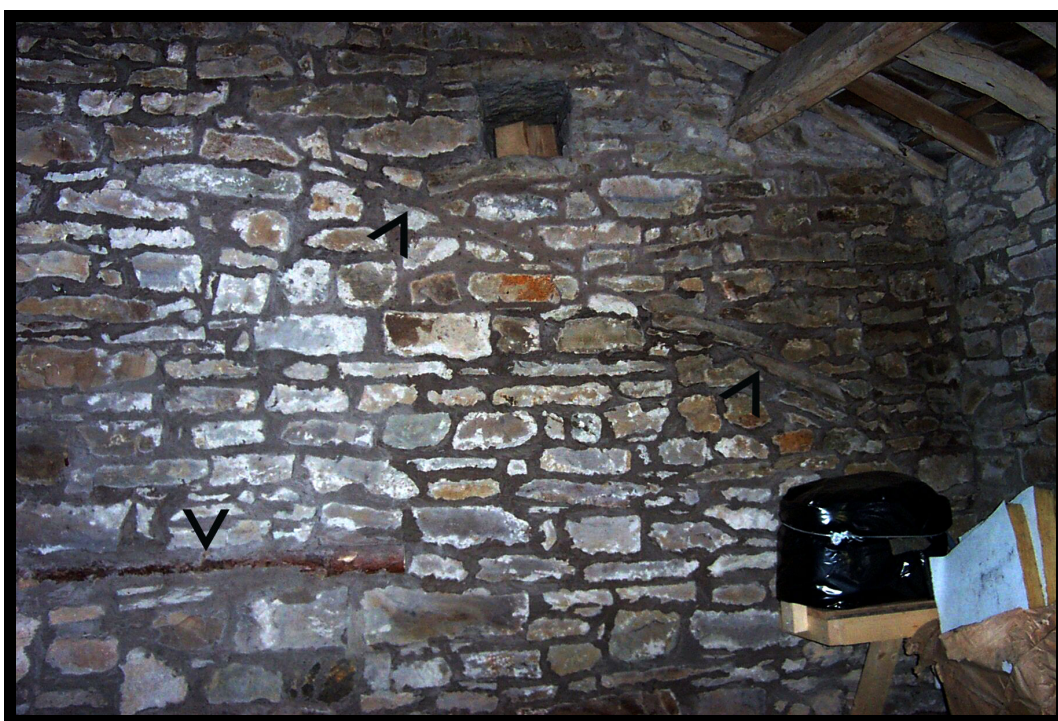
Plate 5

The western wall of the barn with the blocked window in the left-hand corner (arrowed), and the roof line above (arrowed) from the eastern gable of the adjoining building.
(Photograph: F. Wooler)

- 5.1.3 The barn has been added to the existing range of farm buildings. At the western end of the barn, the eastern gable of the adjoining building has been incorporated within the fabric of the western wall of the barn. There is a blocked window with a wooden lintel visible inside the barn in the western wall at first floor level (Plate 5). Similarly, the roof line of the gable end of the adjoining building is visible above the blocked window (Plate 5).

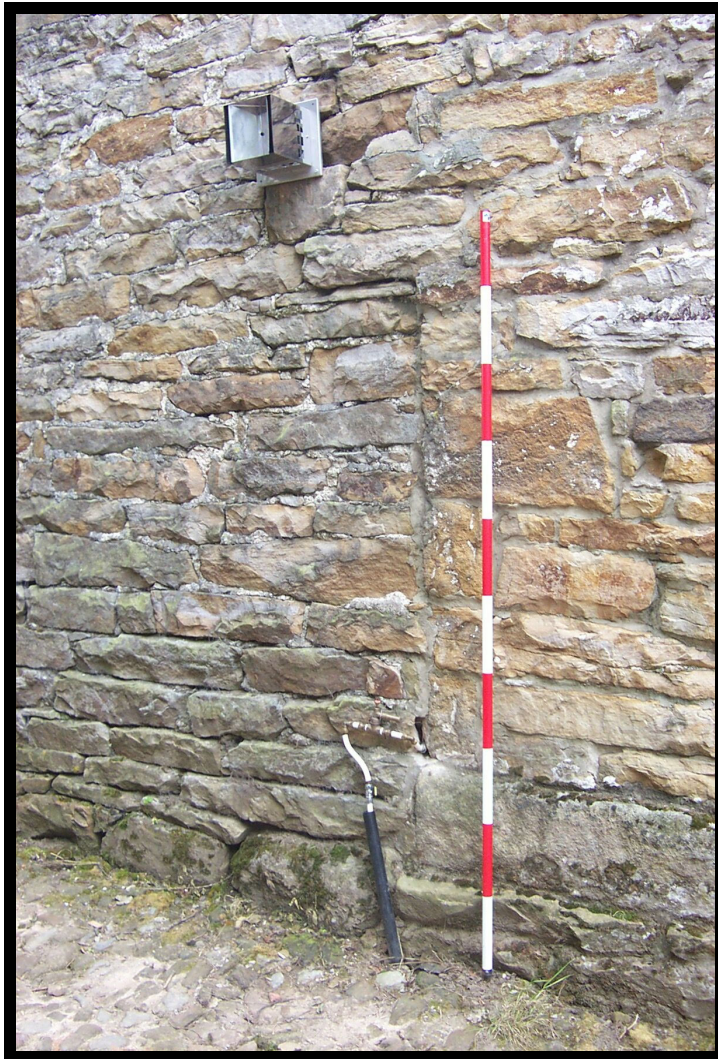
Plate 6

Northern elevation. The vertical construction break, which marks the original eastern end of the adjoining building, can clearly be seen just to the left of the ranging pole. The scale measures 2 metres. (Photograph: F. Wooler)

- 5.1.4 On the northern elevation, towards the western end of the barn there is a clear vertical construction break at ground floor level (Figure 3a and Plate 6), which marks the original eastern end of the adjoining building. At the western end of the barn, on both the northern elevation (Plate 7) and the southern elevation (Plate 8), the large quoinstones, evident at the south-eastern and north-eastern corners, have only been added above the eaves level of the adjoining building.

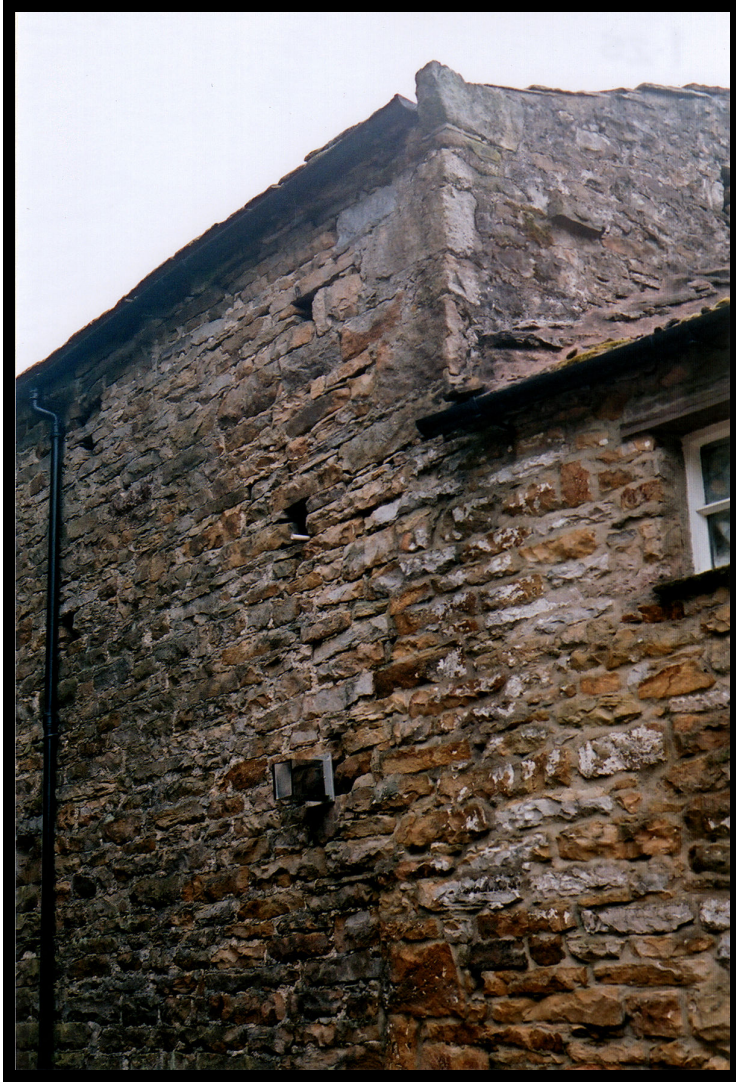
Plate 7

Northern elevation. The large quoin stones above the eaves level of the adjoining building.

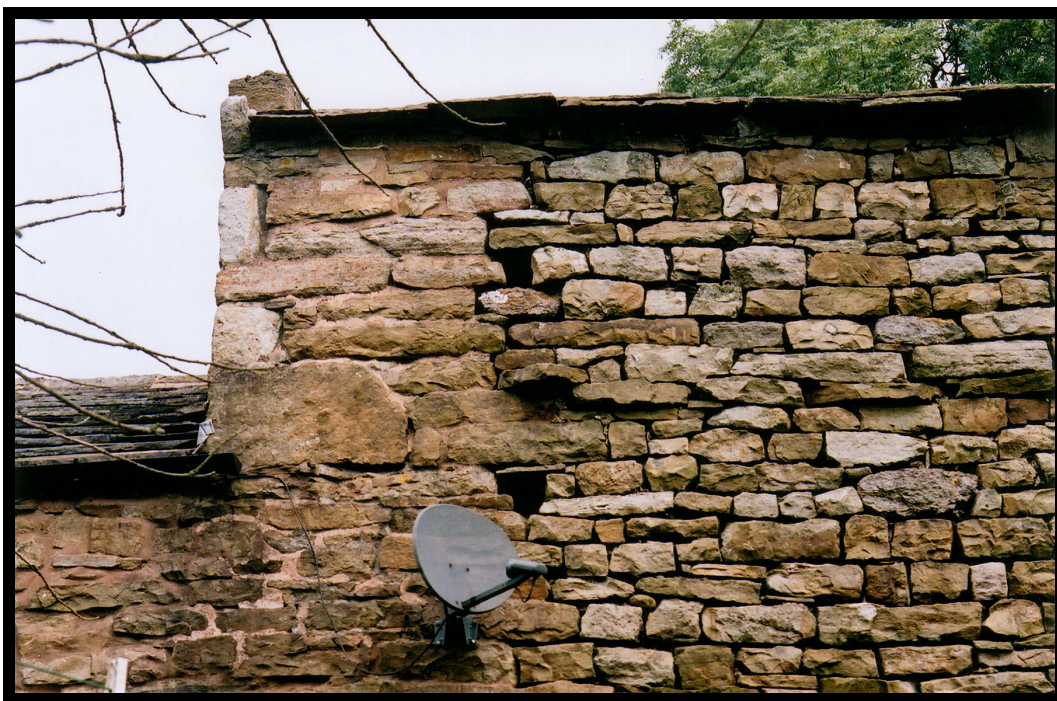
Plate 8

Southern elevation. The large quoin stones above the eaves level of the adjoining building.
(Photograph: P. Cracknell)

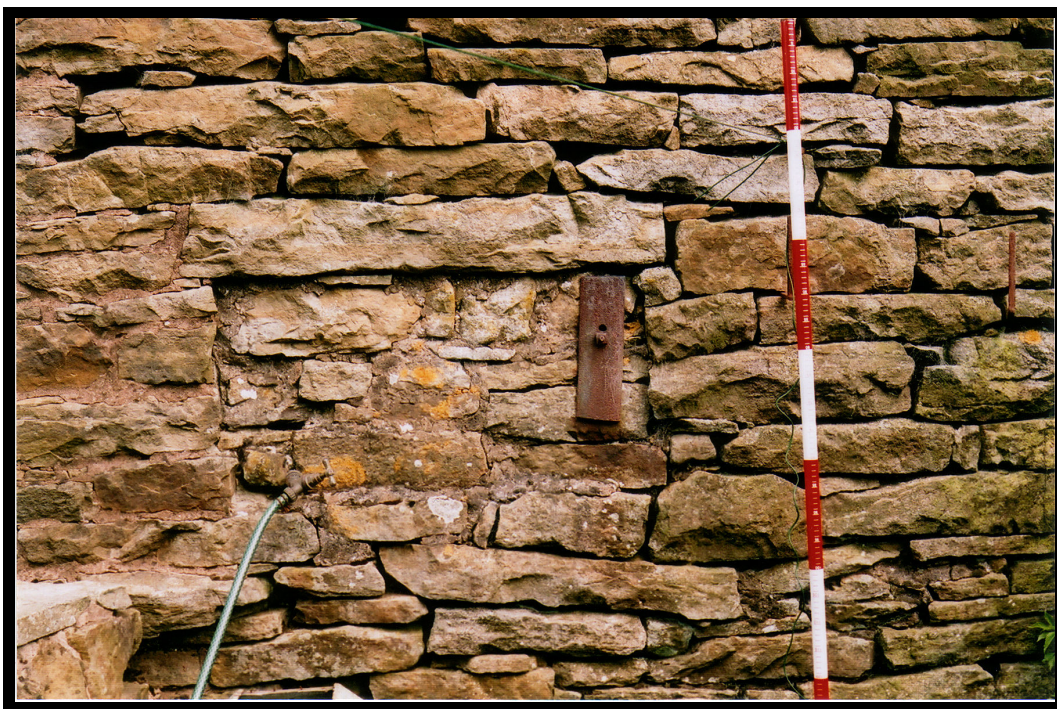
Plate 9

Southern elevation. Blocked window at the western end of the barn.
The scale divisions each measure 200 millimetres. (Photograph: P. Cracknell)

- 5.1.3 There have been no apparent alterations or additions to the original barn, except for the blocking of a small window on the southern elevation near the western end (Figure 3a and Plate 9).

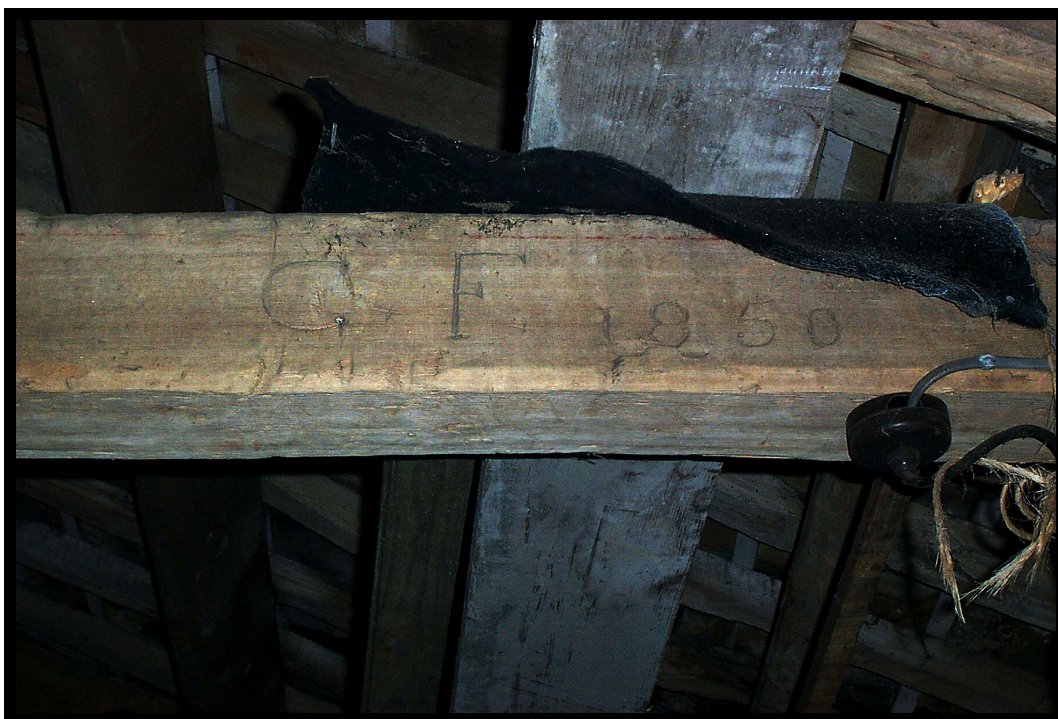
Plate 12

Graffito (GF 1850) on the first roof truss.
(Photograph: F. Wooler).

- 6.5 Inscribed on the first roof truss at the eastern end of the barn opposite to the entrance in the eastern gable end:

G F 1850
(See Plate 12)

- 6.6 It could be tentatively suggested that the reoccurrence of the initials G F, accompanied by the date 1850, in prominent positions, are the initials of the owner or the tenant of the farm at the time of the barns construction.
- 6.7 However, it should be borne in mind that only further documentary research would confirm this suggestion.
