HISTORIC BUILDING RECORDING

CRESSWELL HOME FARM

NORTHUMBERLAND

HISTORIC BUILDING RECORDING AT CRESSWELL HOME FARM, SEPTEMBER 2013

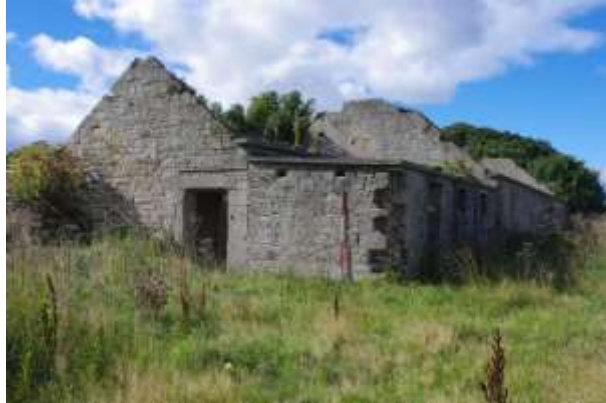
The Detached Byre Range from the north-east

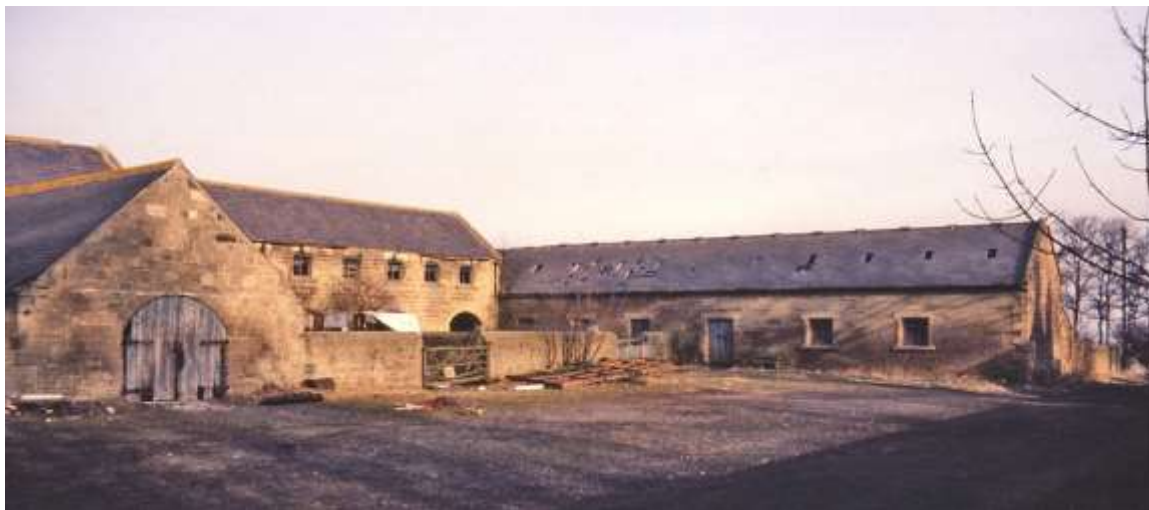
The buildings in 1985, looking north-east, with the Loose Box on the left.

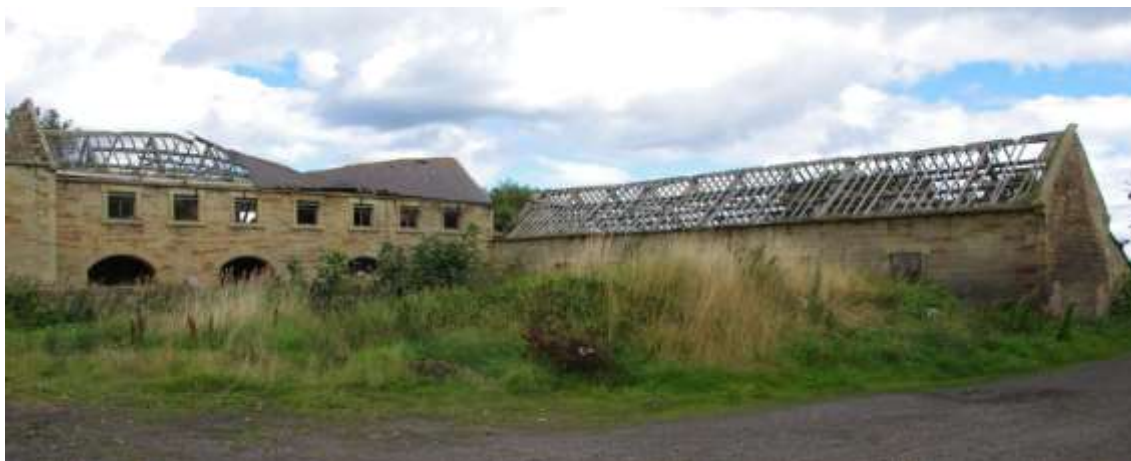
A similar view today, showing the result of thirty years deterioration.

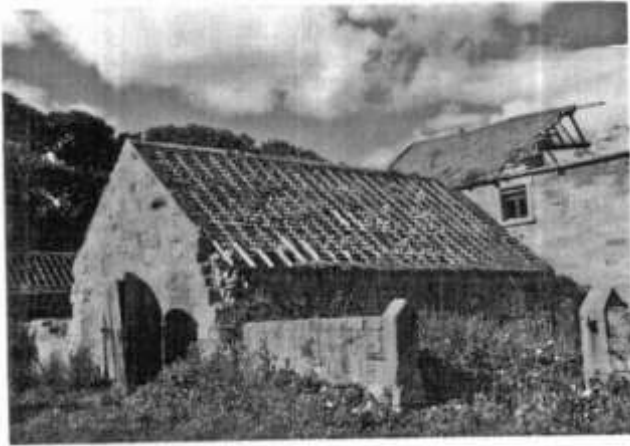
South-east view

The Loose Box before demolition
(photographs supplied by owner)

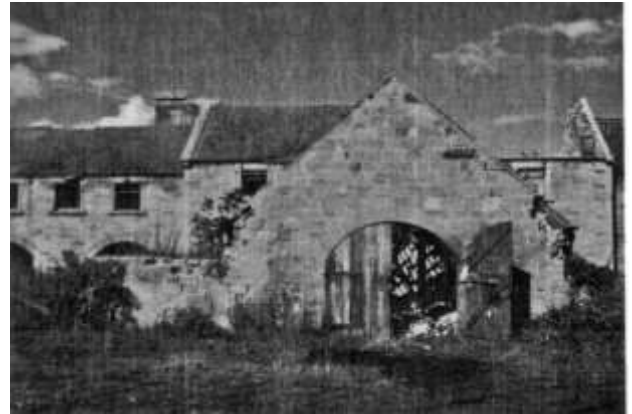
South view

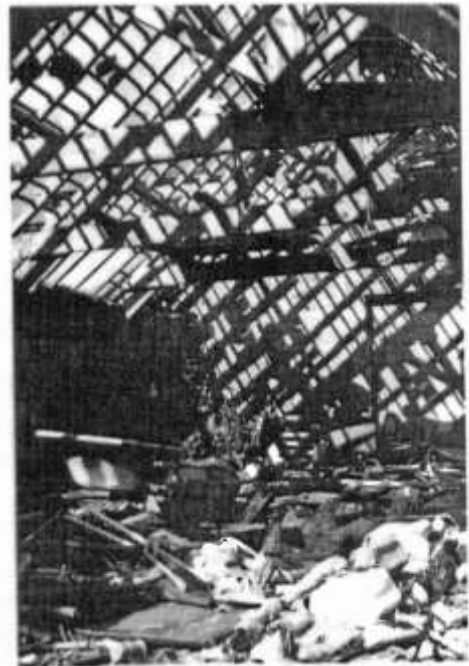
Interior looking north-west

The masonry of the front wall of the building coursed through with the yard walls; the only opening in the wall was a segmental-headed archway holding a pair of boarded double doors. Its dressings were set flush with the wall, rather than raised as in the other buildings; neither did it have cut copings to its gables, which might imply that it was not part of the original design², although it appears to be present on the c 1860 Ordnance Survey 6":1 mile map. The only other opening was a boarded door set centrally in its rear gable. The pre-demolition photographs show a four-bay roof structure with trusses that have raking struts springing from the jewelled foot of a king-post; there appears to have been two levels of purlins, and a ridge.

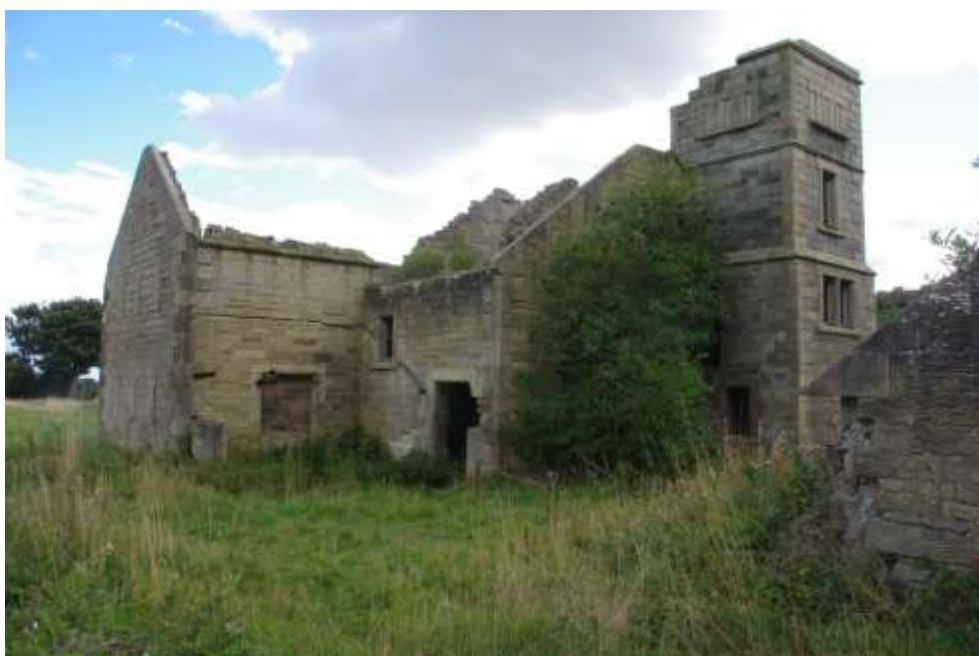
The Dovecote/Chimney and Engine House (with Barn beyond) from the north-west

The structure is now a roofless shell; the top string only survives over its western half, and of the parapet above that, only four blocks on the west and one on the south. Sections of the two courses below the top string have fallen around the north-east corner. Most of the fallen blocks are lying wither inside the dovecote or the adjacent Engine House.

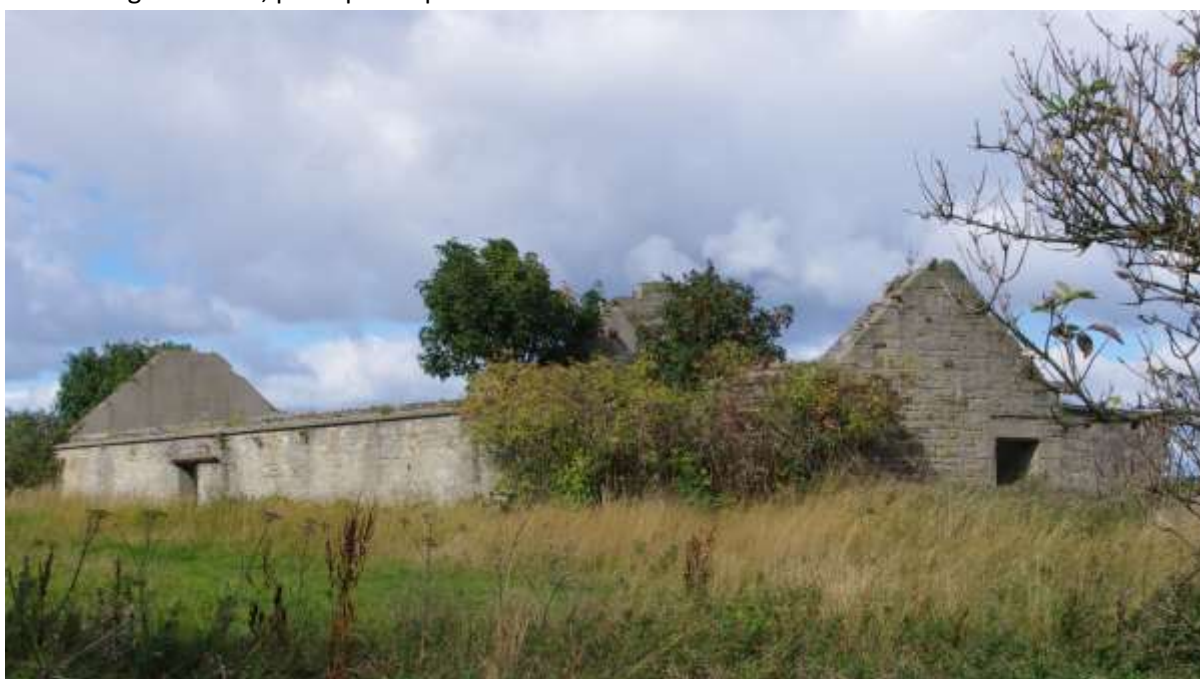
The byre is a rectangular structure c 24 by 8.5 m externally, with walls of roughly-coursed and roughly-squared stone, almost 'snecked' in places, that have pecked-and-margined quoins and dressings, with large trapezoidal blocks to the coping of the broad gable ends. The inner faces of the walls are of brick, largely concealed by the cement coating; there is a 20th century concrete oversailing course to the side walls. Each gable end has a central blocked slit-like window, set quite high. There are an opposed pair of doors in the long walls, set a little east of centre, both of which have alternating-block jambs with a small external rebate, and both of which have had new concrete lintels, presumably when external sliding doors were fitted; the northern door is now infilled with later-20th century blockwork. Towards the east end of the south wall is a third doorway of the same type – also with a renewed lintel – now blocked. Towards the east end of the north wall is an area of more elongate blocks, perhaps a repair.

The Detached Byre range from the south-east

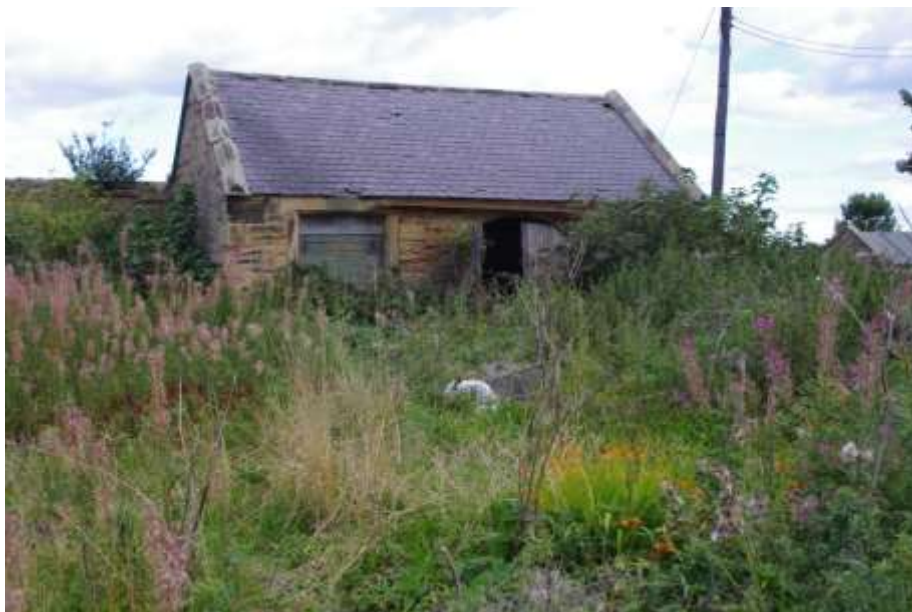
This small stable or storage building fronts onto a separate yard on the east side of the main group of buildings, onto which a range of open sheds (now roofless) backing onto the East Range of the main group also fronted; a further shed, now gone, linked these with the west end of the Stable. It is not clear whether it is part of the same build as the main group, although it is shown on the 1863 Ordnance Survey 6":1 mile map, and is of similar construction and materials. It has a separate listing to the main group, which states that it is included for group value. Its south wall has a segmental archway, with a chamfered window opening to the east; no significant internal features survive. It is understood that there are plans to convert this structure into a plant room, which would entail no significant structural alterations other than the creation of a flue, which in my opinion would not be of any detriment to the building.

The Stable from the south
