Coldwell Farm, Humshaugh, Northumberland

Archaeological Recording March 2007

Planning application no. 200670971

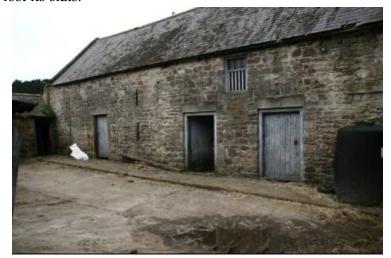
The range from the north-east, showing the original barn door and slit vents in the further section, with a pair of late 19th or early 20th century doors (and a granary window above) nearer the camera

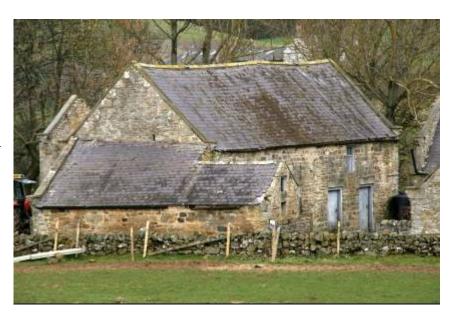
Distant south-east view, showing the Added stable set at an awkward angle to the south end of the barn, and the earlier coping stones re-used (?) in the gable behind.

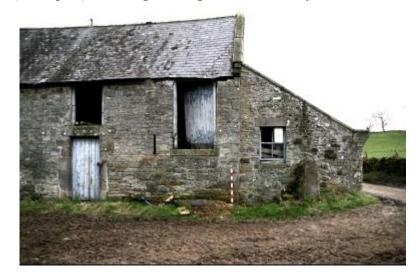
The west side of the range (south part), showing the original west door of the barn, with

secondary openings above and to the right, and, further right, the west end of the added stable.
