**96-108 Portland Street, Kilmarnock:
Stage 1a Archaeological Monitoring**

Data Structure Report

issued 30th March 2012

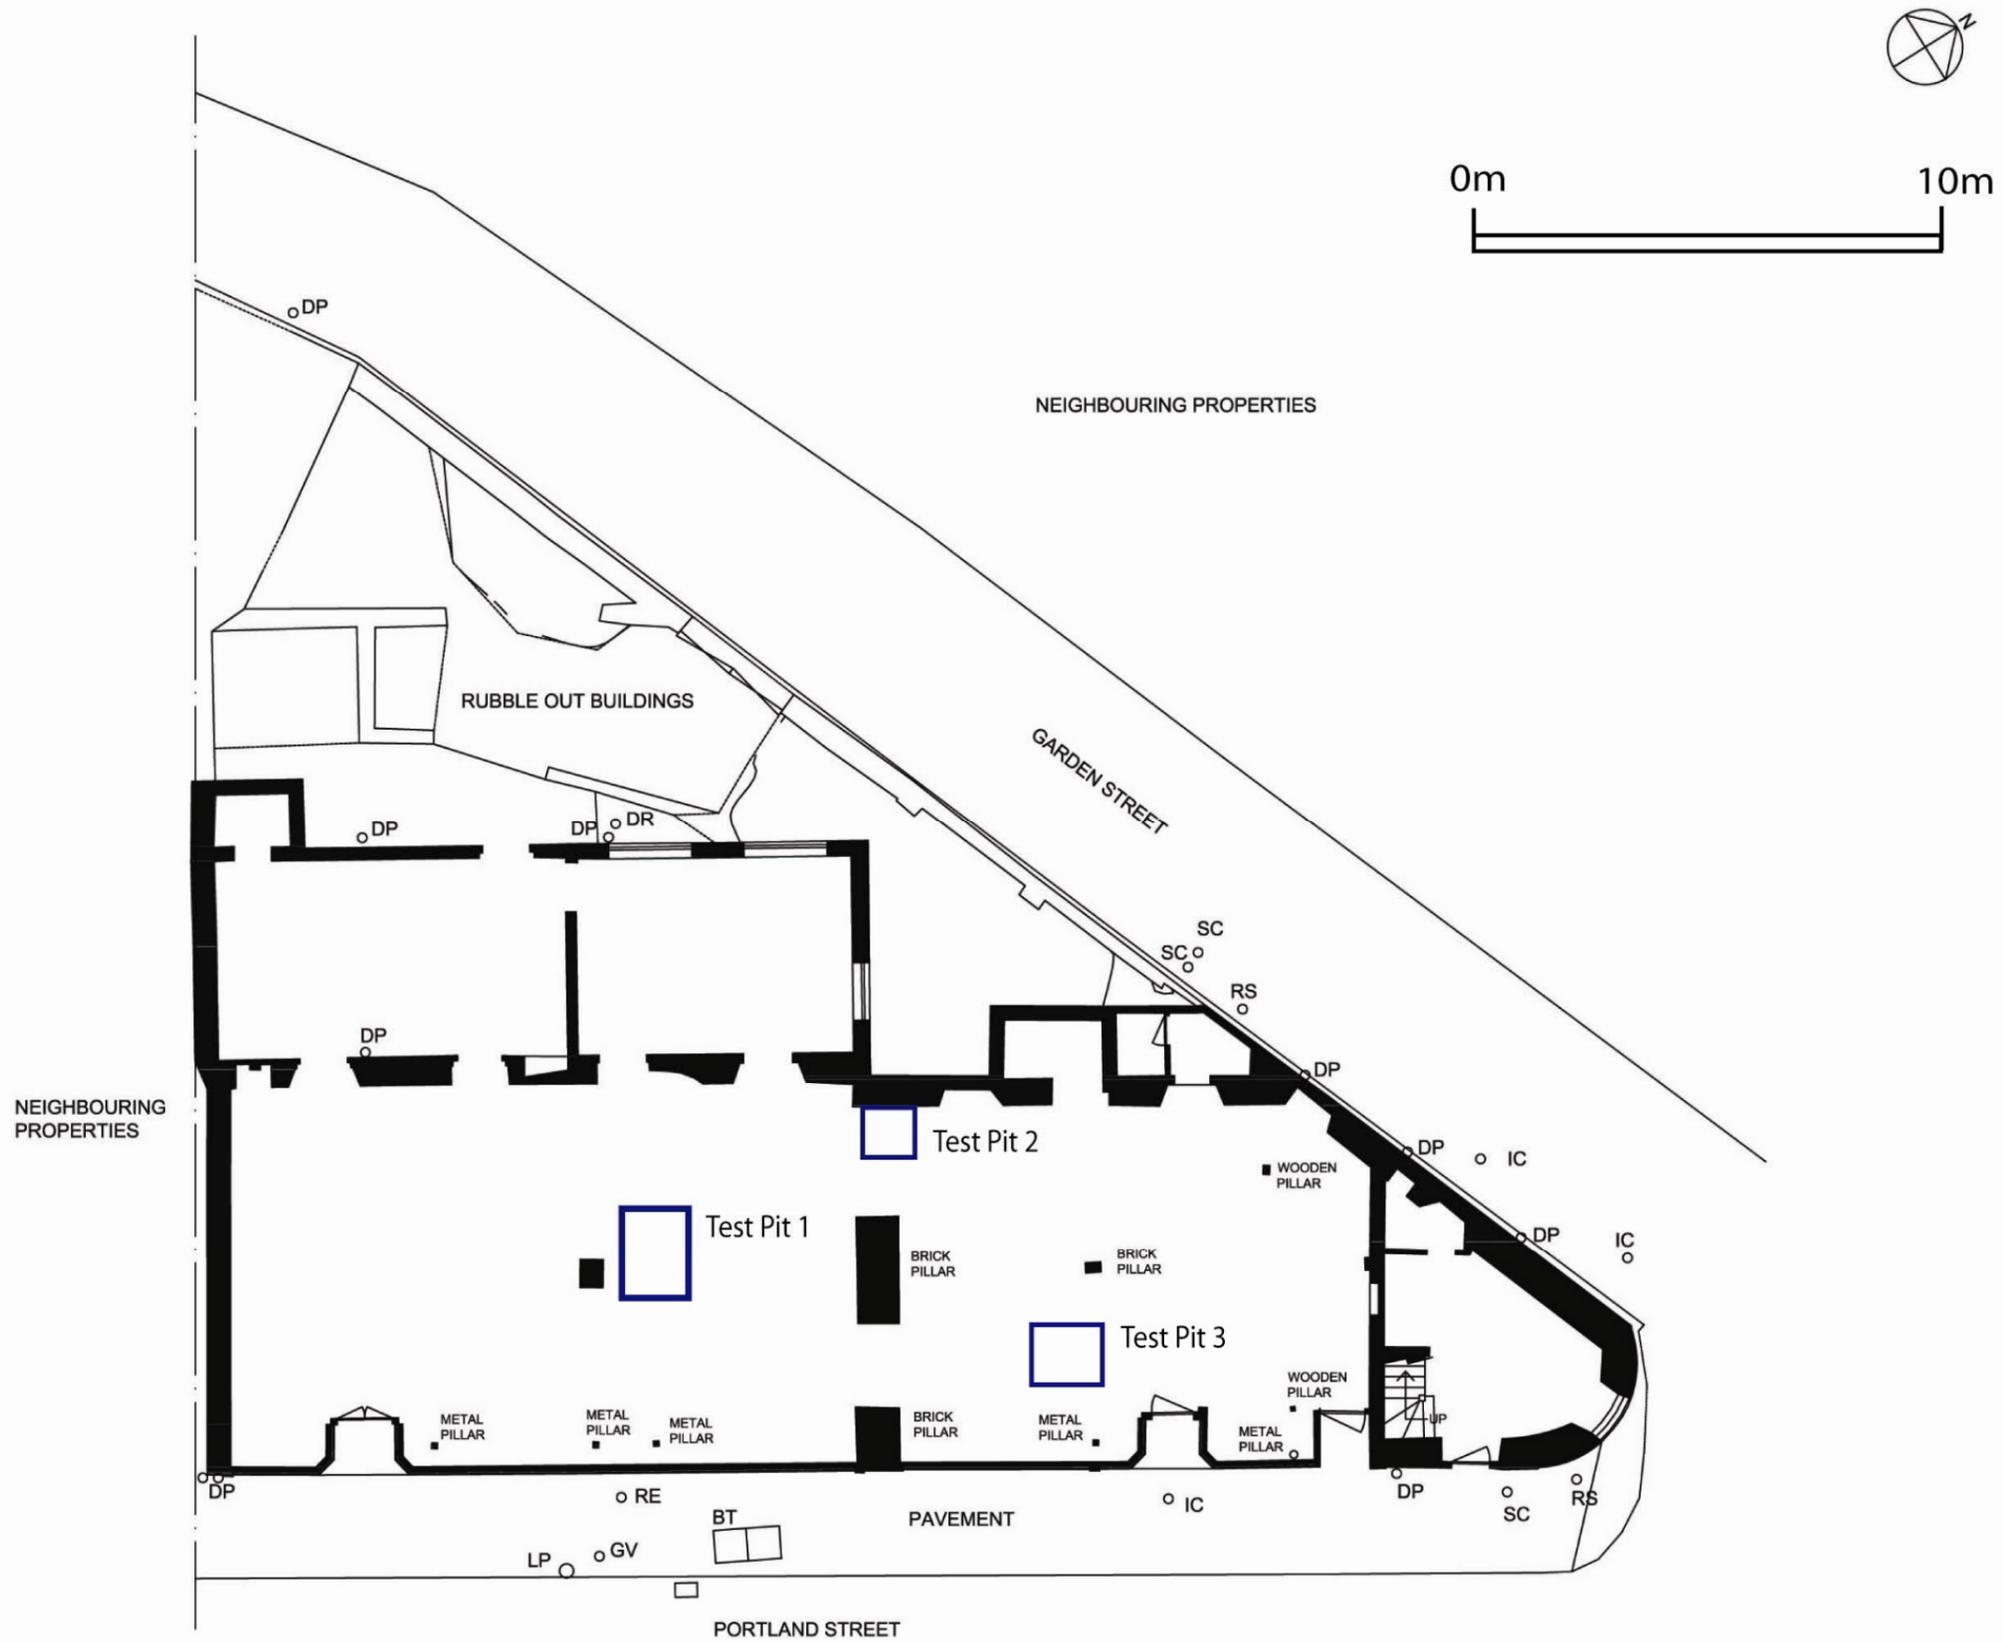
Figure 5: Existing plan of properties with Site Investigation pits noted

13. In total three test pits were hand excavated over 23rd March 2012 (see Figure 5 for locations). A standardised description of each test pit is contained within the *Test Pit Summaries* below.

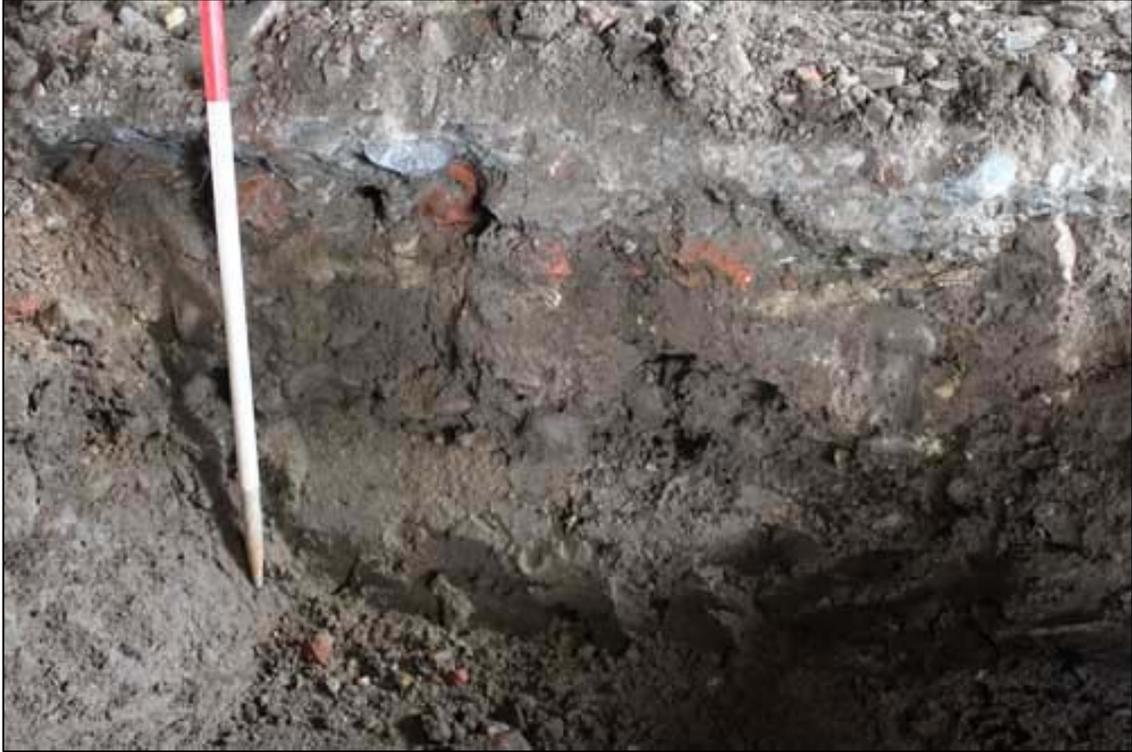
Figure 6: Test Pit 1, South-West Facing Section.

17. Another interesting feature encountered in Trench 2 was the layer of crushed blond sandstone (203) which clearly postdated the foundation deposits (204) and (again refer to Figure 7). A similar layer reappeared consistently across the site in Test Pits 1 and 3 ((101) and (301) respectively (Figures 6 and 9), and it can be surmised that this represents the same layer, resulting perhaps from rebuilding or repairs carried out after the building's original construction, but prior to the laying of the poured concrete floor. Alternatively, it may represent a bedding layer composed of imported material in order to level the interior prior to the pouring of the floor – though this would suggest that the material may have been introduced to the site at a very late date, and that it may have initially been derived from a different location.

18. With Test Pit 2 excepted, the underlying layers revealed in Test Pits 1 and 3 should be considered in more detail. During the excavation of Test Pit 1, it was first thought that the clean mid-brown silty clay layer (104) might have represented surviving traces of a pre-existing garden or cultivation soil (see Figure 6). However, its presence was limited to the north and west sides of the trench, and it directly overlay another layer (102) which was much more ambiguous in character. This was thought at first to represent natural subsoil, but its blackish hue and generally dirty appearance suggested that it may instead have represented redeposited subsoil. A similar deposit was encountered elsewhere across the site in Test Pit 3 (302), and it was also similar in character to the fill of the foundation trench in Test Pit 2 (204), though (204) differed in that it revealed occasional finds of glazed white earthenware, modern glass and roofing slate, and had an intrusive lens of crushed sandstone which may have represented debris from building activities on the site.

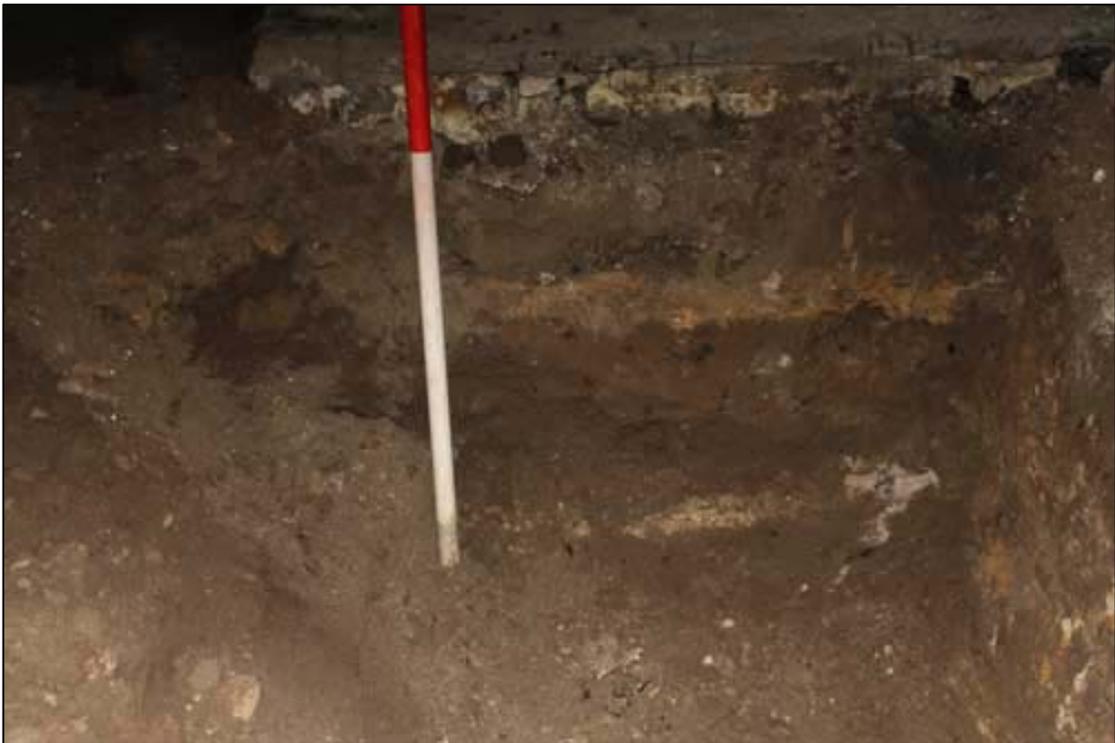
Figure 7: Test Pit 2, North-East Facing Section

16. The photograph of the section (Figure 7) clearly shows what appears to be the cut of an earlier foundation trench, filled with a much cleaner, contrasting mid-brown silty clay fill. It is surmised, however, that this deposit (206) is far more likely to represent a tip line within (204) and that its clean appearance indicates that it represents redeposited material from the original ground surface. Modern ceramic and glass was encountered in both (204) and (206) on an occasional basis (no finds retained), which was consistent with the building's late eighteenth/early nineteenth century date.

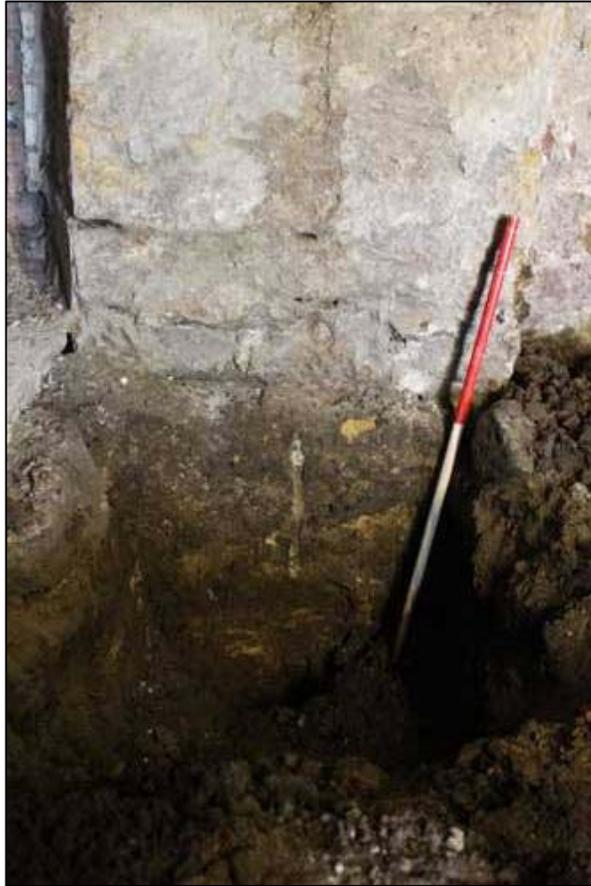
Figure 8: Test Pit 2, South-East Facing Section – View of Foundation

15. Of particular note was the extraordinary depth of the foundation, as exposed in Test Pit 2 (Figure 8). This was exposed to a depth of 0.75m and further exploration in the form of a narrow, hand-dug sondage revealed that it extended further, to a depth of 1.15m. This raised the possibility that the property had once been basemented – however, since the material immediately abutting the rear wall ((204), (205) and (206)) comprised soil, and not broken-up masonry and building debris, it is surmised that this was not the case, and that (204), (205) and indeed (206) instead comprised the fill of the original foundation cut, the full extent of which of which was not identified during these works.

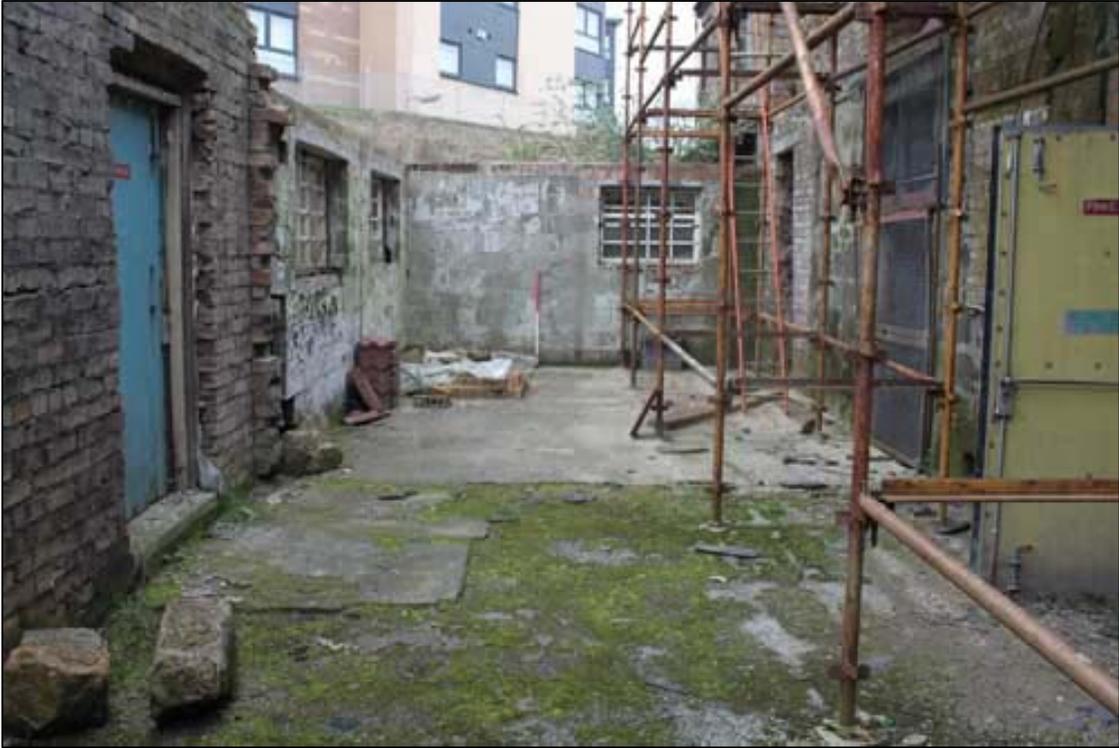
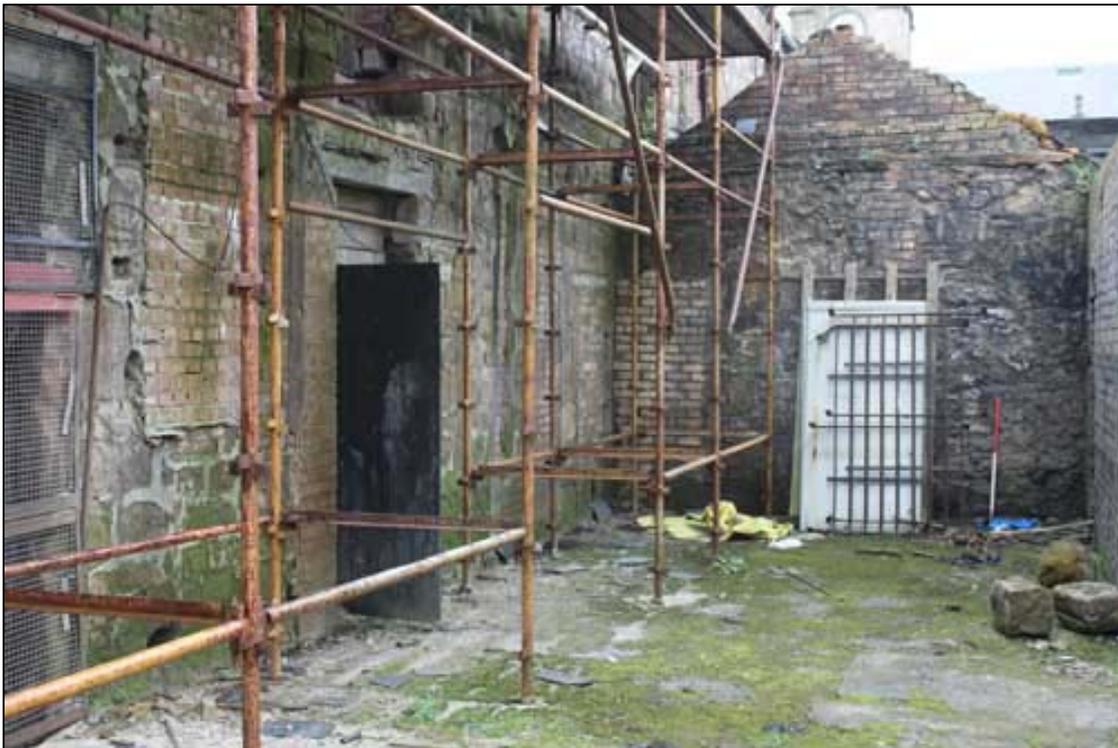
Figure 10: Yard to Rear of Property, Viewed from South-West

Figure 11: Yard to Rear of Property, Viewed From North -East

21. This possibility is further supported by evidence provided from the yard to the rear of the property (Figures 10 and 11). Here, the surface levels are virtually identical to those encountered within the building's interior, suggesting that a sloping landform was built up to form a level surface prior to construction commencing. At some point, the two surfaces (original landform and later infill) will converge and there will be the possibility of encountering archaeologically sensitive material at shallower depth, but in the area towards the street frontage, this seems unlikely to be the case – indeed, the redeposited material (as represented by (104)) extended to a depth of at least 0.65m below the modern ground surface in Test Pit 1, which was located at a central point within the building. This may also explain the unusual depth of the foundation, which was sunk through the redeposited material to the natural subsoil beneath.
