2 Richmond Drive, Rutherglen: Archaeological Mitigation

Data Structure Report

by Douglas Gordon

issued 4th July 2012

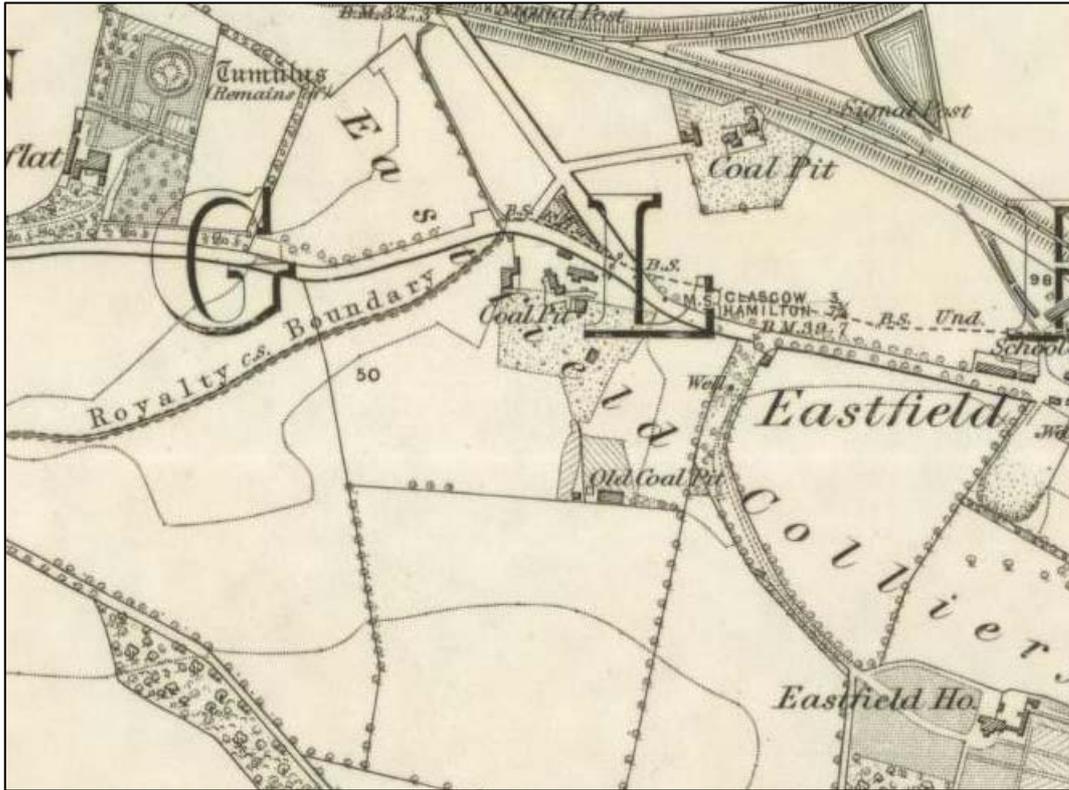
Figure 1a: First Edition Ordnance Survey Map 1864

6. The first usable cartographic evidence comes from the First Edition Ordnance Survey map of 1864 (Figure 1a) which shows the site as a field with the Scion Burn running through the site and acting as the boundary of the Royal Burgh, with boundary stones marked on the map to the north and west. To the east of the study area are several buildings of the Eastfield Colliery. On the Second Edition Ordnance Survey 1893 (Figure 1b) the Scion Burn has been canalised and a boundary stone placed to the west of the study area on the original line of the burn.

19. The pit for the boundary stone also appears to have been disturbed in very recent times, given the presence of CBM and a Golden Wonder crisp packet within the fill. It appears that the stone was moved then replaced during the recent improvement works by the previous owners (Ms Frame *pers comm*). The stone itself is reported to have been dated 1828 though no markings were evident at the time of the works. The first cartographic depiction of the boundary stone is from 1893 after the canalisation of the Scion Burn which formed the original boundary. If this is the case the stone has been removed from elsewhere and placed on the site between the time of the First Edition Ordnance Survey 1864 (Figure 1a) and Second Edition Ordnance Survey Map of 1893 (Figure 1b).

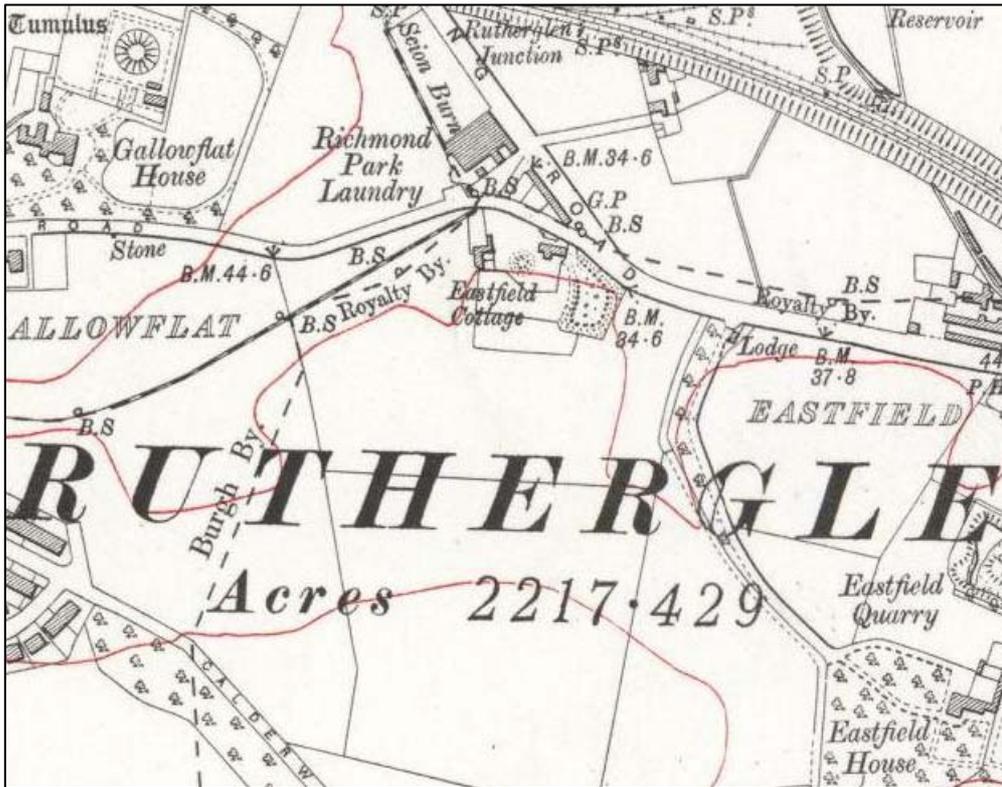
Figure 2a: Ordnance Survey Map 1910

7. By 1910 (Figure 2a) the only change evident is that the buildings of Eastfield Colliery have disappeared, with one exception which is marked as Eastfield Cottage. By the 1934 Ordnance Survey Map (Figure 2b), housing has spread eastward from the core of Rutherglen and has reached the site with the creation of Richmond Drive and the building of 2 Richmond Drive. The Scion Burn appears to have been culverted by this point as it is no longer depicted. The 1934 map shows that the study area was split by a property boundary between 2 Richmond Drive and a property on Hamilton Road, which is no longer the case. When this change took place is uncertain as modern Ordnance Survey maps still show the same property division, though it is known to have been established in its present form for at least the past thirty years.

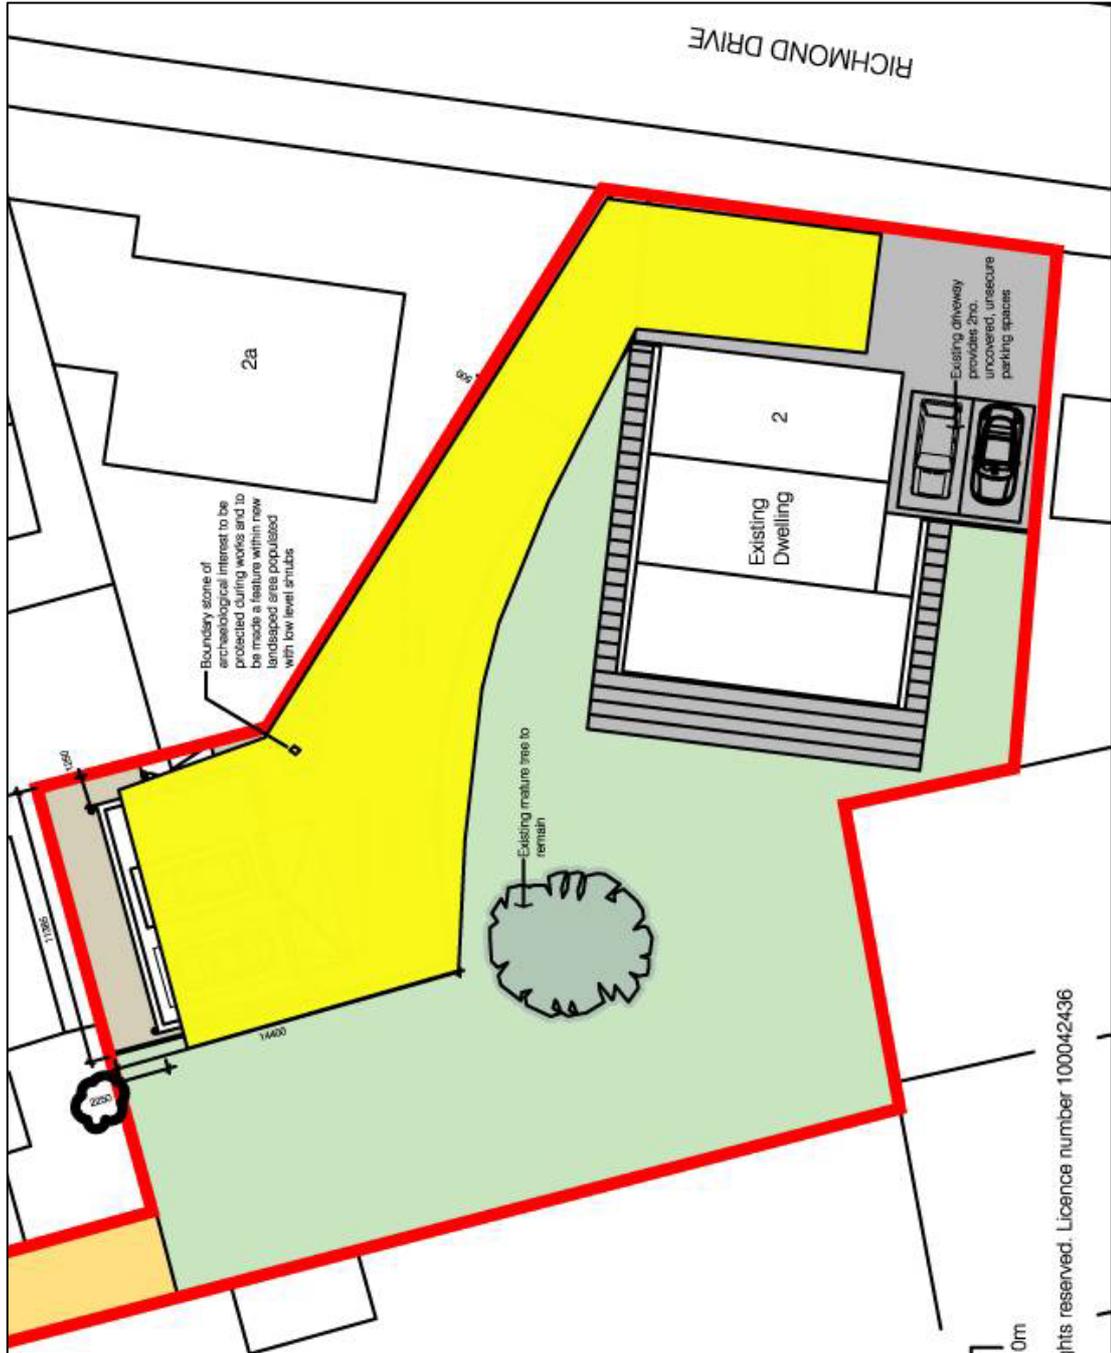
Figure 3: Site Plan with Driveway and garage footprint as striped marked in yellow

11. The study area consisted of residential garden to the front, side and rear of 2 Richmond Drive, Rutherglen (Figure 3). The ground lies flat at the front of the property and gently slopes from southeast to northwest on the northern side of the property.

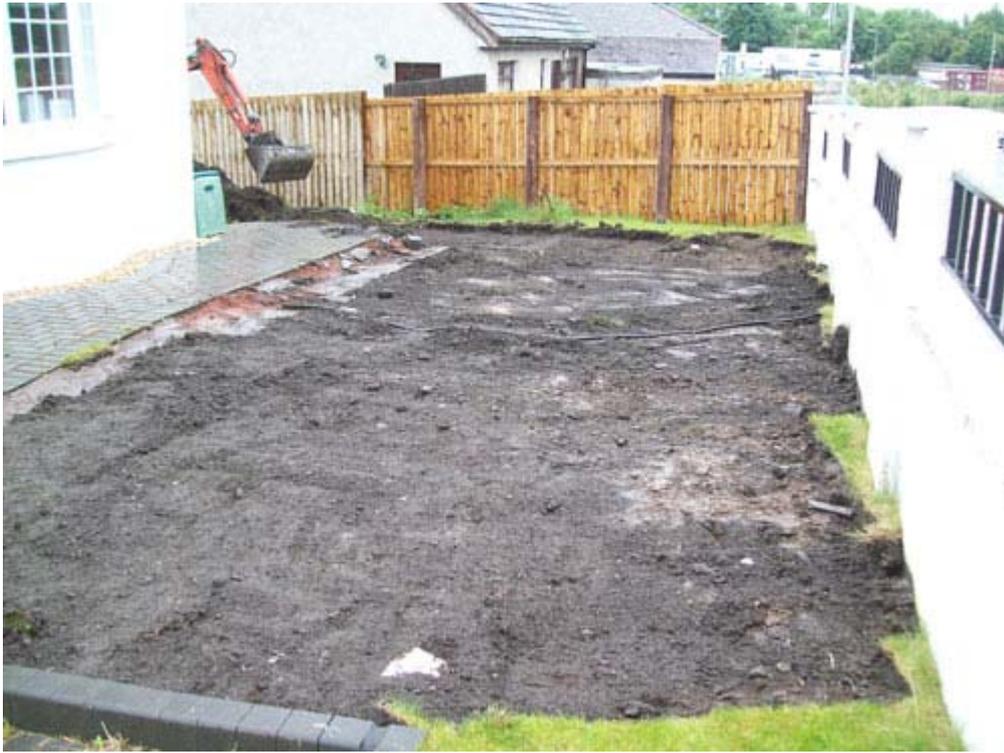
12. The monitoring of the turf strip for the drive revealed two distinct areas to the front and to the north side of the house.
13. At the front of the house the turf was removed to a depth of 80mm to 120mm, revealing a grey brown silty clay topsoil (005) with frequent modern detritus present (Figure 4a). This deposit was investigated further and appears to be at least 250mm in depth. While at the northern side of the house the turf was removed to a depth of about 80-100mm revealing what appears to a disturbed natural subsoil (002): orange brown clay sand with occasional inclusions of coal (Figure 4b). Various amorphous blobs of topsoil were present within (002) along the length of the drive. On investigation these blobs were modern disturbance.

Figure 4a: Shot of the stripped front garden from the S

18. No significant archaeological features were uncovered in the course of the archaeological works, the overly deep topsoil (005) present at the front of the property most likely relates to the flower beds that were present there until improvement works took place at the property in the past couple of years, prior to the present owners. The similarly deep soil within the footprint of the garage may relate to the Scion Burn that originally formed the boundary for the Royal Burgh. However the presence of primarily twentieth to twenty first century detritus within (003) down to a depth of 600mm would indicate that it has been heavily disturbed in recent times, most likely during the recent improvements.

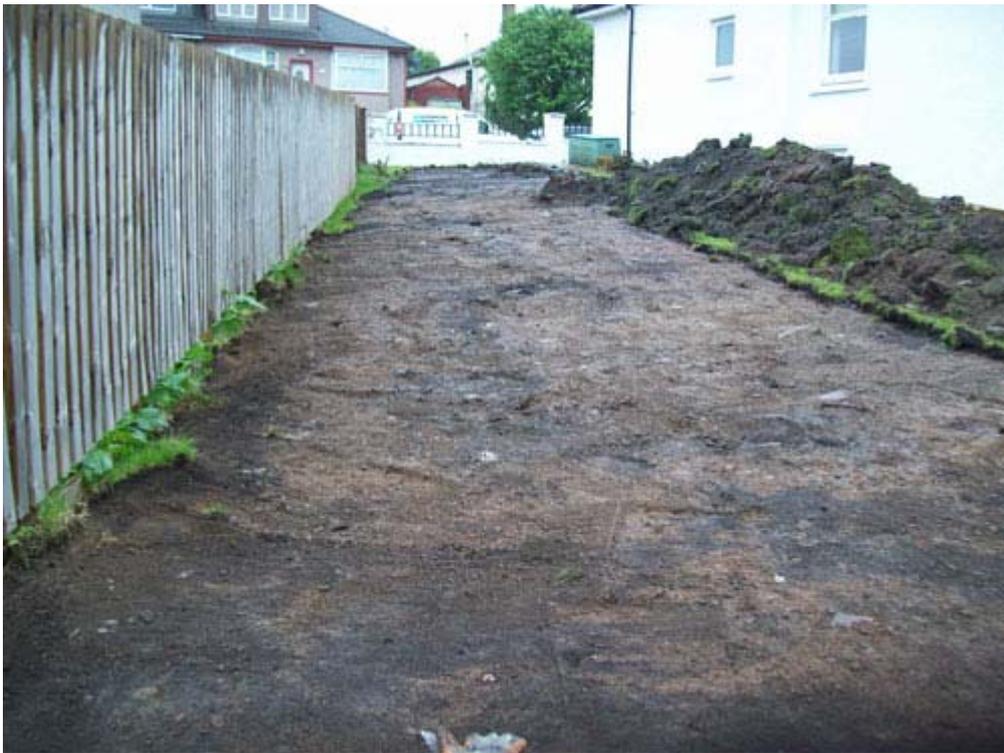
Figure 4b: Shot of the stripped north side of the house from the NE

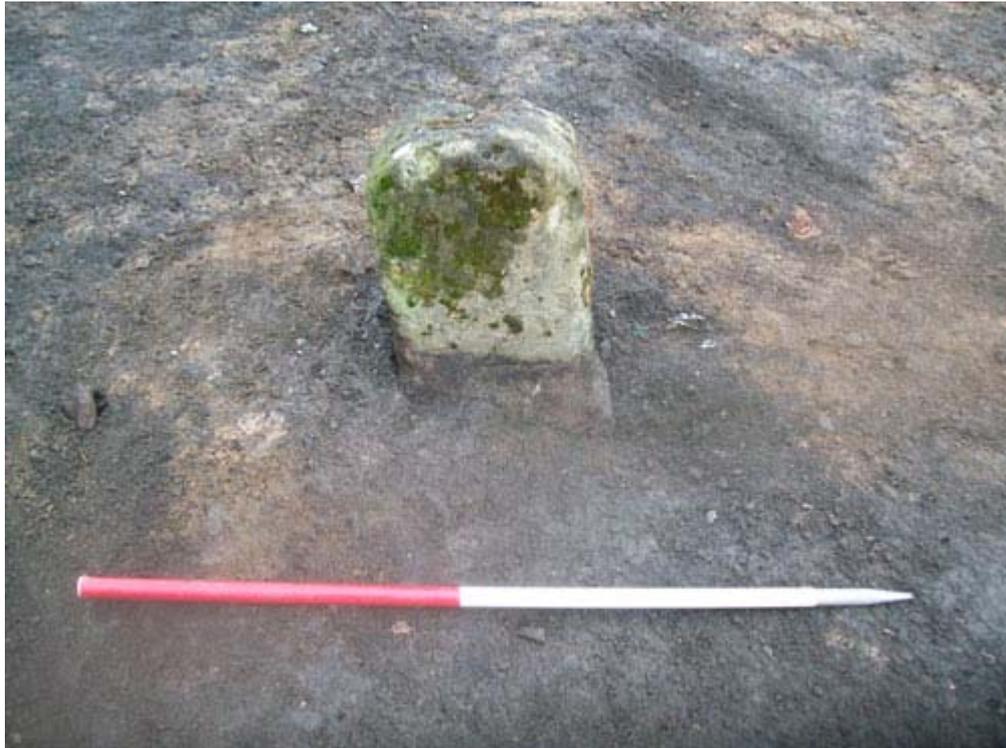
14. The area around the boundary stone (Canmore ID: 45098) was topsoil stripped by hand, revealing an upright rectangular sandstone block with a rounded top (Figure 5a). The stone measures approximately 500mm in length above ground and 250mm in width. No markings were discernible on any of the surfaces of the stone. The stone sat within the fill of a pit (006) which was an irregular rectangle in plan, measuring 515mm wide and 600mm long, though the exact length is unknown as the feature merges with (002) on its northwest side. The fill of pit (006) was a grey brown slightly sandy silt (003) with modern detritus visible including crisp packets.
15. A second pit (007) adjacent to (006), was an irregular square in plan measuring 750mm by 500mm with a (003) fill with red CBM present.

Figure 5a: Boundary stone from the NNE

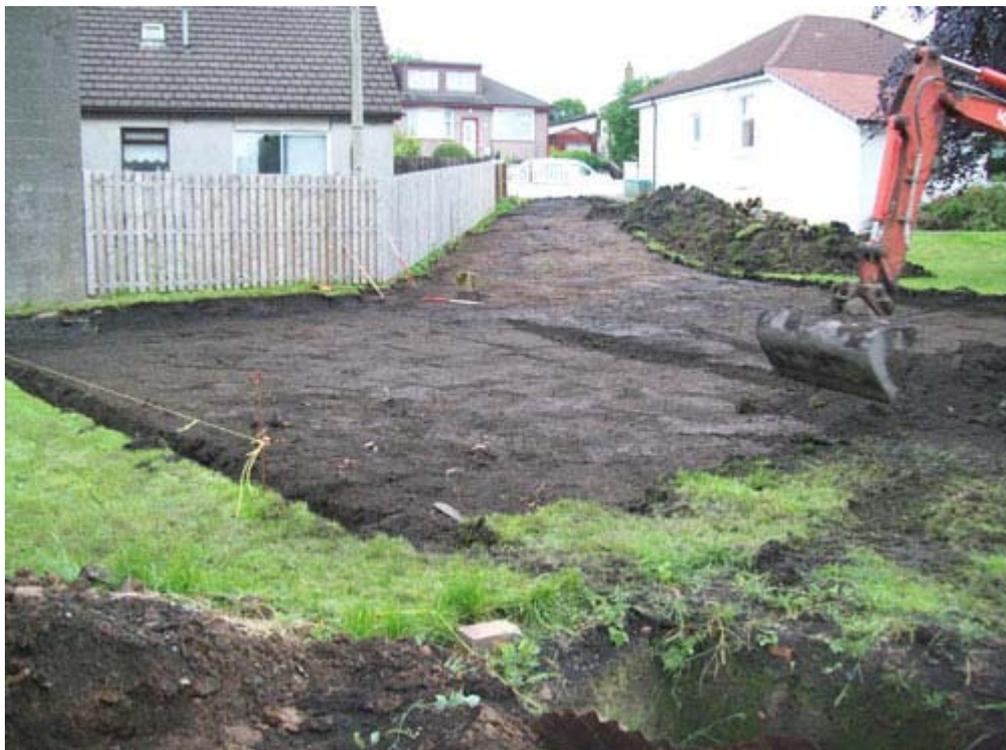
16. The topsoil removal from the footprint of the garage revealed (003) with frequent modern detritus such as CBM, glazed brick, glass crisp packets, whin stone cobbles/kerb stones and frequent large tree roots (Figure 5b).. In addition a linear feature (004) aligned N-S measuring 1.m by ≥450mm wide within the trench was uncovered along the eastern edge of the excavated footprint. This feature consisted of ash and cinder with occasional CBM and wood inclusions.
17. A foundation trench was excavated along the northern side of the footprint, 700mm wide and between 450 to 600mm deep. The trench was excavated down through (003) without any other strata being exposed. Tree roots and modern detritus were present throughout.

Figure 5b: Shot of the stripped garage footprint with boundary stone from the NE
