# **Broomfield Road, Montrose, Angus: Archaeological Mitigation**

## **Data Structure Report**

issued 31<sup>st</sup> May 2013

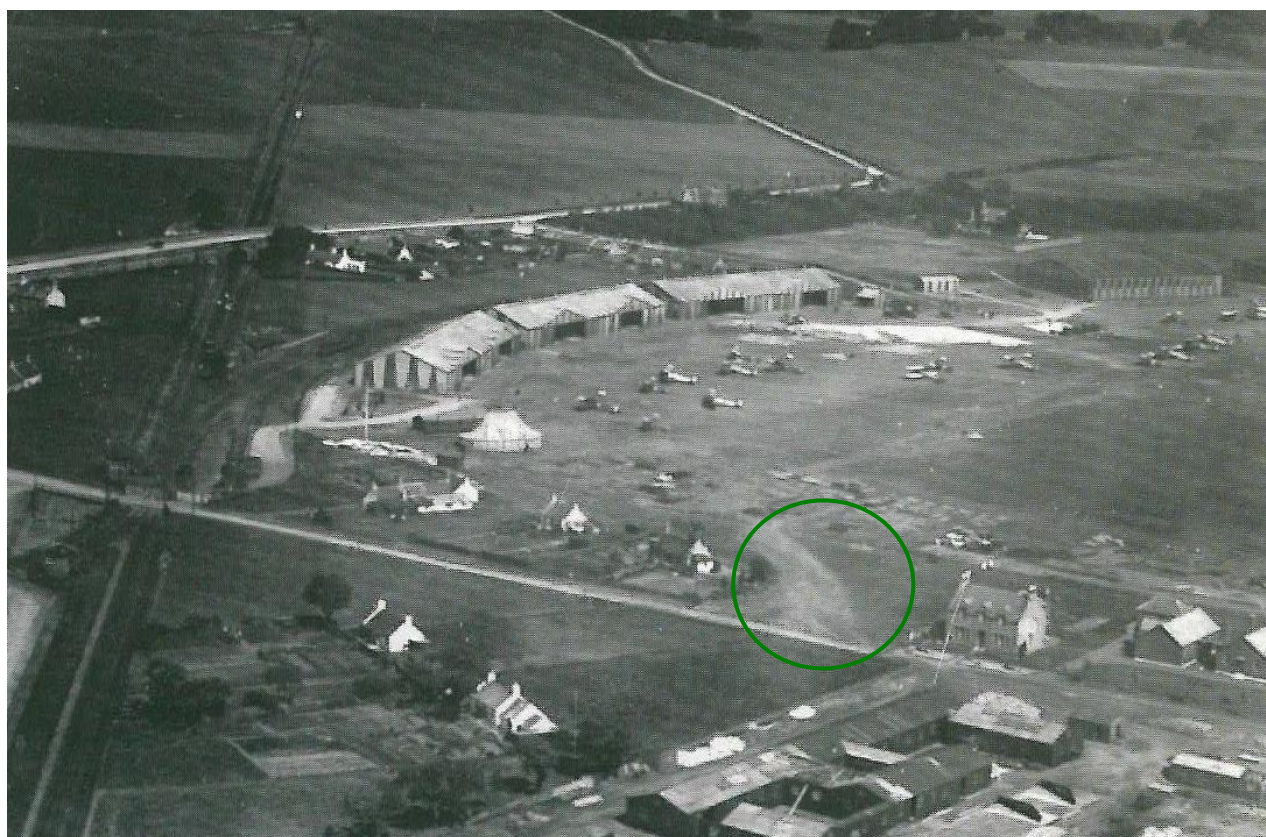
Figure 3b: Aerial photograph of Montrose Airfield from circa 1917, with 11-15 Broomfield highlighted by the green circle

7. Regarding the development area of 11-15 Broomfield Road the earliest image (Figure 3b) available that includes the development area depicts it as an open area which has been used as an access area into the airfield from the south. The structure to the south-east is depicted on the *6-inch 3<sup>rd</sup> and 4<sup>th</sup> edition Ordnance Surveys* along with the access area which still opens out onto Broomfield Road (Figures 2b and 3a). It is not until an aerial photograph flown on the 9<sup>th</sup> July 1941 that a structure is visible in the development area (Figure 4a). The roadway encircling the Fuel Bunker is clearly visible as a white area with a green interior representing the turf of the outer bund of the bunker. The plan from

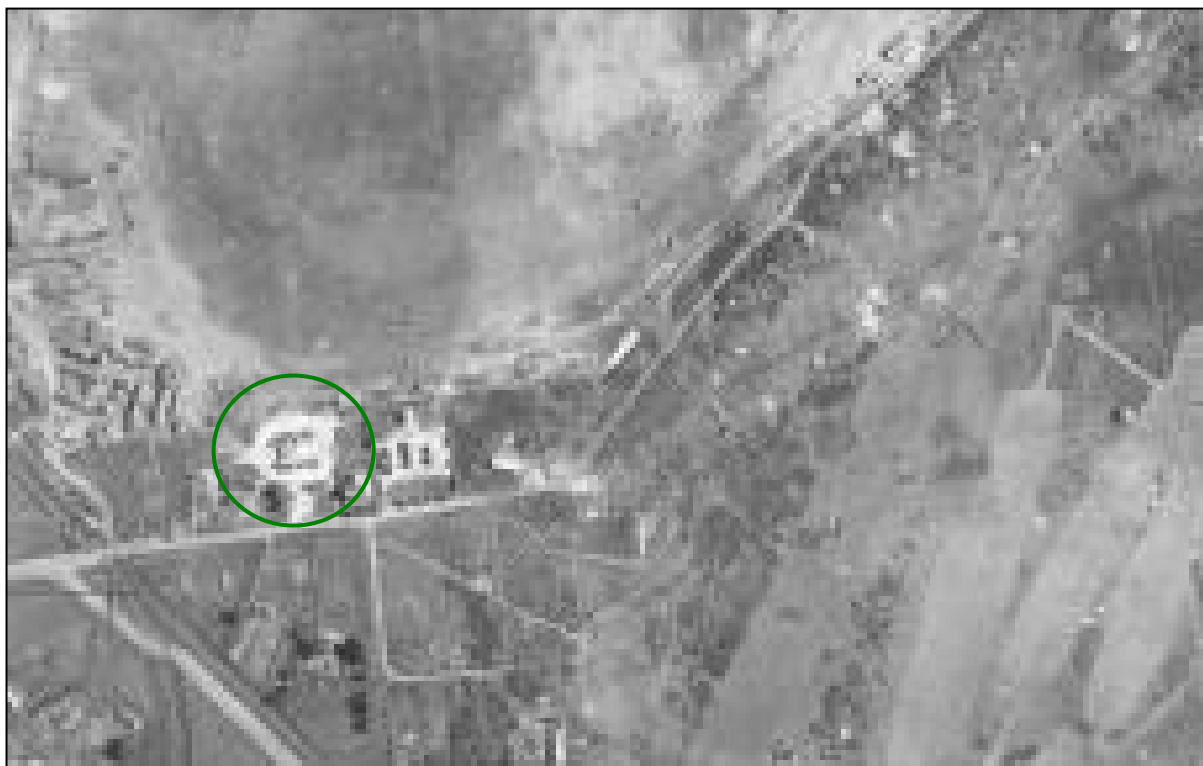
Figure 4a: Aerial photograph of RAF Montrose, development area depicted by the green circle (Sortie M\_019/D 309, Frame 5257 9<sup>th</sup> July 1941)

32. Aerial photographs dating back to 1941 (Figure 4a) show the presence of the large structure represented by (003) and highlighted by the circular concrete road. The Air-raid shelters (001 and 002) along with (003) are all still present on the plan of RAF Montrose from 1945 (Figure 4b). The plan from 1945 (Figure 4b) illustrates that the immediate surrounding area of the Air-raid shelters and Fuel bunker, in this southern area of the former airfield, do not have any other structures and as such these open areas have gradually been filled in with the present development area representing the final area along the southern borders of the former RAF Montrose to be filled in.

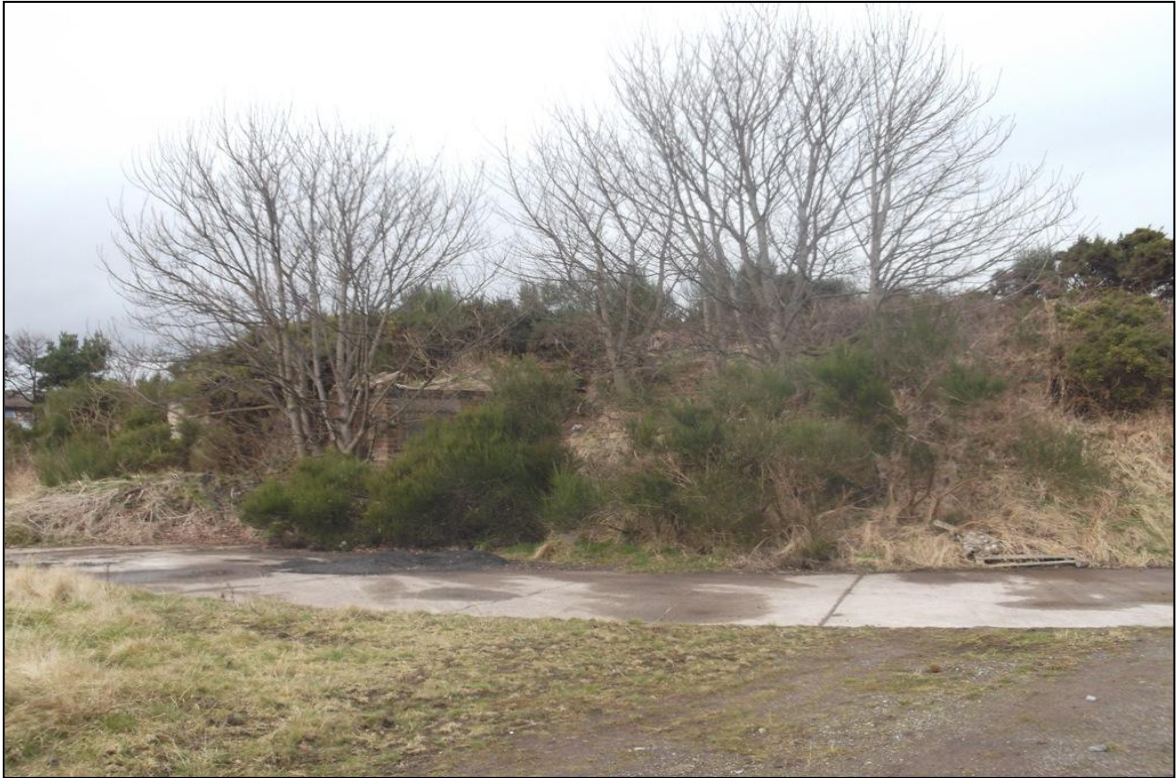
Figure 5a: Structure 003 (Fuel Bunker) demonstrating the thick vegetation and covering mound with the surrounding sectional poured concrete roadway in the foreground

24. Some of the external elevations had a black bitumen render, approximately 40mm thick, covering the brick work. This possibly provided waterproofing from the overlying earth bund. Located on the north and south faces pipes are visible protruding out of the brick work. These may have represented drainage pipes taking water away from the roof. The structure would have originally been covered by an earth and turf mound (Figure 5a).

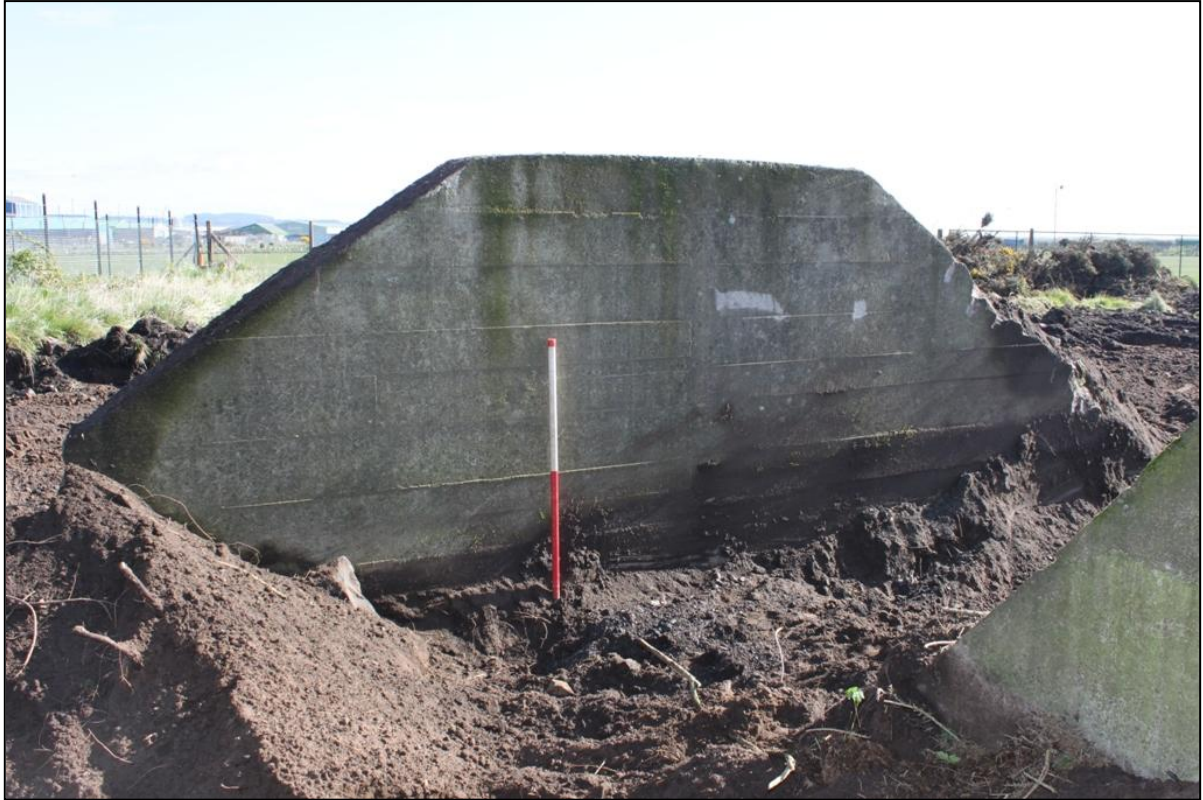
Figure 7a: Structure (001) Blast wall, located in front of the main access

19. Located in front of the main access was a concrete wall constructed using the shuttered method for concrete construction, rectilinear in form and aligned east-west. The maximum dimensions were 6.3m by 1.77 by 300mm and although it was free standing it would originally have been encompassed by earth (Figure 7a). The function of this feature would be to act as a blast wall and protect the main access into the Air-raid shelter. Located externally and at the east end of the structure was a square opening, measuring 650mm by 650mm and surrounded by a square concrete feature (i) measuring 980mm by 480mm and providing protection for the roof access (Figures 7b and 8a). The design of this feature, with the four rectangular spaces on each of the sides, may reflect a possible locking or mating mechanism for a lid or hatch.

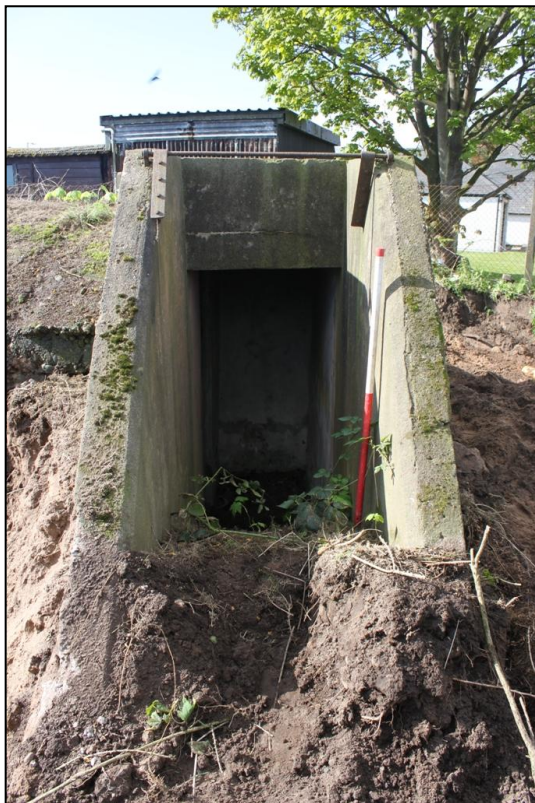
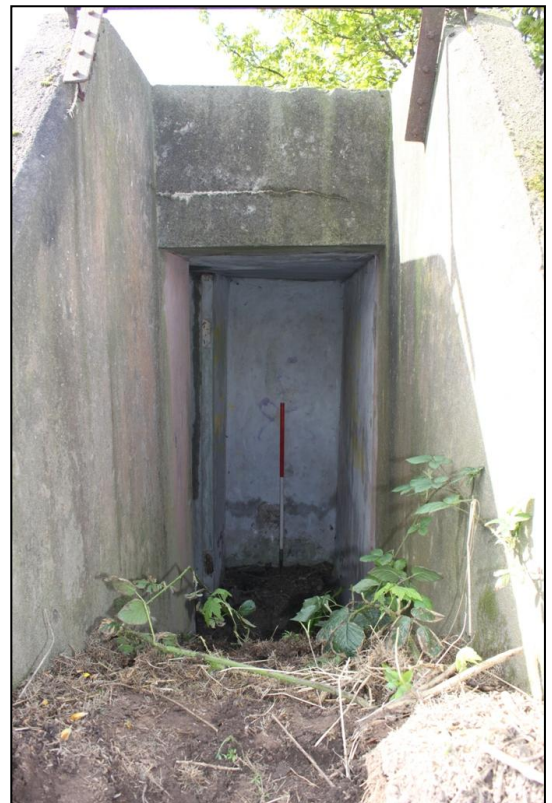
Figure 8b i and ii: Photo (i) illustrates the main access and metal door bracket with photo (ii) demonstrating a closer image of Room A.

20. Internally, structure (001) was divided into two rooms; A and B. Room A was rectangular in shape with maximum internal dimensions of 4.23m by 760mm and 1.94m in height and represented the main access to (001). Evidence for door brackets made from wood are present on the west internal wall and illustrates that this room may possibly have been originally divided into two compartments with the inner compartment measuring 1.79m by 760mm. This is further supported by the remains of door brackets made from metal located on the exterior of Room A. The location of the metal door brackets at the top and on the exterior of Room A possibly reflects the remains of an outer blast door (Figures 8b i and ii). The build up of soil in the outer doorway prevented any measurements being taken. The walls of Room A were rendered light grey with evidence of modern activity in the form of graffiti and pink paint on both the west and east walls.

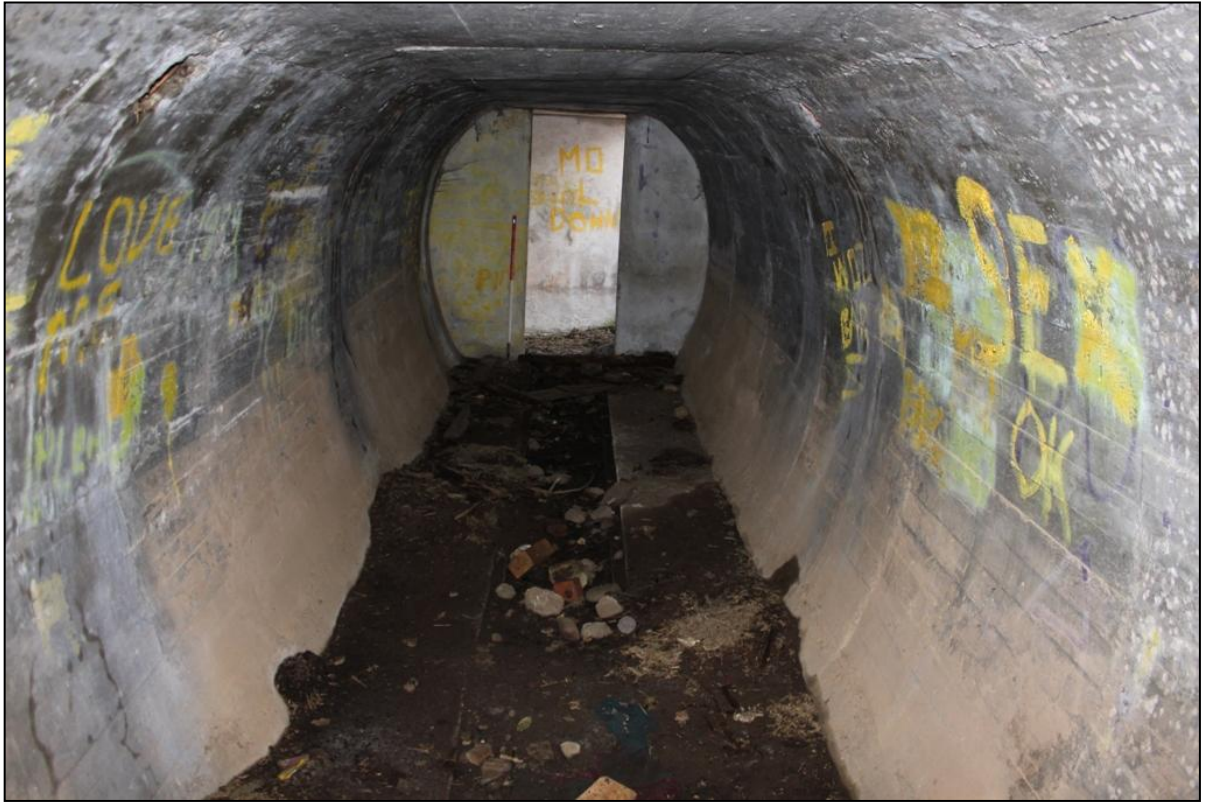
Figure 9a: Room B looking west demonstrating the internal form, graffiti , ceramic air vent in the top left of the image and access from Room A

21. Access to Room B was through a doorway 770mm in width and located on the eastern side of Room A. Room B forms the main chamber of (001) with maximum internal dimensions of 8.58m by 2.18m by 1.98m. The sides of the Room B are untreated shuttered concrete and rounded in profile forming a rectangular cylinder shape (Figure 9a). Along both the north and south walls there are a number of areas of modern graffiti

(Figure 9a). The floor was rectangular in shape with a central channel 580mm wide and 70mm deep, running east-west for the length of Room B. Along either side of the channel there was an edge 500mm wide and 400mm deep which would have been used to possibly lay boards down and take any excess liquids away from the main standing and seating area of the floor. There was no evidence for internal fittings associated with seats/benches, the only fittings present were steel rungs forming the ladder that was fixed into the east wall and enabled access to the roof hatch.

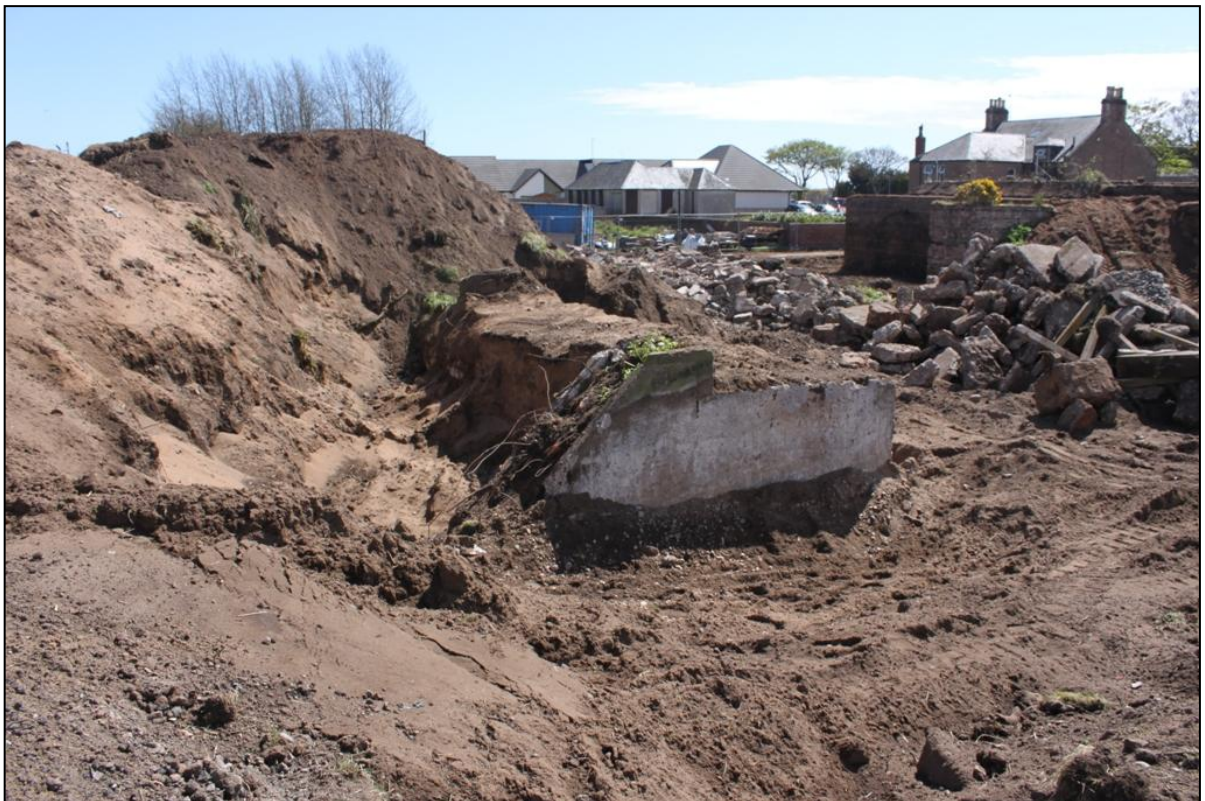
Figure 9b: Structure (002) demonstrating the same design characteristics as (001) and the blocked doorway the western end

22. Structure (002), as with (001) was a single storey, semi-subterranean structure with the main access to the interior located at the western end which steps out slightly to form an 'L-shape'. Constructed using rectangular concrete blocks and rendered using more concrete. The roof access hatch is located at the eastern end with the same concrete square crenulated protection. A short section of the bottom of the blast wall is visible to the north of the main access. The upper portion has been removed, when this occurred is not known. Along the south roof elevation, air vents comprising ceramic pipes are visible. Structure (002) is not in as good condition as (001), however, the overall similar external design and individual component details would suggest that the interior would have been the same as (001) (Figure 9b).

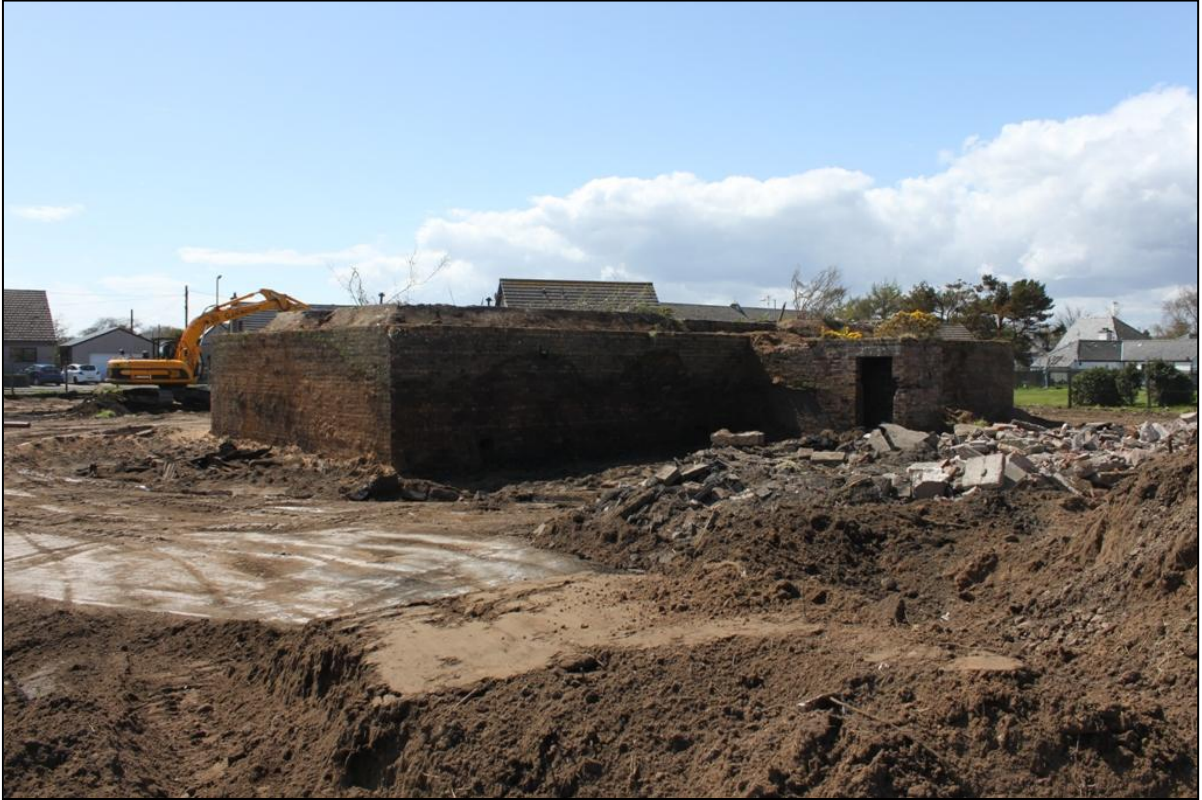
Figure 10a: Structure (003) north facing elevation demonstrating the open doorway and corridor of Room E

31. Room E provided access to Room A from the north and formed by a narrow 'L-shaped' corridor aligned north-south with an east-west section at the southern end. The east-west section of the corridor was blocked by sand and soil due to part of the ceiling possibly having been removed. The north-south corridor measured 8.7m by 1.04m with a doorway located at the northern end on the west wall and measuring 1.11m wide, this had been blocked in recent times re-opened to allow access. As with Rooms B and D it was constructed of brick with a concrete floor and pre-cast metal reinforced concrete ceiling.

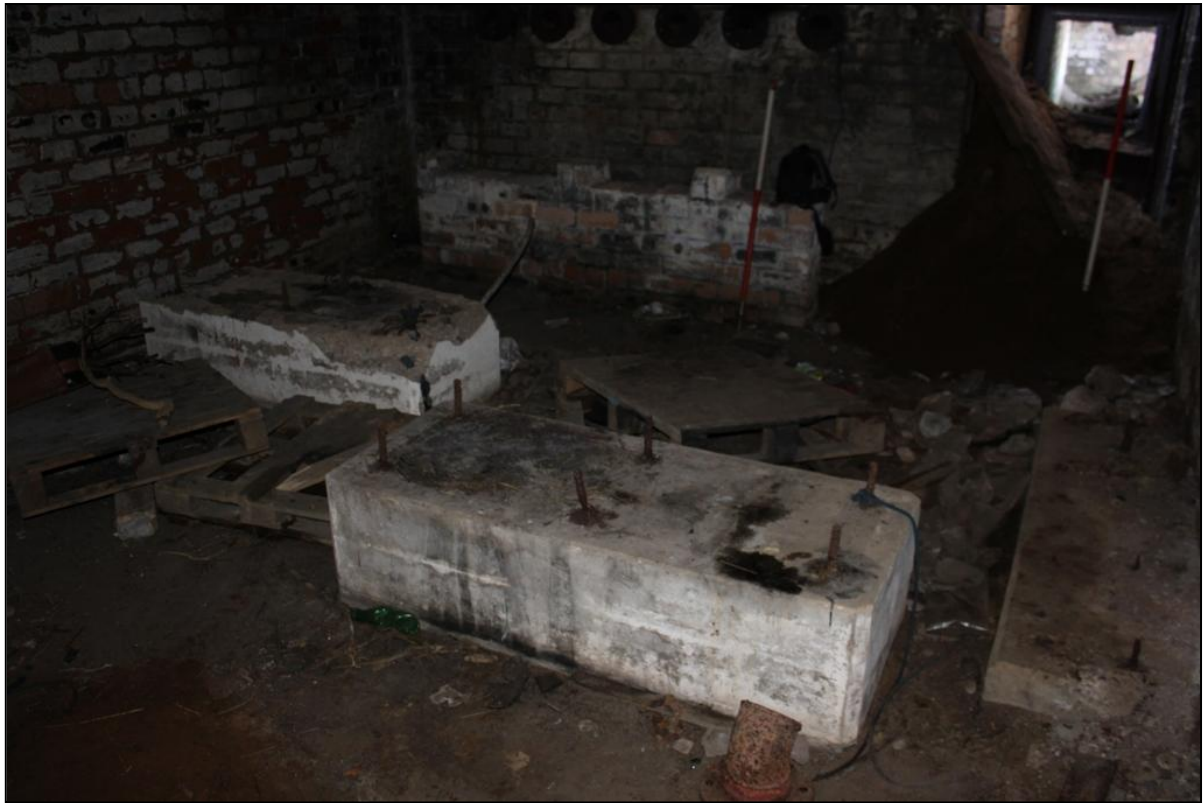
Figure 11a: Concrete plinths (details ii & iii) also demonstrating the metal fixings

27. Iron piping was present running along the roof and on each wall, with brick and concrete plinths (i-vi) recorded on the floor (Figures 11a and 11b). There were two different types of plinths with one constructed from concrete and the other from brick. The concrete plinths were rectangular in shape and ranged in size from 750mm by 480mm by 180mm, 1.67m by 460mm by 110mm and 1.4m by 58mm by 350mm. All the concrete plinths had metal holdfasts rising up from the top of them and would suggest that they once have had some form of equipment/machinery fixed to them (Figure 11a). The brick plinths were all painted white and ranged in size from 2.13m by 710mm, 2.45m by 1.04m and 230mm by 700mm. Their close proximity to piping would suggest that they were possibly used to support the pipes running to machinery fixed to the concrete plinths. One of the brick plinths has black writing on its north facing side, however this was difficult to make out (Figure 11b).
