**Blairhall, Fife:
Archaeological Watching Brief**

Data Structure Report

by Claire Shaw

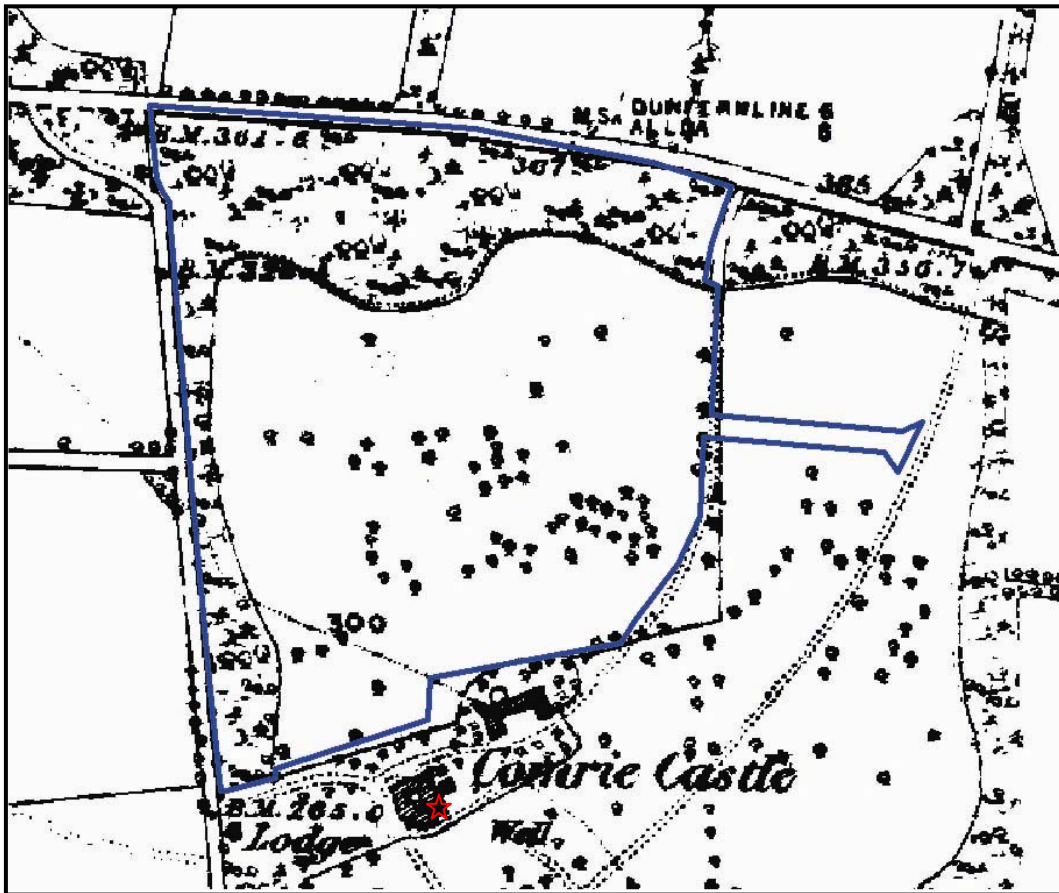
Figure 2a: First edition ordnance survey map (1864) – blue line denoted development area

- 3.3.5 The first edition Ordnance Survey map (1864) (Figure 2a) is the first map that clearly shows the actual layout of Comrie Castle and its auxiliary buildings. This map shows the location of a lodge at the entranceway, the large rectangular structure of the castle and a U-shaped building to the north-east, presumed to be the stable block. It can be seen that the castle sits within a dense wooded area, with more open ground to the immediate north. The landscape depicted in this map is very similar to the current environment encountered.

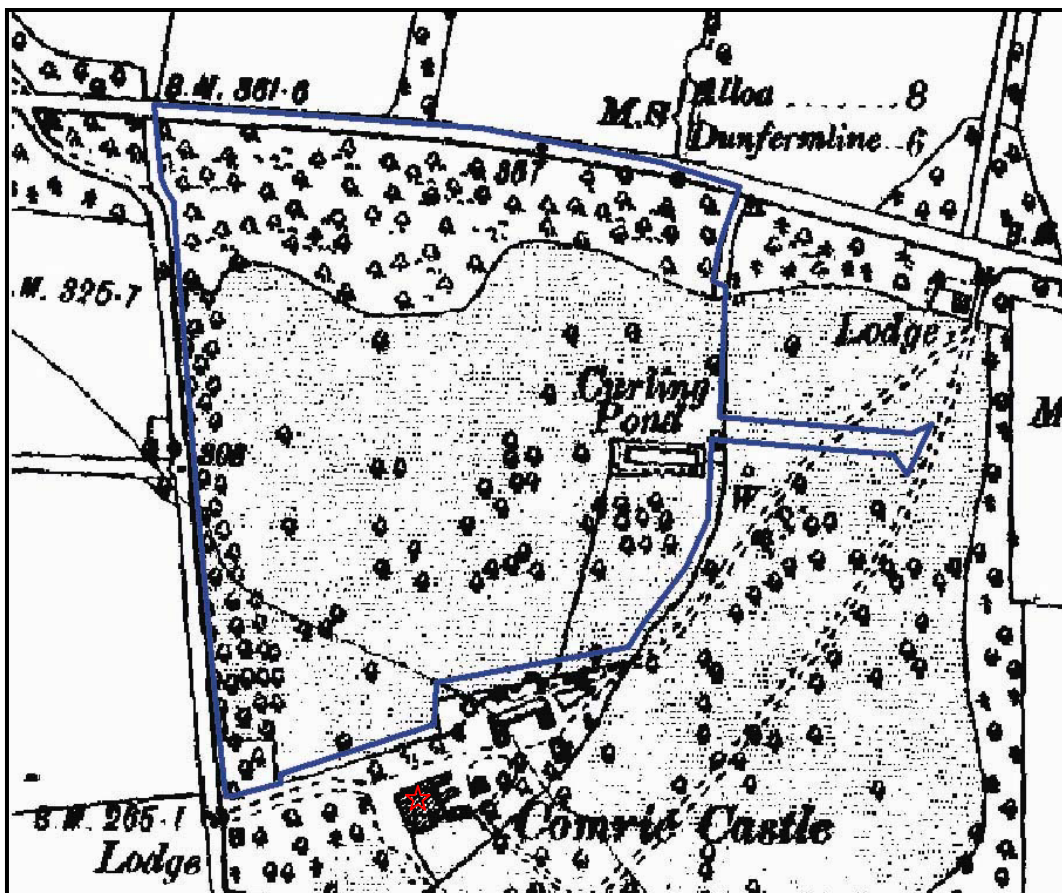
Figure 2b: Third Edition Ordnance Survey map (1913) - blue line denoted development area

- 3.3.6 The 3rd edition Ordnance Survey map of 1913 illustrates the same level of detail as that found on the 1st edition Ordnance map and in doing so indicates that very little has changed in the area. The most significant addition is the curling pond to the north-east of the castle. By the latter half of the 19th century, curling had become a popular pastime across Scotland to the extent that most parishes had their own custom-made pond.

- 3.3.7 Regarding the house, it can be seen that there has been a small extension built at the eastern corner and the small square structure that initially appeared on the 2nd edition as a ruinous building, has been roofed. The main decline can be seen in the stable block where a large portion has become ruinous (Figure 2b).

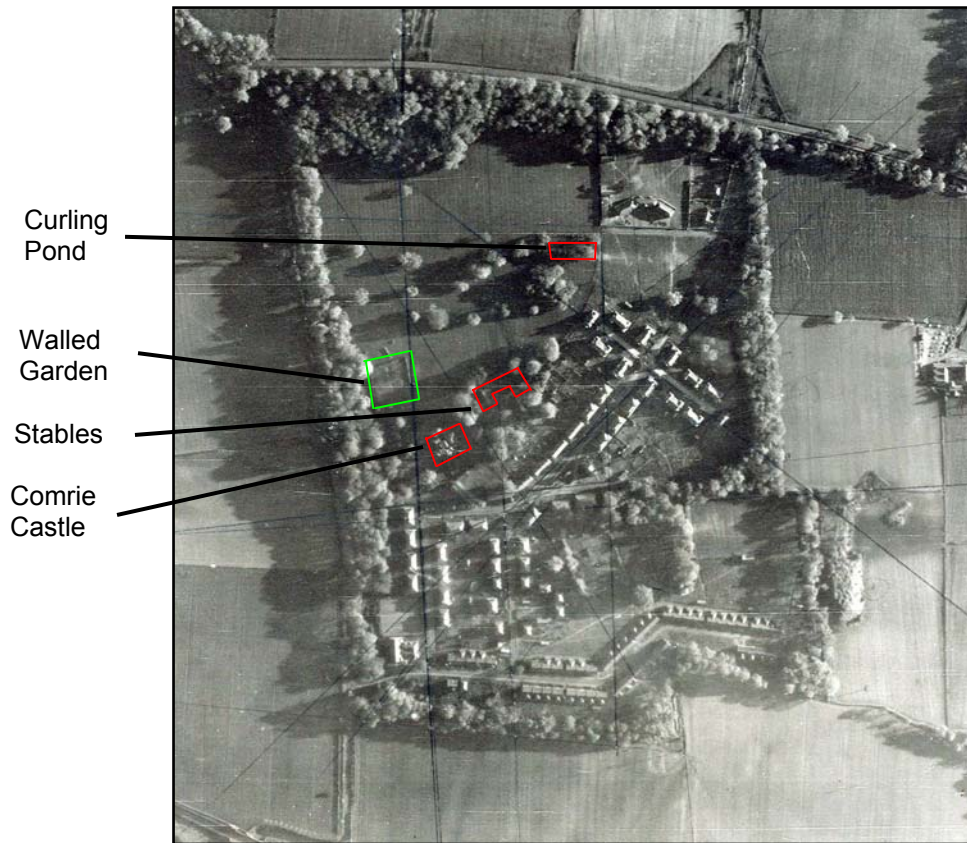
Figure 3a: Aerial Photograph May 1946 (copyright RCAHMS)

- 3.4 *Aerial Photograph*
- 3.4.1 Two aerial photographs taken in 1946 and 1955 are of slightly differing quality, with more clarity in the 1955 image due to the reduced foliage cover of the trees. In the earlier photograph the layout of the castle and its associated buildings can vaguely be defined and the site of the lodge is completely obscured.

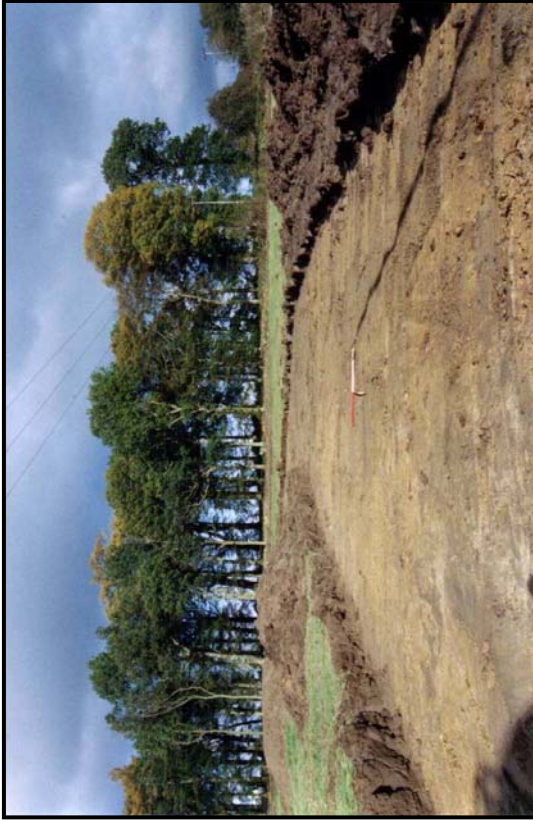
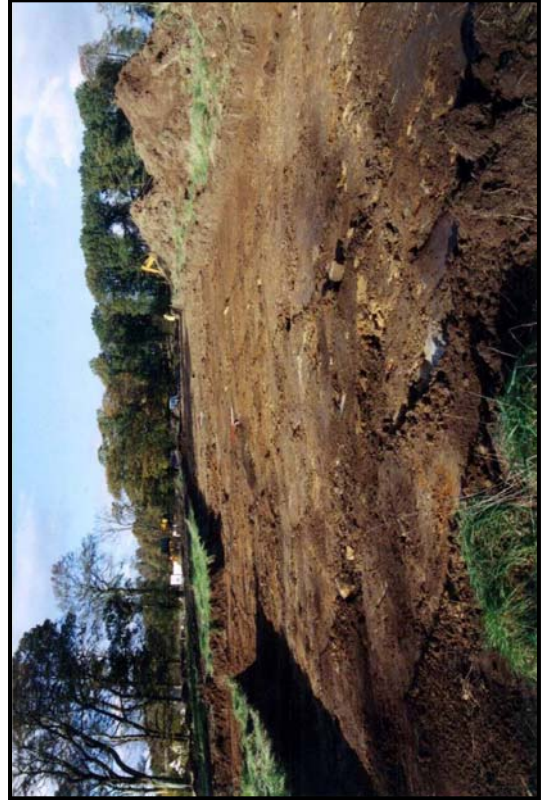
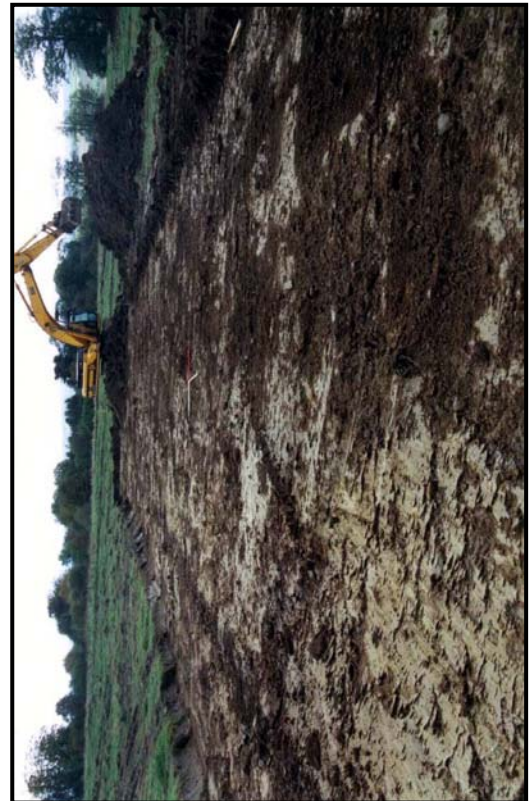
- 4.1.3 The stratigraphic sequence of the site was generally uniform across the entire extent of the area. The overlying turf/vegetation (100, 200, 300 and 400) had an average depth of 90mm. The topsoil (101, 201, 301, and 401) was mid brown (with a slight orange undertone) in colour, with a fine silty/sand composition and occasional small to medium sized stones mixed throughout, with an average depth of 350mm. The topsoil exposed the underlying natural (103, 203, 303 and 304), a light brown/cream coloured boulder clay, with frequent small to medium sized boulders.

Figure 4a: Main E-W spine road – eastern end

Figure 4b: Main E-W spine road 1 – looking northwards past compound

Figure 4d: N-S spine road 3

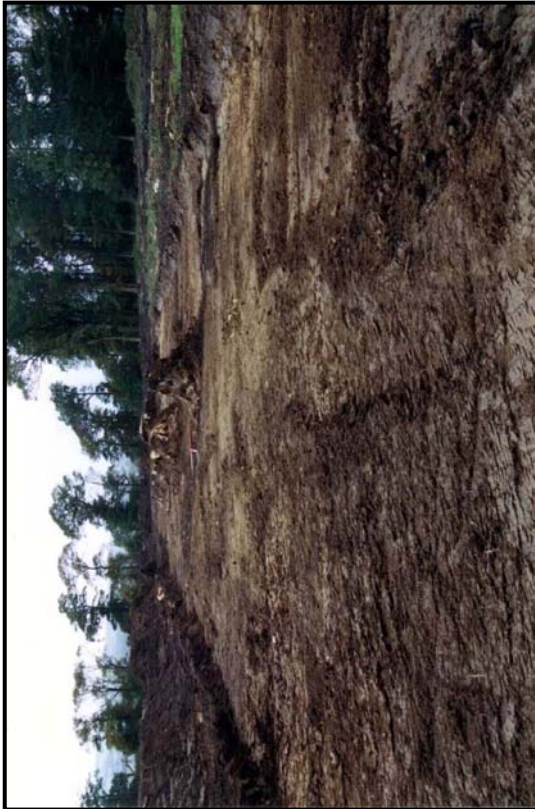
- 4.1.5 Within the path of the spine roads there were a number of tree stumps left *in situ*. These stumps were the results of the thinning of the wood on the northern boundary (Figure 4c). These were left in place and excavated around, and will be removed at a later date by the developer.

Figure 4c: Main E-W spine road with tree stumps

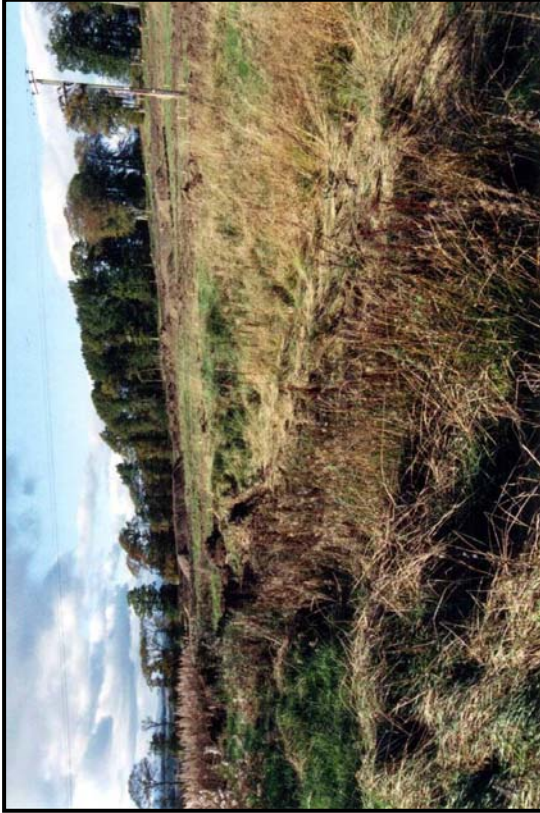
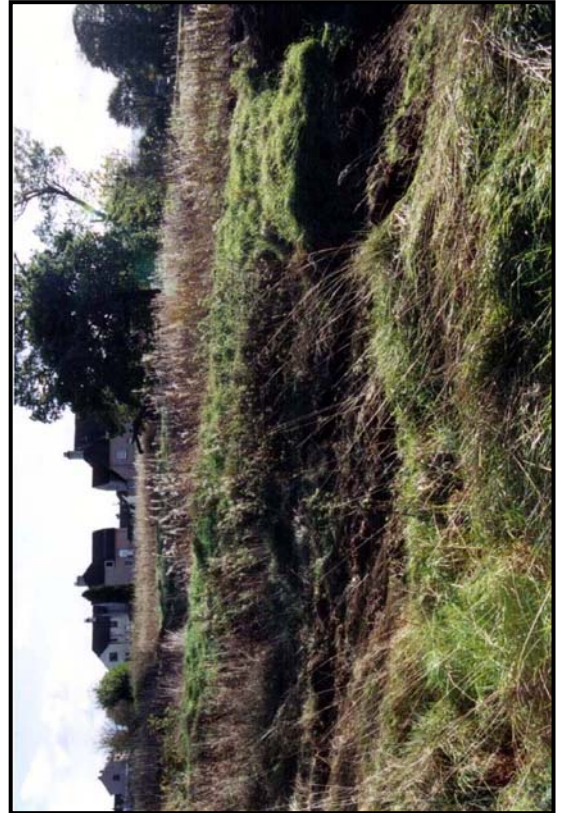
- ### 4.2 *Curling Pond*
- 4.2.1 While on site the developers used the opportunity to excavate the footpath which will pass through the curling pond (Figure 4 e-h). Prior to excavation, the pond was found to be heavily overgrown but still visible. It is composed of a long rectangular banked feature with internal depression. The banks are earthen and vary in width of 1.5 to 2m and stand to a height of 0.5m (501) (Figure 4g). Internally the pond measured 9m wide by 35m in length.

Figure 4e: Curling pond – general photograph

Figure 4f: Curling pond – western end

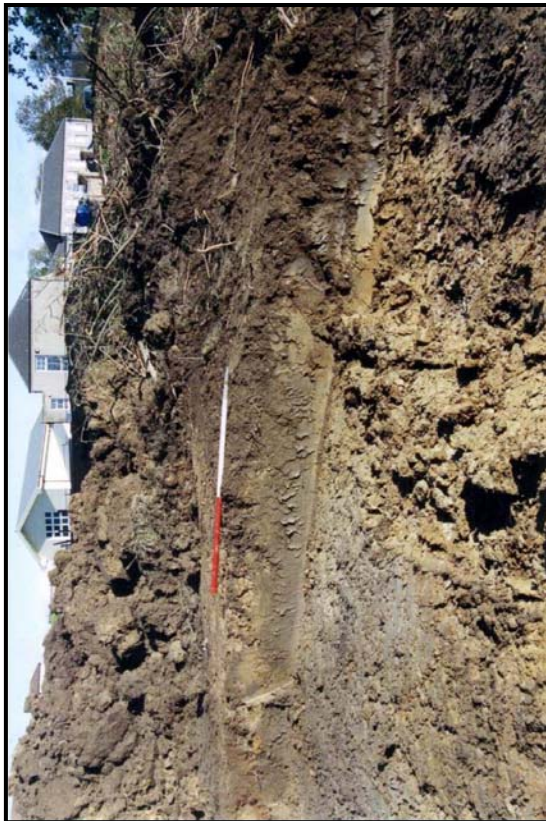
Figure 4g: Curling pond- section through bank (501)

| 501 | Earthen banks | Curling pond | Earthen banks that form the sides of the curling pond. Measure between 1.5-2m wide and stand to a height of 0.5m. Form an enclosing bank with depression to hold the pond. Sit on natural boulder clay |

- 6.4 In terms of the curling pond, a section through this relatively modern feature has been recorded and we believe that this constitutes an adequate record in advance of its loss. This feature was known to the planning authority at time of the grant of planning consent and no scheme to preserve the feature was required.

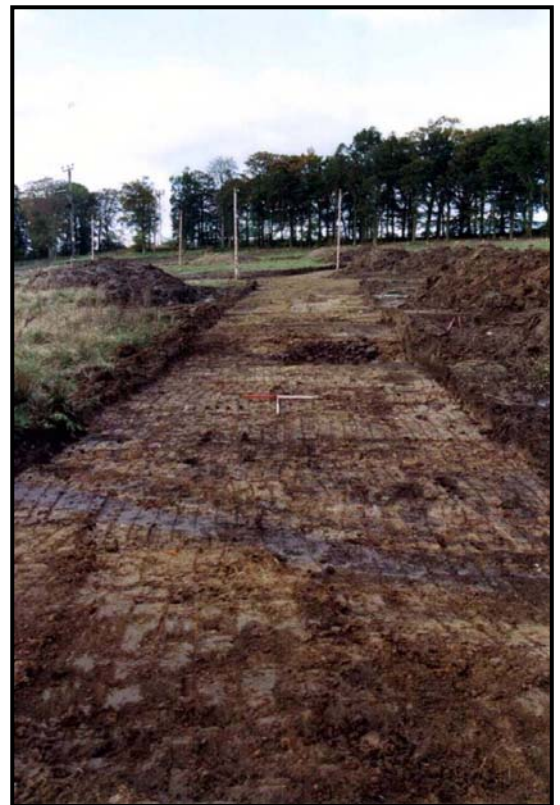
Figure 4h: Curling pond- linear feature within pond (502)

4.2.2 Within the pond it was found that once the vegetation had been removed the underlying boulder clay was exposed, showing that no siltation had taken place. This may indicate that the either the curling pond was not in long term use or that it was regularly maintained. It was also noted that at the inner base of the banks on either side, there was linear tracks, about 0.25m wide (502), presumably running the length of the pond (Figure 4h). The track on the northern side was excavated to a depth of 0.45m and no indication to its purpose was found. It has been concluded that these tracks may have been cut to form slots into which wooden shuttering was place to help retain the sides of the pond.

| 502 | Internal linear tracks on northern and southern side | Curling pond | Linear track on the inner edge of the pond. Excavated to a depth of 0.45m with no finds. Fill was a mid-brown silt/sand. This may indicate a cut for the insertion of wooden shuttering which would have retained the sides of the pond |
