**Eastlands Road, Rothesay, Isle of Bute:
Archaeological Evaluation**

Data Structure Report

by Douglas Gordon

issued 9th February 2007

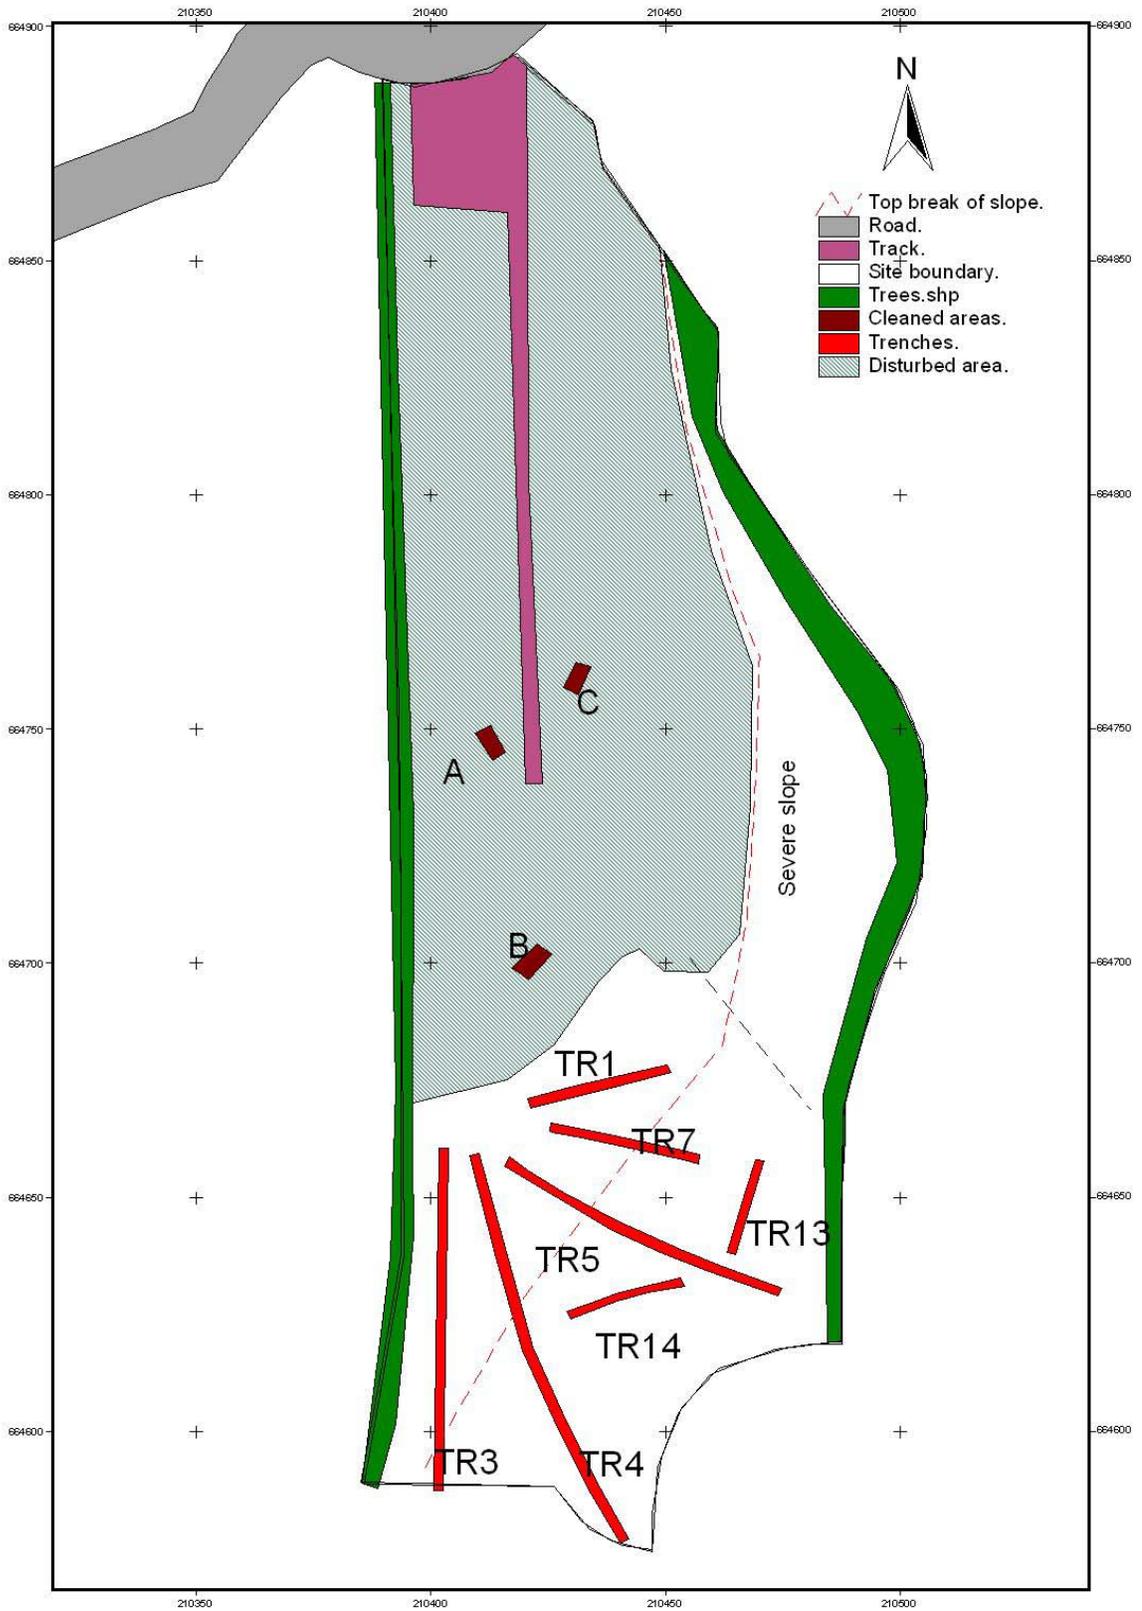
Figure 2: Trench plan

- 4.1.2 Three areas A, B and C (Figure 2) approximately 5m by 4m were cleared of plant re-growth to establish the level of stripping, each area showed the orange red gravel [004]. The more westerly area (A) evidenced a little topsoil, which appeared to have been redeposited. The conclusion reached from these test scrapes on-site and from a general walkover was that there were no areas of topsoil surviving *in-situ* and extensive evidence of the upper surface of the subsoil having been significantly truncated.

- 4.1.3 A graded track had been cut through the middle of the area (see Figure 2), up to a depth of approximately 1.8m at its southernmost limit. A section of the track cutting was observed and showed that the surviving depth of a compact red orange sandy gravel [004] was between 100mm to 300mm thick and sat upon bed rock.

- 4.1.4 The ground to the east of the disturbed area, along the whole eastern flank, was inaccessible due to a steep slope and trees that run along the eastern boundary of the site (Figure 2). The slope become less severe in the southern portion of the site

- 4.2.1 All seven trenches (Figure 2) exhibited a fairly common stratigraphy, with thin dark brown clay silt topsoil, which was in general 50mm or less in depth, overlaying varying subsoil. Hillwash, consisting of brown grey sandy clay silt to a depth of up to 220mm, was evident in Trenches 1, 5, 7 and 13, especially those portions of trench on the eastern downslope of the site.

- 6.1 The archaeological evaluation failed to identify any significant archaeological features or artefacts within the development area. In addition, a significant portion of the site has suffered from a high level of disturbance through previous development. Consequently, we recommend that no further archaeological works are appropriate.
- 6.2 The appropriateness and acceptability of our recommendations rest with Argyll and Bute Council, and their advisors, the West of Scotland Archaeology Service.

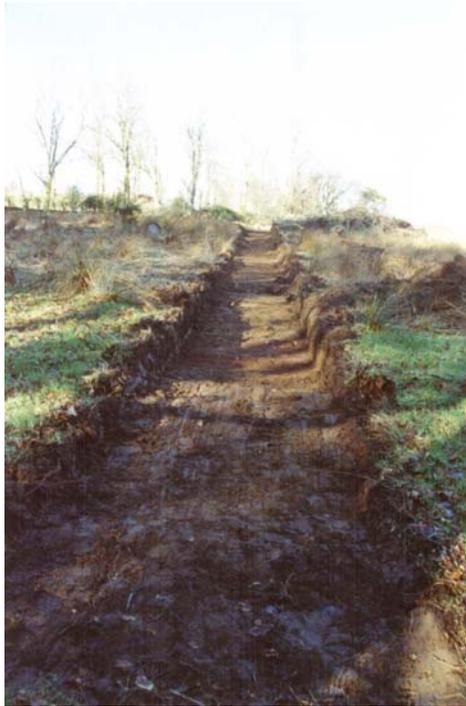
Figure 3a: Trench 4

Orientation: South southwest to North northeast
Size: 21.5m by 2m (43m²).
Topsoil depth: 150mm to 210mm.
Hillwash depth 100mm to 230mm
Subsoil character: Subsoil [006], compact red orange sandy gravel with frequent small stone inclusions becoming more stony after +13.2m
Modern features: None.
Significant features: None.
Artefacts: None.

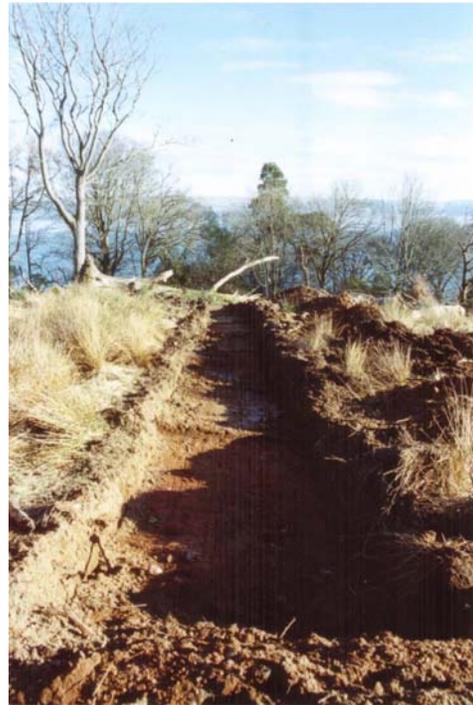
Figure 3b Trench 7

Orientation: East northeast to West southwest

Size: 32m by 2m (64m²).

Topsoil depth: 50mm to 70mm.

Hillwash depth 60mm to 100mm

Subsoil character: Subsoil [010], red orange silty clay with occasional small stone inclusions and tree roots.
