**Plot 1, Golf Road, Millport
Archaeological Watching Brief**

Data Structure Report

issued 25th April 2007

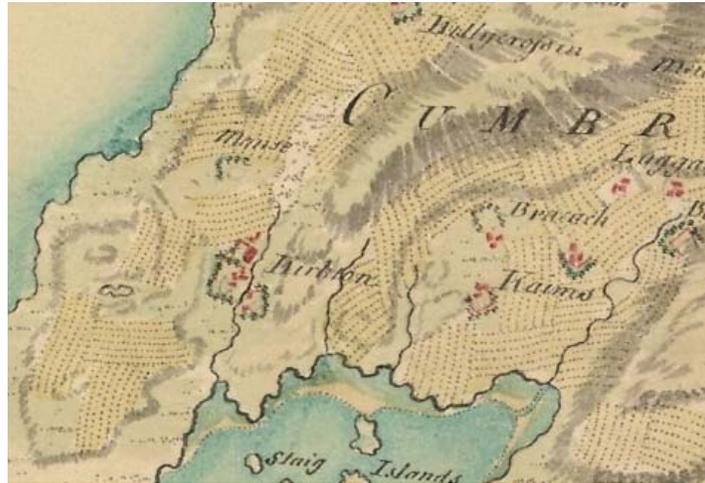
Figure 1: Roy's Military Map 1747-55

- 3.1.2 Roy's map of Millport (Figures 2a) shows the somewhat dispersed layout of farms and settlements spread throughout the island. It illustrates extensive areas under tillage, with vast areas which appear to be uncultivated. It can be seen that a moderately sized settlement of Kirkton has been depicted to the north of the area under investigation. This settlement/hamlet is comprised of nine buildings, including a large building that may be interpreted as the parish church. It can be seen that the land to the immediate south of this settlement is uncultivated and it is believed that this is the location of the development site.

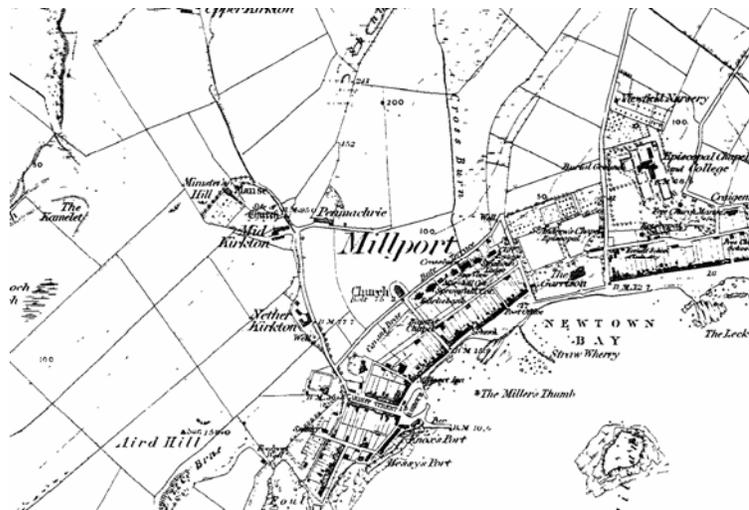
Figure 2: 1st Edition Ordnance Survey Map 1856

- 3.1.3 On the 1st edition Ordnance Survey (1856) it can be seen that the infrastructure on the island has developed considerably. The site is shown to be defined by a road to the south and west and a farm (Penmachrie) to the north (Figure 2b), indicating the land is used for agricultural purposes.

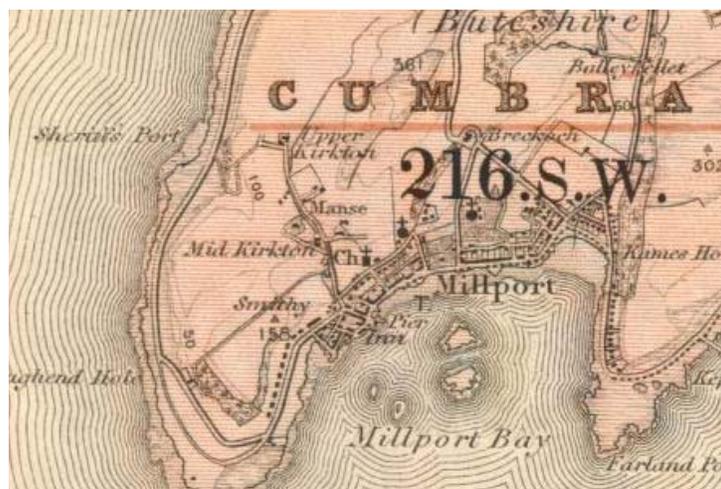
Figure 3: 2nd Edition Ordnance Survey 1899

- 3.1.4 By the second edition Ordnance Survey (1899) it we can see that the town of Millport has expanded within its coastal limits, extending into undeveloped areas. The land upon which the current development is taking place on can be seen to be continued in use for agricultural purposes, allowing us to establish that there are no 18th to 19th century remains on site. However from this alone we can not dismiss the potential for earlier archaeological deposits.

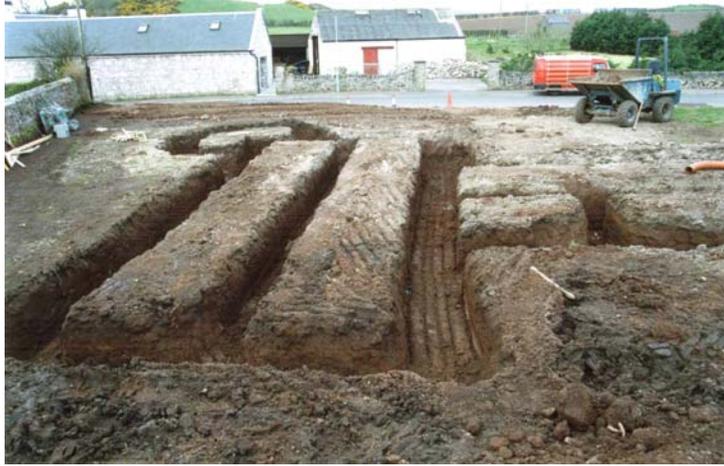
- 4.2 A common stratigraphy was evident across the site with up to 250mm of type 1 hardcore [101], which contained ceramic building material, over a brown silty clay [103] that was up to 100mm in depth, though in general was much less. This in turn overlay a brown red clay subsoil [102] which lay on a yellow brown clay subsoil. The exception to this was the area of the soakaway which had little or no [101] but instead had a 100mm of dark brown humic topsoil [104] over [102].

Figure 4a: Foundations

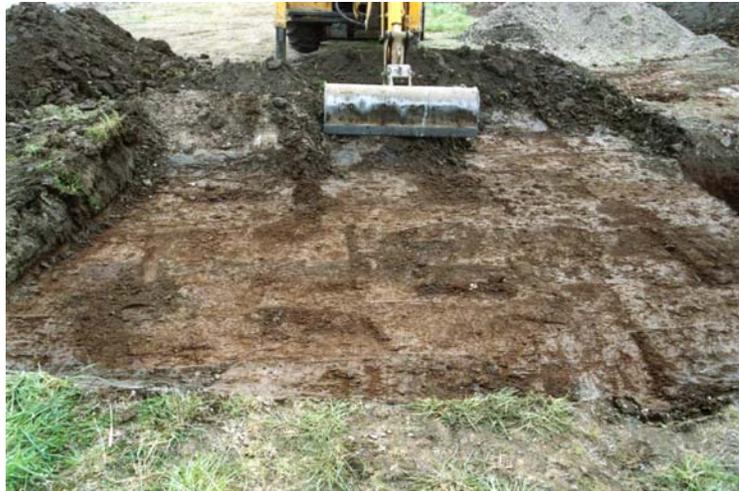
Figure 4b: Footprint for the Garage

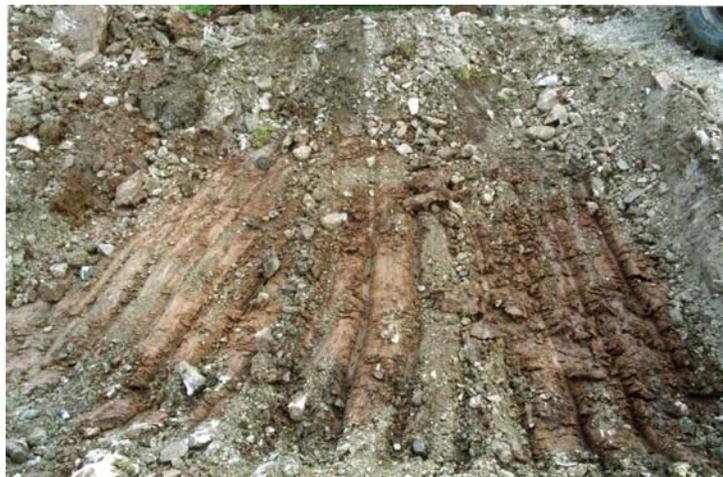
Figure 4c: Driveway
