**Lochnaw Cottage,
Dumfries and Galloway:
Archaeological Mitigation**

Data Structure Report

issued 13th June 2007

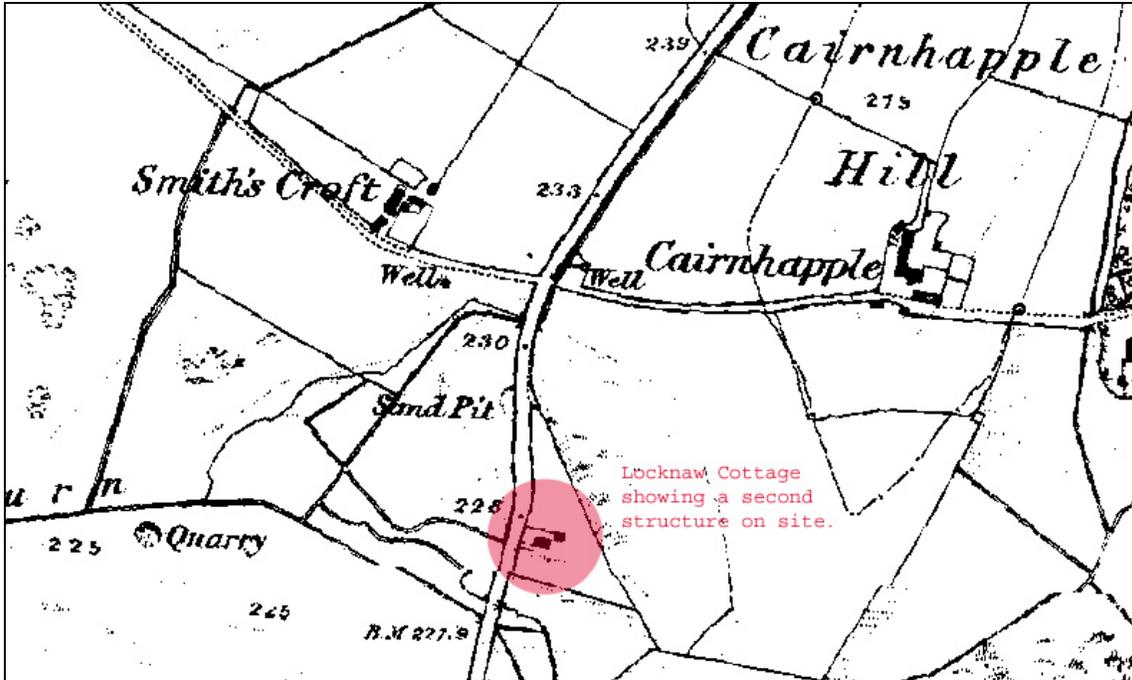
Figure 1a: First Edition Ordnance Survey, 1849, area around Lochnaw Cottage

- 3.3 The 1st edition Ordnance Survey (1849; Figure 1a) depicts two structures at the location of Lochnaw Cottage. The function of these structures cannot be determined and they are unnamed; they are presumed to be a small farmstead with the potential for both structures to be multi-functional including habitation. The smaller north-eastern structure appears to be that which is subject to investigation here. The larger south-western structure was presumably cleared during the building of the current, modern Lochnaw Cottage.

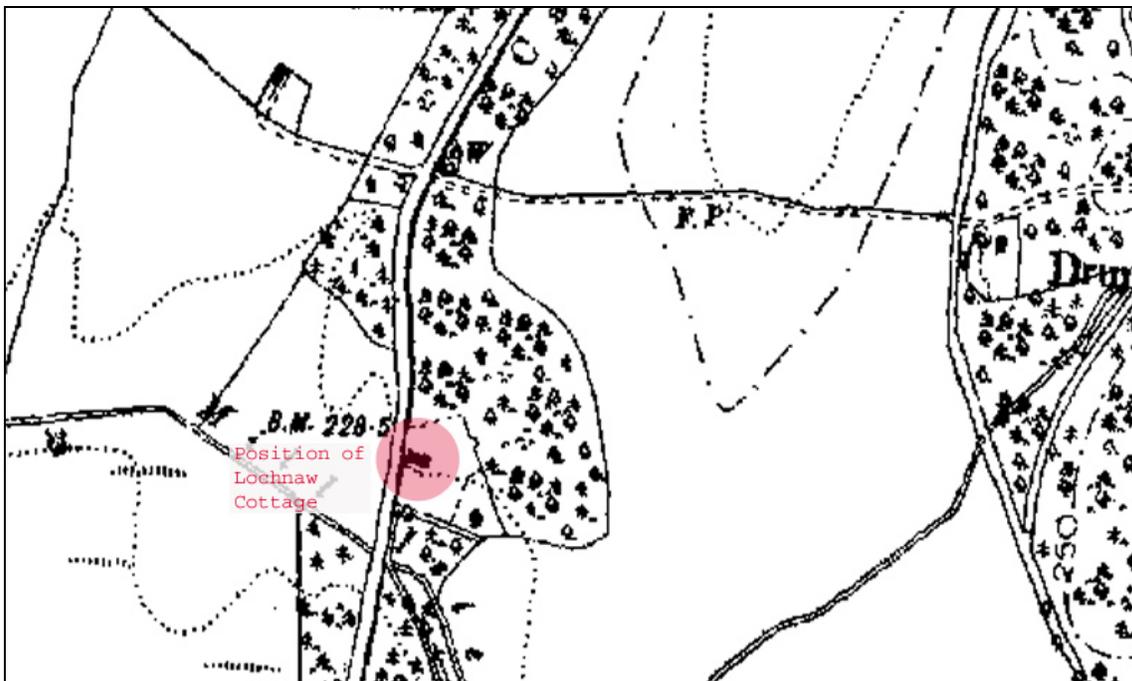
Figure 1b: Second Edition Ordnance Survey, 1909, area around Lochnaw Cottage

- 3.5 The 1909 Ordnance Survey map (Figure 1b) shows a significant contraction in the density of settlement within the immediate landscape. A large number of the surrounding farmsteads have been cleared and the quantity of woodland visible has increased. This change may well have reflected changes in the management and aspiration of the Lochnaw Estate. The site under investigation no longer appears to be depicted, while the south-western structure is still visible and may be slightly larger.

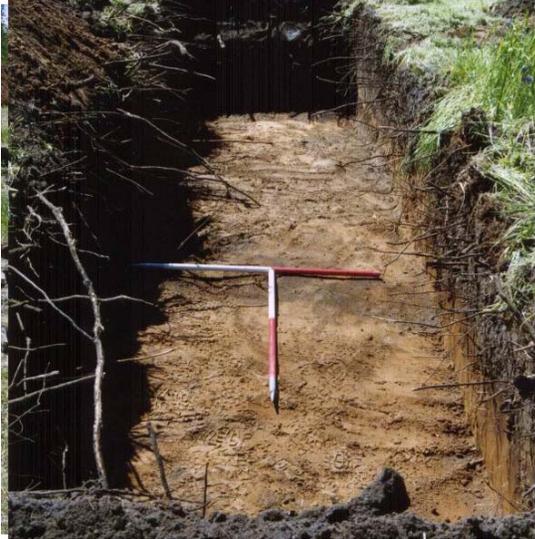
- 4.3 The northernmost trench (Tr 1) showed a little disturbance in the southern end, nearest the structure. This may have been due to the action of tree roots or the digging of animal burrows, with no clear determination possible (Figure 2a). The easternmost trench (Tr 2) showed a cut [121] in the western end running the full width of the trench, most likely related to the construction of the structure (Figure 2b). The fill of this cut appeared to be an ash rich mix of topsoil and subsoil, indicating the addition of other material, with the absence of tip-lines suggesting that deposits were built up quickly or by deliberate action.

Figure 2a: Trench 1

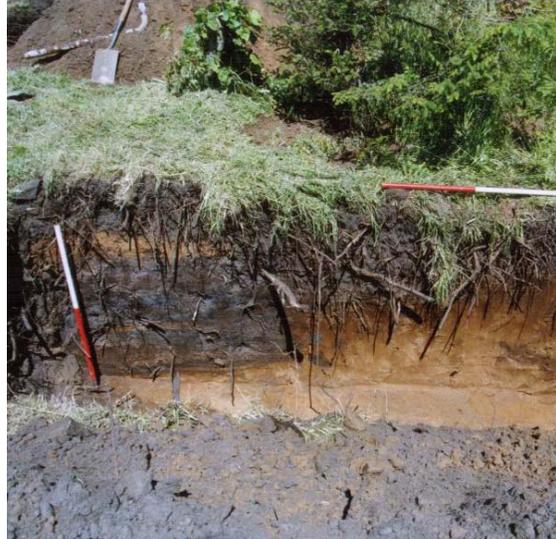
Figure 2b: Trench 2, showing [121]

- 6.2 It would appear that prior to the construction of the walled structures the cut shown in Trench 2 was made into an existing natural mound. Evidence suggests that this cut was partially backfilled with a mixture of natural sediments and other materials, before the construction of the retaining wall faces. The external wall face identified in Trench 3 suggests that the structure was not wholly sunken but did rise above ground level as a composite stone faced, earthen cored wall. There is no surviving evidence to locate the fourth western wall; hence the length of the structure cannot be determined nor the entrance located.

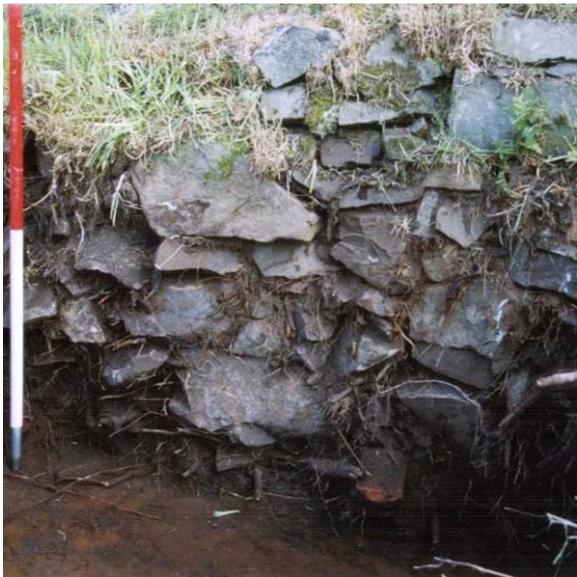
Figure 2c: Trench 3, wall north end [122]

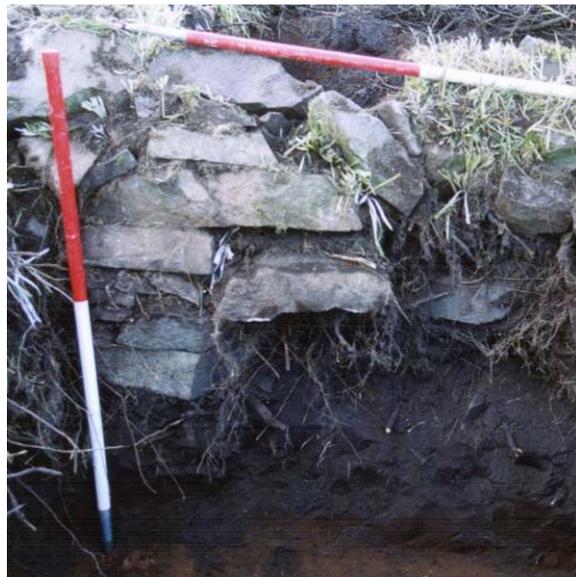
Figure 2d: Trench 3, freestanding wall [120]

- 4.4 Trench 3 (Tr 3) lay to the south of the structure and contained a wall separate from the known upstanding remains (Figure 2d). This wall [120] was about 3m from the known structure and appeared to have been founded at a much shallower depth; with only three courses of stone evident below current ground level. Both sides of this wall were exposed and it appears to have been a freestanding structure. This trench also uncovered a wall face [122] at its northern end (Figure 2c), lying half-way between [120] and the known structure, and composed in a similar fashion to the walls delineating the known structure.
- 4.5 No other features were uncovered during the excavation of the trenches and only modern material (ie post 1850) was noted during the works. These comprised modern glazed white earthenware and modern glass.

- 6.4 The freestanding drystone wall identified in Trench 3 is not of common character with the structure. It is likely that this wall is part of an enclosure wall which may be contemporaneous with the structure investigated. The 1st edition Ordnance Survey (Figure 1a) shows that the two structures are enclosed, so this wall may be an element of these associated yards. It is equally possible that this wall is a later enclosure formed of material from the collapsed structure.

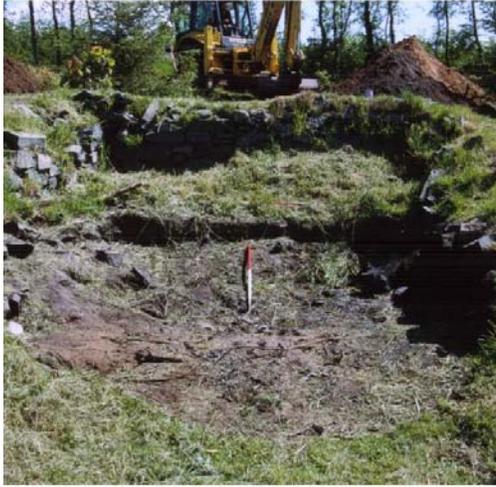
- 3.7 The three walls (there was no wall to the west) defined an area measuring approximately 4m by 4m in extent (Figure 3a). Collapse and possible stone-robbing had allowed the turf to partially overgrow the walling on all sides. The eastern half of the interior had a slightly raised surface, while the western half had been dug away in modern times to below the level of the natural subsoil. Presumably at the same time the western portion of the structure had been removed, with a level lawn formed to the west at a level lower than the structure. Superficial examination suggested that the interior had been used as a fire pit to dispose of rubbish. The fire and perhaps earth dumped from the digging had made the grass in the interior patchy.

- 5.1 The known upstanding remains were recessed into what appears upon inspection of the deposits to be a natural mound (Figure 3a). Prior to excavation the walls were partially overgrown, and the interior surface of the structure entirely obscured by vegetation growth. The western half of the interior had also been excavated down to beneath the level of the natural subsoil [104]. Our first action was to formalise the existing section running north/south (west facing) across the interior.

Figure 3a: Interior, Pre-Excavation

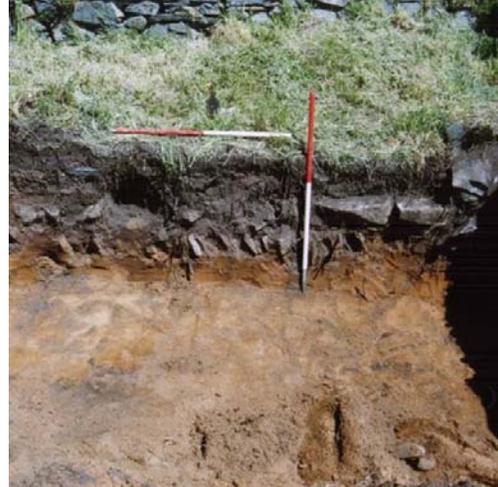
- 5.2 Examination of the west-facing section showed a layering of three deposits within the interior (Figure 4b). Between the topsoil [101] and the natural subsoil [104] a mid-brown layer of silty sand [119] contained several large stones. Those stones at the southernmost end of the section were larger than the rest and appeared to have been laid to give a flat upper surface. With the aim of interpreting these we opened a 2m wide trench running east/west through the surviving deposits of the interior.

Figure 3b: W-facing section through interior

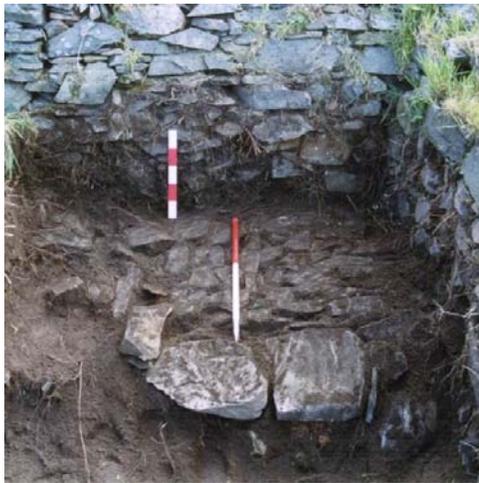
- 5.3 Upon removal of the topsoil this trench (Tr 4) revealed a rough stone surface [115] extending throughout the entire area. This was the surface represented by the large stones noted in the west-facing section (Figure 3c). It was unclear whether or not part of this surface had been removed by modern disturbance or if the stones noted in the section were flagstones marking an edge. However it was clear that this surface was a part of the original structure, though it was constructed after the walls were built.

Figure 3c: Interior floor surface [115]

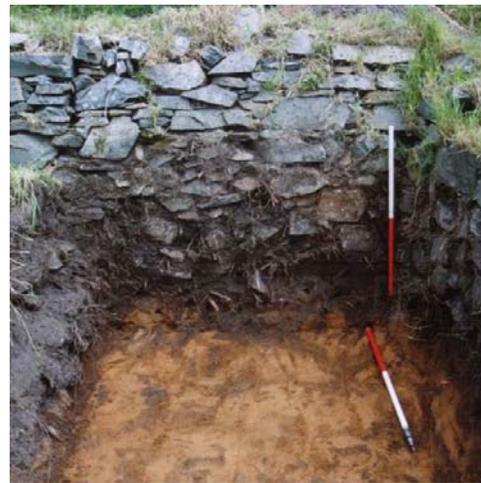
- 5.4 After taking Trench 4 down to the level of the natural subsoil we were able to more clearly determine the composition of the surviving walls [116]. At the eastern edge of the trench, or the back of the structure, the walls survived to a height of about five courses (Figure 3d). They were of dry stone construction and appeared to have been deliberately placed as retaining walls, the structure having been cut into the existing natural mound. When we extended Trench 4 to examine a section through the walls we were able to determine that they were only one layer of stones thick (Figure 3e). Some effort had been made in the interior to create a flat face. This differed from the other walls recorded on site.

Figure 3d: Interior to natural subsoil

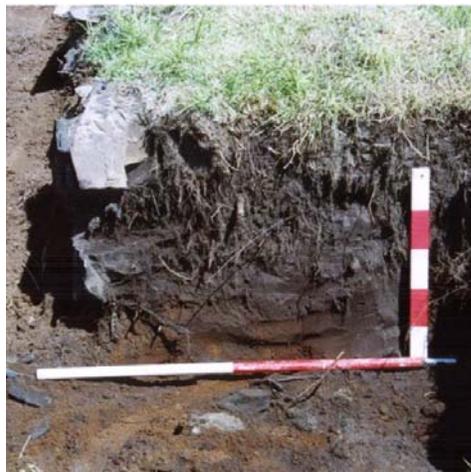
Figure 3e: W-facing section through southern wall [112]

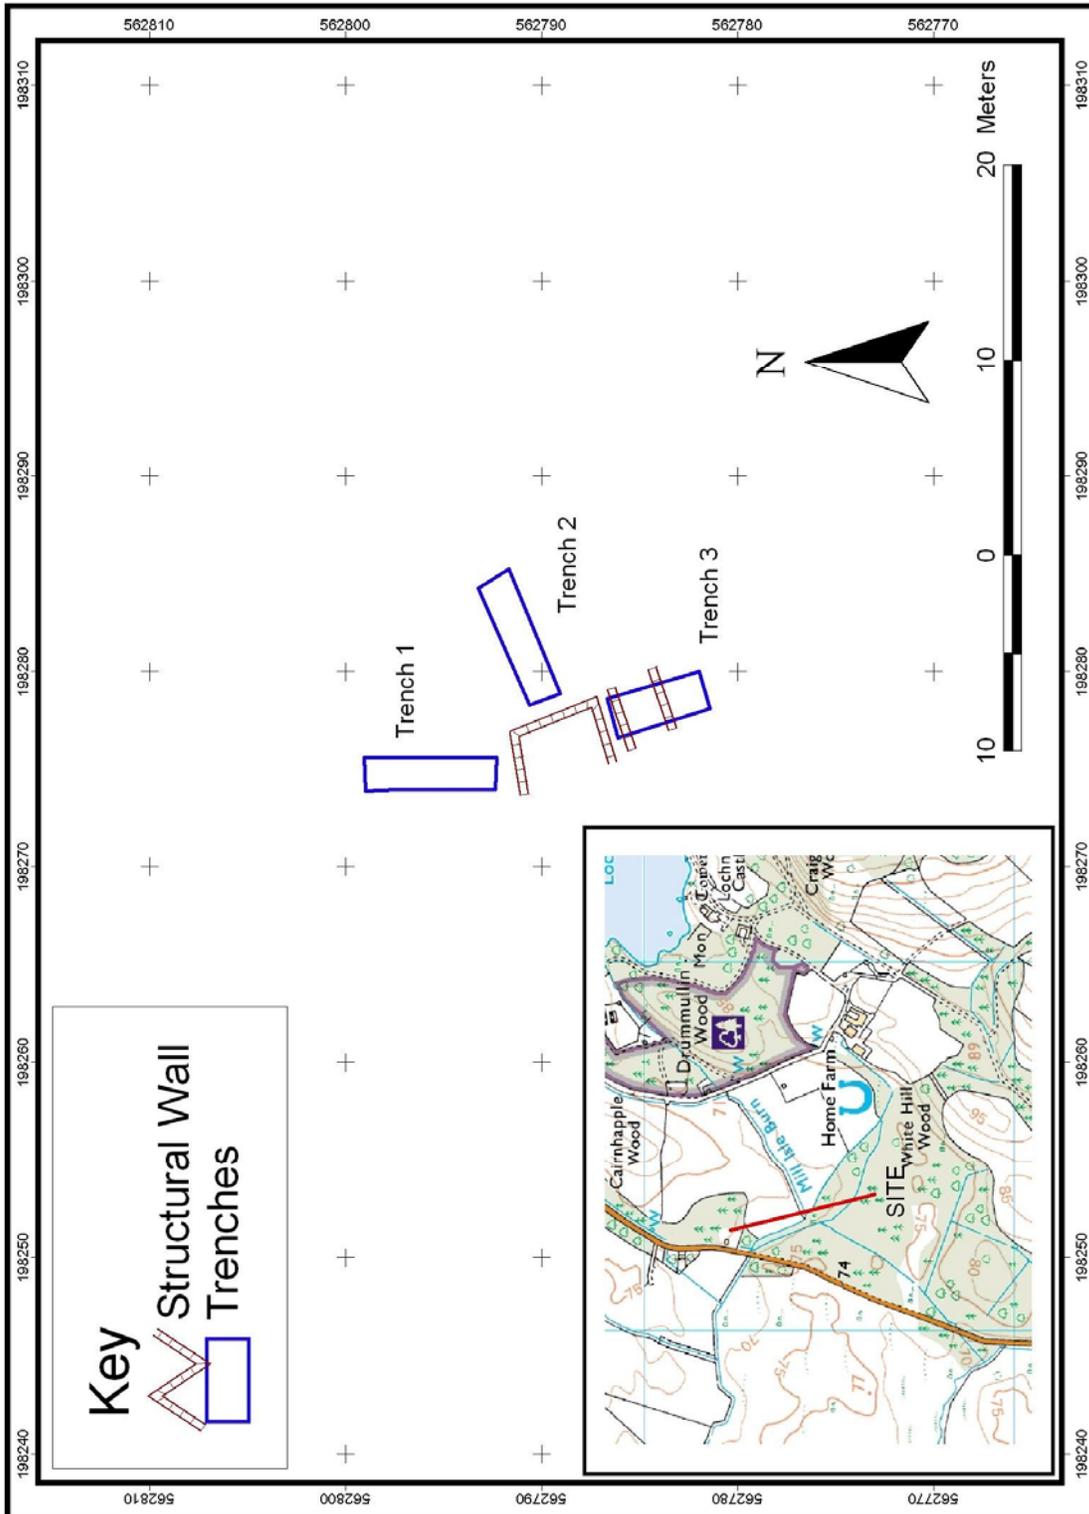
- 4.1 All three radial trenches (Figure 4) exhibited a fairly common stratigraphic sequence with dark grey/brown silty sand topsoil [101] reaching a depth of between 200mm and 700mm. The natural subsoil [104] consisted of orange/brown compact sand. All trenches were reduced to the level of the natural subsoil.

Figure 4: Site plan and location
