**Cardingmill Cottage, Oban:
Archaeological Watching Brief**

Data Structure Report

by Alan Matthews

issued 18th July 2007

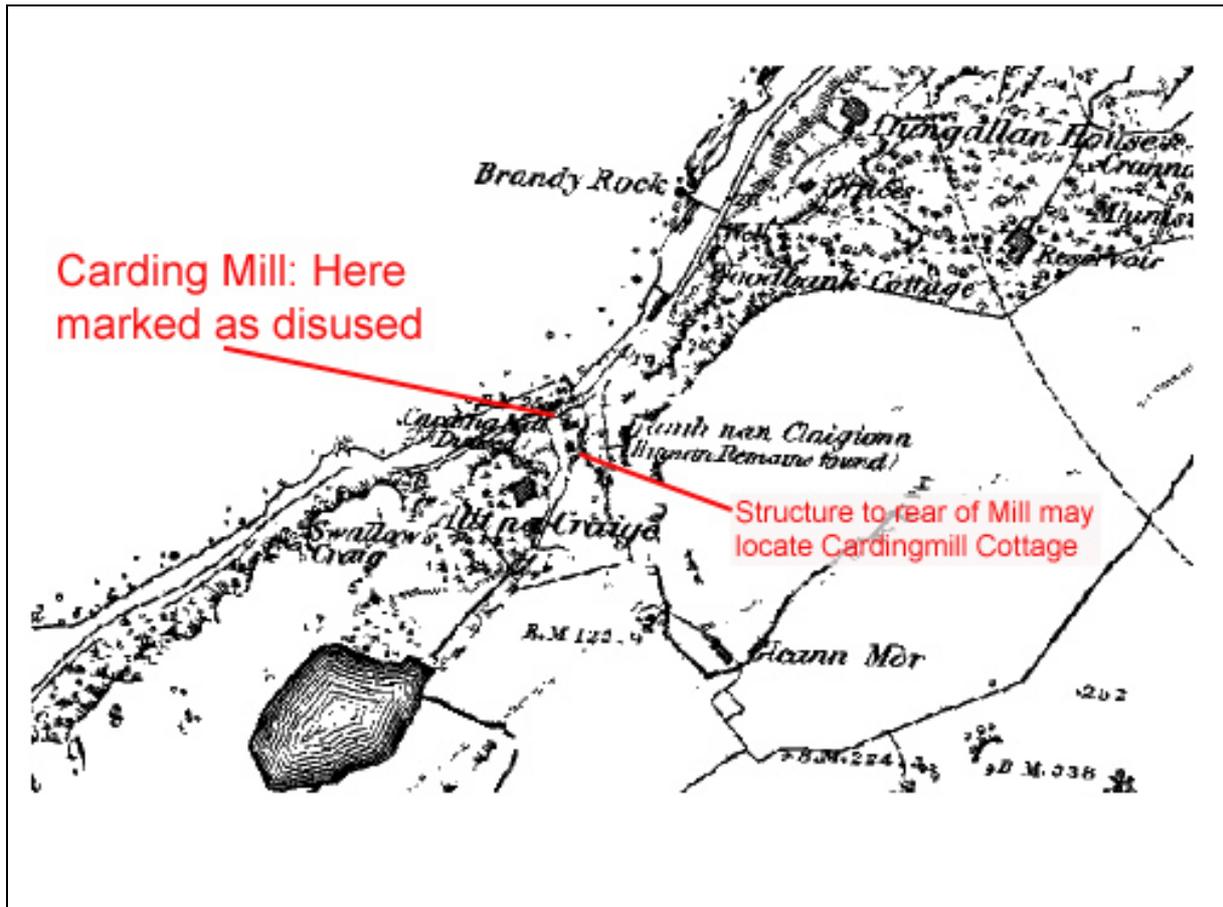
Figure 1a: 1st Edition Ordnance Survey showing Mill and Cottage

- 3.3 There was therefore, due to the amount of archaeology around the development, a hazard of significant archaeological features being present. The concern regarding archaeology, while predominantly focussing on early prehistory, was not solely orientated to this period. The 1st Edition Ordnance Survey shows a disused Carding Mill in proximity to the development area and another upstanding structure in the approximate position of the development site, to the south (Figure 1a).

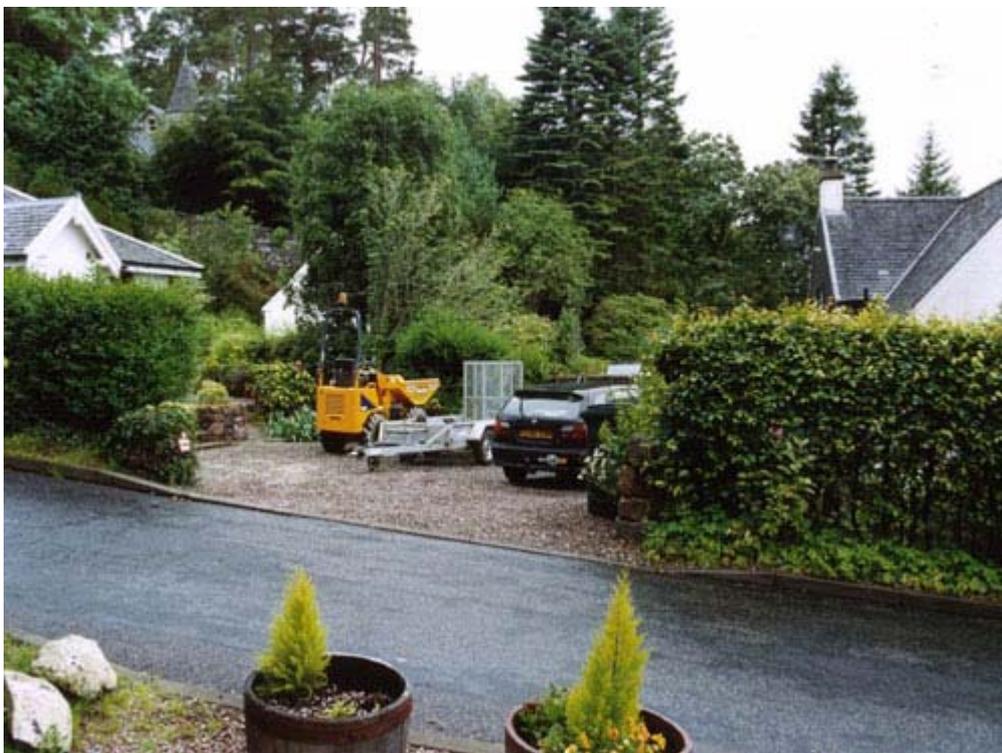
Figure 1b: Showing Cottage on left and Mill building on right

- 3.4 Consultation with local sources indicated that the building (now a house) immediately to the north of Cardingmill Cottage was the Carding Mill building and that the cottage itself was the Mill manager's cottage (Figure 1b). This seemed to confirm the supposition that the structures shown on the 1st Edition Ordnance Survey matched the location of the development area. It is unclear how the industrial development on the site had affected the development area. It is possible that later industrial development has removed any trace of prehistoric archaeology.

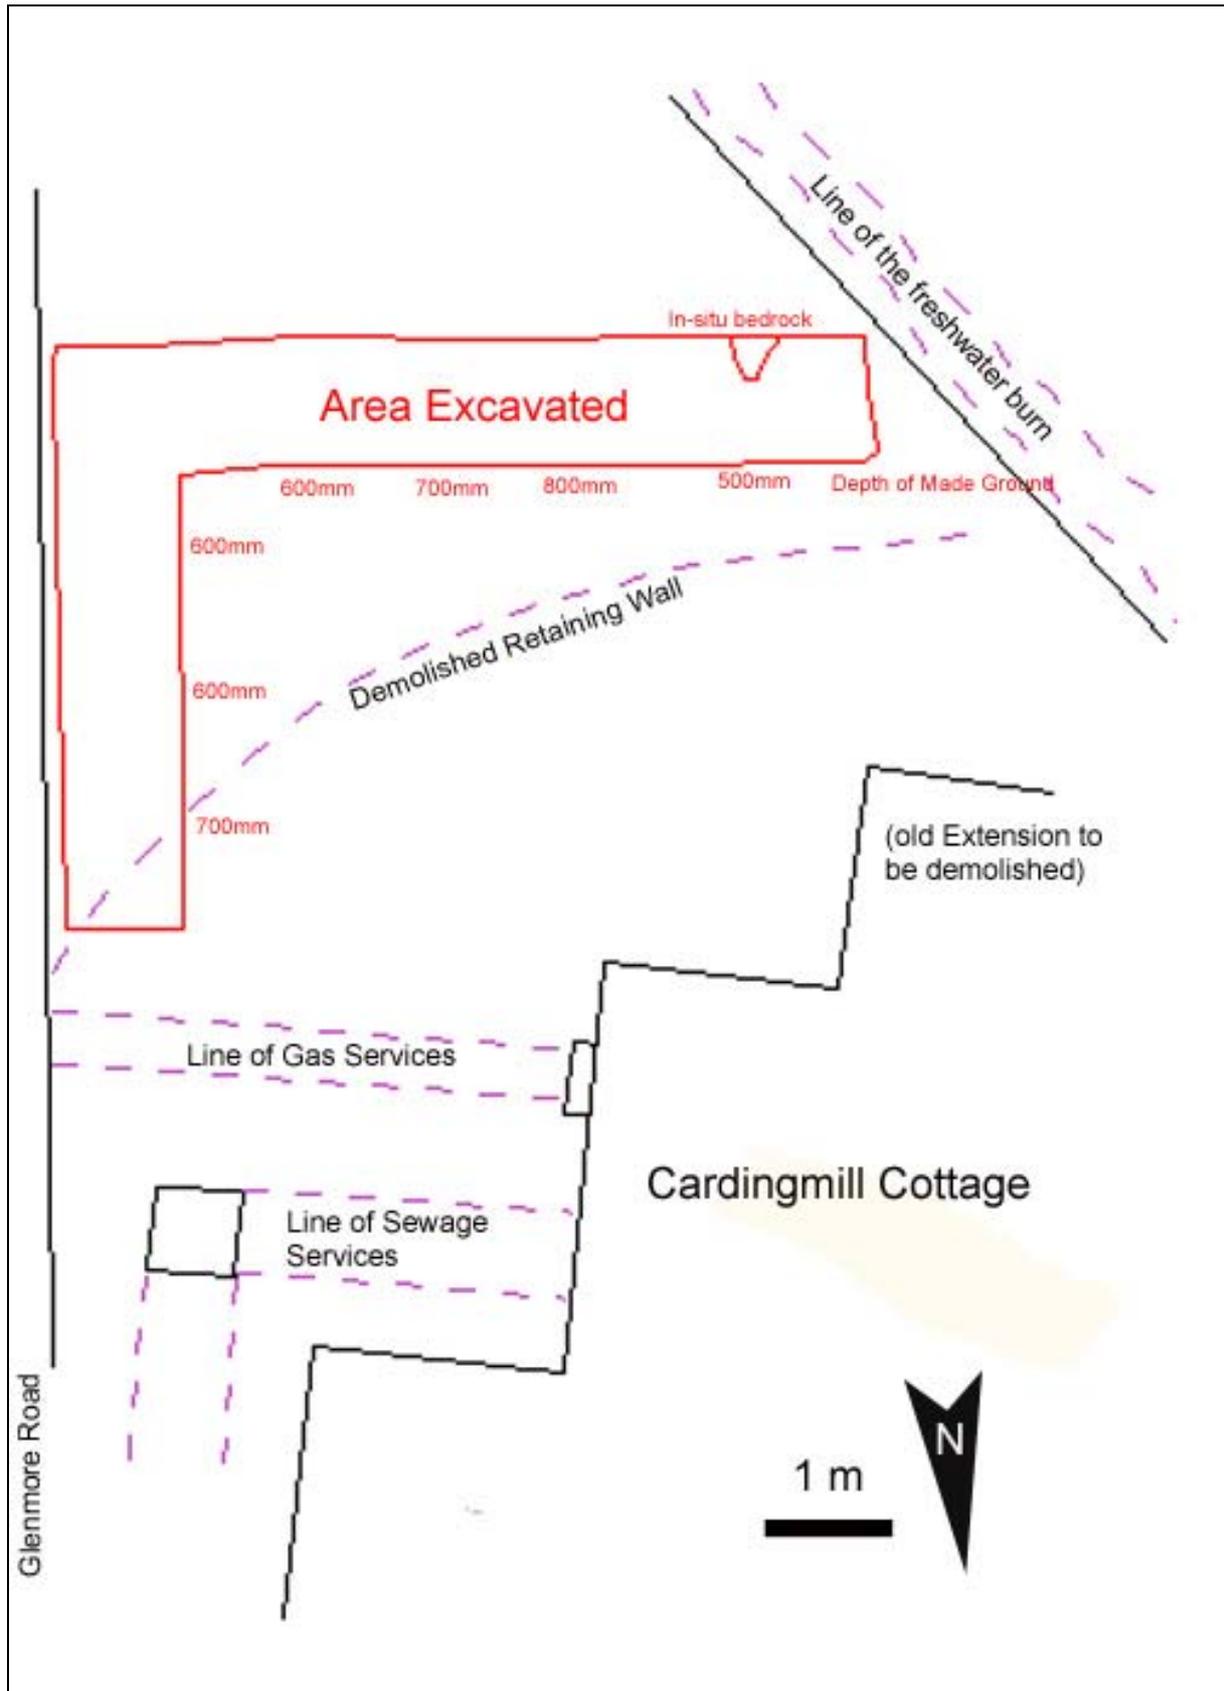
Figure 2: Site plan with trench positions

- 2.2 A single L-shaped trench was opened which enclosed the southern and eastern perimeter of the development area (Figure 2). The inner edge of this corresponded to the position of the foundation trenches for the extension to the Cottage while the outer edge marked, approximately, the intended position for the new garden retaining wall. Examining the base and sections of this trench provided profiles running both north/south and east/west across the development area.

- 4.2 No features were uncovered during this excavation. The nature of the subsoil was uniform throughout the uncovered area with only made ground above. Excavation closer to the existing Cottage would, on the west, have come close to the foundation excavations for the existing extension and on the east impacted on service trenches for gas and sewage (Figure 2).

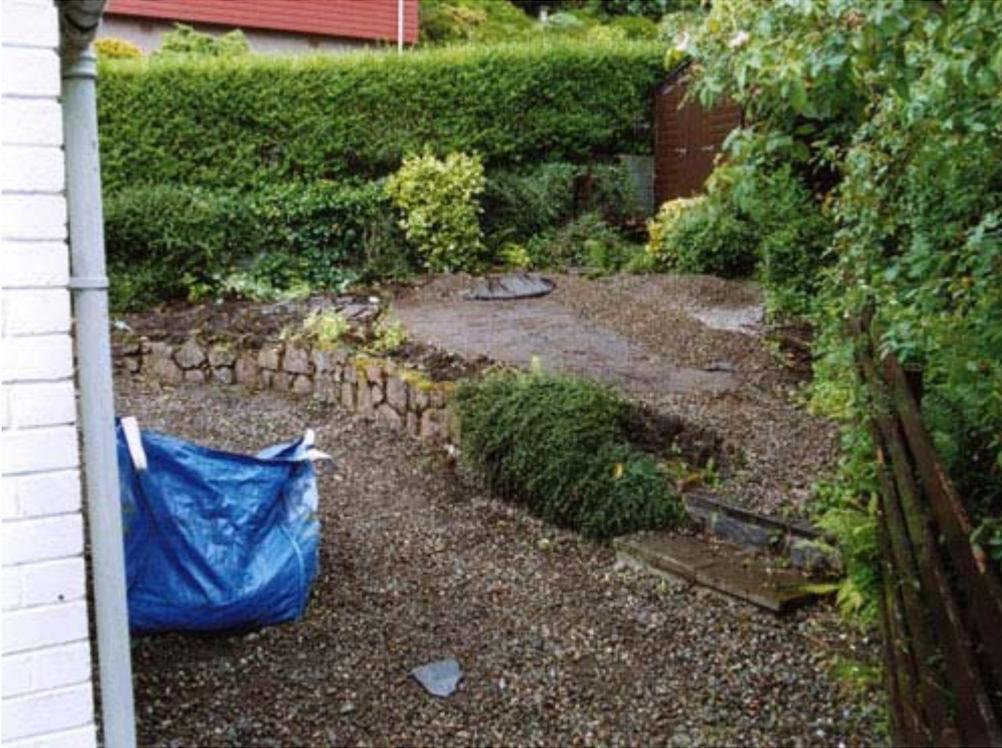
Figure 3a: Pre-Excavation shot of site

- 5.2 The landscaped surface deposit was composed entirely of made ground. The artefacts recovered within this were of 20th century date, suggesting that the current state of the ground resulted from the construction of the garden (Figure 3a). It was clear from examination of this sediment that the entire depth of the development area had been excavated in recent times (Figure 4a and b).

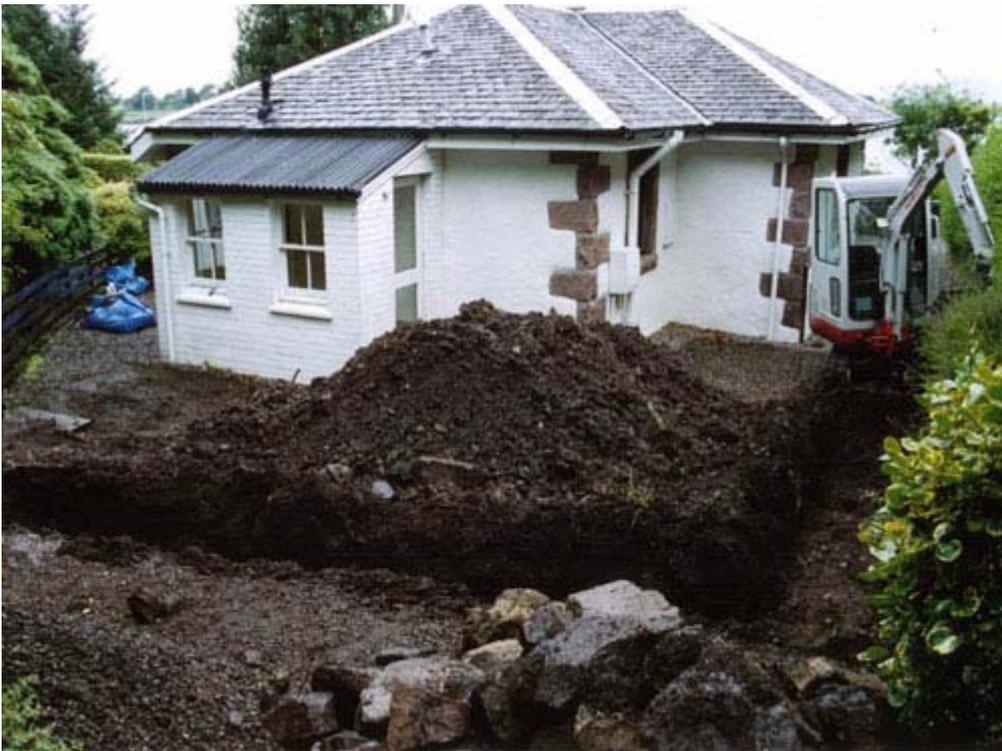
Figure 3b: Post-Excavation shot of site

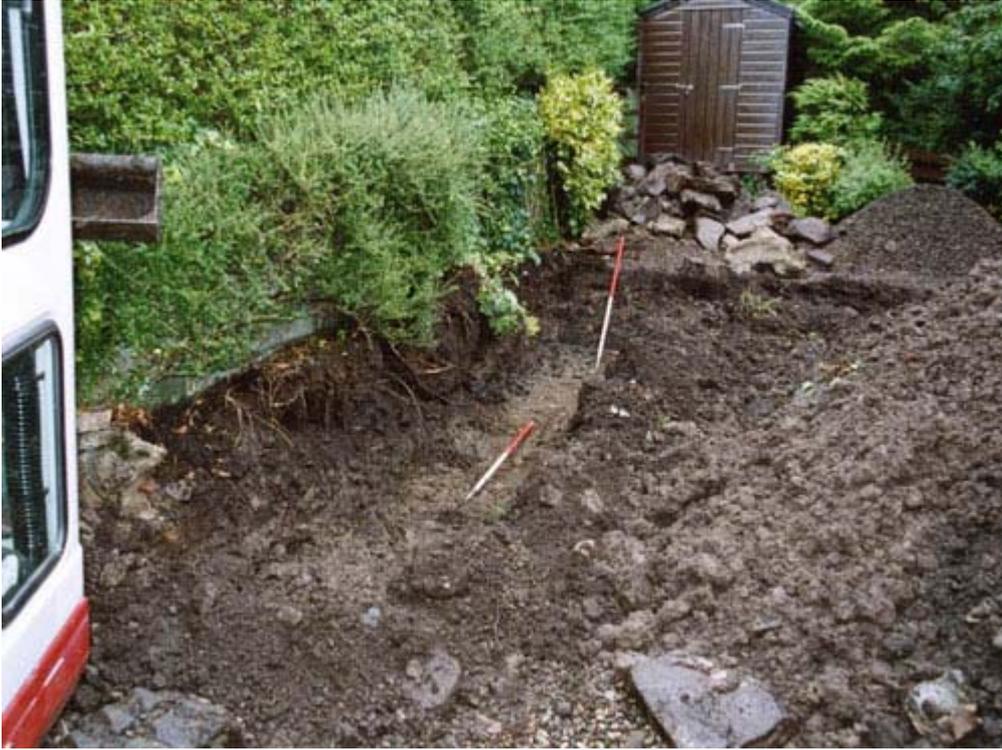
Figure 4a: Trench running north/south

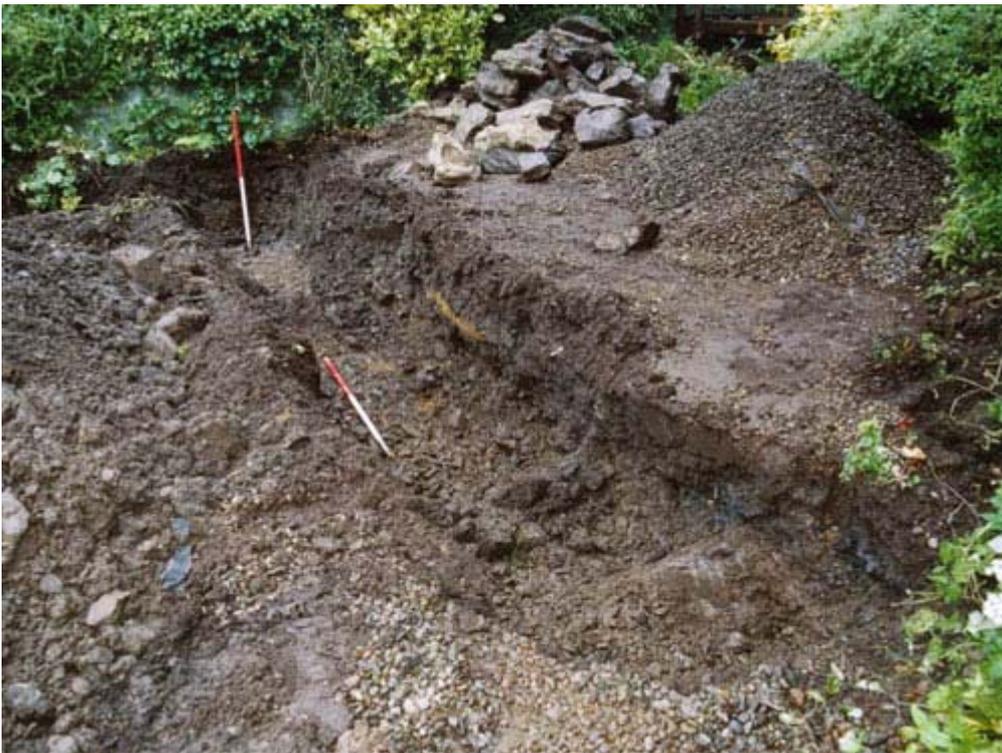
Figure 4b: Trench running east/west
