**Castlehill House, Ayr:
Archaeological Evaluation**

Data Structure Report

by Katie Sludden & Claire Williamson

issued 31st March 2008

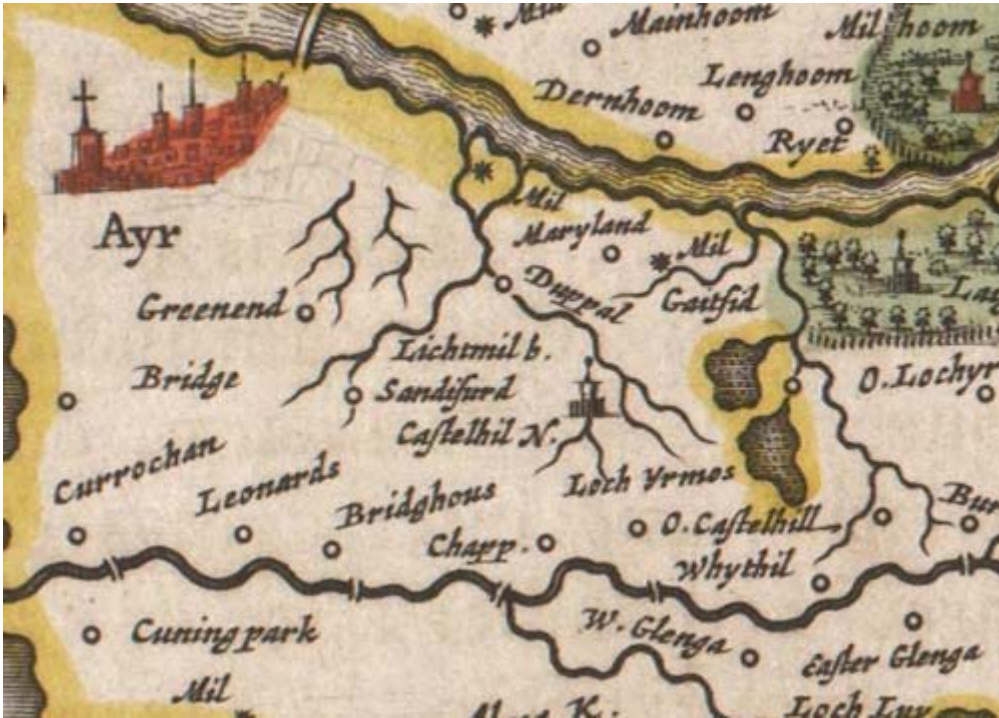
Fig. 1.1: Bleau's Map showing the tower at Castlehill (Bleau's Map, 1654).

- 2.2.1 The earliest cartographic evidence of occupation on Castlehill is the map evidence from Bleau's Map of 1654 which names and depicts a significant house at this location. By 1656 the Castlehill estate is held by Agnes Lockhart, relict of William Kelso, and was acquired in 1676 by the Fergussons. From 1776 to 1779 the owner was Robert Fergusson who suffered severely because of the collapse of the Ayr Bank, disposing of the estate to cover his liabilities. Until 1791 the estate may have been tenanted by David Fergusson. However, before the end of the century the estate was disposed of to Patrick Ballantine.

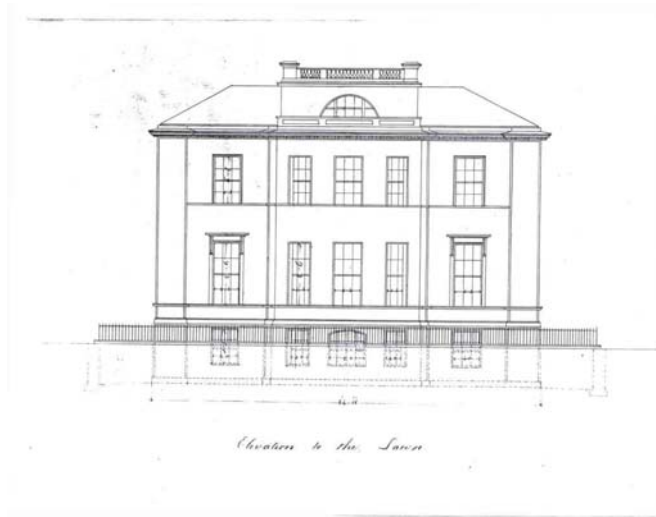
Fig. 2.1: Front Elevation of Hamilton's Castlehill House

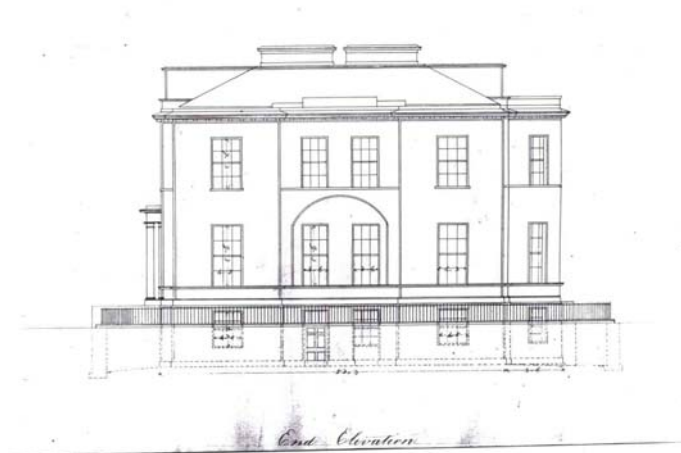
Fig. 2.3: Side Elevation of Hamilton's Castlehill House

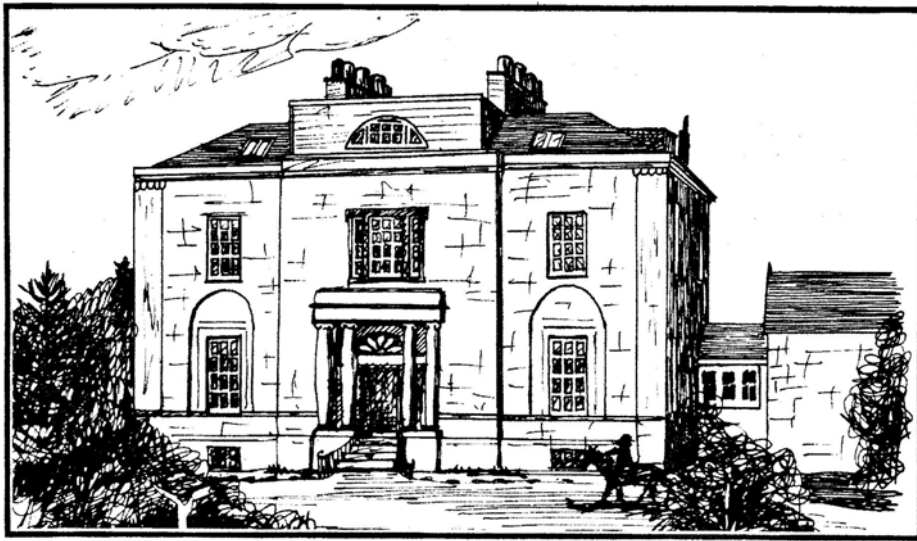
Figure 3.1 Castlehill House also showing subterranean levels, after Dane Love's Pictorial history of Ayr, 1995.

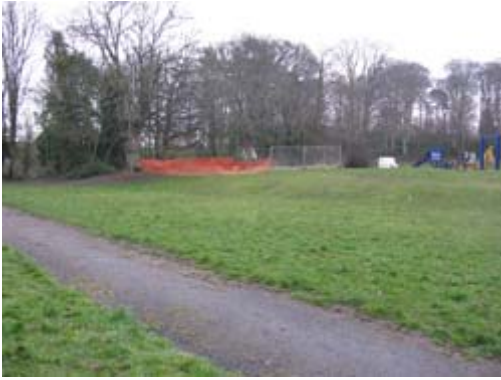
Fig. 5.1: Pre-Excavation Shot

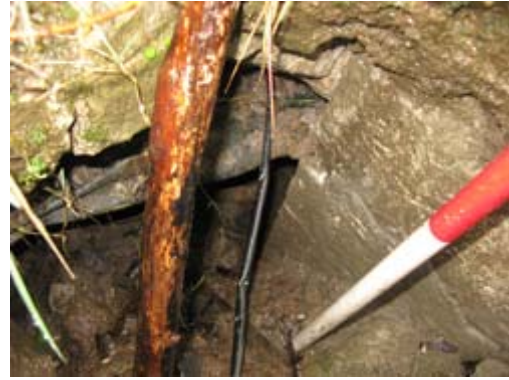
4.3.3 The nature of the exposed vault presents an obvious danger to other site users especially with its' proximity to a children's play area. One of the aims of this exercise was to assess any further danger to the public and since the discovery of the Northwest vault has been

made, the danger can now be measured. It seems safe to assume that the internal subterranean structure would have been in-filled or levelled during the demolition of Castlehill House. The northeast corner room did not have a surviving barrel vault so does not pose a danger to other site users. The southeast range of the building sits under the present car park due to a continuous use of this ground over time with heavy vehicles it therefore poses minimal risk of collapse. The serious risk of hazard may then be restricted to that of the area around the second exposed vault in the northeast corner of the building.

Fig.5.2: Inside the Vault

- 5.2 In consideration of the potential risk to site users it seems appropriate that remediation takes place. There is not sufficient archaeological value to the vault to warrant its protection or preservation as the building has already been well documented with its extents now well established – rather we recommend that any remediation to make this structure safe should be monitored by an archaeologist.

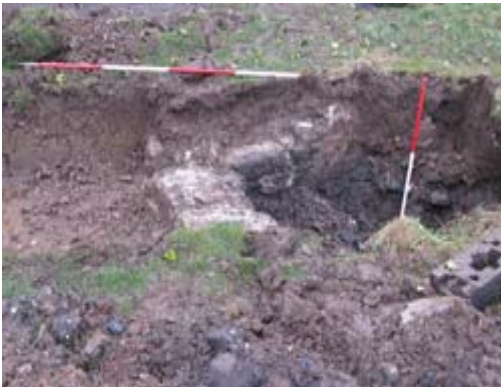
4.2.3 The waste deposit (004) in Trench 1 was taken down to a depth of 1.2m and was still remaining; suggesting that the vaults survive to their original height, possibly up to 2.5m in depth. The second trench contained a wall ([012] which is probably a continuation of [005] to the southeast and had a clean-cut face on its' southwest side suggesting that this was the front wall of Castlehill House. The third trench contained a wall of a possible further vault to the southeast also but it survives mainly as rubble and did not have the clear form that [005] and [012] had. The two vaults surrounding that of the exposed vaults contained rubble in-fill and had no surviving roof structure. It seems then that the risk posed may only stem from this singular cavity.

Fig. 5.3: General Shot of Trench 1

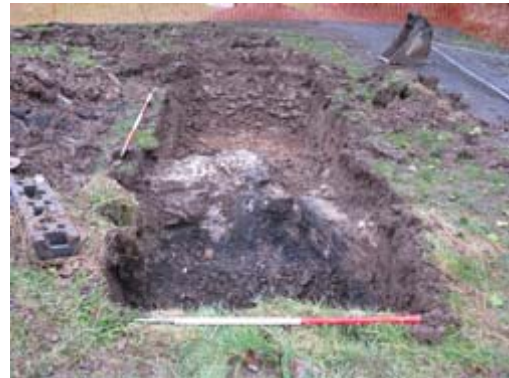
4.2.2 Three trenches were dug within 10m of the exposed vault (Figure 6.1-6.2). The first trench uncovered two walls ([005] and [017]) probably comprising the Northwest corner of the outer retaining wall of Castlehill House since the north side of the walls comprised of natural clay (003) at a depth of 400mm. The interior of the building extended significantly deeper than that of the natural subsoil on the exterior of the walls which is strong evidence that these walled structures are the vaults of the 1804 Castlehill House.

Fig. 5.4: Walls in Trench 1

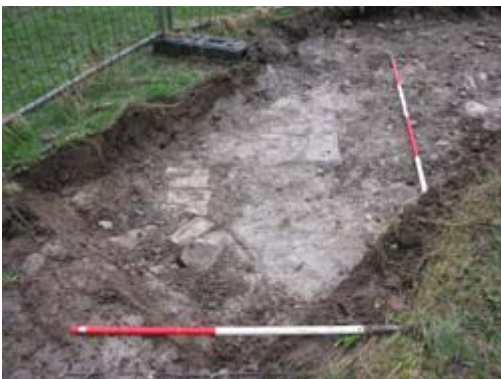
Fig. 5.5: Walls in Trench 2

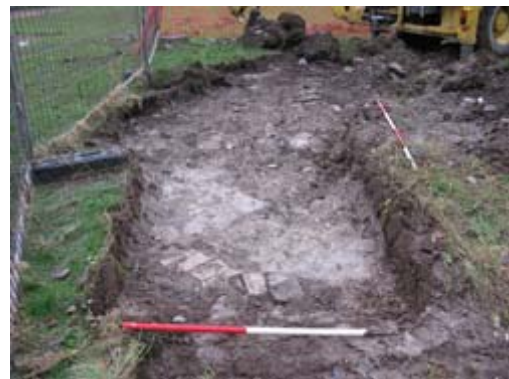
Fig. 5.6: General Shot of Trench 2

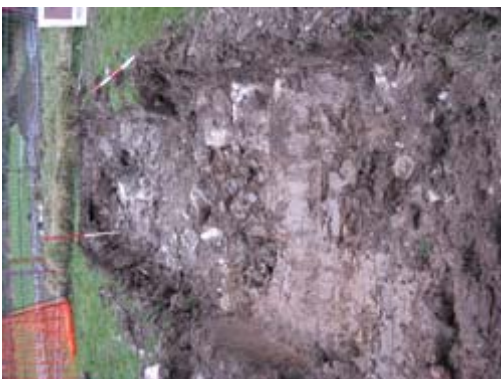
Fig. 5.7: General Shot of Trench 3

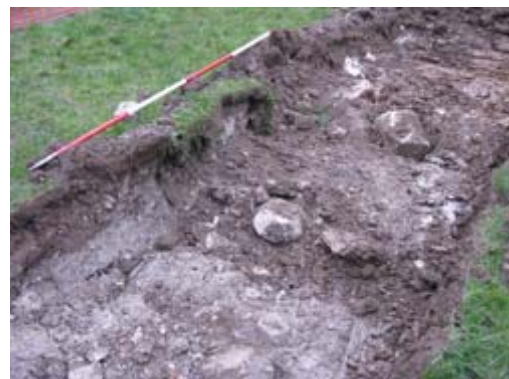
Fig.5.8: Close up of Rubble in Trench 3
