Southfield, Wigtown: Archaeological Evaluation

Data Structure Report

by Alan Matthews

issued 15th November 2007

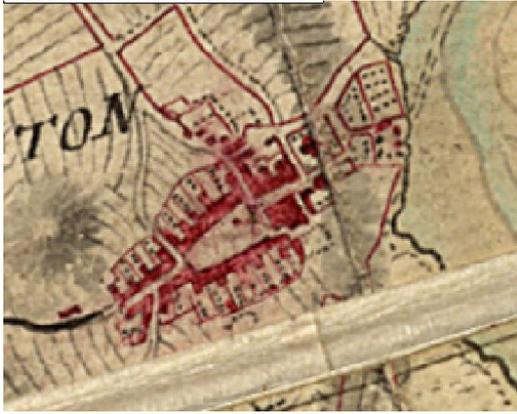
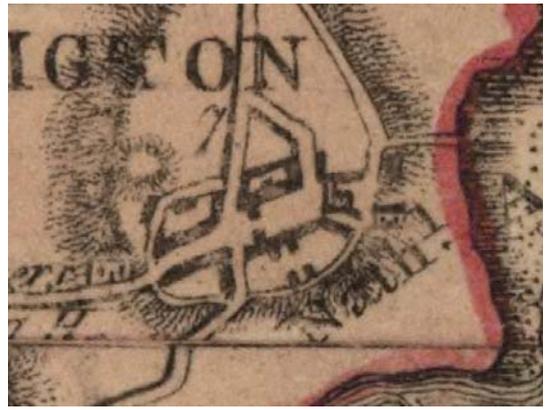
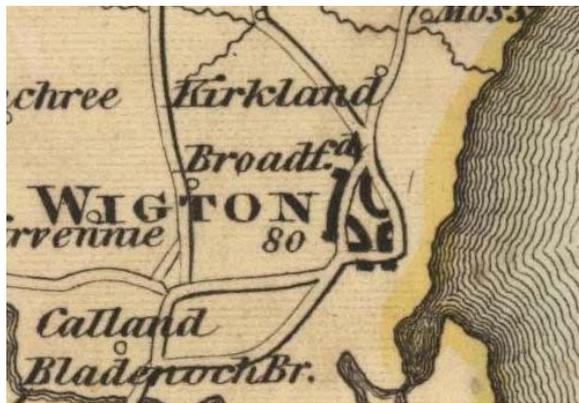
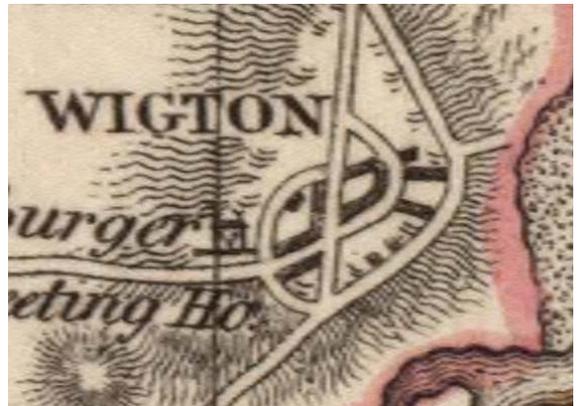
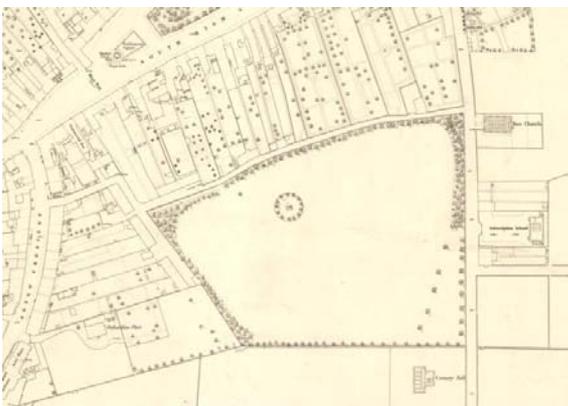
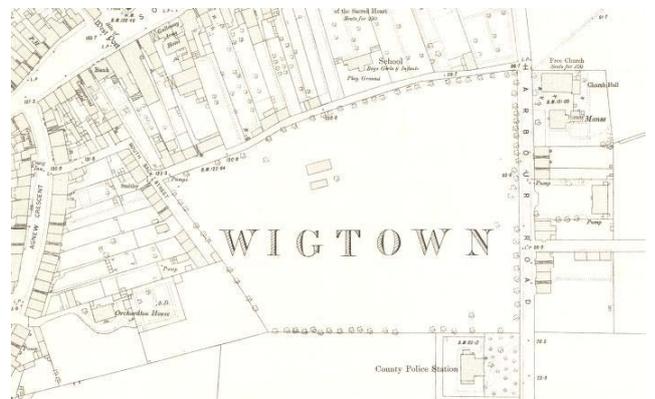
- 1.6.6 The available pre-Ordnance Survey mapping (1747-1826) does not provide any evidence for significant activity within the development area (Figure 1). The Ordnance Survey maps show a consistent use of the ground as a park or open space. A structure is shown on the second edition Ordnance Survey of 1895 and this structure is likely to have been in use as part of Southfield’s use as a showground during the 20th century.

Figure 1a: Roy 1747-55

Figure 1b: Ainslie 1782

Figure 1c: Ainslie 1821

Figure 1d: Thomson 1826

Figure 1e: 1st ed. Ordnance Survey 1850

Figure 1f: 2nd ed. Ordnance Survey 1895

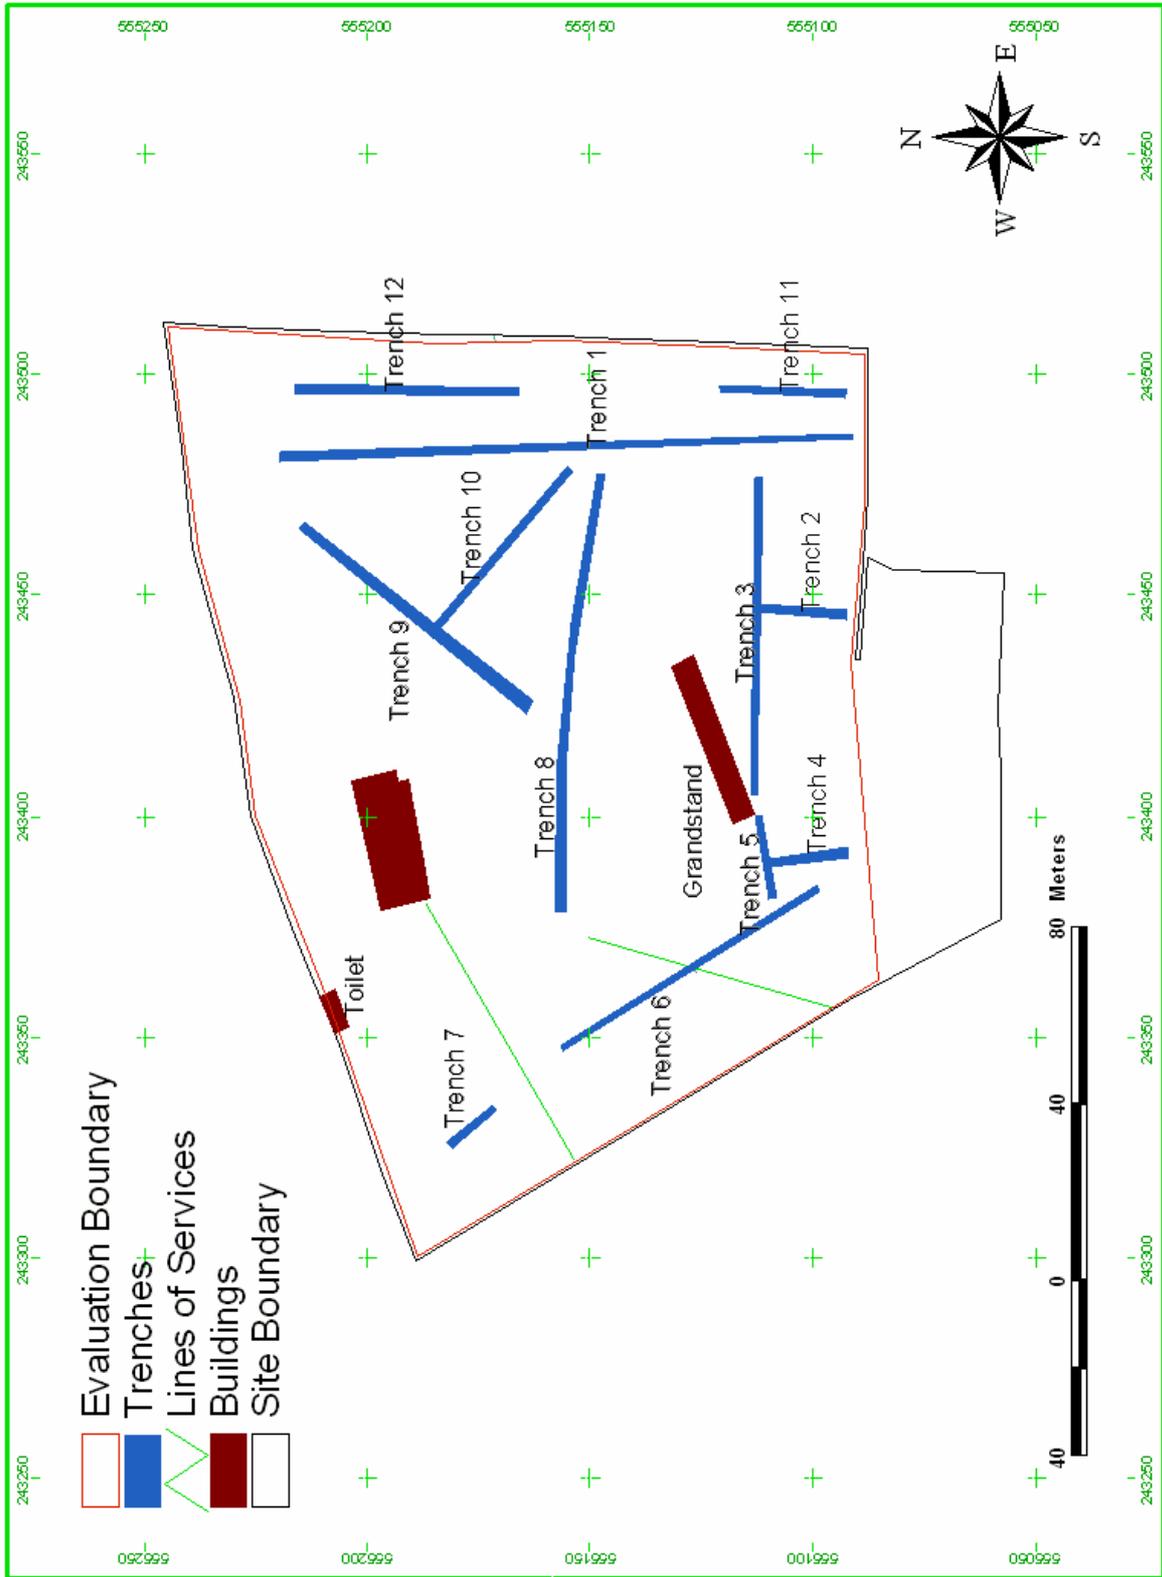
Figure 2: Site Plan

All measurement distances quoted along the trench measure based on the quoted orientation of the trench. See Figure 2 for trench locations.

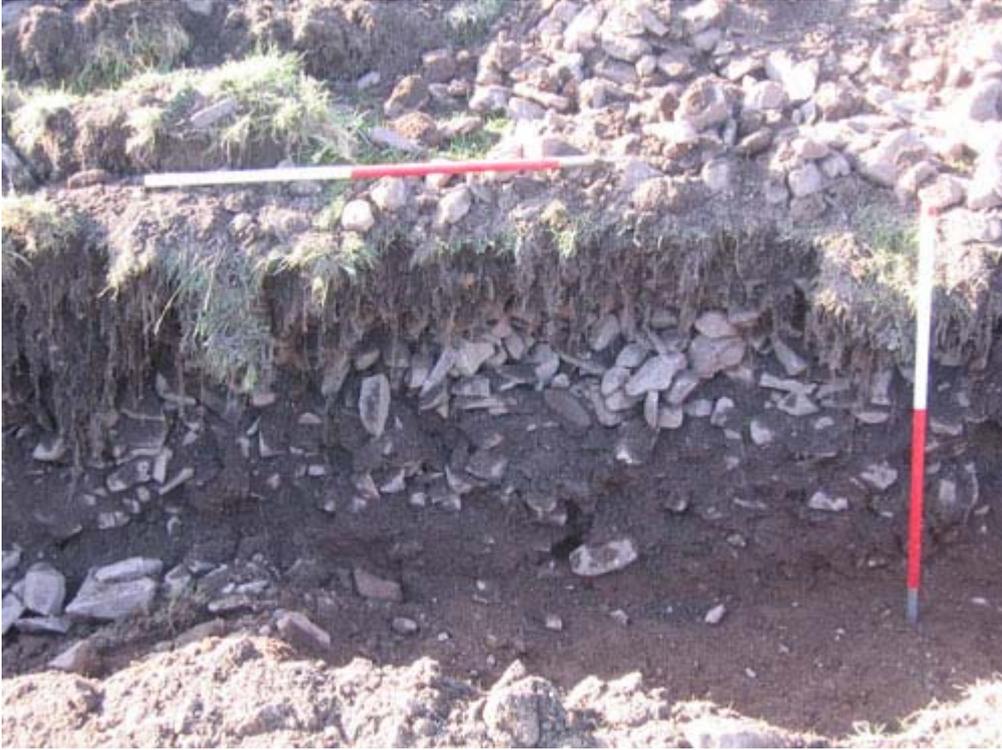
- 3.2 The southern half of Trench 1 had deposits of over 1m deep before natural subsoil or bedrock was reached. The accumulation of deposits in this area did not appear to be connected with the construction or demolition of any structure and no anthropic material was recovered. Visible in the section was a large concentration of small to mid sized sub-rounded stones. There was no evidence that these had been used as a structural element; no mortar was present and all were too small and irregular for dry-stoning (Figure 3a). The deposits here support the idea that the site has been progressively cleared and levelled.

Figure 3a: Accumulation of stones at southern end of Trench 1

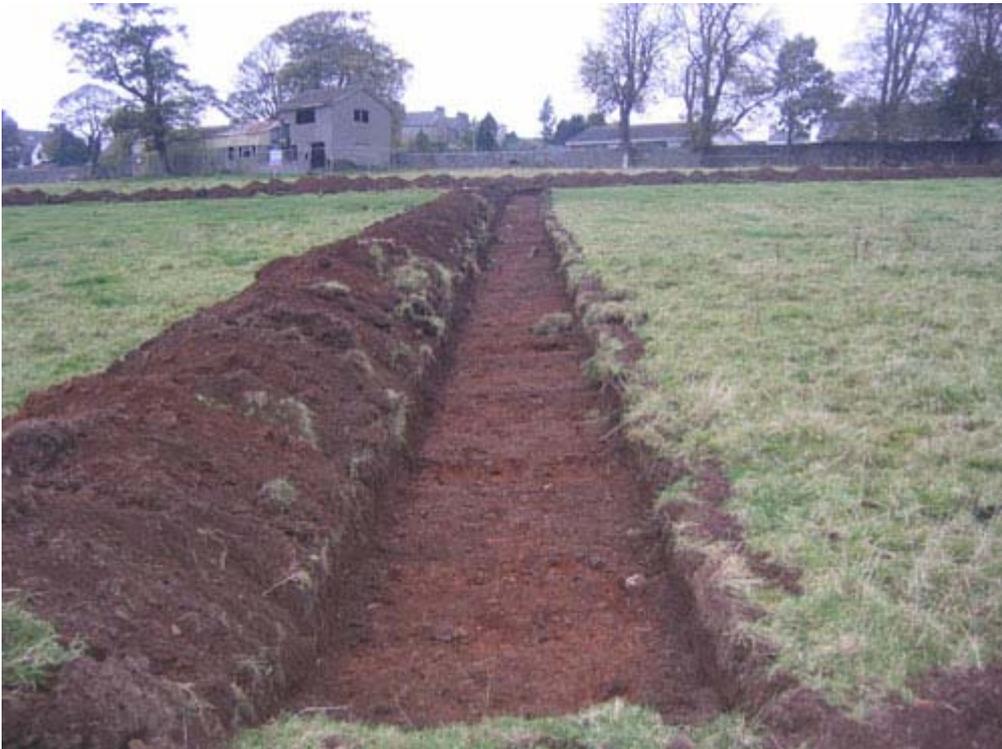
- 3.3 The northern half of Trench 1 (Figure 4b) was extremely shallow, reaching subsoil after as little as 200mm. Other trenches cut in this area; Trenches 8, 9, 10 and 12, had similar shallow sediment which dropped quickly down onto natural subsoils or bedrock (Figure 3b). No features were observed in these Trenches and no anthropic material was recovered. The subsoil was well drained silt and sand. The shallow nature of the soils here supports the idea that this entire site has been artificially levelled in its role as a showground.

Figure 3b: Trench 10

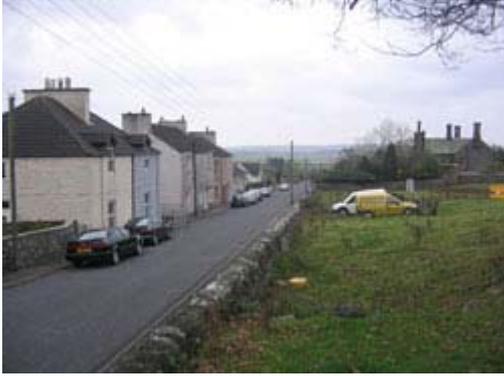
- 1.2 The area concerned is currently an open area site, bounded to the north by the Southfield Lane, to the east by Harbour Road (Figure 4a), to the West by Back Street and to the south by housing. The site gently slopes down from north to south but is an extremely even and level surface. Several old established trees exist around the edge and two semi-derelict buildings are fenced off on the site. The remains of a disused toilet block are connected to the northern wall.

Figure 4a: Harbour Road

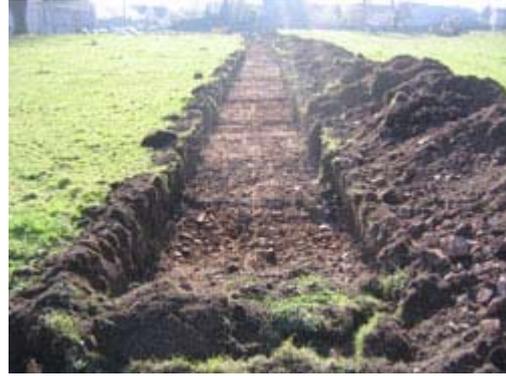
Figure 4b: Trench 1

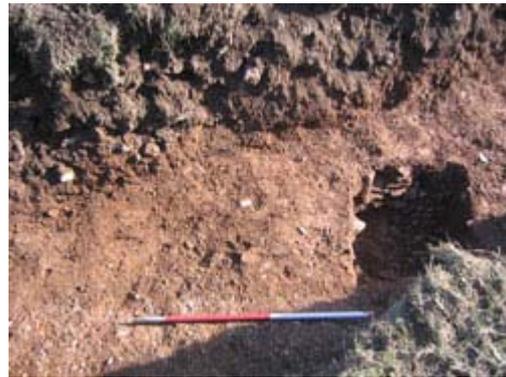
- 3.6 Three potential features were observed and investigated. One was at the southern end of Trench 1. It appeared to be a linear feature [105] cut into the natural at the base of the Trench. It was 700mm wide and about 400mm deep (Figure 4d). No artefacts or anthropic material was recovered from the fill of this feature. The irregular shape of the base and the fact that it could not be traced into Trench 11 suggest make it difficult to attach any archaeological significance to this feature.

Figure 4d: Feature 105

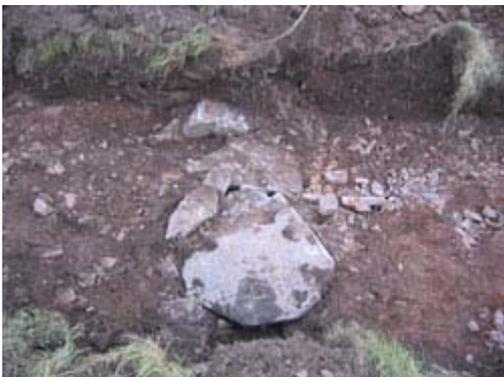
Figure 4e: Drain in Trench 7

Modern features: Drain (703) runs SW-NE across trench at 5.6m. Stone lined on both sides and covered by flat stone slabs. Measures 0.6m wide.

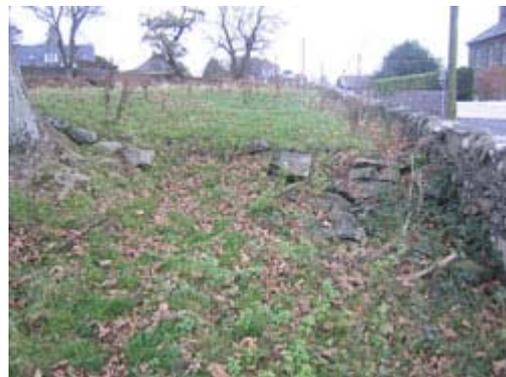
Figure 4h: Rubble, possible retaining wall

- 4.3 It is a curious feature of the surrounding landscape that there is almost a 2m height difference between the north-eastern corner of the site and the adjacent portion of Harbour Road; the presence of bedrock in Trenches 1 and 12 means that either the construction of the road involved substantial removal of bedrock or it was built around a natural and very steep drop off in the topography. The potential remains of a retaining wall (Figure 4g and 4h) picked up in Trench 12 may be the remains of landscaping of this area.

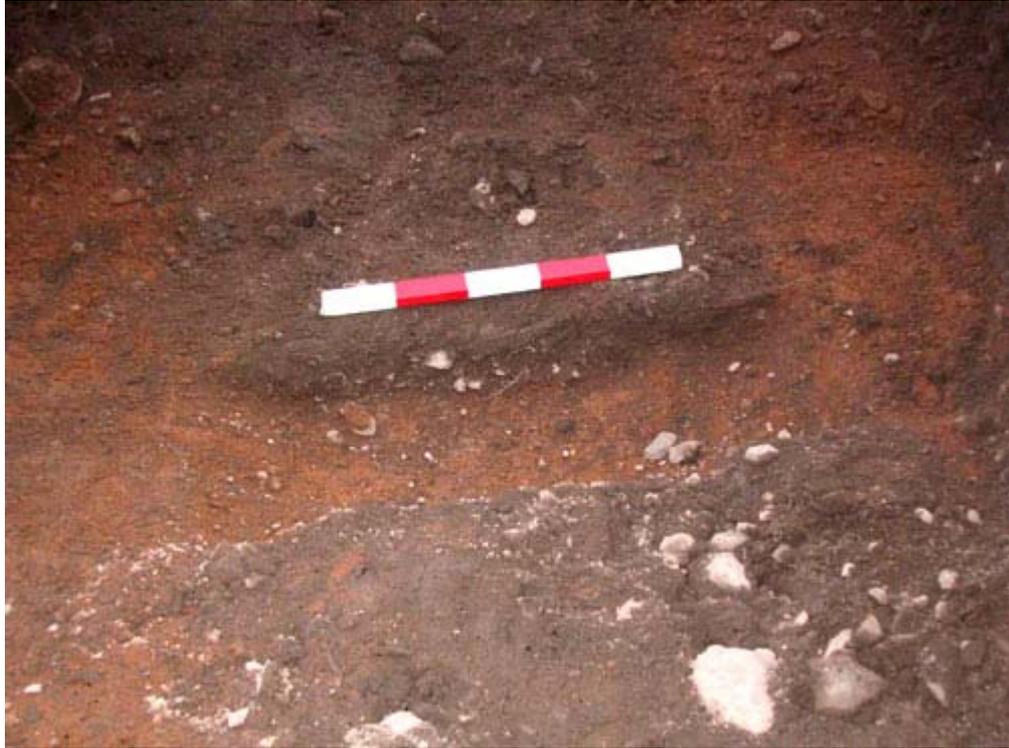
- 3.7 The other two features on site were both recorded in Trench 6. The southern feature [604] was an irregular linear feature similar to that found in Trench 1 but much more shallow (Figure 5a). The other was a roughly circular pit [605] in which was partially exposed and excavated to a depth of 300mm. Neither yielded any diagnostic material and both fills were remarkable only for their lack of artefacts and uniformity. None of the three features excavated could be confidently linked with any historical period or human design.

Figure 5a: Feature 604

Significant features: Linear ditch (604) runs SE-NW across the trench at 24.5m until 29m. Gently sloping sides with a rounded flattish base. Filled with loosely compacted light grey clayey silt with small sub-angular stone inclusions, occasional gravel inclusions and very occasional flecks of charcoal. Measures 0.8m wide and maximum of 130mm deep. Circular feature (605) is located at 68.2m. Sloping sides with rounded base. Filled with moderately compacted light grey silty clay with occasional gravel and small angular stone inclusions. Measures a maximum depth of 330mm.

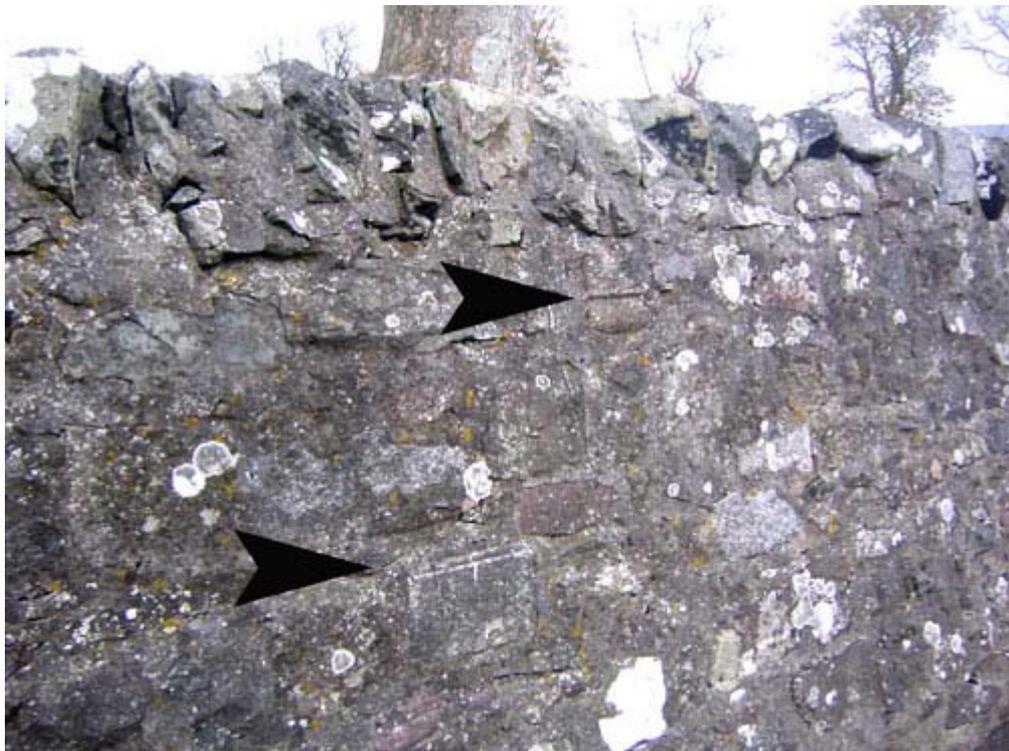
- 1.6.4 The location of the Dominican Friary (NMRS NX45NW5) is still poorly understood and there is an outside possibility that this site may extend into the development area. This potential is derived from the presence of re-used masonry and carved stone in the wall along Southfield Lane. This material presumably deriving from demolished, significant structures which may include Friary buildings. The Friary was founded (most likely) in 1296, there are currently no remains of the friary still standing and although three possible locations can be identified:

Figure 5b: Example of dressed masonry in western boundary wall
