# **Southern Gateway, Dunfermline: Archaeological Mitigation**

Data Structure Report

issued 30<sup>th</sup> July 2008

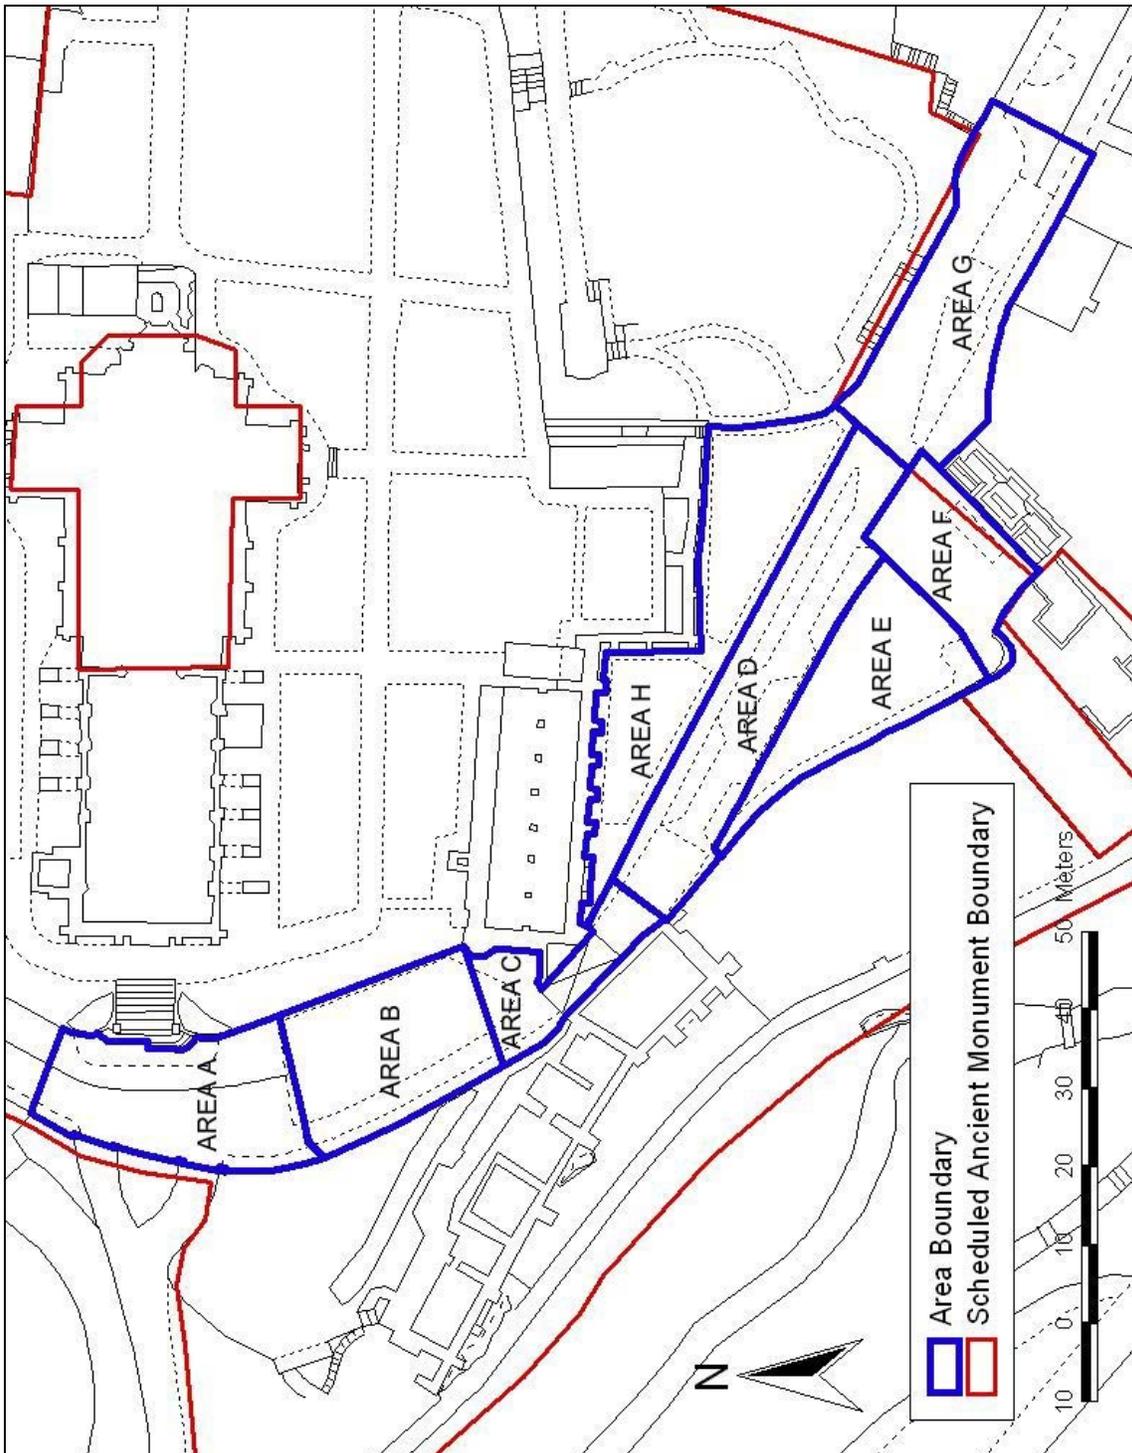
Fig 1: Showing Area boundaries and the limits of the Scheduled Ancient Monument

- 2.3 The excavation and ground reduction for the paving works was initially intended to be carried out intermittently. However staffing concerns forced Gilmartin Contractors Ltd to undergo a continuous period of excavation simultaneous with the paving works. Several archaeological deposits were located and recorded during this work. Damage to archaeological deposits was kept to a minimum; however it was occasionally necessary for additional archaeologists to be on site to carry out recording where archaeology was to be lost and avoid delay to the contractor. In order to facilitate recording and understanding, the development area was split into 8 areas; listed Area A to Area H.

- 2.4 The boundaries of these areas were determined by a combination of the nature of the archaeology found and the impact of the development work. As a result the archaeology is not evenly distributed from area to area. Nor should the individual areas be thought of as delimiting individual sites. Although it can be demonstrated from the remains recovered that islands of survival do exist, these do not exist in isolation but make up part of the complex of structures that surrounded the Abbey. The discussion section of this report will attempt to bring together the disparate remains found and interpret them alongside historical sources.

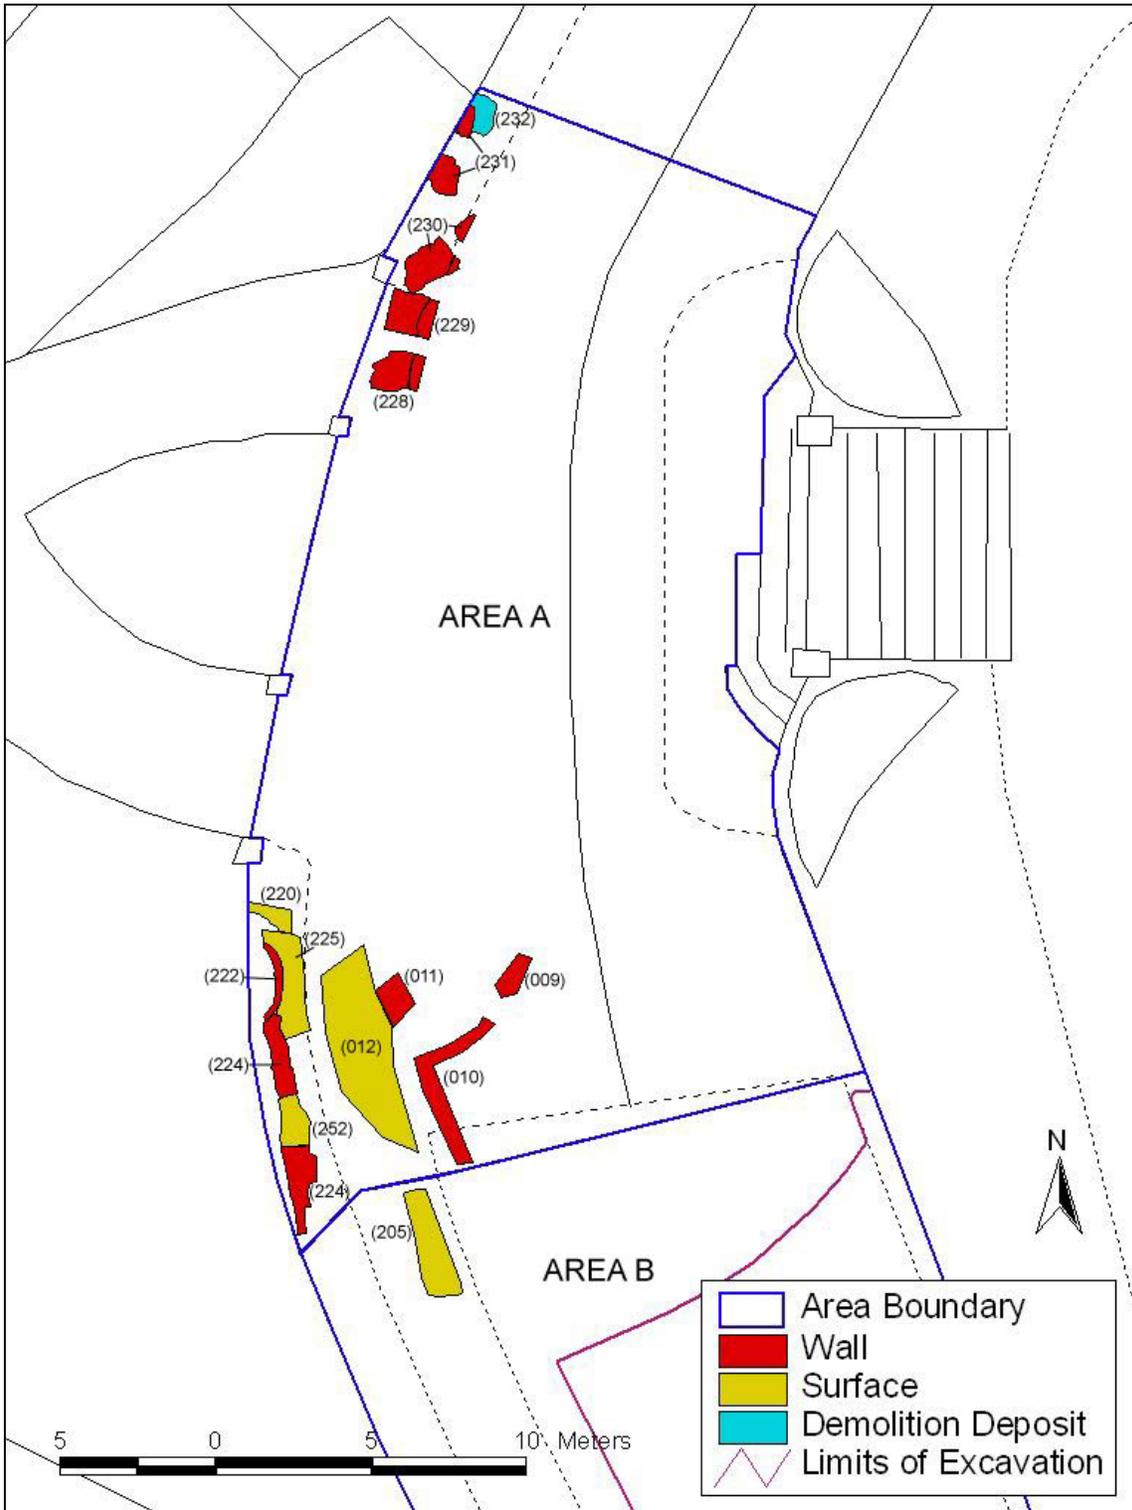
Fig 4: Area A

- 4.3 Removal of the concrete in an area to the south and west of the entrance to the Church revealed the remains of medieval walls. These were excavated and recorded by hand. The remains of at least two portions of a single wall (010) and a trampled/compacted surface were uncovered in the course of this excavation. The character of the subsoil was such that these features were hard to define without hand cleaning, supported by machine stripping. The features were at a depth where they would be subject to disturbance prior to the reinstatement of the road surface – hence a programme of excavation and recording.

- 4.5 In the excavation area sufficient archaeological material remains were excavated to allow the characterisation of a wall (010). The remains uncovered may be characterised as the lowest surviving course of a wall foundation with a single face being extant for 8.35m (though discontinuous in two portions). The wall core survived to a thickness of some 0.6m with the stone work characterised as yellow worked sandstone with irregular blocks running for one course. Overall, the Wall 010 suggested a straight wall running south to north for 5.5m before curving out to the northeast (at its northern end) for another 3m. Additional offshoots of masonry were also observed but the extent of the disturbance hampered the examination of physical relationships.

- 4.6 To the immediate west of the wall core (but separated by the cut of the gas main that may have removed the opposing wall face) was a trampled/compacted surface (012). The surface was formed of a very compact stony deposit of dark stained yellow sandstone which sloped downhill towards The Pends. The upper surface was also rich in midden material, specifically animal bone (inc. cow), marine shell (inc. oyster) and medieval ceramics (white gritty ware). This last material, the ceramic, is commonly dated from the 12<sup>th</sup> to 15<sup>th</sup> centuries. Overall the exposed surface extended, at most, to 6.3m long by 2.4m wide.

- 4.7 To the west of Surface 012, beneath the pavement which was removed later, more walls (222, 224) were uncovered. The physical relationship between these walls and Wall 010 is uncertain due to truncation by modern services; however, they were of very similar composition. Wall 224 continued on a north-south alignment for 7m before extending to the north in a narrow curve (222). As with Wall 010 these remains survived to only one course and may be characterised as the lowest foundation course of a structural feature.

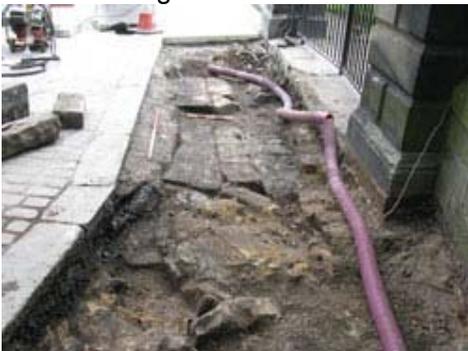
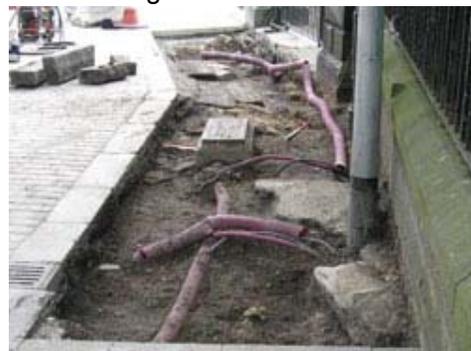
Fig 5e: Walls 230, 229 and 228

- 4.15 To the south of Wall 230 were the remains of two large structural elements (228 and 229) which may have been the remains of a foundation of a much larger structure. They were composed of sandstone blocks and were more than 1m square. Again, restricted space and the extent of modern disturbance prevented further investigation; however the area surrounding these features contained a significant amount of demolition material, some of which included decorative structural elements. It is clear that the remains uncovered here represent a much larger building.

- 12.4.1 The remains uncovered at the northernmost extreme of the development area, (228), (229) and (230), were consistent with the demolition of a large structure. There was some evidence that the remains continued to the north and west of the development area. That this may have been a small part of a larger structure is supported by the fact that fragments of decorative structural elements were found within the demolition deposits. Without dating evidence or further excavation of the remains it is impossible to say for certain what these remains represent. With reference to the 1859 composite map we can suggest a location for the remains of St Catherine's Lodge.

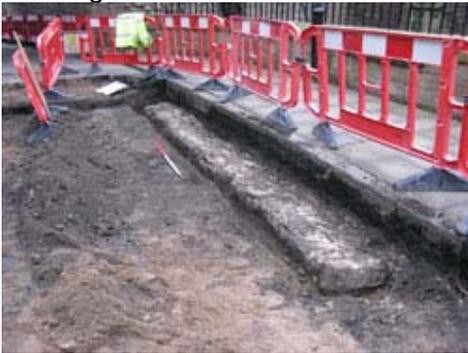
Fig 7c: Wall 207

- 6.3 The surviving Wall 207 was composed of roughly worked sandstone and compact sand and lime mortar. The wall survived to a length of 5.5m, was exposed to a width of at least 0.5m and to a depth of approximately 250mm. The wall was well formed and probably represents the undisturbed lower foundation courses of a larger wall. There was some suggestion, from observation of the sediments, that the wall may have continued to the north-west but had been removed, possibly to make way for modern services.

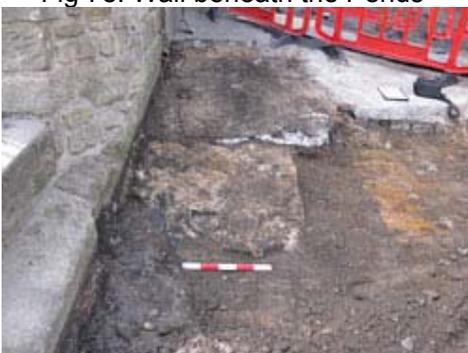
Fig 7g: Wall 227

- 6.7 Immediately beneath The Pends on the south-eastern side a short fragment of wall (227) extended out from the walls of the Kitchen. Wall 227 was exposed to the extent of about 1m<sup>2</sup>. Two other walls (234) and (235) were recorded further to the south east of The Pends and were exposed to a similar extent, however, there was some indication that they continued at greater depth. The extent of disturbance of services in this area makes relationships difficult to determine.

- 12.5.3 On the south east side of The Pends, evidence of additional structures was found but these were outwith the scope of the 1975 excavation. Wall 227 appeared to extend the structure of The Pends but it was not clear if this was part of an earlier configuration or part of a now removed extension to the structure. Walls 234 and 235 existed a few metres to the south east of The Pends. The extent of modern disturbance in this area has destroyed potential physical relationships and the walls exist in isolation. However, the size of the walls suggests that they formed part of a substantial structure. It is clear that the evidence of previous phases of the configuration of the Abbey exist in the deposits around The Pends.

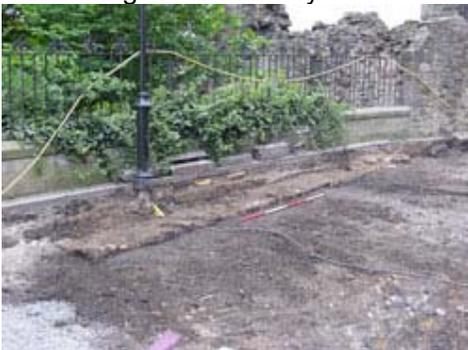
Fig 9g: Wall 208

- 7.2 The most significant discovery within this area was a virtually unbroken length of wall (208) more than 42m long and in places almost 1m wide. *Sondages* were carried out in three places to attempt to determine the depth of the surviving wall. These revealed that the wall survived to a depth of more than three courses, more than 600mm, but further investigation was constrained by the conditions of SMC and safety considerations. Each course of the wall was substantial and well formed in most places. The depth of each course was about 200mm and some of the roughly worked blocks were about 1m long. It is clear that the surviving wall represents a substantial structure.

- 7.6 At the northernmost end of the Wall 208 it was necessary, as part of the development process, to excavate to a depth of more than 1m for the placement of a drain pot. This revealed an elevation of a second wall very similar in construction to Wall 208. This wall was only exposed for a distance of 1.5m but appeared to run beneath the current wall which marks the edge of the park. It is possible that a much older wall has been used as the foundation construction for the more modern park wall.

- 7.7 Wall 208 continued beyond the placement of the drain pot, towards the south side of The Pends, for 5m, at which point it combined with Wall 219. Wall 219 was of very similar construction to Wall 208. It was composed of large sandstone blocks and rough lime and sand mortar.

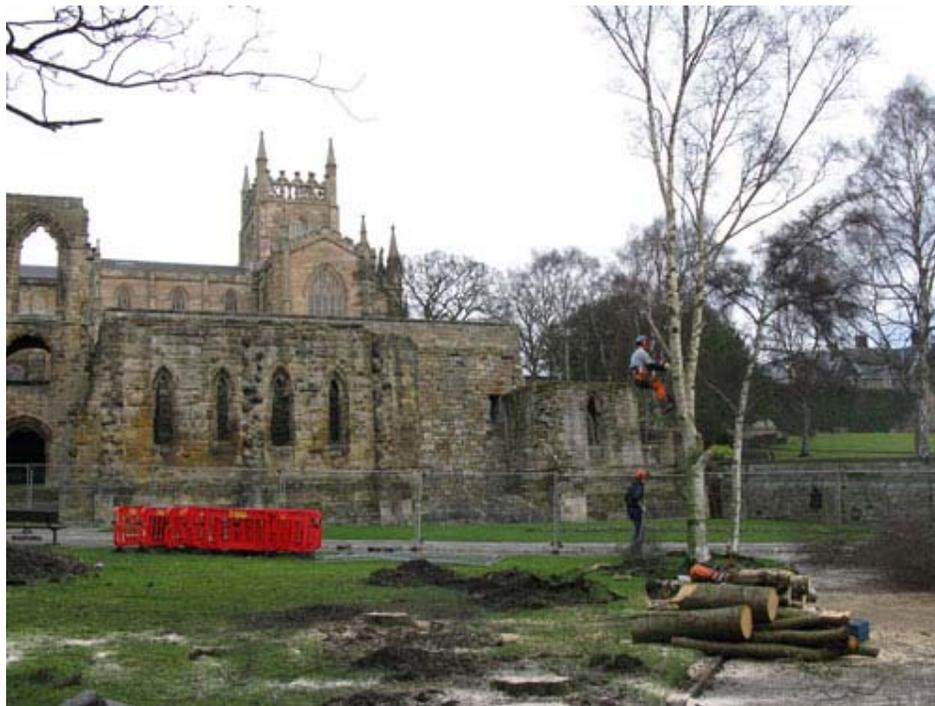
Fig 10b: Tree felling in Area E

- 8.3 Further excavation was undertaken by hand around the stumps of each of the nine trees in the scheduled area, prior to felling. This excavation was in direct response to the SMC which requires an archaeological assessment of the deposits around the buttress roots of the trees. None of the trees had buttress roots, so the excavation proceeded as a general assessment of the potential disturbance. No archaeological material was observed around any of the trees within a depth of 300mm. The exception to this was Tree 5 which was the furthest south and surrounded by cobbles. A shallow and irregular extension of the demolition material found in the Test Pits was observed here.

12.8.1 At the request of Historic Scotland and according to the agreed terms of SMC two test pits were excavated in Area E in order to investigate the potential disturbance caused by the removal of the trees (to a depth of 400mm) and assess the archaeological potential of the area. These test pits were of limited success; although they did show that there were no significant archaeological deposits within the scope of the tree removal, they did not fully quantify the archaeological potential of the area. However, excavations in service trenches in Areas D, F and G demonstrate potential survival of archaeological material at depths greater than 800mm.

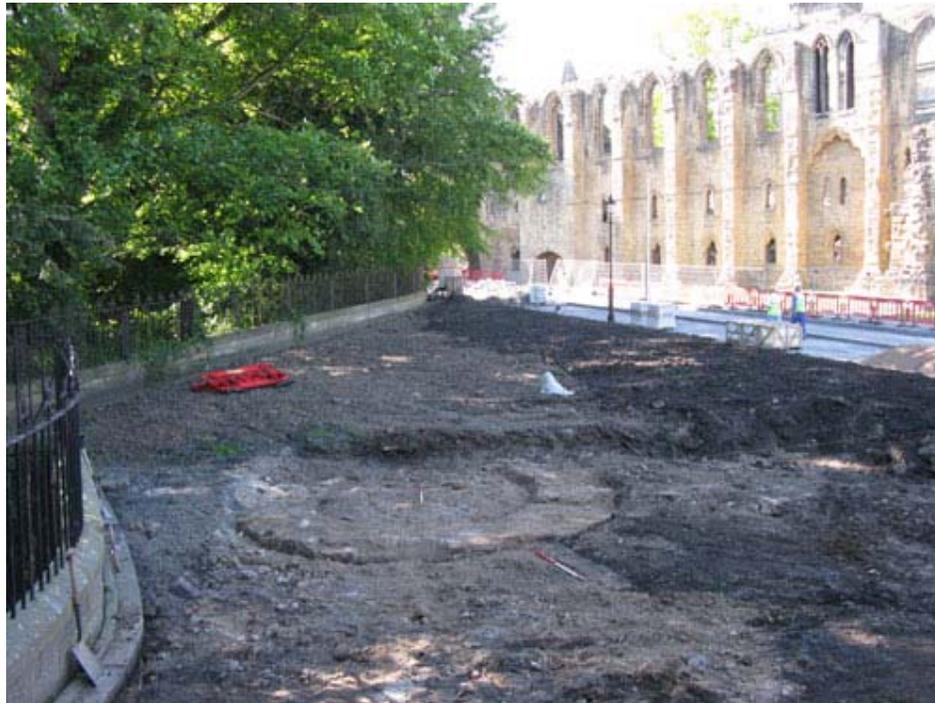
Fig 11a: Circular Structure 239

- 9.2 One significant feature was exposed in Area F and this was a large circular, stone structure measuring 6m exterior and 3m interior diameter. The structure (239) was composed of large and irregular masonry blocks bonded with sand and lime mortar. Contained within the fabric of the wall were fragments of ceramic, most likely tiles. Only one course of construction was fully exposed but there was evidence, from damaged sections, that further courses survive beneath the surrounding sediments.

- 9.3 Circular Structure 239 was of an unusual construction given that the interior wall face appeared to deliberately slope inward. This may be an indicator of function as it does not appear to be an effect of degradation of the structure or, given the width of the walls, necessary for stabilisation or support. It was also observed that several of the large stones used in the construction of the structure were cut to form the shape of the interior or exterior face. It is clear therefore that the structure represents a substantial and specialist form of construction.

- 12.7.1 The older structures referred to in section 12.6.3 are the remains of Heugh Mills. Cartographic evidence suggests that the name Heugh Mills migrated around the area on both sides of Monastery Street and referred to several structures in the area. The 1<sup>st</sup> Edition Ordnance Survey Town Plan shows an iron foundry and corn mills on the north eastern side of Monastery Street, as well as a complex of corn mills on the south side. The corn mills on the south side of Monastery Street were, in part, beneath the area now occupied by the War Memorial; however the remains of their walls can be seen beyond this into the park. The circular feature 239 in Area F is interpreted as the corn drying kiln which is also depicted on several old maps.

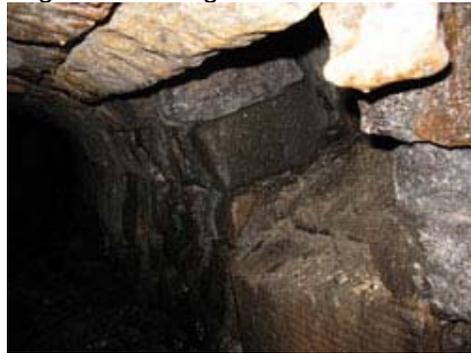
Fig 12d: Interior of Lade

- 10.6 The most significant archaeological feature exposed within Area G was first discovered as a result of collapse caused by the passage of heavy plant. The resulting hole broke through the top covering of a narrow stone passageway/drain (242) running south from the Abbey Park into Monastery Street. Upon further excavation in the area it was discovered that Passageway 242 dropped steeply down to the east, three metres after it extended into Monastery Street. Furthermore, the drain/passageway was flanked on either side by sandstone walls (263) and (264) which ran parallel to the passage itself and were truncated to the NE by the construction of the Abbey Park gate. The SW terminals of these walls were also aligned to the SW faces of Wall 259, and Wall 267 indicating that Passageway 242 may have been contemporary. A decision was taken by Gilmartin Contractors Ltd with the support of Ironside Farrar to cover this section with a steel plate before the laying of concrete and paving, therefore maintaining the water course.

- 10.7 Further investigation into where the drain/passageway led revealed that it, as well as the drains on the south side of Monastery Street, were plumbed into an existing underground chamber. It was discovered, upon investigation by Douglas Speirs of Fife Council Archaeology Unit, that this underground chamber was a modification of the Mill Lade (or Lead) shown on several cartographic sources. The Lade formerly fed the Mill buildings, now standing ruins, to the SW of Monastery Street before meeting up with the burn in Pittencreif Park. Investigations demonstrated that the Lade was accessible for more than 35m from the southern base of the War Memorial, under the development area, to the area under the Abbey Park. The accessible space consisted of two large chambers connected by a long narrow stone tunnel.

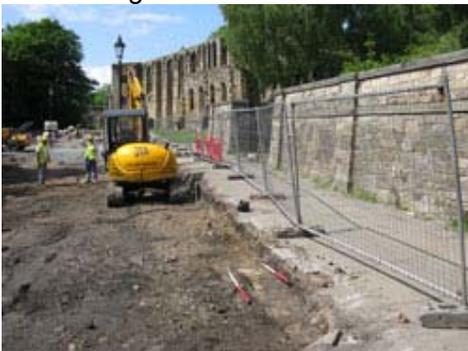
Fig 12e: Wall 267

- 10.4 In the eastern corner of Area G a short section of wall measuring 5.07m by 840mm was exposed. This wall (267) consisted of large, regular pieces of masonry bonded with a sand and lime mortar. The wall survived to at least two courses and obviously formed part of a substantial structure. A further extension of Wall 267 was also exposed to the NW (271) which ran for a further 1.95m, but had been physically detached from Wall 267 by a service trench. Furthermore, abutting Wall 267 to the NE, an arced sandstone feature (268) was also exposed. The feature measured 1.29m long by 1.12m externally, and 1.04m by 0.69m internally and contained a layer of sediment that differed from the sediments surrounding the feature. However, the absence of associated finds or features makes interpretation of the feature difficult.
