A9 Loaninghead Junction: Archaeological Excavation

Data Structure Report

- 1.1 This Data Structure Report presents the findings of archaeological excavation works required by Muir Homes in respect to the proposed plan for the A9 Loaninghead Junction Development, Auchterader. These works were designed to mitigate the adverse impact on the archaeological remains within their proposed development area, based on the findings of the preceding evaluation (Gordon 2008). The scope and remit of these works were agreed with Perth and Kinross Heritage Trust and Perth and Kinross Council through a Written Scheme of Investigation (Matthews 2008).

- 1.2 The excavation area (NGR: NN9210 0964) , which was located to the immediate north of Peterhead Standing Stone (AMH 4061), covers the footprint of the proposed roadway in the area of Evaluation Trenches 11 and 12. It ran for a distance of 120m along the proposed roadway and was 7m wide, giving a total area of 840m² (see Figure 1).

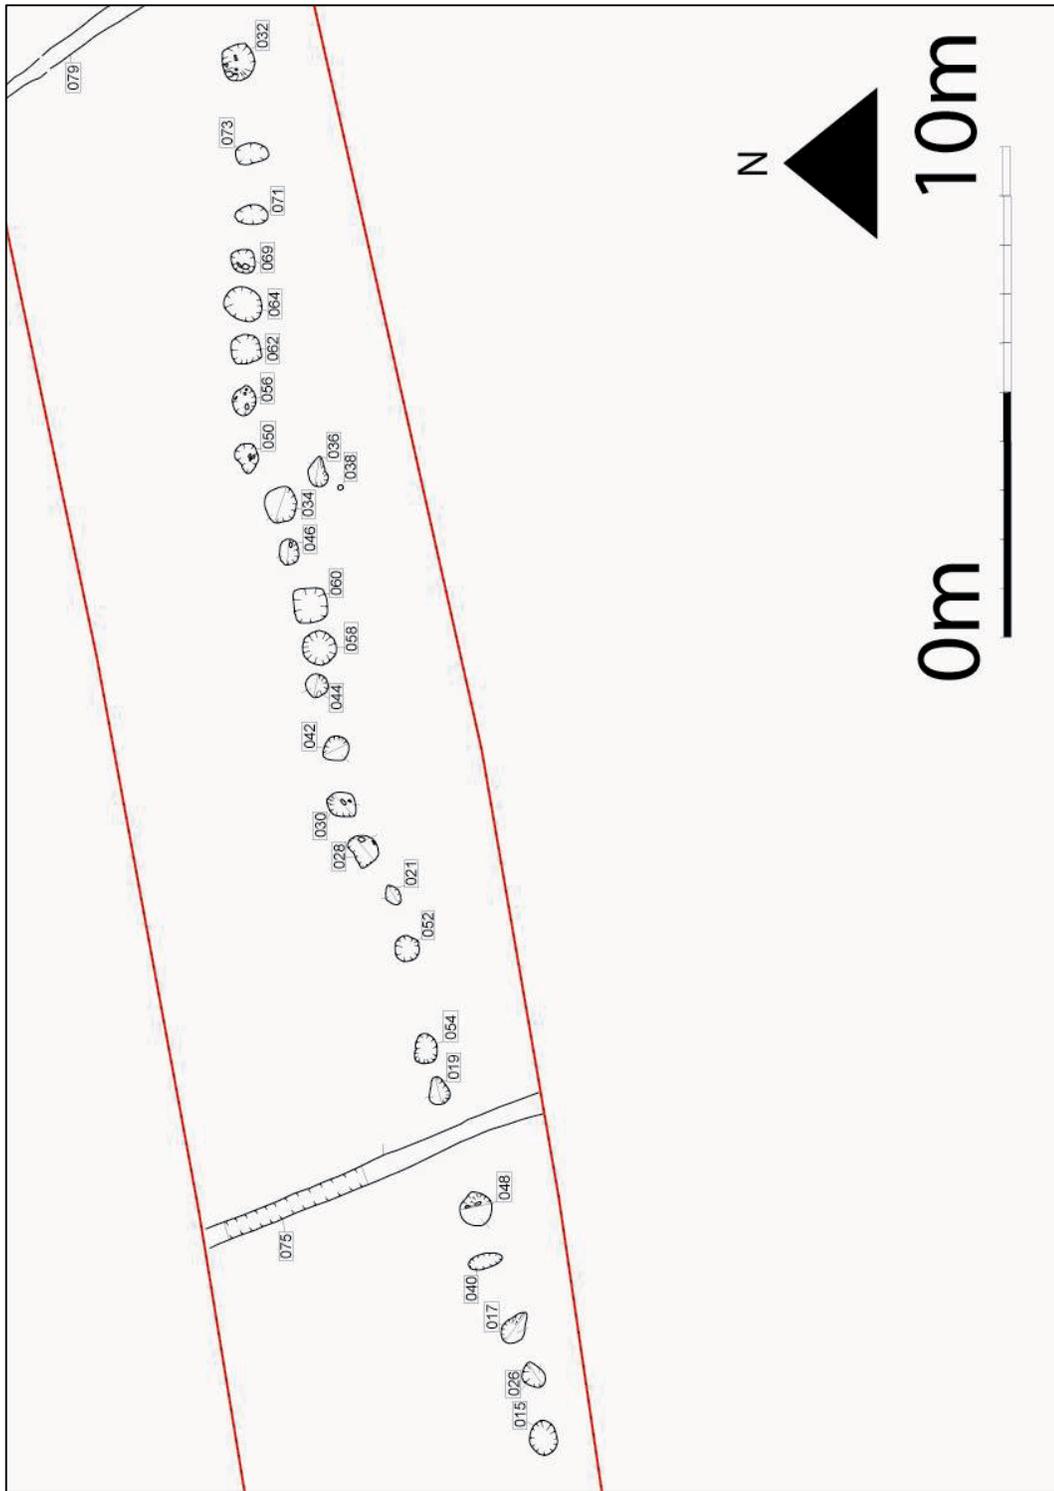
Figure 2: Pit/Post holes

- 3.4.1 In the western half of the excavation trench, twenty six pit/post holes and one stake hole were revealed. The pit/post holes lay predominantly in a single row roughly aligned ESE-WNW, with an irregular spacing between each individual element that served to make up the feature. Overall the row bowed out slightly to the north while there was a slight suggestion that it may have been formed in discrete sections comprising straight blocks of six features with a slight step evident between each section.

- 3.4.2 The pit/post holes ranged in size from 0.33m in diameter to 0.76m by 0.79m, and varied from 0.08m to 0.26m in depth; they varied in form along the line, with some having flat bases ([021], [026], [028], [030], [032], [034], [040], [044] [050], [064] and [071]) and others rounded bases. They also varied in shape; pit/post holes [040], [071] and [073] were oblong in plan, whereas [028], [060] and [062] were sub-square, with the remainder being sub-circular/oval. The degree of truncation varied from east to west, with the western features being quite shallow in comparison with those in the east.

- 4.2.1 The row of pit/post holes in the western half of the excavation site formed an irregular curving line running from W to E. The presence of a post pipe in one of the features and stone packing in others suggests that some of them at least once contained upright timber posts, some of which rotted *in situ*. Certainly these features appear to be hand dug and potentially all were excavated for the setting of posts or uprights. The coherent form of the row is highly suggestive of this being a contemporaneous feature or structure.

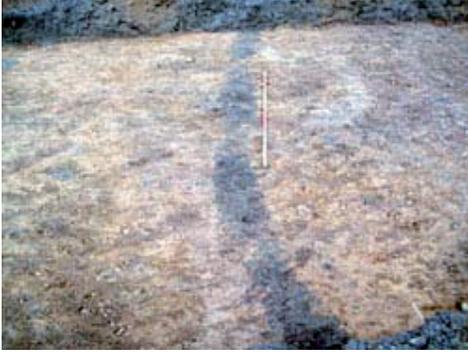
Figure 3a: Curvilinear [007]

- 4.1.1 A series of linear features were uncovered within the excavation area. In general these were ephemeral in nature and devoid of datable material. Curvilinear feature [007] was the most shallow, being only 80mm deep; if it continued onwards to form a circle it would circumscribe an area of approximately 6-8m diameter returning outwith the eastern end of the trench. It may represent the remains of a ring groove for a round house or the foundation trench of a small enclosure; however given the highly ephemeral nature of the feature any interpretation is highly speculative.

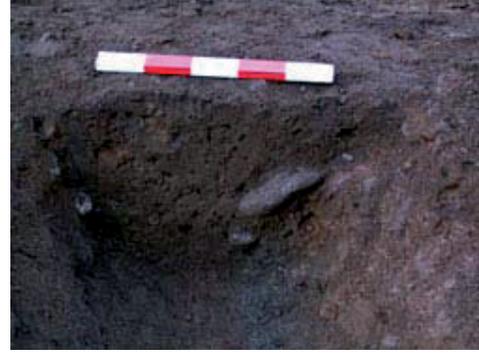
Figure 3b: SSE Facing section of

[011]

- 3.3.2 The second was linear feature [011], described in the evaluation text as [1105] (Fig. 3b). It was filled with mid greyish brown silty sand (012) and measured 0.94m by 0.41m deep with sloping sides and a rounded base.
- 3.3.3 At the western end of the excavation trench, two more linear features were recorded. Lying furthest to the west was ditch [066], which ran from NW-SE measuring 0.34m wide by 0.09m deep with sloping sides and an irregular rounded base. The remaining ditch [075], described previously as [1204] in the evaluation text, was located approximately 16m to the east of this, running almost parallel and measuring 420mm by 110mm with sloping sides and an irregular base. Both features also contained very similar dark grey brown sandy silt with occasional small stone inclusions (fills (067) and (076) respectively).

- 4.1.2 Linear feature [011] on the other hand was relatively substantial being 410mm deep, though unfortunately no further information was recovered during the excavation to add to that obtained during the evaluation phase. Given its form and its location in proximity to the Peterhead Standing Stone (AMH 4061) it has the potential to be prehistoric in origin as suggested in the original evaluation (Gordon 2008).

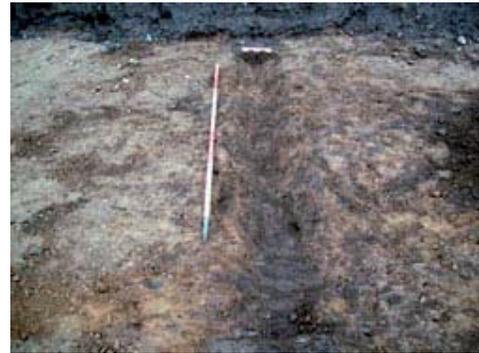
Figure 3d: Linear [075]

- 4.1.3 The other two linear features [066] and [075], located in the western half of the excavation area, were similar in form and fill to [011] and may be contemporaneous. Like [011] these two linears were initially interpreted as being prehistoric in origin given their form and position relative to the standing stone; however, no datable material was recovered from either which could elucidate their likely age. It is more probable that they may in fact be more recent agricultural boundaries, given that [075] cuts through the post row leaving an anomalous gap, suggesting that [075] was a later feature which obliterated a post hole.

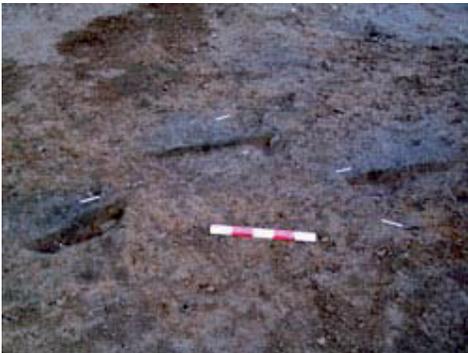
Figure 3e: [046], [036], [038]

- 3.4.4 Stake hole [038], which had shallow sloping sides and a rounded base, measured 130mm by 110mm and 30mm deep. It was situated to the immediate south of feature [036], possibly indicating a relationship. These two features were also anomalous as they did not appear to lie within the common row, rather being offset to the immediate south...

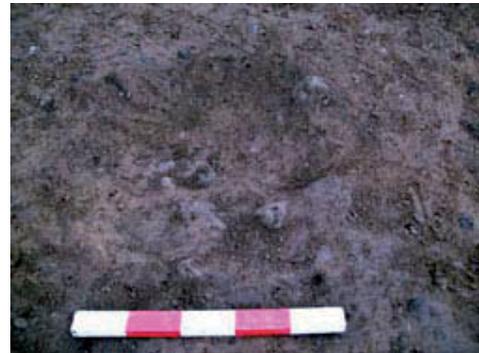
Figure 3f: Post excavation of [050]

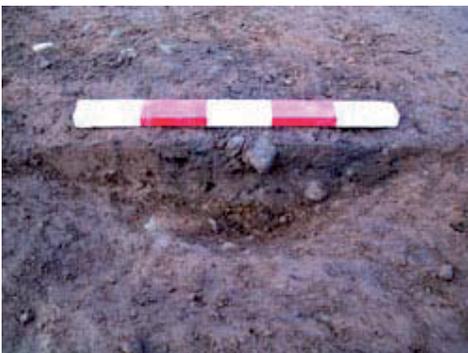
Figure 3g: S facing section of [050]

- 3.4.3 Some of these features ([028], [030], [032], [040], [042], [044], [048], [054] and [056]) contained medium sized stones ($\leq 120\text{mm}$) within their fill and [050] appears to have a possible post pipe present (Fig 3g).

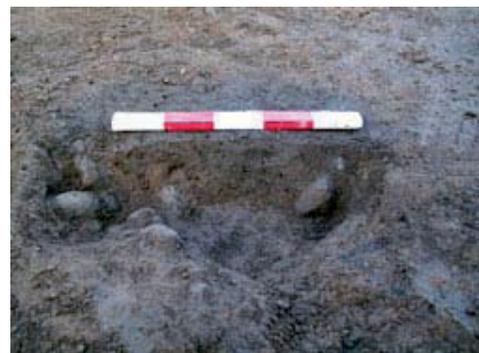
Figure 3h: SSW facing section of [036]

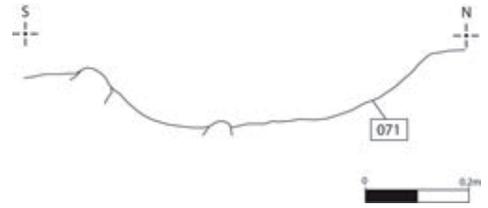
Figure 4b: Profile of [039]
