**15A High Street, Stewarton, Ayrshire:
Archaeological Watching Brief**

Data Structure Report

issued 24th July 2009

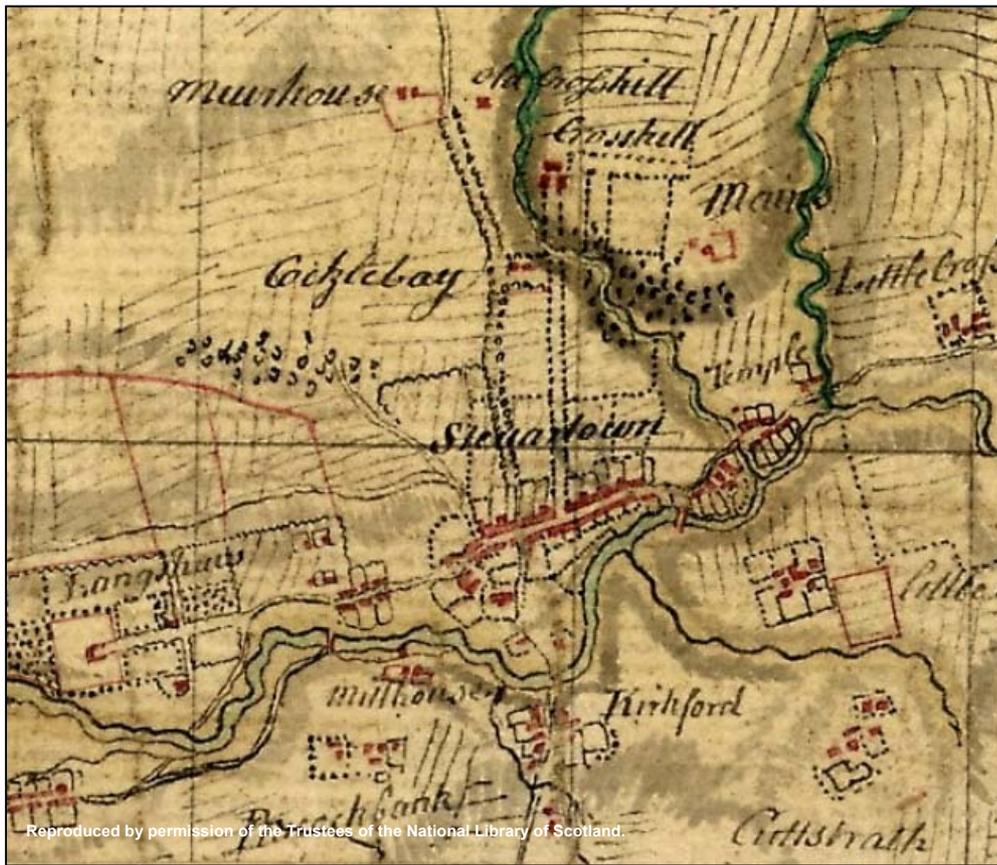
Figure 1a: Detail from Roys' Military Survey of Scotland (1747-55)

6. The earliest viable mapping evidence comes from Roy's military survey of 1747-55 (Figure 1a) which shows the Main Street with buildings fronting along the street, with back plots running off behind the frontage. The 1st edition Ordnance Survey of 1858 (Figure 1b) shows defined backplots with a building within the study area.

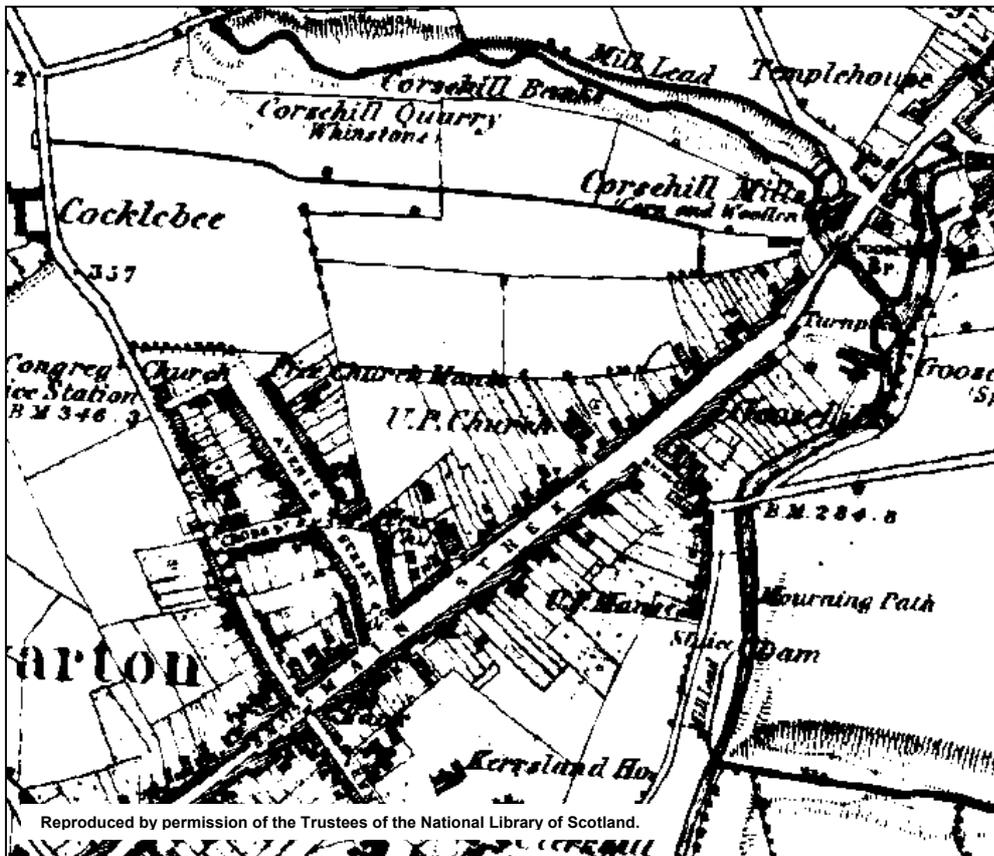
Figure 1b: Detail from 1st edition Ordnance Survey (1858)

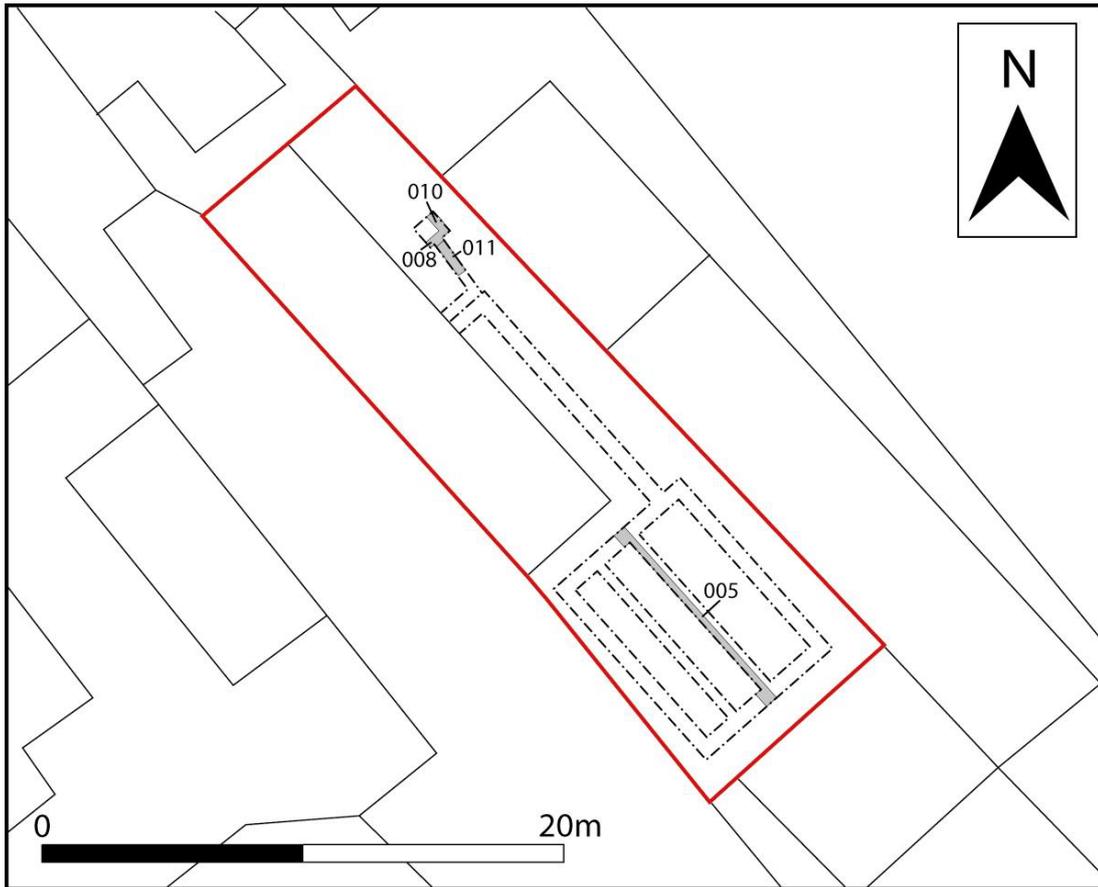
Figure 2a: Site Plan

11. In total seven foundation trenches were excavated to a depth of 700mm for the walls of the new extension (Figure 2a). Four trenches outlined a rectangular area to the rear of the dental surgery measuring approximately 8.8m SE-NW by 6.45m SW-NE. These trenches were for the outer walls of the extension and measured 600mm wide. The area within these trenches was then subdivided by two further trenches running SE-NW; one of which was 400mm wide while the other 500mm wide. These were for the location of two dwarf walls. A final trench was dug for an outer wall which ran SE-NW parallel to the dental surgery along its northeastern side joining the existing building with the extension. This measured approximately 10.35m long and 600mm wide.

15. A narrow channel was excavated for a new drain to run from the northwestern end of the final foundation trench to the southeastern end of an existing drain located within the alley adjacent to the dental surgery (see Figure 2a). The channel measured 350mm wide, 450-500mm deep and 2.6m long before ending in a 1m by 1m square trench dug 500mm deep around the end of the existing drain pipe to allow for the joining of the new pipe.

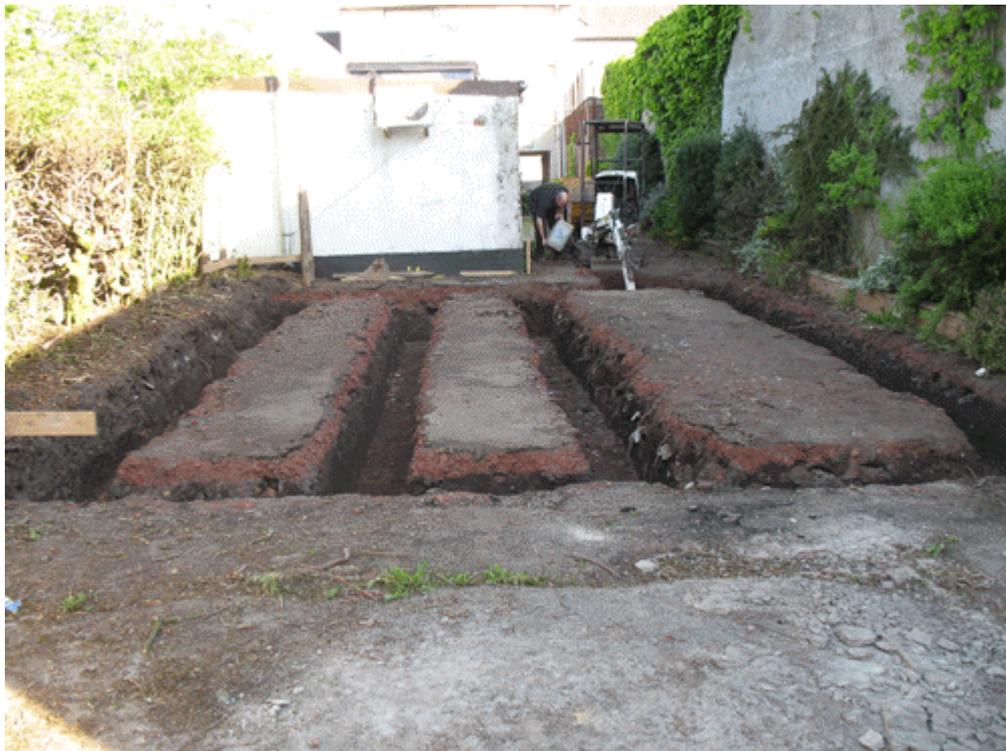
Figure 2b: General shot of foundation trenches from the southeast

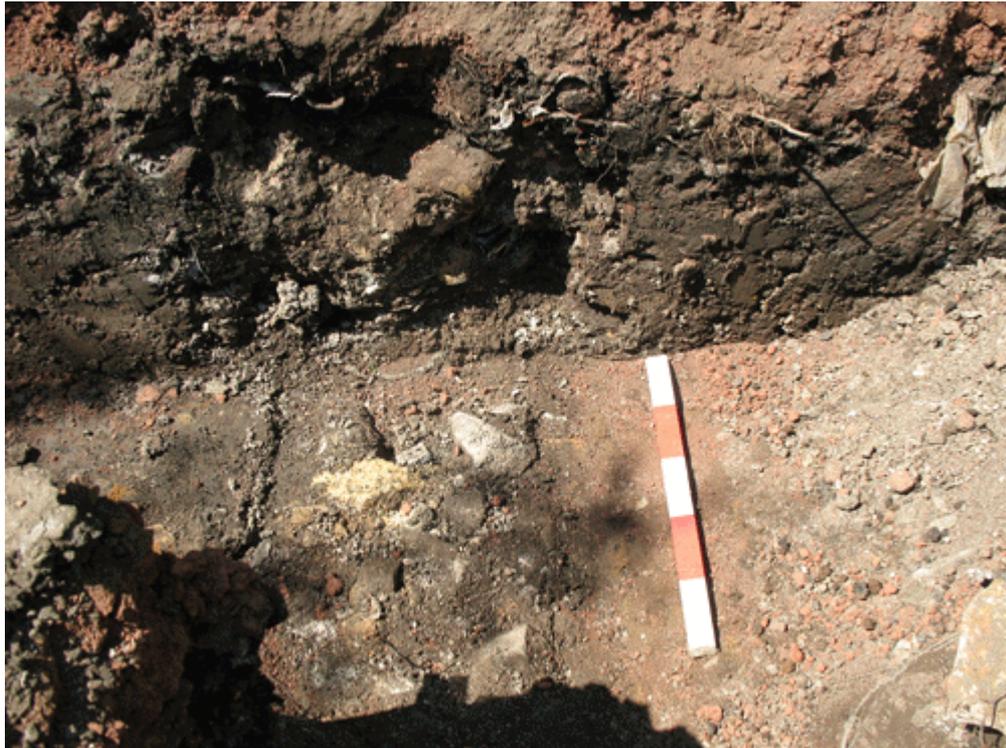
14. One feature discovered within the foundation trenches had the potential for archaeology. A linear cut [005] (Figure 3a) runs SE-NW across the site along the southwestern edge of the trench excavated for the insertion of the northeastern dwarf wall (see Figure 2a). The cut measures a maximum of 700mm wide and a minimum of 8.8m long and 700mm deep. The feature ran outwith the area of the trenches and its full depth was not revealed. It was filled by a mixture of sandstone blocks, mortar and gravel (004) and featured several fragments of 19th to 20th century pottery and glass.

Figure 3a: Linear feature [005] – southeast facing section

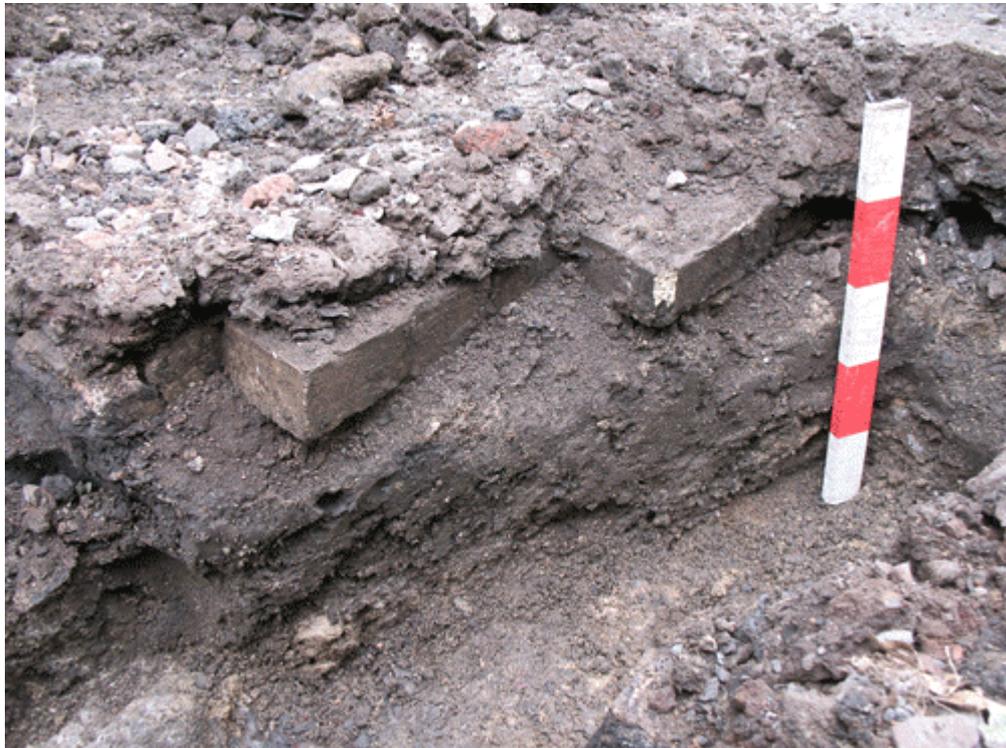
Figure 3b: Bricks (011) – southwest facing section

18. Also present was a single layer of yellow bricks (011) (Figure 3b) revealed at the northwest end of the drainage channel, below the tarmac/blaze (001) (see Figure 2a). This layer appeared to extend out from the southeast edge of (008) although no direct relationship between the two could be ascertained. It extended along the channel for 1.5m although its full width was never exposed. The layer sat on top of deposit (002) and modern dumped material was observed coming out of the area directly below it.

20. The trenches excavated for the insertion of a new drainage pipe exposed potentially more significant features. The deposit (009) situated around the end of the existing drain pipe contained modern material and seems most likely to date from its insertion. The brick layer (011) may represent a former ground surface although the presence of modern material within the deposit directly below places its date as being of no great antiquity either.

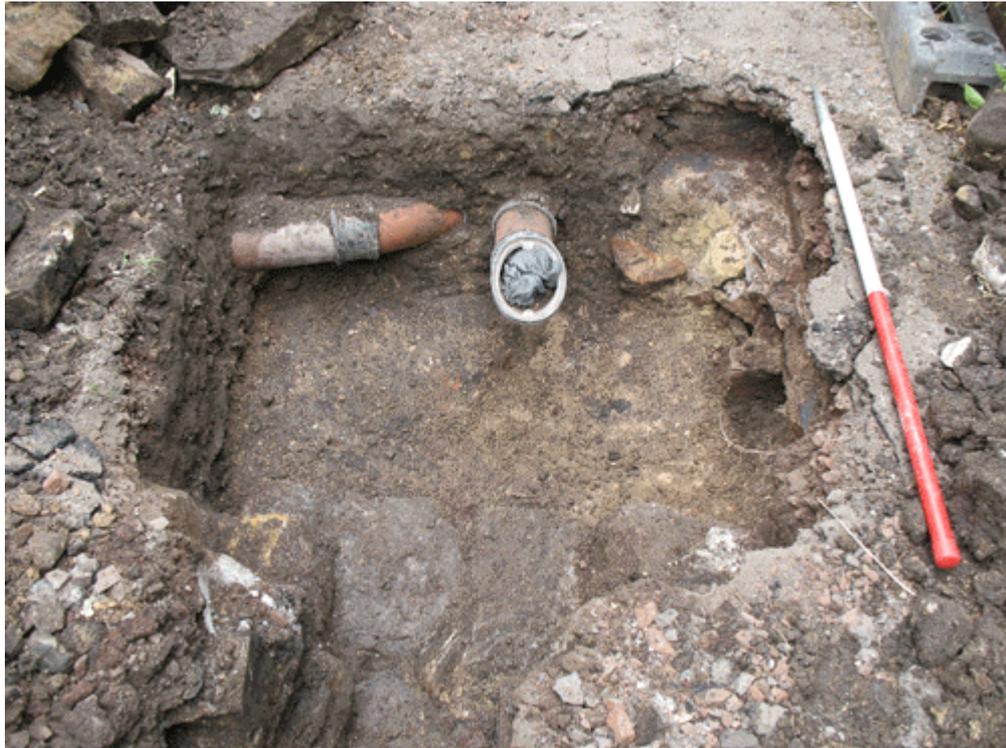
16. The channel and square trench excavated for the new drain pipe revealed further potential archaeology. The square trench exposed two lines of rough sandstone blocks which formed an 'L' shape running along its southeast and northeast edges (see Figures 2a and 4a). The southeast segment (008) comprised a line of irregular shaped sandstone blocks covering a total extent of 400mm wide, 1m long and 300mm deep although neither its entire length nor depth were exposed. The northeast segment (010) (Figure 4b) comprised a line of irregular shaped sandstone blocks, one course deep, with a single course of yellow bricks lying on top. This measured a total extent of 350mm wide, 1m long and 380mm deep although neither its entire length, width nor depth were exposed. Amongst the lower course of sandstone blocks, some red bricks were observed which appear to possibly be handmade.

21. The two lines of sandstone blocks (008) and (010) have the most potential and appear likely to be the possible foundations for an earlier structure. The presence of handmade brick may place the sandstone foundations as being of late 18th to early 19th century in date with later yellow brick being placed on top; although it is also possible that these handmade bricks are earlier materials being reused within foundations constructed later. On balance it is more probable that the foundation course of the wall is of composite opportunistic construction with the yellow brick being the contemporary building material.

Figure 4a: Shot of square drainage trench from the southeast showing (008) and (010)

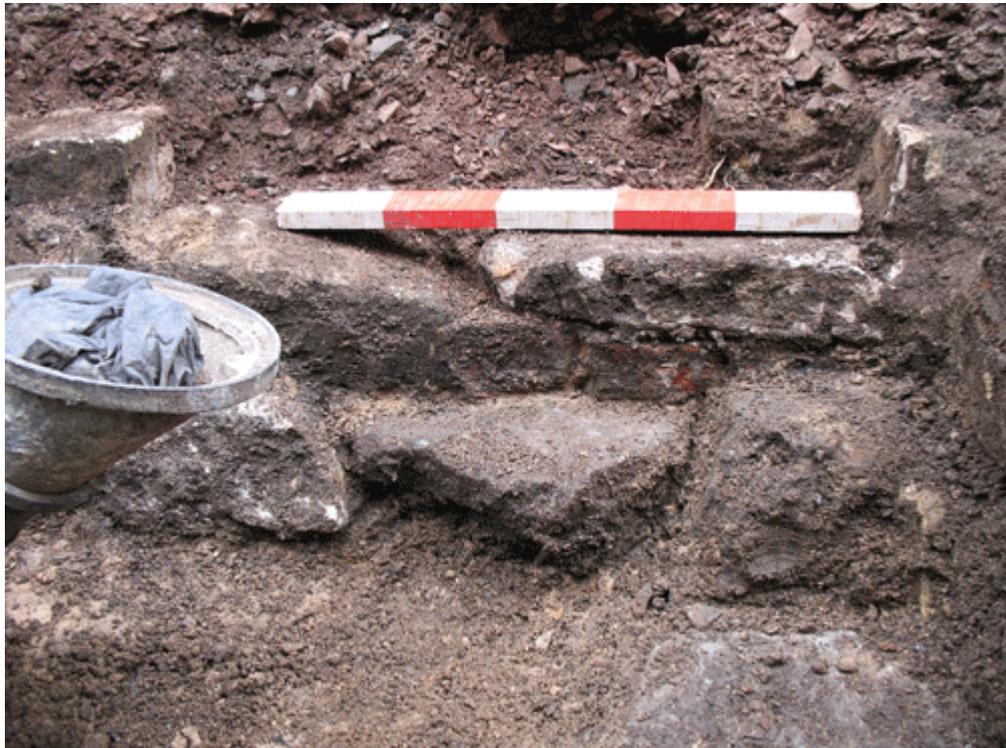
Figure 4b: Feature (010) from the southwest
